Your Ref: 582747
Our Ref : CS/MSG19001334/N

25 January 2019

**TECHNICAL INVESTIGATION REPORT OF FIRE INCIDENT INVOLVING THE
INSURED VEHICLE SFS 2846S ON 16 JANUARY 2019**

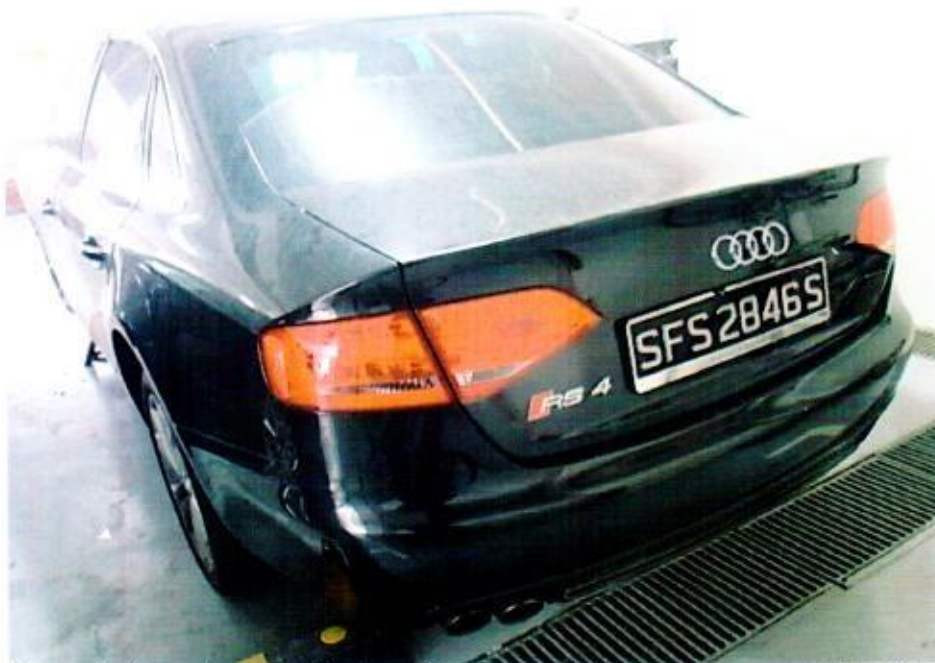
Photo 1 shows the rear left view of the Insured Vehicle. The rear portion of the Insured Vehicle was observed to be relatively unaffected by the fire.

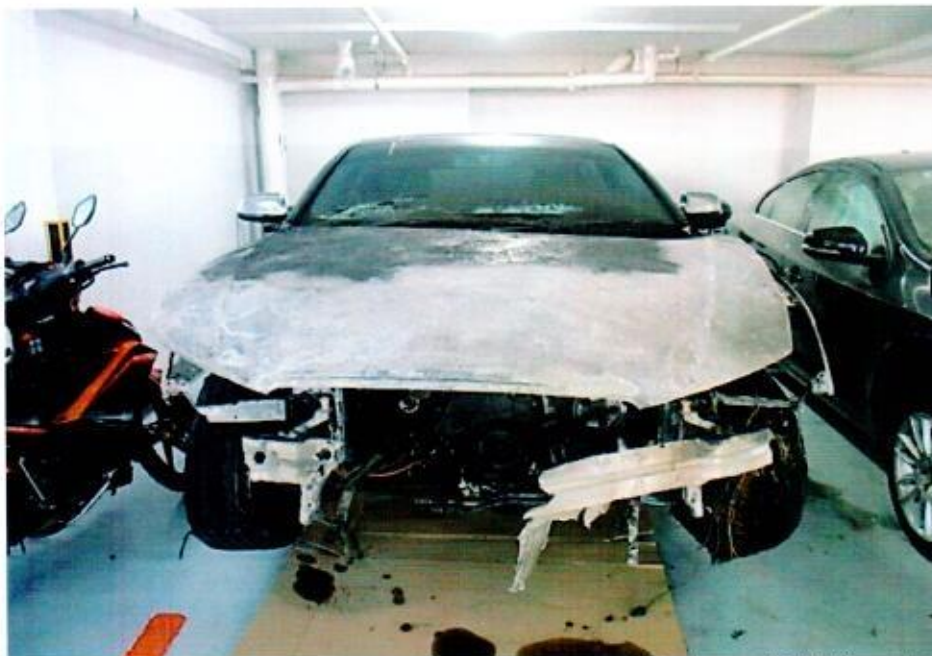
5. The exterior front body of the Insured Vehicle sustained visible fire damage. This included its windscreen, front bonnet, headlights, front bumper, side panels, front rims and front tyres.
6. The fire had resulted in extensive damage to the engine compartment of the Insured Vehicle. Most of the components inside the engine compartment were found to be severely burnt and/or melted as a result of the fire. The interior compartment was observed to have been relatively unaffected by the fire. See photos 1 – 7 below.

Photo 2 shows the general view of the front portion of the Insured Vehicle at the time of our inspection. The exterior body of the Insured Vehicle had sustained visible fire damage. This included its front windscreen, front bonnet, headlights, front bumper, side panels, front rims and front tyres.

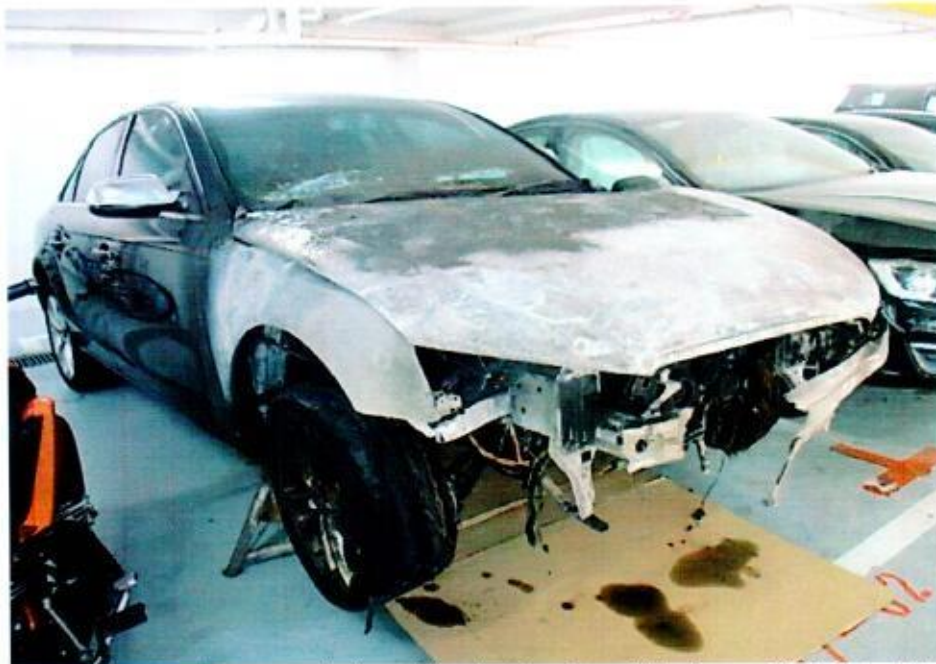
Photo 3 shows the general view of the right portion of the Insured Vehicle at the time of our inspection. The exterior body of the Insured Vehicle had sustained visible fire damage. This included its front windscreen, front bonnet, front bumper, right front panel, right headlight, right front rim and right front tyre.

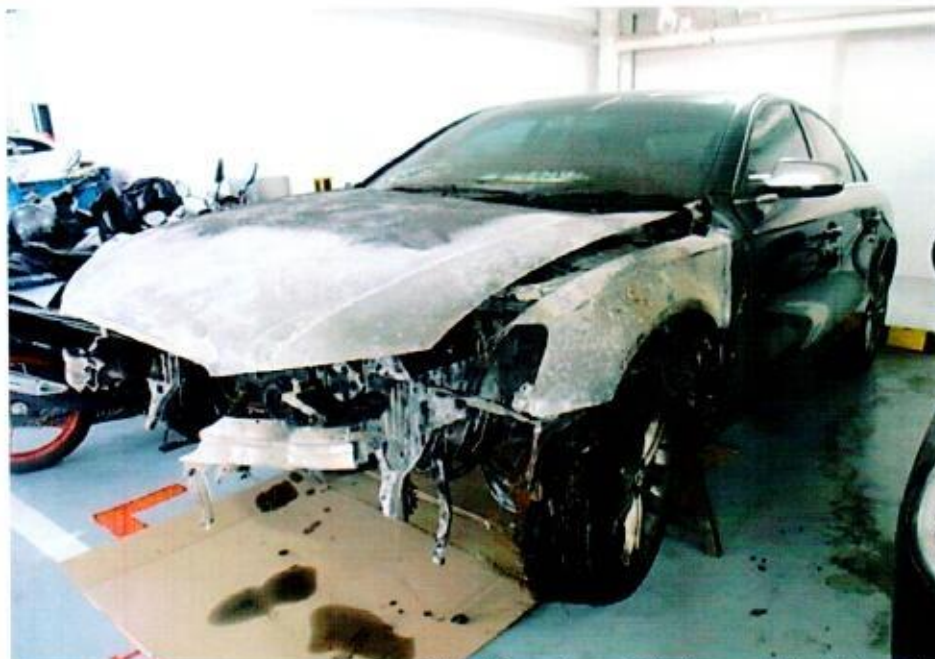
Photo 4 shows the general view of the left portion of the Insured Vehicle at the time of our inspection. The exterior body of the Insured Vehicle had sustained visible fire damage. This included its front windscreen, front bonnet, left headlight, front bumper, left front panel, left front rim and left front tyre.

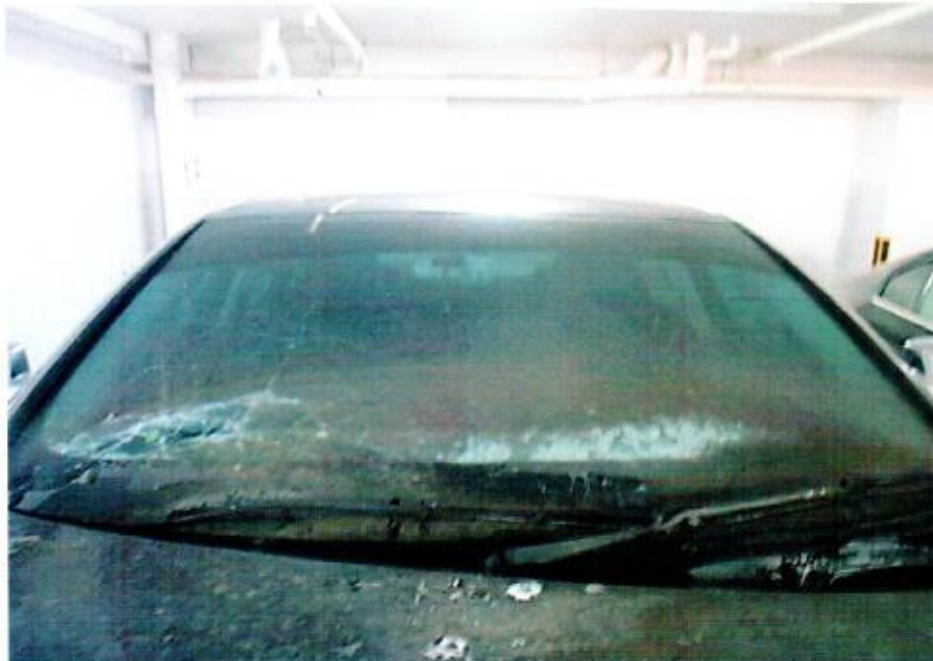
Photo 5 shows a closer view of the front windscreen of the Insured Vehicle at the time of our inspection. The front windscreen had sustained serious fire damage.

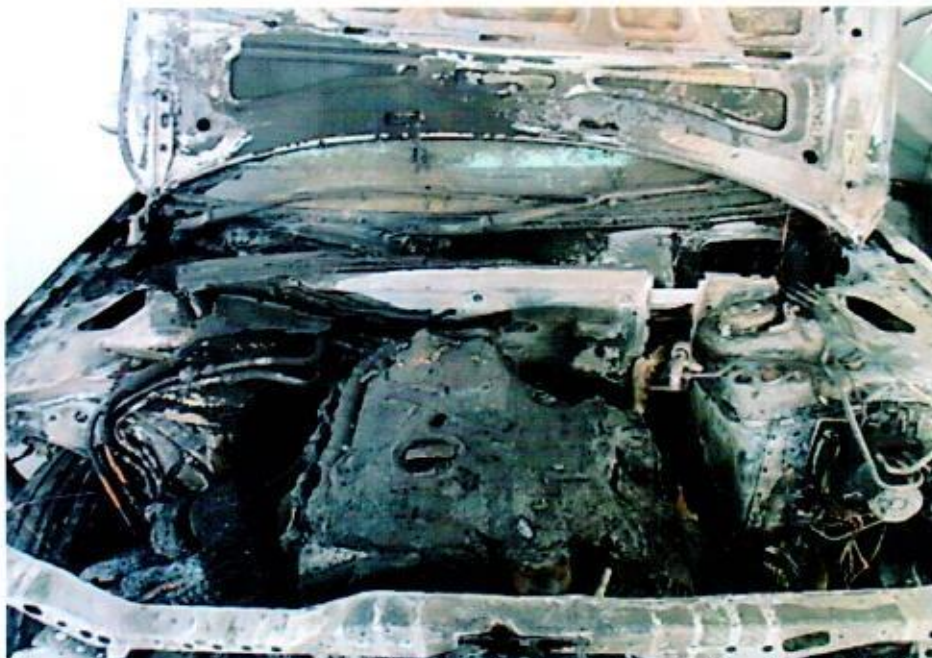
Photo 6 shows a general view of the engine compartment of the Insured Vehicle at the time of our inspection. Most of the components inside the engine compartment were found to be severely burnt and/or melted as a result of the fire.

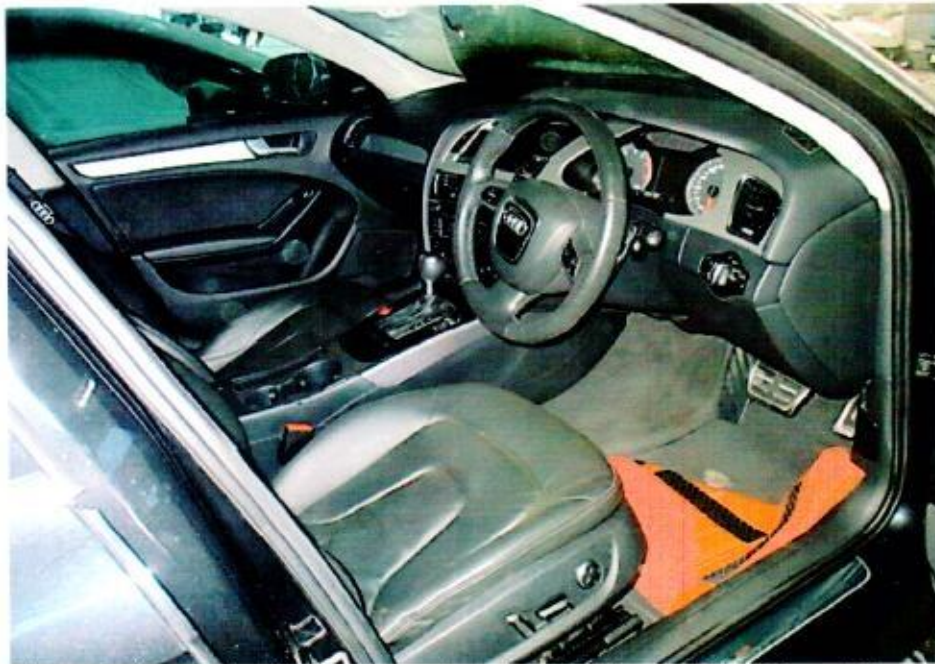
Photo 7 shows the interior compartment of the Insured Vehicle, which was observed to be relatively unaffected by the fire.

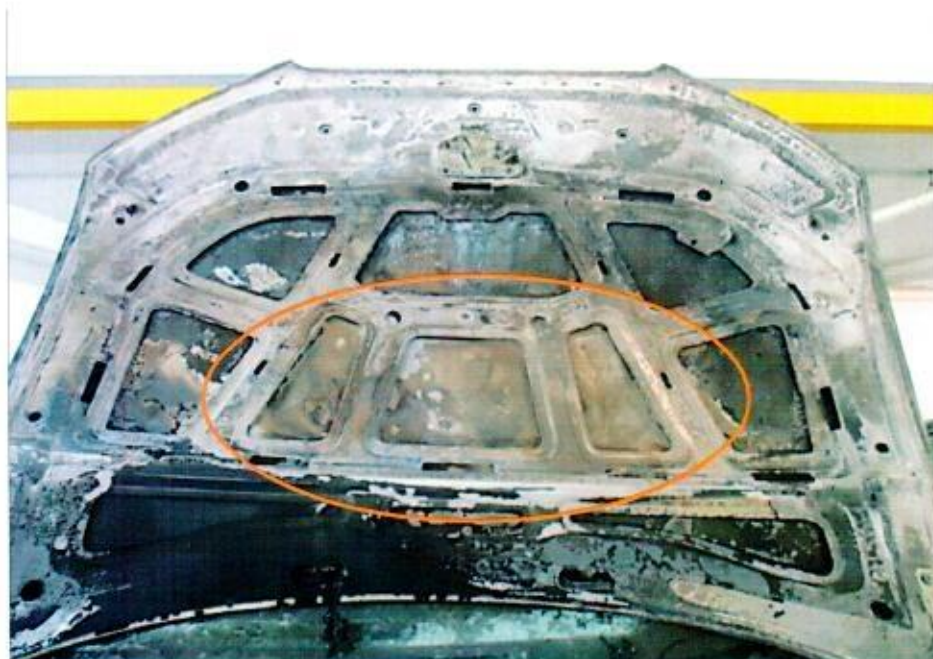
8. For this particular case, the fire appears to have originated within the engine compartment of the Insured Vehicle, somewhere around the rear centre portion of the engine compartment. This can be determined from the burn pattern and the high heat intensity burn marks (whitish burn marks) that had developed on the underside of the front bonnet, at the rear centre portion.

9. The whitish burn marks are a result of exposure to prolonged heat intensity. Rust would normally start to develop around these areas soon after a fire as prolonged exposure to high heat intensity usually causes steel/metal material body parts to be exposed to natural environmental condition. The rust that had developed on the underside of the front bonnet, around the rear centre portion, is an indication that the rear centre portion of the engine compartment had sustained exposure to prolonged high heat intensity. See photo 8 below.

Photo 8 shows the rust that had developed on the underside of the front bonnet, around the rear centre portion (circled). The development of rust is an indication that this area was subjected to prolonged exposure to high heat intensity, which had caused the steel/metal material of the front bonnet to be exposed to natural environmental condition. Hence the fire to the Insured Vehicle can be determined to have originated towards the rear centre portion of the engine compartment.

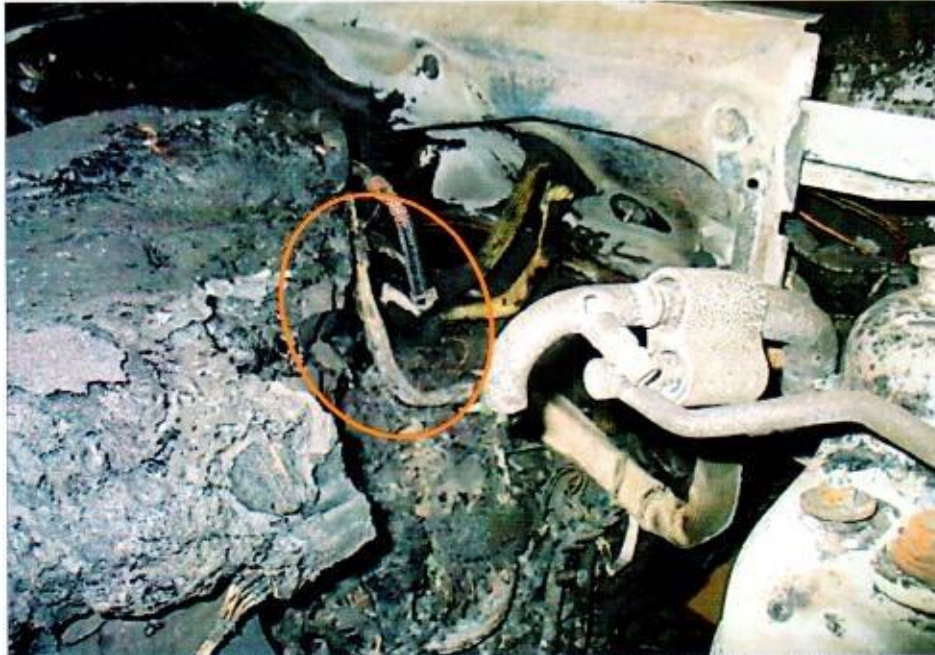
10. Upon closer examination of the rear centre portion of the engine compartment, which was where the fire to the Insured Vehicle had likely started, we had found traces of greenish residue on several stretches of burnt wirings. The presence of greenish residue indicates internal heating of copper wires, a sign of an electrical short circuit occurring. The greenish residue is normally left behind from oxidation as a result of chemical reaction involving the copper wires. This physical evidence would then appear to suggest that the cause of fire to the Insured Vehicle could have possibly been due to electrical in nature. See photos 9 - 12 below.

Photo 9 shows the burnt wirings around the rear centre portion of the engine compartment (circled), which is in the immediate vicinity where the fire to the Insured Vehicle had likely started.

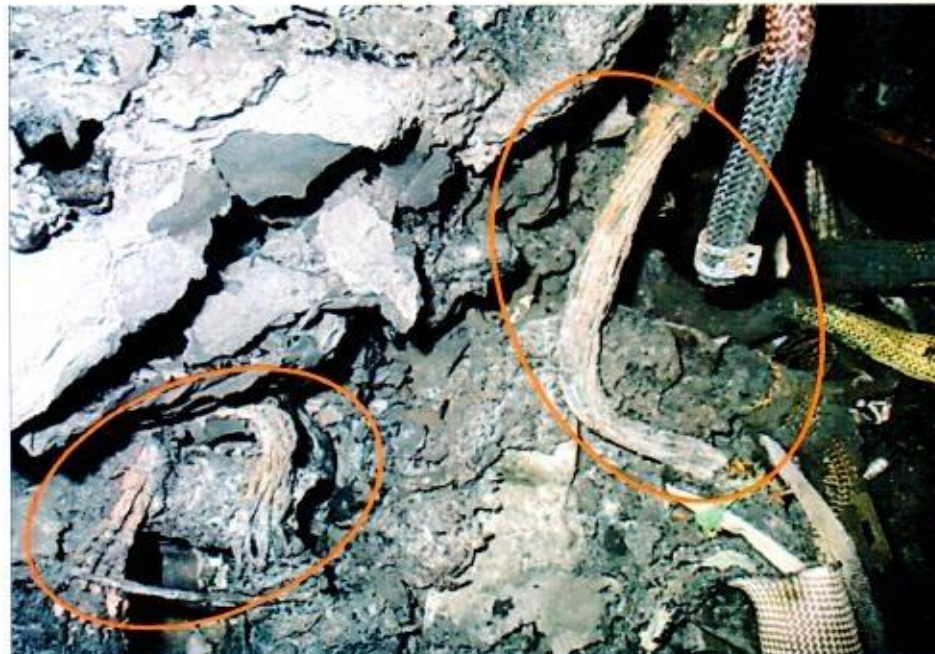
Photo 10 shows a closer view of the burnt wirings around the rear centre portion of the engine compartment, which is in the immediate vicinity where the fire to the Insured Vehicle had likely started. We noticed greenish residue on several stretches of burnt wirings (circled). The presence of greenish residue indicates internal heating of copper wires, a sign of an electrical short circuit occurring. The greenish residue is normally left behind from oxidation as a result of chemical reaction involving the copper wires.

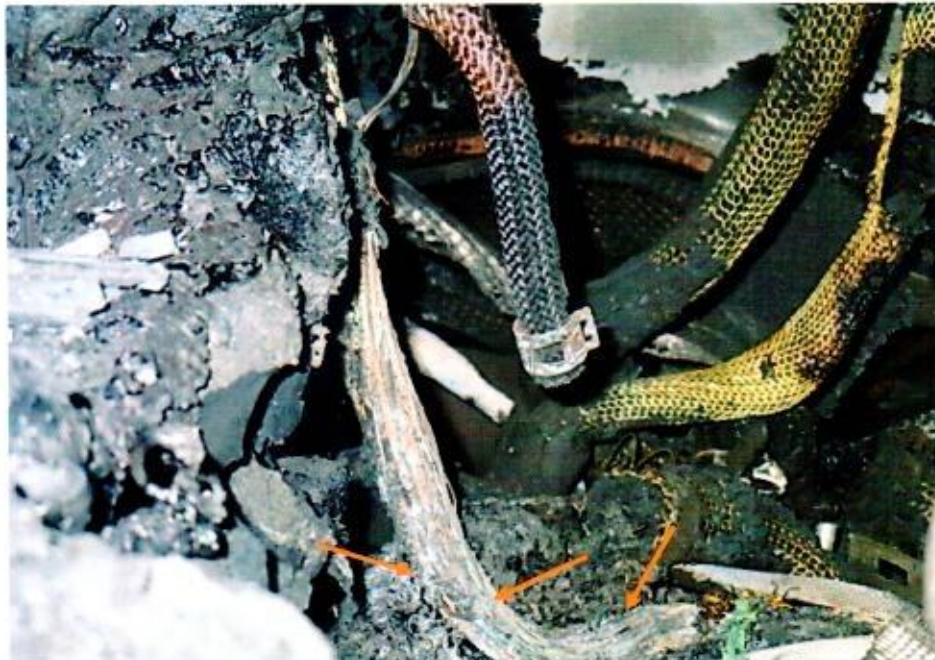
Photo 11 shows a close up view of the greenish residue found on several stretches of burnt wirings (red arrows). The presence of such greenish residue suggests occurrence of an electrical short circuit.

26. The possibility of the fire being due to electrical in nature would then seem more likely given that engine overheating and external factors would both seem unlikely. The fire being due to electrical nature is also supported by the condition of the wirings that were found in the engine compartment of the Insured Vehicle, which was earlier discussed in paragraph 10 above.

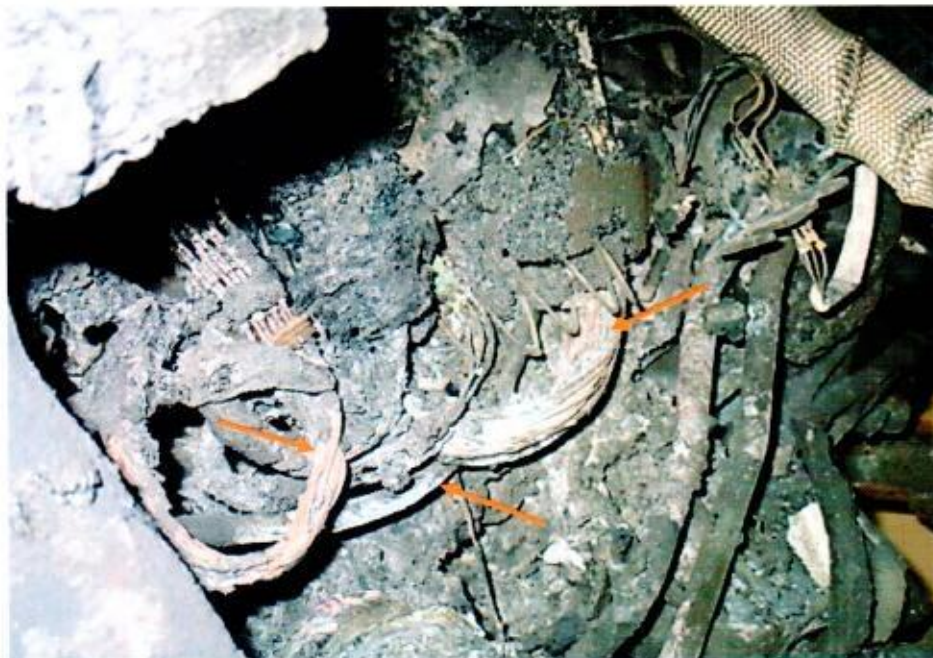
Photo 12 shows a close up view of the greenish residue found on several stretches of burnt wirings (red arrows). The presence of such greenish residue suggests occurrence of an electrical short circuit.

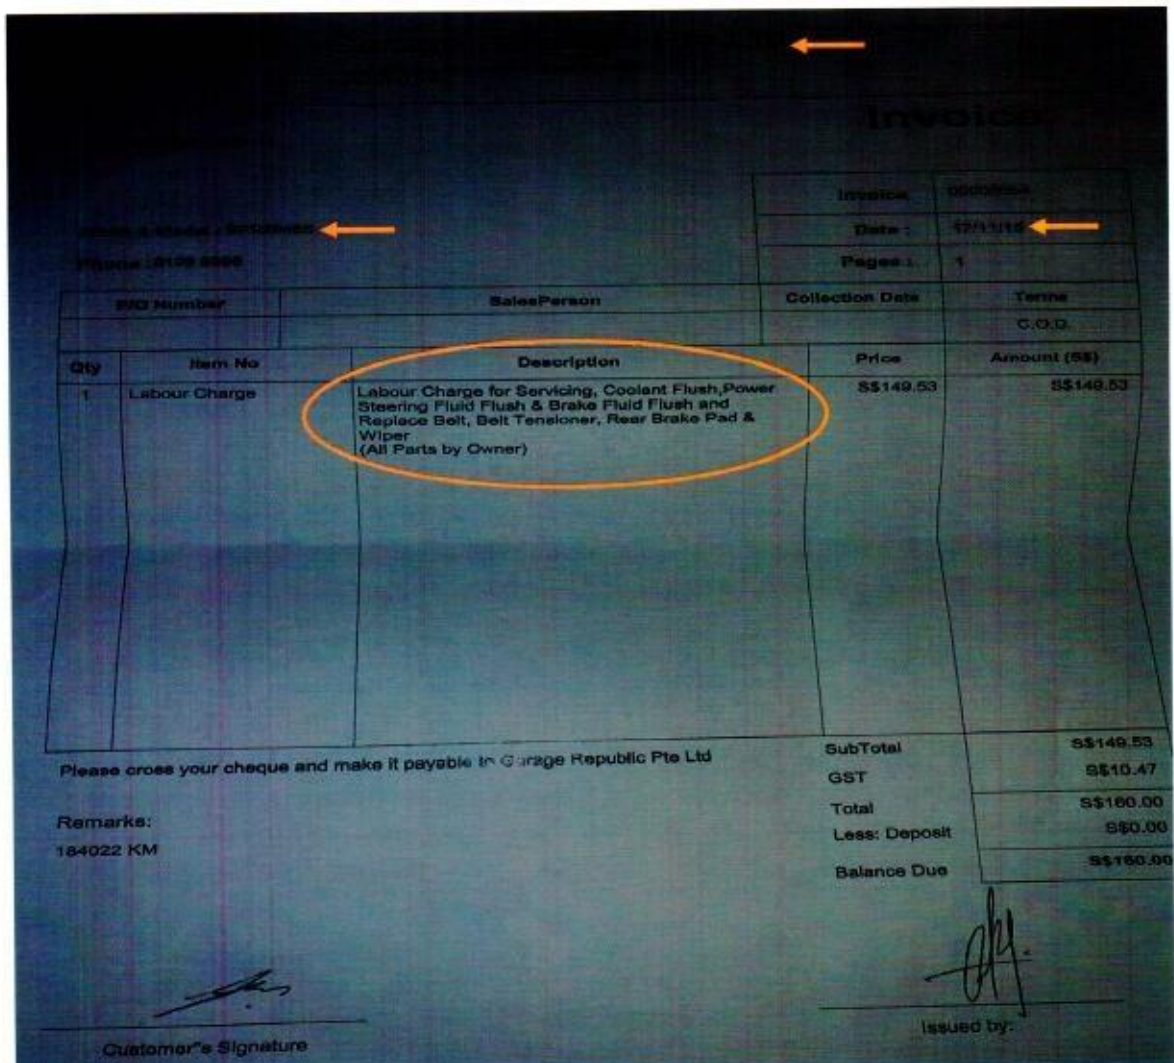
Invoice 1 shows the last servicing done on the Insured Vehicle on 12 November 2018 (red arrows). The servicing package included changing of engine oil, oil filter, belt, belt tensioner, rear brake pads and wiper. The radiator coolant, power steering fluid and brake fluid were also flushed (circled).

23. Based on the vehicle service record invoice provided, we are of the opinion that it is unlikely that the fire could have been caused by poor maintenance of the Insured Vehicle.
24. Given the circumstances of the incident as reported, the possibility of the cause of fire to the Insured Vehicle being due to engine overheating would seem unlikely as Mr Koh had mentioned to us there were no indications of abnormally high temperatures on the Insured Vehicle when he was driving on that day.

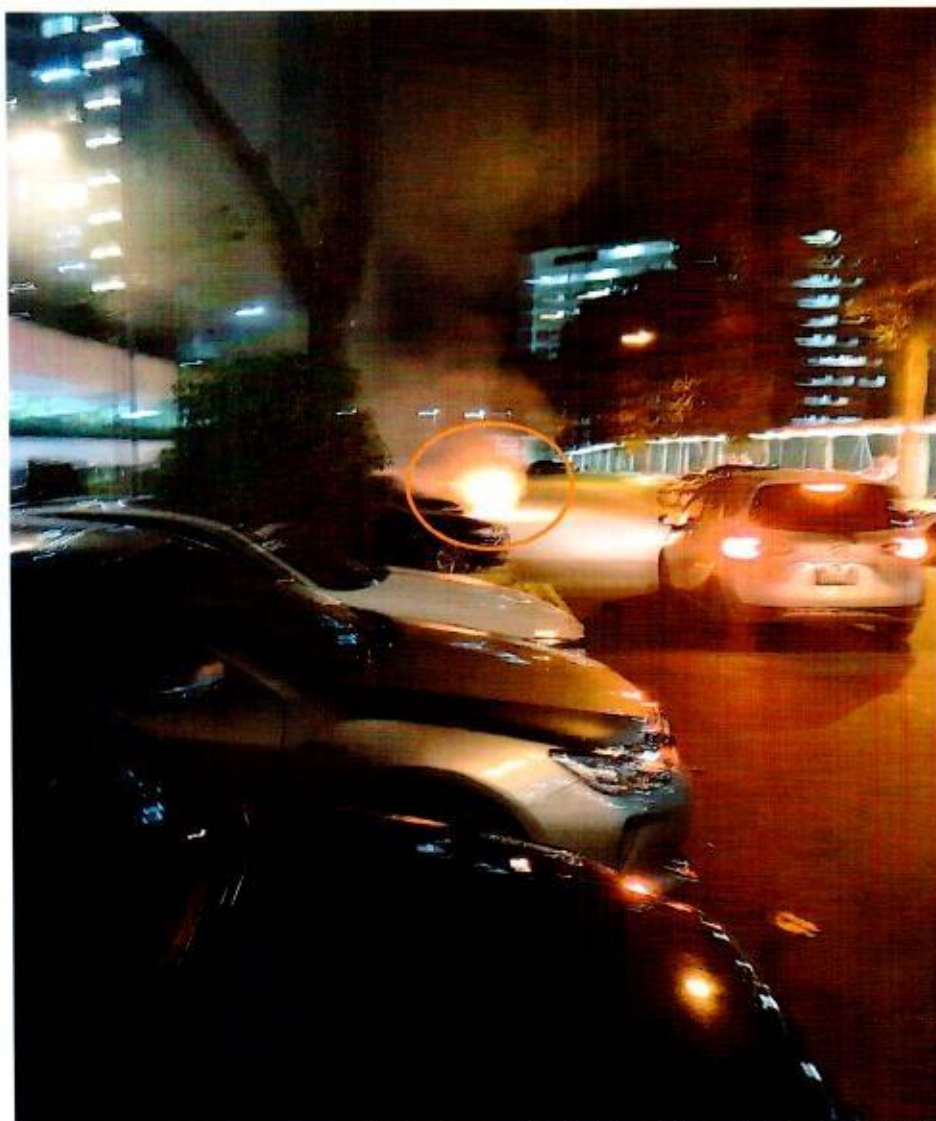
Photo 13 shows the Insured Vehicle on fire before the arrival of the SCDF (circled).

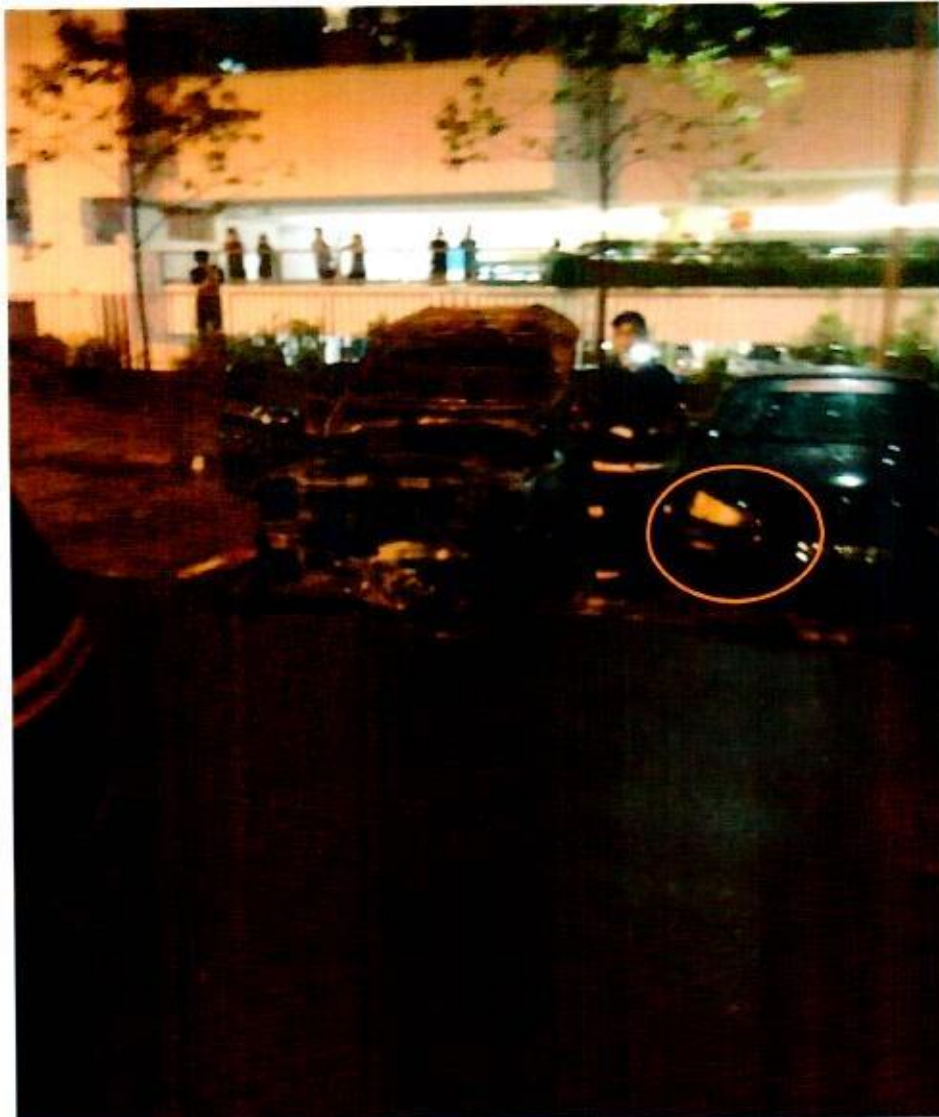
Photo 14 shows the SCDF having just put out the fire on the Insured Vehicle. The Volkswagen Scirroco parked on the left side of the Insured Vehicle had sustained damage of heat nature at its right front side (circled).

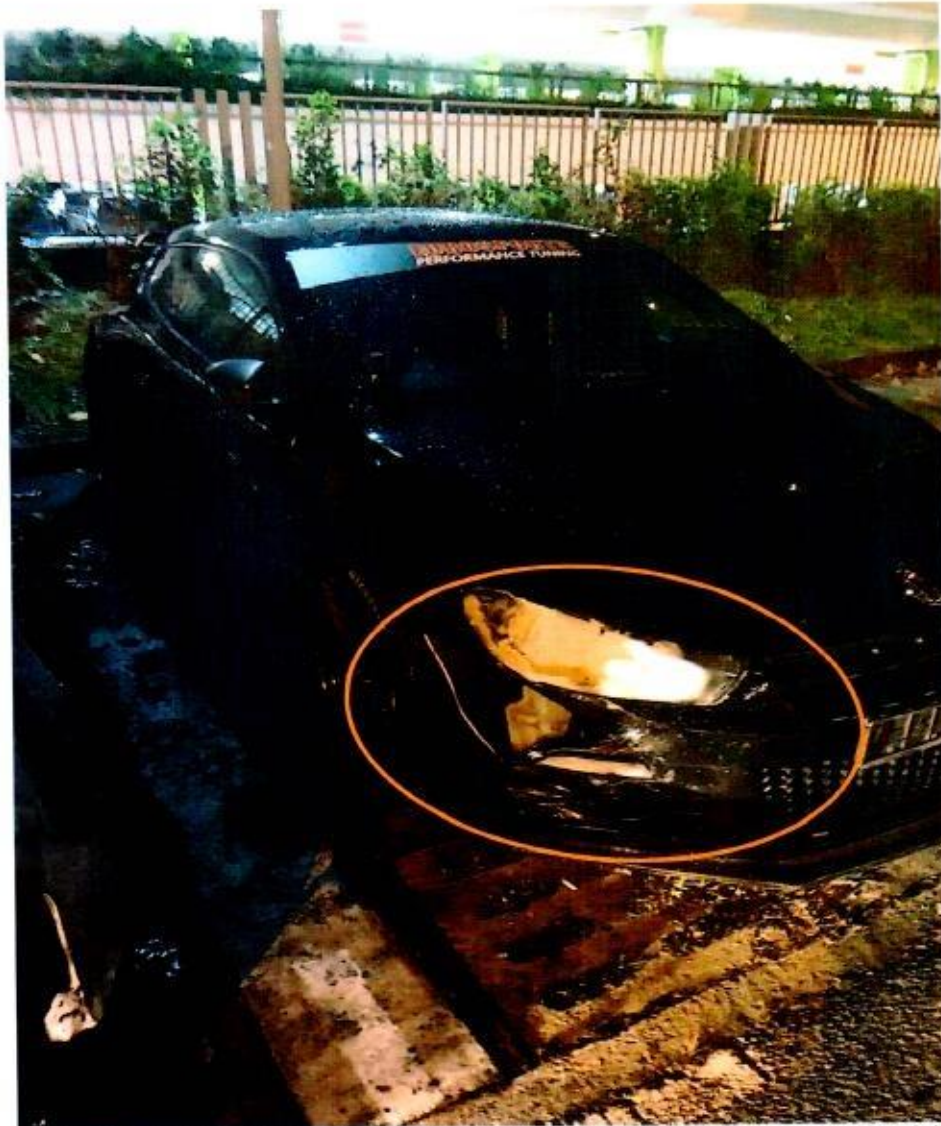
Photo 15 shows a closer view of the damage of heat nature sustained to the right front portion of the Volkswagen Scirocco which was parked on the left side of the Insured Vehicle when the incident occurred (circled).

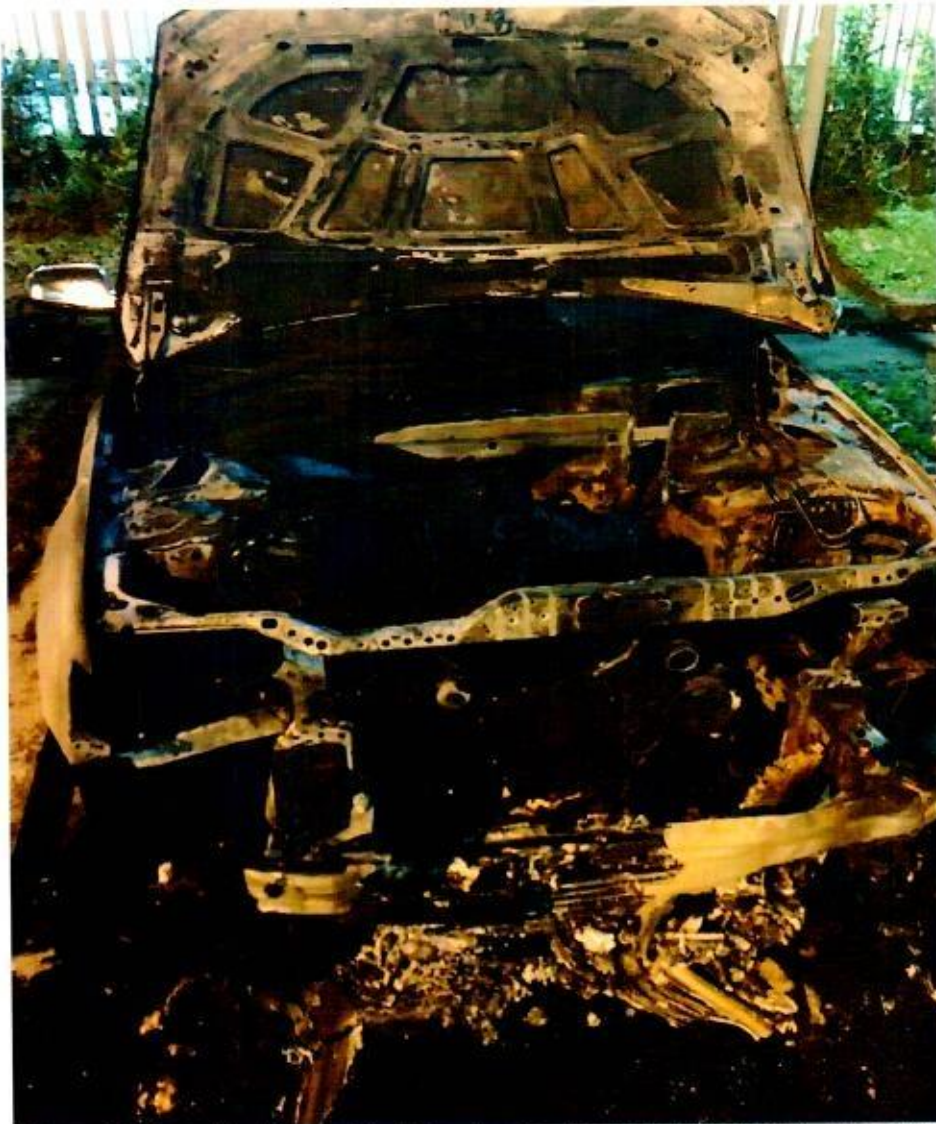
Photo 16 shows the Insured Vehicle after the fire was extinguished. The extent of damage is consistent with Mr Koh's statement in which the fire started from the engine compartment.
