**Preliminary Advice**

| Insured Vehicle No | : SLE3871P | | |
| TP Vehicle No | : SHD3508S | Accident Date | : 21/01/2019 |

## VEHICLE DAMAGE INSPECTION REPORT

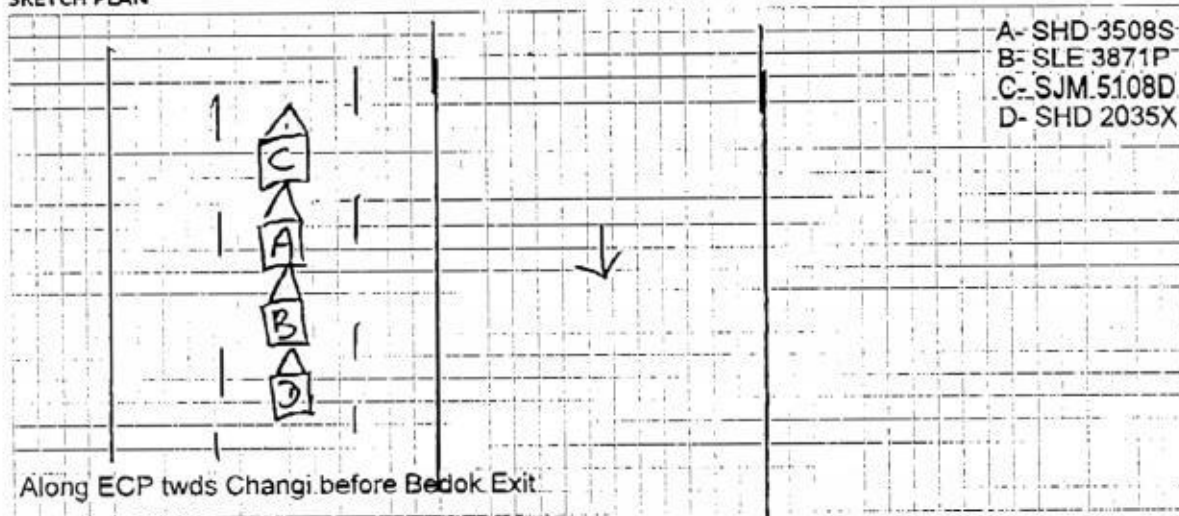
## SKETCH PLAN

A- SHD 3508S  
 B- SLE 3871P  
 C- SJM 5108D  
 D- SHD 2035X

I was travelling straight and suddenly Veh(B) SLE 3871P from my back hit onto my vehicle rear portion and caused my vehicle to surge forward and hit onto veh(C) SJM 5108D.
