Your Ref: VA1/GA105225/1
Our Ref :CS/ASM19001580/Z

31st January 2019

**TECHNICAL INVESTIGATION REPORT OF FIRE INCIDENT INVOLVING THE
INSURED VEHICLE SGG 7507P ON 21st January 2019**

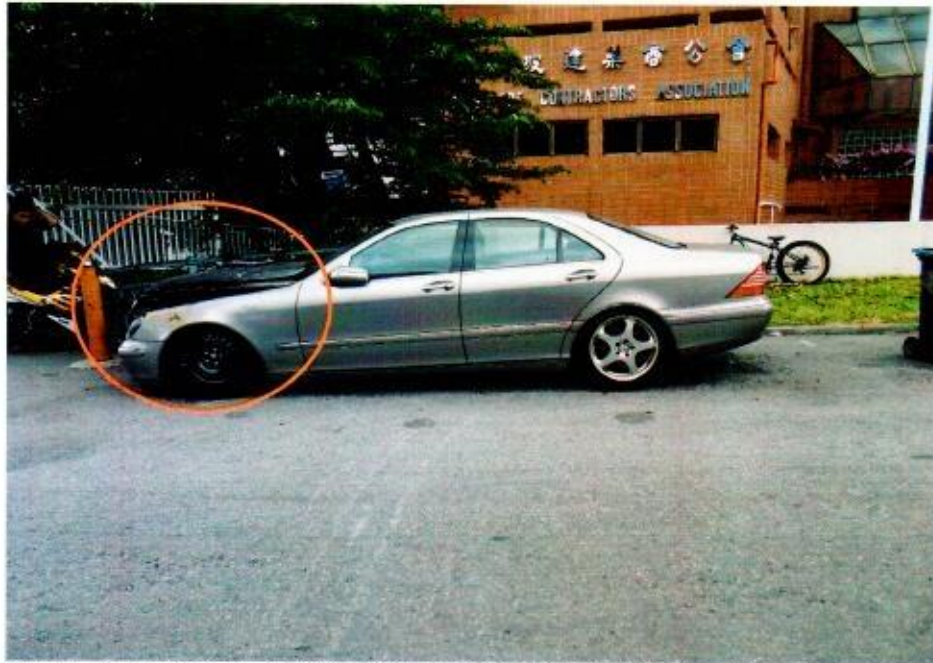
Vehicle Registration No.	: SGG 7507P
Make / Model	: Mercedes-Benz
Chassis No	: WDB22000632A480740
Year of Registration	: 2006 (May)
Mileage	: N.A (Electronic System Damage)
5. The Insured Vehicle was noted to have sustained fire damages to its front portion. The entire engine compartment of the Insured Vehicle was observed to be severely burnt by the fire.
6. The fire had resulted in the body parts at the front portion of the Insured Vehicle to be burnt. This had included its front bonnet and several parts of the engine components especially at the front left of the engine. Except for the exterior rear, interior, exterior rear left & exterior rear right portion was not affected by the fire. See photo 1 – 4 below.

Photo 1 shows the general view of the Insured Vehicle at the time of our inspection. The fire damage to the Insured Vehicle was confined to its front bonnet and entire engine parts were amongst the body parts that were found to have been affected as a result of the fire.

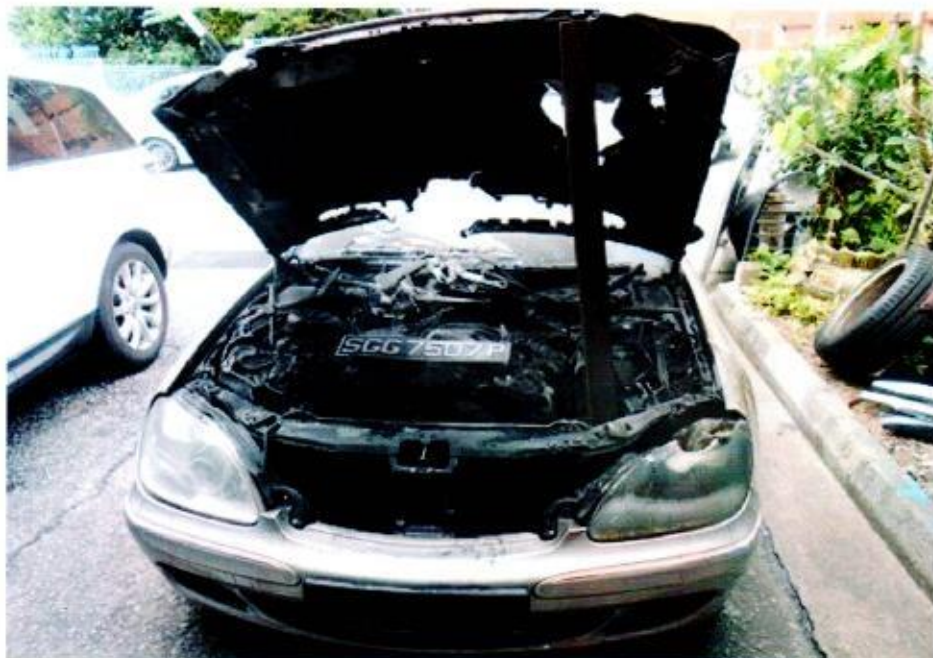
Photo 2 shows the general view of the front centre portion of the Insured Vehicle at the time of our inspection. The fire damage to the Insured Vehicle was confined to its front bonnet and entire engine parts were amongst the body parts that were found to have been affected as a result of the fire.

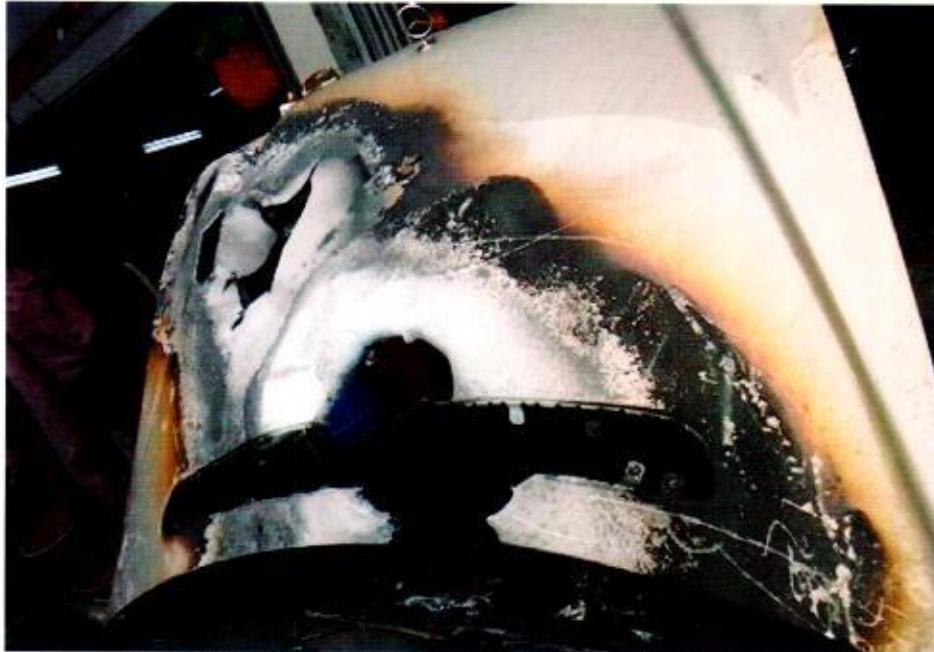
Photo 3 shows the topside bonnet of the Insured Vehicle at the time of our inspection. It was observed to sustain with burnt marks.

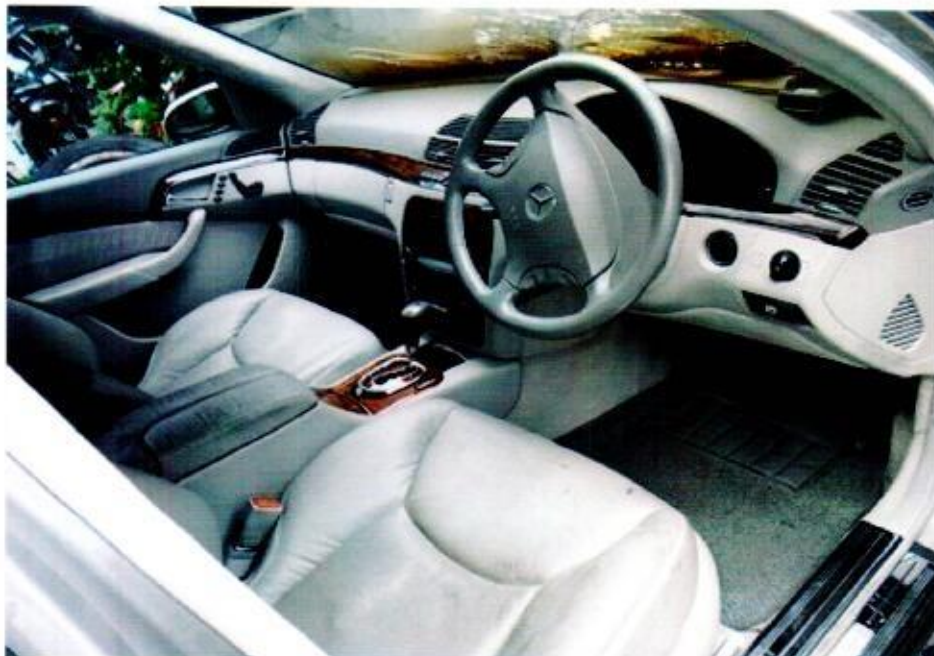
Photo 4 shows the interior compartment of the Insured Vehicle, which was observed to be unaffected by the fire incident.

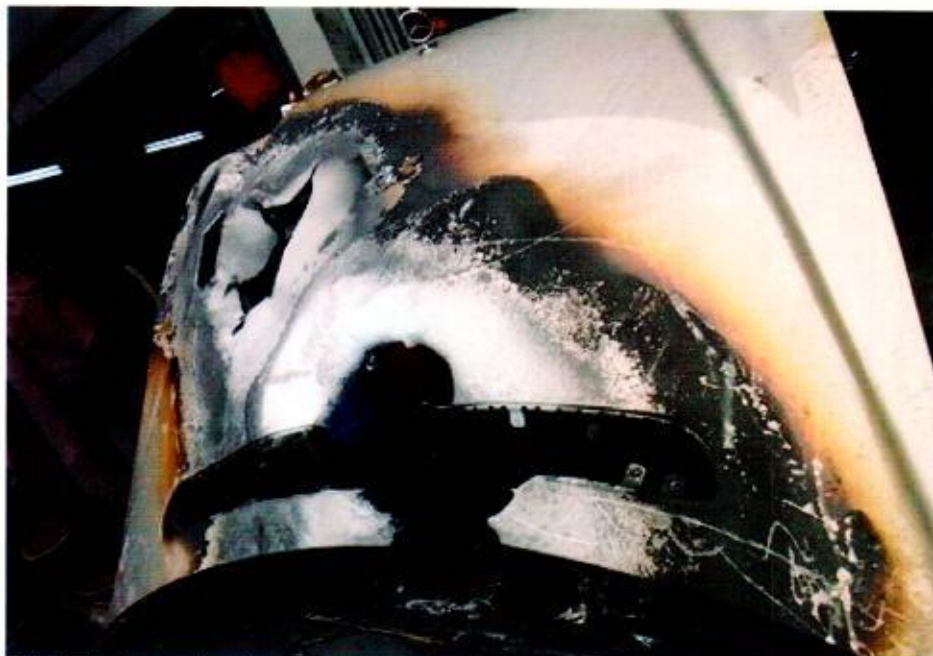
8. For this particular case, the fire appears to have originated within the engine compartment of the Insured Vehicle, somewhere around the front left of the engine compartment. This can be determined from the burn pattern and the high heat intensity burn marks (whitish burn marks) found on the front bonnet of the Insured Vehicle, at both its top and under side.
9. These (whitish) burn marks are a result of exposure to prolong heat intensity. Rust would normally start to develop around these areas soon after a fire as prolonged exposure to high heat intensity usually causes steel/metal material body parts to be exposed to natural environmental condition. See photo 5 below.

Photo 5 shows the burn pattern and whitish burn marks that were found on the topside of the front bonnet of the Insured Vehicle. Such whitish burn marks are a result of exposure to prolong heat intensity, which may indicate where the fire had started. Rust would also begin to develop on these areas soon after the fire.

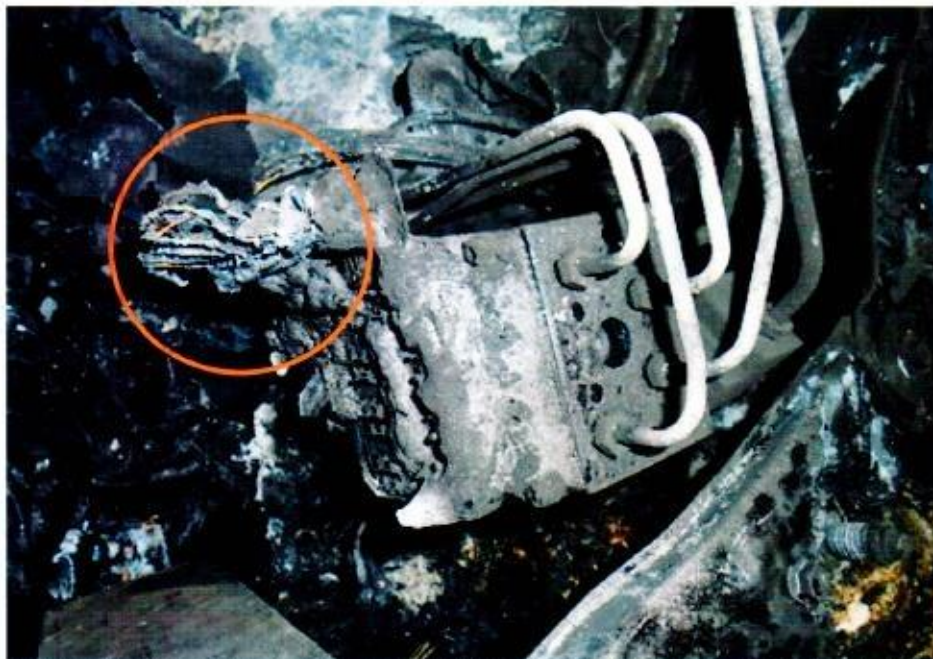
10. Upon closer examination of the area around the front left of the engine compartment, which was in the immediate vicinity of where the fire to the Insured Vehicle had likely started, we had found several stretches of wiring burnt internally to its bare copper state. There's also traces of greenish residue as evidence to show that such condition normally indicate internal heating of copper wires which is a sign of an electrical short circuit occurring. This would then appear to suggest that the cause of fire to the Insured Vehicle could have possibly been due to electrical in nature. See photo 6 & 7 below.

Photo 6 shows a closer view of the ABS motor pump wirings around the front left of the engine compartment, which was in the immediate vicinity where the fire to the Insured Vehicle had likely started.

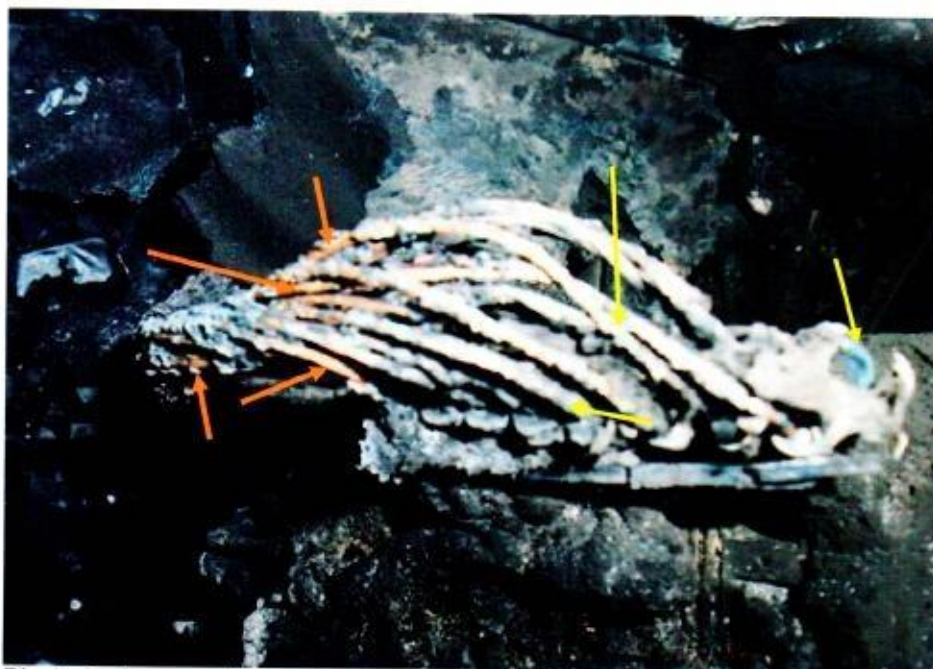
Photo 7 shows a closer view of the ABS motor pump wirings (red arrow) which were found to have been burnt internally to its bare copper state, suggesting occurrence of an electrical short circuit. These wirings were observed to be greenish (yellow arrow) believe to be the focal point of the fire ignition.

29. Basing on the situation, the engine of the Insured Vehicle was still running at the material time of incident, therefore electrical current were flowing within the electrical system for operational purposes. Several electrical and/or electronic components on the Insured Vehicle would require current to remain in operation and/or in idling mode. This would also include ABS (Anti-Locking Braking System) would require electrical power to perform its operations. As we found evidence on the ABS wiring which leave a greenish residue as a result of short circuit on the electrical wiring.

32. Having investigated and technically analysed the damages of burnt nature to the Insured Vehicle, We are of the view that the cause of fire to the Insured Vehicle was of electrical in nature. For this particular case, the fire had originated along the wiring inside the engine compartment, somewhere around the ABS motor pump section of the engine. The wirings were likely to be from the original manufacturer's installation wire harness.

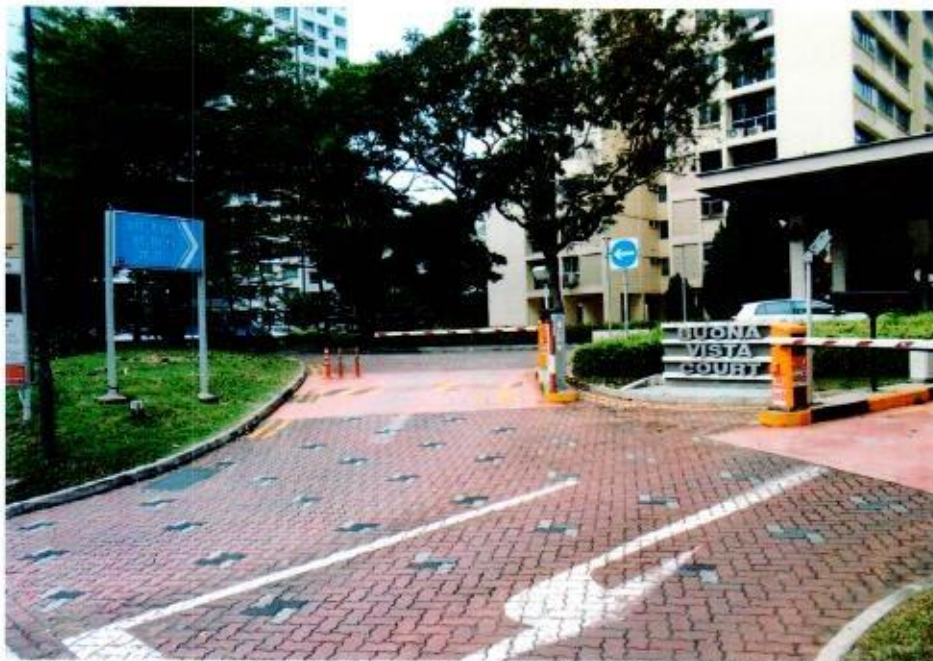
Photo 8 shows the general view of Blk 20 Holland Drive where the open carpark was located opposite this HDB block.

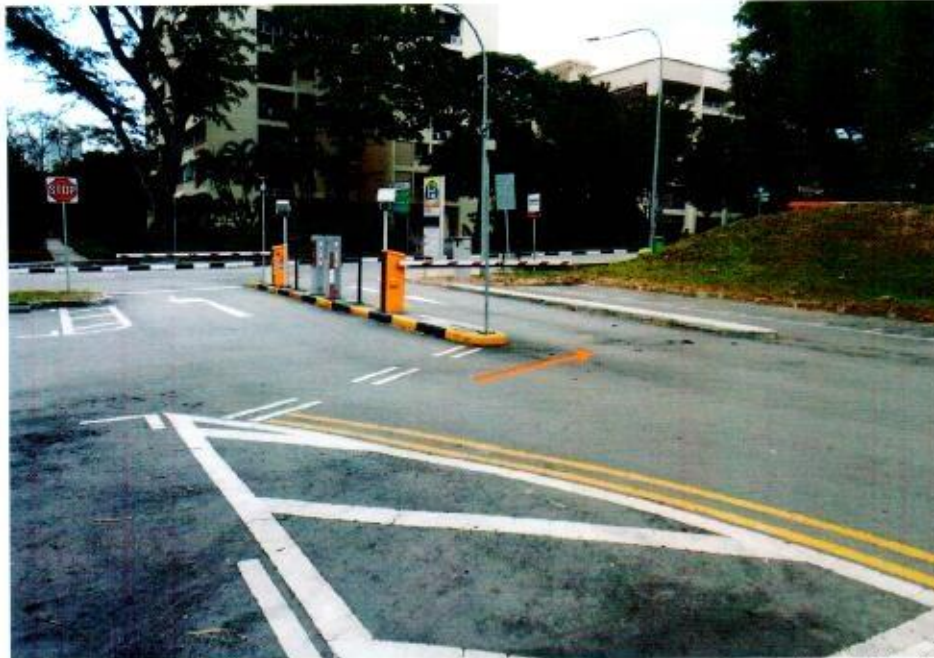
24. When driving into the open car-park driveway of Holland Drive opposite Blk 20 open carpark, the fire incident took place right after the entrance of the barrier. At the time of the fire incident, the Insured Vehicle engine was stalled right after the entrance barrier. Further observations on the ground, we found burnt marks/ burnt residual on the tar road surface. This reveals that there's evidence that fire incident happen at the said spot. See photo 8 – 11 below.

Photo 9 shows the general view of the carpark entrance opposite of Blk 20 Holland Drive. Arrow shows where the Insured Vehicle last position before it caught fire.

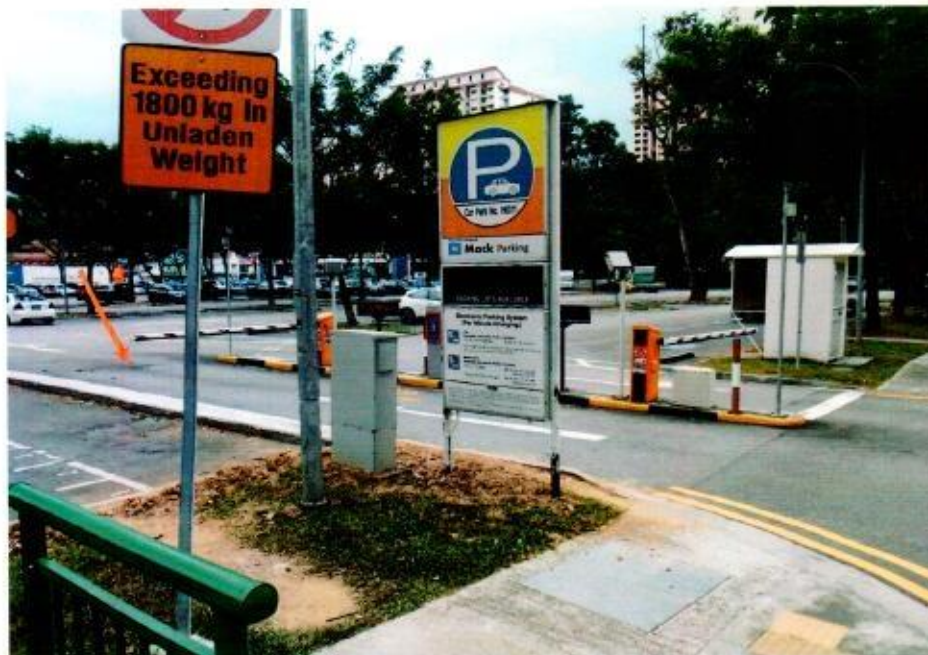
Photo 10 shows the general view of the carpark entrance opposite of Blk 20 Holland Drive. Arrow shows where the Insured Vehicle last position before it caught fire.

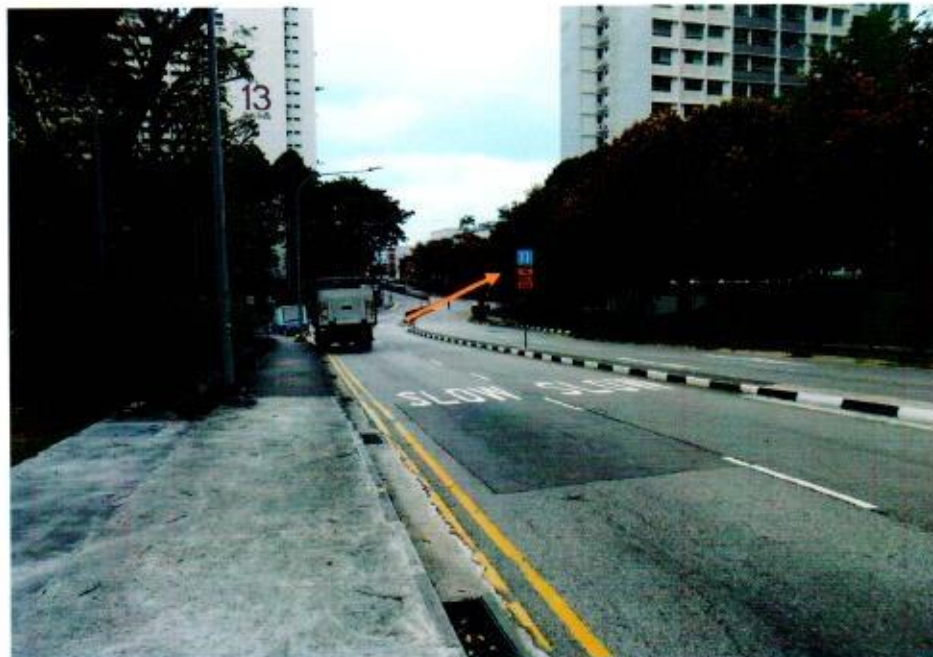
Photo 11 shows the general view of the road that she uses for make a U-turn to enter back into the carpark prior the fire incident.

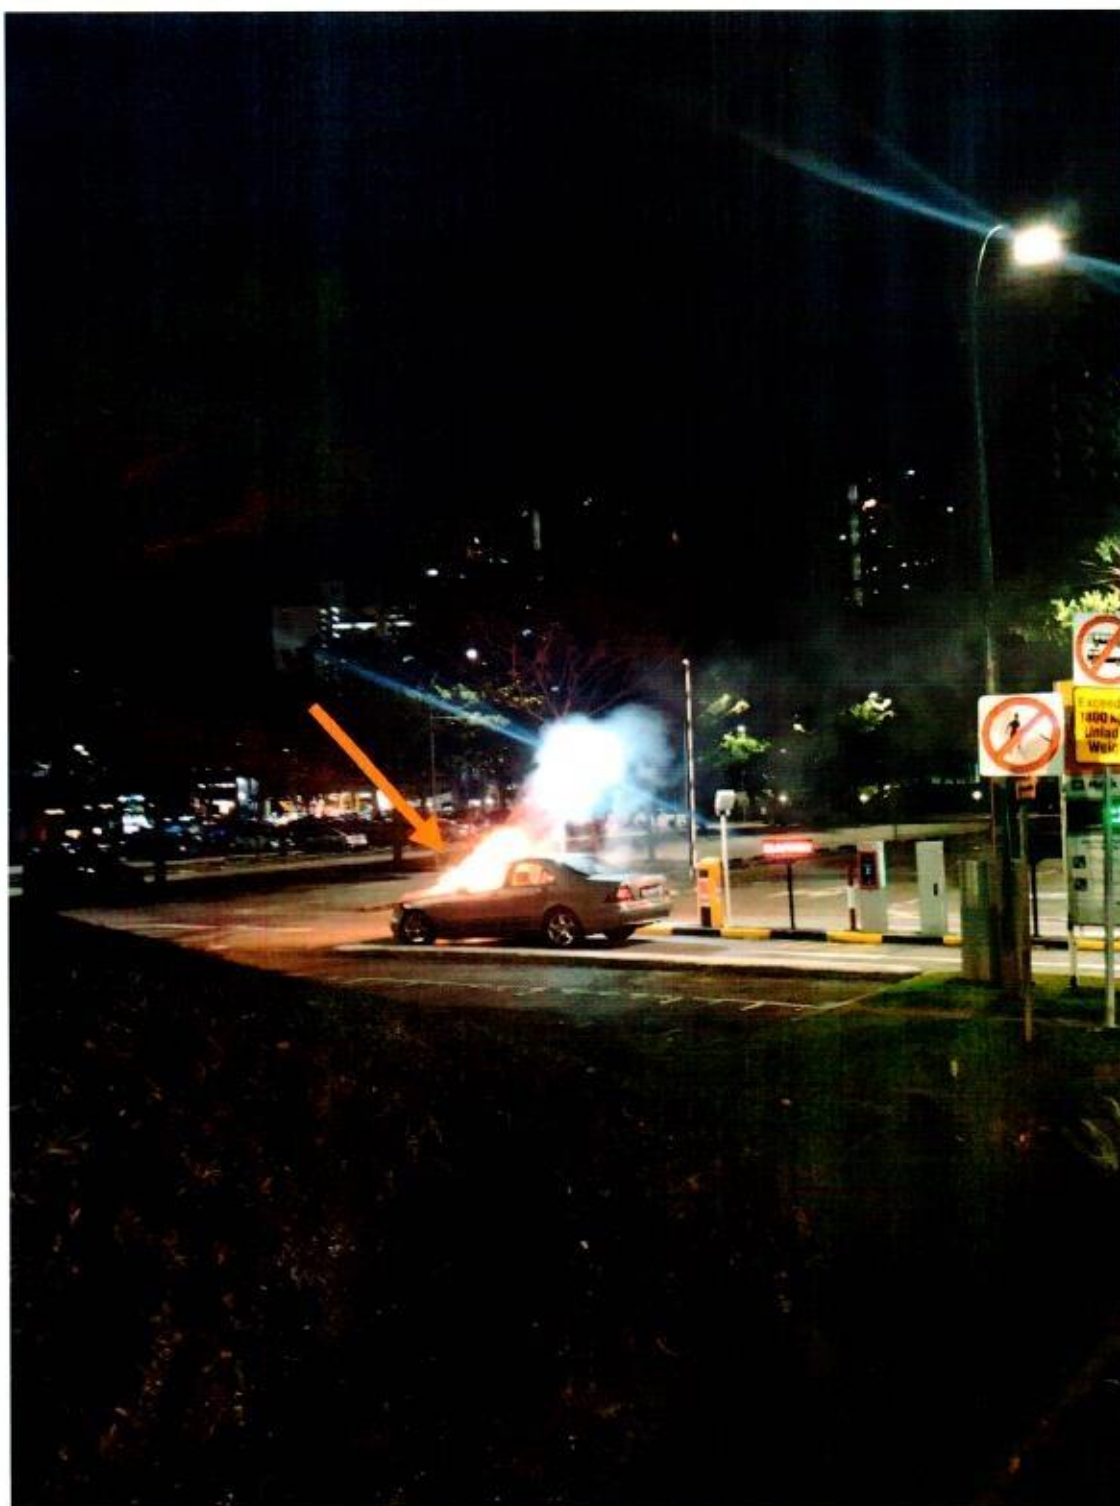
Photo 12 shows the Insured Vehicle at the fire incident scene. There appears to be no abnormal foreign material(s) and/or object(s) found on the ground in the immediate area where the Insured Vehicle was located. In general, the information that could be gathered from these photographs had corresponded to the events that were related to us by Ms Ivy.

28. The possibility of the fire being due to external factor (foreign material(s) stuck on hot surfaces, arson and sabotage amongst others) would also seem unlikely given that our examination of the available incident scene photographs did not reveal any unusual material(s)/object(s) found on the ground near where the Insured Vehicle was parked.
