Your Ref: TP/IP/60191/2018
Our Ref : CI/TPD18022477/Z

30th January 2019

MECHANICAL INSPECTION REPORT OF MOTOR CAR SJH 4642K

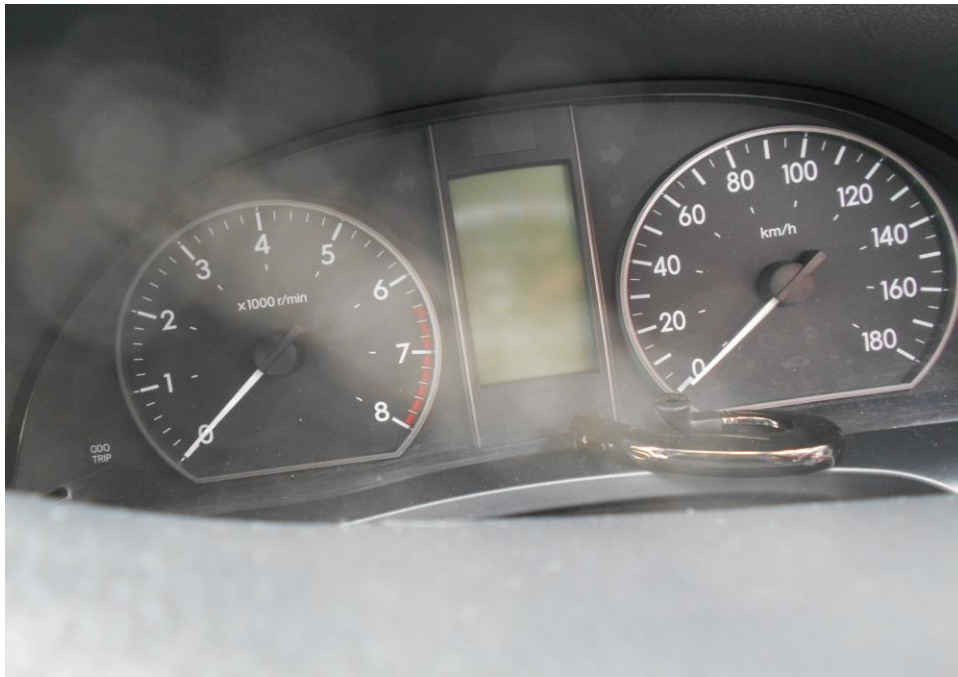
4. The mileage of the Motor Car at the time of our inspection was not recorded due to the extensive damages which affects the ignition system of the Motor Car as a result of the accident.

Photo 1 shows the mileage of the Motor Car at the time of our inspection was not recorded due to the extensive damage which affects the ignition system of the Motor Car as a result of the accident

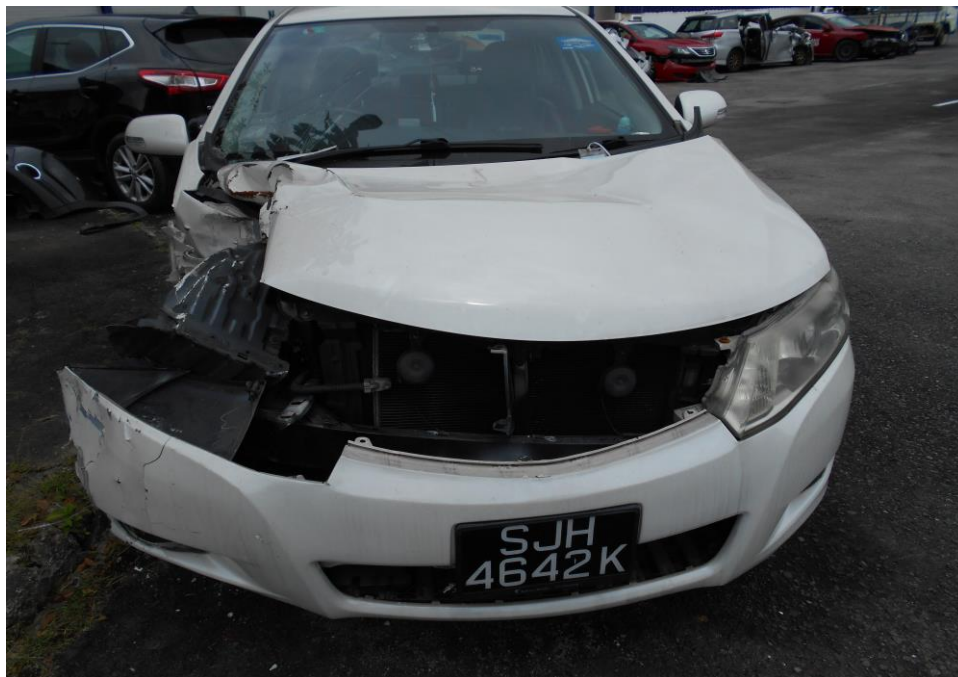
5. The Motor Car had sustained a relatively extensive impact damages that was confined to its frontal right & left portion. Its front right headlamp was observed to have been crushed; its front right lower bumper was observed to be pushed inwards; its front bonnet was observed to be buckled; its windshield was noted to be cracked; buckle right side fender; its radiator, air intake & its left front re-inforcement bar was observed to be damaged amongst others.

Photo 2 shows a general view of the front body of the Motor Car at the time of our inspection. The Motor Car was observed to have sustained extensive damages at the front right portion.

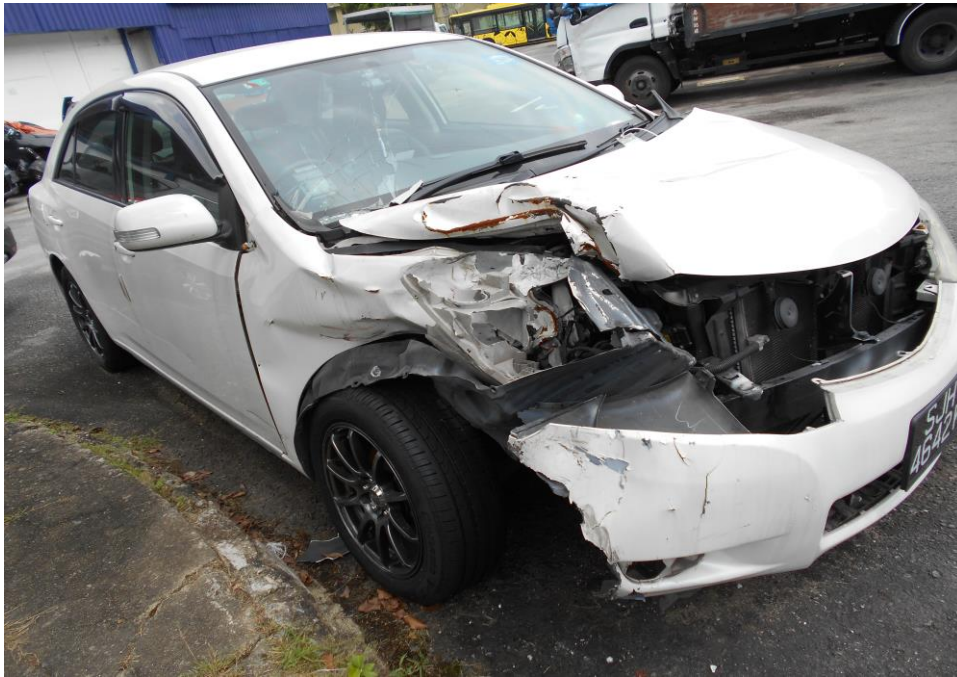
Photo 3 shows a general view of the right front body of the Motor Car at the time of our inspection. The Motor Car was observed to have sustained extensive damages at the front right portion.

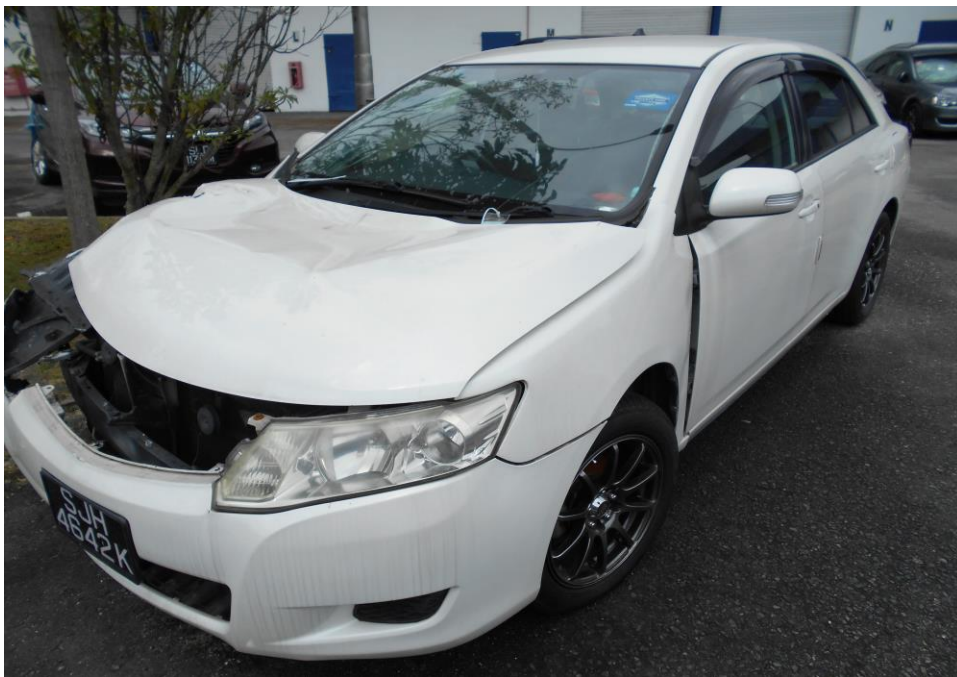
Photo 4 shows a general view of the front left body of the Motor Car at the time of our inspection. The Motor Car was observed to have sustained minor damages at the left frontal portion.

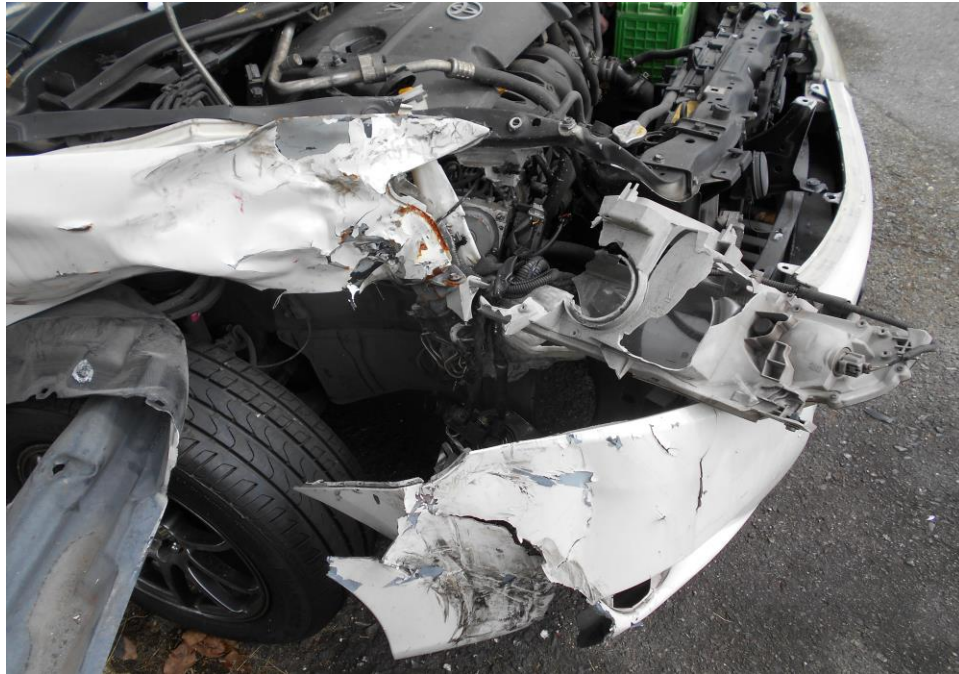
Photo 5 shows a close up view of the front right headlamp of the Motor Car at the time of our inspection. It had sustained damages likely due to the accident.

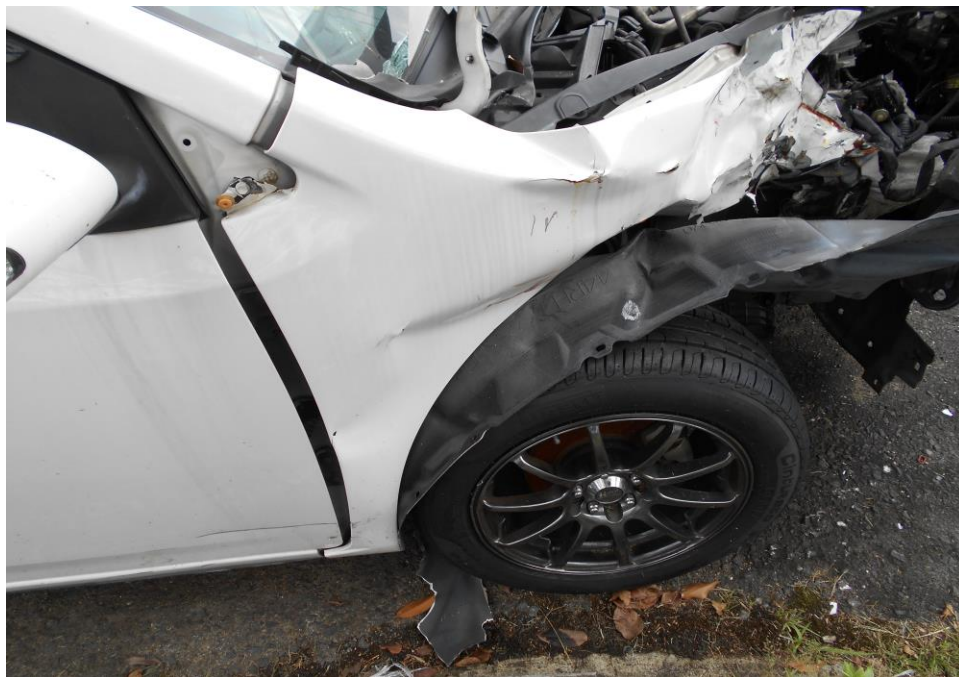
Photo 6 shows a close up view of the right side fender of the Motor Car at the time of our inspection. It had sustained damages likely due to the accident.

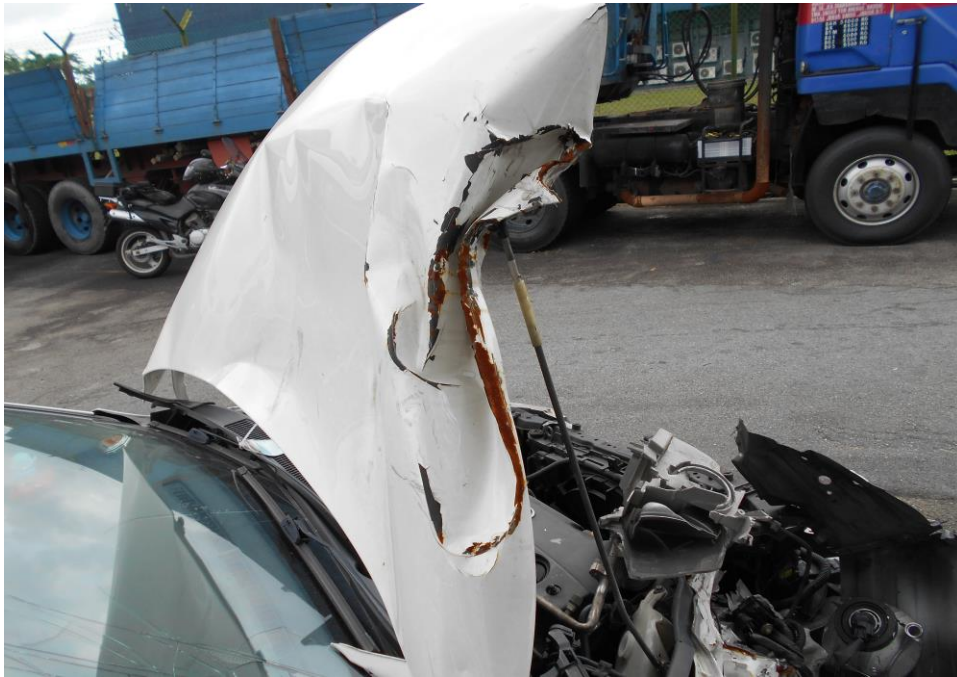
Photo 7 shows a close up view of the front bonnet of the Motor Car at the time of our inspection. It had sustained damages at the right front bonnet of the Motor Car.

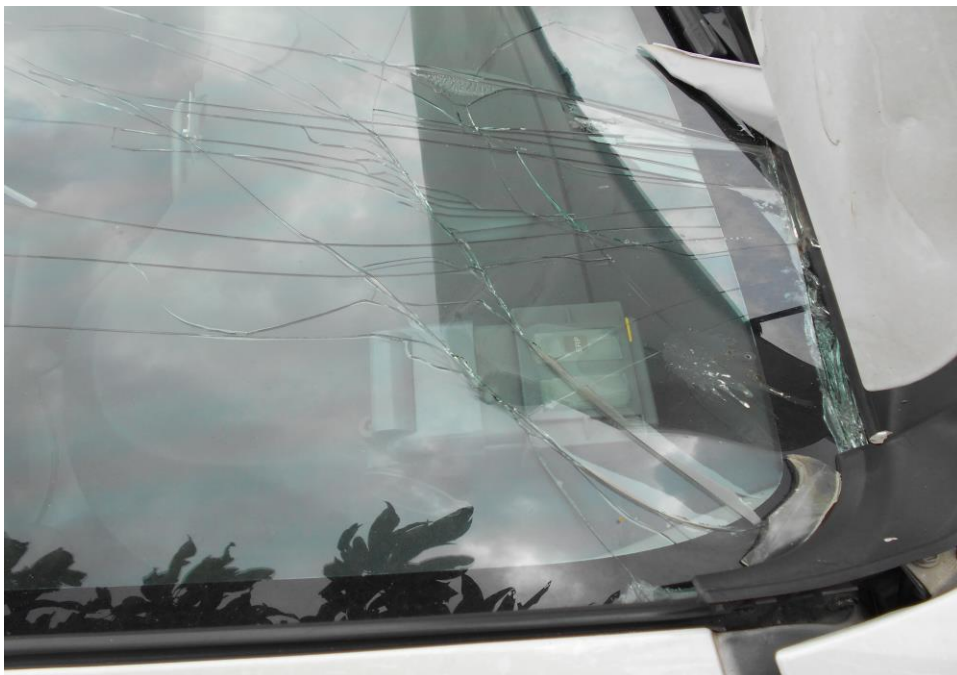
Photo 8 shows a close up view of the shattering cracked of the Motor Car's windshield at the time of our inspection.

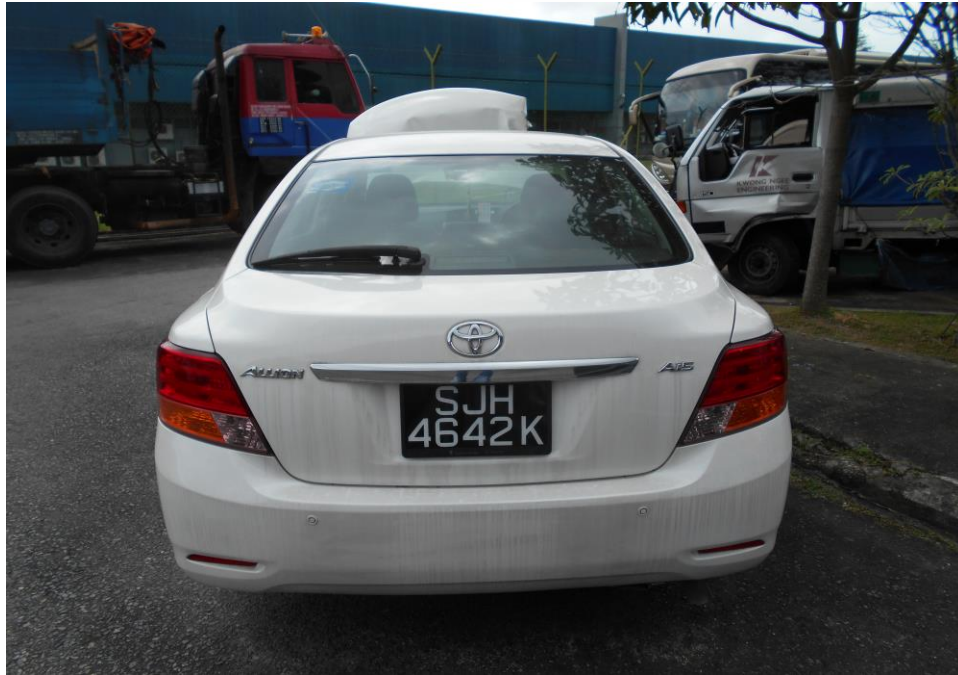
Photo 9 shows a general view of the rear body of the Motor Car at the time of our inspection. The Motor Car was observed to be in good general condition.

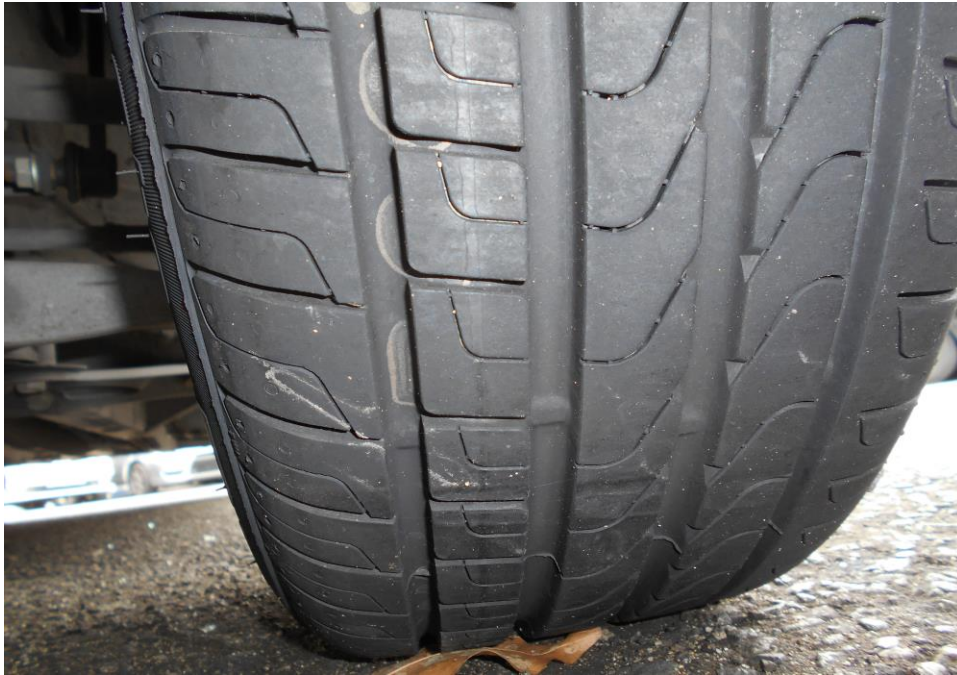
Photo 10 shows the condition of the front left tyre of the Motor Car, which was observed to be in serviceable condition with remaining tread depth of approximately 7mm. The tyre was also observed to be sufficiently inflated for vehicular operation.

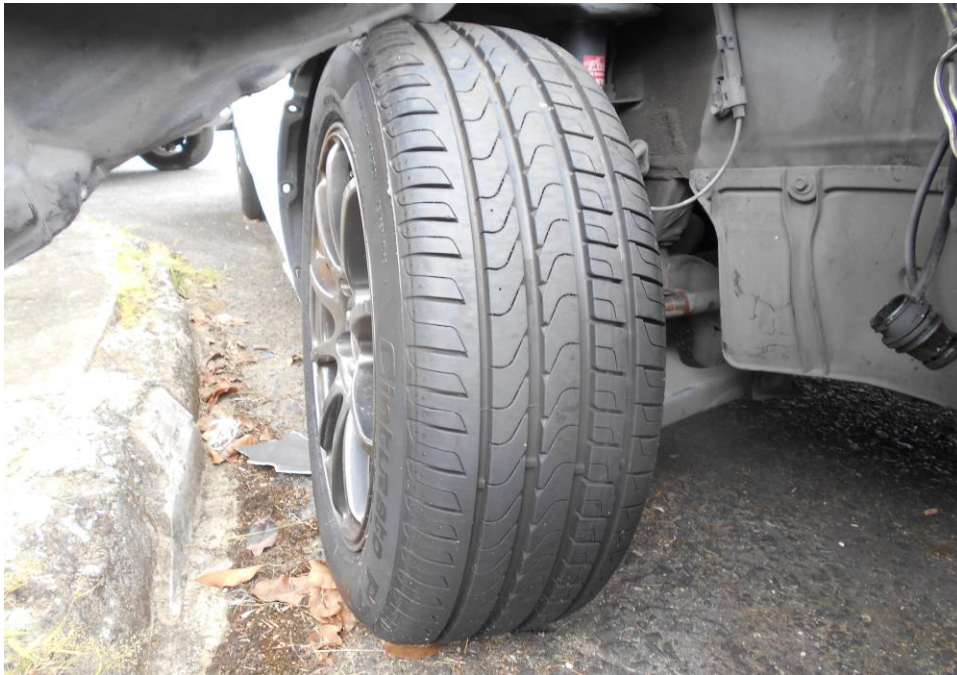
Photo 11 shows the condition of the front right tyre of the Motor Car, which was observed to be in serviceable condition with remaining tread depth of approximately 7mm. The tyre was also observed to be sufficiently inflated for vehicular operation.

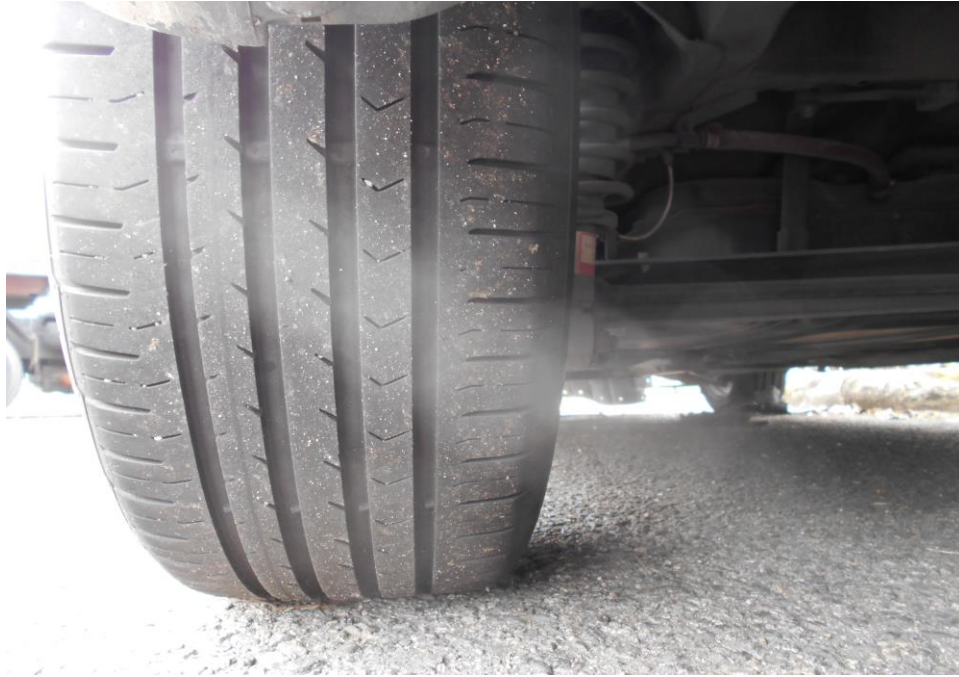
Photo 12 shows the condition of the rear left tyre of the Motor Car, which was observed to be in serviceable condition with remaining tread depth of approximately 7mm. The tyre was also observed to be sufficiently inflated for vehicular operation.

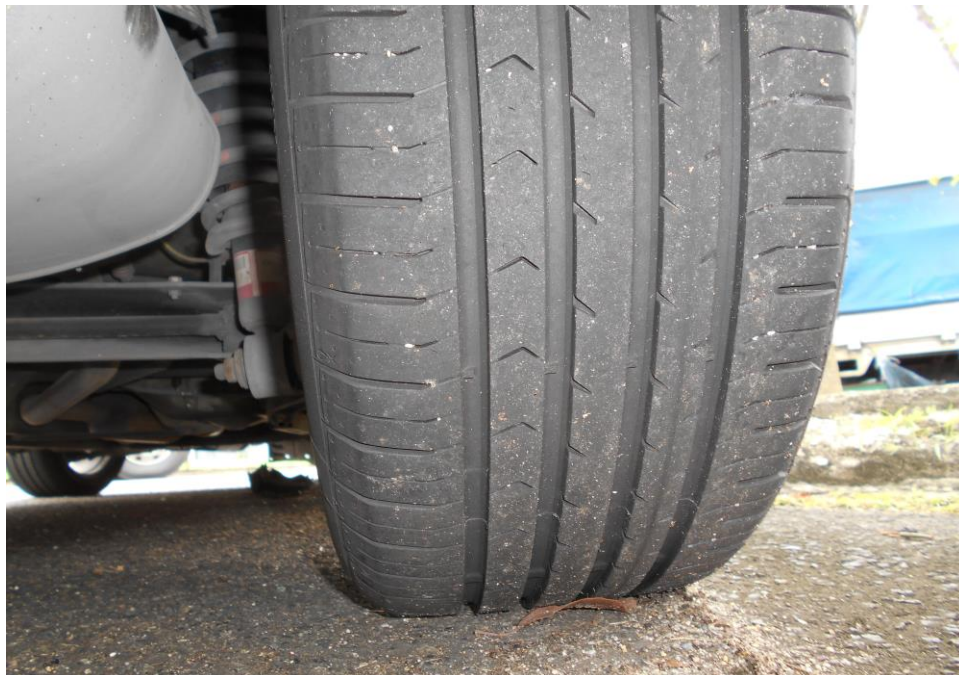
Photo 13 shows the condition of the rear right tyre of the Motor Car, which was observed to be in serviceable condition with remaining tread depth of approximately 7mm.

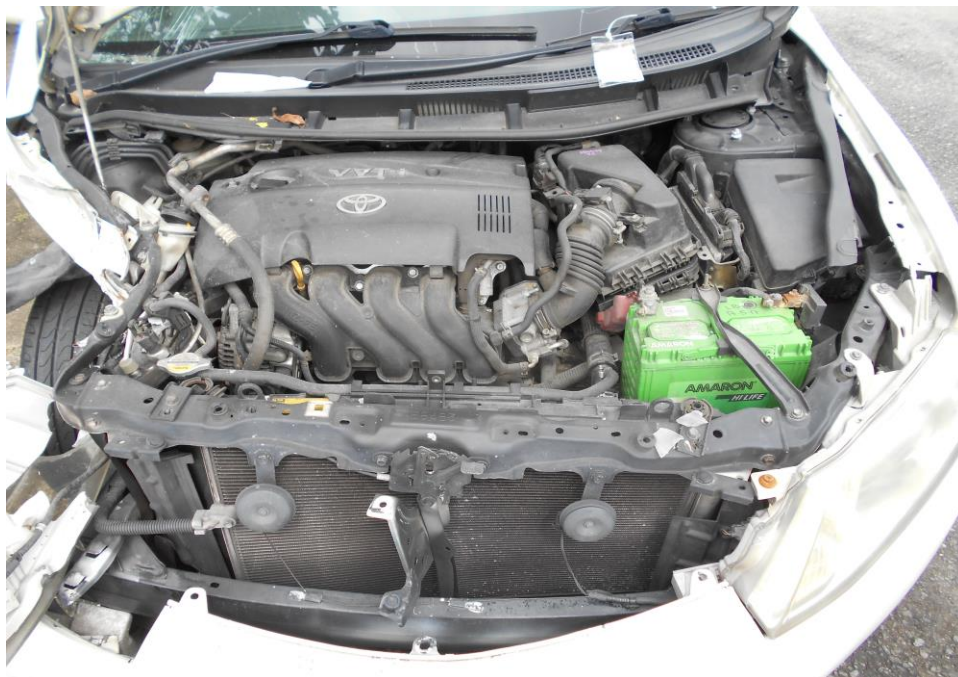
9. Upon examination of the engine compartment of the Motor Car, we had observed most parts and components inside the engine compartment to be intact. However, some components such as radiator, air-intake component, compressor/ alternator belting amongst other were observed to sustained impact damages as a result of the accident.

Photo 14 shows a general view of the Motor Car's top engine compartment. Some parts and components inside the engine compartment were affected by the accident.

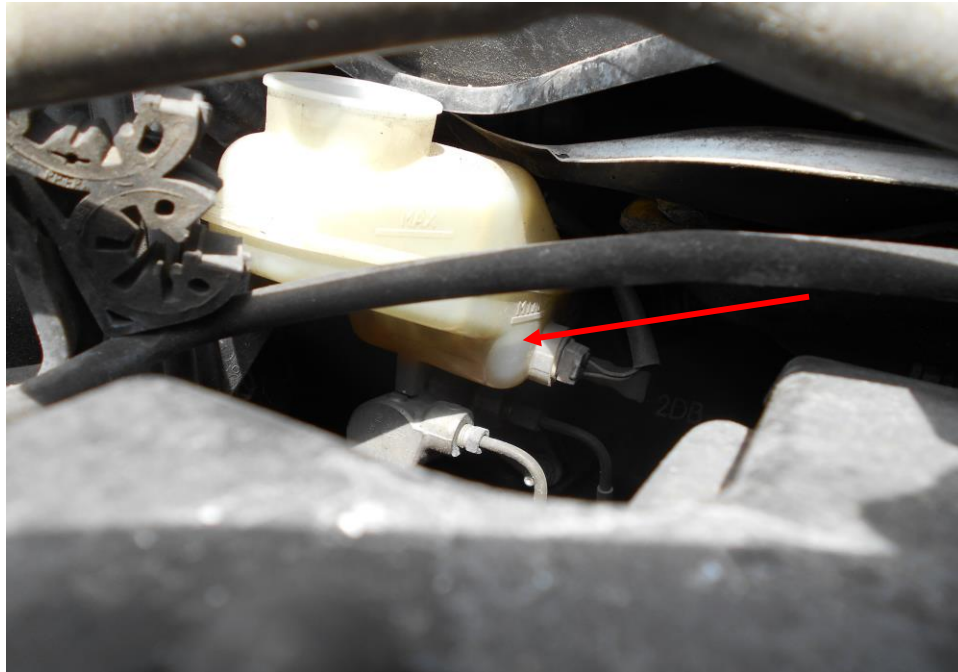
Photo 15 shows the brake fluid reservoir of the Motor Car at the time of our inspection. The brake fluid was observed to be of insufficient level (arrowed) falls below the minimum mark as a result of the accident.

13. As for the braking system, the brake fluids were observed to be insufficient in the brake fluid reservoir tank. There was possible brake fluid leakage as a result of the accident. See photo 22 - 25 below.

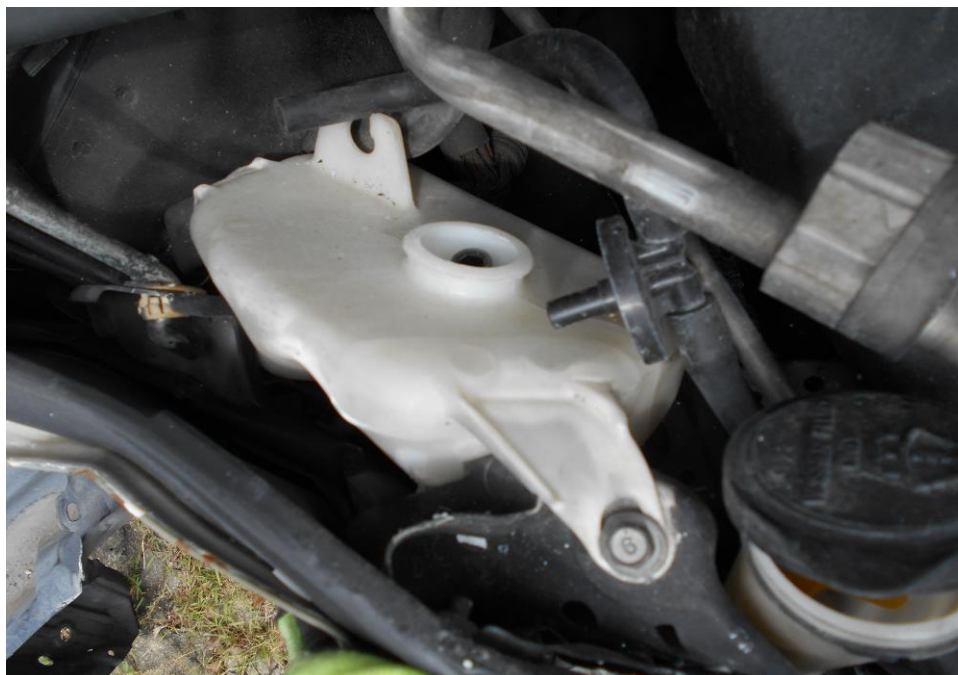
Photo 16 shows the coolant fluid reservoir of the Motor Car at the time of our inspection. The coolant fluid reservoir was observed to be damaged due to the accident's impact.

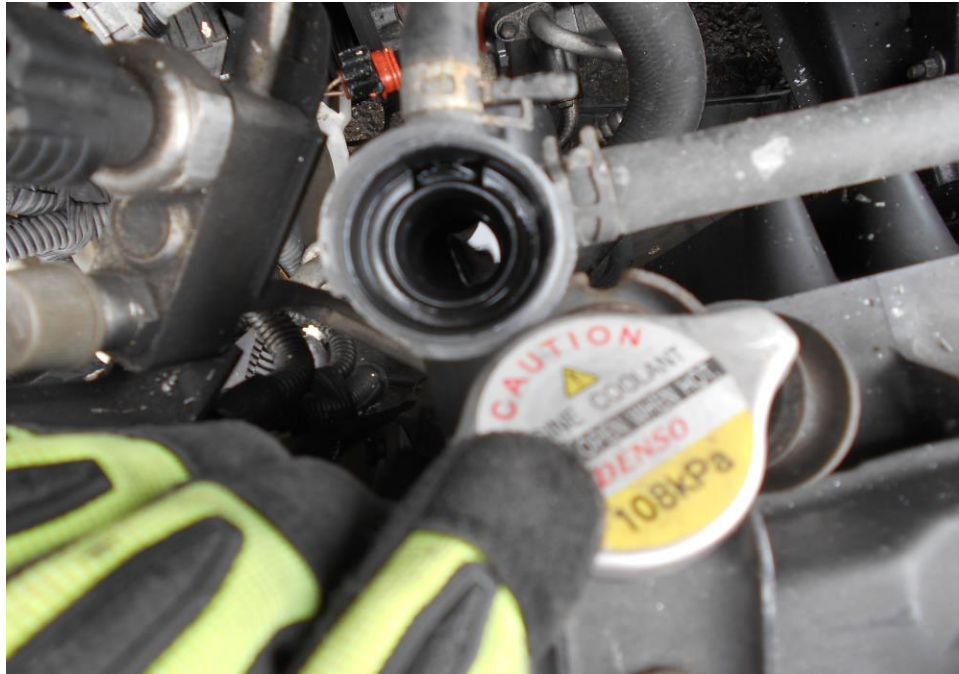
Photo 17 shows the coolant fluid tank of the Motor Car at the time of our inspection. The coolant fluid was observed to be of insufficient level as a result of the damaged radiator due to the accident.

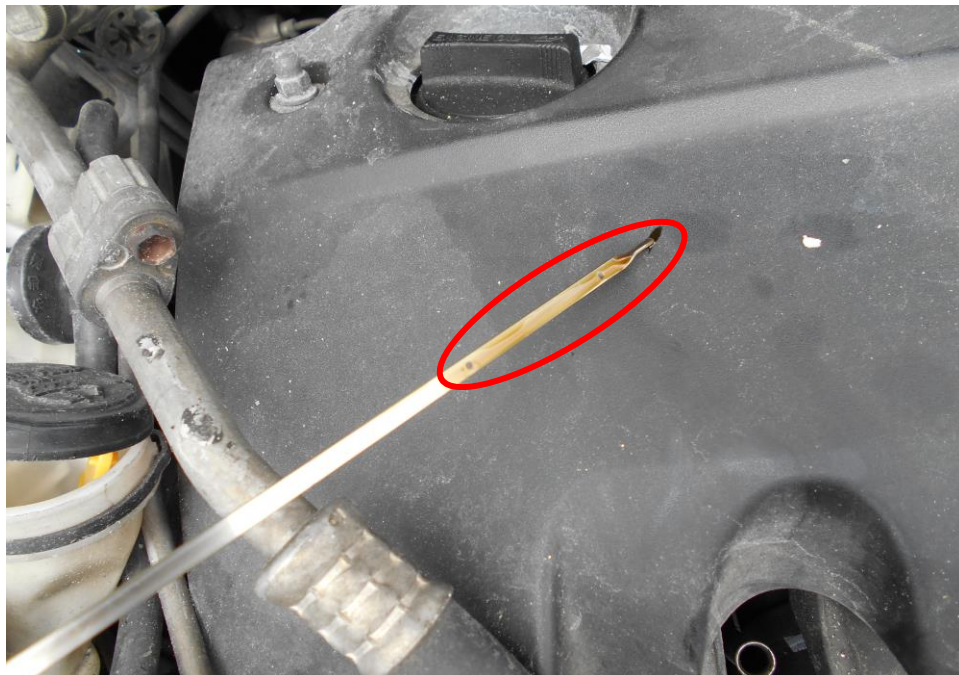
Photo 18 shows the engine oil dip stick of the Motor Car at the time of our inspection. The engine oil was observed to be of sufficient level and without any visible contamination.

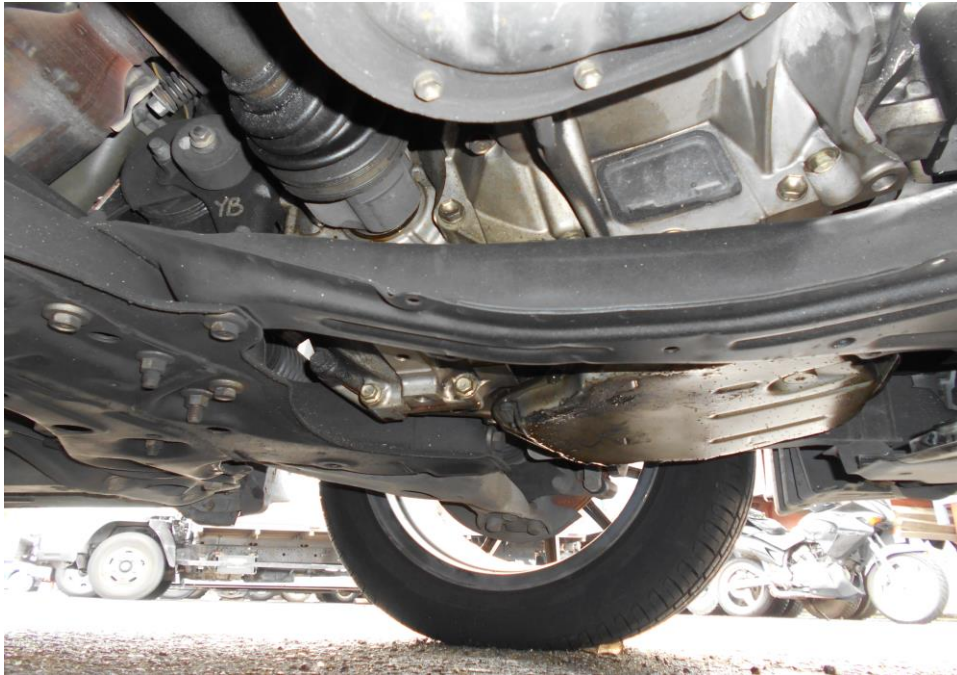
10. The engine fluid was found to be of sufficient level for operating purposes. Visually, there was also no contamination found to the fluid. Leakage of the various operating fluids such as engine coolant & brake fluid was noted. Given the extent of damages to the engine compartment, the engine undercarriage was also observed to be covered with reddish fluid, suggesting leakage of fluid leakages were likely due to the accident. There was no accumulation of dust and/or dirt particles on the engine housing where the fluid stains had formed. This would indicate that the fluid leakage was a fresh leak and likely to be a result of the accident. We were therefore unable to comment whether these operating fluids were of sufficient level and without contamination for vehicular operation prior to the accident. See photo 14 – 21 below.

Photo 19 shows leakage of the various operating fluids such as engine fluid & brake fluid was noted. Given the extent of damages to the engine compartment, the leakages were likely due to the accident. The engine undercarriage was however observed to be covered with reddish fluid, suggesting leakage of fluid. There was no accumulation of dust and/or dirt particles on the engine housing where the fluid stains had formed. This would indicate that the fluid leakage was a fresh leak and likely to be a result of the accident.

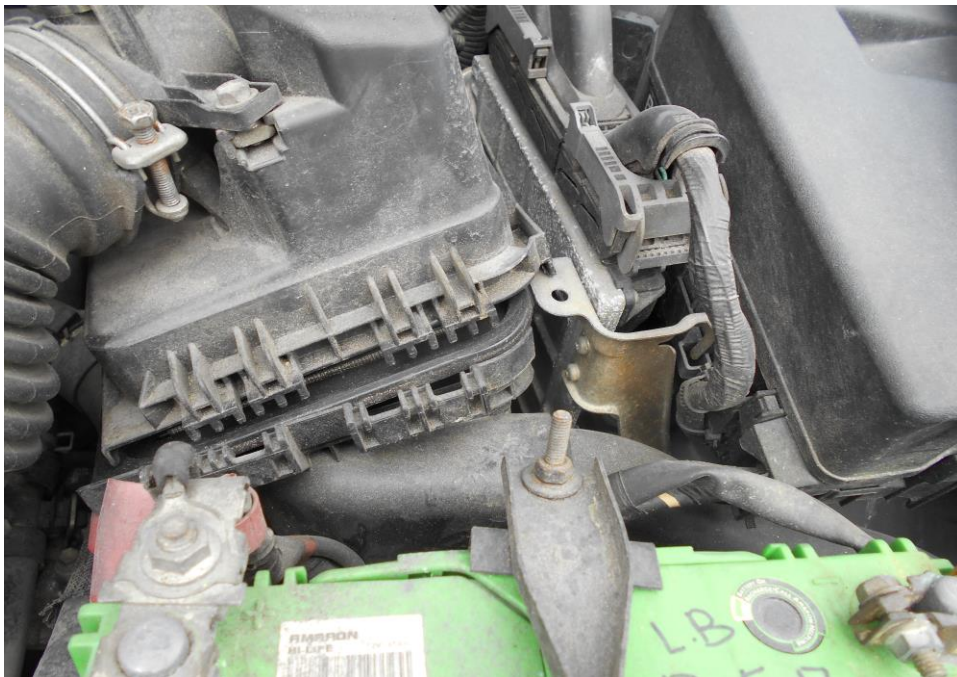
Photo 20 shows the engine air-intake component of the Motor Car at the time of our inspection. It was observed to be damaged due to the accident's impact.

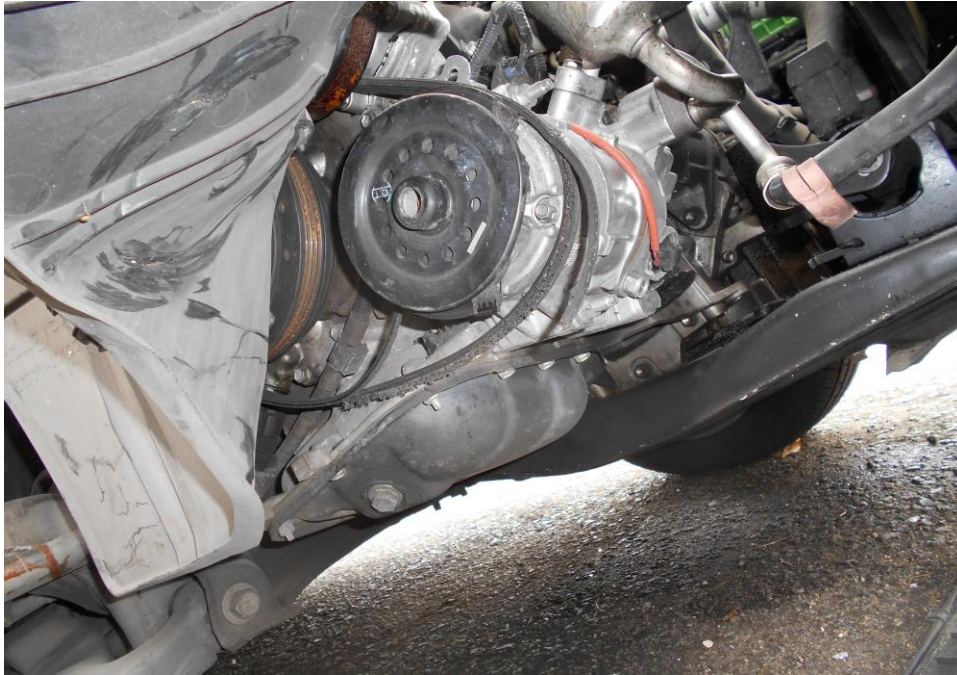
Photo 21 shows the belting of the Motor Car at the time of our inspection. It was observed to be damaged due to the accident's impact.

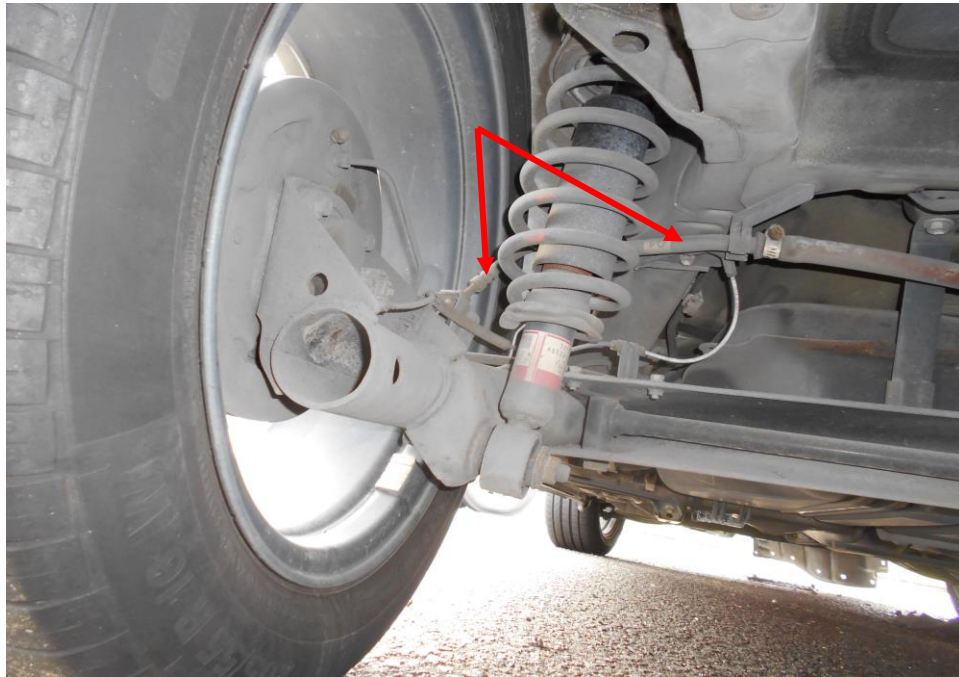
Photo 22 shows the brake hose (arrowed) at the rear left wheel of the Motor Car. Our visual inspection of the various mechanical components of the Motor Car's braking system revealed all to be intact and without visible damage, indicating that the braking system was likely to be in serviceable condition at the material time of accident.

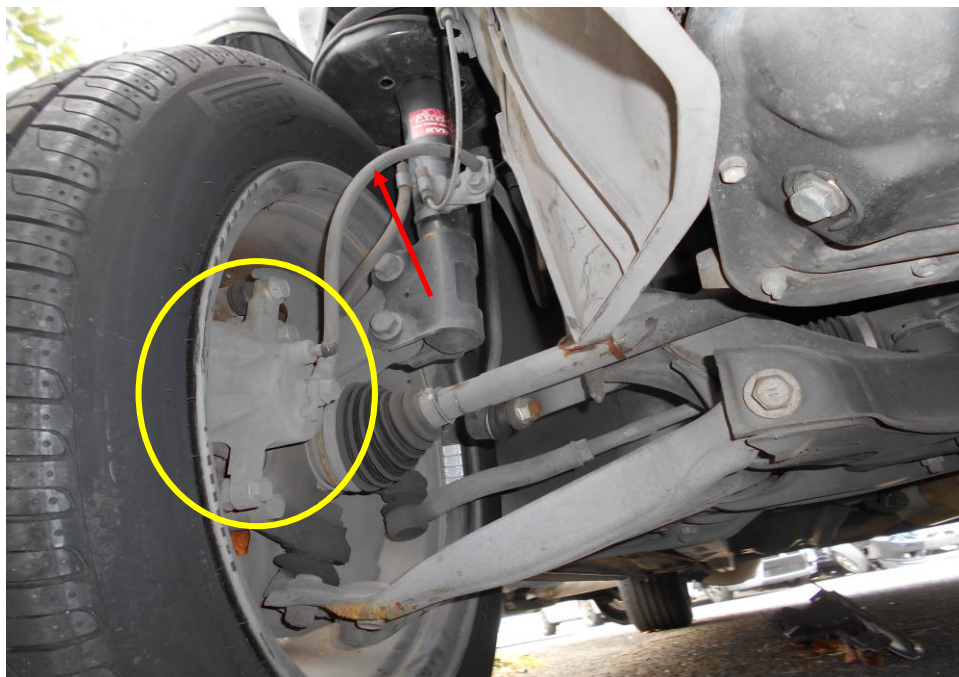
Photo 23 shows the brake hose (arrowed) at the front right wheel of the Motor Car. Our visual inspection of the various mechanical components of the Motor Car's braking system, including its brake calliper (circled), revealed all to be intact and without visible damage, indicating that the braking system was likely to be in serviceable condition at the material time of accident.

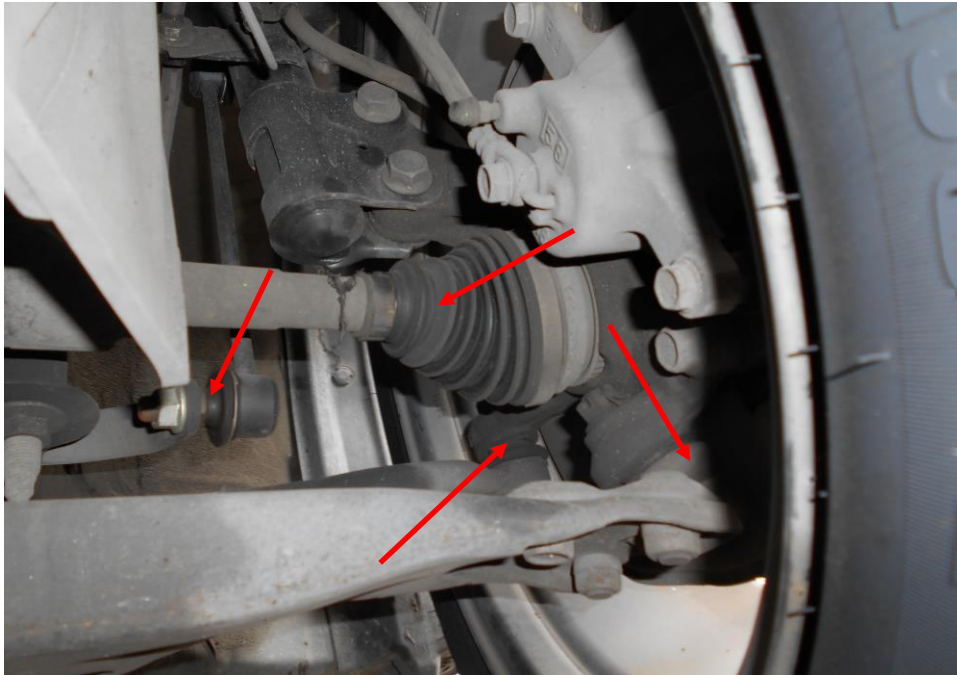
Photo 24 shows the various undercarriage components at the front left wheel of the Motor Car, in particular the steering tie rod (arrowed). The various steering components were all found to be intact, suggesting that the steering system of the Motor Car was likely to be in serviceable condition.

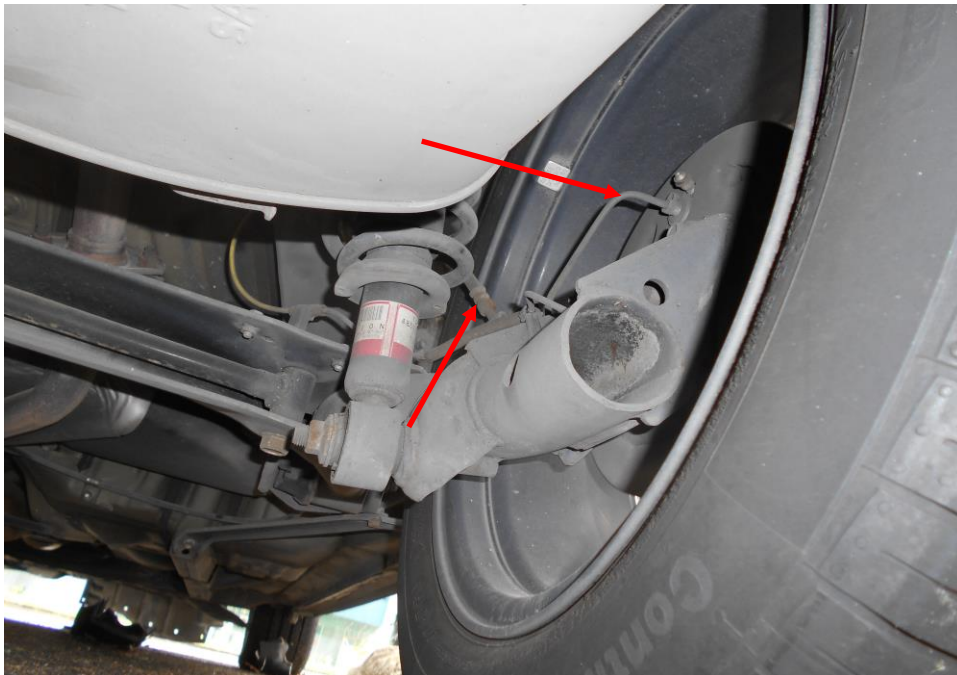
Photo 25 shows the various undercarriage components at the rear right wheel of the Motor Car. We did not observe any leakage of brake fluid at the time of our inspection of the Motor Car. Our visual inspection of the various mechanical components of the Motor Car's braking system revealed all to be intact and without visible damage, indicating that the braking system was likely to be in serviceable condition at the material time of accident.

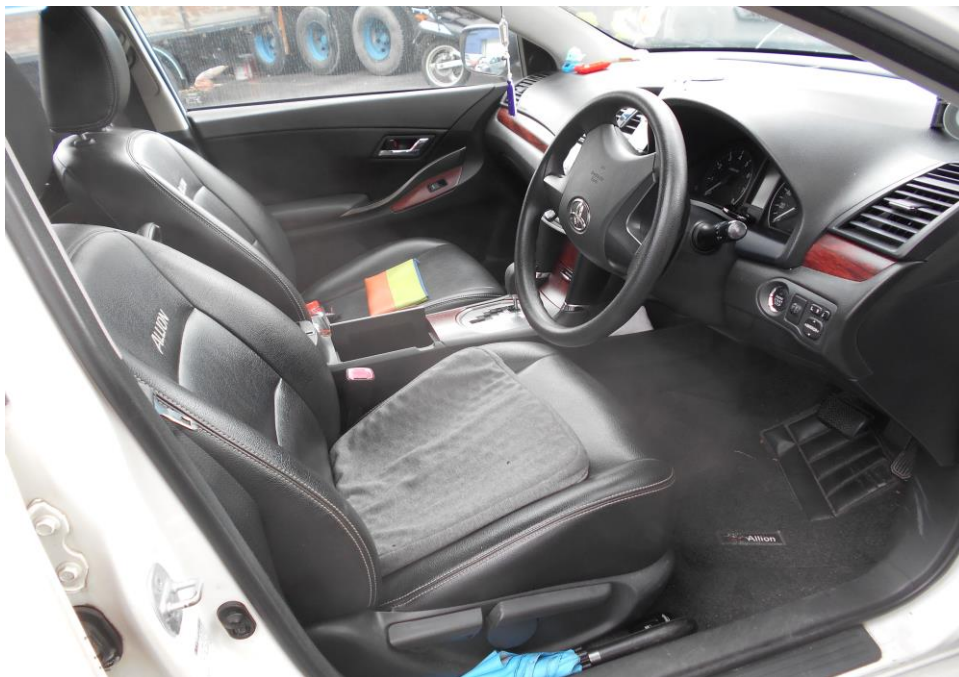
14. The Motor Car's automatic self-test of the functionality of its various operating systems like the Anti-Brake Lock System (ABS) and Supplemental Restraint System (SRS) was not able to be initiated as the engine of the Motor Car could not be started due to damage of the ignition system and engine system of the Motor Car as a result of the accident. See photo 26 below.

Photo 26 shows a general view of the interior cabin of the Motor Car. It was observed to be slightly affected by the accident which likely to cause the engine unable to be started.
