Your Ref: 1201900003140/LT  
Our Ref : CS/FWD19001712/D

01 February 2019

**TECHNICAL INVESTIGATION REPORT OF FIRE INCIDENT INVOLVING THE INSURED VEHICLE SJR 1275D ON 23 JANUARY 2019**

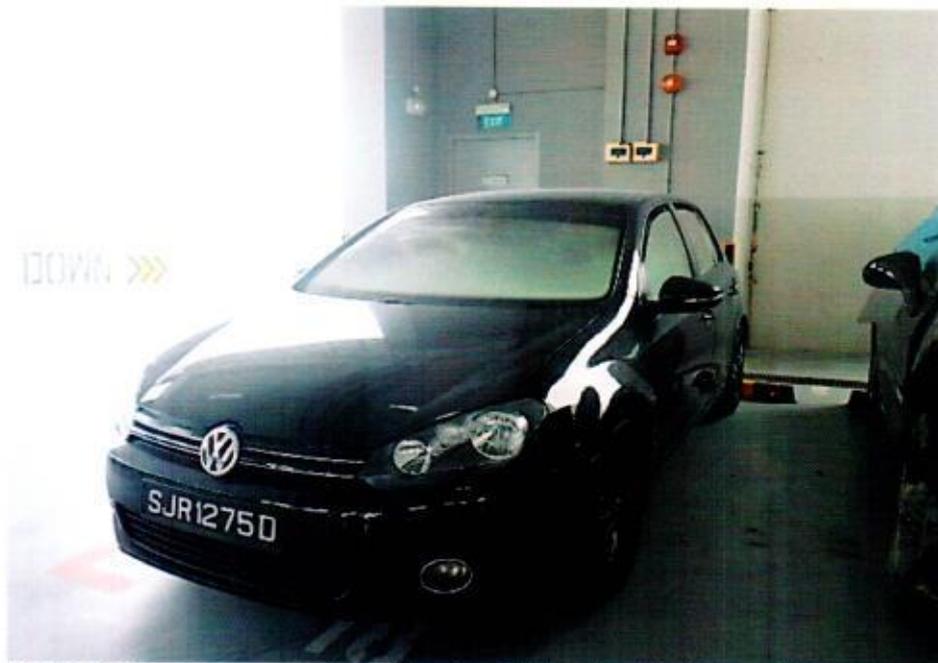
**Photo 1** shows a general view of the front left body of the Insured Vehicle at the time of my inspection. The exterior body of the Insured Vehicle was observed to be in good general condition with no damage of burn nature found apart from a blackened and cracked front windscreen.

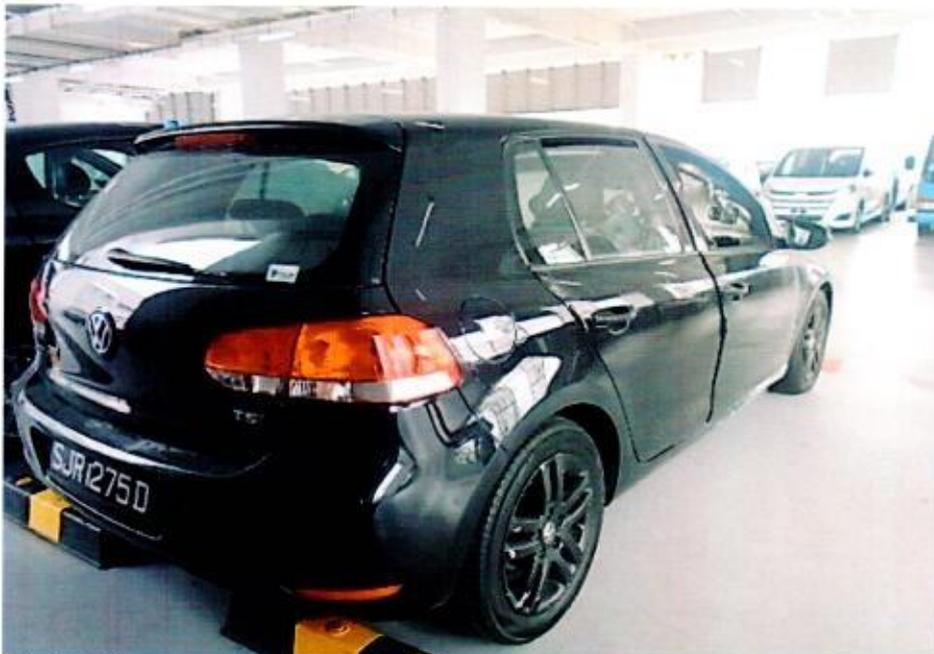
**Photo 2** shows a general view of the rear right body of the Insured Vehicle at the time of inspection. The rear body of the Insured Vehicle was observed to be unaffected by the fire.

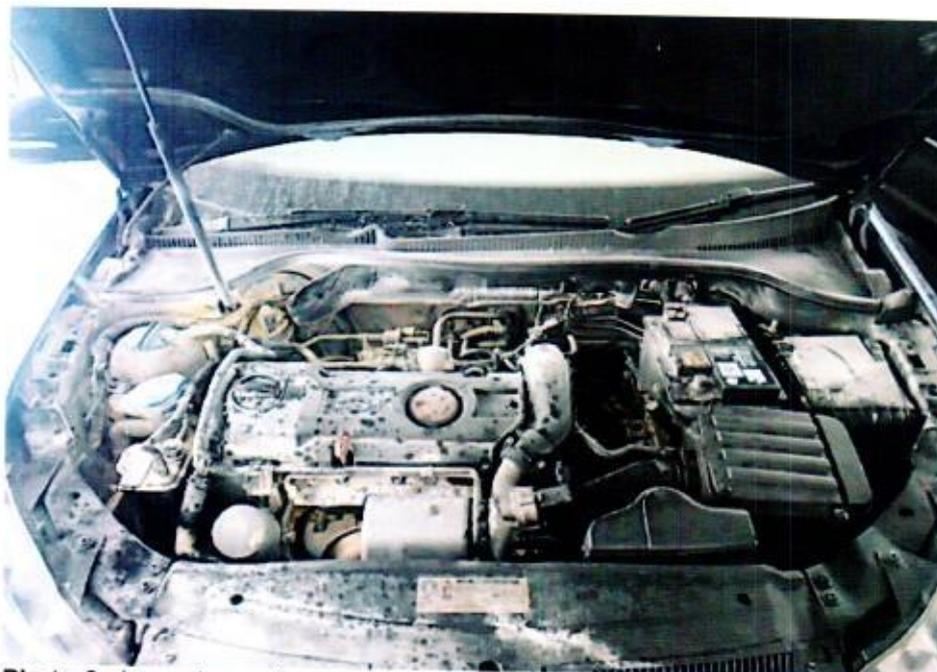
**Photo 3** shows the engine compartment of the Insured Vehicle at the time of my inspection. Although powdery residue from fire extinguishers were seen on the surfaces of various components inside the engine compartment, there was however no damage of burn nature observed within the engine compartment.

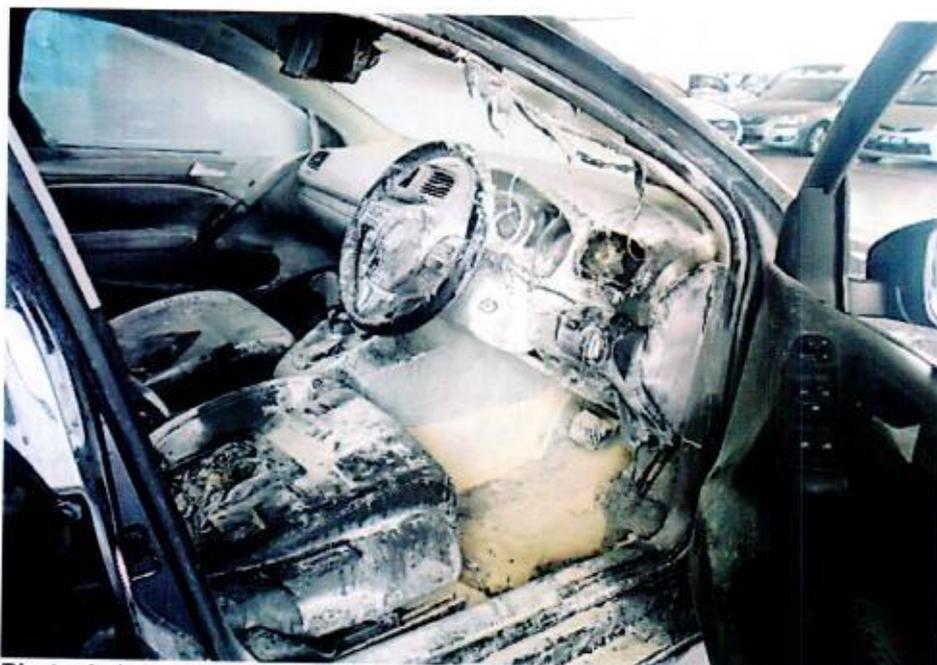
**Photo 4** shows a general view of the interior compartment of the Insured Vehicle. The fire damage to the Insured Vehicle was confined to the driver's side of its interior compartment. The front dashboard, upholstery and various plastic trims around the driver's side area were observed to have been partially melted/burnt.

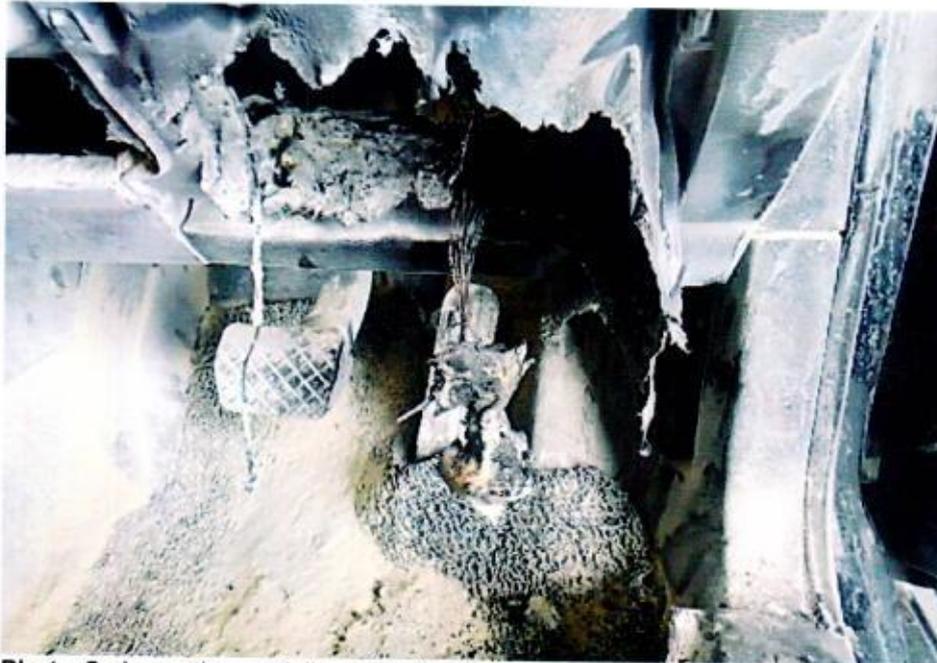
**Photo 5** shows the partially melted/burnt front dashboard at the leg area of the driver's side. The fire damage to the Insured Vehicle was confined to a single area. This was at the driver's side of the interior compartment.

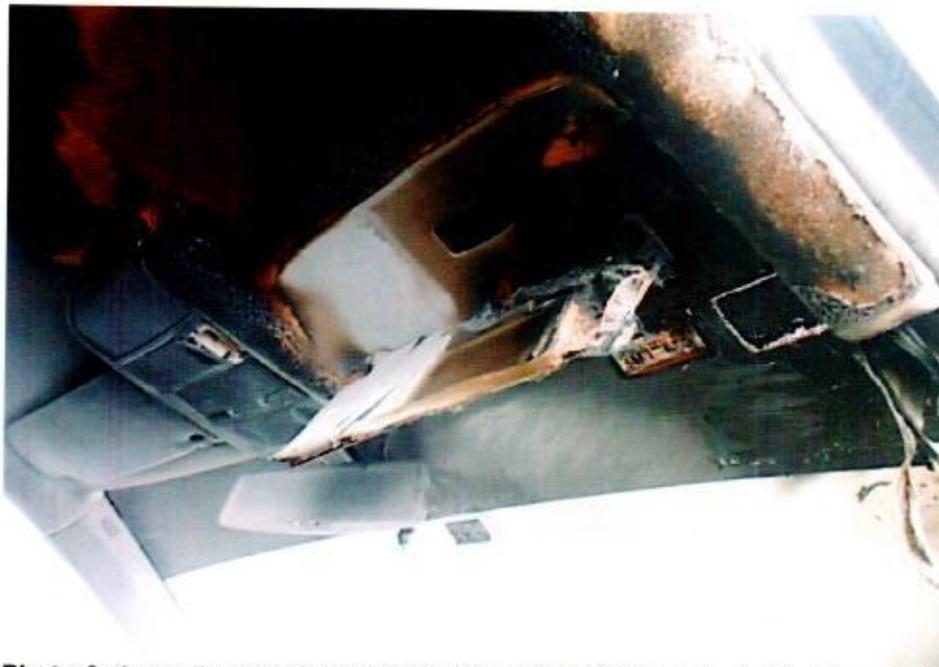
**Photo 6** shows the partially melted/burnt roof upholstery and plastic trims at the driver's side of the Insured Vehicle. These damages were a result of smoke/heat arising from the fire.

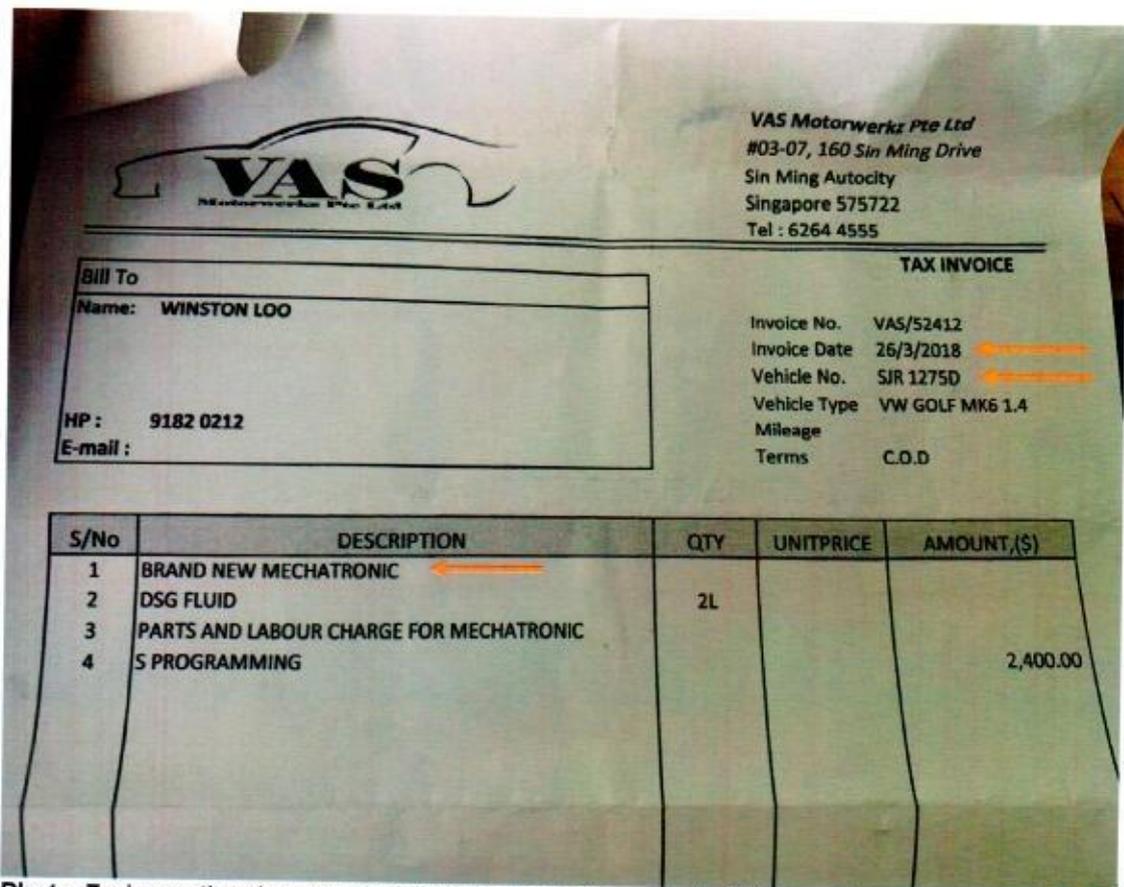
Photo 7 shows the document relating to the replacement of the mechatronic of the Insured Vehicle on 26 March 2018. Along with the mechatronic replacement, the transmission fluid was also replaced.

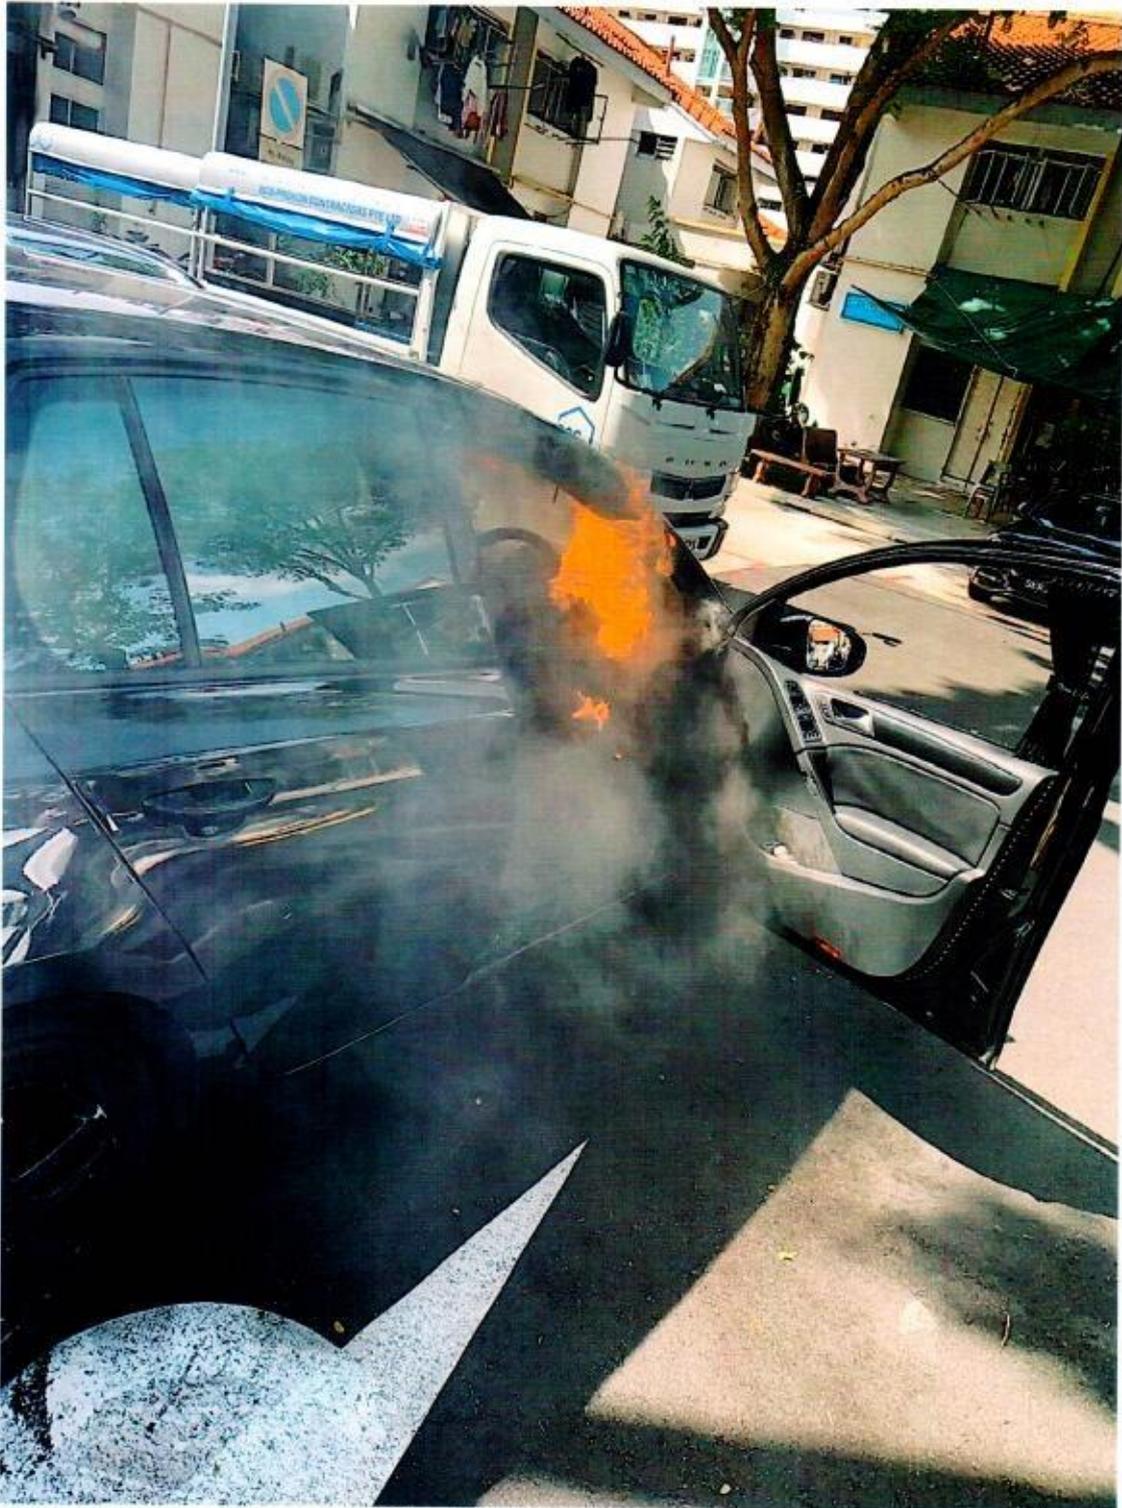
**Photo 9** shows the Insured Vehicle at the incident scene (photograph provided to me by Mr Loo). Flames could be seen coming out from the dashboard area at the driver's side of the Insured Vehicle. Since there were no flames emitting from other areas of the Insured Vehicle, the origin of fire can be established to have been from the area behind the front dashboard, at the driver's side of the Insured Vehicle.

16. For this case, the fire to the Insured Vehicle can be established to have originated from the interior compartment, at the area behind the front dashboard, at the driver's side. This was established from information gathered upon reviewing the photographs provided by Mr Loo, as well as, from the physical damage to the Insured Vehicle, where the fire damage to the Insured Vehicle was observed to be confined to a single area ie at the driver's side inside the interior compartment of the Insured Vehicle.

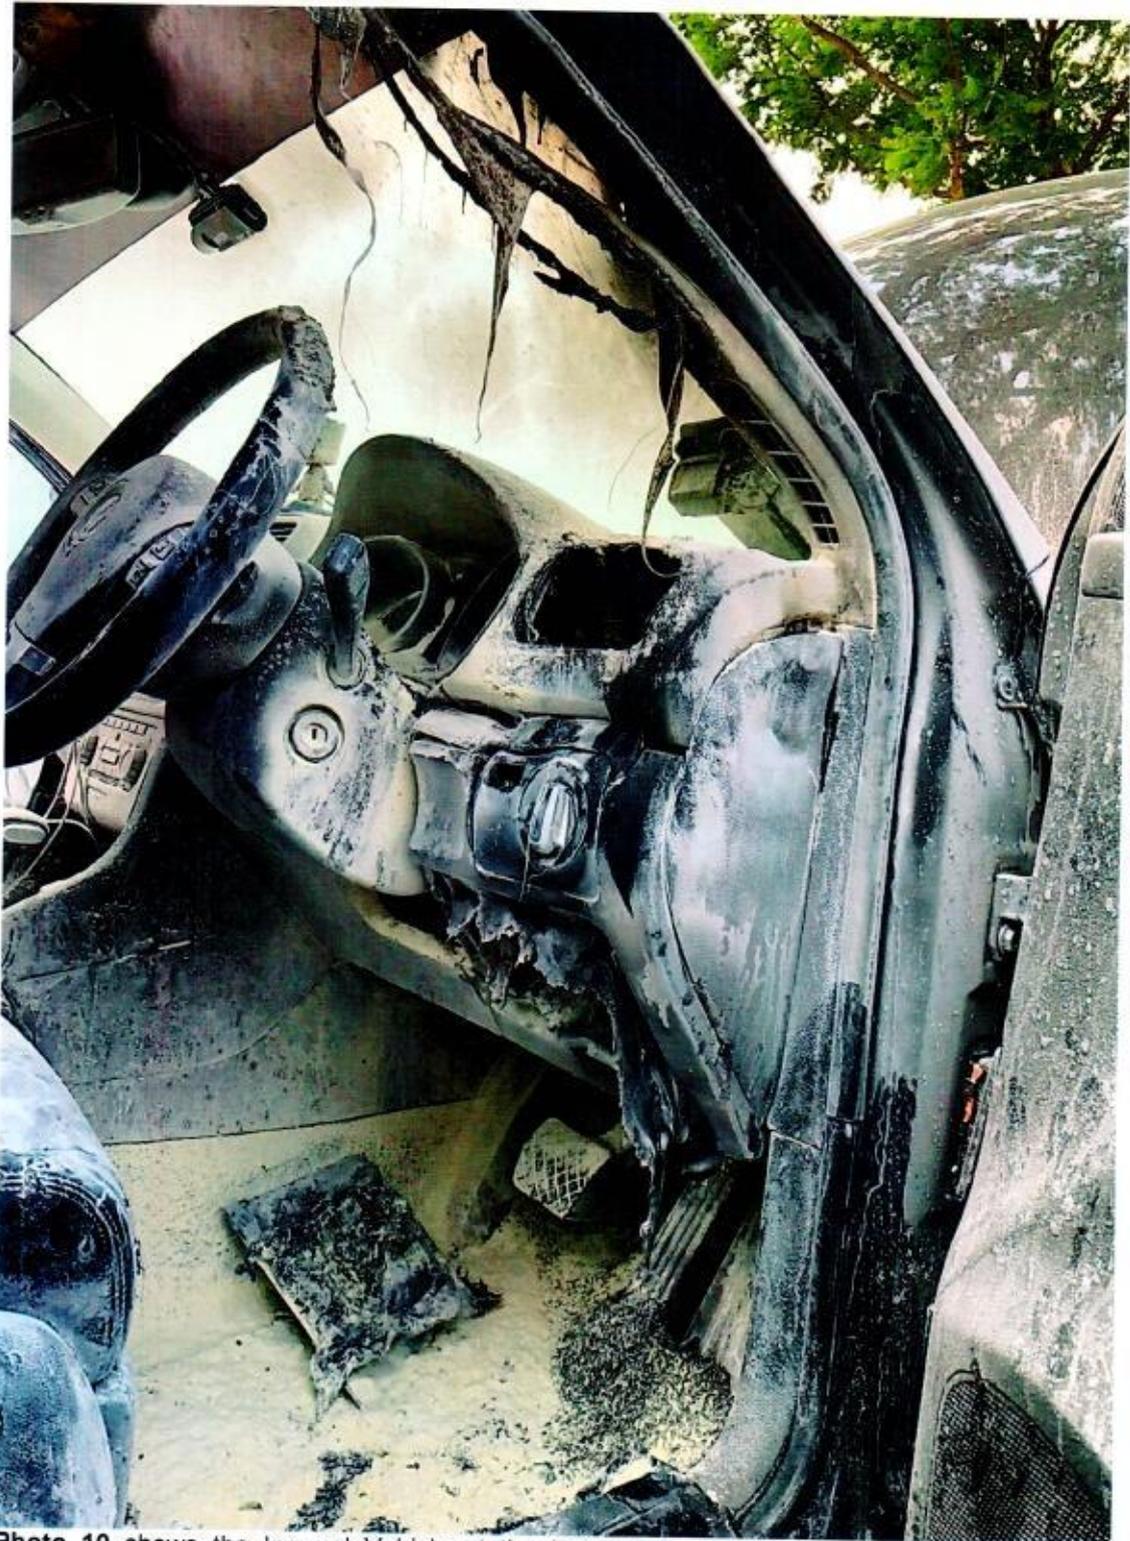
Photo 10 shows the Insured Vehicle at the incident scene after the fire was extinguished (photograph provided to me by Mr Loo). the fire damage seen inside the interior compartment of the Insured Vehicle immediately after the fire was extinguished was observed to be similar to what I had observed during my inspection of the Insured Vehicle.

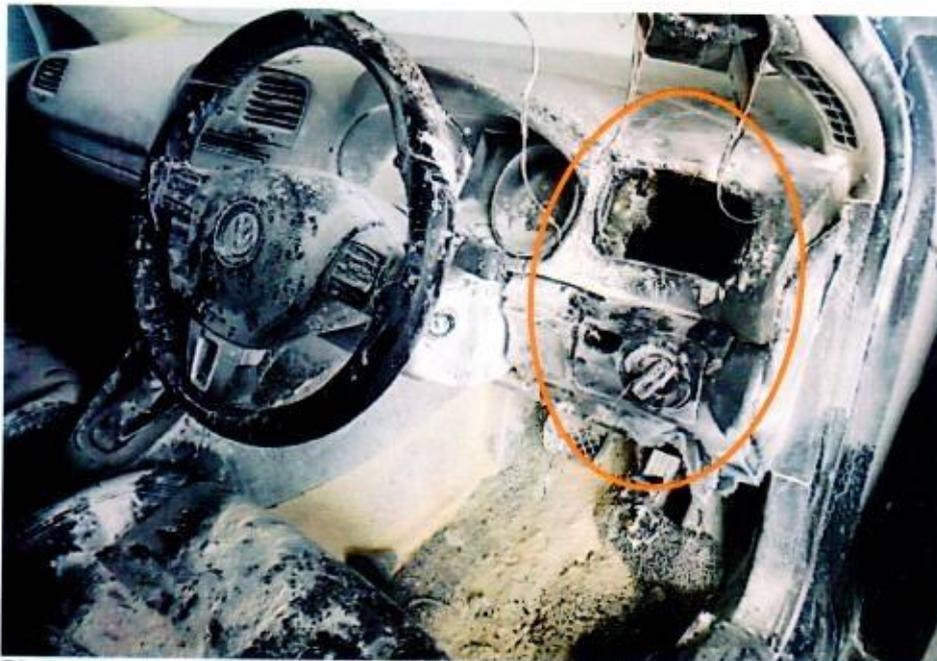
**Photo 11** shows the interior compartment of the Insured Vehicle, at the driver's side. Basing on the information gathered during the course of my investigations, and the physical damage to the Insured Vehicle, the fire had originated at the area (circled) behind the front dashboard.

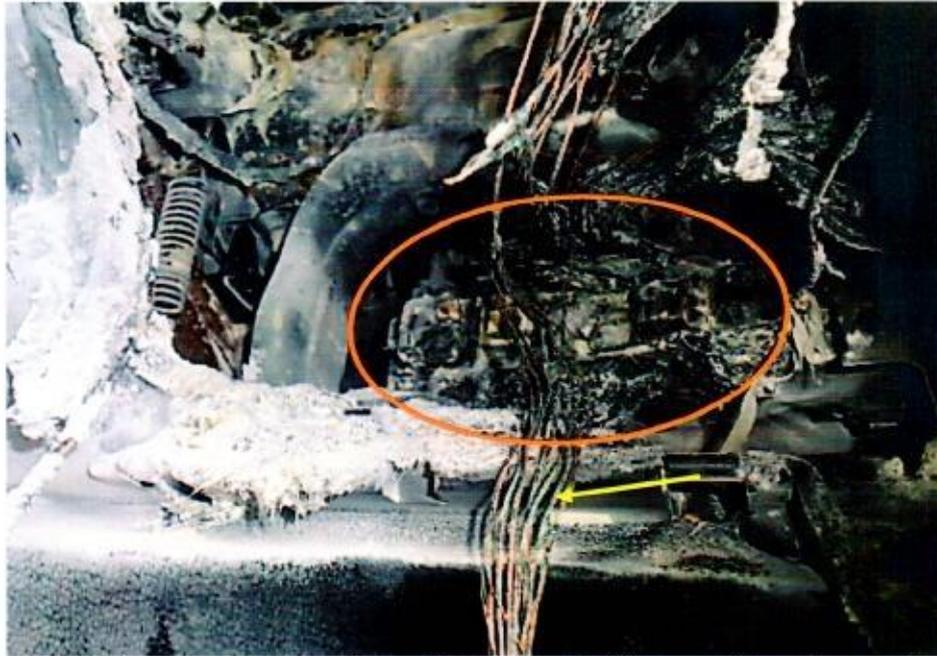
17. My examination of the area behind the front dashboard at the driver's side, which was where the fire to the Insured Vehicle had originated, revealed burnt wirings that were with faint greenish colour residue. The wirings were observed to be original factory fitted wirings leading to the interior fuse box of the Insured Vehicle that was located directly behind the front dashboard, where the fire had originated. The presence of greenish residue indicates internal heating of copper wires, a sign of an electrical short circuit occurring. The greenish residue is normally left behind from oxidation as a result of chemical reaction involving the copper wires. This physical evidence would then appear to indicate that the cause of fire to the Insured Vehicle was due to electrical in nature. See photo 11 - 13 below.

**Photo 12** shows the burnt wirings that were with faint greenish colour residue (arrowed). The wirings were observed to be wirings leading to the interior fuse box (circled) of the Insured Vehicle that was located directly behind the front dashboard at the driver's side, where the fire had originated. The presence of greenish residue indicates internal heating of copper wires, a sign of an electrical short circuit occurring. The greenish residue is normally left behind from oxidation as a result of chemical reaction involving the copper wires. This physical evidence would then appear to indicate that the cause of fire to the Insured Vehicle was due to electrical nature.

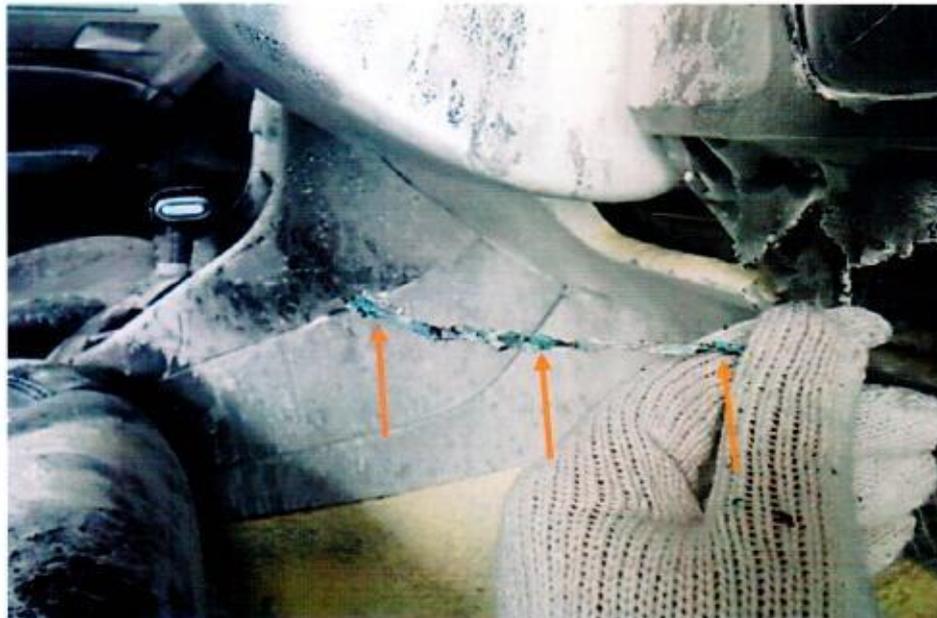
**Photo 13** shows a closer view of the burnt wirings that were with faint greenish colour residue (arrowed). The presence of greenish residue indicates internal heating of copper wires, a sign of an electrical short circuit occurring.

19. Having investigated and technically analysed the damages of burnt nature to the Insured Vehicle, I am of the view that the cause of fire to the Insured Vehicle was of electrical in nature. For this particular case, the fire had originated along the wirings behind the front dashboard inside the interior compartment, at the driver's side of the Insured Vehicle. The wirings were original fitted wirings leading to the interior fuse box of the Insured Vehicle that was located directly behind the front dashboard, where the fire had originated.
