Your Ref: 1201900003140/LT
Our Ref : CS/FWD19001712/D

FWD Singapore Pte Ltd

TECHNICAL INVESTIGATION REPORT OF FIRE INCIDENT INVOLVING THE INSURED VEHICLE SJR 1275D ON 23 JANUARY 2019

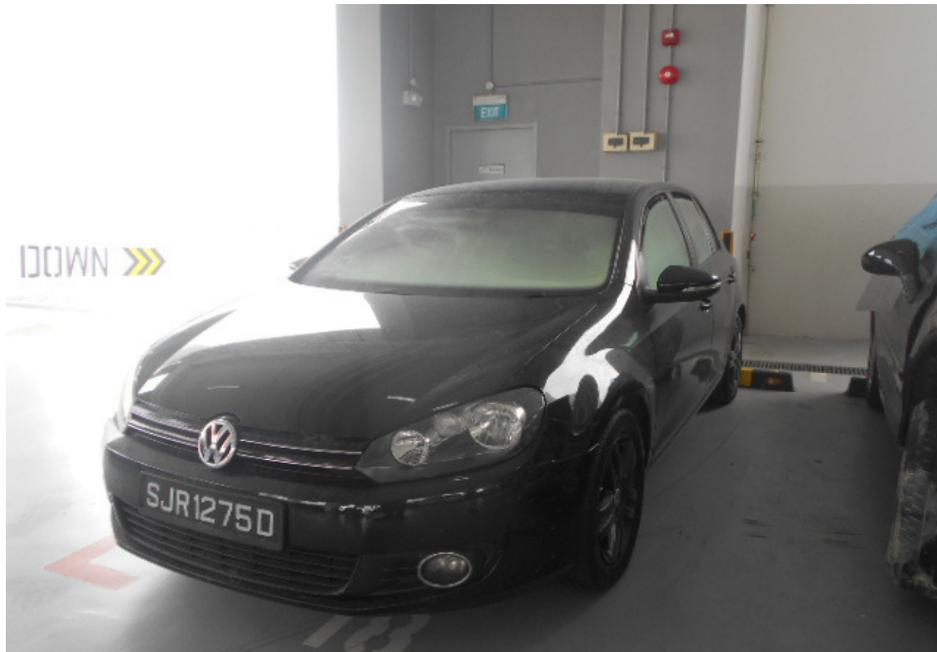
Photo 1 shows a general view of the front left body of the Insured Vehicle at the time of my inspection. The exterior body of the Insured Vehicle was observed to be in good general condition with no damage of burn nature found apart from a blackened and cracked front windscreen.

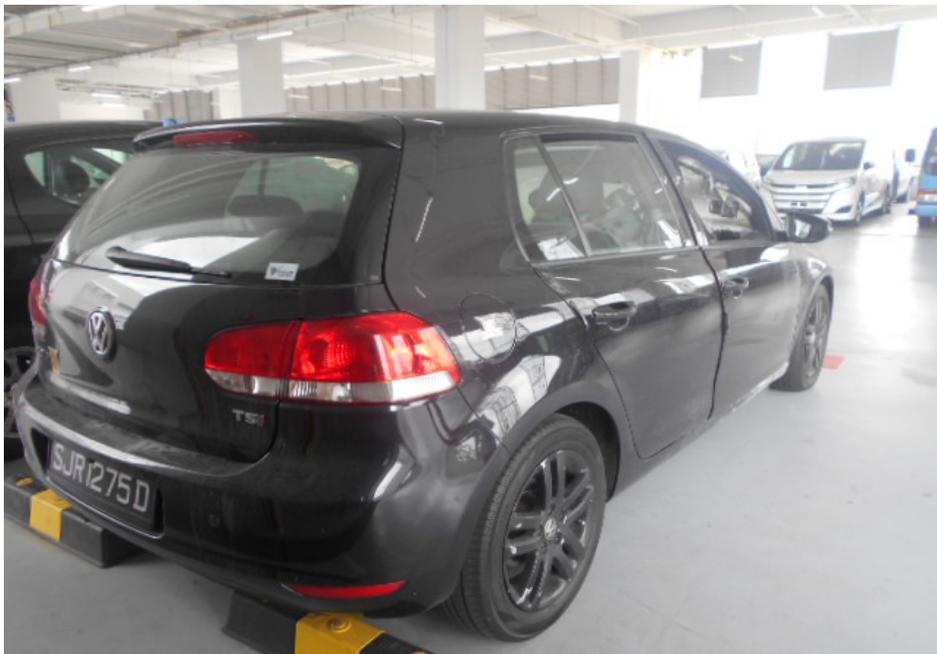
Photo 2 shows a general view of the rear right body of the Insured Vehicle at the time of inspection. The rear body of the Insured Vehicle was observed to be unaffected by the fire.

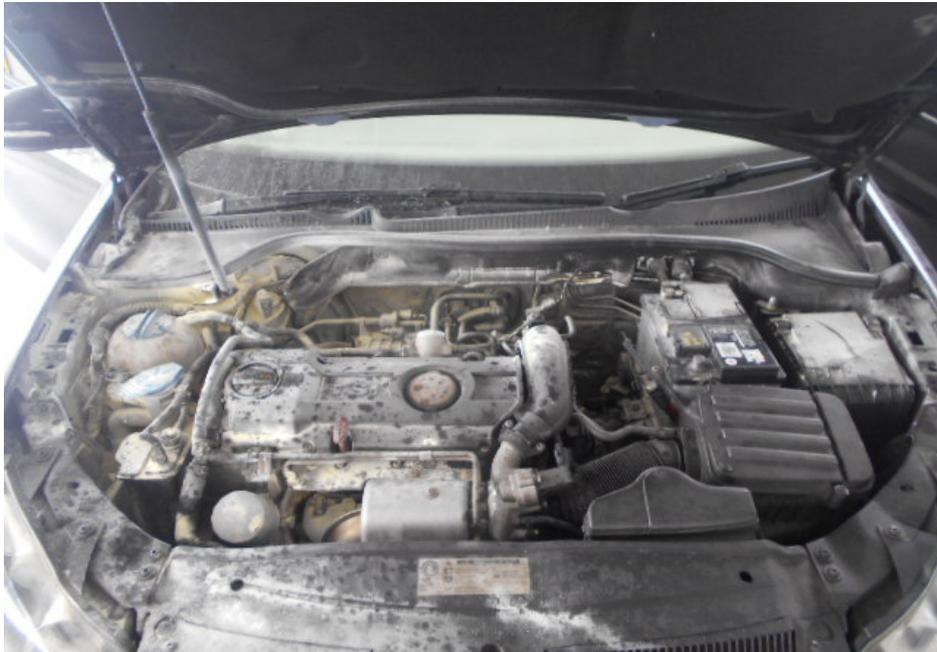
Photo 3 shows the engine compartment of the Insured Vehicle at the time of my inspection. Although powdery residue from fire extinguishers were seen on the surfaces of various components inside the engine compartment, there was however no damage of burn nature observed within the engine compartment.

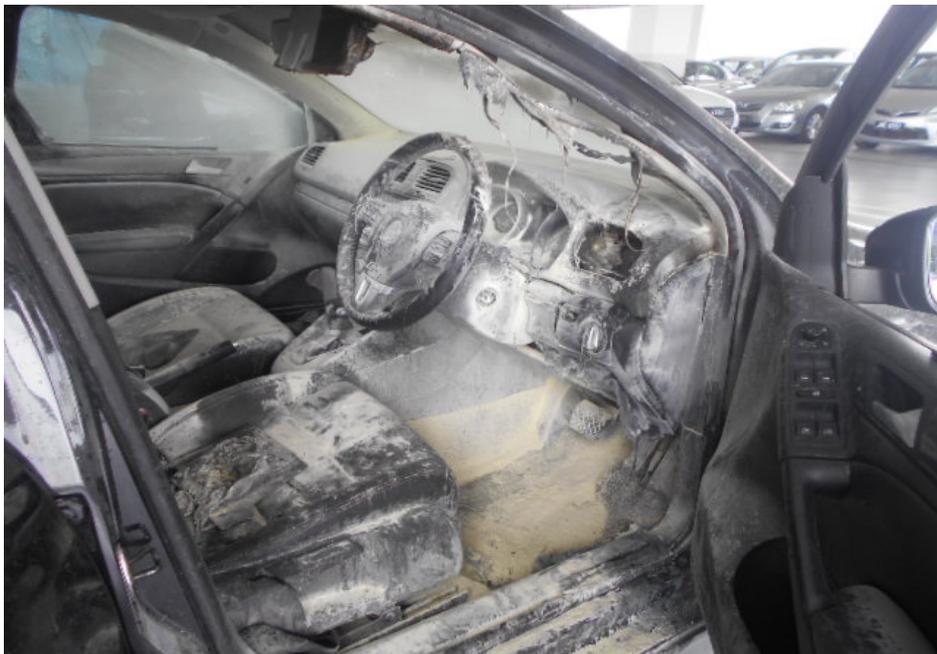
Photo 4 shows a general view of the interior compartment of the Insured Vehicle. The fire damage to the Insured Vehicle was confined to the driver's side of its interior compartment. The front dashboard, upholstery and various plastic trims around the driver's side area were observed to have been partially melted/burnt.

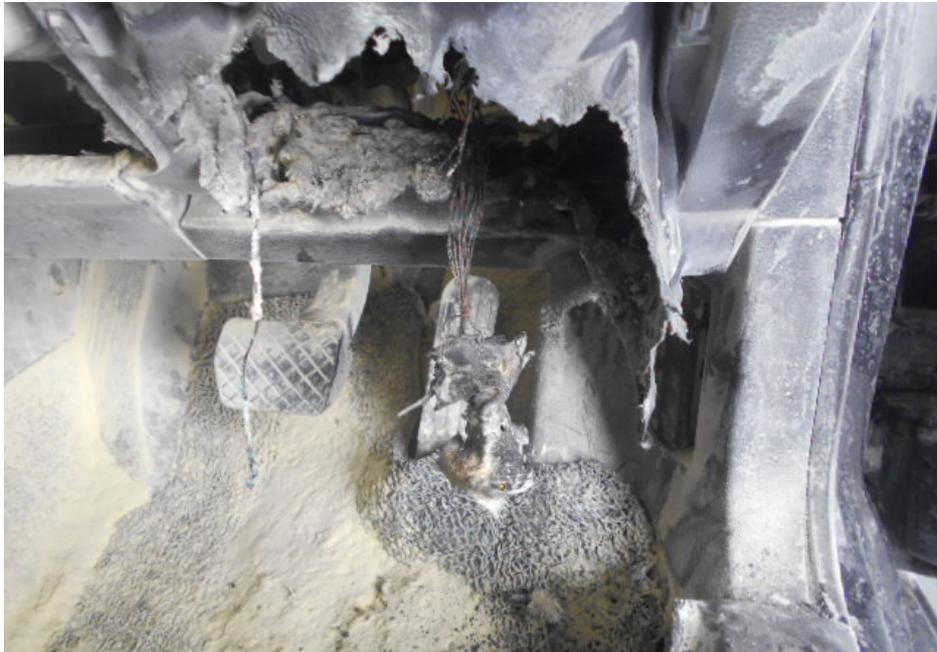
Photo 5 shows the partially melted/burnt front dashboard at the leg area of the driver's side. The fire damage to the Insured Vehicle was confined to a single area. This was at the driver's side of the interior compartment.

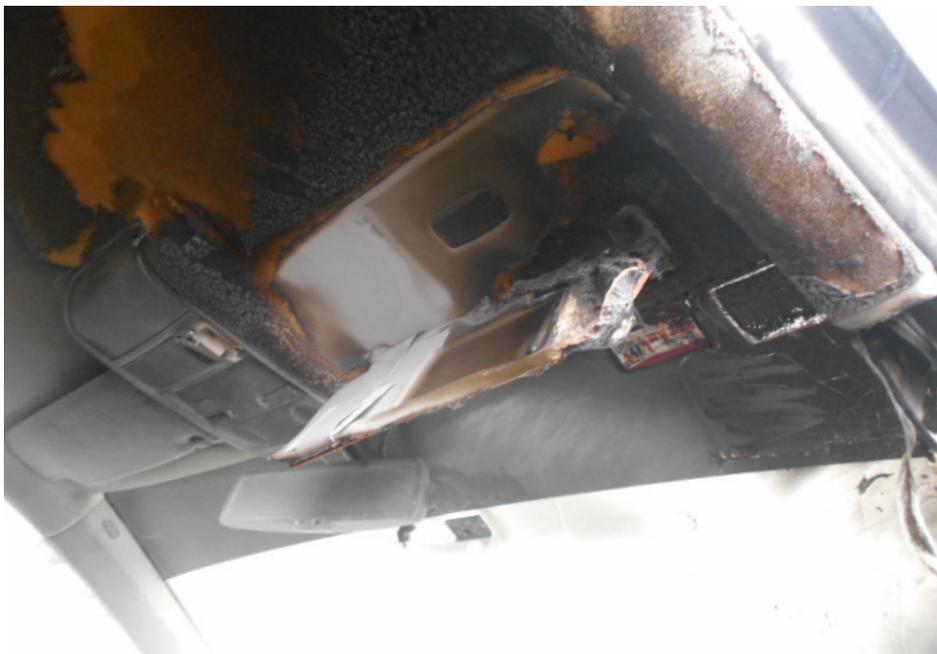
Photo 6 shows the partially melted/burnt roof upholstery and plastic trims at the driver's side of the Insured Vehicle. These damages were a result of smoke/heat arising from the fire.

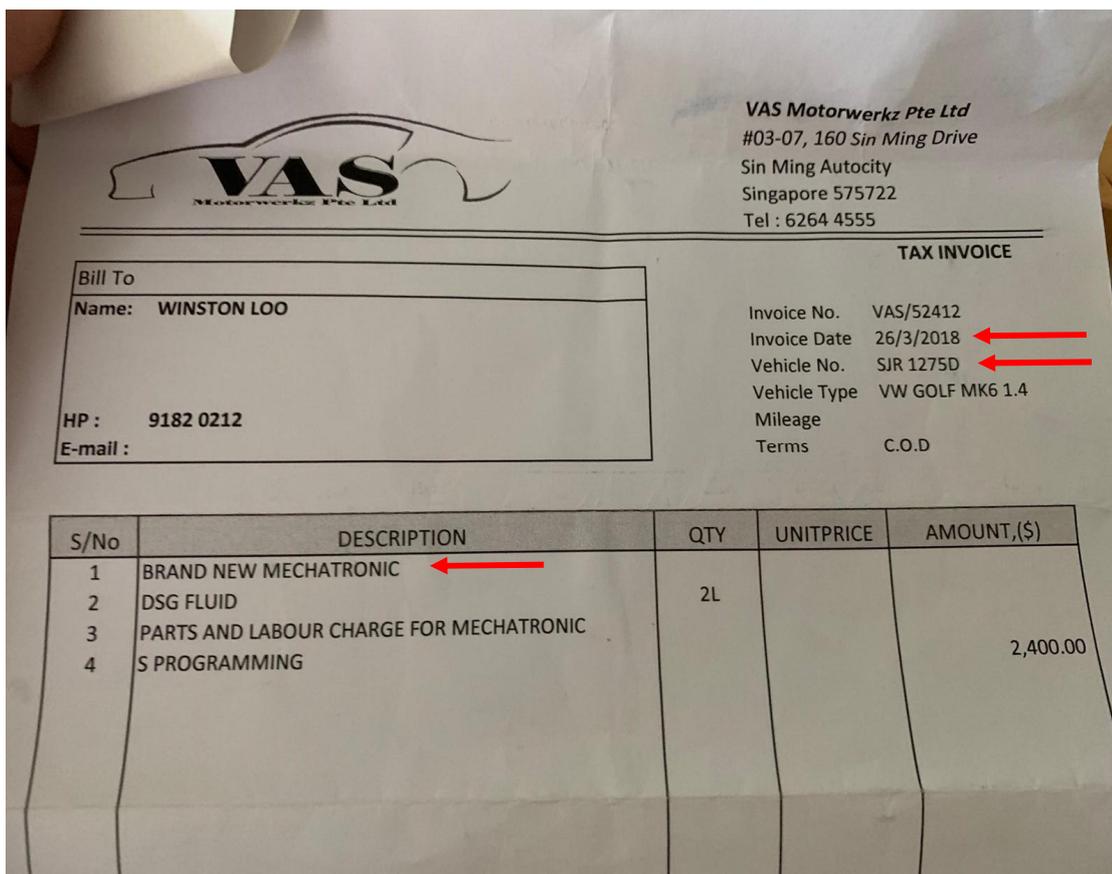
Photo 7 shows the document relating to the replacement of the mechatronic of the Insured Vehicle on 26 March 2018. Along with the mechatronic replacement, the transmission fluid was also replaced.

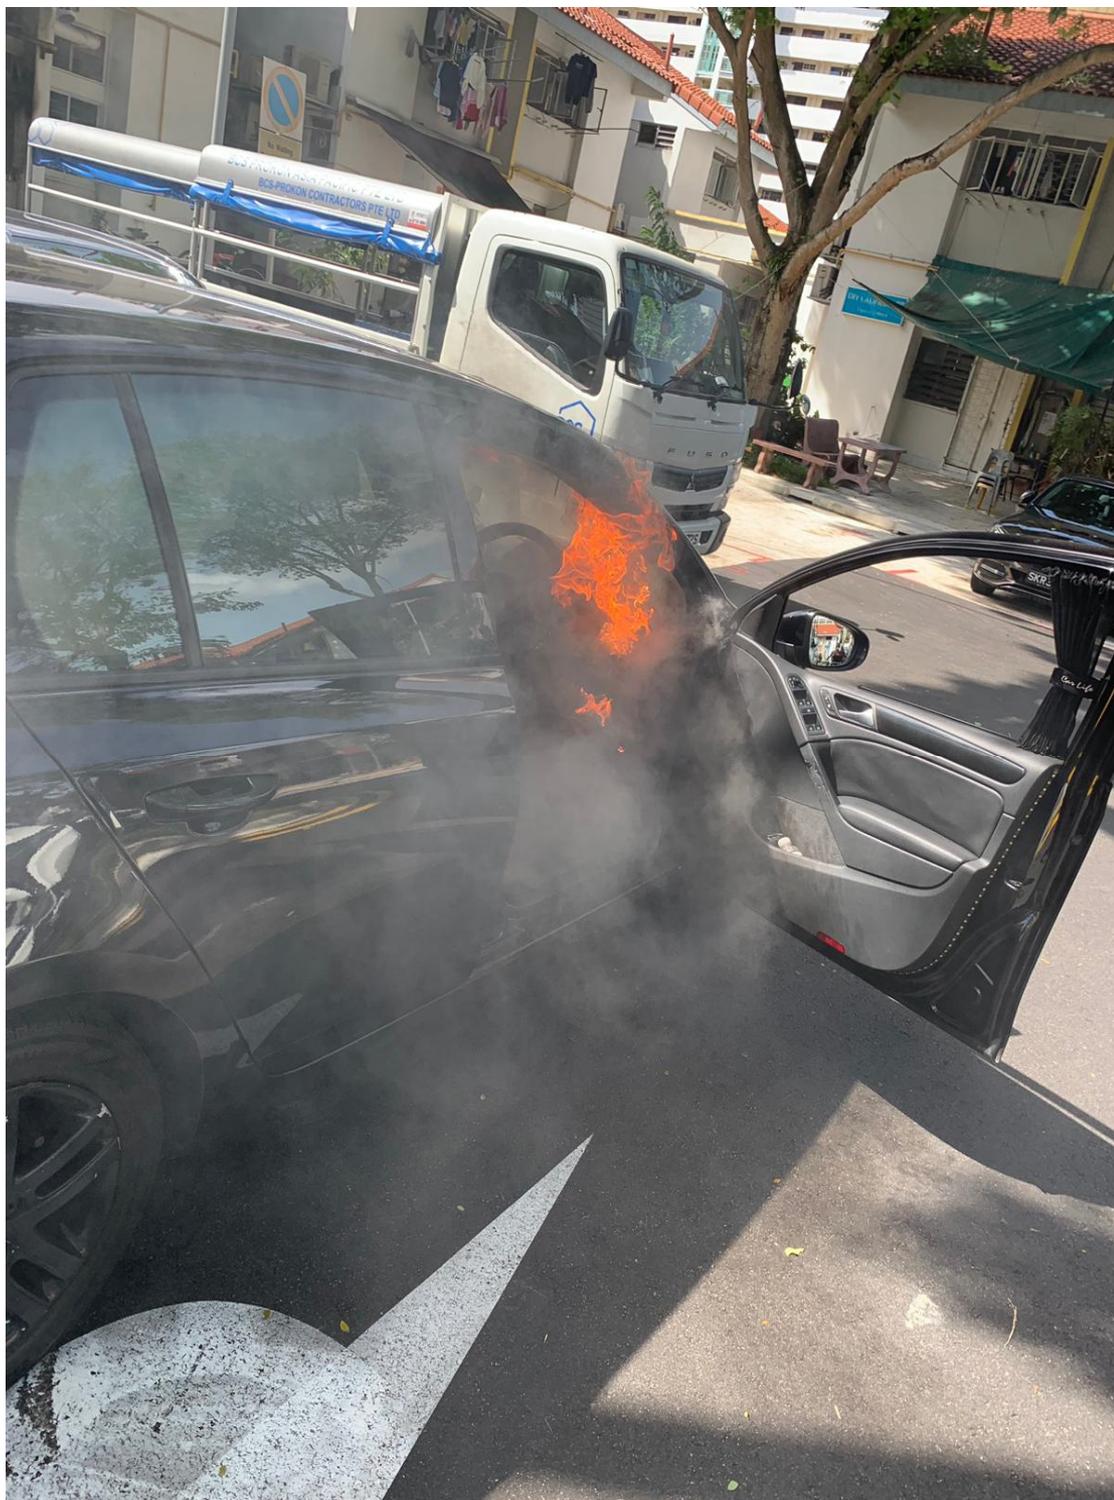
Photo 9 shows the Insured Vehicle at the incident scene (photograph provided to me by Mr Loo). Flames could be seen coming out from the dashboard area at the driver's side of the Insured Vehicle. Since there were no flames emitting from other areas of the Insured Vehicle, the origin of fire can be established to have been from the area behind the front dashboard, at the driver's side of the Insured Vehicle.

16. For this case, the fire to the Insured Vehicle can be established to have originated from the interior compartment, at the area behind the front dashboard, at the driver's side. This was established from information gathered upon reviewing the photographs provided by Mr Loo, as well as, from the physical damage to the Insured Vehicle, where the fire damage to the Insured Vehicle was observed to be confined to a single area ie at the driver's side inside the interior compartment of the Insured Vehicle.

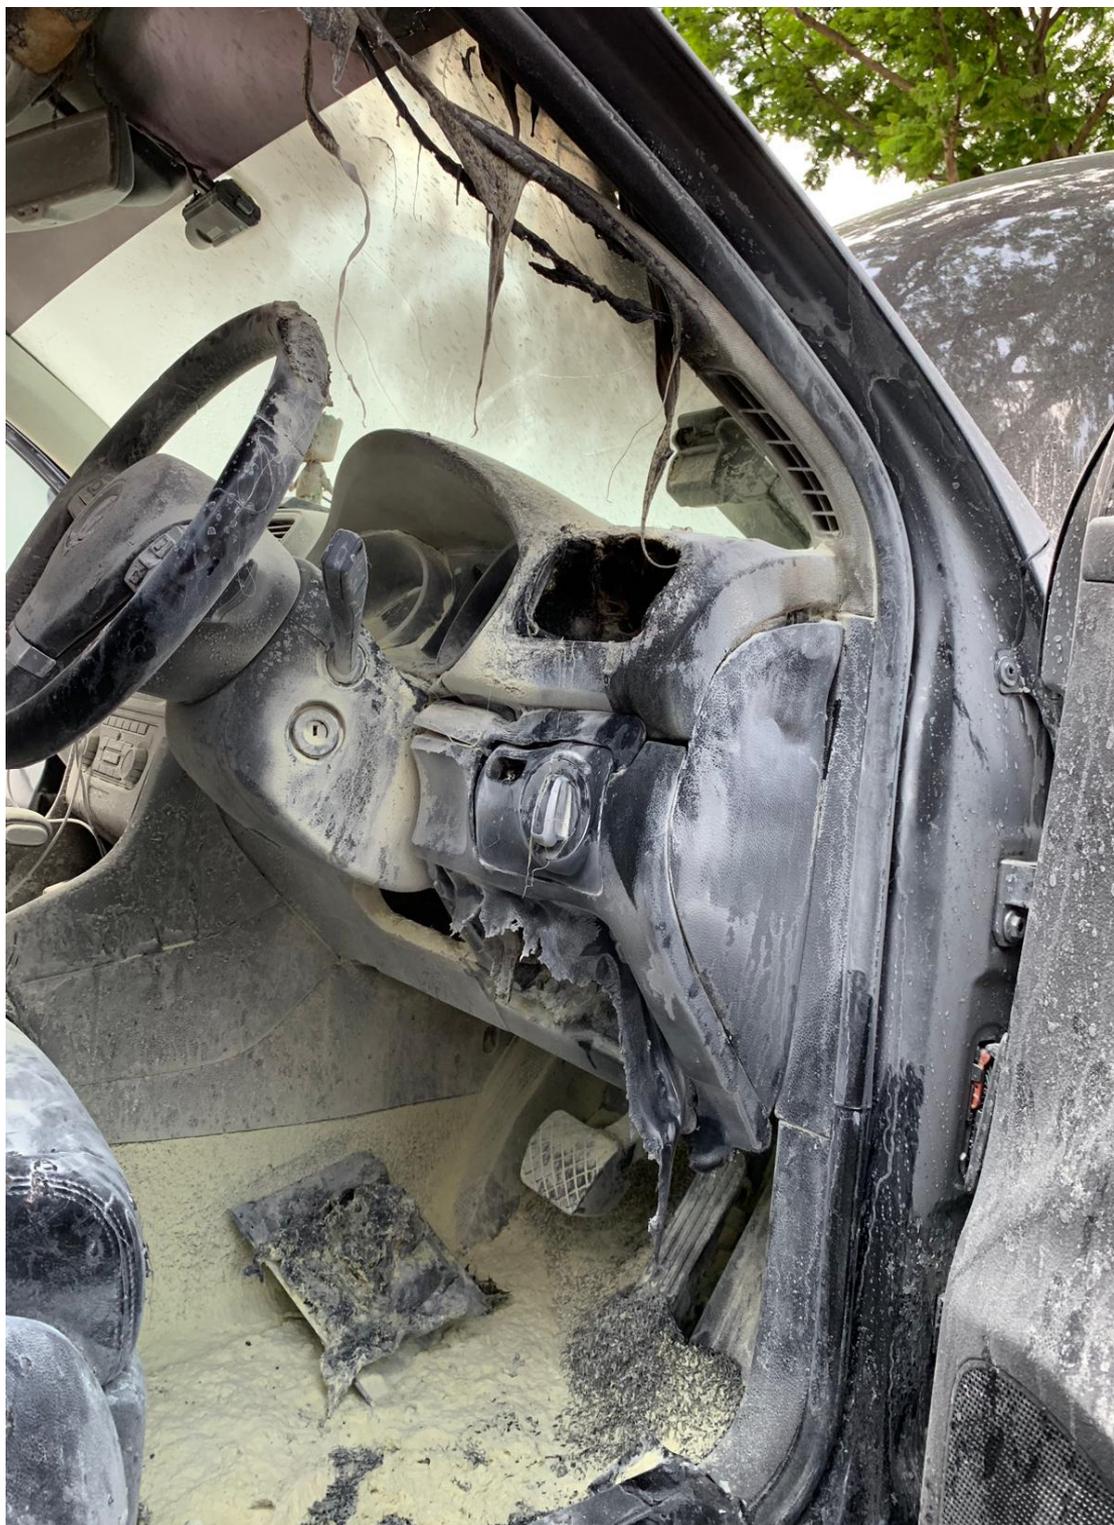
Photo 10 shows the Insured Vehicle at the incident scene after the fire was extinguished (photograph provided to me by Mr Loo). the fire damage seen inside the interior compartment of the Insured Vehicle immediately after the fire was extinguished was observed to be similar to what I had observed during my inspection of the Insured Vehicle.

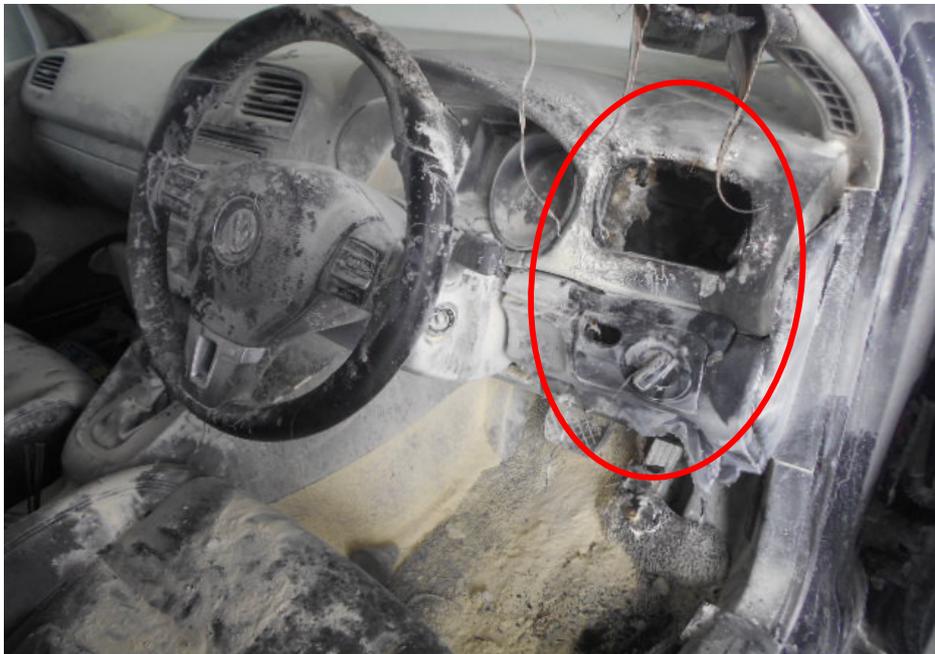
17. My examination of the area behind the front dashboard at the driver's side, which was where the fire to the Insured Vehicle had originated, revealed burnt wirings that were with faint greenish colour residue. The wirings were observed to be original factory fitted wirings leading to the interior fuse box of the Insured Vehicle that was located directly behind the front dashboard, where the fire had originated. The presence of greenish residue indicates internal heating of copper wires, a sign of an electrical short circuit occurring. The greenish residue is normally left behind from oxidation as a result of chemical reaction involving the copper wires. This physical evidence would then appear to indicate that the cause of fire to the Insured Vehicle was due to electrical in nature. See photo 11 - 13 below.

Photo 11 shows the interior compartment of the Insured Vehicle, at the driver's side. Basing on the information gathered during the course of my investigations, and the physical damage to the Insured Vehicle, the fire had originated at the area (circled) behind the front dashboard.

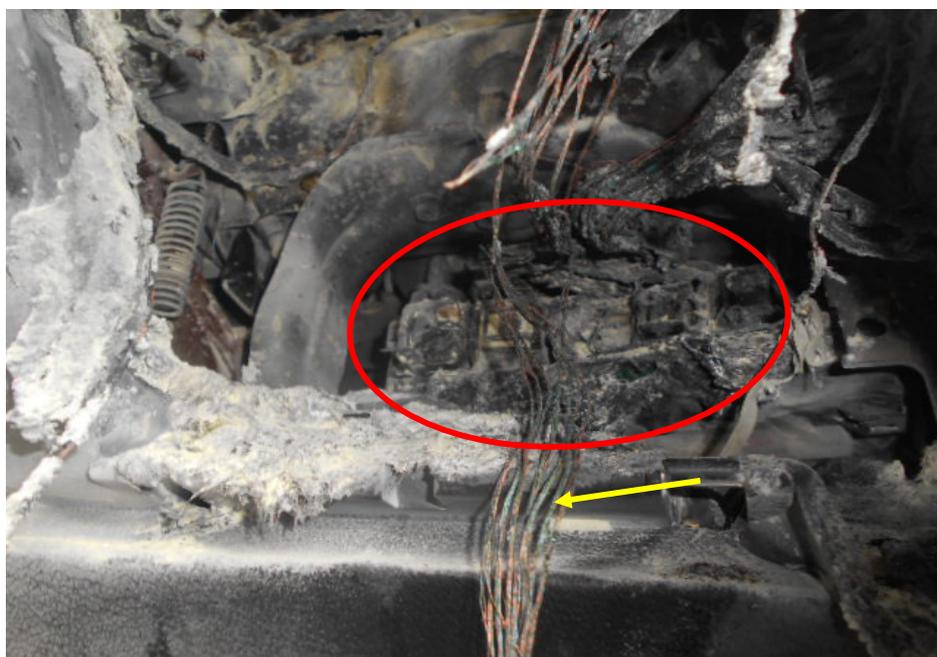
Photo 12 shows the burnt wirings that were with faint greenish colour residue (arrowed). The wirings were observed to be wirings leading to the interior fuse box (circled) of the Insured Vehicle that was located directly behind the front dashboard at the driver's side, where the fire had originated. The presence of greenish residue indicates internal heating of copper wires, a sign of an electrical short circuit occurring. The greenish residue is normally left behind from oxidation as a result of chemical reaction involving the copper wires. This physical evidence would then appear to indicate that the cause of fire to the Insured Vehicle was due to electrical nature.

19. Having investigated and technically analysed the damages of burnt nature to the Insured Vehicle, I am of the view that the cause of fire to the Insured Vehicle was of electrical in nature. For this particular case, the fire had originated along the wirings behind the front dashboard inside the interior compartment, at the driver's side of the Insured Vehicle. The wirings were original fitted wirings leading to the interior fuse box of the Insured Vehicle that was located directly behind the front dashboard, where the fire had originated.

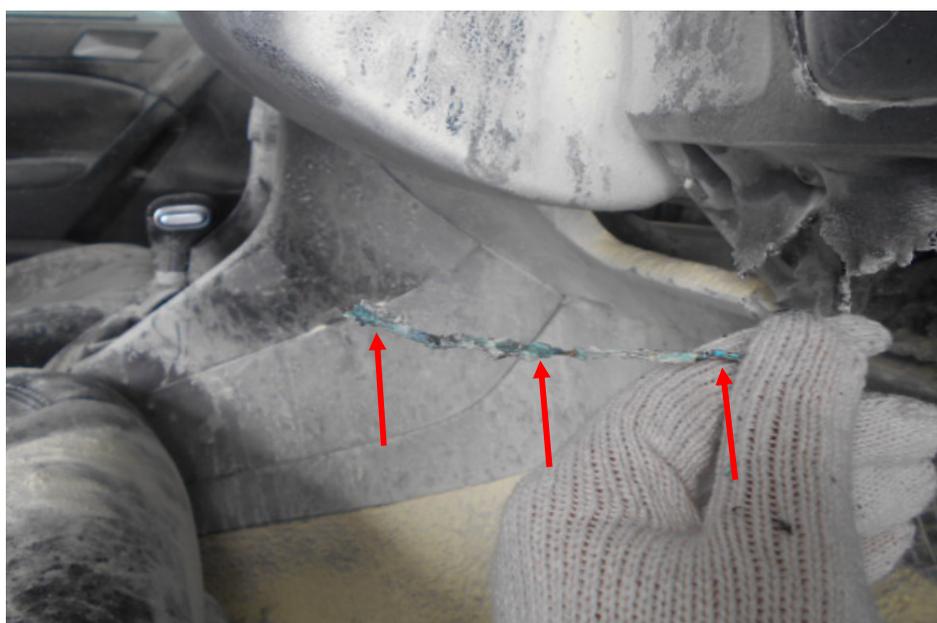
Photo 13 shows a closer view of the burnt wirings that were with faint greenish colour residue (arrowed). The presence of greenish residue indicates internal heating of copper wires, a sign of an electrical short circuit occurring.
