THIRD PARTY SURVEY

ACCIDENT HAPPENED ON 15 Nov 2018

Vehicle No: SJV 6617 Y
 Report No: TP/ 11-18039/AY / 2018

VEHICLE DAMAGE INSPECTION REPORT

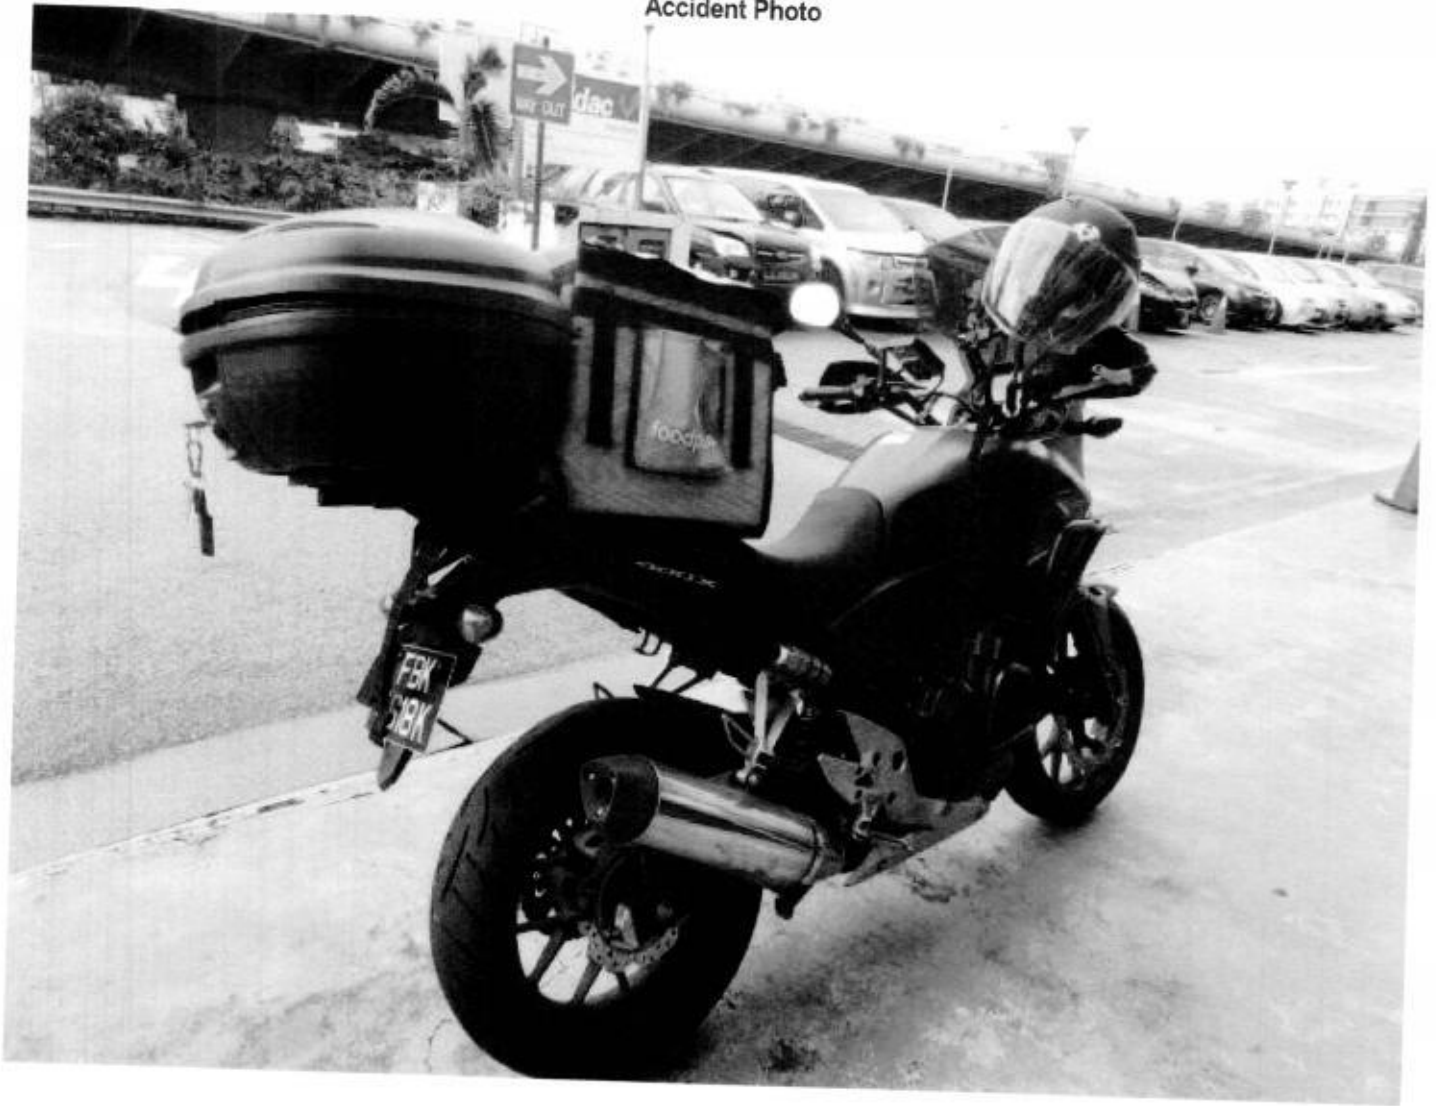
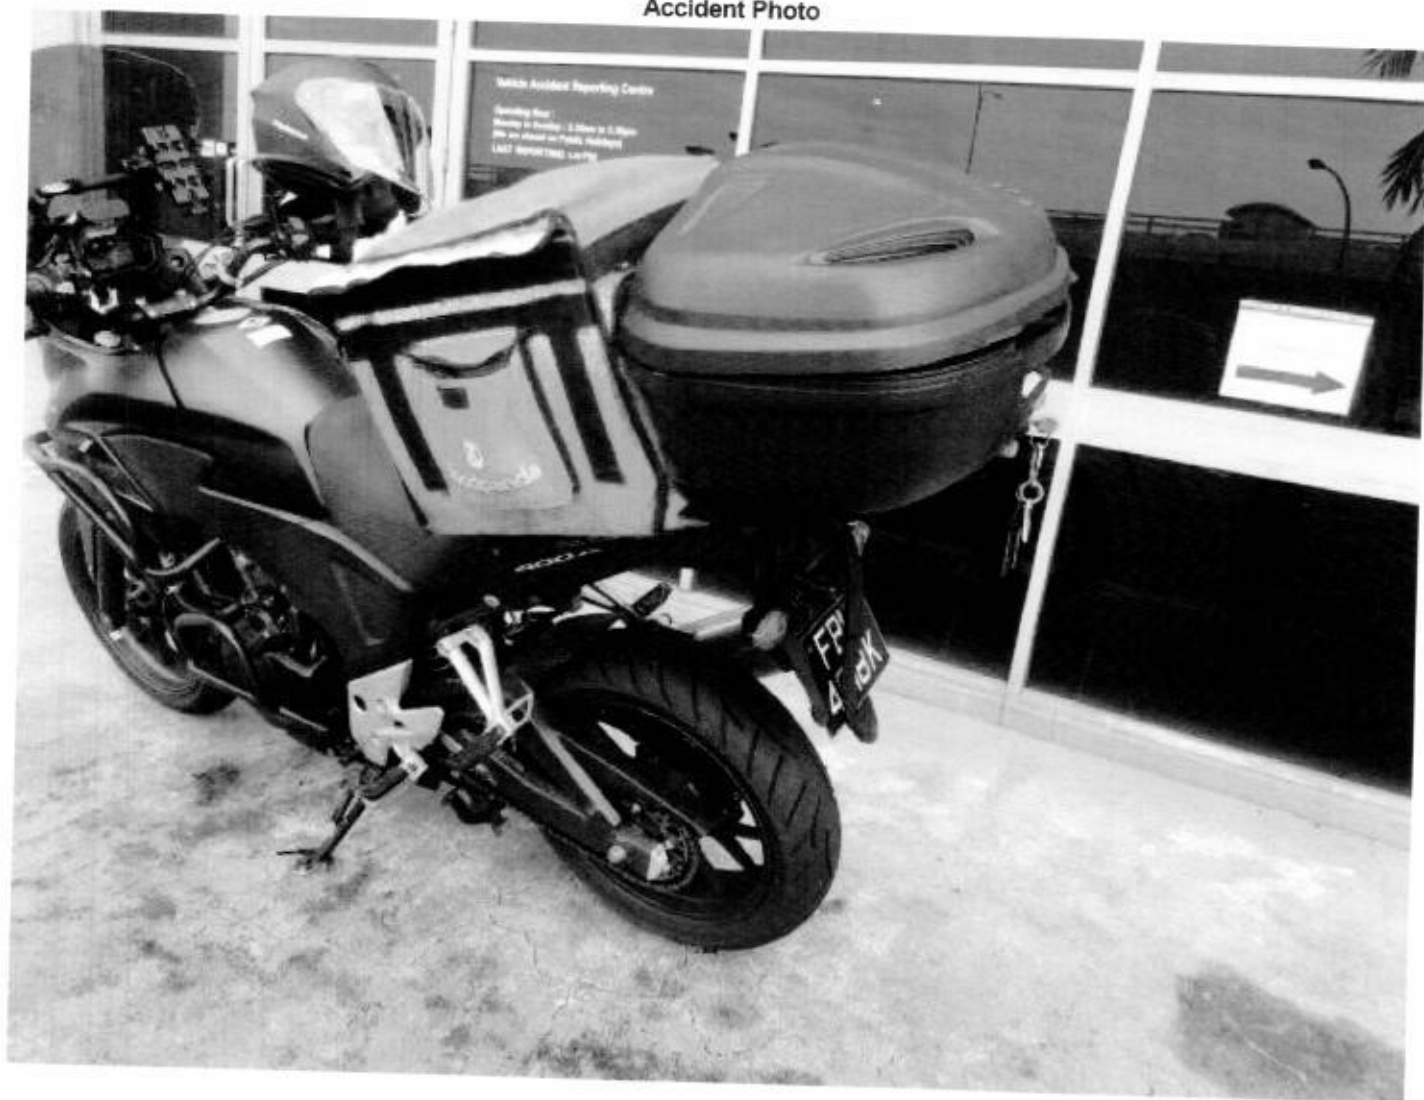
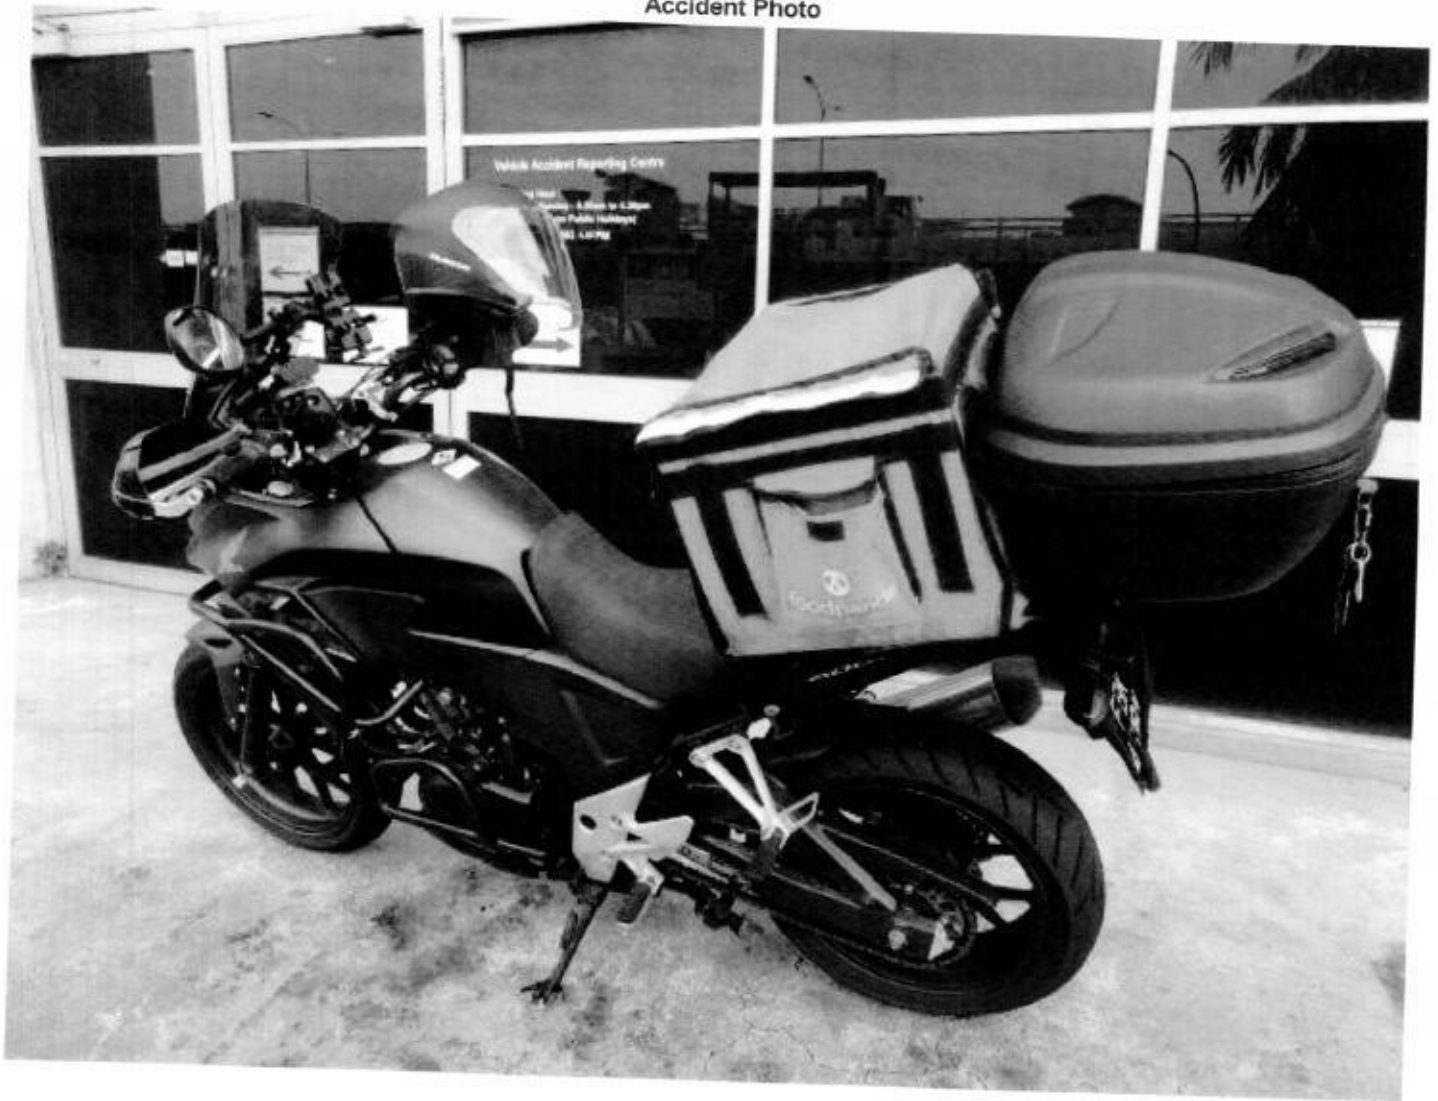
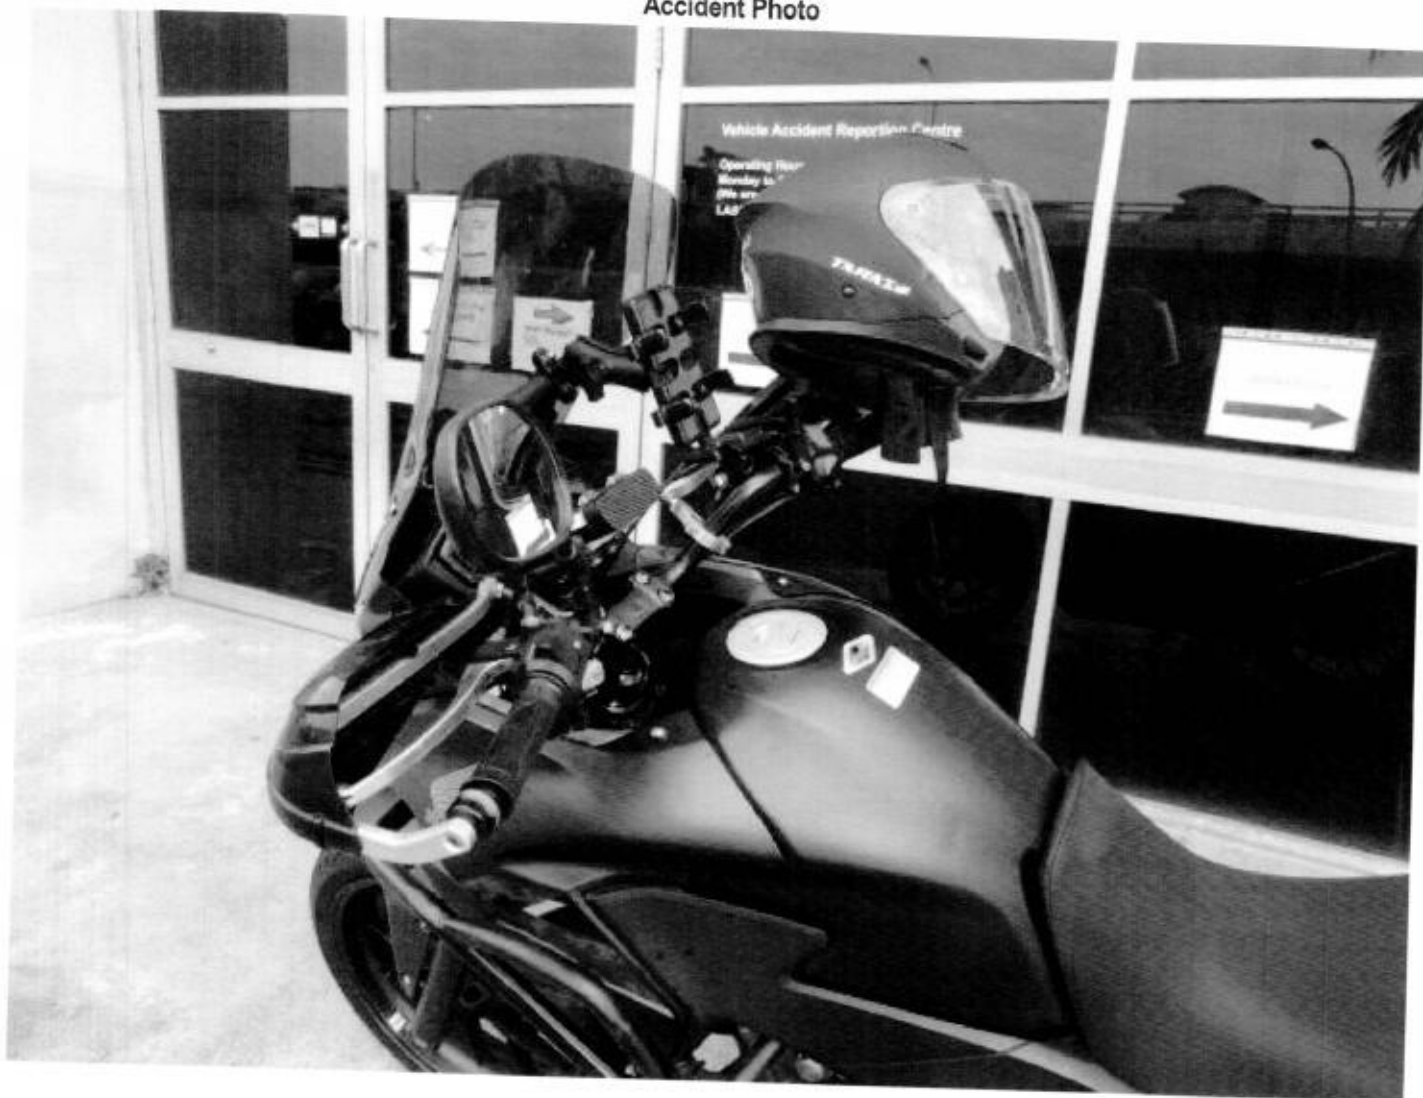
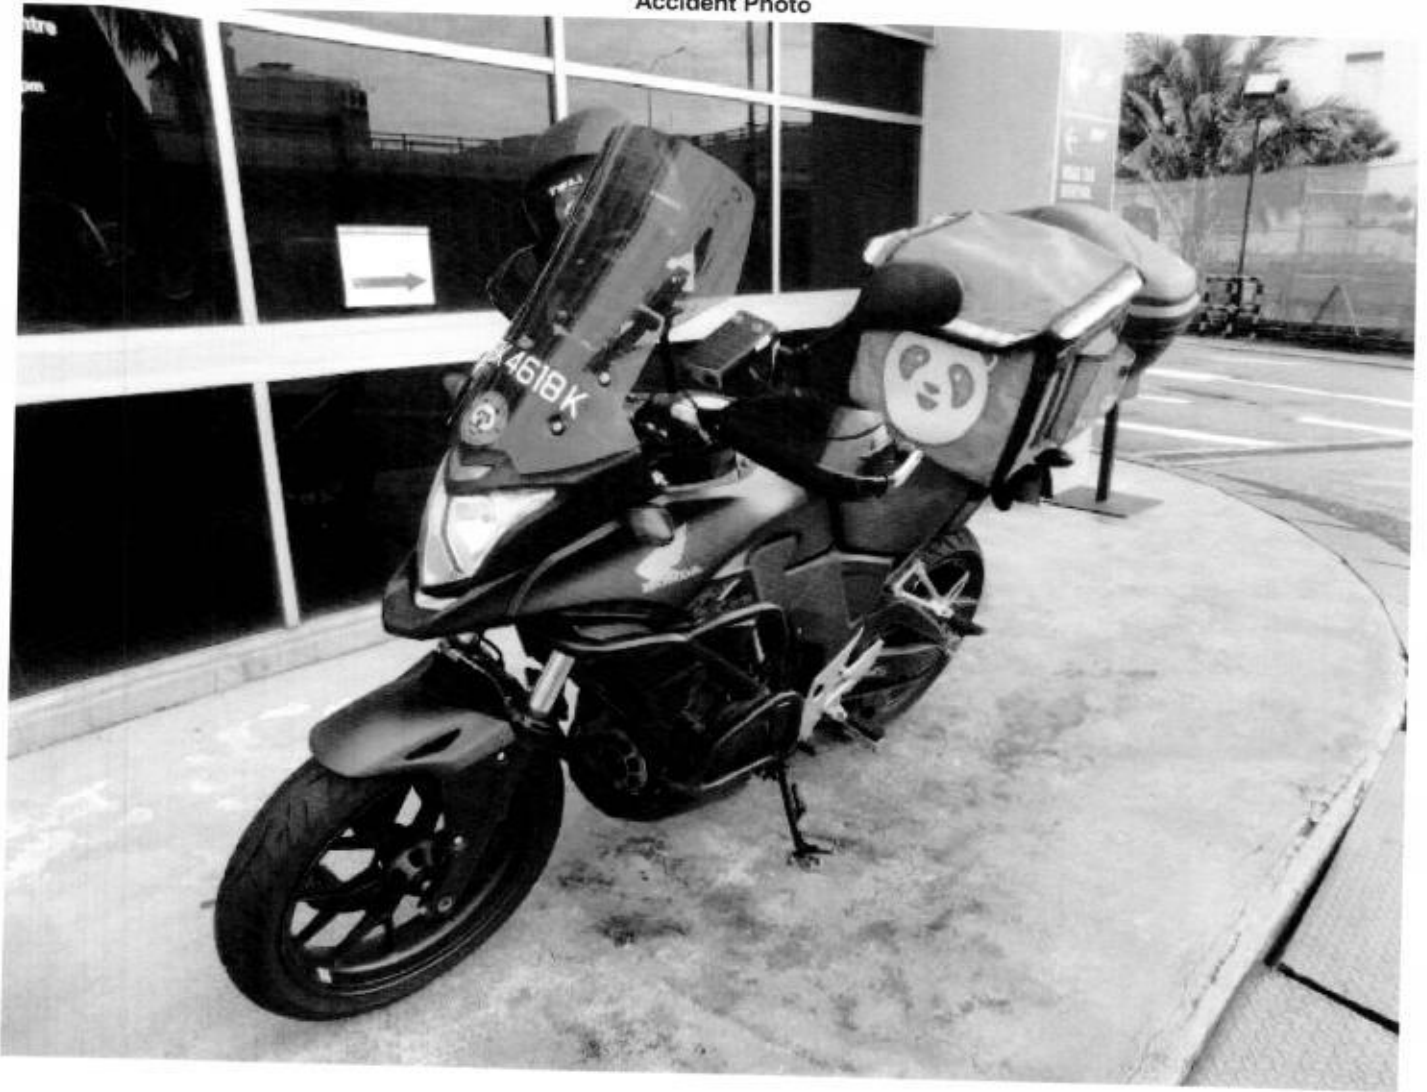
Accident Photo

At the time of inspection, we noted that the vehicle has sustained an impact damages on the front n/s portion(s). For more detail of the damages, please see photograph attached.
