Your Ref: BMW 420i  
(chassis number WBA4H32050BH12422)  
Our Ref : CI/TP19002147/D

01 February 2019

**INSPECTION REPORT OF AN UNREGISTERD BMW 420i MOTOR CAR WITH CHASSIS NUMBER WBA4H32050BH12422**

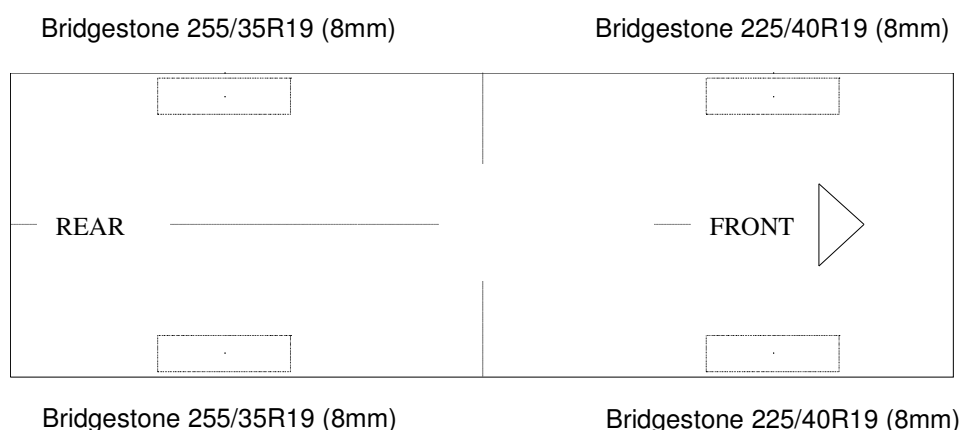
6. It was fitted with 19inch sport wheel rims that were wrapped with tyres that were observed to be of serviceable condition. The tyres were also sufficiently inflated for vehicular operation. The tyre brand, tyre size and approximate remaining tread depth of the 4 tyres of the Motor Car were recorded as follows: -

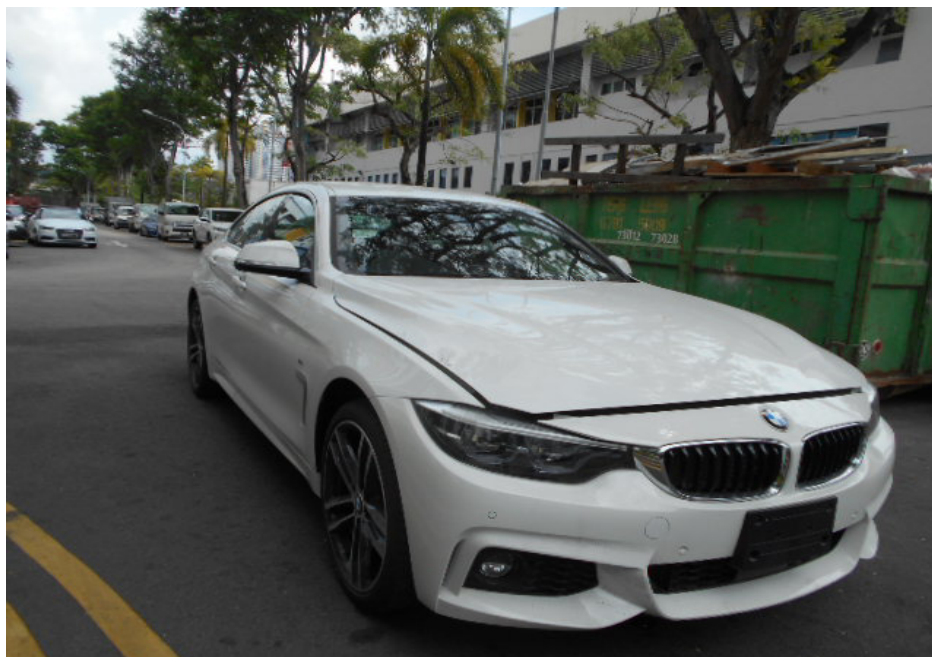
**Photo 1** shows a general view of the front right body of the Motor Car at the time of my inspection. The Motor Car was observed to be in relatively good general condition with no loose exterior fittings observed.

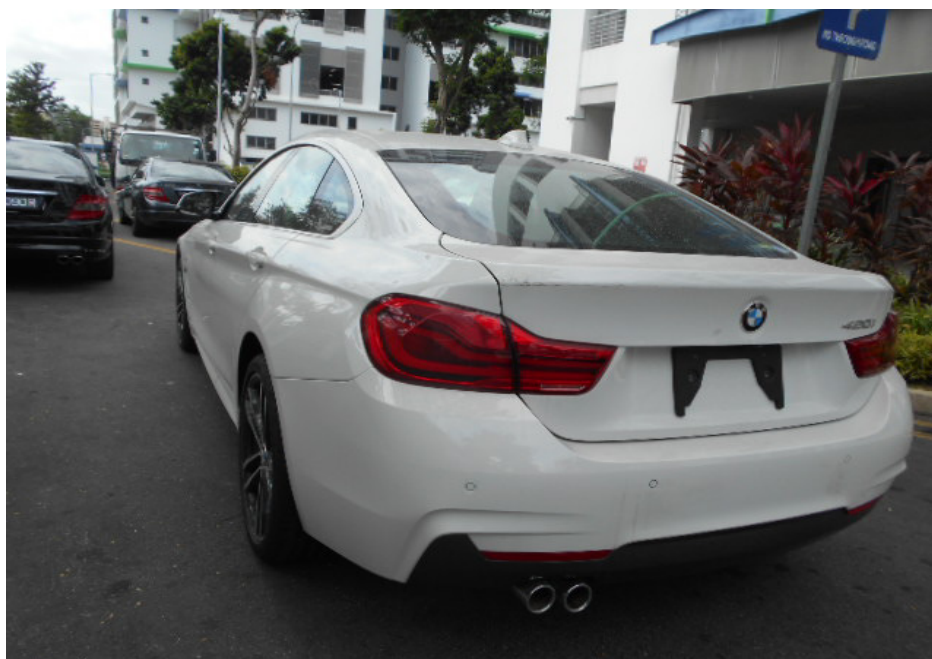
**Photo 2** shows a general view of the rear left body of the Motor Car at the time of my inspection. The Motor Car was observed to be in relatively good general condition with no loose exterior fittings observed.

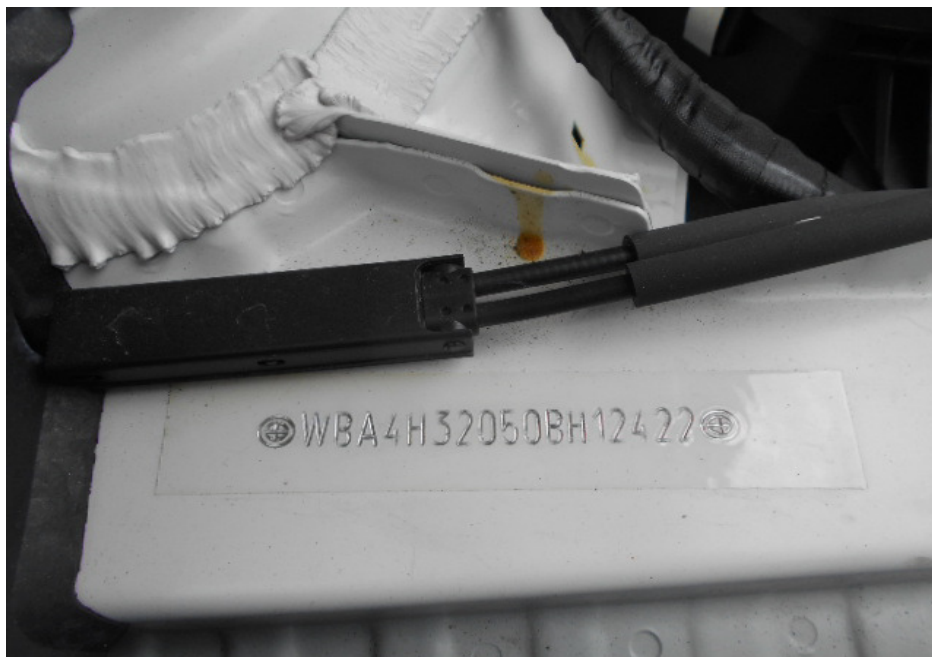
**Photo 3** shows the chassis number of the Motor Car. The chassis number recorded was WBA4H32050BH12422.

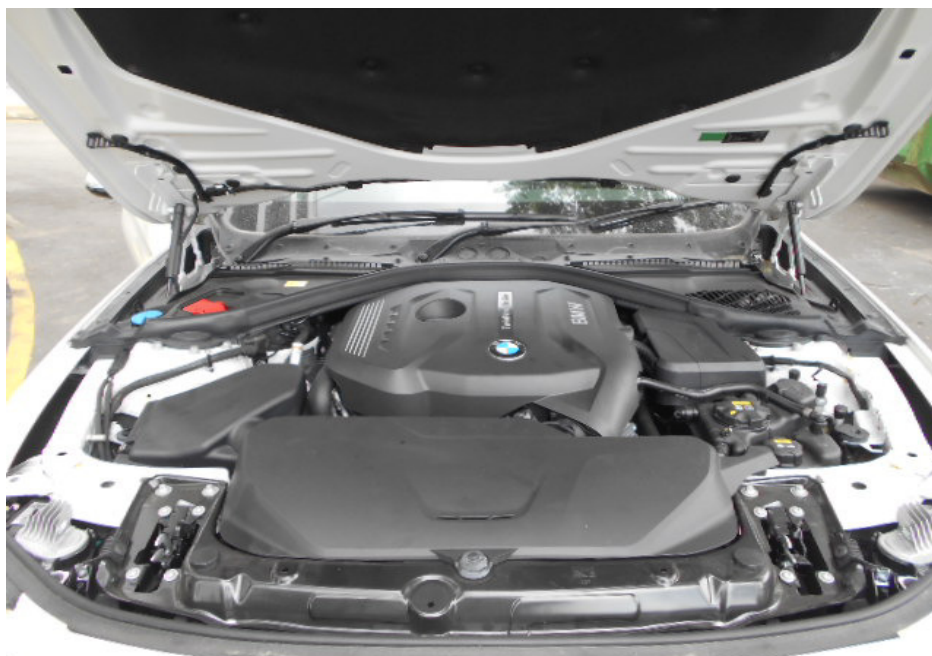
12. My examination of the engine compartment of the Motor Car revealed that the various parts and components inside the engine compartment were all intact and properly fitted. The engine oil, transmission fluid, brake fluid and engine coolant were all found to be of sufficient level for operating purposes. Visually, there was also no contamination found to these fluids.
13. My checks on the underside of the Motor Car revealed no sign(s) or indication(s) of fluid leakage and/or fluid stain(s). The engine block and automatic transmission assembly were both secured properly. They were not mounted onto the chassis body or any integral body part of the Motor Car. All undercarriage components of the Motor Car were also observed to be intact and secured in an appropriate manner.

**Photo 4** shows a general view of the engine compartment of the Motor Car at the time of my inspection. The various parts and components inside the engine compartment were all observed to be intact and properly fitted. There was also no sign(s) or indication(s) of fluid leak and/or fluid stain found inside the engine compartment.

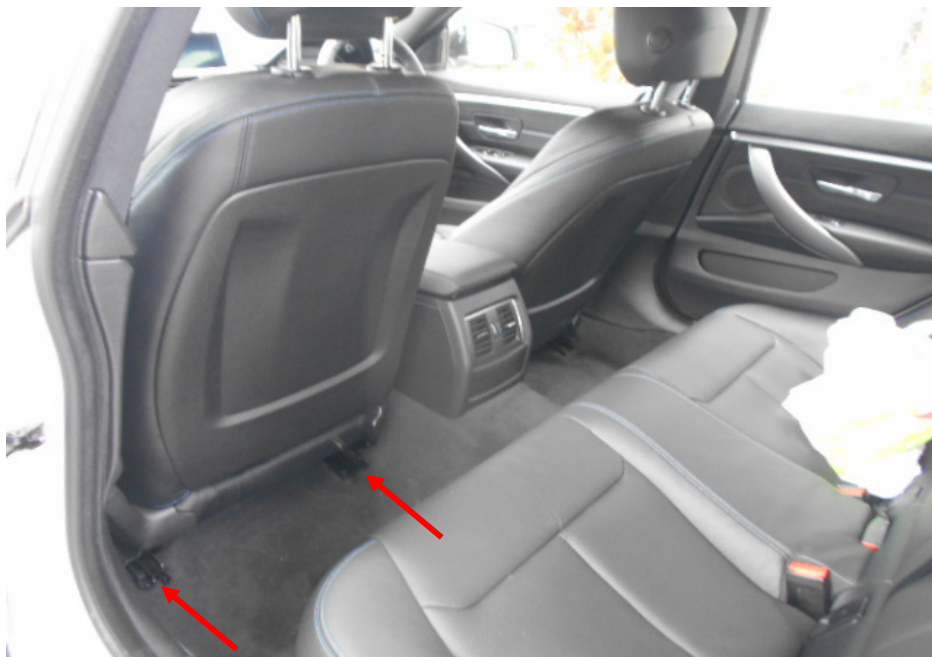
10. The seats of the Motor Car were found to be secured to the floor board of the Motor Car via seat rails bolted onto the floor board. Retractable seat belt reels and pre-tensioners were fitted on all seats of the Motor Car. The seat belt reels were able to be fastened securely to the respective pre-tensioner that is fixed to the side of all the seats.

**Photo 5** shows the seats of the Motor Car, which were secured via seat rails (arrowed) to the floor board. All the seats of the Motor Car were fitted with a retractable seat belt reel and pre-tensioner. The seat belts were also able to be fastened to the pretension that were fitted on the side of each individual seat.

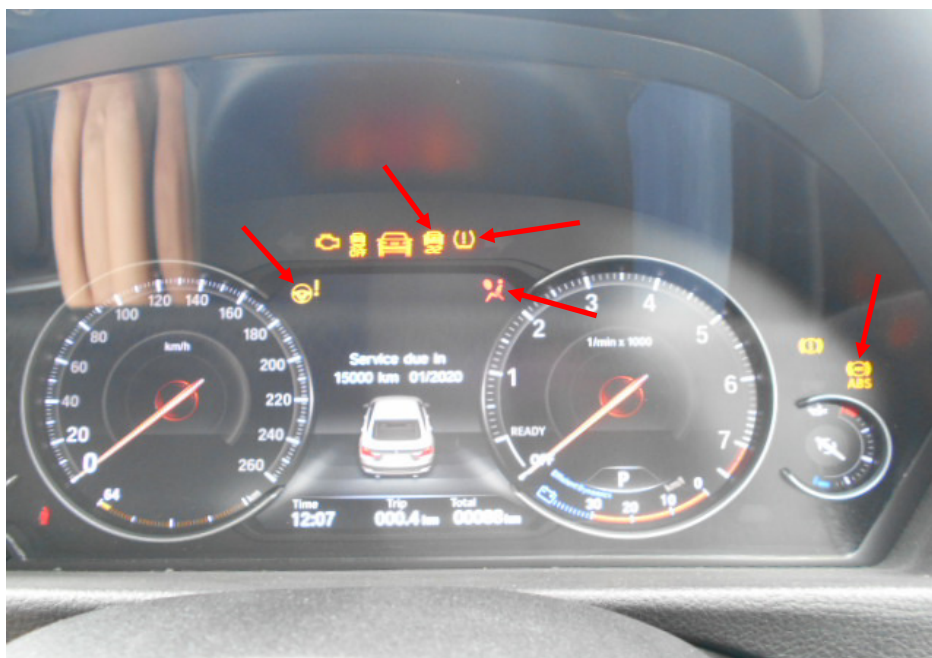
**Photo 6** shows the warning lights for the various electronic safety features appearing on the instrument panel of the Motor Car during its self-test when the engine is cranked, in particular the ABS, SRS, IAS, TPM and DSC lights (arrowed).

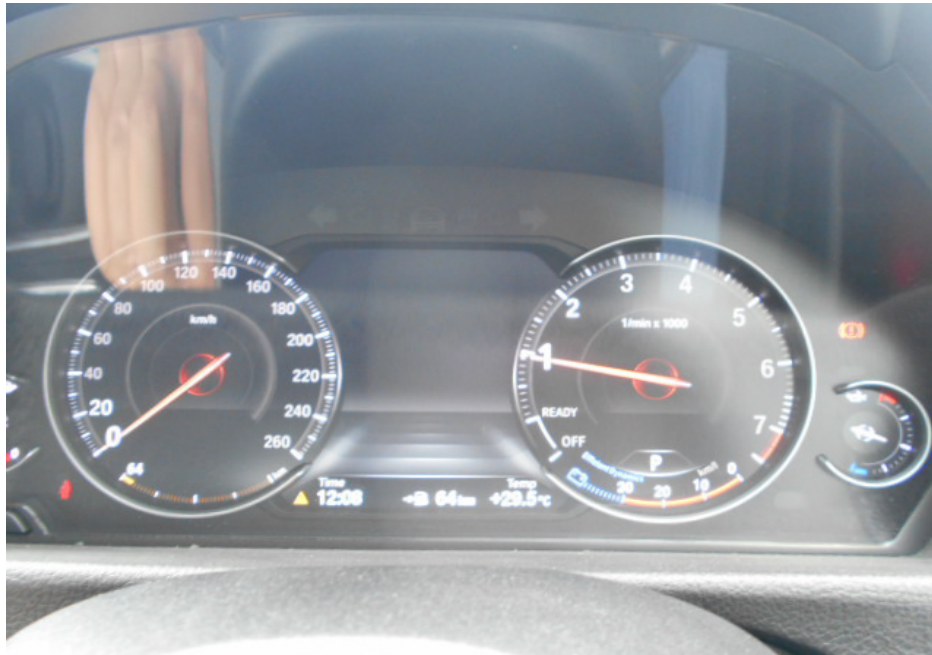
11. The Motor Car's automatic self-test of the functionality of its various electronic safety features like the Anti-Brake Lock System (ABS), Supplemental Restraint System (SRS), Integral Active Steering (IAS), Tyre Pressure Monitor (TPM) and Dynamic Stability Control (DSC) during cranking of the engine had indicated that these electronic systems were in working condition. This was determined from the respective warning lights disappearing from the instrument panel after the self-test.

**Photo 7** shows the respective warning lights no longer illuminated, indicating that there is no fault detected to the ABS, SRS, IAS, TPM and DSC systems of the Motor Car during the self-test. These electronic systems were hence in working condition at the time of my inspection.

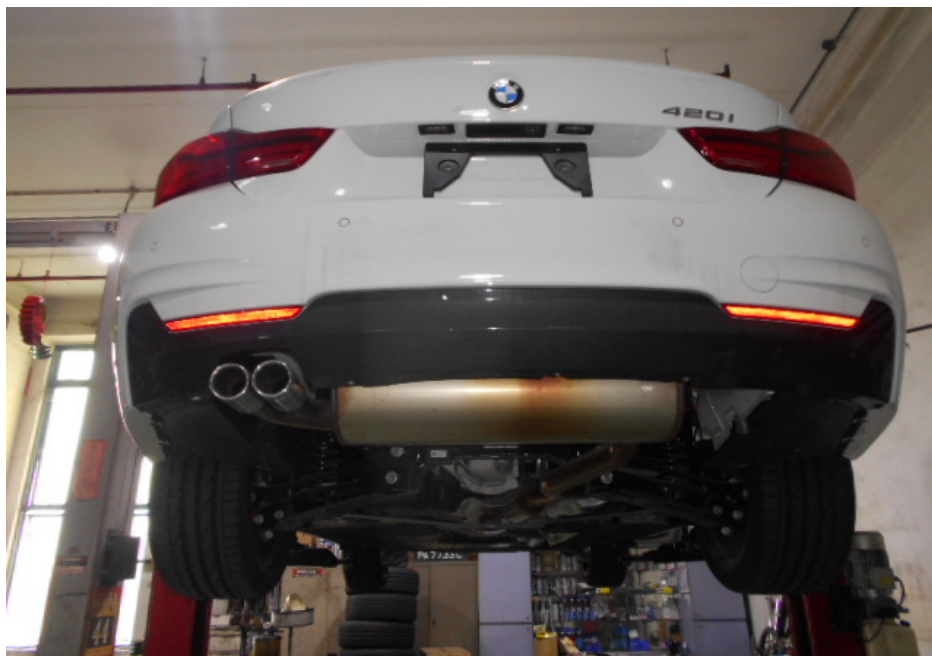
**Photo 8** shows the Motor Car hoisted up for checks on its undercarriage. There was no sign(s) or indication(s) of fluid leakage and/or fluid stain(s). The undercarriage components of the Motor Car were also all observed to be intact and secured in an appropriate manner.

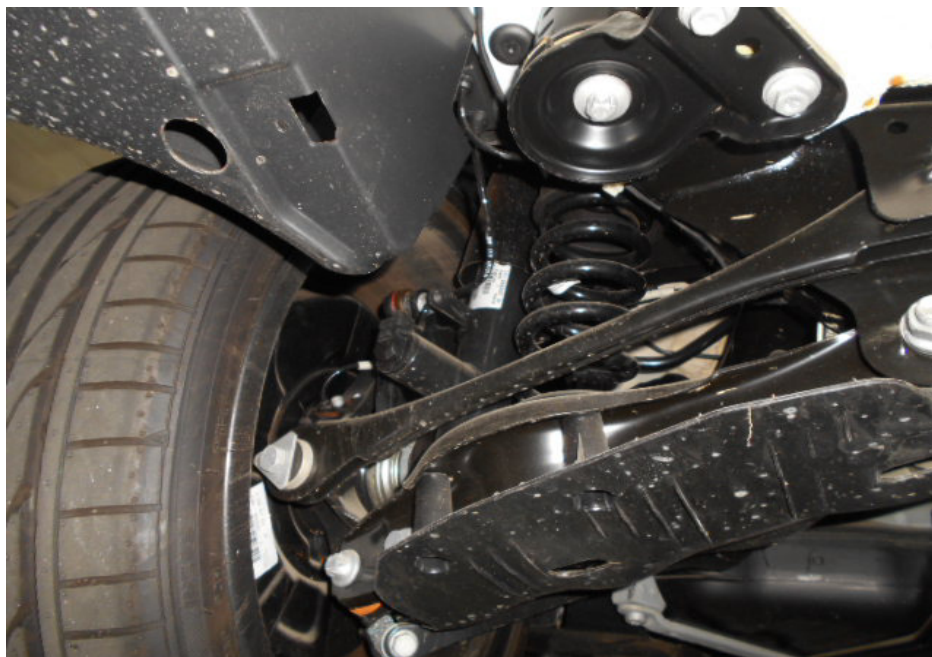
**Photo 9** shows a general view of the control arms and linkages at the rear left wheel of the Motor Car. I did not observe any fluid leak and/or fluid stain on the underside of the Motor Car. All of the Motor Car's undercarriage components were observed to be intact and secured in an appropriate manner.

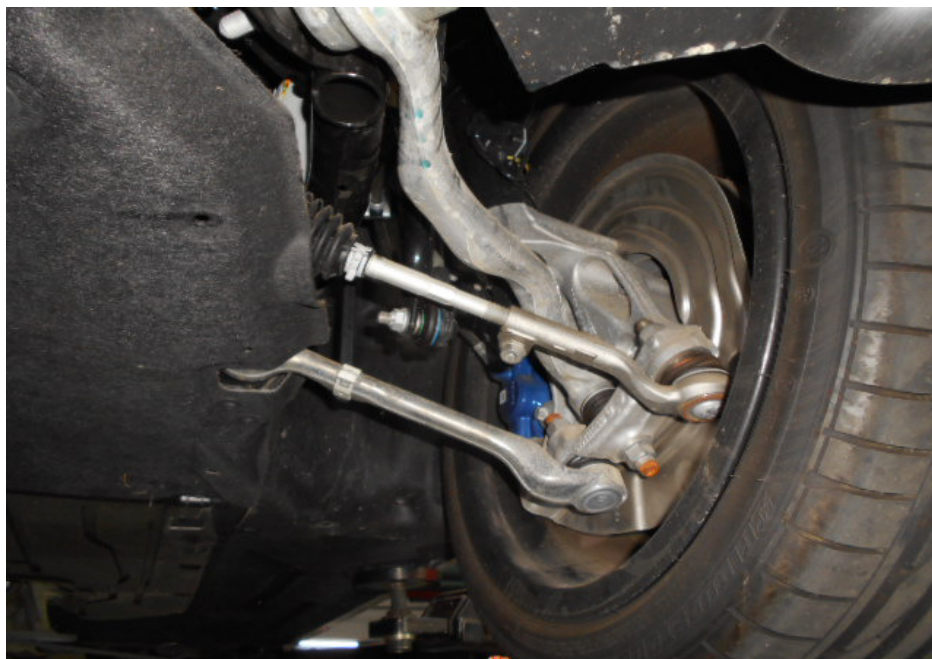
**Photo 10** shows the various undercarriage components at the front left wheel of the Motor Car. The mechanical components, control arms and linkages were all found to be intact and secured in an appropriate manner.

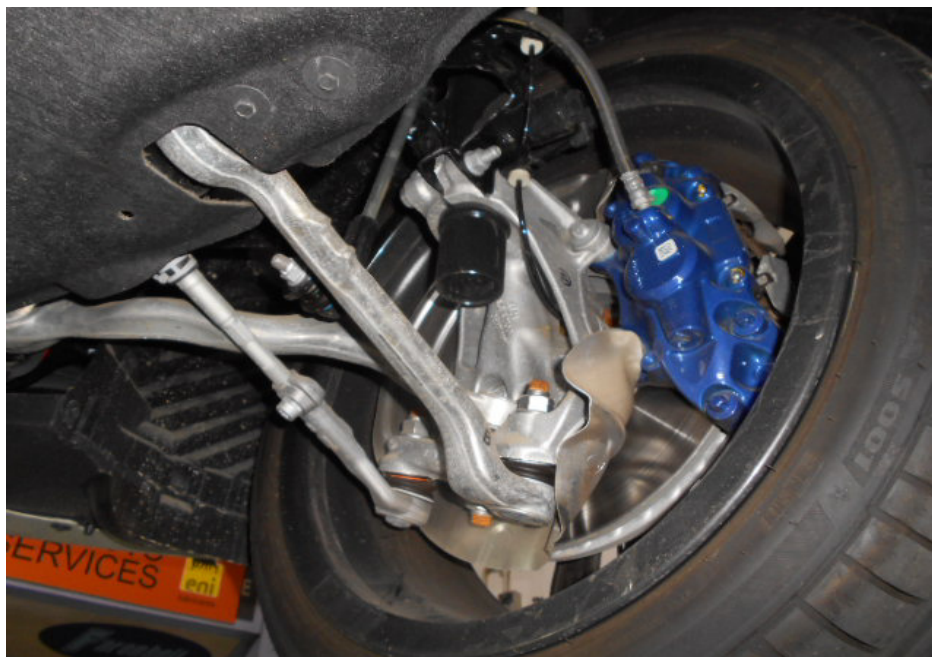
**Photo 11** shows the various undercarriage components at the front right wheel of the Motor Car. The mechanical components, control arms and linkages were all found to be intact and secured in an appropriate manner.

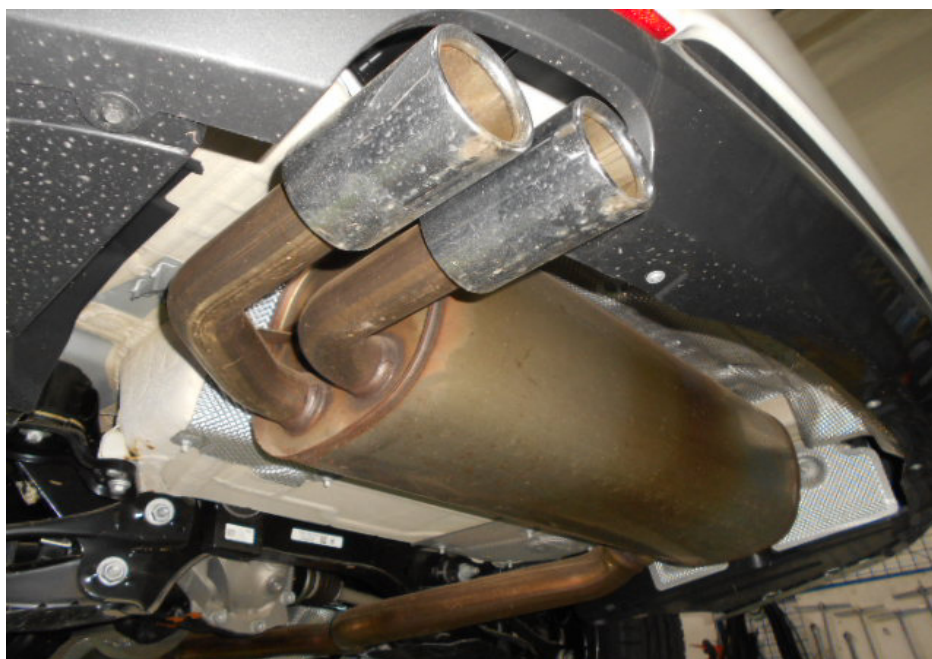
**Photo 12** shows the Motor Car's rear exhaust muffler. My examination of the Motor Car's exhaust system revealed no sign(s) or indication(s) of any cut or weld marks along its exhaust pipes and on its rear mufflers.

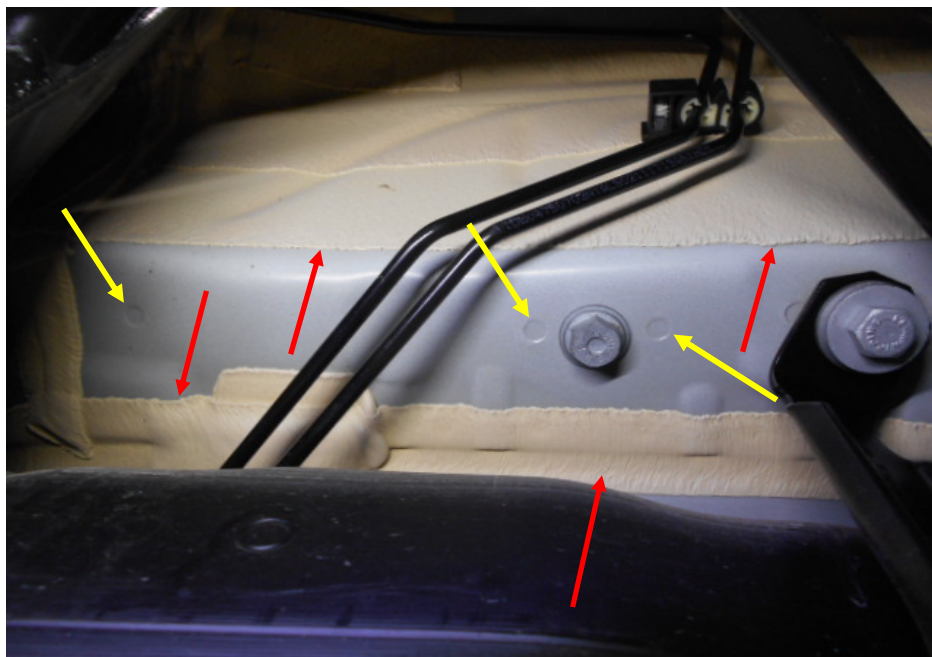
9. Visually, I did not find any weld marks, other than the original spot weld marks, on the chassis body of the Motor Car. The original factory sealant at the joints along the chassis body was also untouched, again indicating that no replacement of the chassis body was carried out; and that the chassis body was originally fitted.

**Photo 13** shows the structural body at the underside left centre of the Motor Car. Visually, I did not find any weld marks other than original spot weld marks (yellow arrow) on the chassis body of the Motor Car. The original factory sealant (red arrow) at the joints along the chassis body was also untouched, indicating no work was done on the chassis body of the Motor Car and that the chassis body was originally fitted.

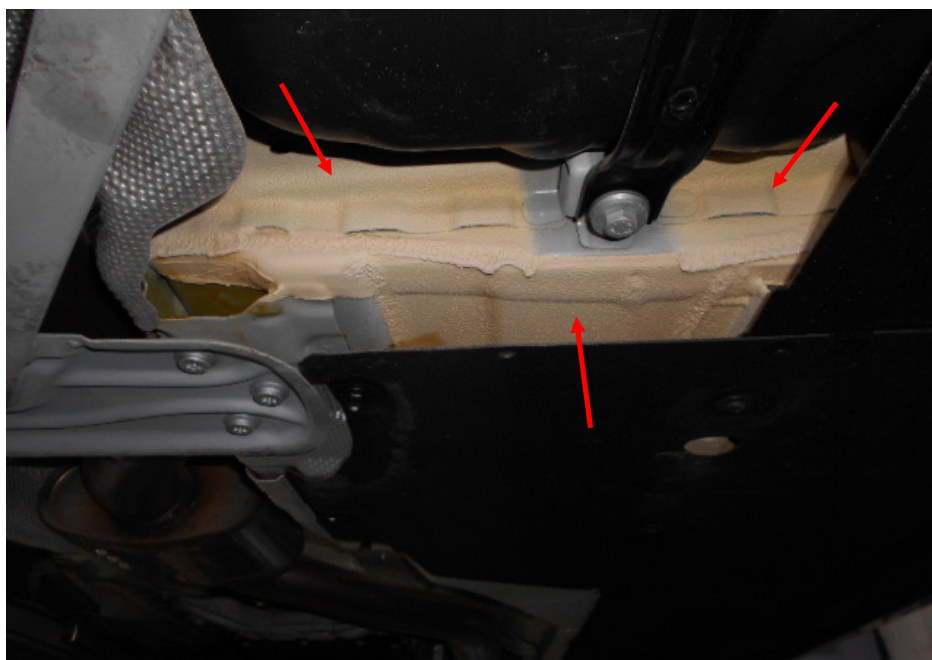
**Photo 14** shows the structural body at the underside right centre of the Motor Car. Visually, The original factory sealant (arrowed) at the joints along the chassis body was untouched, indicating no work was done on the chassis body of the Motor Car and that the chassis body was originally fitted.

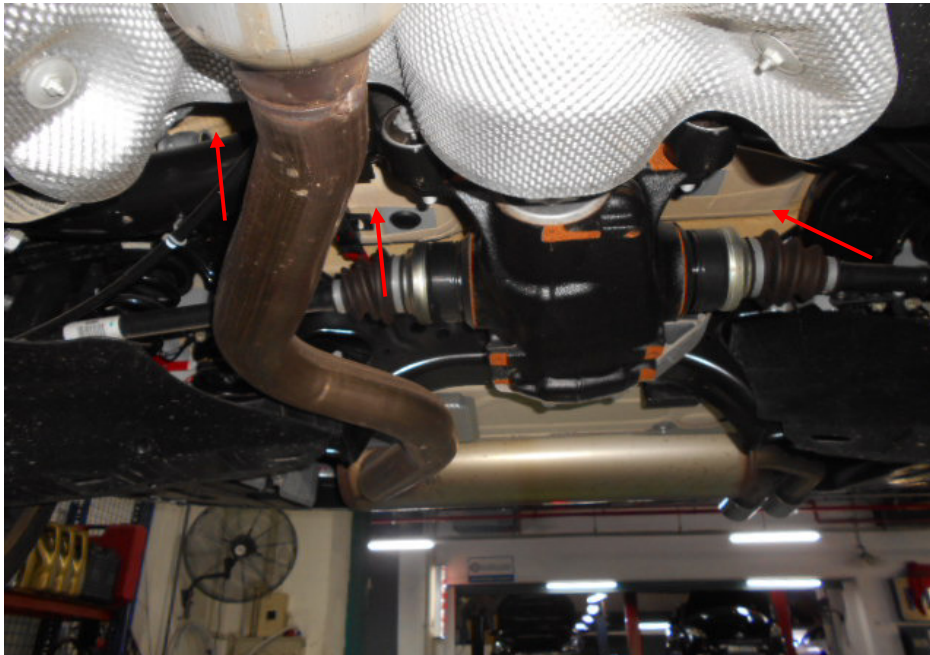
**Photo 15** shows the structural body at the underside rear centre of the Motor Car. The original factory sealant (arrowed) at the joints along the chassis body was untouched, indicating no work was done on the chassis body of the Motor Car and that the chassis body was originally fitted.

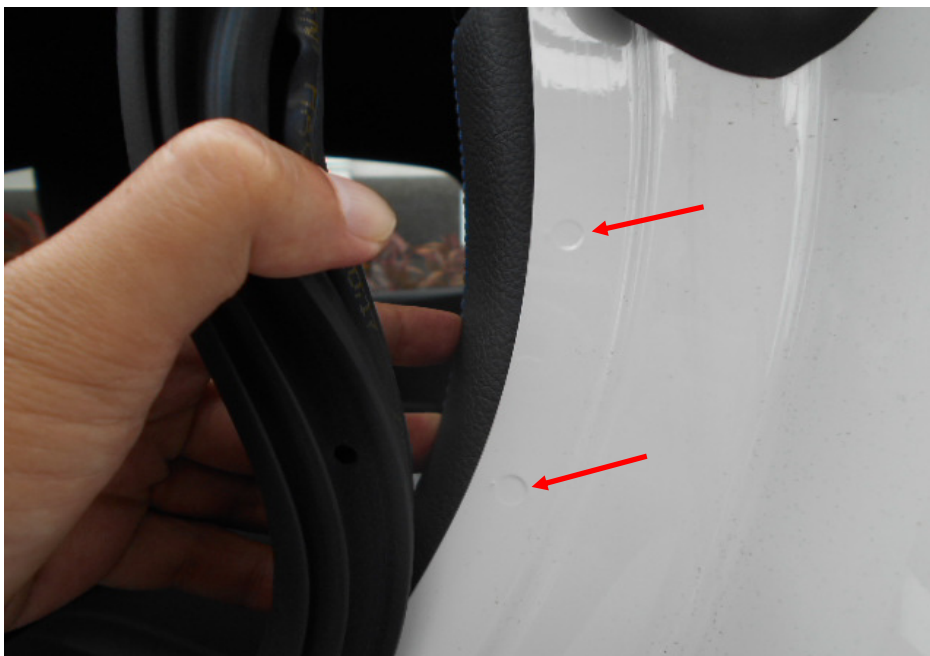
**Photo 16** shows the rear left "C" pillar of the Motor Car. I did not find any weld marks other than original spot weld marks (arrowed) on the body panels of the Motor Car, indicating that there was no re-welding works carried out; and that the body panels of the Motor Car were originally fitted

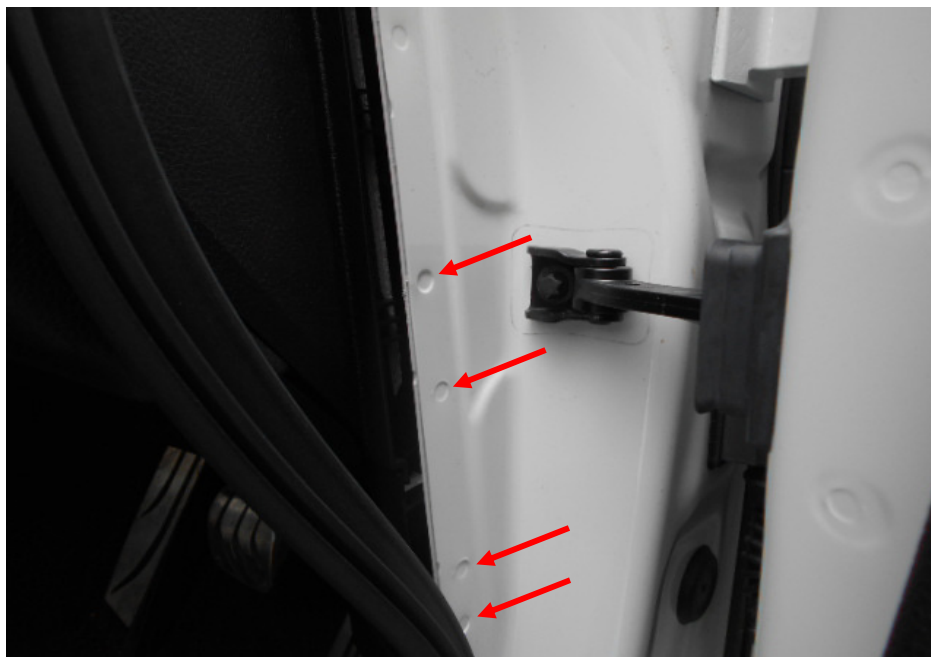
**Photo 17** shows the front right “A” pillar of the Motor Car. I did not find any weld marks other than original spot weld marks (arrowed) on the body panels of the Motor Car, indicating that there was no re-welding works carried out; and that the body panels of the Motor Car were originally fitted.
