Your Ref: Honda Engine
(number B16A5205833)
Our Ref : CI/TP19002148/D

01 February 2019

INSPECTION REPORT OF A HONDA ENGINE WITH NUMBER B16A5205833

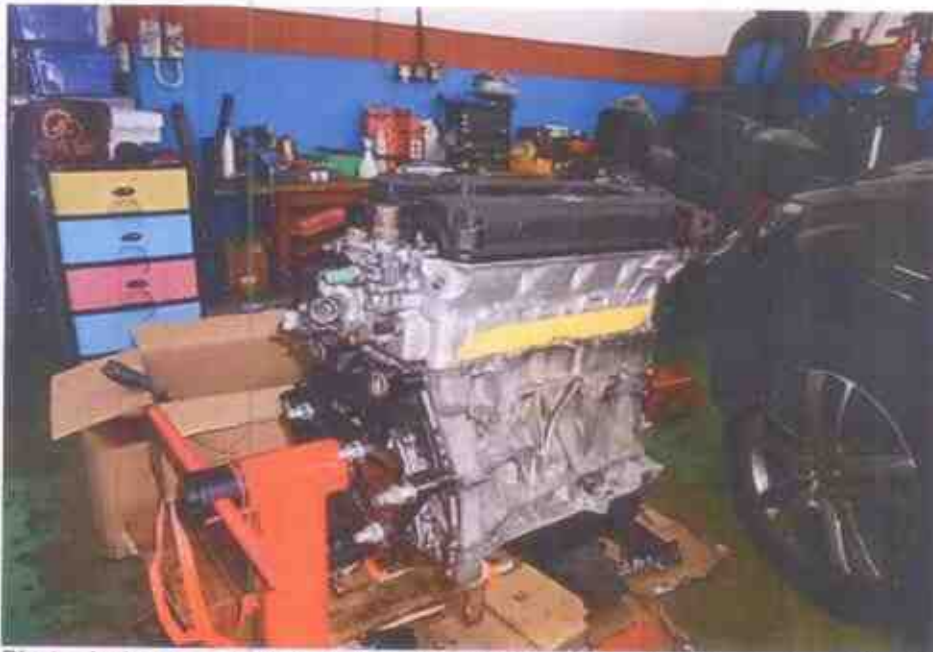
Photo 1 shows a general view of the Honda engine that I had inspected. The Honda engine was observed to be a used engine and was not fitted on any motor car. My visual examination of the engine housing revealed the housing to be of serviceable/satisfactory condition. There was no crack and/or hole observed on the engine housing.

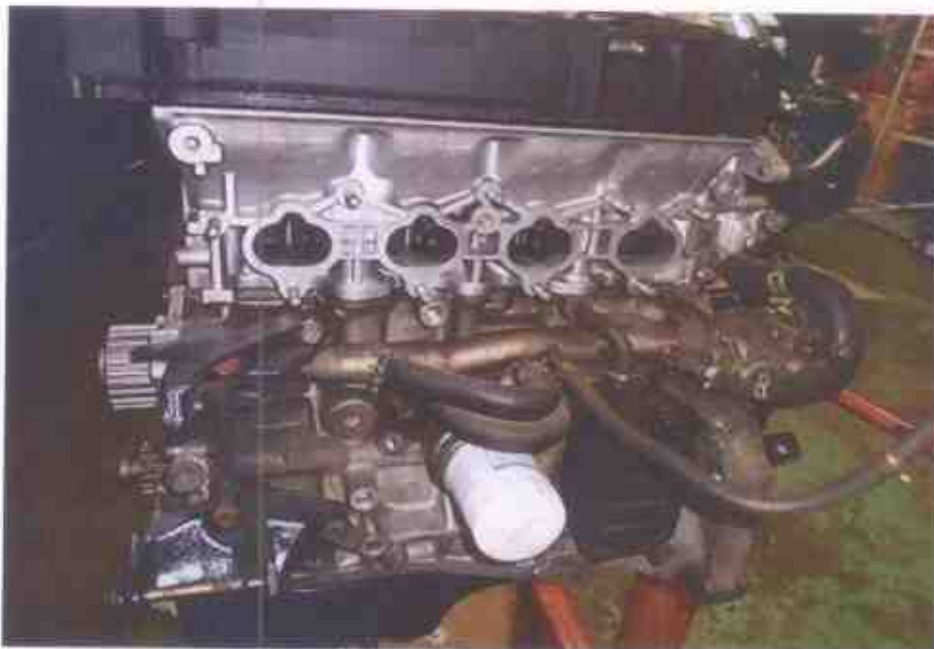
Photo 2 shows a general view of the Honda engine that I had inspected. My visual examination of the engine housing revealed the housing to be of serviceable/satisfactory condition. There was no crack and/or hole observed on the engine housing.

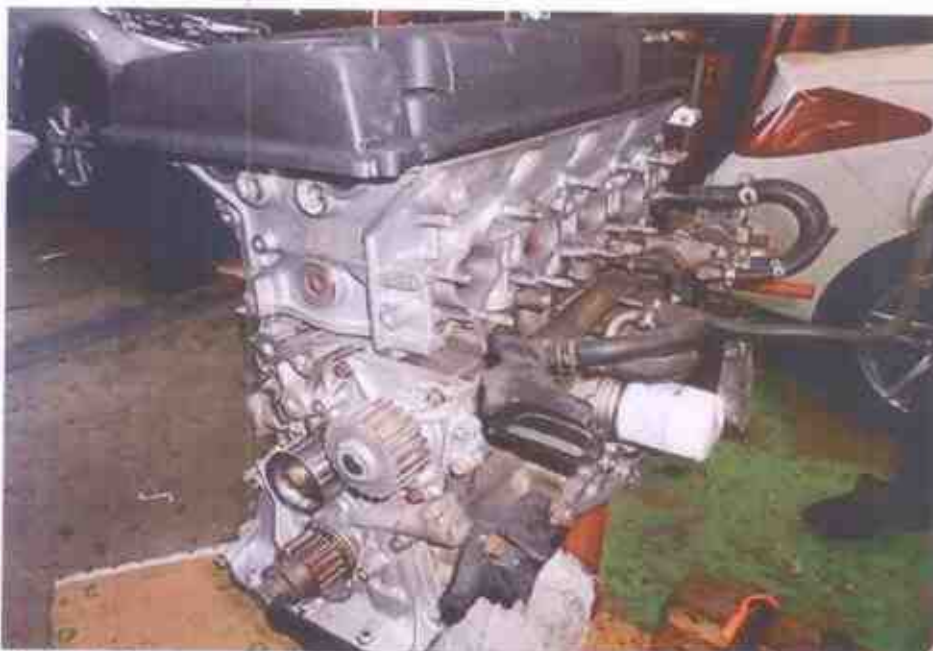
Photo 3 shows a general view of the Honda engine that I had inspected. My visual examination of the engine housing revealed the housing to be of serviceable/satisfactory condition. There was no crack and/or hole observed on the engine housing.

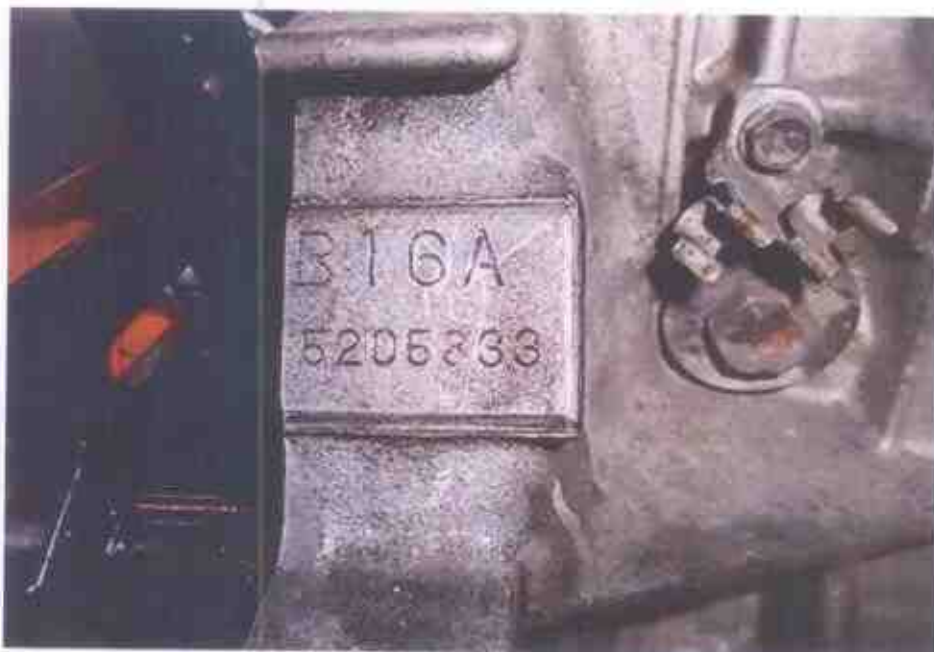
Photo 4 shows the engine number engraved on the housing of the Honda engine that I had inspected. The engine number was B16A5205833.

13. In summary, the Honda engine that I had inspected is a Honda B16A model engine. The engine number engraved on the housing of this Honda engine was B16A5205833.

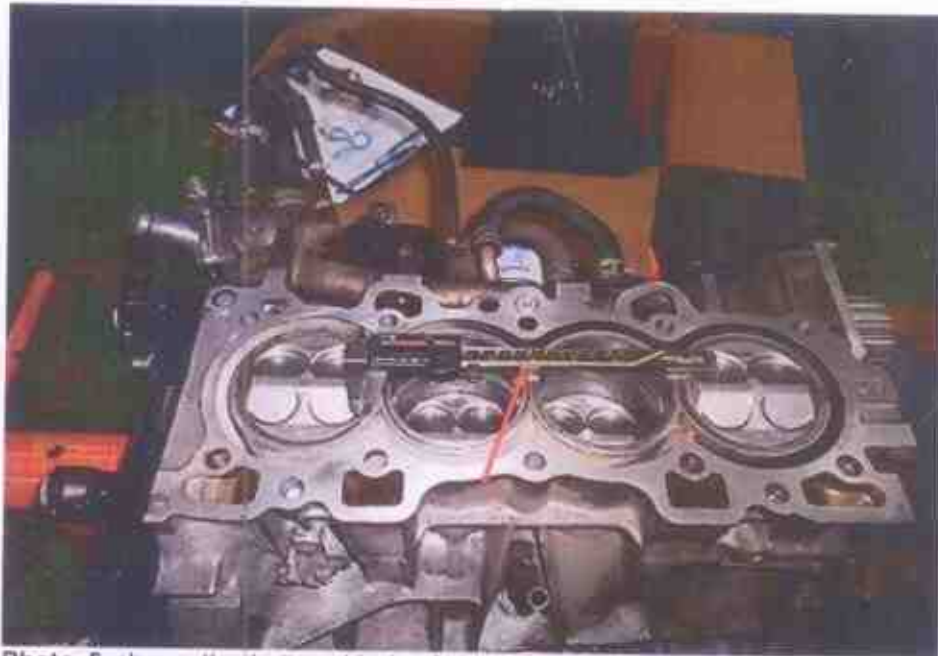
Photo 5 shows the bottom block of the Honda engine. The top block of the Honda engine was separated from its bottom block to enable me to carry out measurements of its cylinders, in particular the bore and stroke measurements of each cylinder, which typically can be used to determine the engine displacement or more commonly referred to as engine cc. A digital Vernier Caliper (arrowed) was used for the measurements. The digital Vernier Caliper was calibrated before the start of the measurements.

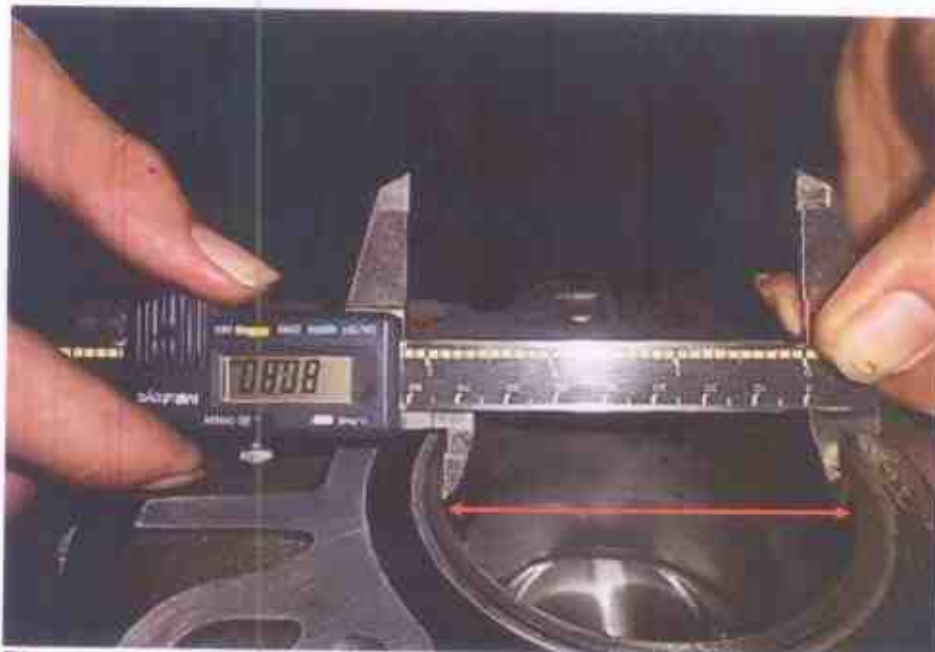
Photo 6 shows measurement being carried out to the bore (arrowed) of cylinder 1 of the Honda engine. The bore measurement of cylinder 1 was recorded to be 80.80mm.

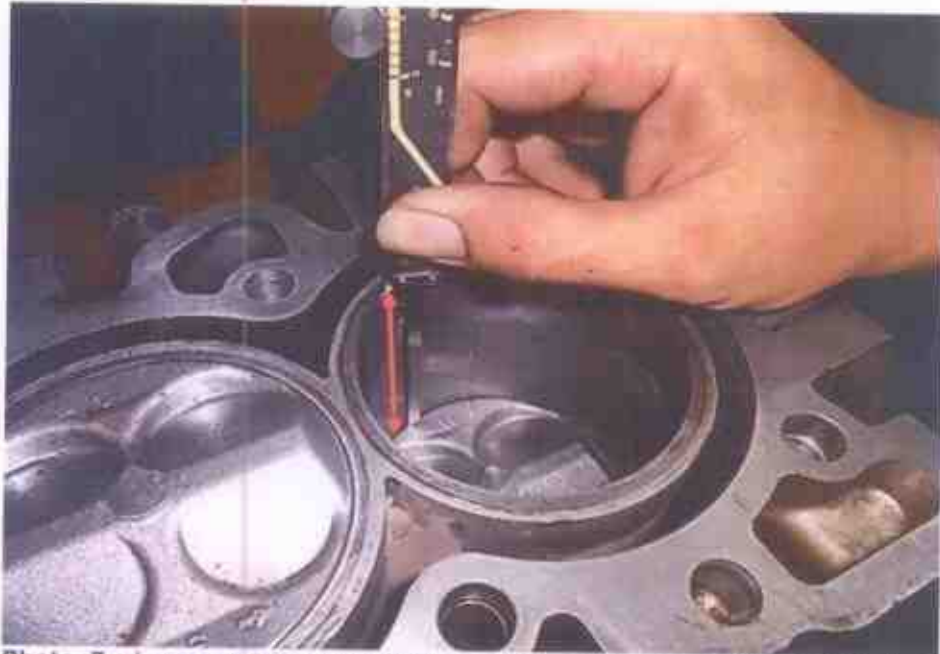
Photo 7 shows measurement being carried out to the stroke (arrowed) of cylinder 1 of the Honda engine. The bore and stroke measurements of the Honda engine were carried out using a digital Vernier Caliper that was calibrated before the start of the measurements.

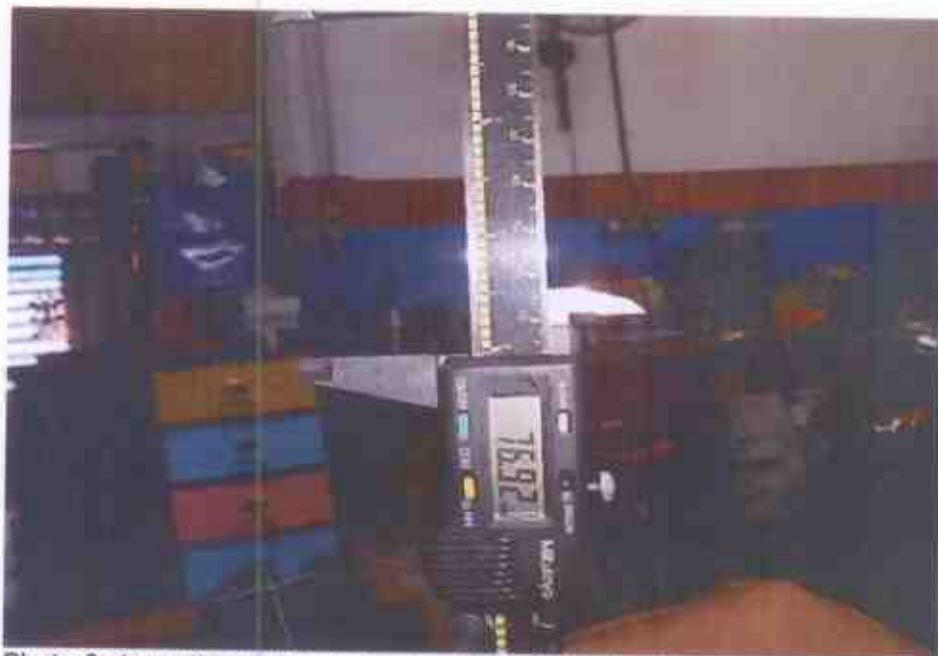
Photo 8 shows the stroke measurement of cylinder 1, which was recorded to be 76.92mm.

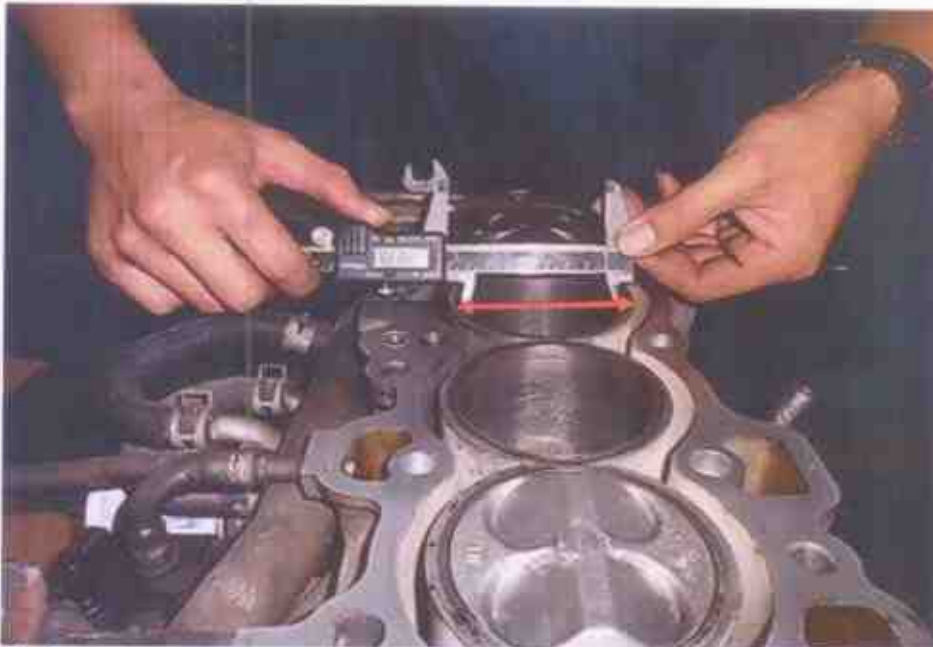
Photo 9 shows measurement being carried out to the bore (arrowed) of cylinder 2 of the Honda engine. The bore measurement of cylinder 2 was recorded to be 80.20mm.

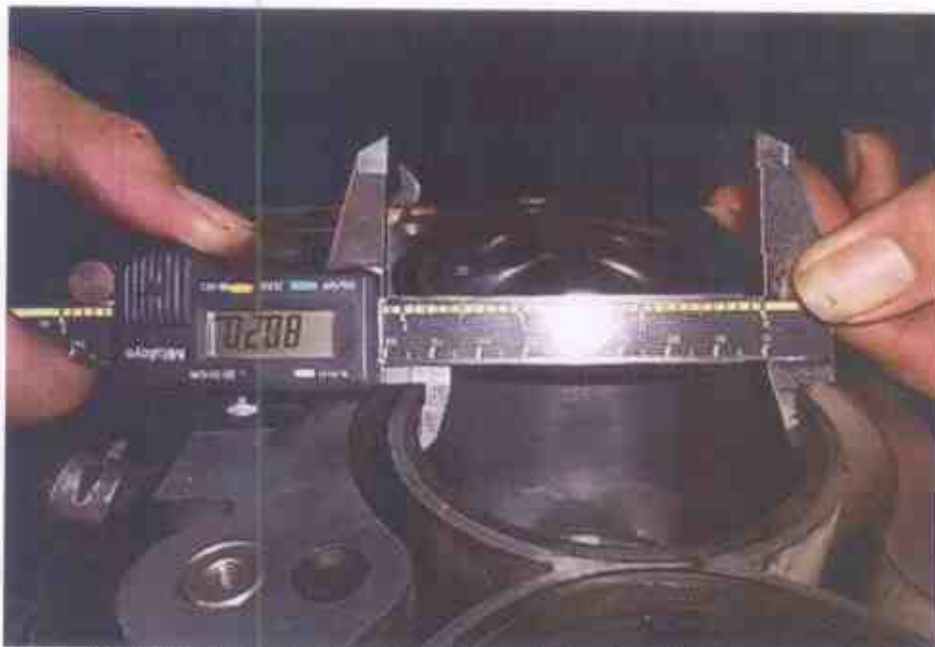
Photo 10 shows the bore measurement of cylinder 2, which was recorded to be 80.20mm.

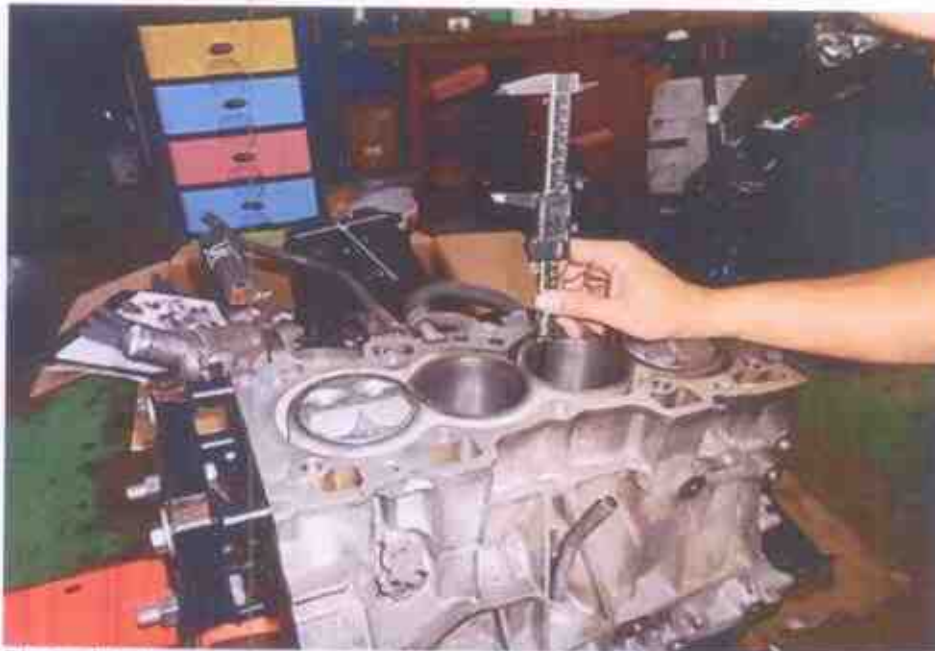
Photo 11 shows measurement of the stroke of cylinder 2 of the Honda engine that I had inspected. The bore and stroke measurements of the Honda engine were carried out using a digital Vernier Caliper that was calibrated before the start of measurements.

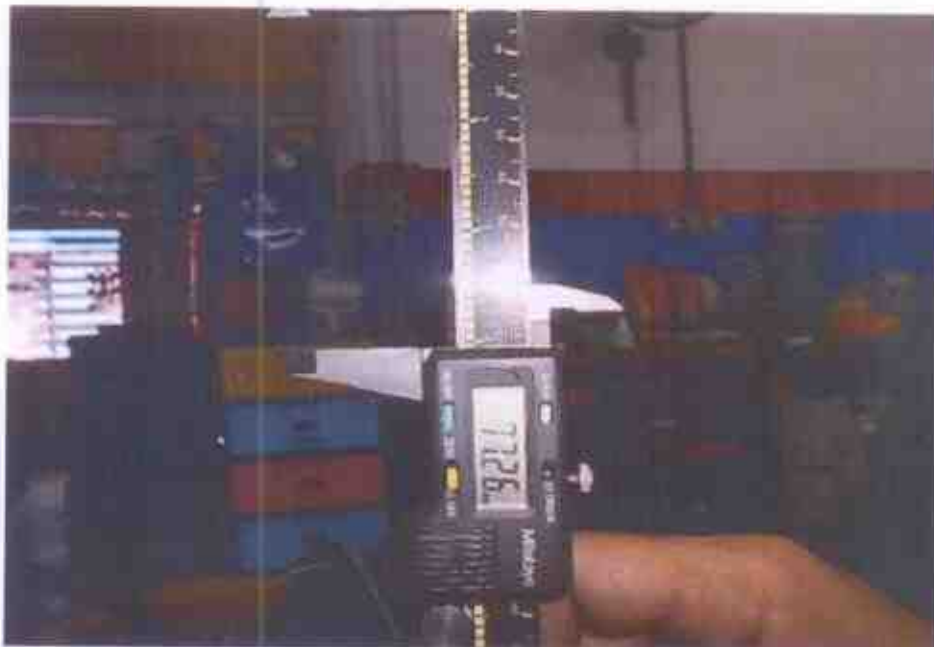
Photo 12 shows the stroke measurement of cylinder 2, which was recorded to be 77.26mm.

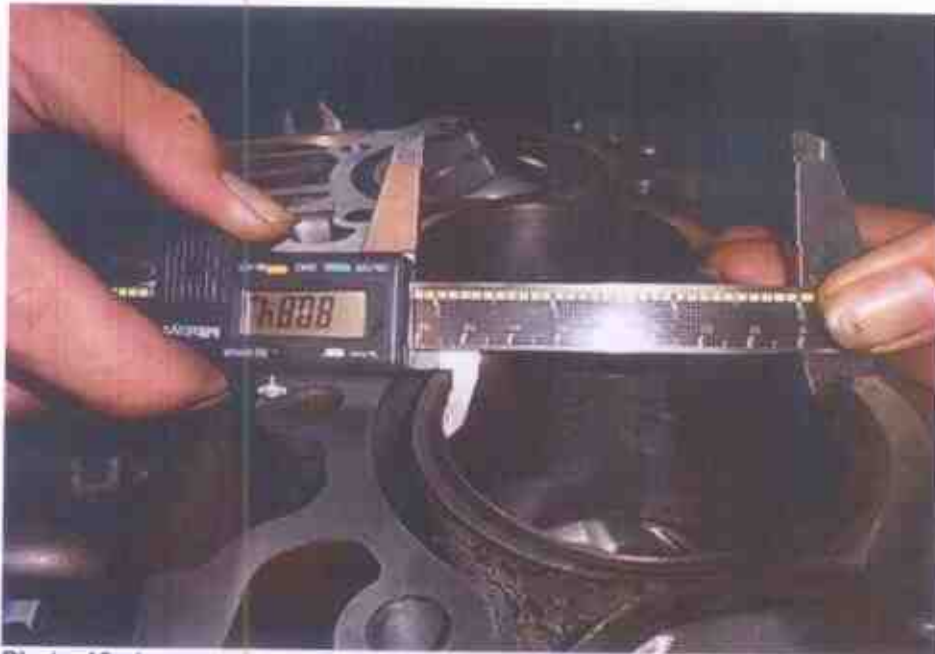
Photo 13 shows measurement being carried out to the bore of cylinder 3 of the Honda engine. The bore and stroke measurements of the Honda engine were carried out using a digital Vernier Caliper. The bore measurement of cylinder 3 was recorded to be 80.84mm.

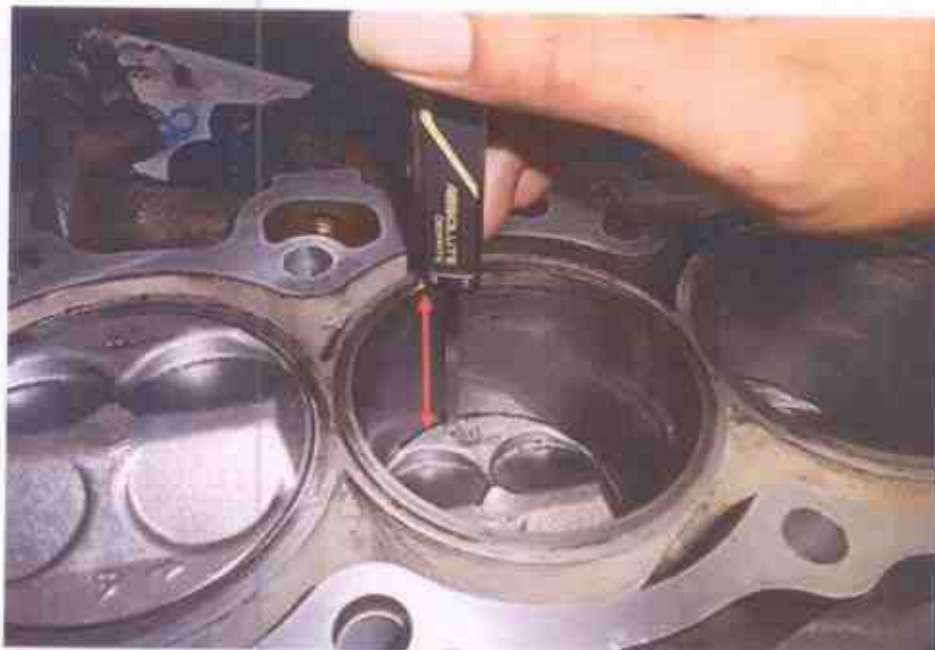
Photo 14 shows measurement of the stroke (arrowed) of cylinder 3 of the Honda engine that I had inspected. The bore and stroke measurements of the Honda engine were carried out using a digital Vernier Caliper that was calibrated before the start of measurements.

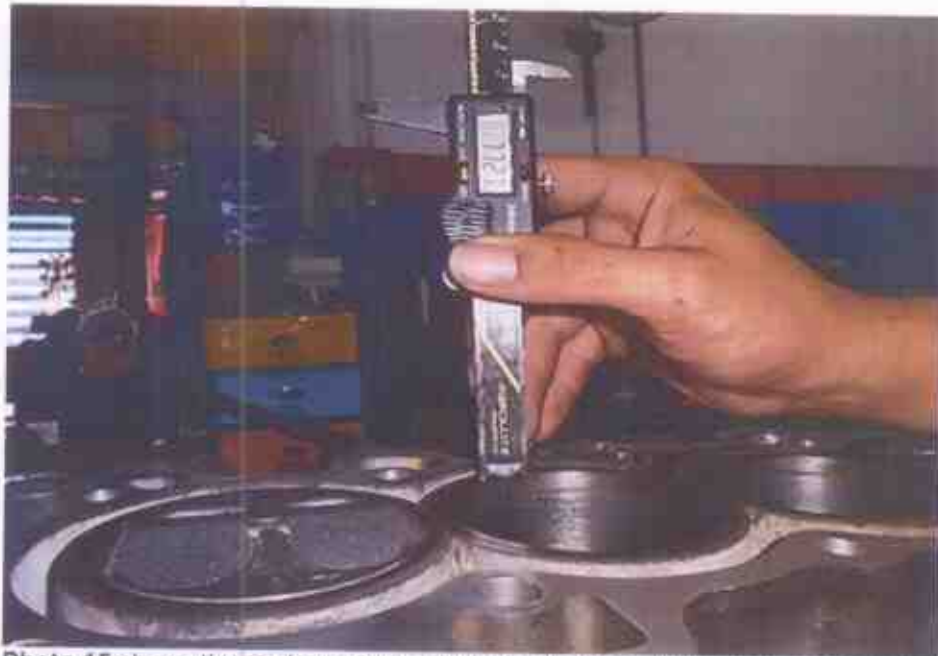
Photo 15 shows the stroke measurement of cylinder 3, which was recorded to be 77.27mm.

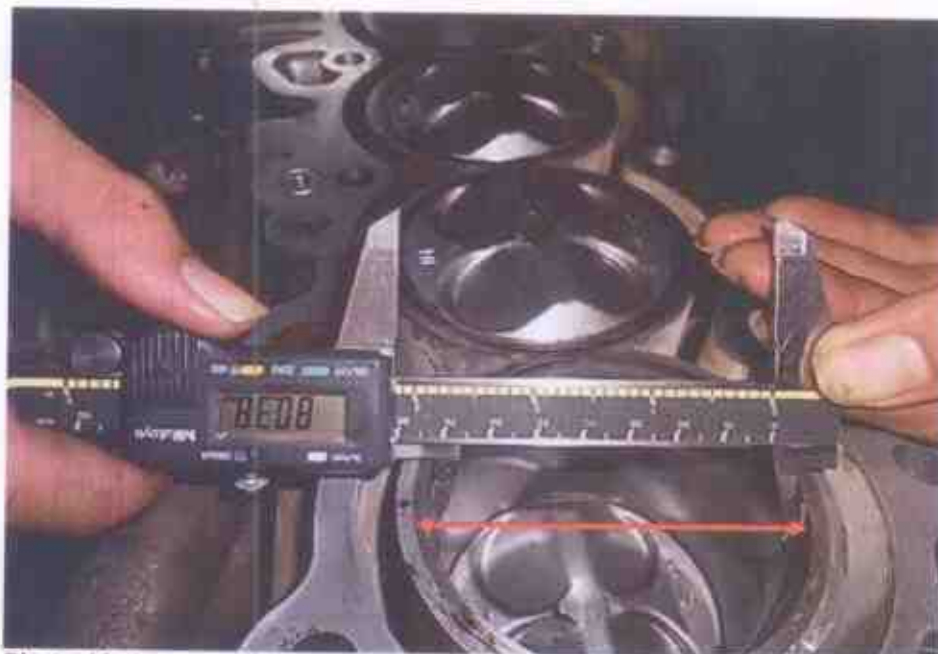
Photo 16 shows measurement being carried out to the bore (arrowed) of cylinder 4 of the Honda engine. The bore and stroke measurements of the Honda engine were carried out using a digital Vernier Caliper. The bore measurement of cylinder 4 was recorded to be 80.38mm.

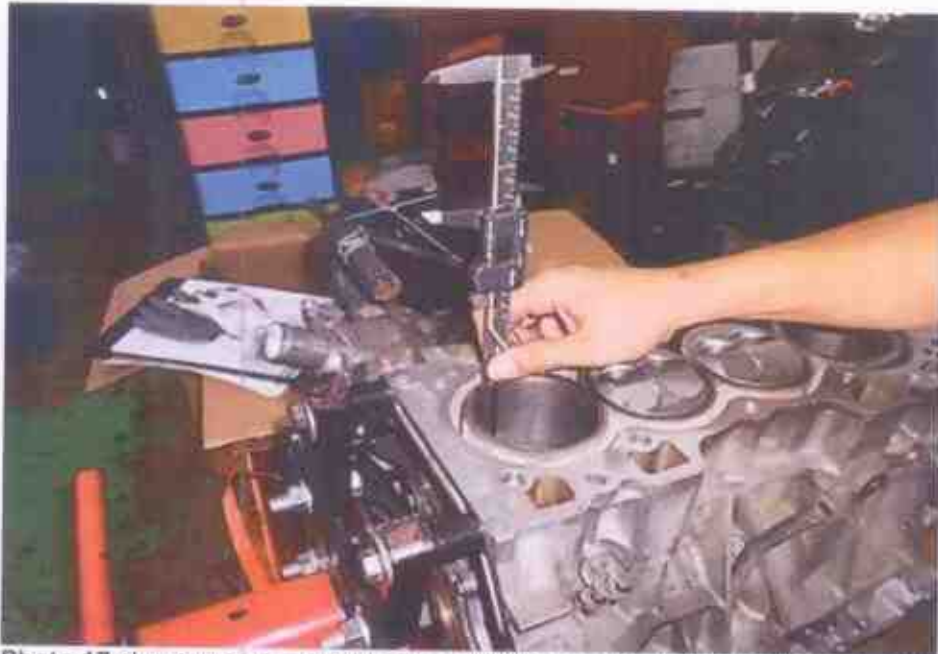
Photo 17 shows measurement being carried out to the stroke of cylinder 4 of the Honda engine. The bore and stroke measurements of the Honda engine were carried out using a digital Vernier Caliper that was calibrated before the start of measurements.

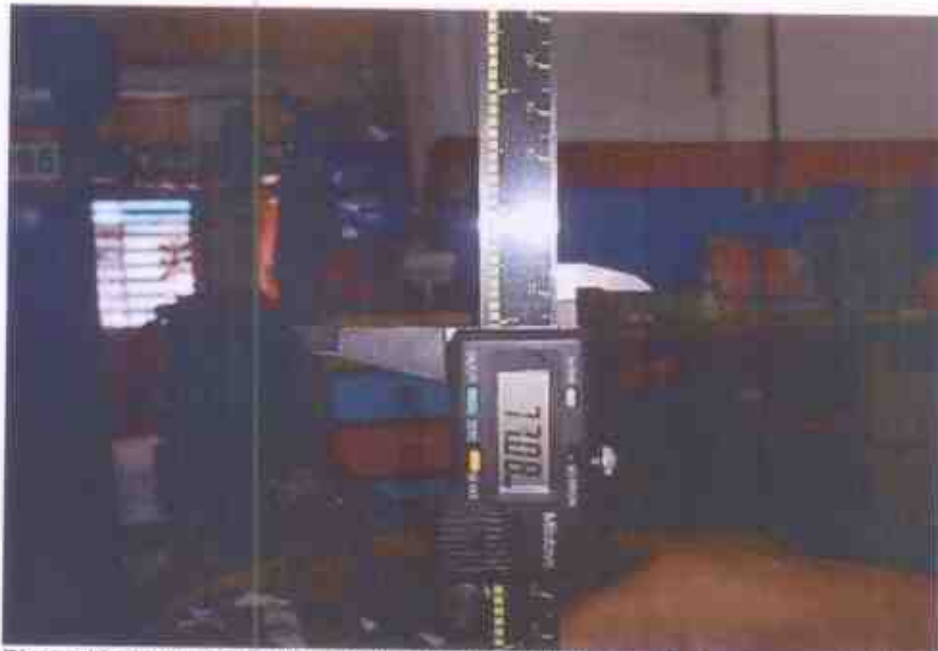
Photo 18 shows the stroke measurement of cylinder 4, which was recorded to be 77.08mm.
