Your Ref: Honda Engine  
(number B16A5205833)  
Our Ref : CI/TP19002148/D

01 February 2019

### **INSPECTION REPORT OF A HONDA ENGINE WITH NUMBER B16A5205833**

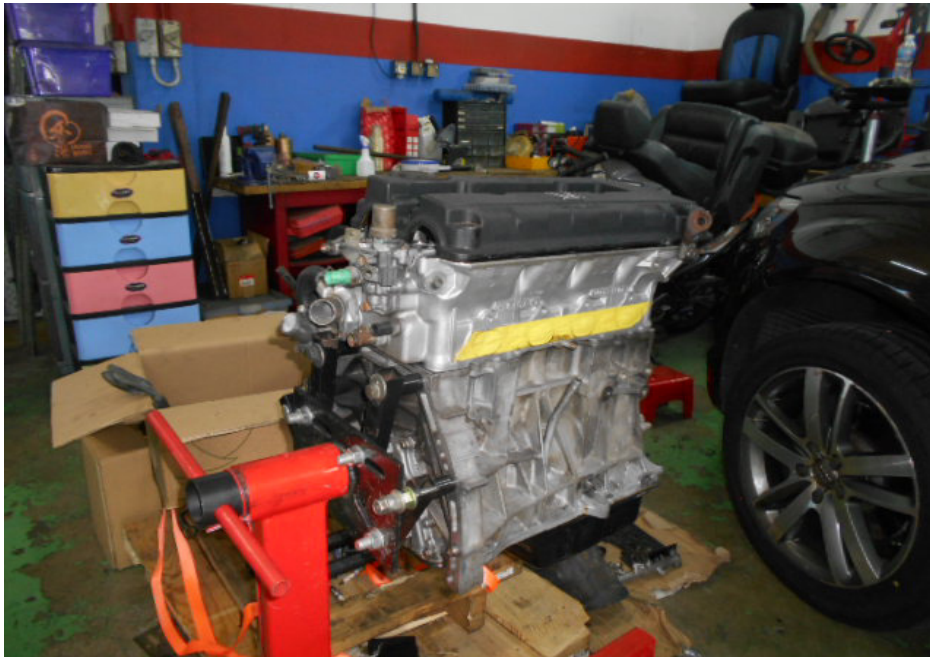
**Photo 1** shows a general view of the Honda engine that I had inspected. The Honda engine was observed to be a used engine and was not fitted on any motor car. My visual examination of the engine housing revealed the housing to be of serviceable/satisfactory condition. There was no crack and/or hole observed on the engine housing.

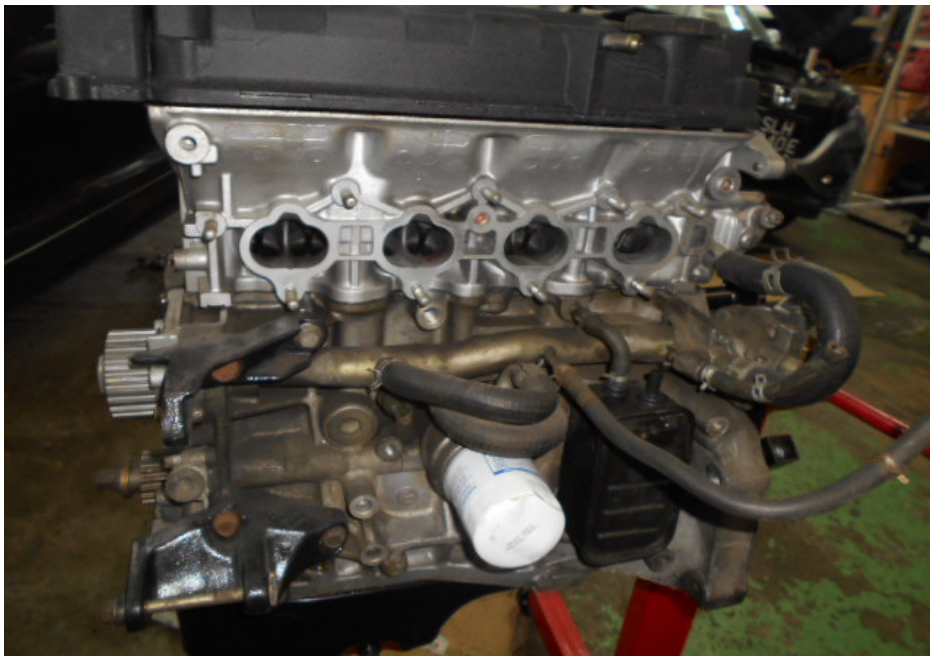
**Photo 2** shows a general view of the Honda engine that I had inspected. My visual examination of the engine housing revealed the housing to be of serviceable/satisfactory condition. There was no crack and/or hole observed on the engine housing.

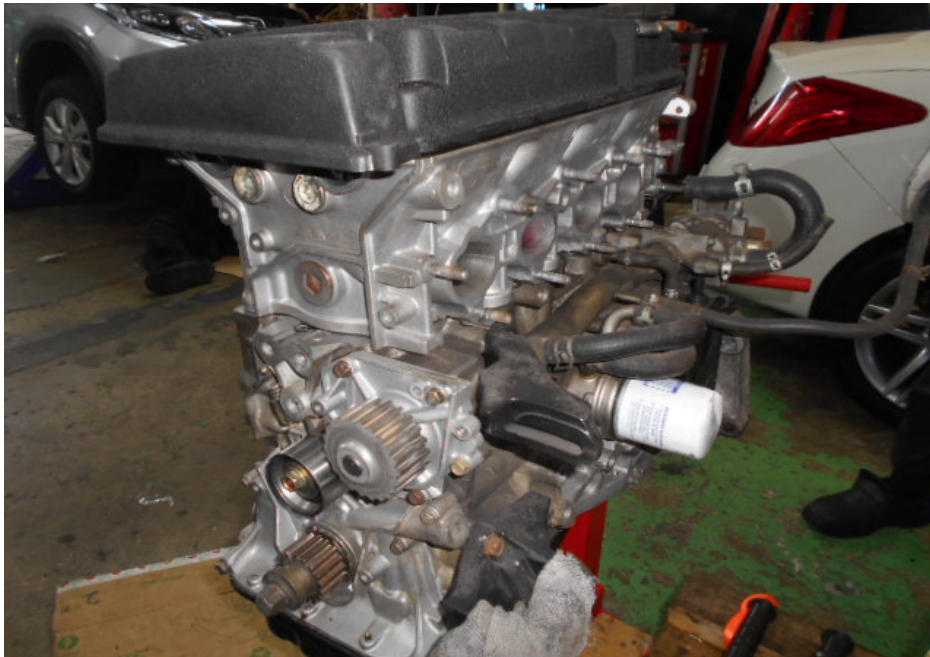
**Photo 3** shows a general view of the Honda engine that I had inspected. My visual examination of the engine housing revealed the housing to be of serviceable/satisfactory condition. There was no crack and/or hole observed on the engine housing.

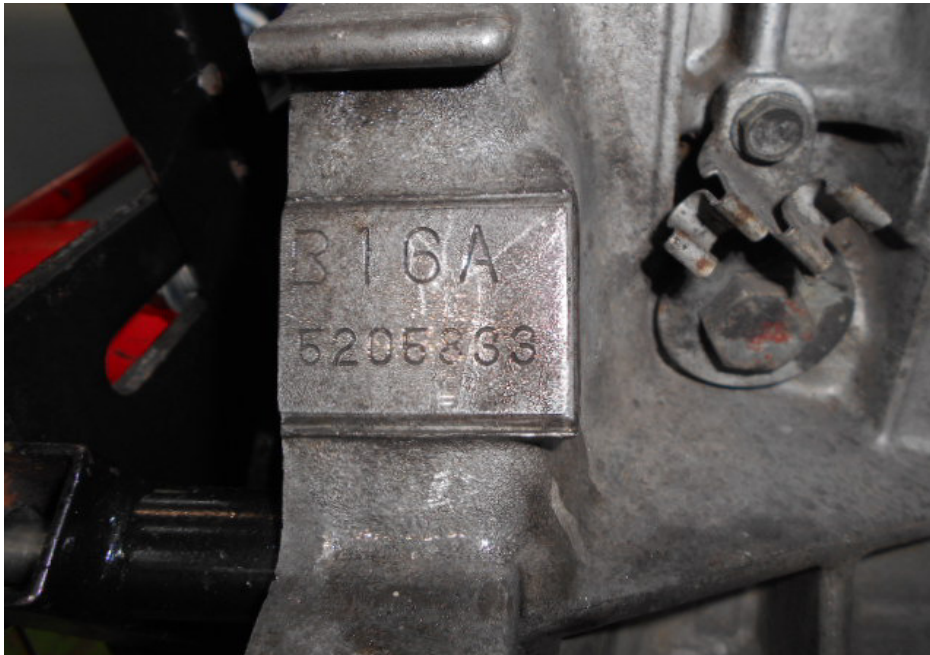
**Photo 4** shows the engine number engraved on the housing of the Honda engine that I had inspected. The engine number was B16A5205833.

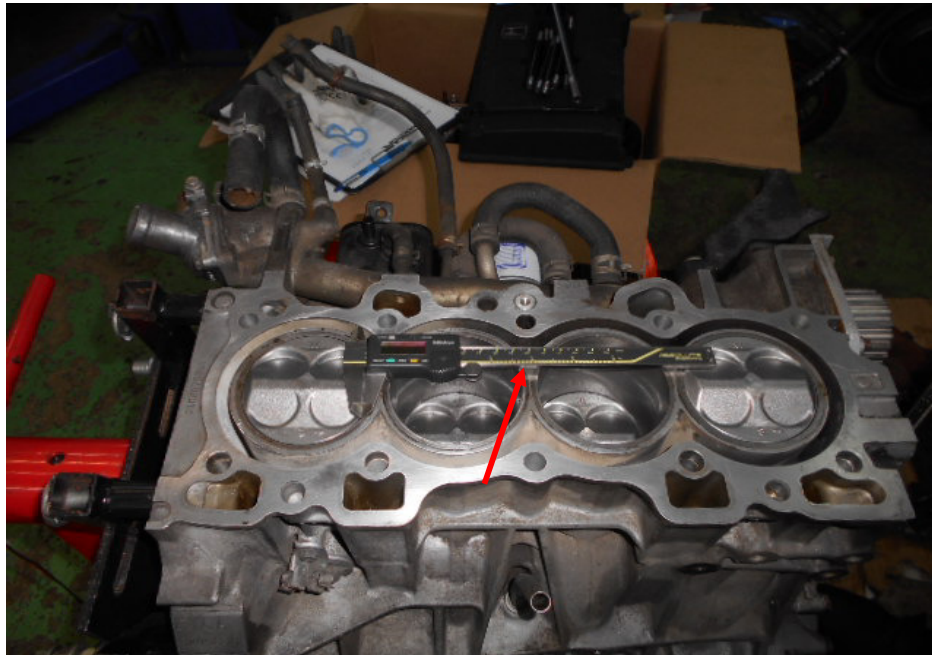
**Photo 5** shows the bottom block of the Honda engine. The top block of the Honda engine was separated from its bottom block to enable me to carry out measurements of its cylinders, in particular the bore and stroke measurements of each cylinder, which typically can be used to determine the engine displacement or more commonly referred to as engine cc. A digital Vernier Caliper (arrowed) was used for the measurements. The digital Vernier Caliper was calibrated before the start of the measurements.

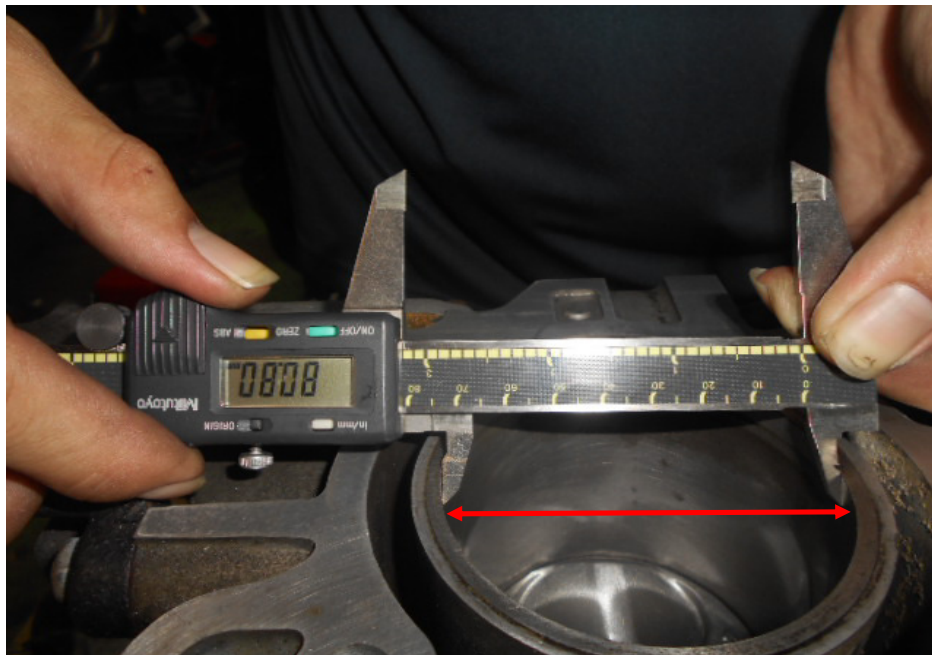
**Photo 6** shows measurement being carried out to the bore (arrowed) of cylinder 1 of the Honda engine. The bore measurement of cylinder 1 was recorded to be 80.80mm.

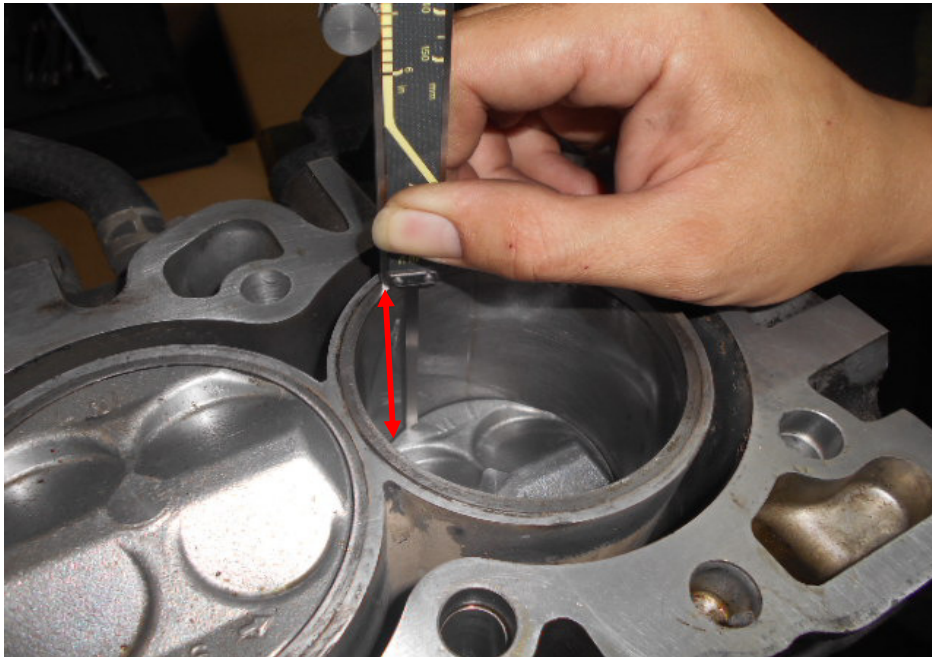
**Photo 7** shows measurement being carried out to the stroke (arrowed) of cylinder 1 of the Honda engine. The bore and stroke measurements of the Honda engine were carried out using a digital Vernier Caliper that was calibrated before the start of the measurements.

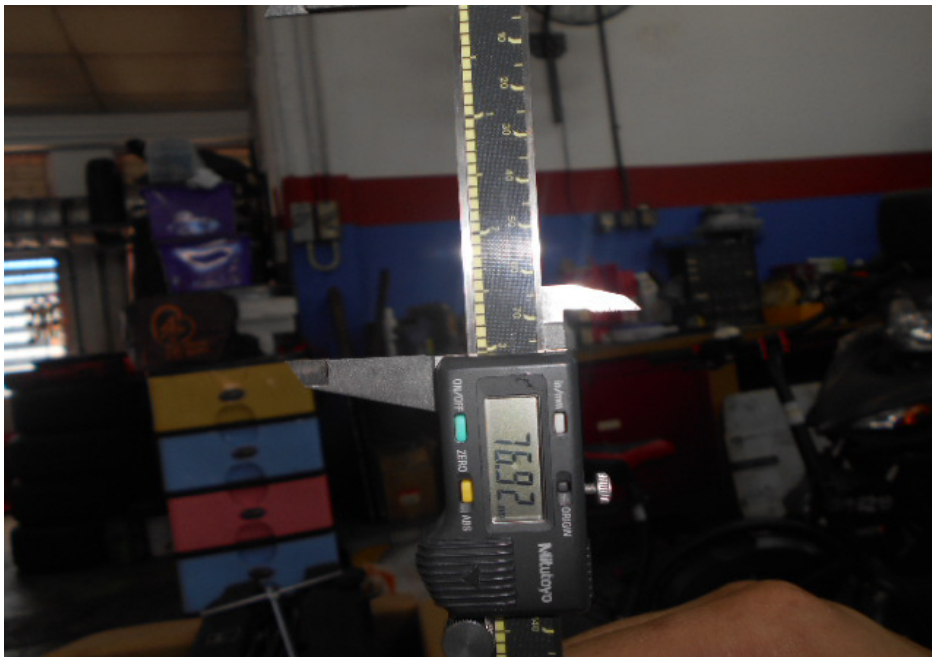
**Photo 8** shows the stroke measurement of cylinder 1, which was recorded to be 76.92mm.

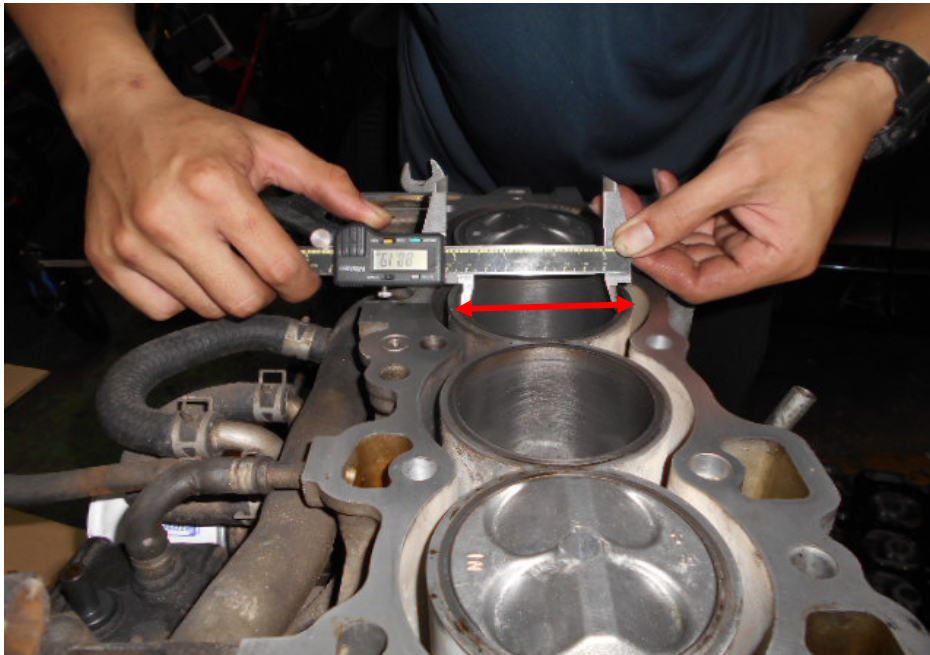
**Photo 9** shows measurement being carried out to the bore (arrowed) of cylinder 2 of the Honda engine. The bore measurement of cylinder 2 was recorded to be 80.20mm.

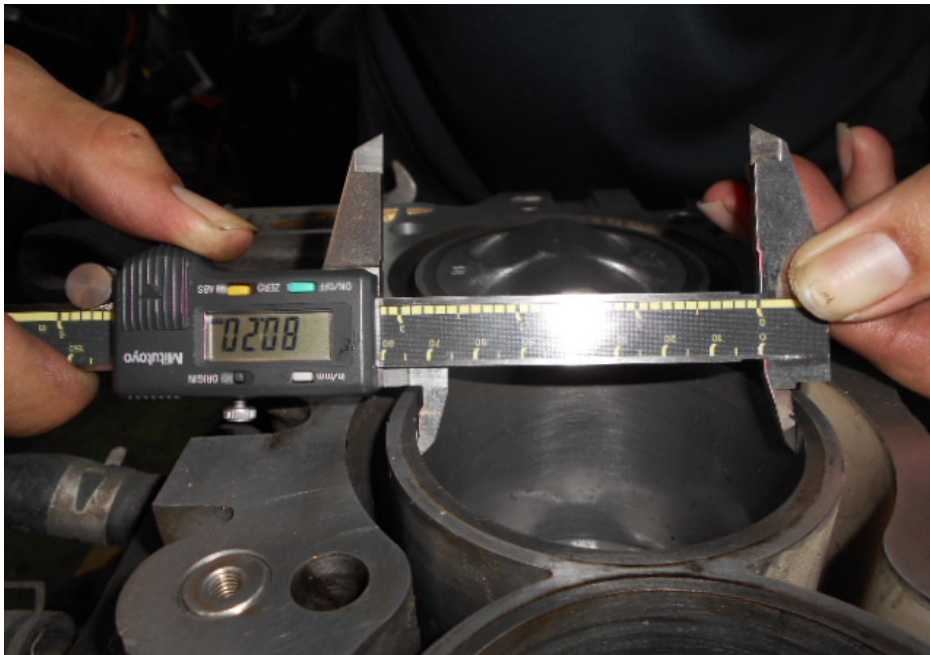
**Photo 10** shows the bore measurement of cylinder 2, which was recorded to be 80.20mm.

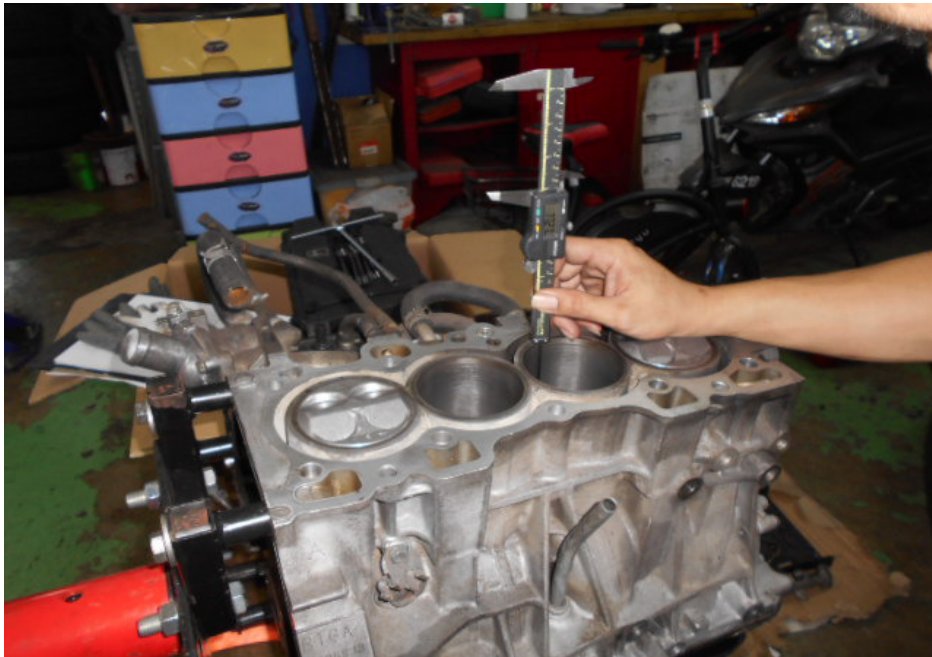
**Photo 11** shows measurement of the stroke of cylinder 2 of the Honda engine that I had inspected. The bore and stroke measurements of the Honda engine were carried out using a digital Vernier Caliper that was calibrated before the start of measurements.

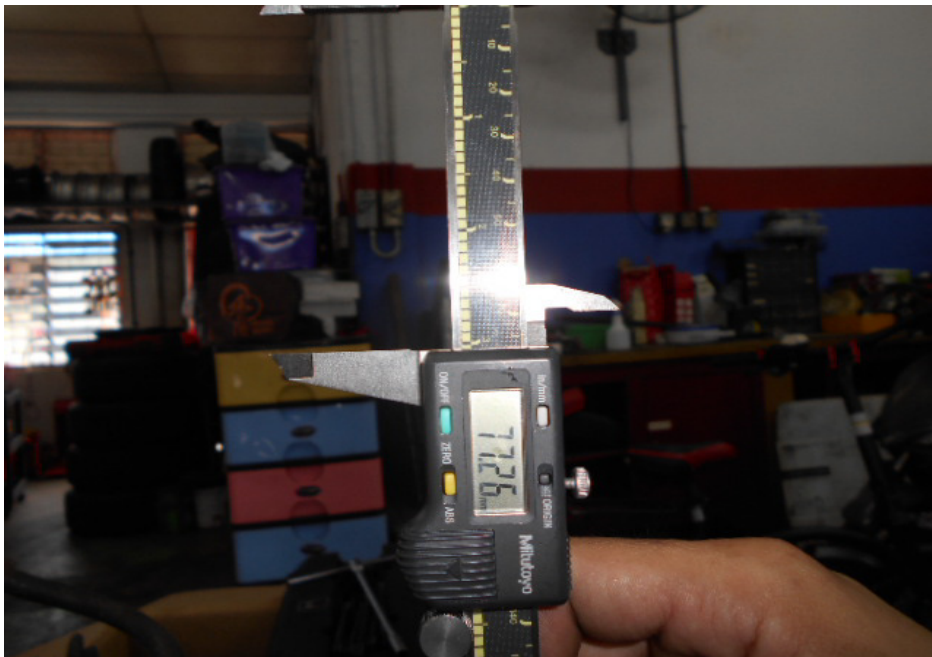
**Photo 12** shows the stroke measurement of cylinder 2, which was recorded to be 77.26mm.

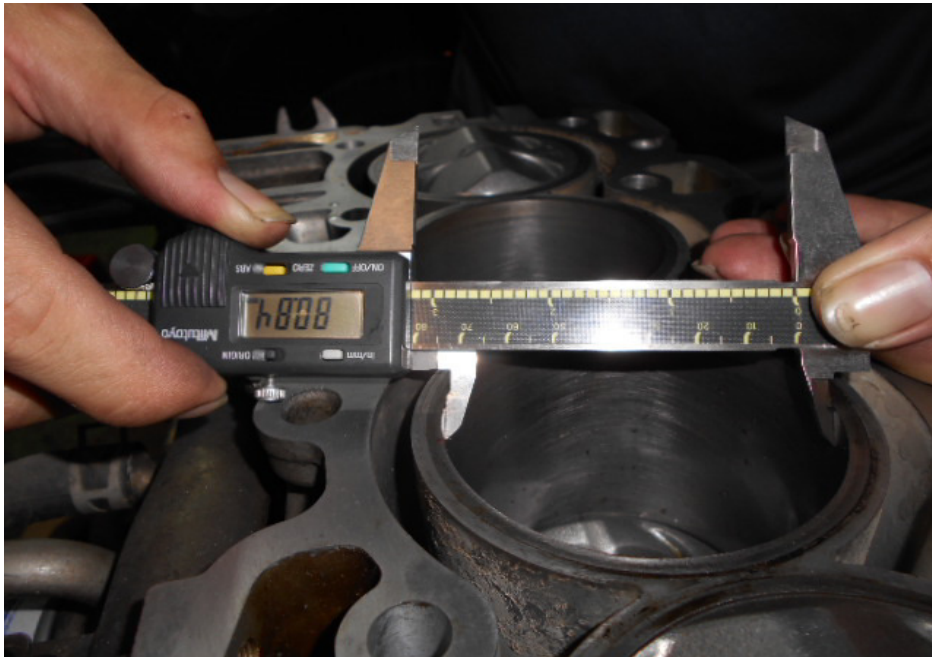
**Photo 13** shows measurement being carried out to the bore of cylinder 3 of the Honda engine. The bore and stroke measurements of the Honda engine were carried out using a digital Vernier Caliper. The bore measurement of cylinder 3 was recorded to be 80.84mm.

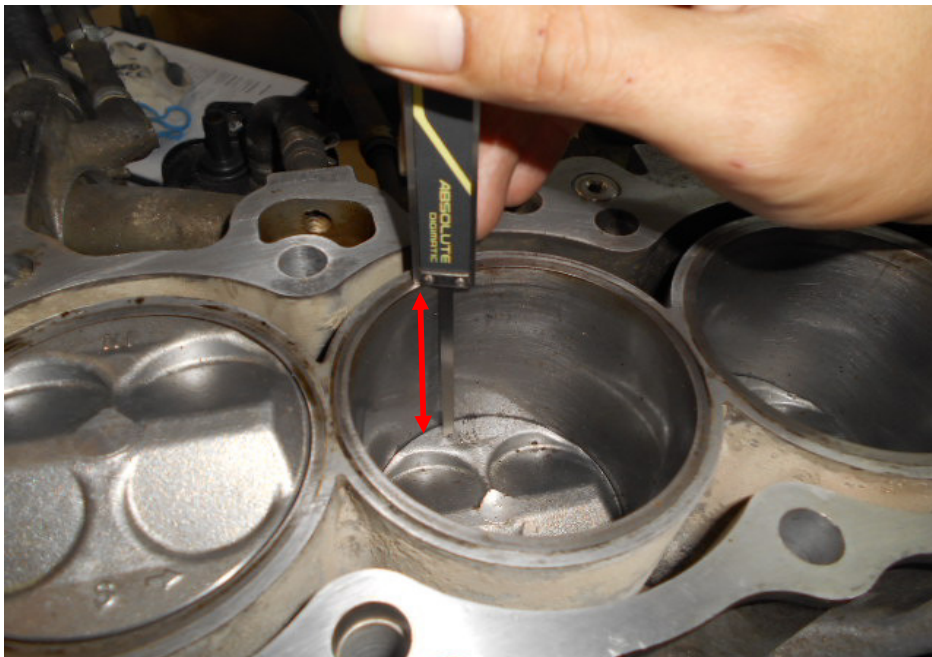
**Photo 14** shows measurement of the stroke (arrowed) of cylinder 3 of the Honda engine that I had inspected. The bore and stroke measurements of the Honda engine were carried out using a digital Vernier Caliper that was calibrated before the start of measurements.

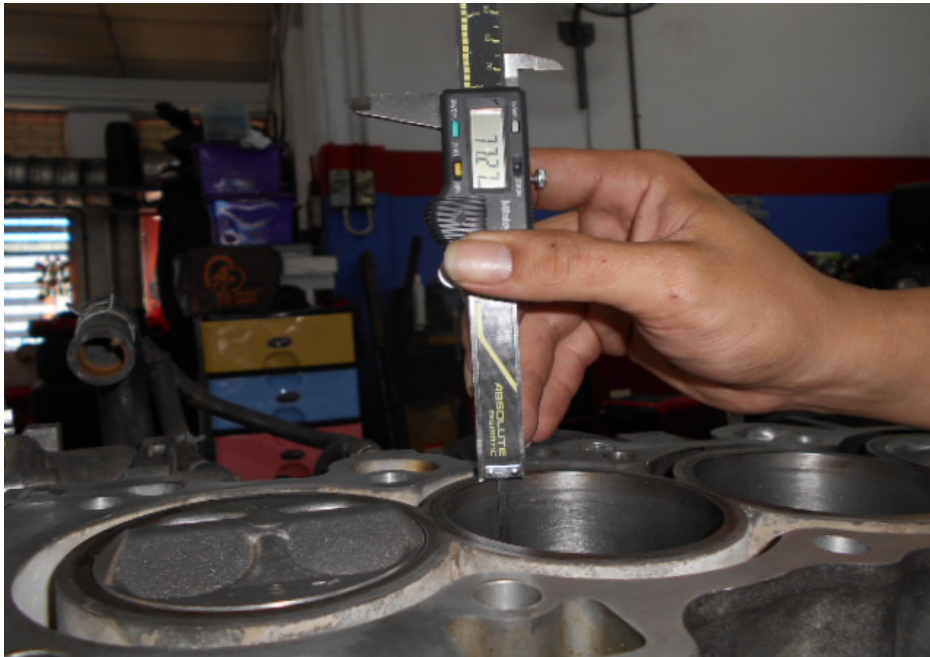
**Photo 15** shows the stroke measurement of cylinder 3, which was recorded to be 77.27mm.

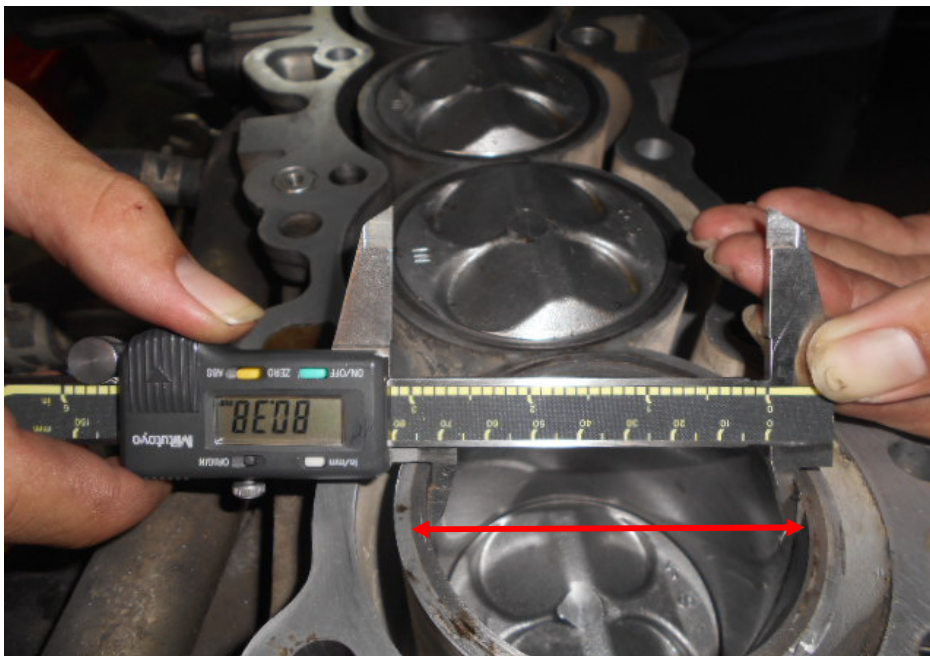
**Photo 16** shows measurement being carried out to the bore (arrowed) of cylinder 4 of the Honda engine. The bore and stroke measurements of the Honda engine were carried out using a digital Vernier Caliper. The bore measurement of cylinder 4 was recorded to be 80.38mm.

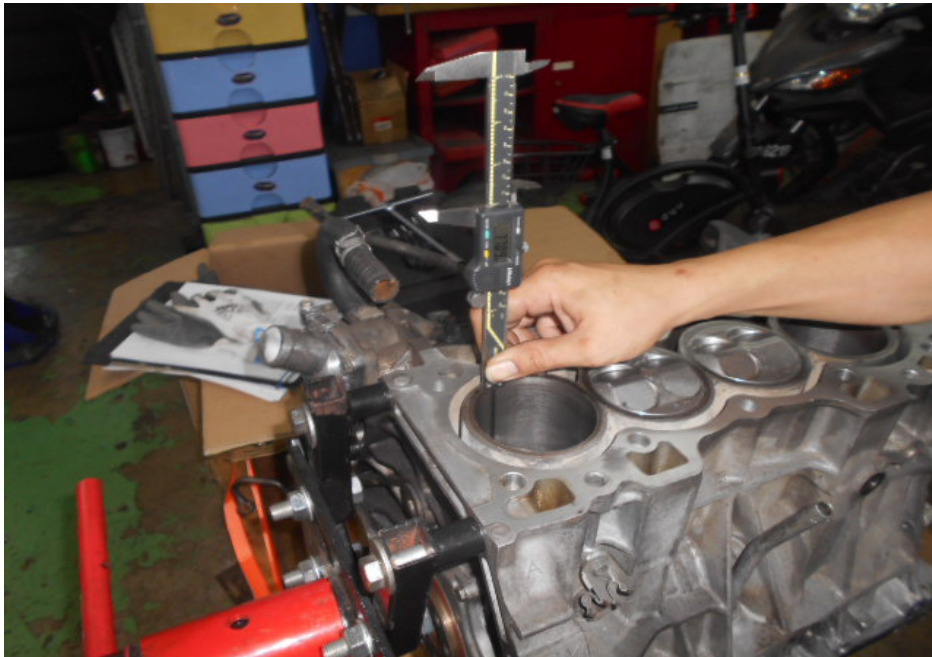
**Photo 17** shows measurement being carried out to the stroke of cylinder 4 of the Honda engine. The bore and stroke measurements of the Honda engine were carried out using a digital Vernier Caliper that was calibrated before the start of measurements.

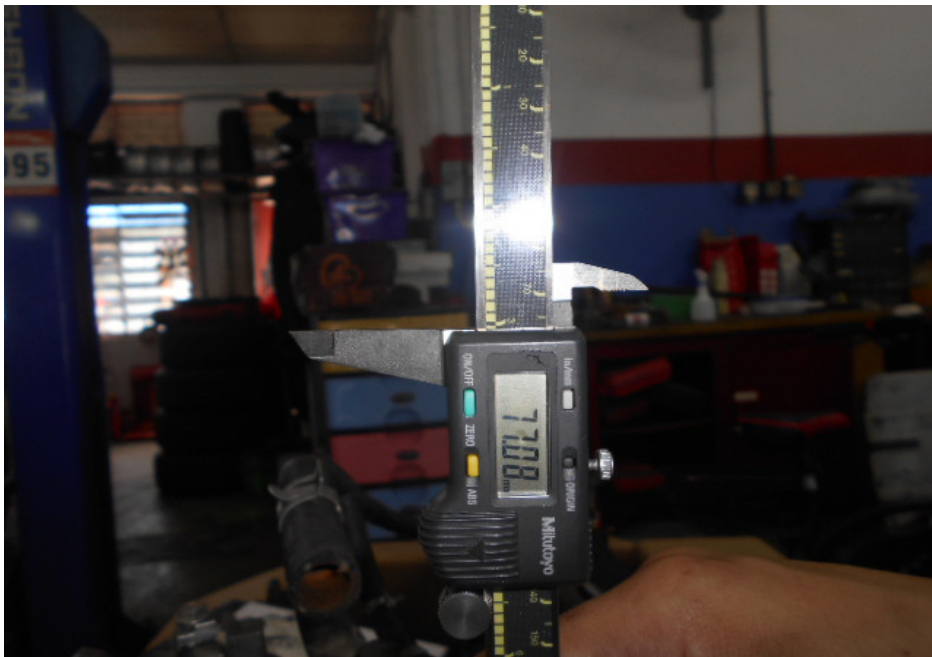
**Photo 18** shows the stroke measurement of cylinder 4, which was recorded to be 77.08mm.
