Your Ref: S9M01AFN
Our Ref : CI/AXA19002150/D

**AUTOMOBILE INSPECTION REPORT OF INSURED VEHICLE YP 3747D
INVOLVED IN AN ACCIDENT ON 11 JANUARY 2019**

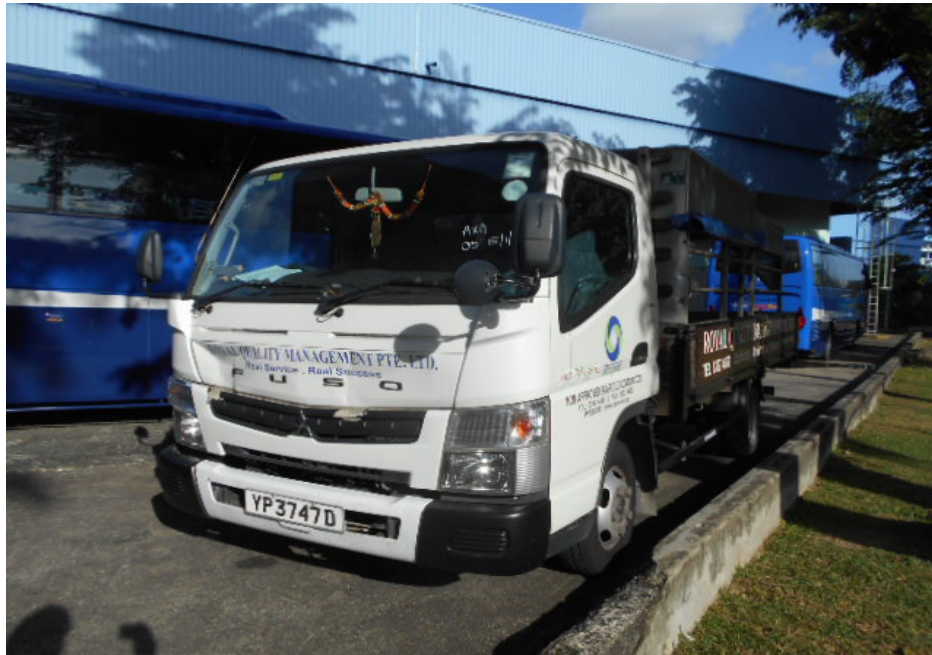
3. The insured vehicle was observed to have sustained impact damages on its frontal body. Its front bumper, front centre panel, front grille and front right signal lamp were amongst the exterior body parts that were observed to have been damaged.
4. Examination carried out to the front tyres that were fitted on the insured vehicle revealed both its front tyres to be in serviceable condition with remaining tread depth of approximately 7mm each. Both the front tyres were also found to be sufficiently inflated for vehicular operation and without any tear, cut or burst mark(s) on the outer and the inner sidewalls as well as across the tread. See photo 1 – 3 below.

Photo 1 shows a general view of the front left body of the insured vehicle at the time of my inspection. The front bumper, front centre panel, front grille and front right signal lamp were amongst the exterior body parts that had sustained impact damages as a result of the accident.

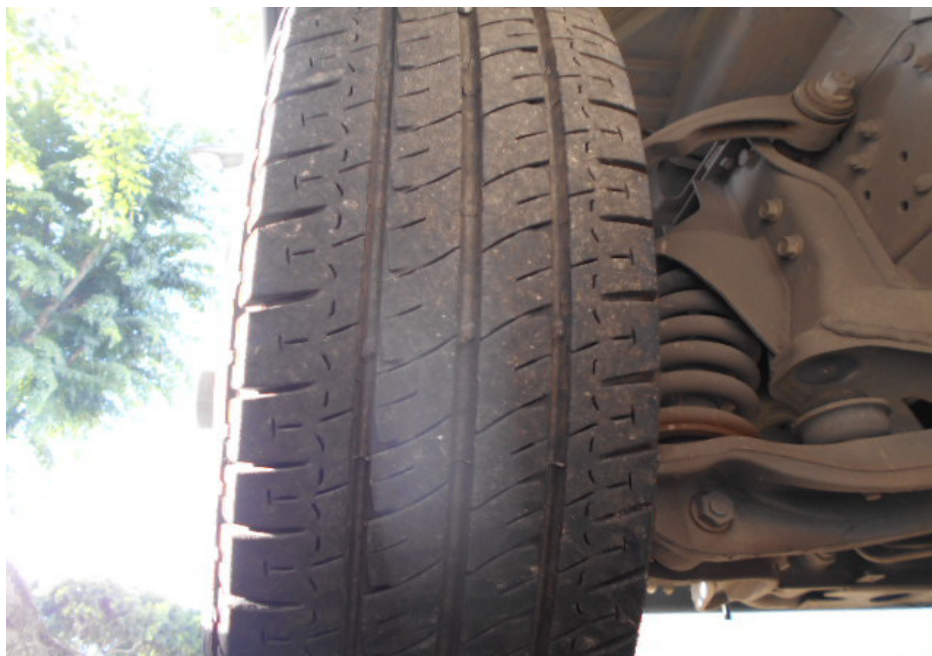
Photo 2 shows the condition of the front left tyre of the insured vehicle, which was observed to be in serviceable condition with remaining tread depth of approximately 7mm. It was also found to be sufficiently inflated for vehicular operation and without any tear, cut or burst mark(s) on the outer and the inner sidewalls as well as across the tread.

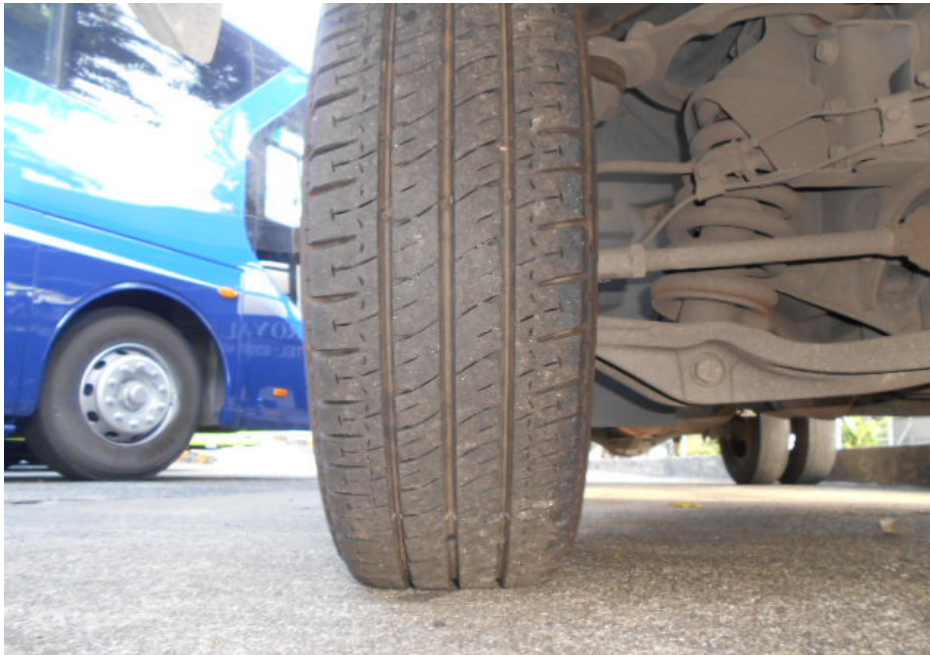
Photo 3 shows the condition of the front right tyre of the insured vehicle, which was observed to be in serviceable condition with remaining tread depth of approximately 7mm. The front right tyre was also observed to be sufficiently inflated for vehicular operation with no tear, cut or burst mark(s) on its outer and inner sidewalls, as well as across its tread.

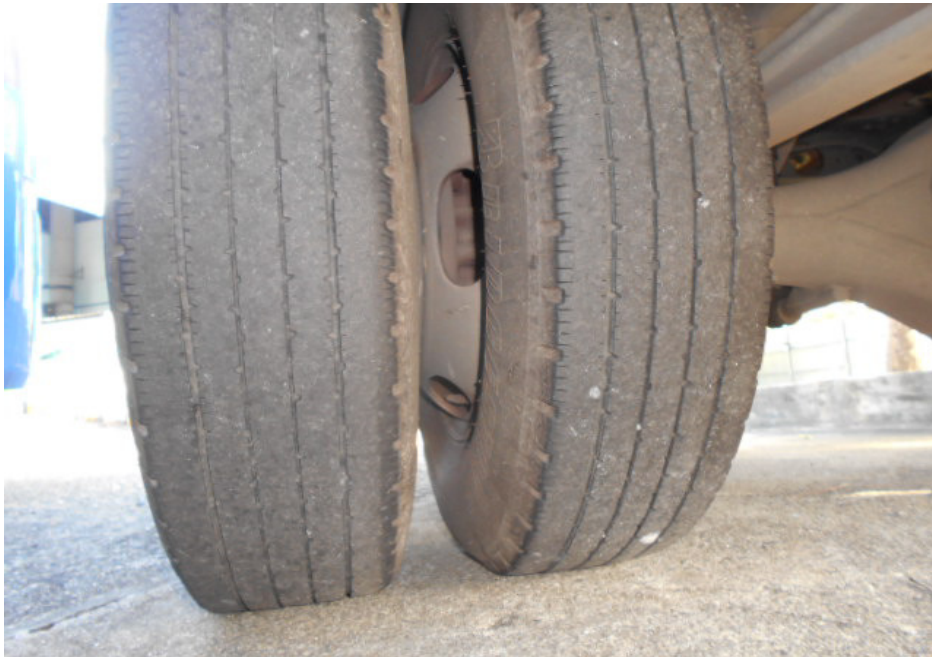
5. Upon examination of the insured vehicle's rear tyres, I note that there was a total of 4 tyres fitted. 2 at the rear right axle and 2 at the rear left axle. The pattern of the tread of both rear right tyres were observed to be still visible. Both the rear right tyres were also found to be sufficiently inflated for vehicular operation and without any tear, cut or burst mark(s) on the outer and the inner sidewalls as well as across the tread. My measurements of the tread depth of the 2 rear right tyres revealed remaining depth of approximately 2mm to 3mm each. The 2 rear right tyres of the insured vehicle are thus in serviceable condition. See photo 4 & 5 below.

Photo 4 shows the rear right tyres of the insured vehicle at the time of my inspection. The pattern of the tread of both rear right tyres were observed to be still visible. Both these tyres were found to be sufficiently inflated for vehicular operation and without any tear, cut or burst mark(s) on the outer and the inner sidewalls as well as across the tread. The remaining tread depth of the 2 rear right tyres were measured to be approximately 2mm to 3mm each.

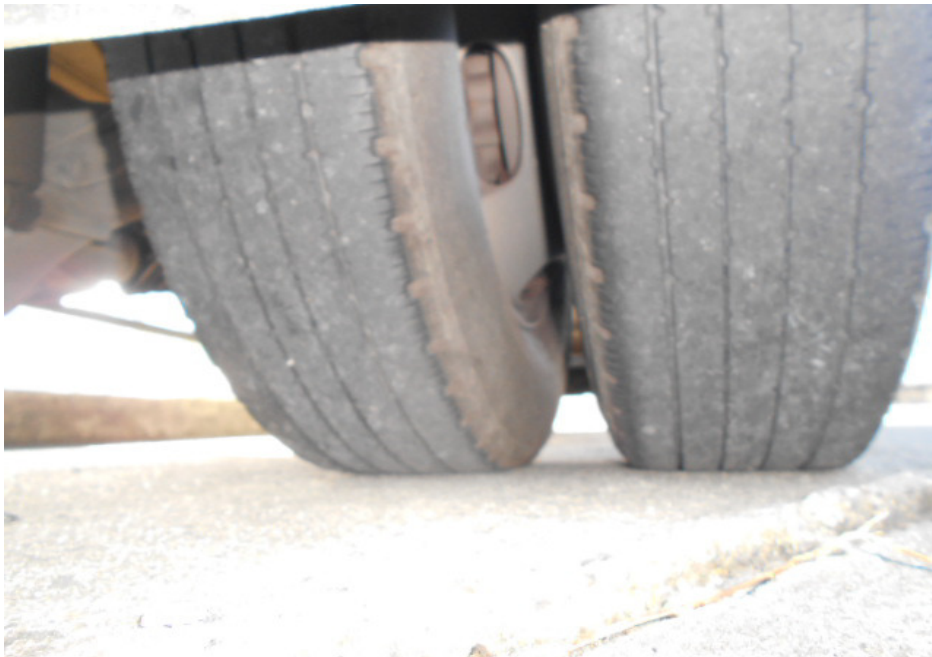
Photo 5 shows the rear right tyres of the insured vehicle at the time of my inspection. The 2 rear right tyres were in serviceable condition with remaining tread depth measured to be approximately 2mm to 3mm each. Both these tyres were also sufficiently inflated for vehicular operation.

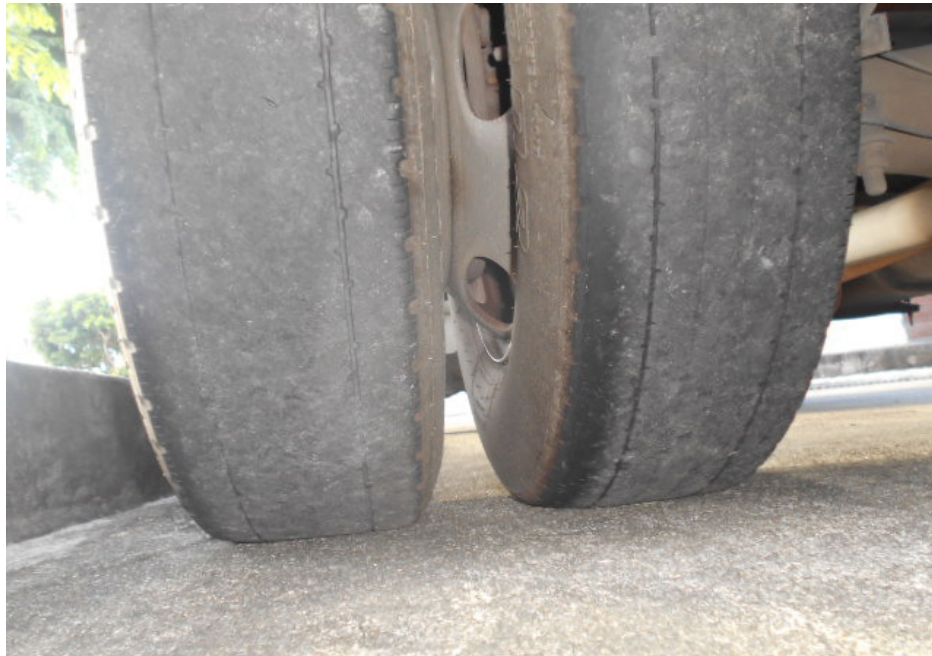
6. The 2 rear left tyres of the insured vehicle on the other hand, were observed to be in a condition with the pattern of the tread at the centre area of both rear left tyres no longer visible. This was observed to be around the entire circumference of both rear left tyres. The non-visible tread pattern was due to rubber wearing off. The pattern of the tread at the outer areas of both the rear left tyres were also observed to be barely visible around the entire circumference of both rear left tyres. The 2 rear left tyres were found to be sufficiently inflated for vehicular operation and without any tear, cut or burst mark(s) on the outer and the inner sidewalls as well as across the tread.

Photo 6 shows the rear left tyres of the insured vehicle at the time of my inspection. The pattern of the tread at the centre area of both rear left tyres were observed to be no longer visible while the pattern of the tread at the outer areas were barely visible. The non-visible tread pattern was due to the rubber wearing off. Both these tyres were found to be sufficiently inflated for vehicular operation and without any tear, cut or burst mark(s) on the outer and the inner sidewalls as well as across the tread.

11. Basing on my observations and measurements of the 2 rear left tyres of the insured vehicle, the centre area of both the rear left tyres does not have a depth of at least 1mm around the entire circumference of the tyres. Both the rear left tyres also do not have a pattern at the centre area that is clearly visible around the entire circumference of the tyres.

14. In conclusion, having examined the 6 tyres of the insured vehicle, I am of the view that the condition of the 2 rear left tyres of the insured vehicle do not comply with SECTION 109(fr) CAP 276 of THE ROAD TRAFFIC ACT, ROAD TRAFFIC (MOTOR VEHICLES, CONSTRUCTION AND USE) RULES. The remaining 4 tyres of the insured vehicle ie 2 front tyres and 2 rear right tyres were in serviceable condition and were within the requirements of the local governing body.

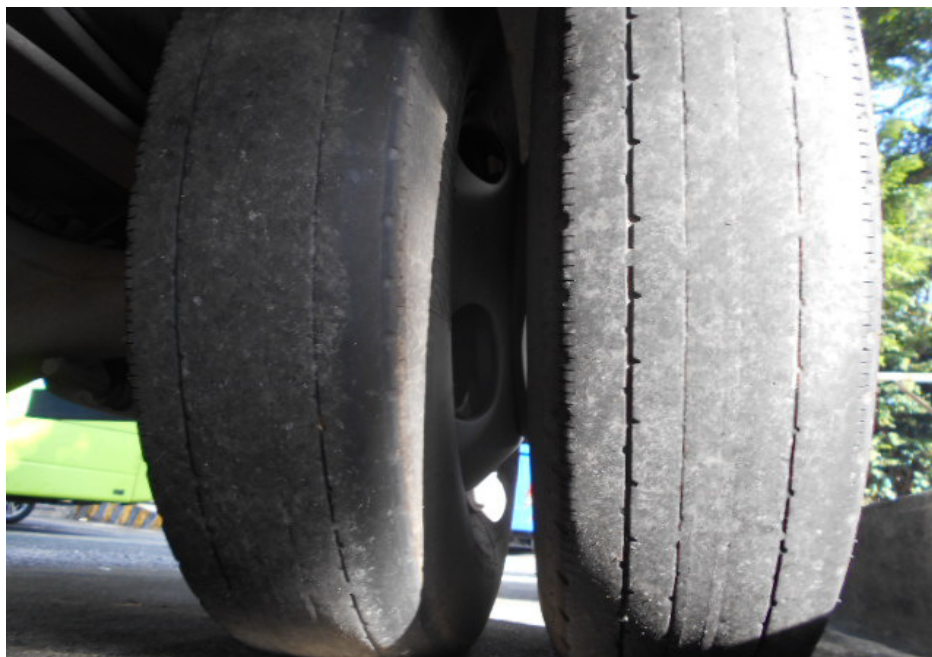
Photo 7 shows the rear left tyres of the insured vehicle at the time of my inspection. The pattern of the tread at the centre area of both rear left tyres were observed to be no longer visible while the pattern of the tread at the outer areas were barely visible. The non-visible tread pattern was due to the rubber wearing off. Both these tyres were found to be sufficiently inflated for vehicular operation and without any tear, cut or burst mark(s) on the outer and the inner sidewalls as well as across the tread.

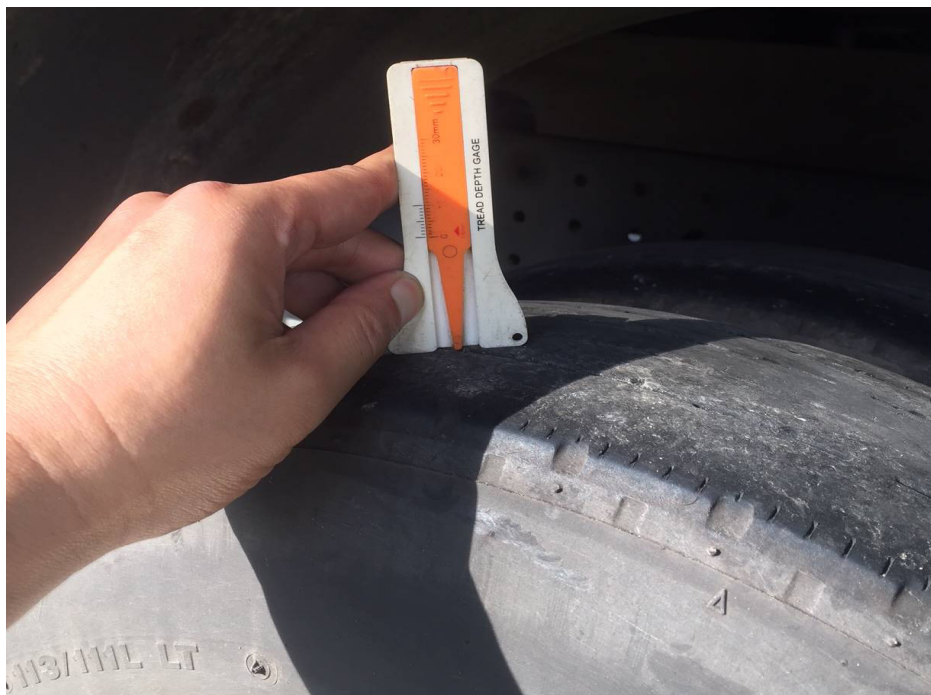
Photo 8 shows measurement being carried out to the remaining tread depth of the insured vehicle's rear left tyres.

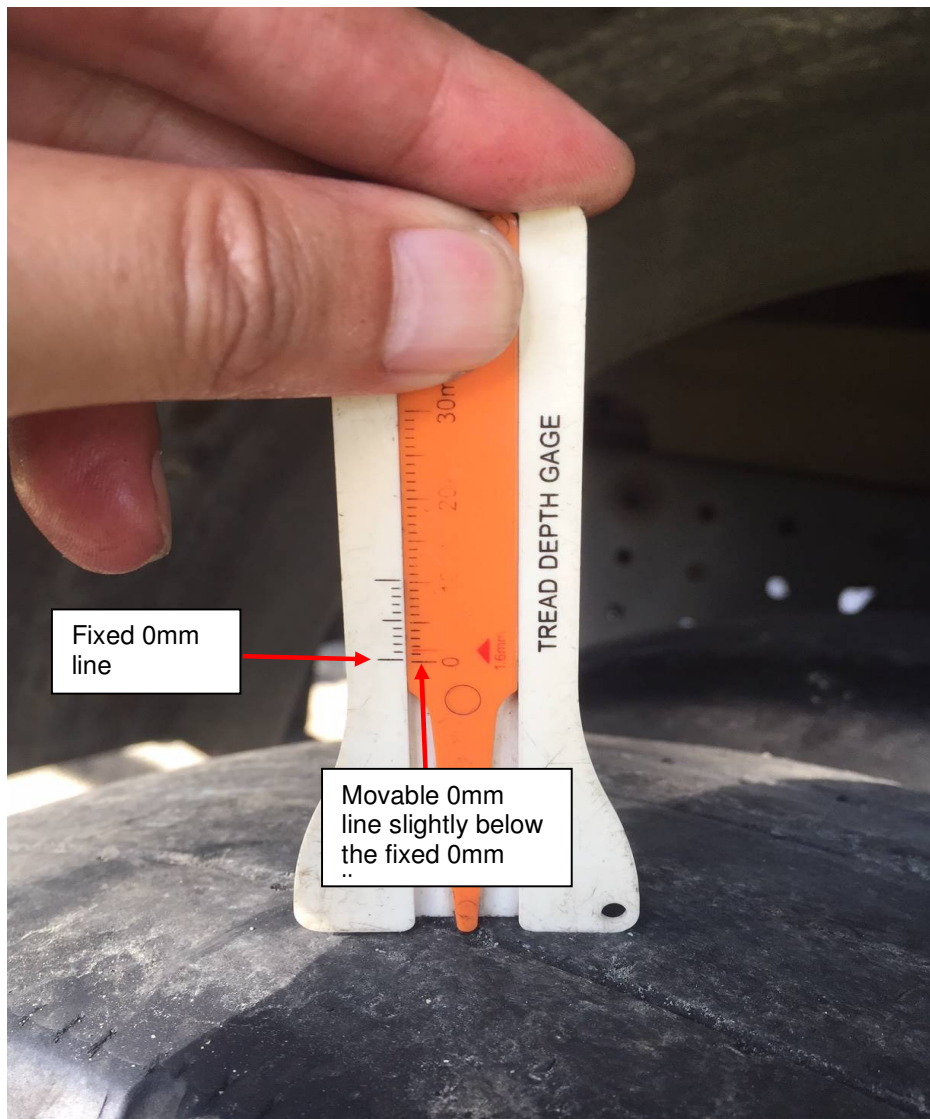
7. Measurements of the remaining depth of the tread pattern at the outer areas of the 2 rear left tyres revealed remaining depth of approximately slightly above 0mm to below 1mm. Since the tread pattern at the centre area of both the rear left tyres was no longer visible at some areas, the depth of the remaining tread pattern for the centre area can be considered to be 0mm at the area where the pattern of the tread is no longer visible. The 2 rear left tyres of the insured vehicle are hence not in serviceable condition. See photo 6 - 10 below.

Photo 9 shows the measurement of the remaining depth of the tread pattern at the outer area of the outer rear left tyre. The measurement had indicated slightly above 0mm. In general, measurements of the outer areas of the insured vehicle's rear left tyres, where the pattern of the tread was still barely visible reveal remaining tread depth of approximately slightly above 0mm to below 1mm.

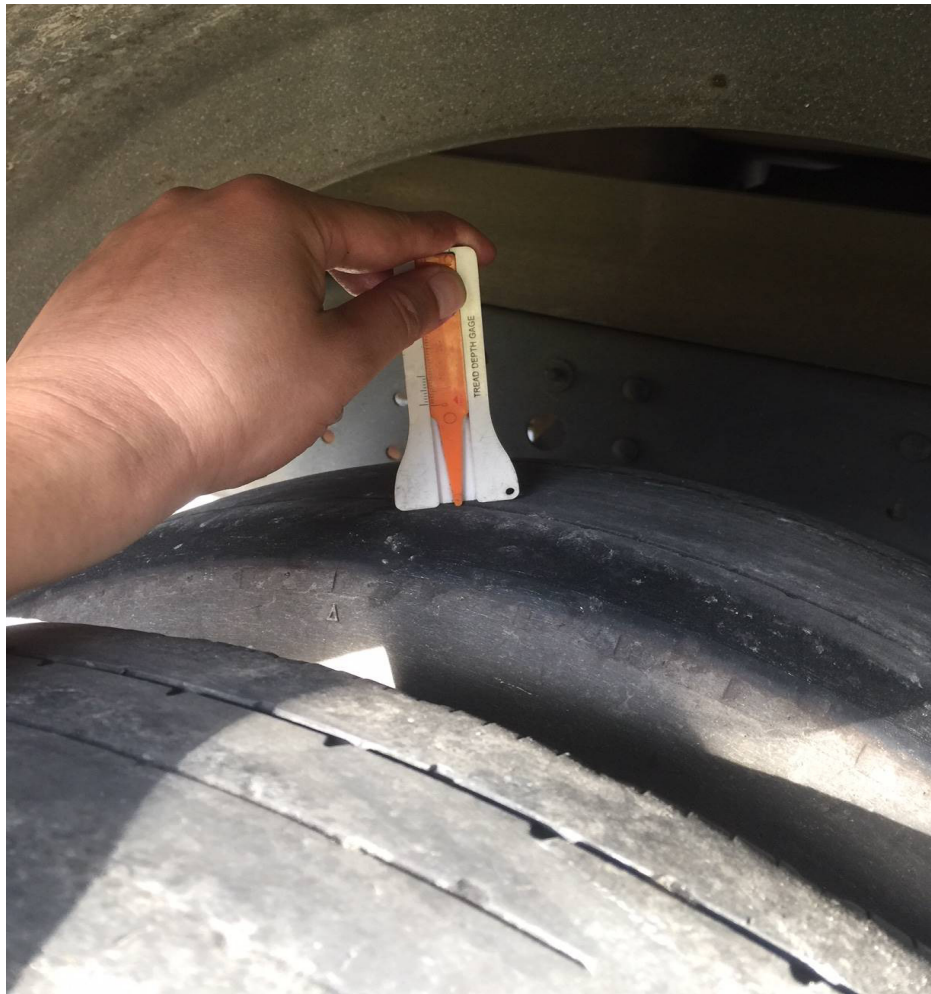
Photo 10 shows the measurement of the remaining depth of the tread pattern at the outer area of the inner rear left tyre. The measurement had indicated slightly above 0mm. In general, measurements of the outer areas of the insured vehicle's rear left tyres, where the pattern of the tread was still barely visible reveal remaining tread depth of approximately slightly above 0mm to below 1mm.
