Your Ref: S9M01AFN
Our Ref : CI/ASM19002150/D

01 February 2019

**AUTOMOBILE INSPECTION REPORT OF INSURED VEHICLE YP 3747D
INVOLVED IN AN ACCIDENT ON 11 JANUARY 2019**

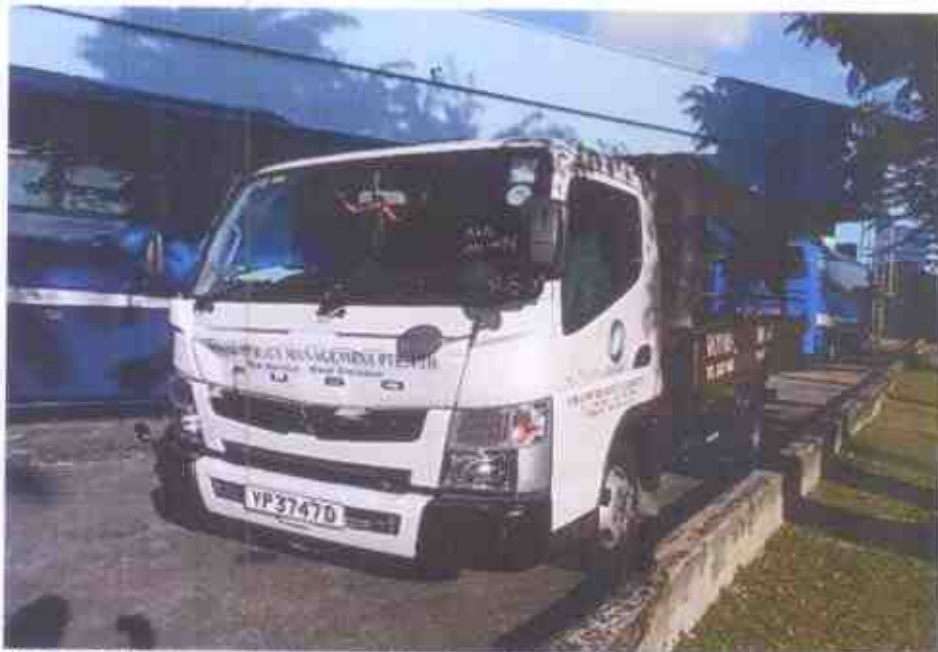
Photo 1 shows a general view of the front left body of the insured vehicle at the time of my inspection. The front bumper, front centre panel, front grille and front right signal lamp were amongst the exterior body parts that had sustained impact damages as a result of the accident.

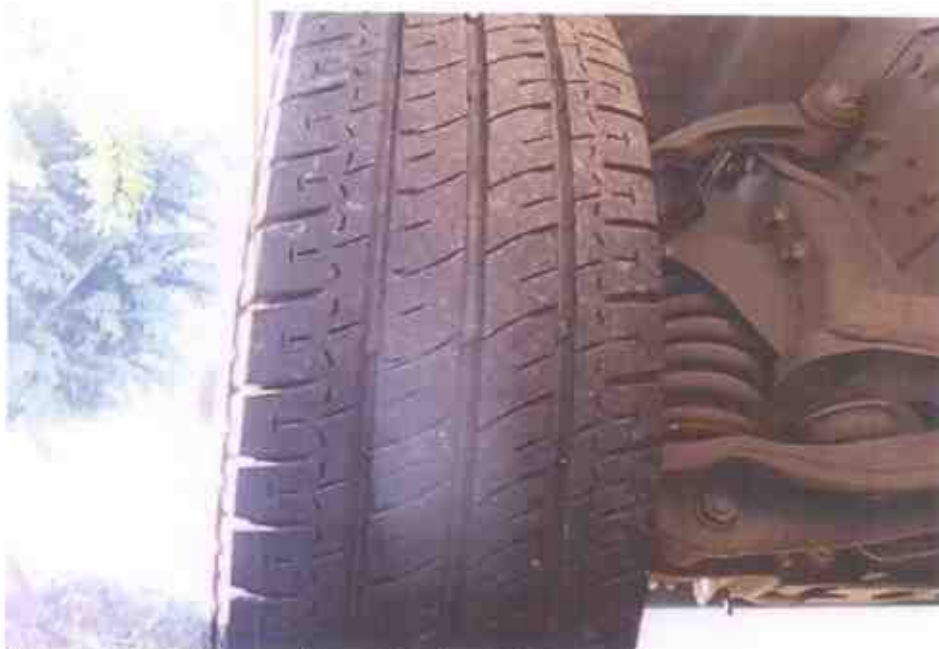
Photo 2 shows the condition of the front left tyre of the insured vehicle, which was observed to be in serviceable condition with remaining tread depth of approximately 7mm. It was also found to be sufficiently inflated for vehicular operation and without any tear, cut or burst mark(s) on the outer and the inner sidewalls as well as across the tread.

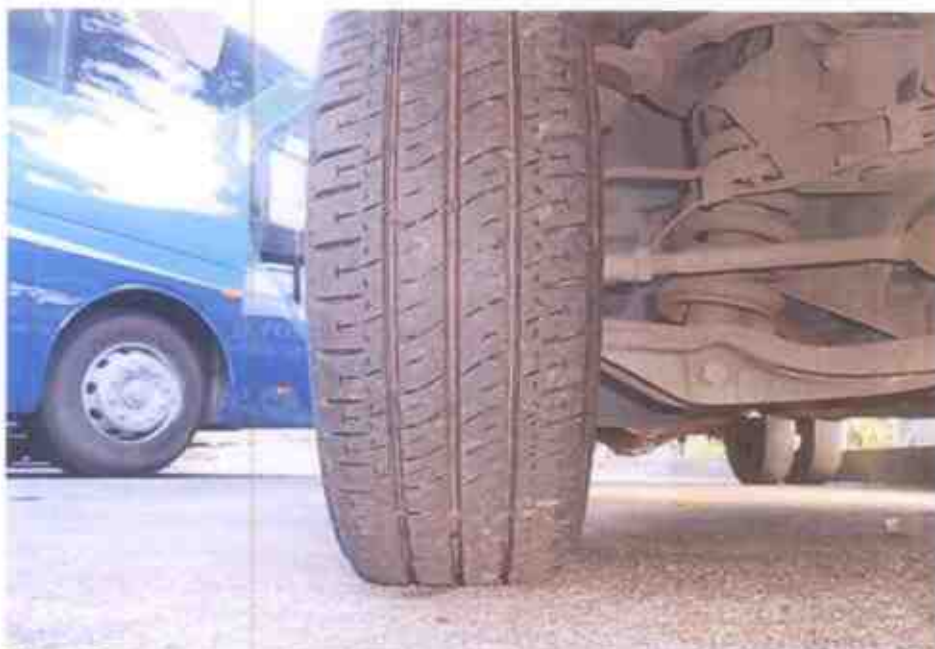
Photo 3 shows the condition of the front right tyre of the insured vehicle, which was observed to be in serviceable condition with remaining tread depth of approximately 7mm. The front right tyre was also observed to be sufficiently inflated for vehicular operation with no tear, cut or burst mark(s) on its outer and inner sidewalls, as well as across its tread.

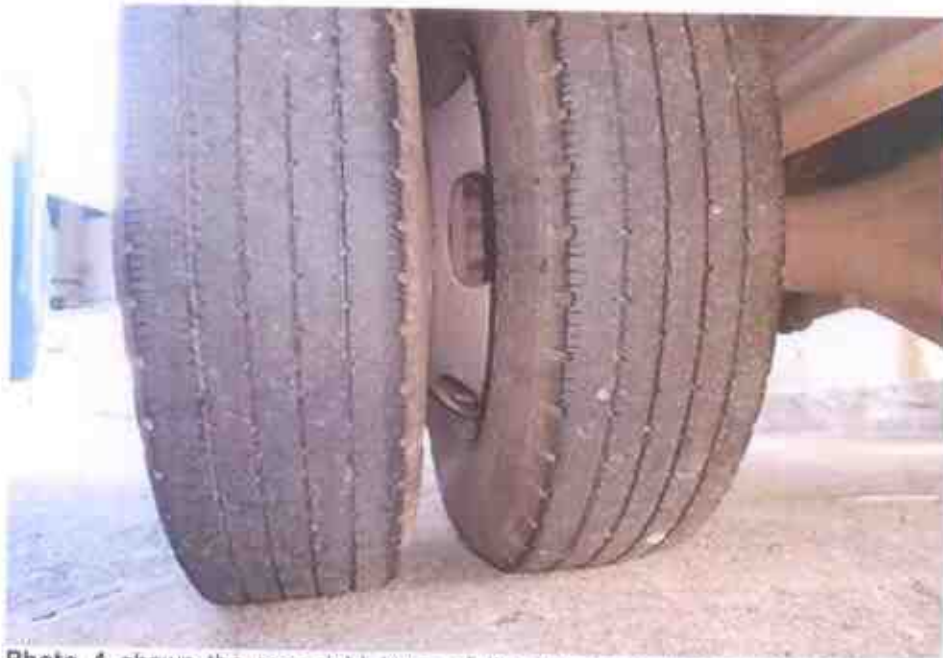
5. Upon examination of the insured vehicle's rear tyres, I note that there was a total of 4 tyres fitted. 2 at the rear right axle and 2 at the rear left axle. The pattern of the tread of both rear right tyres were observed to be still visible. Both the rear right tyres were also found to be sufficiently inflated for vehicular operation and without any tear, cut or burst mark(s) on the outer and the inner sidewalls as well as across the tread. My measurements of the tread depth of the 2 rear right tyres revealed remaining depth of approximately 2mm to 3mm each. The 2 rear right tyres of the insured vehicle are thus in serviceable condition. See photo 4 & 5 below.

Photo 4 shows the rear right tyres of the insured vehicle at the time of my inspection. The pattern of the tread of both rear right tyres were observed to be still visible. Both these tyres were found to be sufficiently inflated for vehicular operation and without any tear, cut or burst mark(s) on the outer and the inner sidewalls as well as across the tread. The remaining tread depth of the 2 rear right tyres were measured to be approximately 2mm to 3mm each.

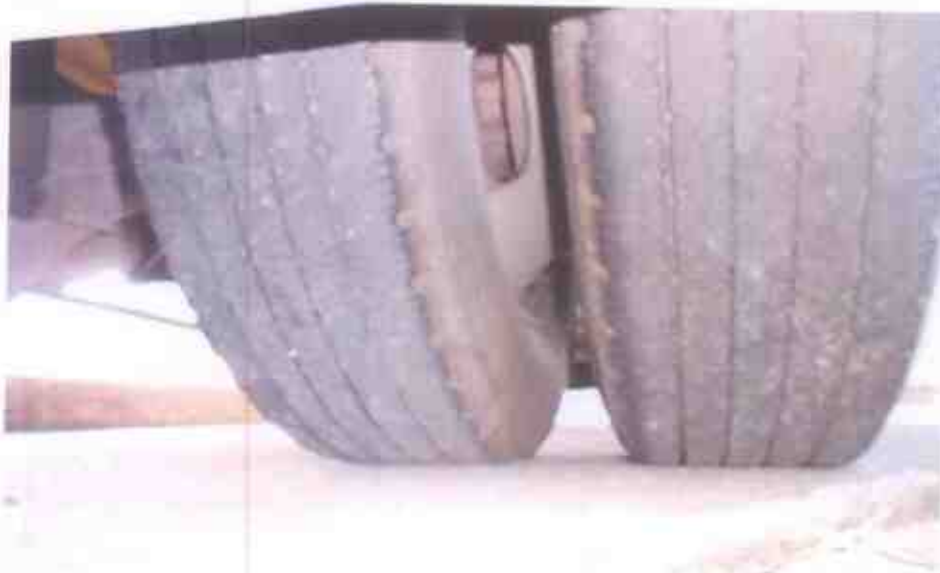
Photo 5 shows the rear right tyres of the insured vehicle at the time of my inspection. The 2 rear right tyres were in serviceable condition with remaining tread depth measured to be approximately 2mm to 3mm each. Both these tyres were also sufficiently inflated for vehicular operation.

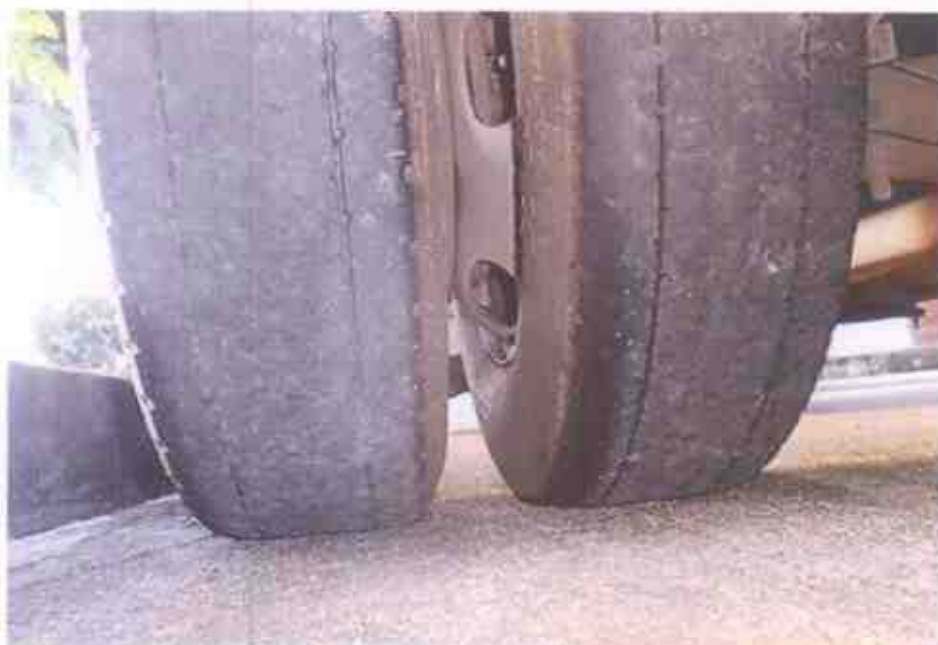
6. The 2 rear left tyres of the insured vehicle on the other hand, were observed to be in a condition with the pattern of the tread at the centre area of both rear left tyres no longer visible. This was observed to be around the entire circumference of both rear left tyres. The non-visible tread pattern was due to rubber wearing off. The pattern of the tread at the outer areas of both the rear left tyres were also observed to be barely visible around the entire circumference of both rear left tyres. The 2 rear left tyres were found to be sufficiently inflated for vehicular operation and without any tear, cut or burst mark(s) on the outer and the inner sidewalls as well as across the tread.

Photo 6 shows the rear left tyres of the insured vehicle at the time of my inspection. The pattern of the tread at the centre area of both rear left tyres were observed to be no longer visible while the pattern of the tread at the outer areas were barely visible. The non-visible tread pattern was due to the rubber wearing off. Both these tyres were found to be sufficiently inflated for vehicular operation and without any tear, cut or burst mark(s) on the outer and the inner sidewalls as well as across the tread.

8. Having examined the 6 tyres of the insured vehicle, I am of the view that the 2 front tyres and 2 rear right tyres are in serviceable condition, and are within the requirements of the local governing body.
9. The condition of the inner and outer rear left tyres of the insured vehicle, on the other hand, were not in serviceable condition and does not comply with SECTION 109(f) CAP 276 of THE ROAD TRAFFIC ACT, ROAD TRAFFIC (MOTOR VEHICLES, CONSTRUCTION AND USE) RULES.

11. Basing on my observations and measurements of the 2 rear left tyres of the insured vehicle, the centre area of both the rear left tyres does not have a depth of at least 1mm around the entire circumference of the tyres. Both the rear left tyres also do not have a pattern at the centre area that is clearly visible around the entire circumference of the tyres.

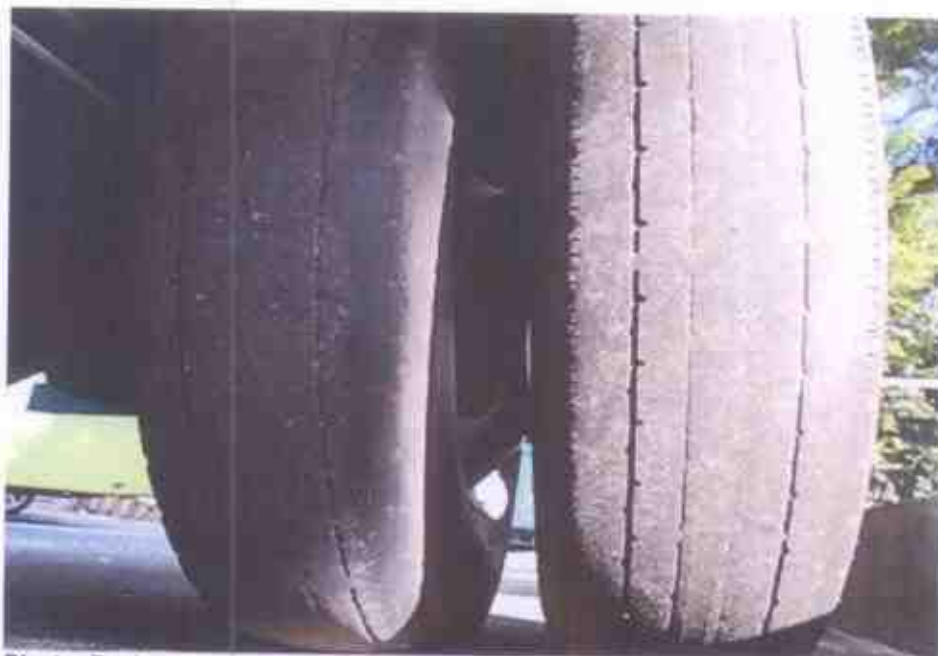
Photo 7 shows the rear left tyres of the insured vehicle at the time of my inspection. The pattern of the tread at the centre area of both rear left tyres were observed to be no longer visible while the pattern of the tread at the outer areas were barely visible. The non-visible tread pattern was due to the rubber wearing off. Both these tyres were found to be sufficiently inflated for vehicular operation and without any tear, cut or burst mark(s) on the outer and the inner sidewalls as well as across the tread.

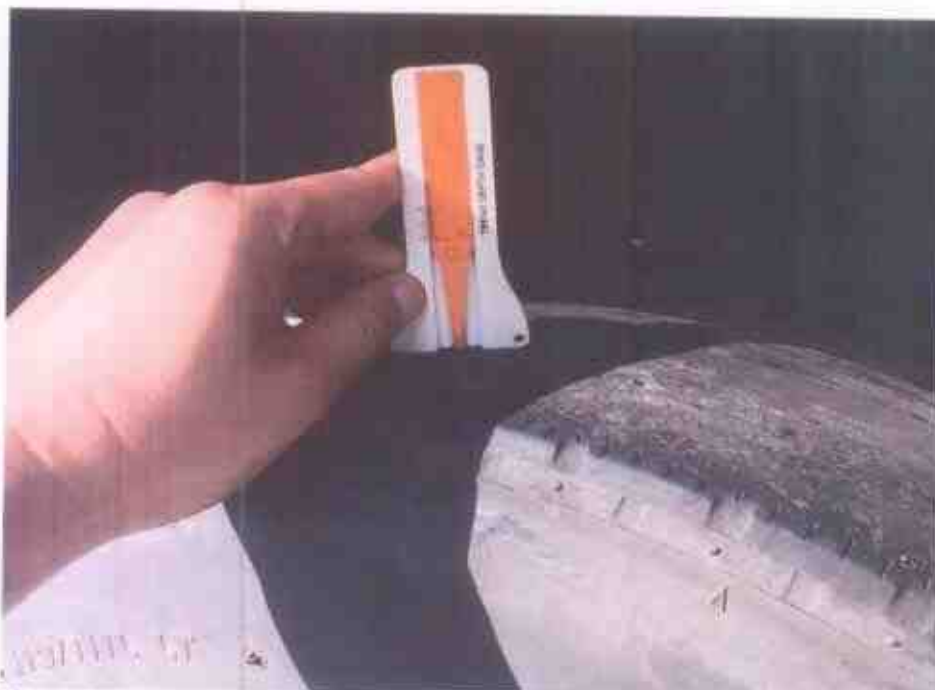
7. Measurements of the remaining depth of the tread pattern at the outer areas of the 2 rear left tyres revealed remaining depth of approximately slightly above 0mm to below 1mm. Since the tread pattern at the centre area of both the rear left tyres was no longer visible at some areas, the depth of the remaining tread pattern for the centre area can be considered to be 0mm at the area where the pattern of the tread is no longer visible. The 2 rear left tyres of the insured vehicle are hence not in serviceable condition. See photo 6 - 10 below.

Photo 8 shows measurement being carried out to the remaining tread depth of the insured vehicle's rear left tyres.

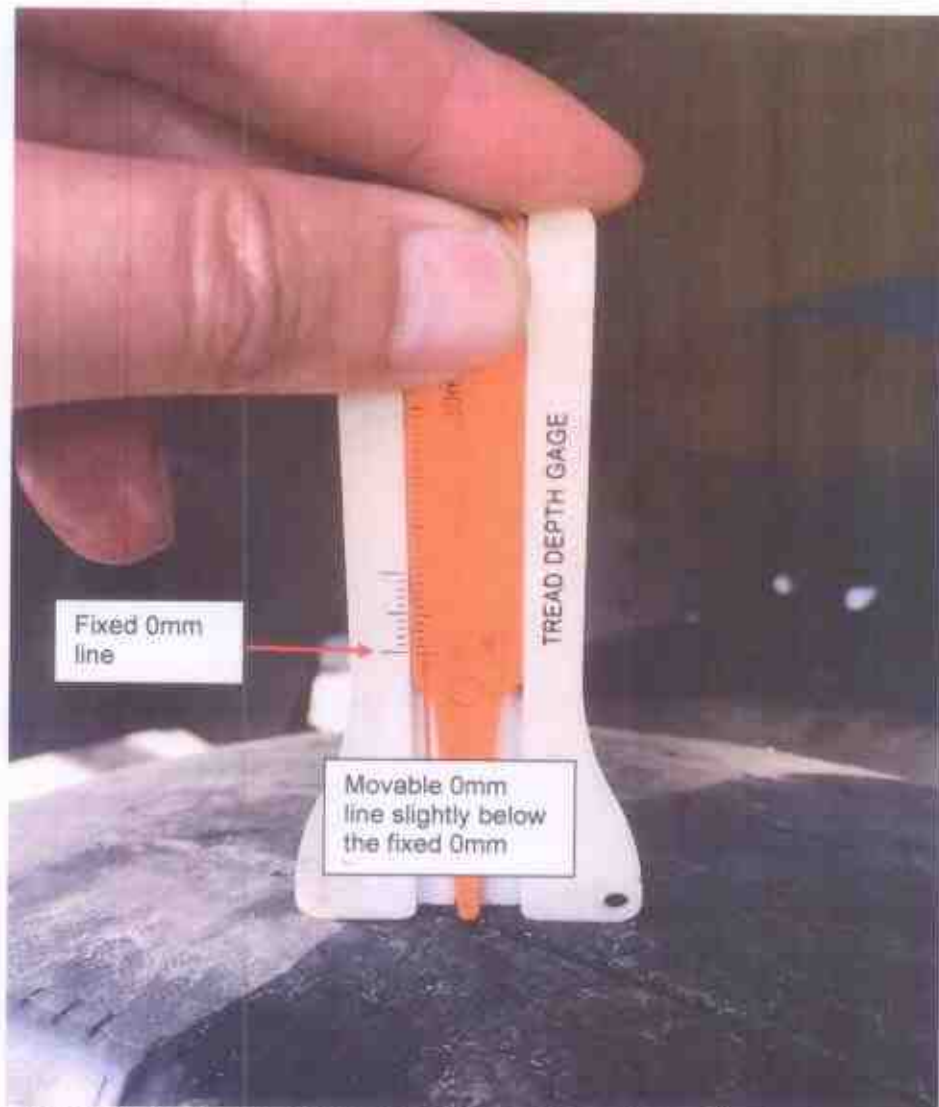
Photo 9 shows the measurement of the remaining depth of the tread pattern at the outer area of the outer rear left tyre. The measurement had indicated slightly above 0mm. In general, measurements of the outer areas of the insured vehicle's rear left tyres, where the pattern of the tread was still barely visible reveal remaining tread depth of approximately slightly above 0mm to below 1mm.

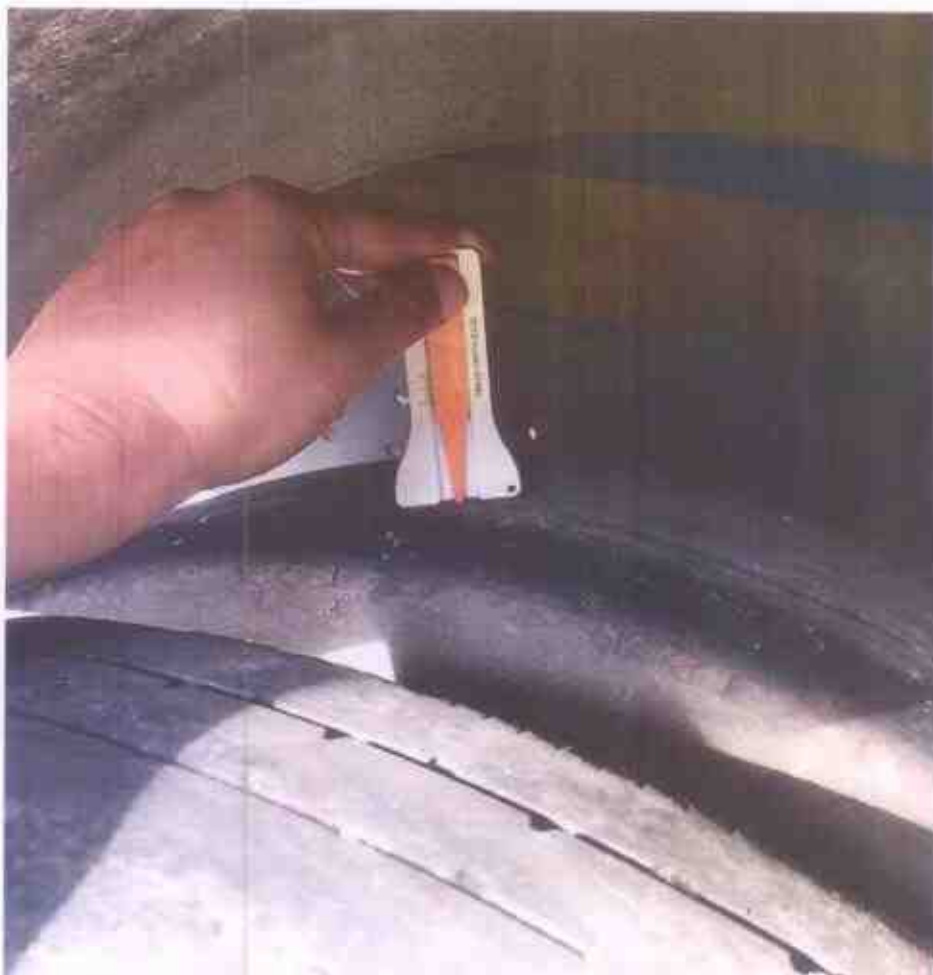
Photo 10 shows the measurement of the remaining depth of the tread pattern at the outer area of the inner rear left tyre. The measurement had indicated slightly above 0mm. In general, measurements of the outer areas of the insured vehicle's rear left tyres, where the pattern of the tread was still barely visible reveal remaining tread depth of approximately slightly above 0mm to below 1mm.
