Your Ref: 1506100037SG
Our Ref : CI/AIG19002163/D

01 February 2019

**TECHNICAL INVESTIGATION REPORT OF FIRE INCIDENT INVOLVING THE
INSURED VEHICLE SFU 8778E ON 11 JANUARY 2019**

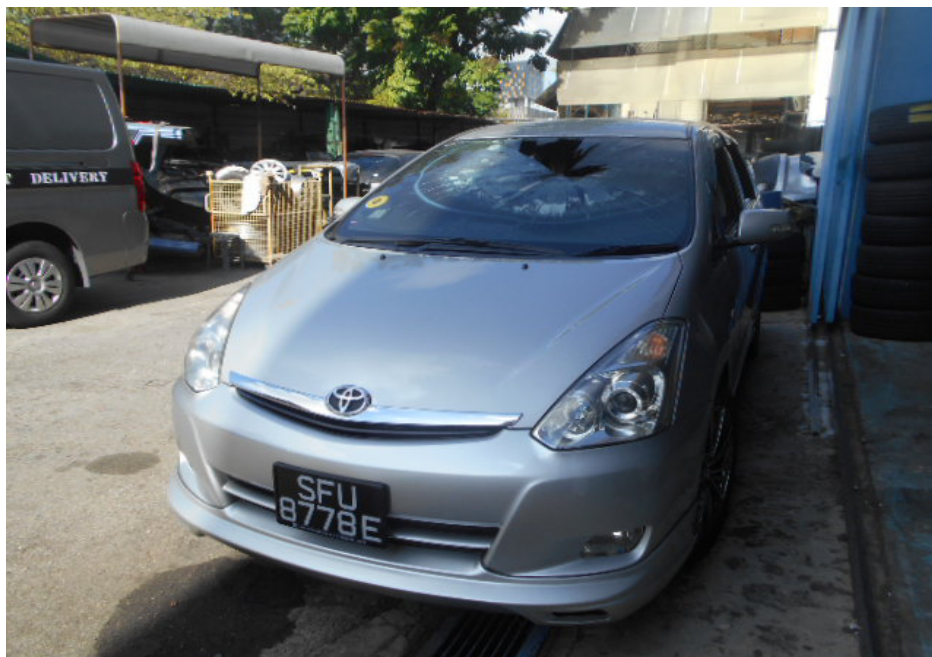
Photo 1 shows a general view of the front left body of the Insured Vehicle at the time of my inspection. The exterior body of the Insured Vehicle was observed to be in good general condition with no damage of burn nature found apart from a cracked front windscreen.

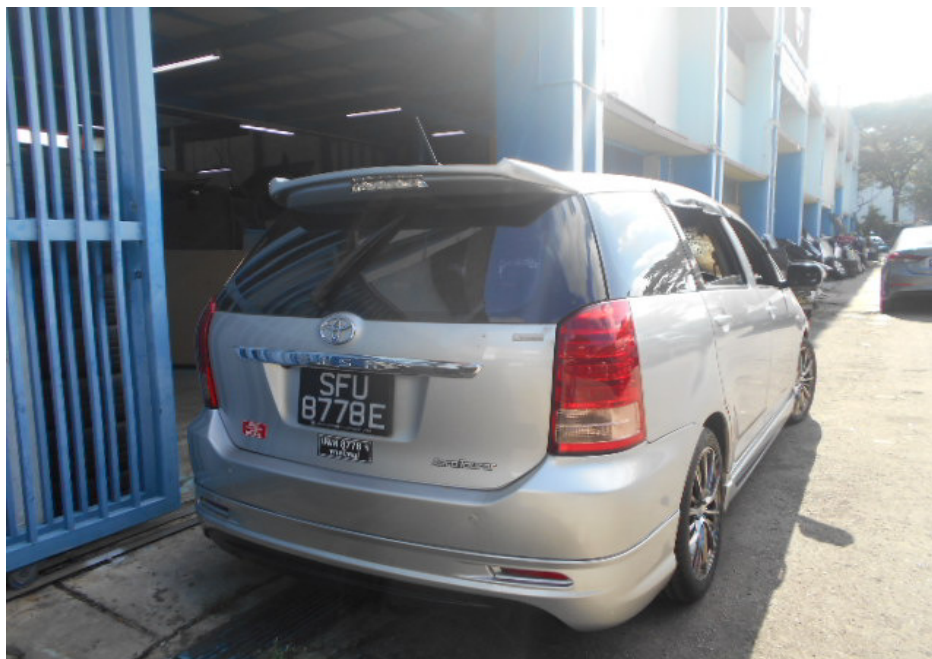
Photo 2 shows a general view of the rear right body of the Insured Vehicle at the time of inspection. The rear body of the Insured Vehicle was observed to be unaffected by the fire.

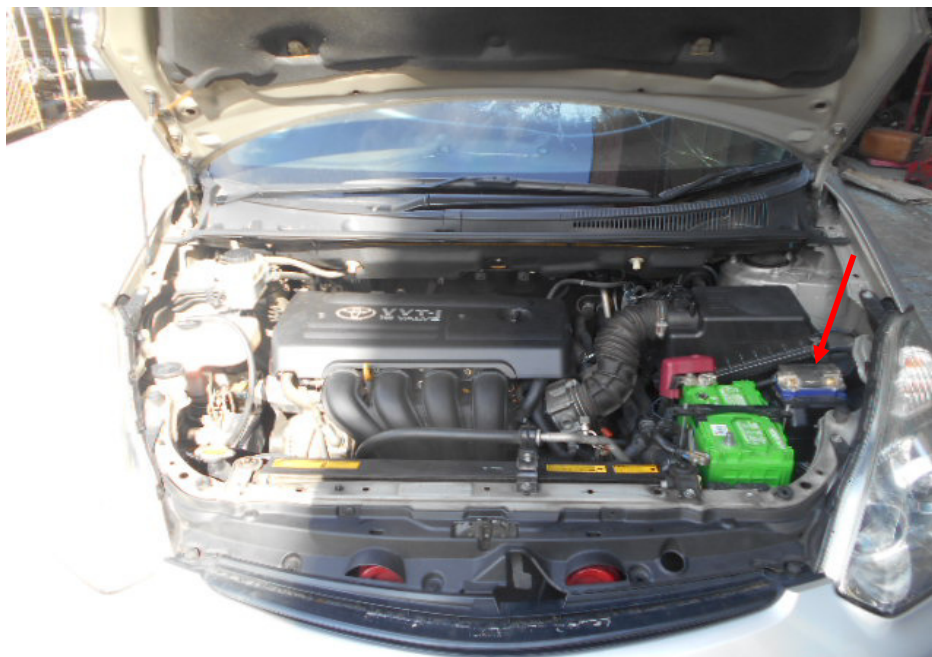
Photo 3 shows the engine compartment of the Insured Vehicle at the time of my inspection. There was no damage of burn nature observed within the engine compartment. A high ampere fuse (arrowed) was observed to be additionally fitted inside the engine compartment.

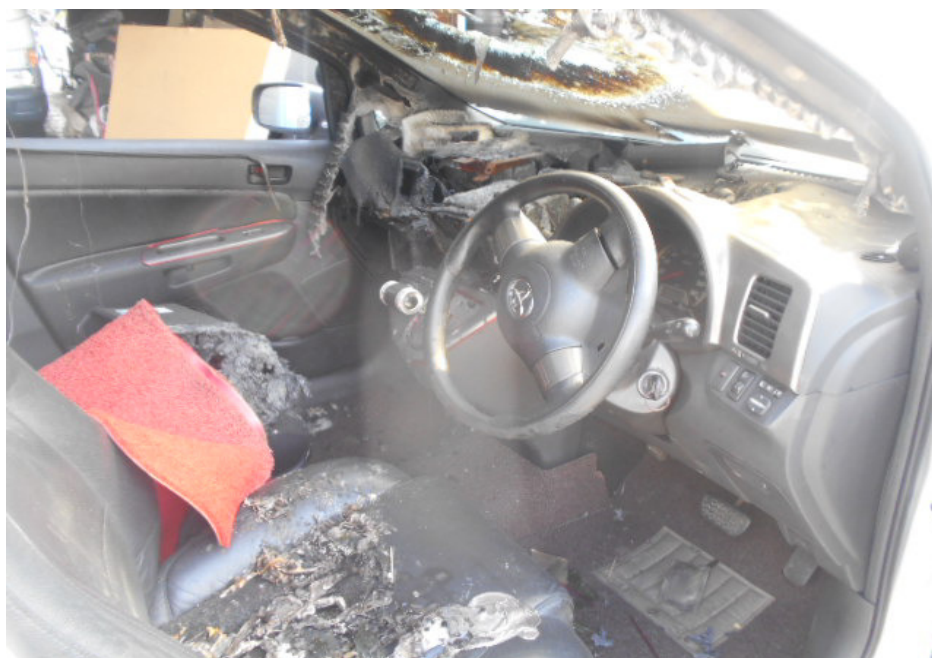
Photo 4 shows a general view of the interior compartment of the Insured Vehicle. The fire damage to the Insured Vehicle was confined to mainly the front area of its interior compartment. The front dashboard, seats, upholstery, carpets and various plastic trims amongst others were observed to have been partially melted/burnt.

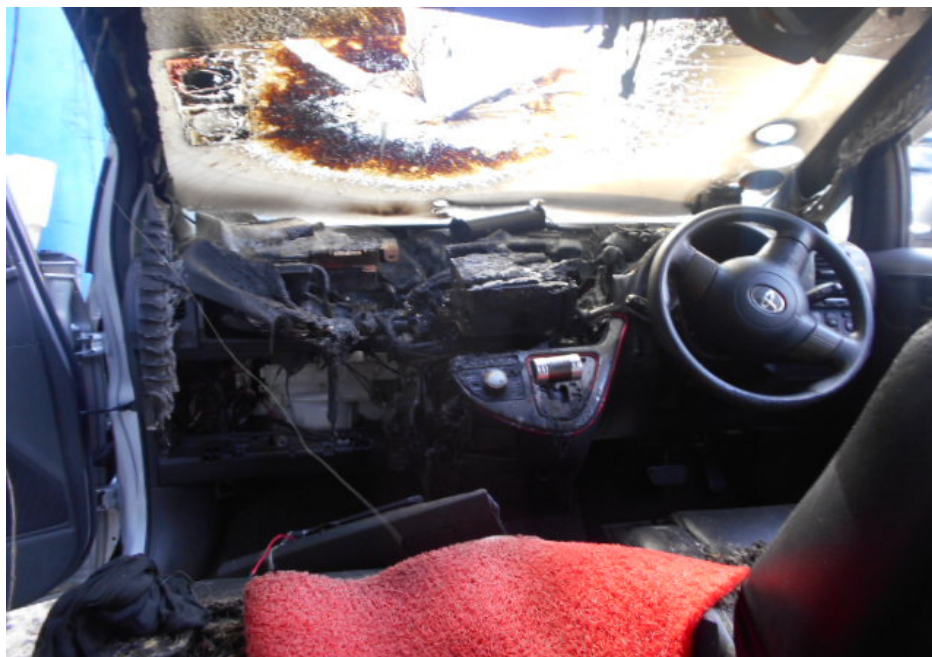
Photo 5 shows a general view of the interior compartment of the Insured Vehicle. The fire damage to the Insured Vehicle was confined to mainly the front area of its interior compartment. The front dashboard, seats, upholstery, carpets and various plastic trims amongst others were observed to have been partially melted/burnt.

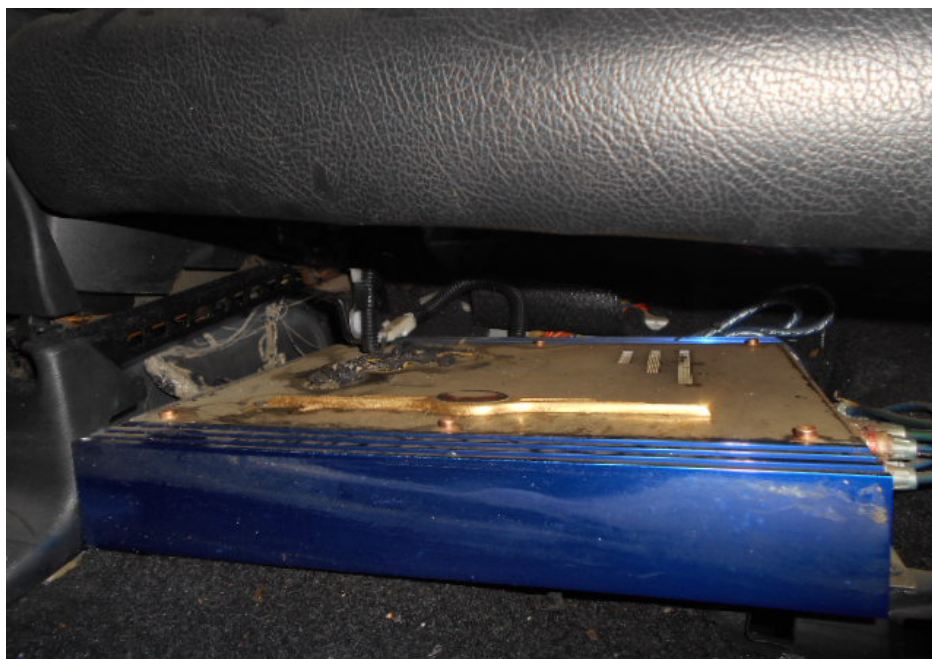
Photo 6 shows the audio amplifier that was found to be additionally fitted under the front left passenger seat of the Insured Vehicle. The audio amplifier and the connecting wire cables were found to be without any burnt marks.

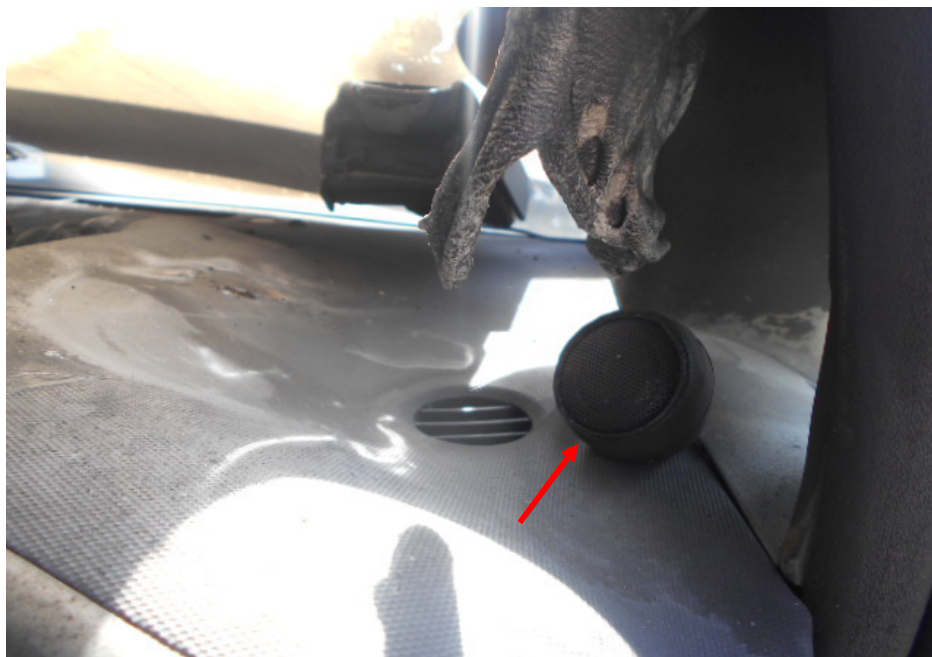
Photo 7 shows the audio speaker (arrowed) that was found to be additionally fitted near the right side "A" pillar trim of the Insured Vehicle. The same audio speaker fitted near the left side "A" pillar trim was observed to be partially melted/burnt as a result of the fire.

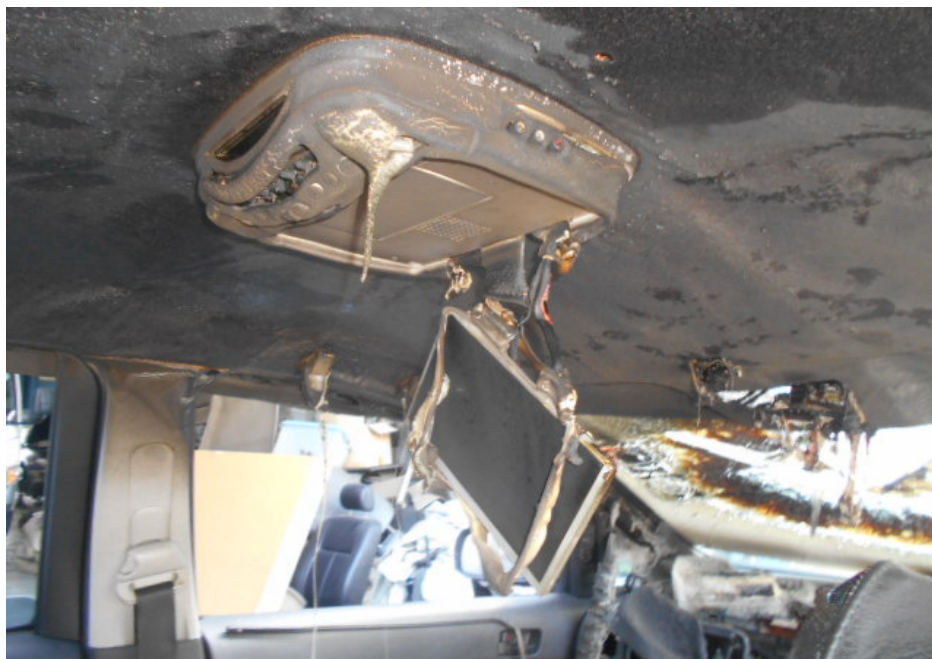
Photo 8 shows the media screen that was additionally fitted on the roof of the Insured Vehicle. The media screen was observed to be partially melted/burnt as a result of the fire.

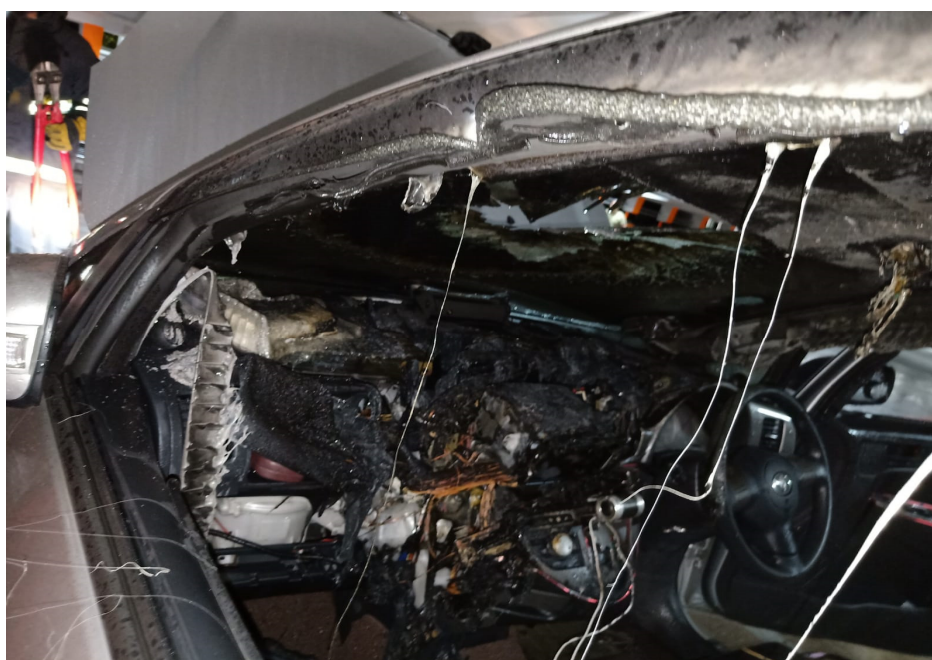
Photo 9 shows the interior compartment of the Insured Vehicle (photograph taken by Mr Naser at the incident scene). In general, the fire damage seen inside the interior compartment of the Insured Vehicle immediately after the fire was extinguished was observed to be similar to what I had observed during my inspection of the Insured Vehicle.

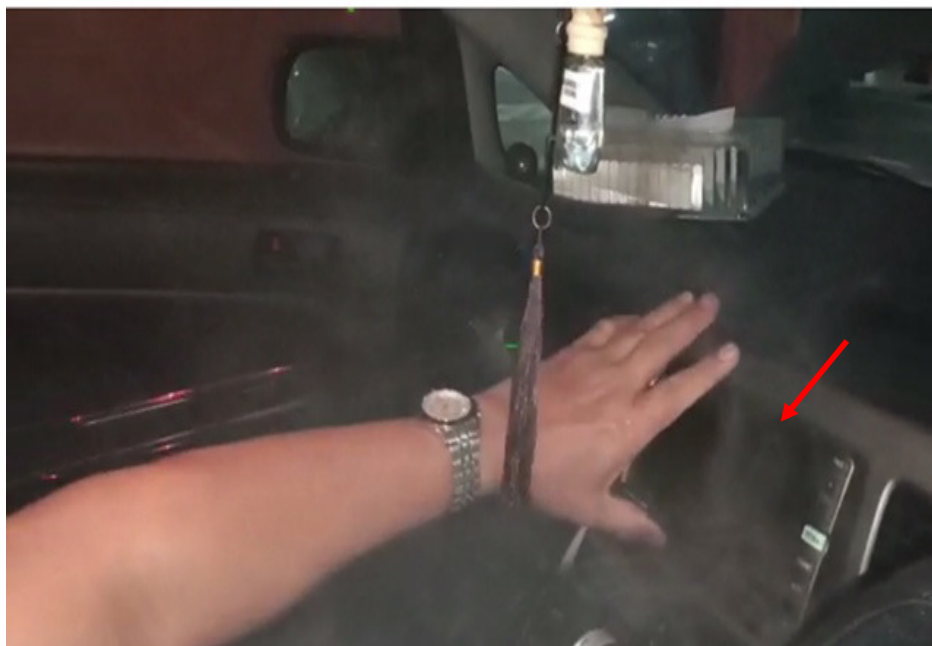
17. My review of the video recordings provided by Mr Naser had produced notable information with regard to the origin of fire. From the video recordings, smoke was indeed seen emitting from the interior compartment of the Insured Vehicle, at the area where the stereo was fitted. Fire could also be seen engulfing the interior compartment of the Insured Vehicle before it was extinguished by members of public using a fire hose. See photo 10 and 11 below which were extracted from the video recordings that I had reviewed.

Photo 10 shows smoke in the interior compartment of the Insured Vehicle before the fire. From the video recordings, the smoke appear to be emitting from the area where the stereo (arrowed) is fitted.

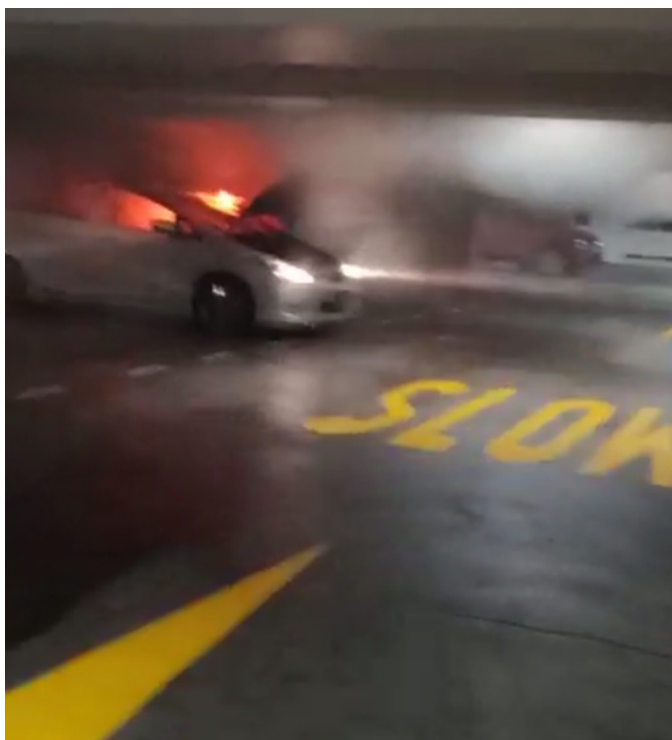
Photo 11 shows fire engulfing the interior compartment of the Insured Vehicle before it was extinguished by members of the public using a fire hose.

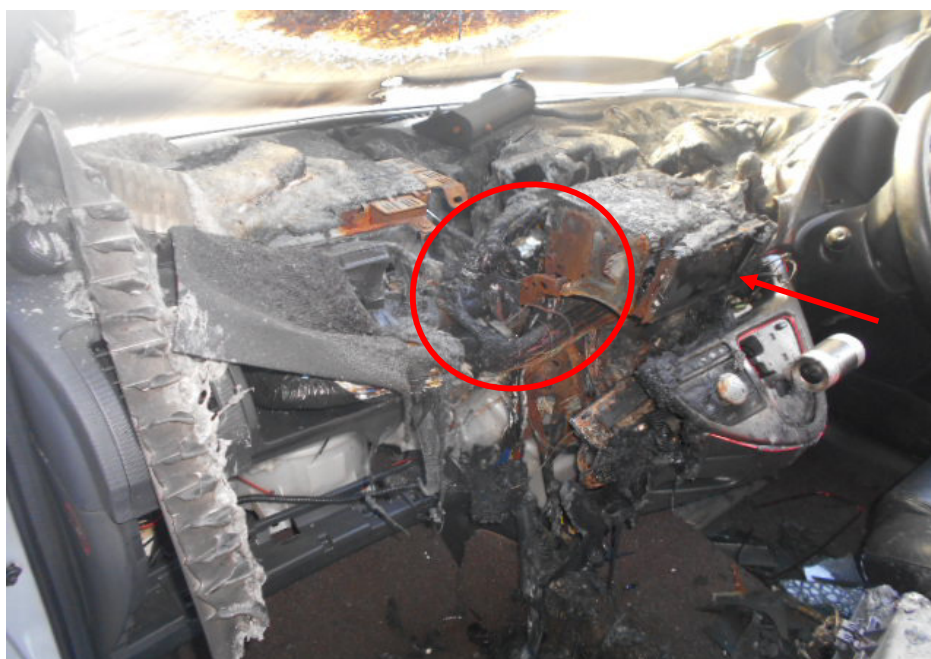
18. For this case, the fire to the Insured Vehicle can be established to have originated from the interior compartment, at the area behind the centre of the front dashboard. This was established from information gathered upon reviewing the photographs and videos provided by Mr Naser, as well as, from the physical damage to the Insured Vehicle, where the fire damage to the Insured Vehicle was observed to be confined to the front area of its interior compartment.

Photo 12 shows the interior compartment of the Insured Vehicle. Basing on the information gathered during the course of my investigations, and the physical damage to the Insured Vehicle, the fire had originated at the area (circled) behind the centre of the front dashboard. This was also behind and slightly below the location where the stereo (arrowed) is located.

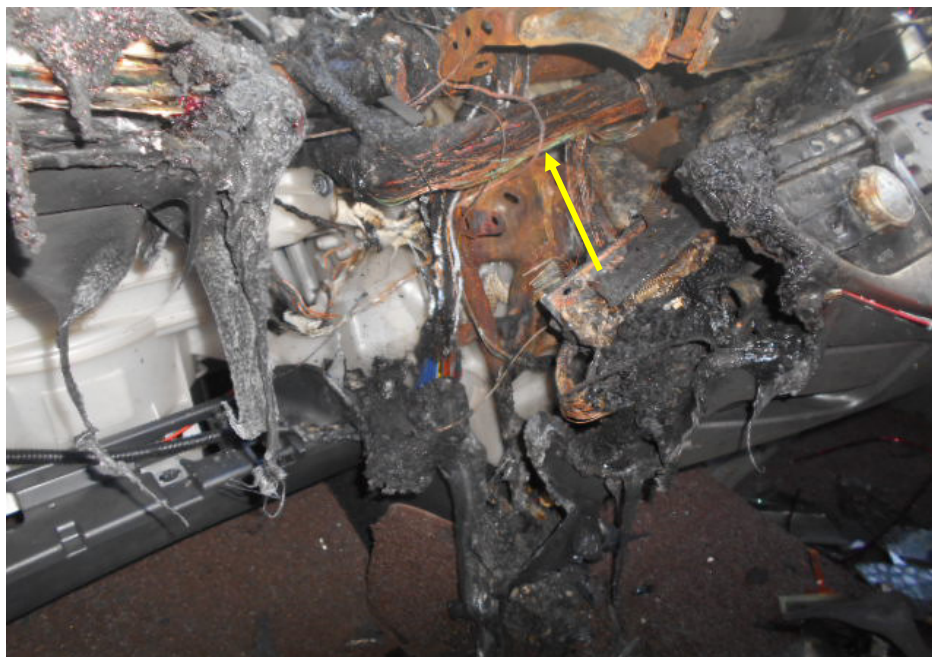
19. My examination of the centre area of the front dashboard, which was where the fire to the Insured Vehicle had originated, revealed burnt wirings that were with greenish colour residue. The presence of greenish residue indicates internal heating of copper wires, a sign of an electrical short circuit occurring. The greenish residue is normally left behind from oxidation as a result of chemical reaction involving the copper wires. This physical evidence would then appear to indicate that the cause of fire to the Insured Vehicle was due to electrical in nature. See photo 12 - 14 below.

Photo 13 shows the burnt wirings that were with greenish colour residue (arrowed). This was at the area behind the centre of the front dashboard, behind and slightly below the location of the stereo. The presence of greenish residue indicates internal heating of copper wires, a sign of an electrical short circuit occurring. The greenish residue is normally left behind from oxidation as a result of chemical reaction involving the copper wires. This physical evidence would then appear to indicate that the cause of fire to the Insured Vehicle was due to electrical nature.

21. Having investigated and technically analysed the damages of burnt nature to the Insured Vehicle, I am of the view that the cause of fire to the Insured Vehicle was of electrical in nature. For this particular case, the fire had originated along the wirings behind the centre area of the front dashboard, inside the interior compartment of the Insured Vehicle.

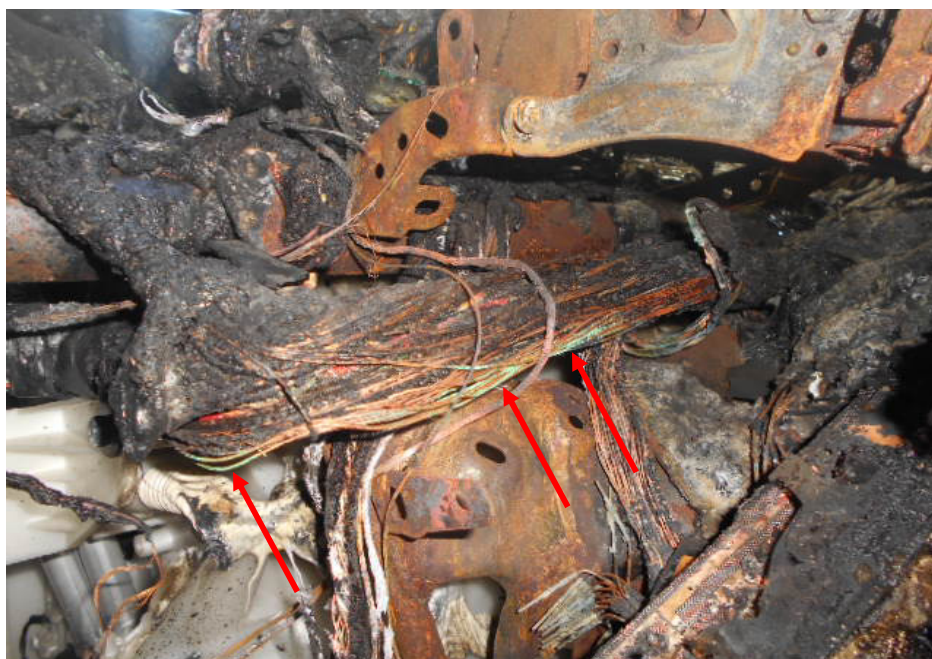
Photo 14 shows a closer view of the burnt wiring that were with greenish colour residue (arrowed). The presence of greenish residue indicates internal heating of copper wires, a sign of an electrical short circuit occurring.
