Your Ref : S9M01D3B
Our Ref : CS/ASM19002267/N

14 February 2019

**TECHNICAL INVESTIGATION REPORT OF FIRE INCIDENT INVOLVING THE
INSURED VEHICLE SDB 9812G ON 6 FEBRUARY 2019**

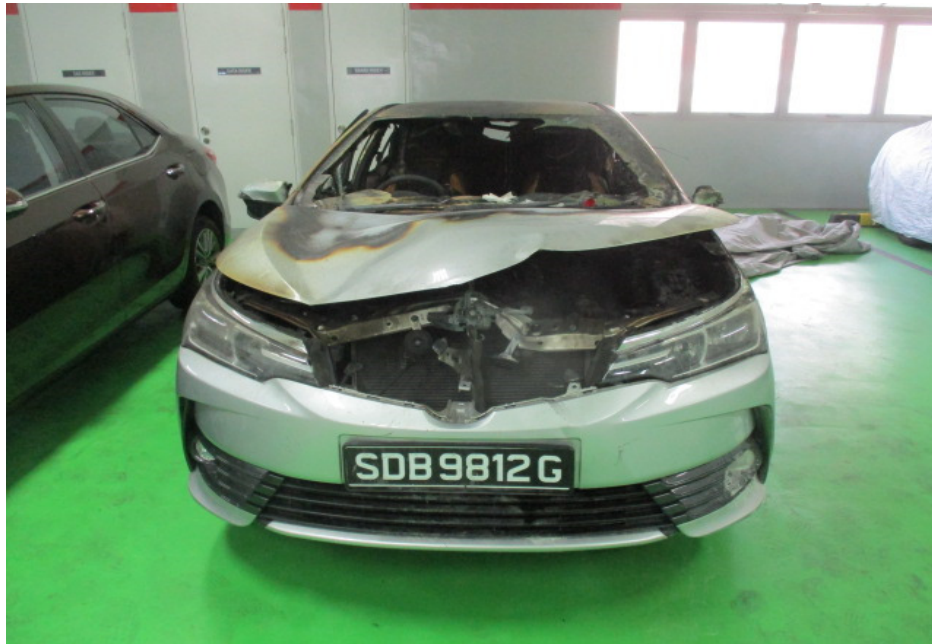
Photo 1 shows the general view of the front portion of the Insured Vehicle at the time of our inspection. The Insured Vehicle was observed to have sustained extensive fire damage all around. Its engine compartment and interior compartment were completely burnt. Rust had accumulated all over the rear and centre portion of the Insured Vehicle as a result of exposure to environmental condition for a period of time.

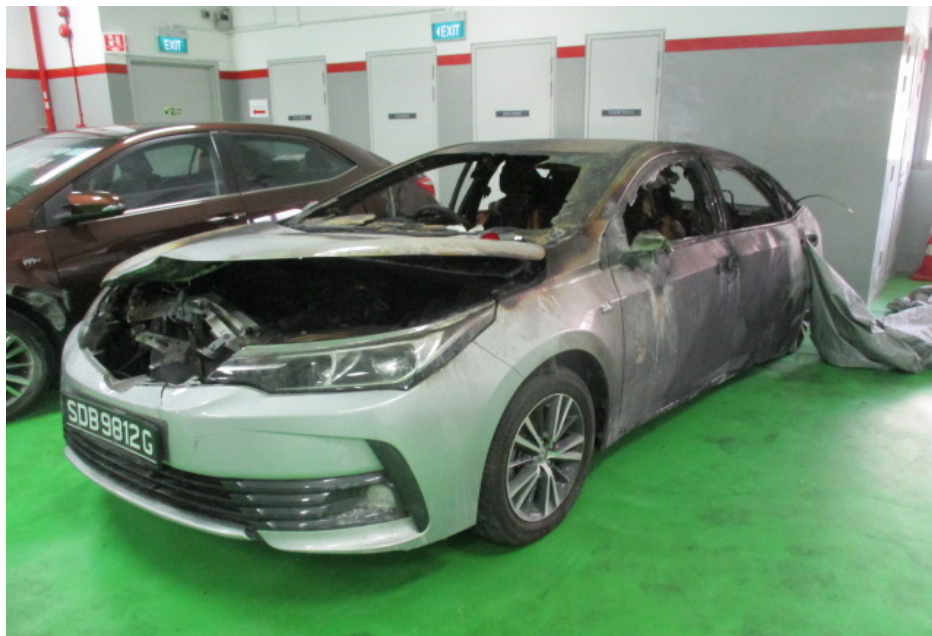
Photo 2 shows the general view of the left body of the Insured Vehicle at the time of our inspection. The Insured Vehicle was observed to have sustained extensive fire damage all around. Rust had accumulated all over the rear and centre portion of the Insured Vehicle as a result of exposure to environmental condition for a period of time.

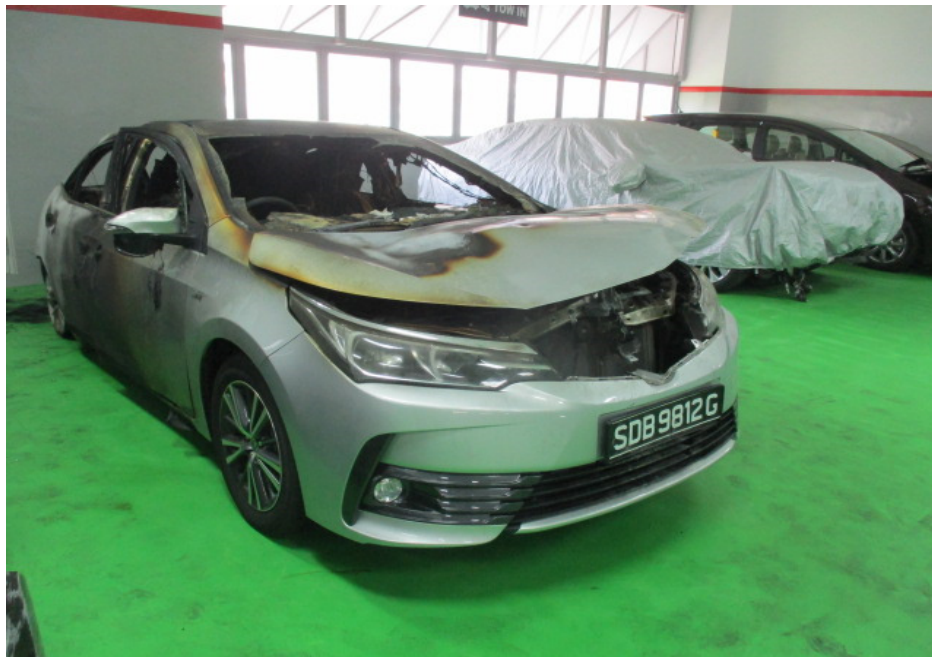
Photo 3 shows the general view of the right body of the Insured Vehicle at the time of our inspection. The Insured Vehicle was observed to have sustained extensive fire damage all around. Rust had accumulated all over the rear and centre portion of the Insured Vehicle as a result of exposure to environmental condition for a period of time.

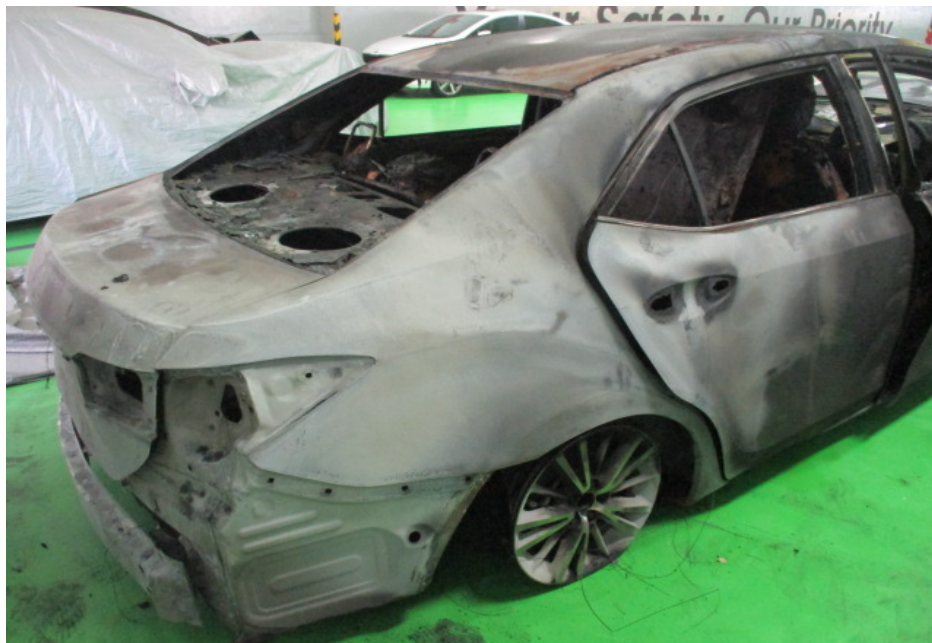
Photo 4 shows the general view of the rear right body of the Insured Vehicle at the time of our inspection. The Insured Vehicle was observed to have sustained extensive fire damage all around. Rust had accumulated all over the rear and centre portion of the Insured Vehicle as a result of exposure to environmental condition for a period of time.

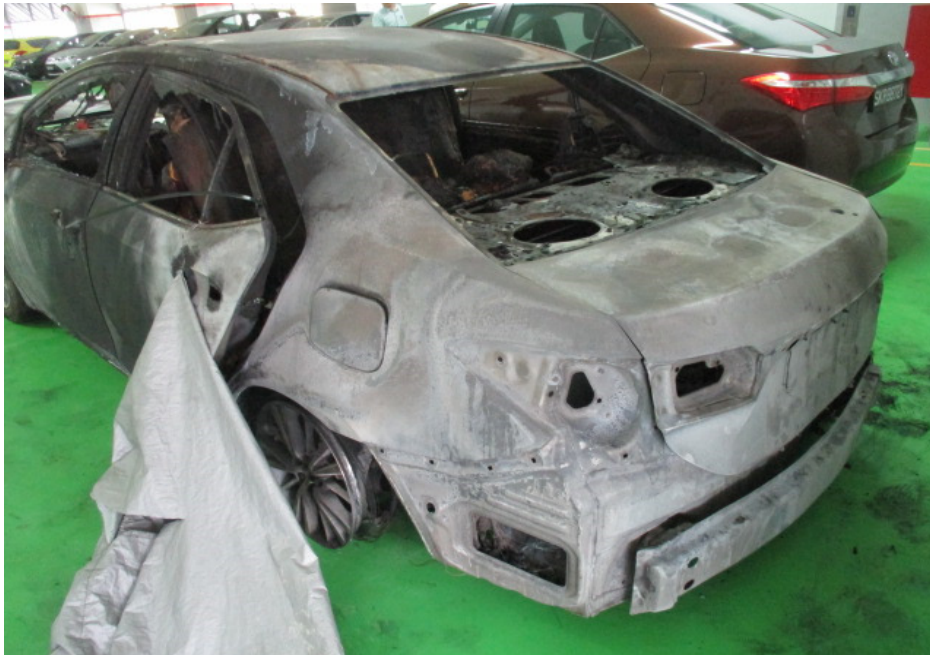
Photo 5 shows the general view of the rear left body of the Insured Vehicle at the time of our inspection. The Insured Vehicle was observed to have sustained extensive fire damage all around. Rust had accumulated all over the rear and centre portion of the Insured Vehicle as a result of exposure to environmental condition for a period of time.

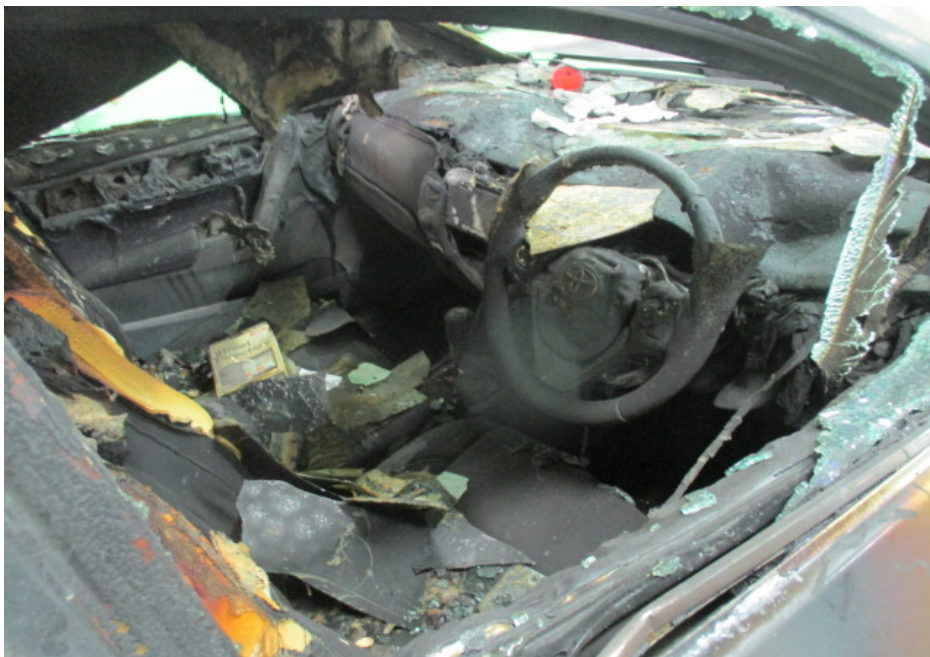
Photo 6 shows the general view of the interior compartment of the Insured Vehicle at the time of our inspection. Its interior compartment was completely burnt as a result of the fire.

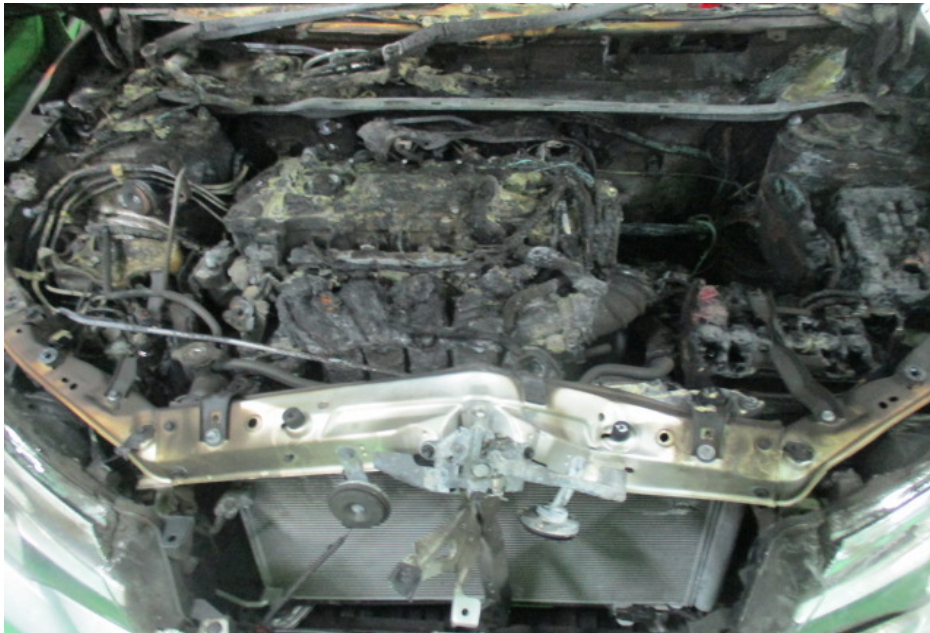
Photo 7 shows the engine compartment of the Insured Vehicle at the time of our inspection. The entire engine compartment of the Insured Vehicle was observed to be severely burnt. Most of the parts inside the engine compartment were found to be burnt and/or melted as a result of the fire.

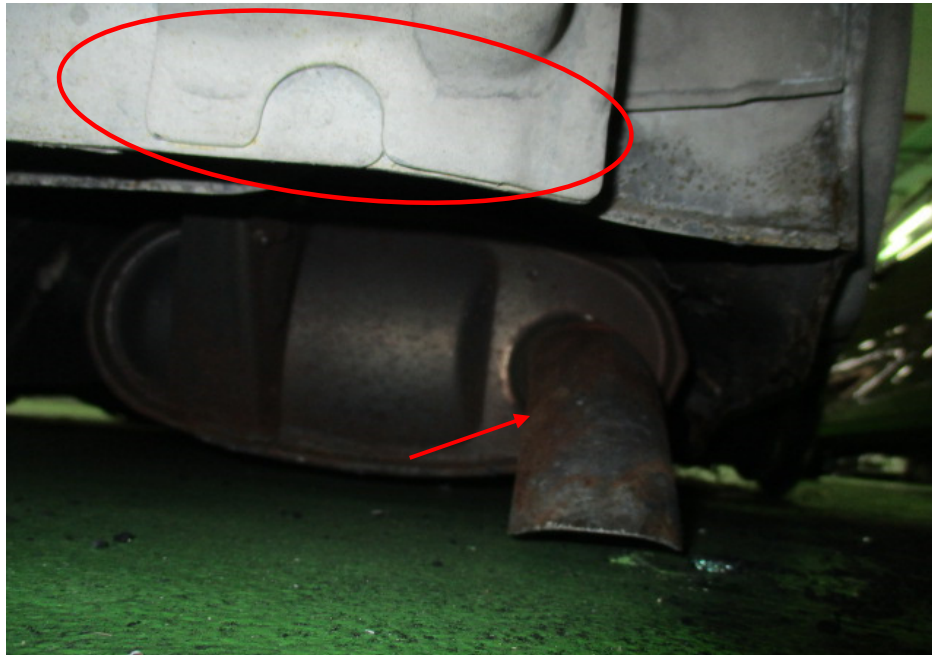
7. Based on the circumstances for this particular case, the fire appears to have originated from the exterior portion of the undercarriage of the Insured Vehicle, somewhere around the rear exhaust muffler. This can be determined basing on the area where the extent of fire damage was most severe, the circumstances of the fires' origin at the material time of incident and also the high heat intensity burn marks (whitish burn marks) that were found on the exterior surface of its rear exhaust muffler. These whitish burn marks are a result of exposure to prolong heat intensity. Rust would normally start to develop around these areas soon after a fire as the prolonged exposure to high heat intensity usually causes the bare steel/metal material of the body parts to be exposed to natural environmental condition. The rust that had developed on the rear exhaust muffler, in the immediate vicinity of where these whitish burn marks were found, would also support our findings of where the fire to the Insured Vehicle had originated. See photo 8 below.

Photo 8 shows the fire damage at the exterior portion of the undercarriage of the Insured Vehicle. The high heat intensity burn marks (whitish burn marks) found on the exterior surface of its rear end panel (circled) and rust that had developed on the rear exhaust muffler (arrowed) indicates that the fire to the Insured Vehicle had originated from the exterior of the Insured Vehicle.

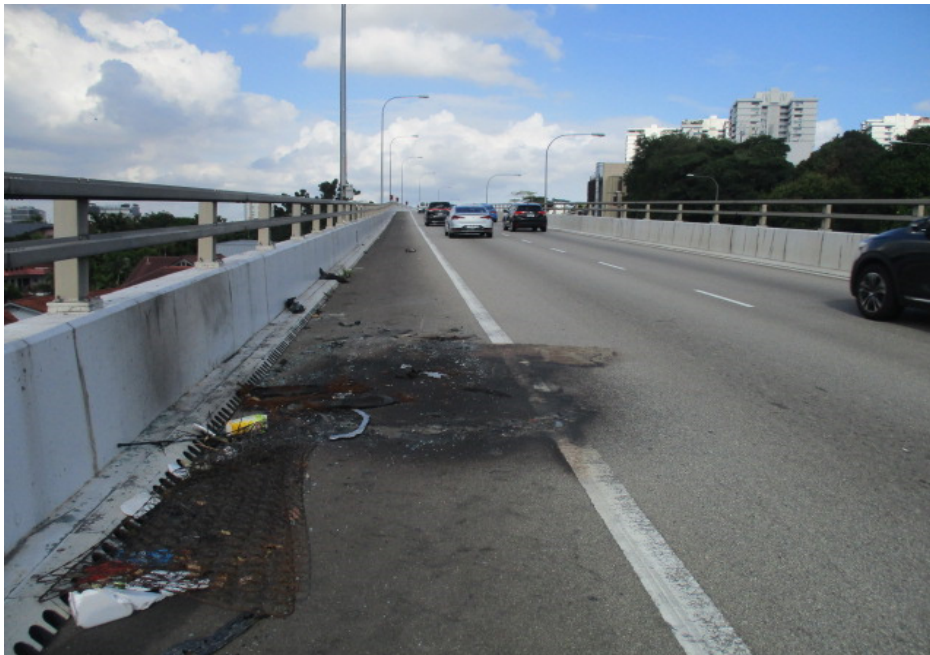
Photo 9 shows the general view of the location where the fire incident had occurred. The Insured Vehicle was positioned at the road shoulder of the Lornie Viaduct towards Toa Payoh/CTE. From our observations, there was no CCTV camera(s) located in the vicinity of the viaduct.

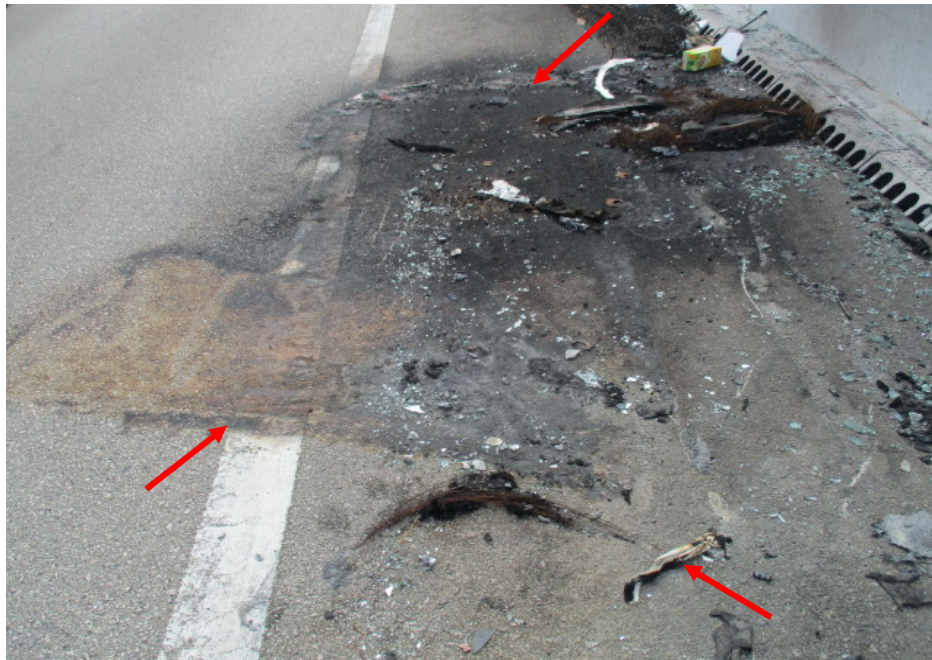
Photo 10 shows the burn marks and/or burnt residual remains on the ground at the road shoulder of the Lornie Viaduct towards Toa Payoh/CTE where the incident occurred (arrowed).

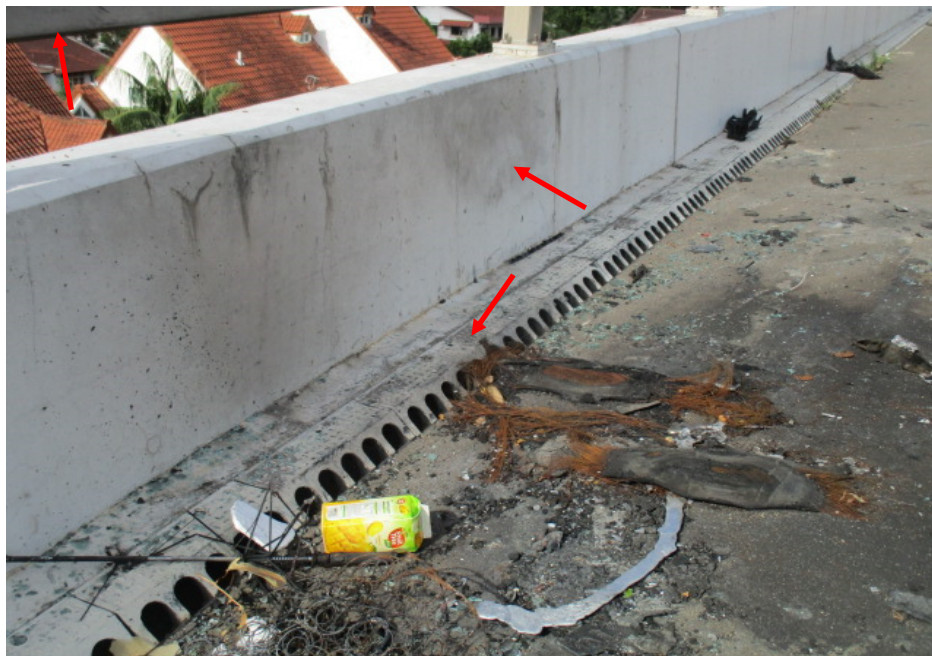
Photo 11 shows the burn marks on the adjacent kerb, barrier and railing nearest to where the Insured Vehicle was positioned when the fire occurred (arrowed).

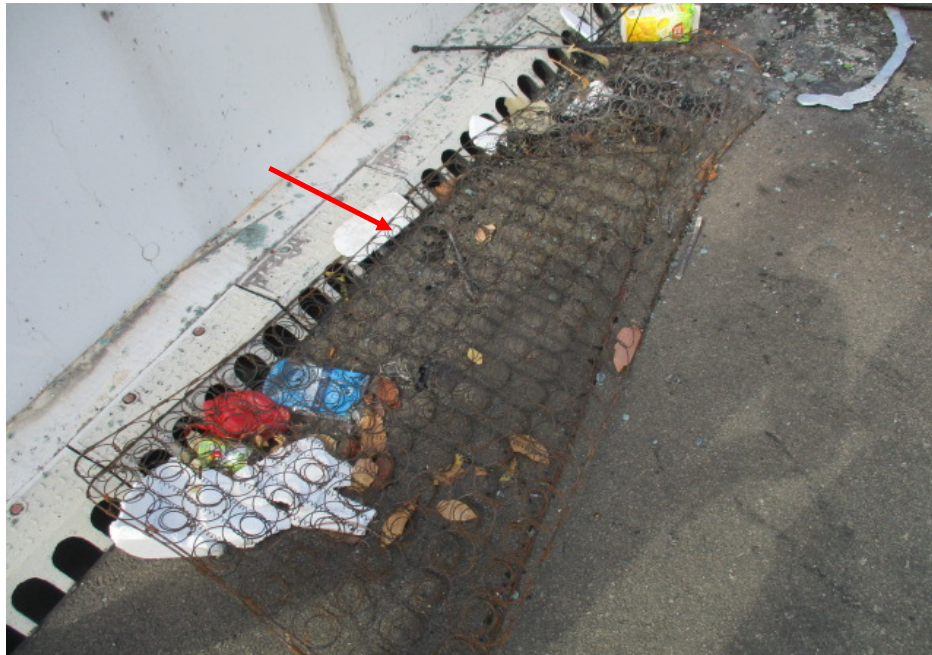
Photo 12 shows the charred residual remains of the mattress on the ground (arrowed). We did not observe any other damaged or newly replaced government property at the time of our visit to the incident location.

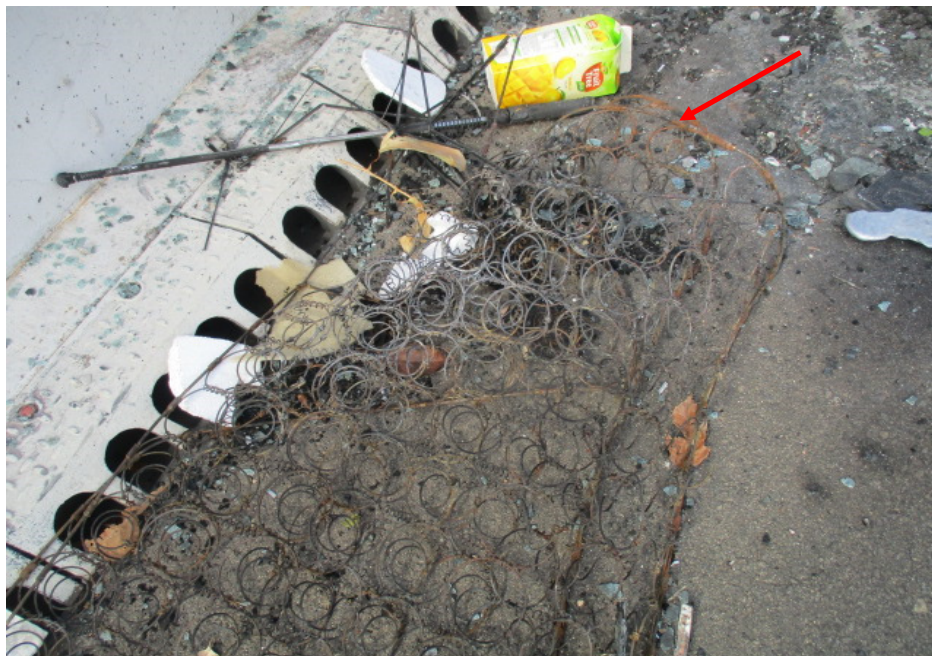
Photo 13 shows a close up view of the charred residual remains of the mattress found on the ground where the incident occurred (arrowed).

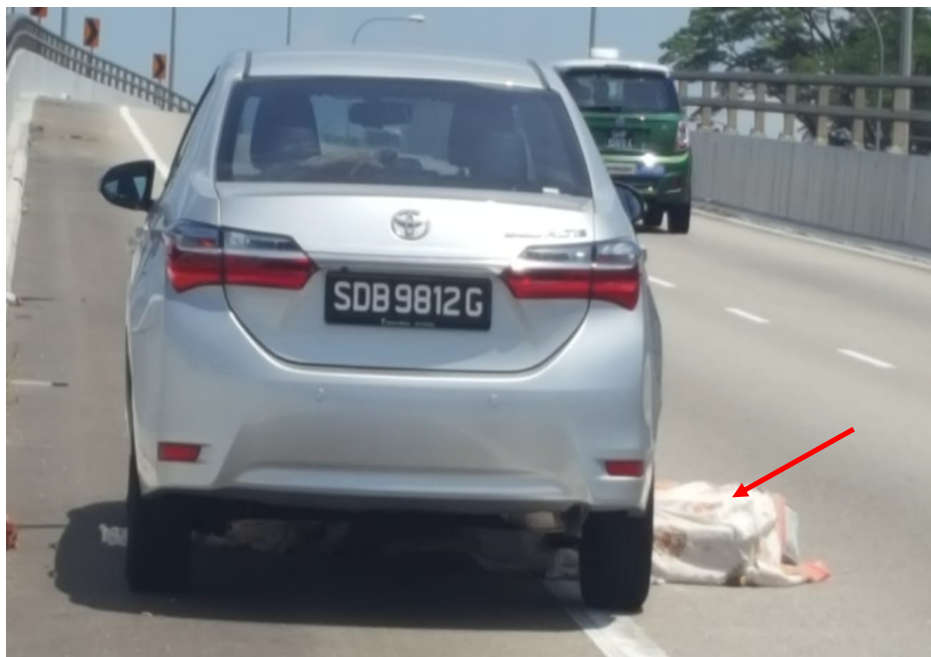
Photo 14 shows the Insured Vehicle stopping at the road shoulder after Mr Cheng drove over the mattress (arrowed).

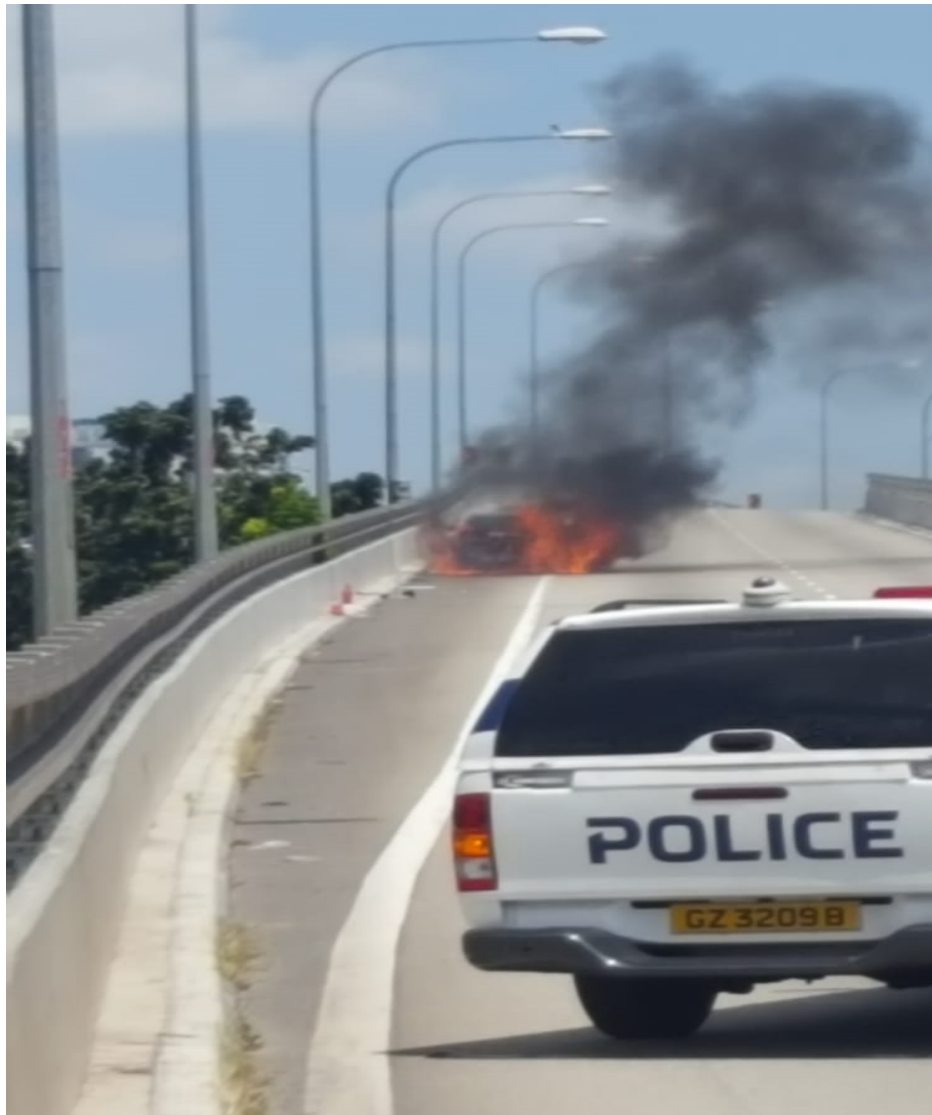
Photo 15 shows the Insured Vehicle on fire before the arrival of the SCDF. In general, the information that could be gathered from this photograph had corresponded to the events that were related to us by Mr Cheng, which is the police were present at the incident location when the fire broke out.

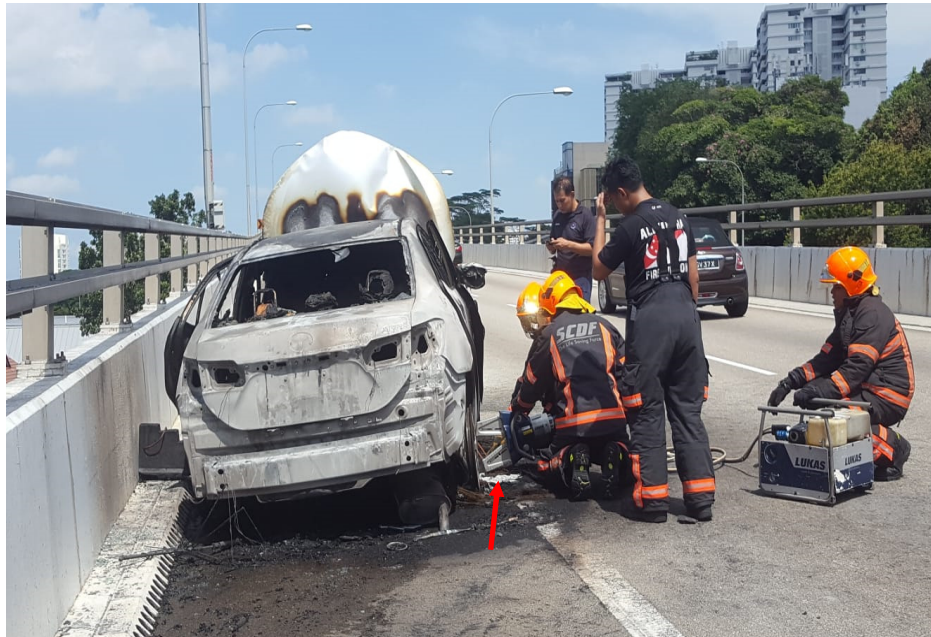
Photo 16 shows the Insured Vehicle at the incident location after the fire was extinguished by SCDF personnel. Firefighters can be seen using a hydraulic winch to remove the remnants of the burnt mattress that was stuck under the rear exhaust muffler of the Insured Vehicle (arrowed). The extent of damage and burn pattern to the Insured Vehicle was observed to be similar to what we had observed during our physical inspection of the Insured Vehicle.

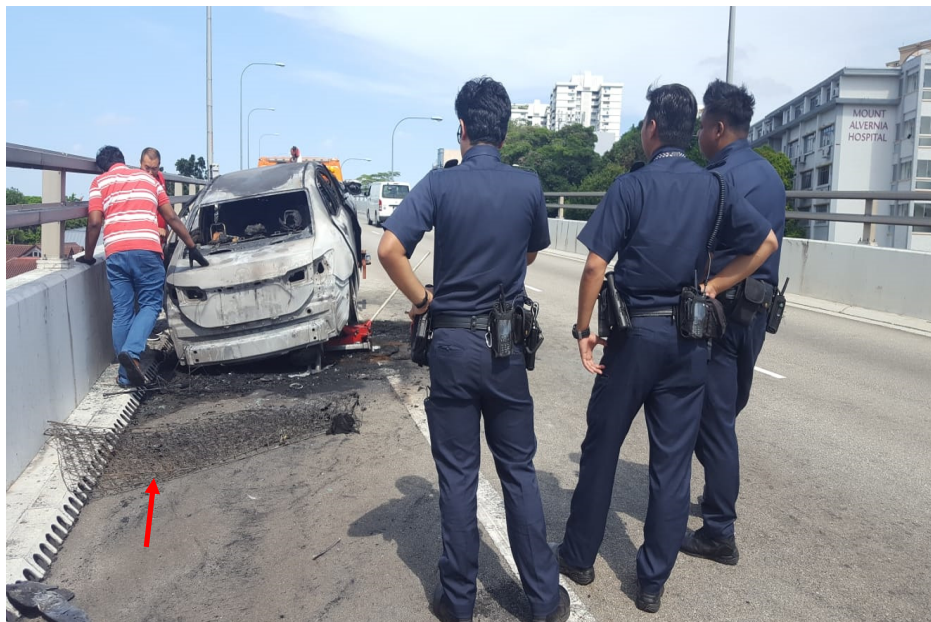
Photo 17 shows the Insured Vehicle being prepped to be towed post-incident. In general, the information that could be gathered from this photograph had corresponded to the events that were related to us by Mr Cheng, which is the fire was caused by the mattress (arrowed) that was stuck under the rear exhaust muffler of the Insured Vehicle.

16. Having investigated and technically analysed the damages of burnt nature to the Insured Vehicle, we are of the view that the cause of fire to the Insured Vehicle was likely due to external factor from the mattress that was stuck under the rear exhaust muffler of the Insured Vehicle.
17. The cause of fire being due to the mattress is also supported by our visit to the incident location where we had found the remnants of the burnt mattress at the area where the Insured Vehicle had stopped.
18. There was no modification(s) or additional electronic and/or electrical component(s) fitted on the Insured Vehicle at the time of our inspection of the Insured Vehicle.
