Your Ref: 3963673214SG
Our Ref : CC3/AIG19002331/D

15 March 2019

**TECHNICAL INVESTIGATION REPORT OF FIRE INCIDENT INVOLVING THE
INSURED VEHICLE SKM 3566R ON 28 JANUARY 2019**

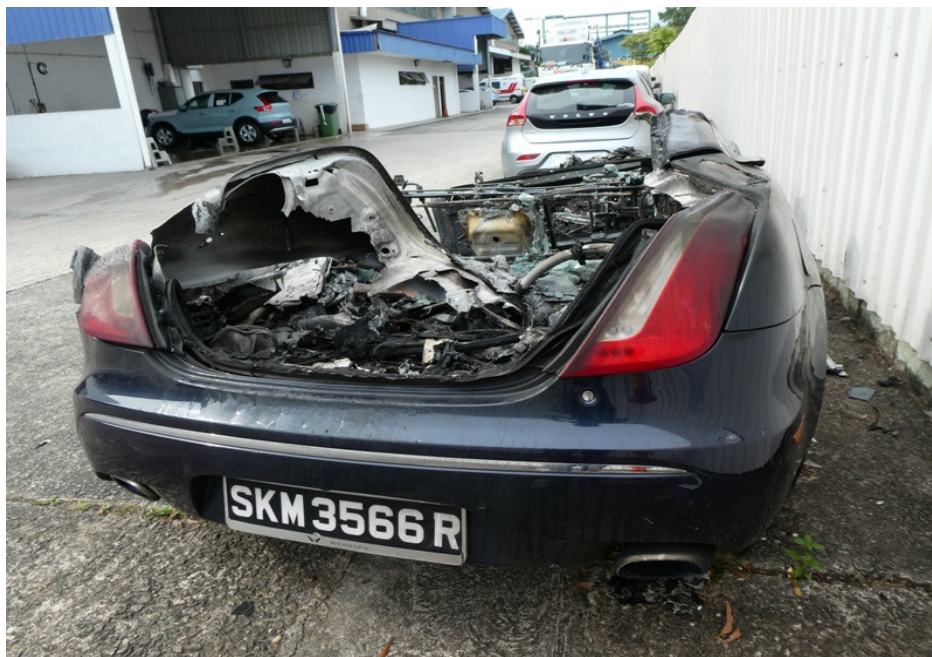
Photo 1 shows a general view of the rear portion of the Insured Vehicle at the time of my inspection. The Insured Vehicle was observed to have been extensively burnt. Its rear bumper was the only part that was relatively unaffected by the fire.

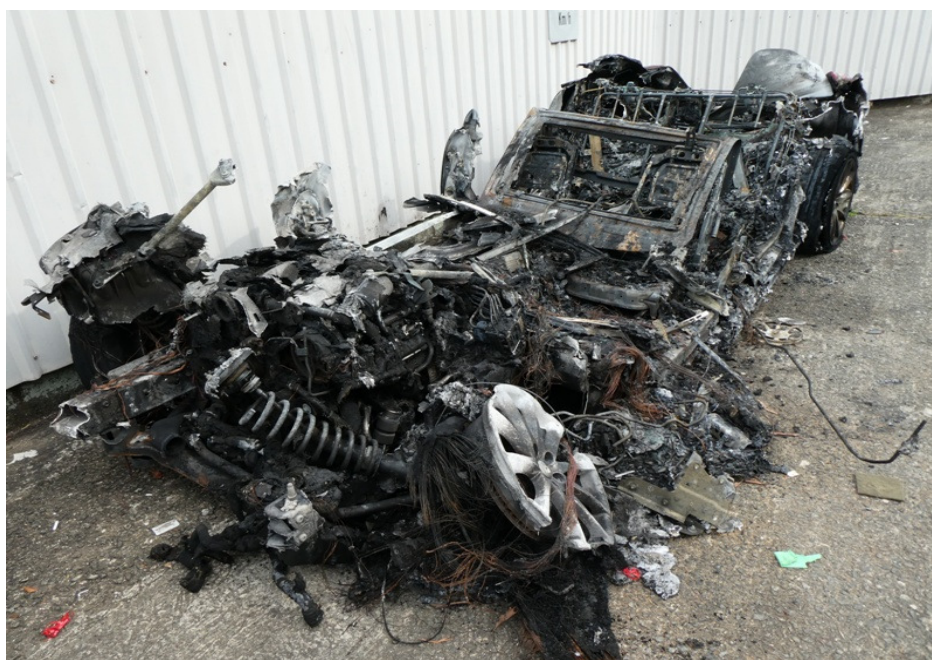
Photo 2 shows a general view of the front portion of the Insured Vehicle at the time of my inspection. Its front portion and centre portion were burned to char leaving skeletal remains.

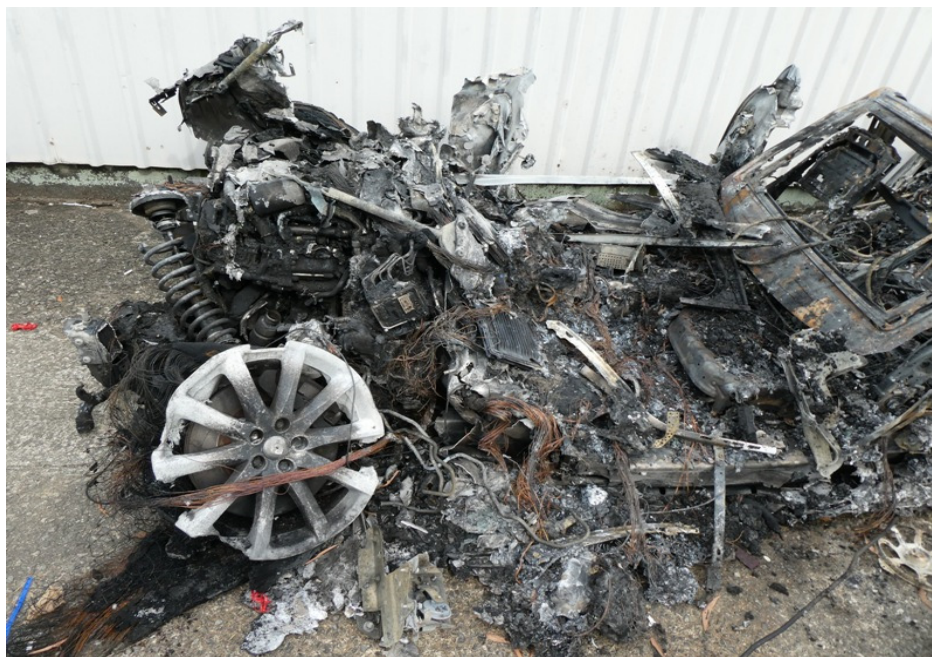
Photo 3 shows a general view of the front portion of the Insured Vehicle at the time of my inspection. Its front portion and centre portion were burned to char leaving skeletal remains.

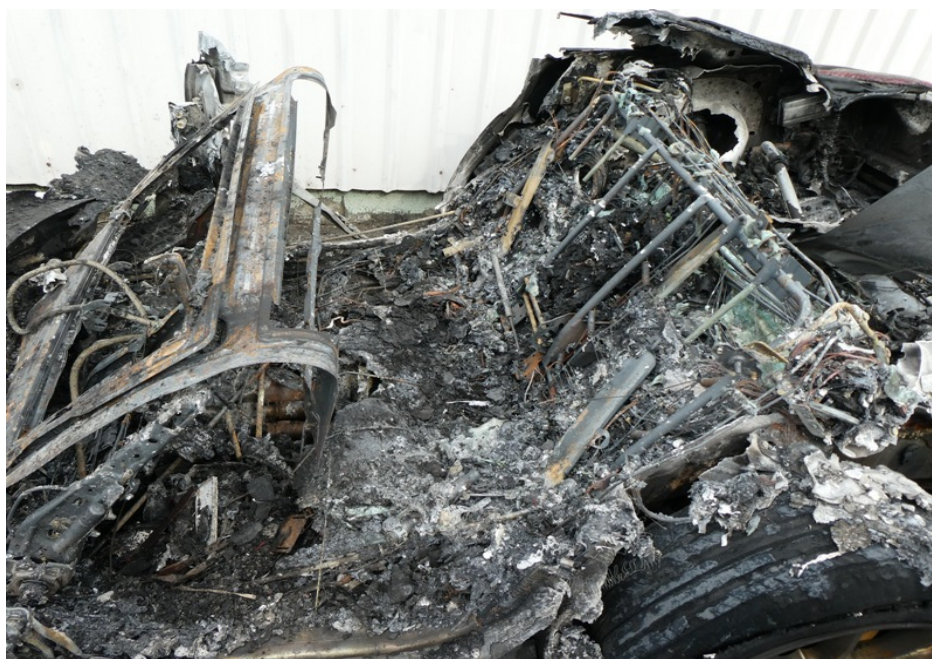
Photo 4 shows a general view of the centre portion of the Insured Vehicle at the time of my inspection. Its centre portion were burned to char leaving skeletal remains.

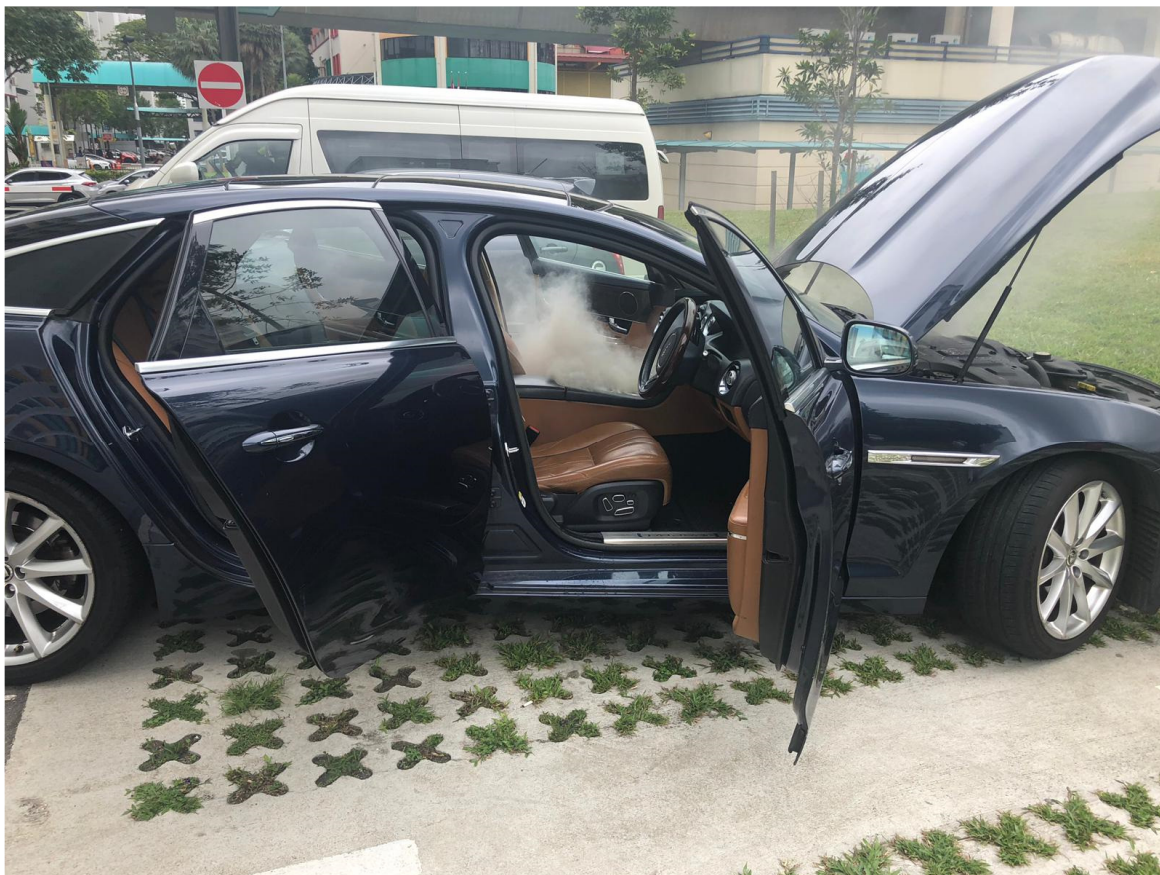
Photo 5 shows the Insured Vehicle just before the fire (photograph taken by Mr Wong at the incident scene). Smoke could be seen coming out from the interior compartment, at the centre console area.

18. As seen in photograph 5 above, the smoke was coming out from the centre console area of the Insured Vehicle. The subsequent outbreak of fire was also at the centre body of the Insured Vehicle as seen in photograph 6 above. Given these observations from the photographs that were taken at the incident scene, the origin of fire can be established to be at the centre body of the Insured Vehicle.

23. Having investigated and technically analysed the damages of burnt nature to the Insured Vehicle, I am of the view that the cause of fire to the Insured Vehicle was due to fire that had occurred within the Diesel Particulate Filter (DPF) of the Insured Vehicle. For this particular case, heat from a fire that had occurred within the DPF had radiated to the surrounding components leading to fire within the interior compartment of the Insured Vehicle.

24. The diesel particles (soot, carbon etc) trapped by the filter element inside the DPF of the Insured Vehicle had self-ignited when the exhaust temperature within the DPF had increased as a result of clogging in the DPF.

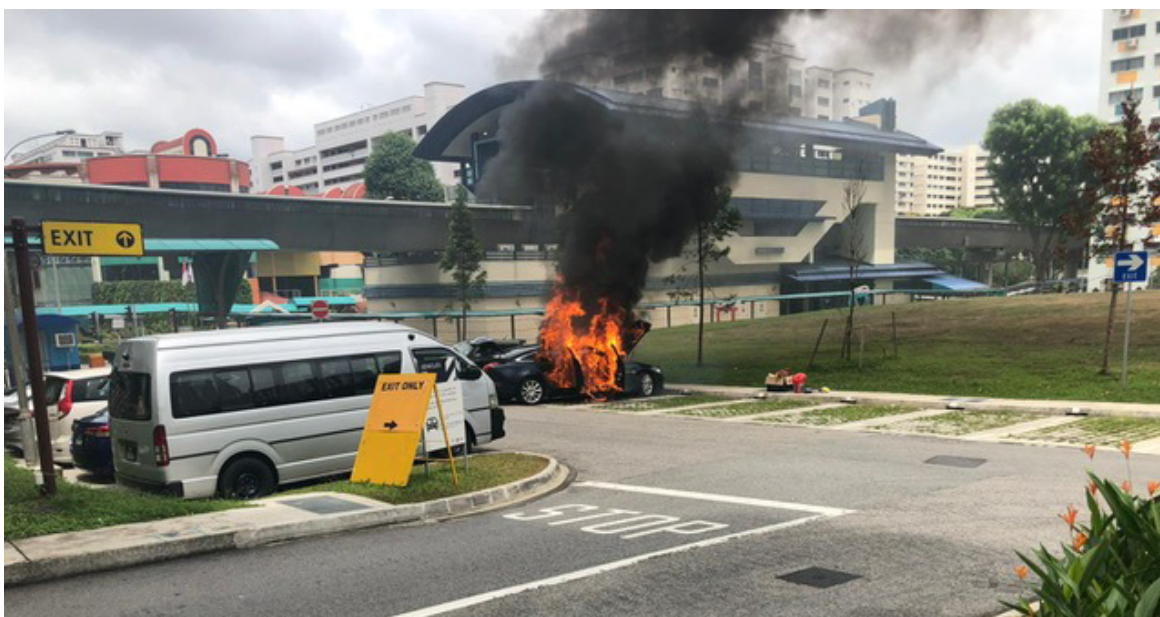
Photo 6 shows the Insured Vehicle with fire engulfing the interior compartment, at the centre body of the Insured Vehicle (photograph taken by Mr Wong at the incident scene).

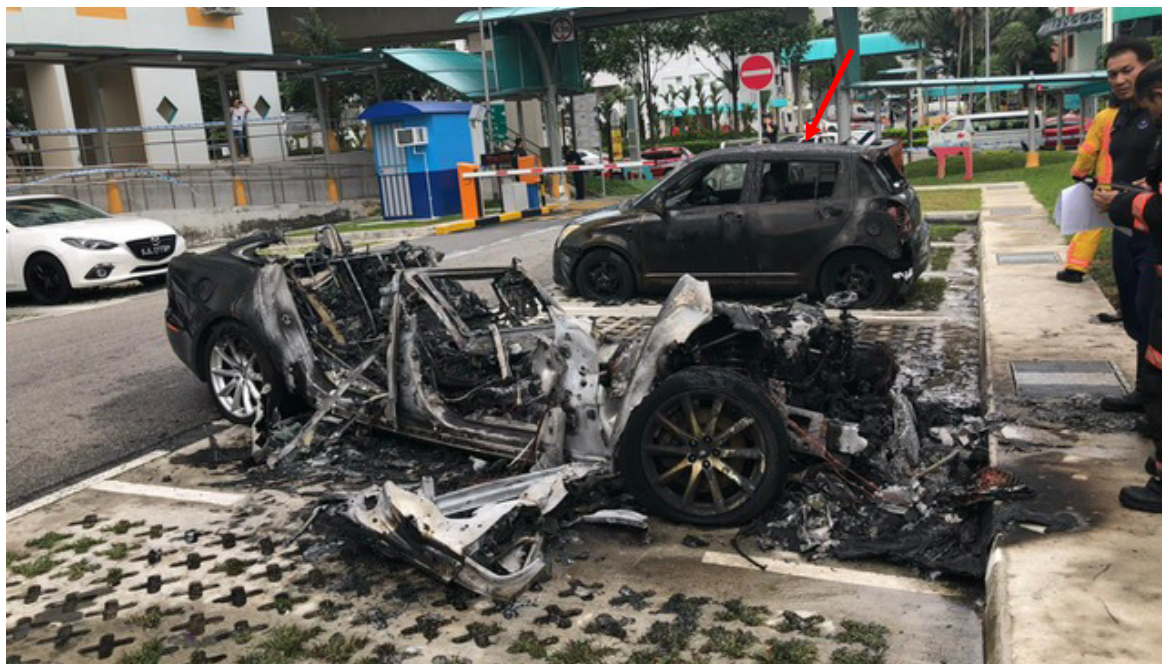
Photo 7 shows the Insured Vehicle at the incident scene after the fire was extinguished. The Insured Vehicle had burned to char as a result of the fire. Another vehicle (arrowed) parked to the left of the Insured Vehicle had also sustained damage of fire nature to its left side.

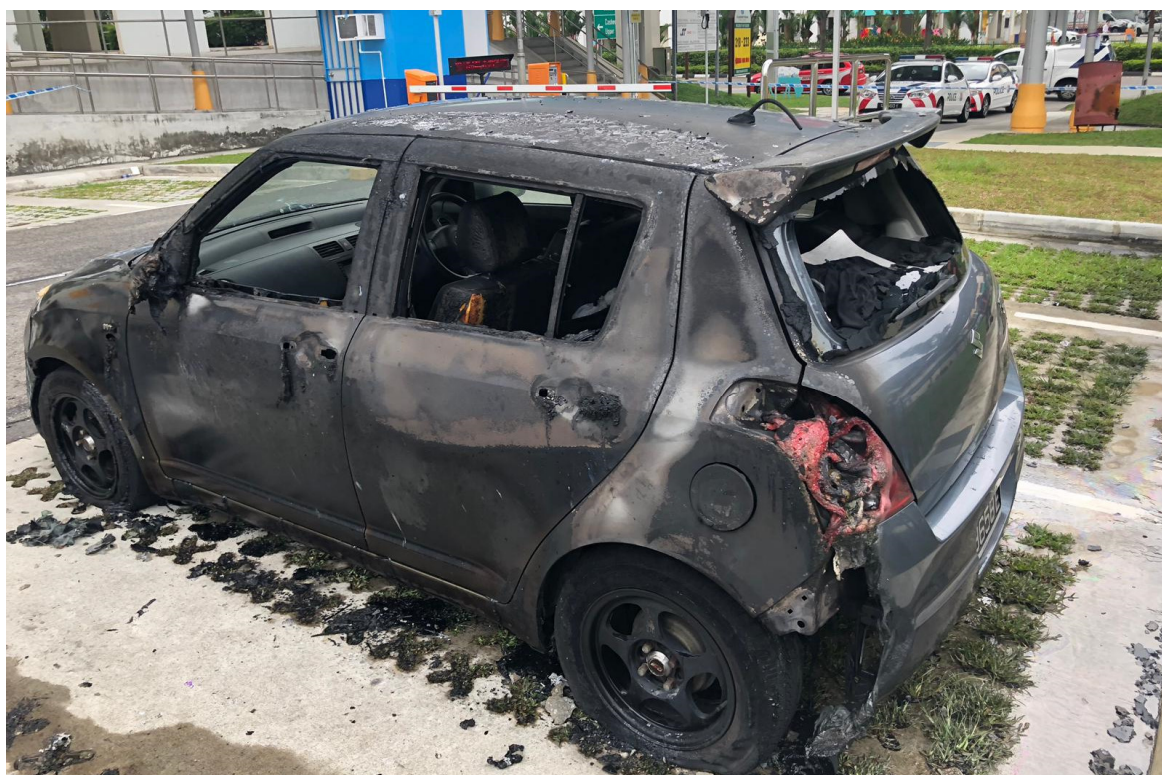
Photo 8 shows a closer view of the vehicle that had also sustained damage of fire nature to its left side as a result of the fire spreading from the Insured Vehicle. The registration number plate of this vehicle was SLW 9658E.
