Your Ref: 583341
Our Ref : CS/MSG19002385/N

**TECHNICAL INVESTIGATION REPORT OF FIRE INCIDENT INVOLVING THE
MOTOR VEHICLE WC 4290P ON 24 JANUARY 2019**

Vehicle Registration No.	: WC 4290P
Make / Model	: NISSAN CGB45CLSMNB
Chassis No	: CGB4CLS00197
Year of Registration	: June 2011
Mileage	: N.A (wiring affected)

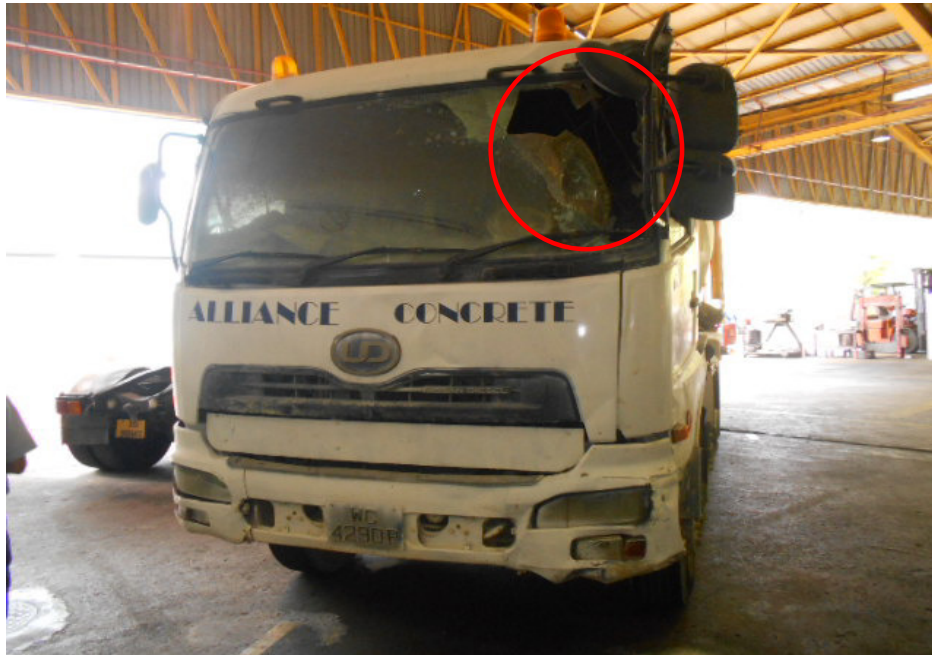
Photo 1 shows the front view of the Insured Vehicle at the time of our inspection. The fire damage to the Insured Vehicle was confined to its interior compartment. Most parts of the front portion were unaffected by the fire except for the front windscreen (circled).

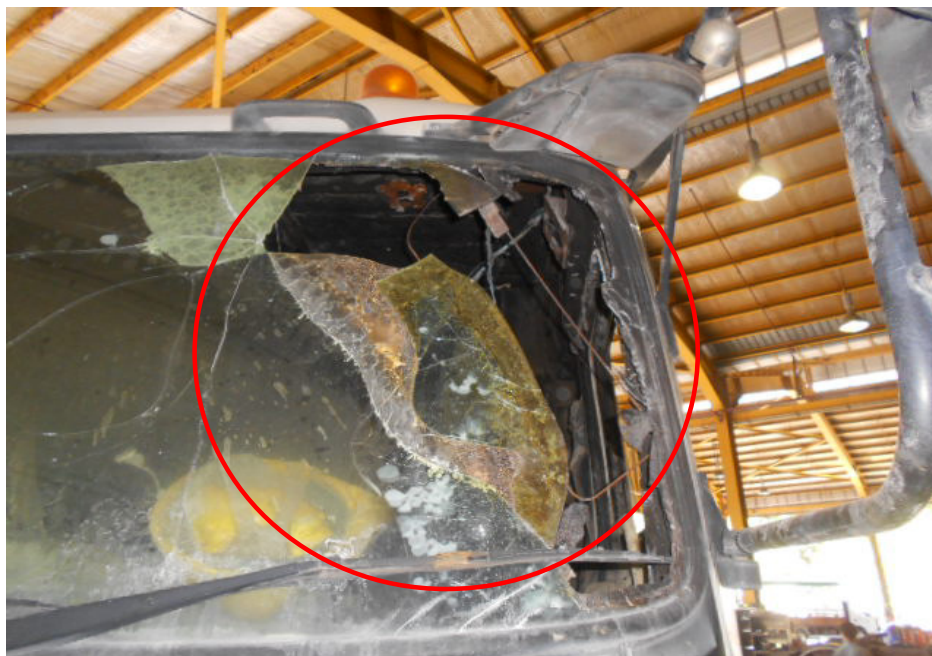
Photo 2 shows a close up view of the front windscreen of the Insured Vehicle. The left portion of the front windscreen seemed to have sustained serious fire damage (circled).

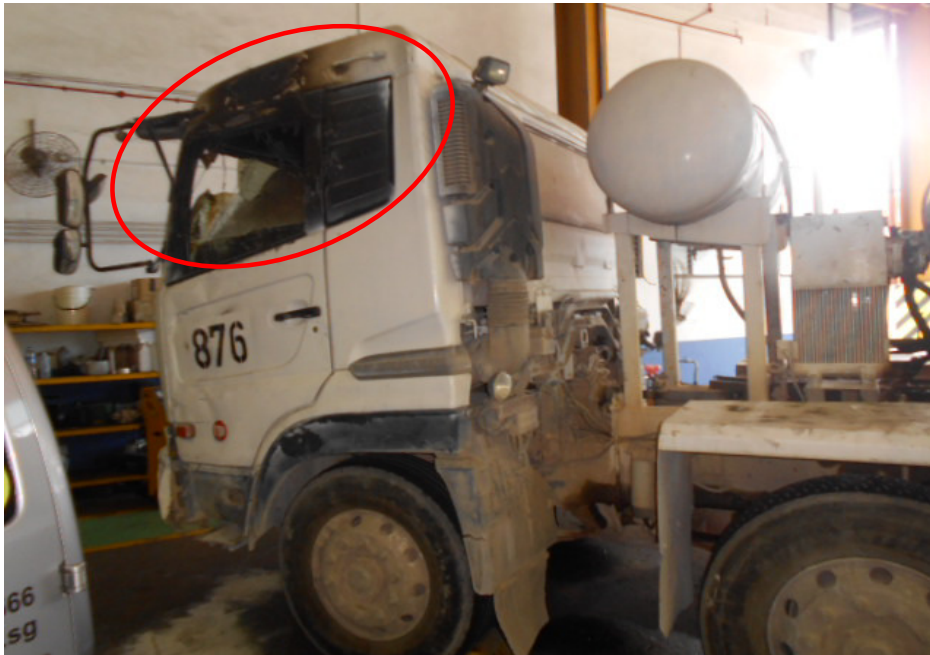
Photo 3 shows the left side view of the Insured Vehicle at the time of our inspection. The fire damage to the Insured Vehicle was confined to its interior compartment. The left side was observed to have been unaffected by the fire except for the left passenger door window (circled).

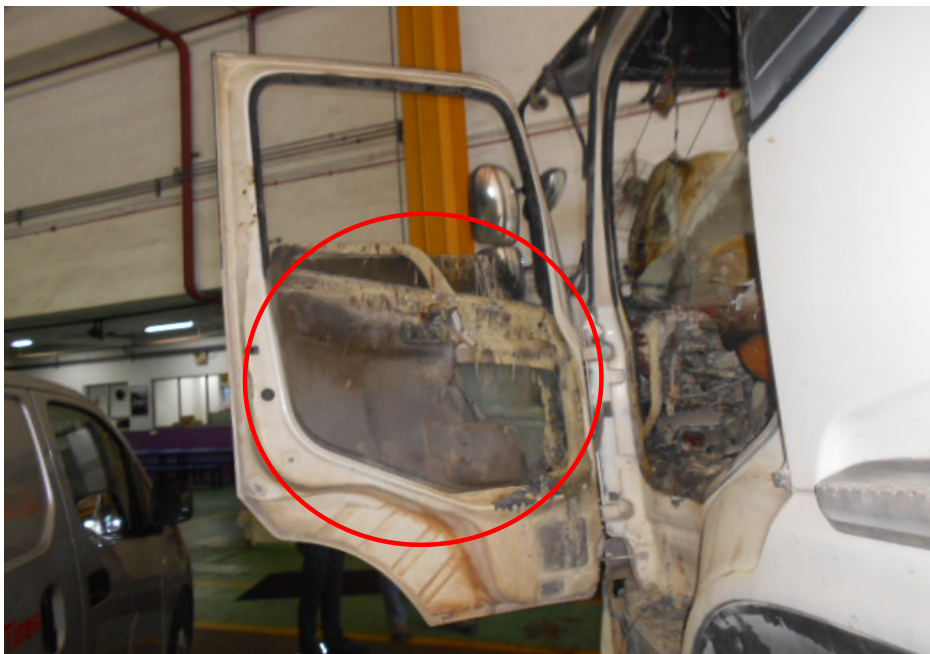
Photo 4 shows a closer view of the interior portion of the left passenger door of the Insured Vehicle at the time of our inspection. The left passenger door was observed to have sustained serious fire damage (circled).

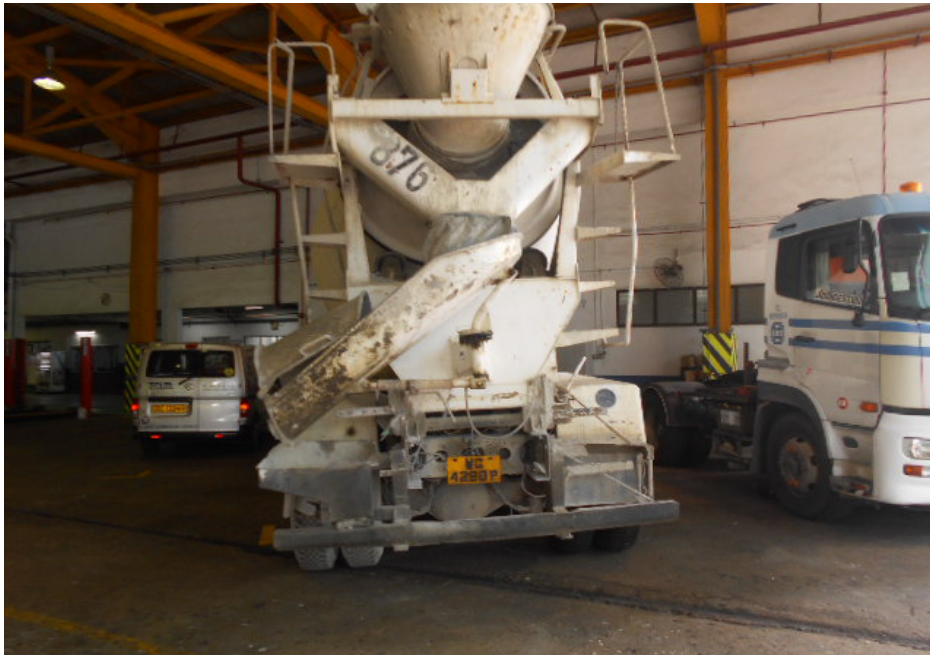
Photo 5 shows the rear view of the Insured Vehicle at the time of our inspection. The fire damage to the Insured Vehicle was confined to its interior compartment. The rear portion was observed to have been unaffected by the fire.

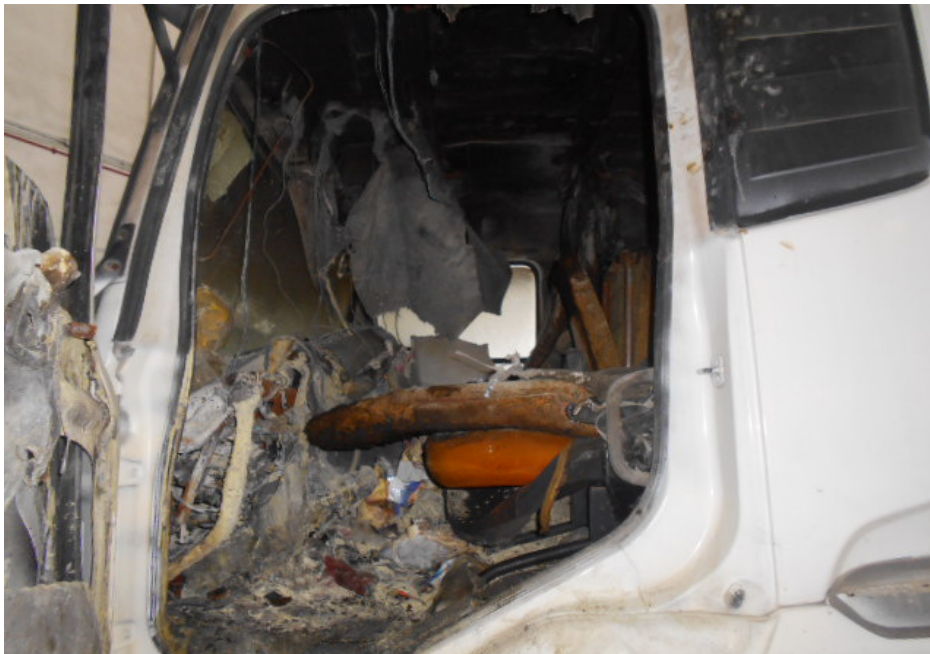
Photo 6 shows the interior compartment of the Insured Vehicle at the time of our inspection. Most of the components in the interior compartment were found to be burnt and/or melted as a result of the fire.

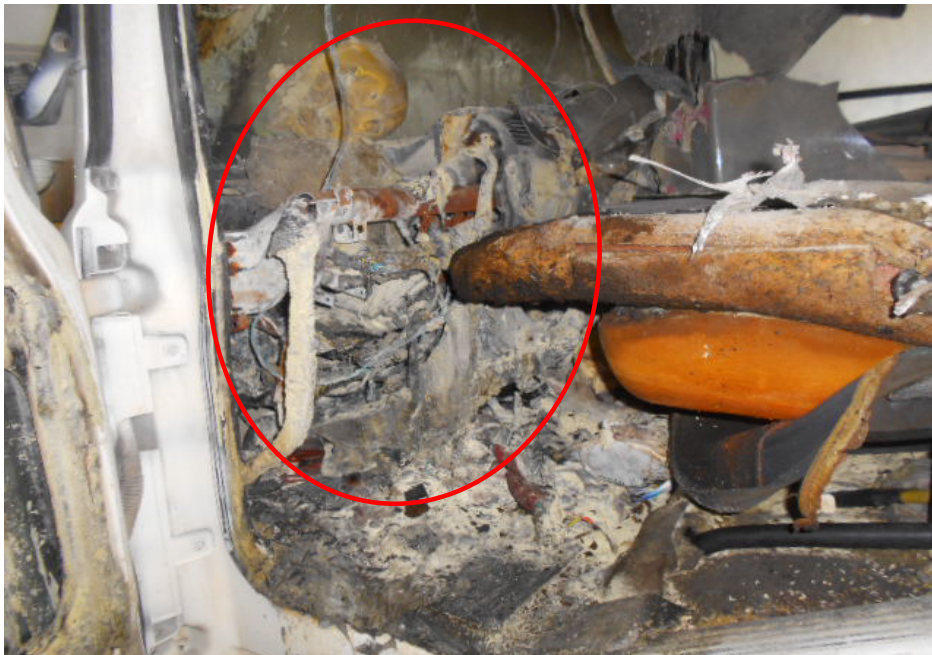
7. For this particular case, the fire appears to have started from the left portion of the dashboard instrument panel. This can be determined basing on the area where the extent of fire damage was most severe which was the left portion of the dashboard instrument panel. Various components of the dashboard instrument panel were observed to have been burnt and/or partly melted from prolonged exposure to high heat intensity which included the glove compartment, upper and central parts of the instrument panel assembly, amongst others. See photos 7 & 8 below.

Photo 7 shows the dashboard instrument panel of the Insured Vehicle. The fire seemed to have originated from the left portion of the dashboard basing on the area where the extent of fire damage was most severe. Various components of the instrument panel were observed to have been burnt and/or partly melted from prolonged exposure to high heat intensity which included the glove compartment, upper and central parts of the instrument panel assembly (circled).

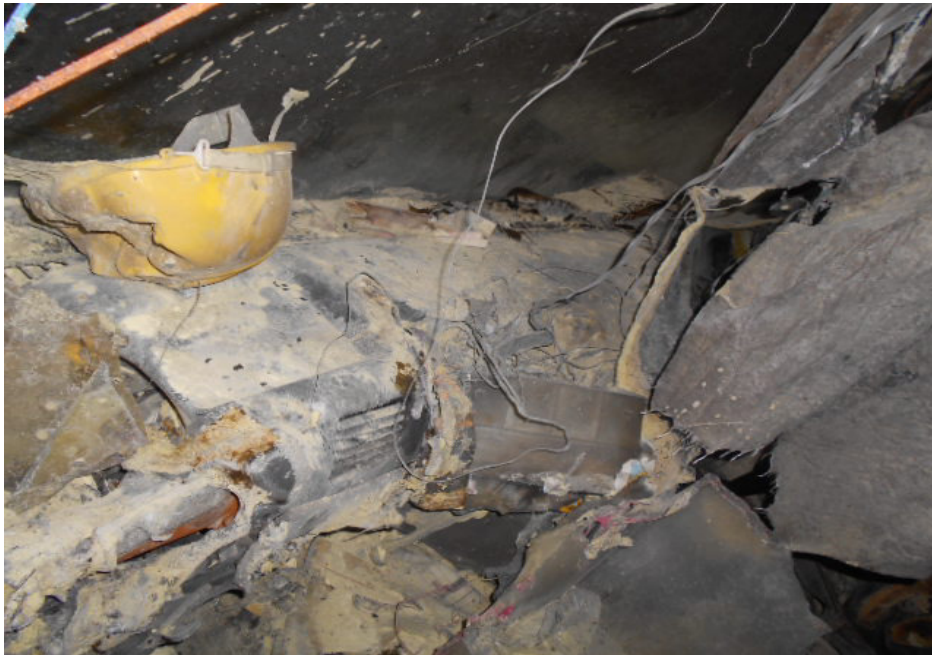
Photo 8 shows a closer view of the centre portion of the instrument panel. Various components of the instrument panel were observed to have been burnt and/or partly melted from prolonged exposure to high heat intensity which included the glove compartment, upper and central parts of the instrument panel assembly.

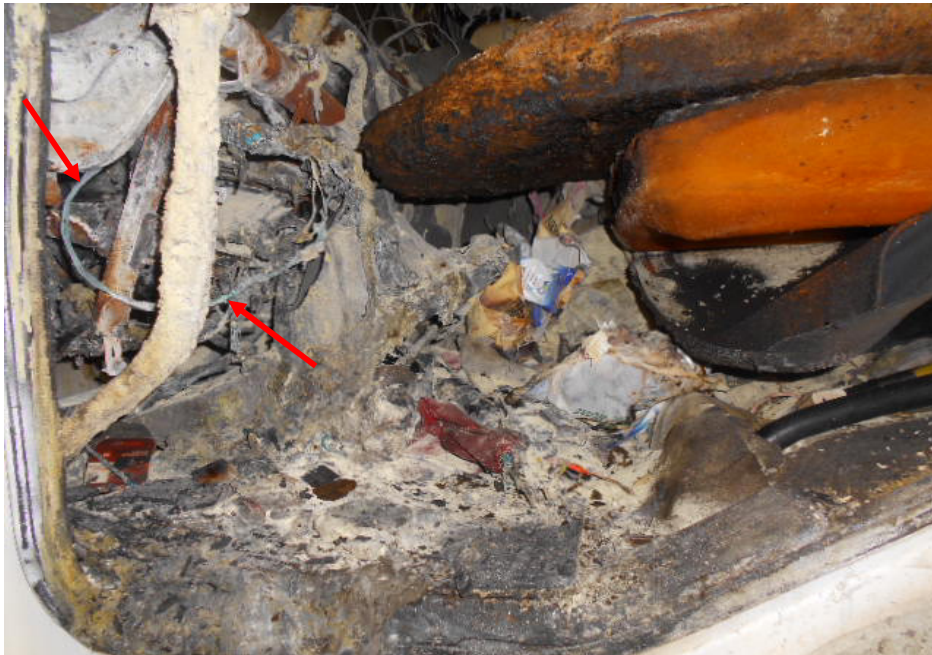
8. Upon closer examination of the various components contained within the glove compartment of the dashboard instrument panel, which was where the fire to the Insured Vehicle had likely started, we had found greenish residue on some of the wirings. The wirings were original factory fitted wirings. The presence of greenish residue indicates internal heating of copper wires, a sign of an electrical short circuit occurring. The greenish residue is normally left behind from oxidation as a result of chemical reaction involving the copper wires. This physical evidence would then appear to suggest that the cause of fire to the Insured Vehicle could have possibly been due to electrical in nature. See photos 9 & 10 below.

Photo 9 shows some original factory fitted wirings within the glove compartment with greenish residue (arrowed). The presence of greenish residue indicates internal heating of copper wires, a sign of an electrical short circuit occurring. The greenish residue is normally left behind from oxidation as a result of chemical reaction involving the copper wires.

24. The possibility of the fire being due to electrical in nature would then seem more likely given that engine overheating and external factors would both seem unlikely. The fire being due to electrical nature is also supported by the condition of the wirings that were found inside the left portion of the dashboard instrument panel of the Insured Vehicle, which was earlier discussed in paragraph 8 above.

26. Having investigated and technically analysed the damages of burnt nature to the Insured Vehicle, we are of the view that the cause of fire to the Insured Vehicle was of electrical in nature. For this particular case, the fire had originated from the wirings within the left portion of the dashboard instrument panel of the Insured Vehicle. The wirings were original factory fitted wirings of the Insured Vehicle.

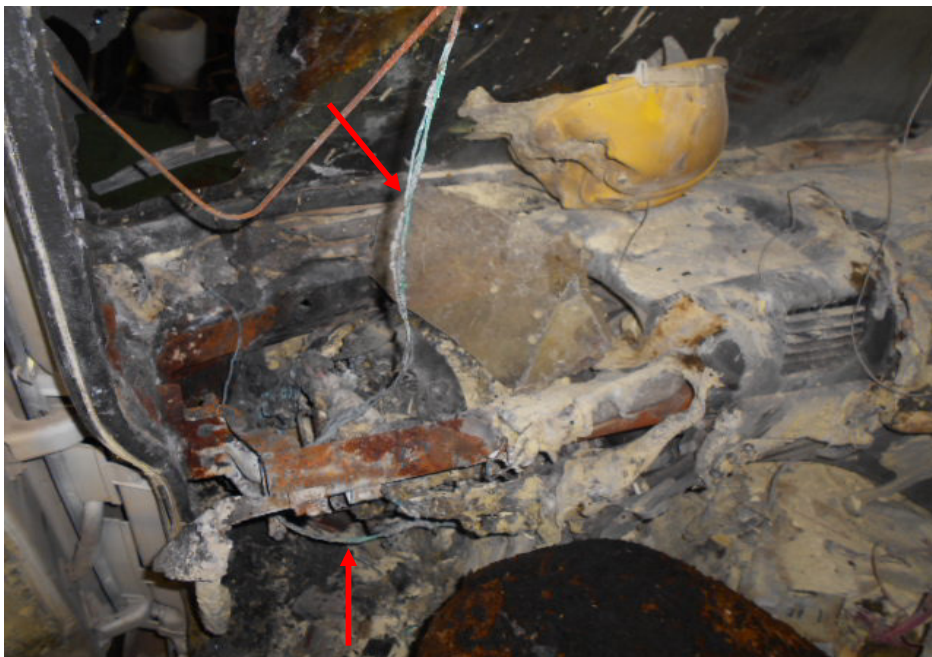
Photo 10 shows a closer view of the original factory fitted wirings within the glove compartment with greenish residue (arrowed). The presence of such greenish residue suggests occurrence of an electrical short circuit.

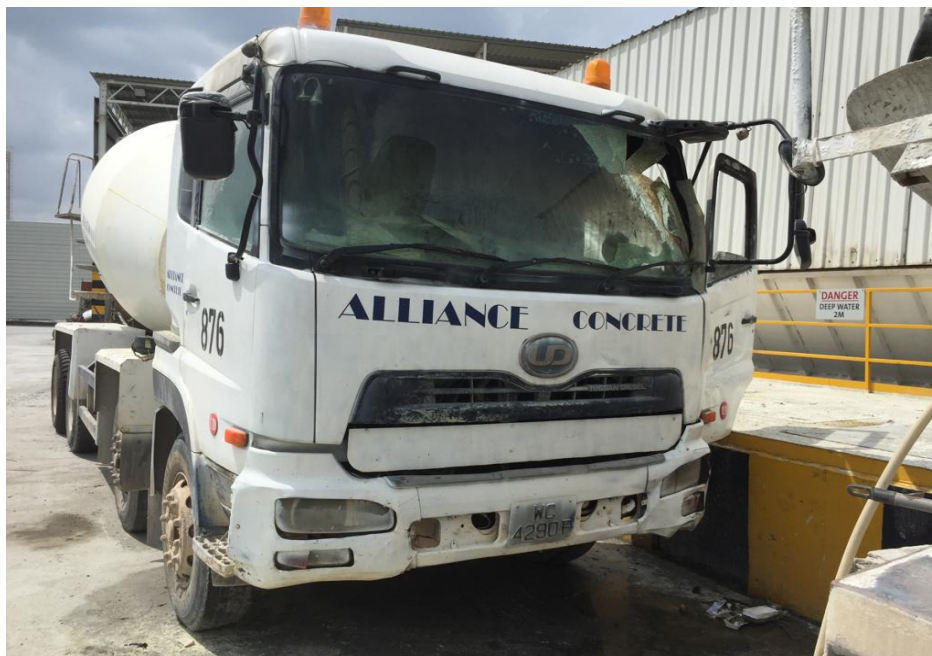
Photo 11 shows the Insured Vehicle after the fire was extinguished by Mr Siva. In general, the information that could be gathered from this photograph had corresponded to the events that were related to us by Mr Siva, which is the fire started from the interior compartment.

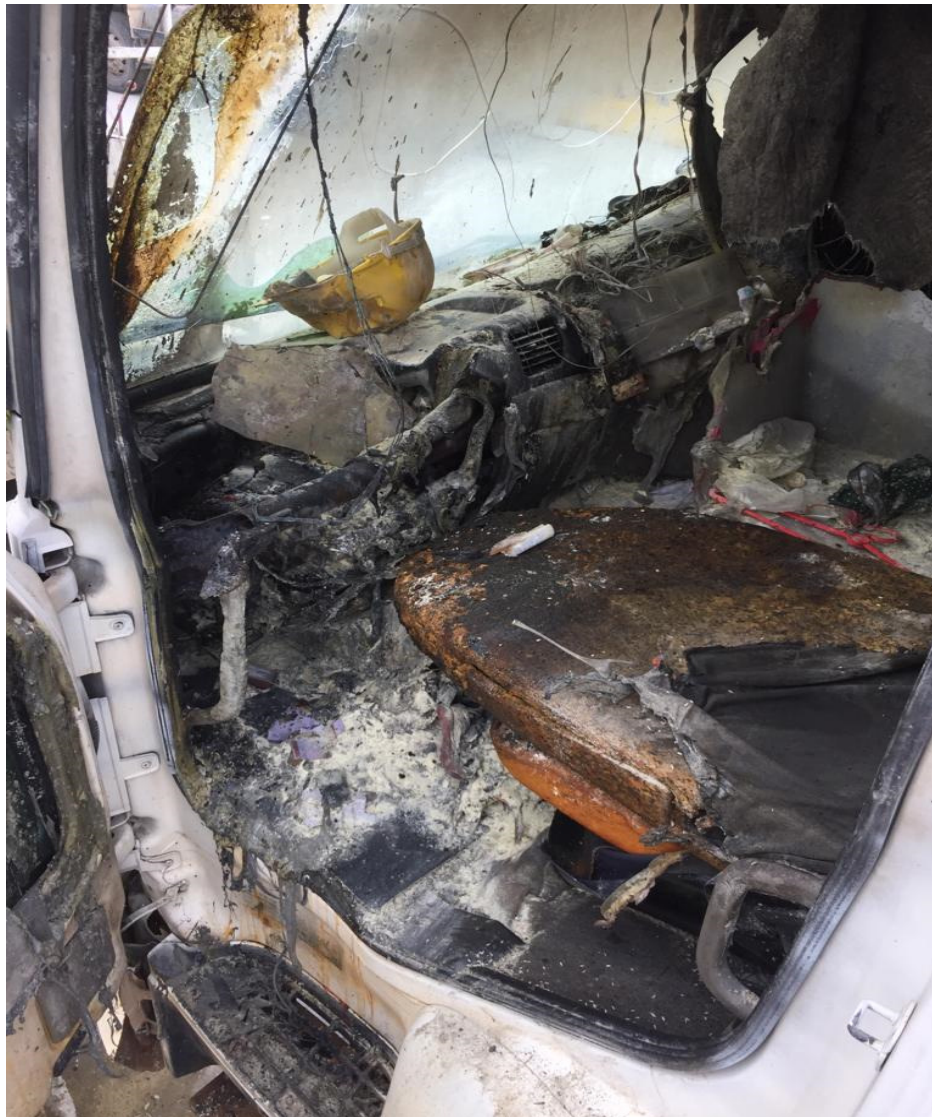
Photo 12 shows the interior compartment of the Insured Vehicle after the fire was extinguished. In general, the extensive damages sustained to the left portion of the dashboard had corresponded to the events that were related to us by Mr Siva, which is the fire started from the left portion of the interior compartment of the Insured Vehicle.
