Your Ref: 583341
Our Ref : CS/MSG19002385/N

18 February 2019

**TECHNICAL INVESTIGATION REPORT OF FIRE INCIDENT INVOLVING THE
MOTOR VEHICLE WC 4290P ON 24 JANUARY 2019**

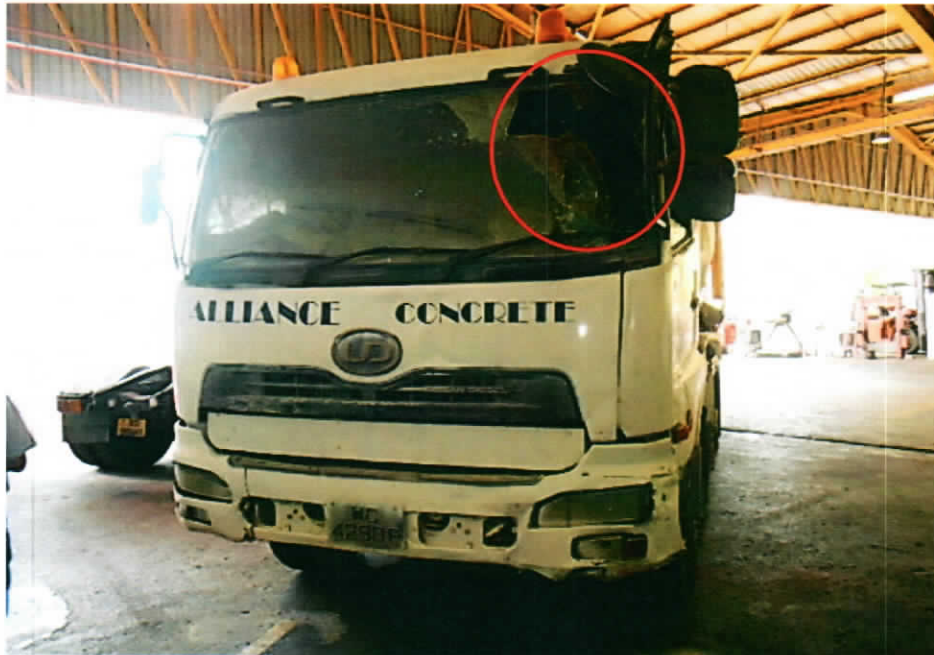
5. The Insured Vehicle was noted to have sustained fire damage that was confined to its interior portion. The fire damage was observed to be most severe at its interior compartment. The front exterior portion was unaffected by the fire except for the front windscreen. The engine compartment was unaffected by the fire. See photos 1 – 6 below.

Photo 1 shows the front view of the Insured Vehicle at the time of our inspection. The fire damage to the Insured Vehicle was confined to its interior compartment. Most parts of the front portion were unaffected by the fire except for the front windscreen (circled).

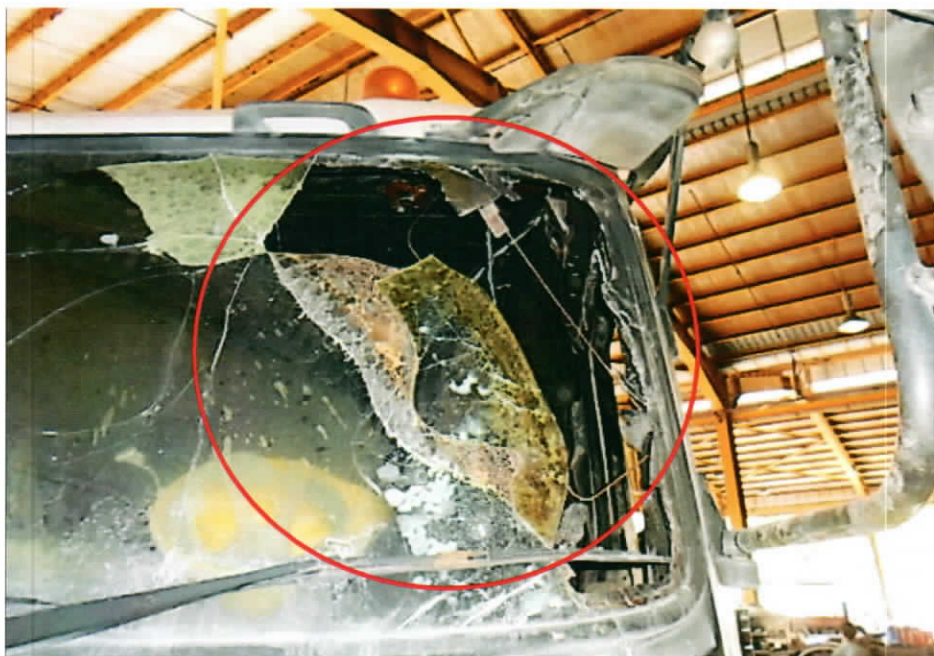
Photo 2 shows a close up view of the front windscreen of the Insured Vehicle. The left portion of the front windscreen seemed to have sustained serious fire damage (circled).

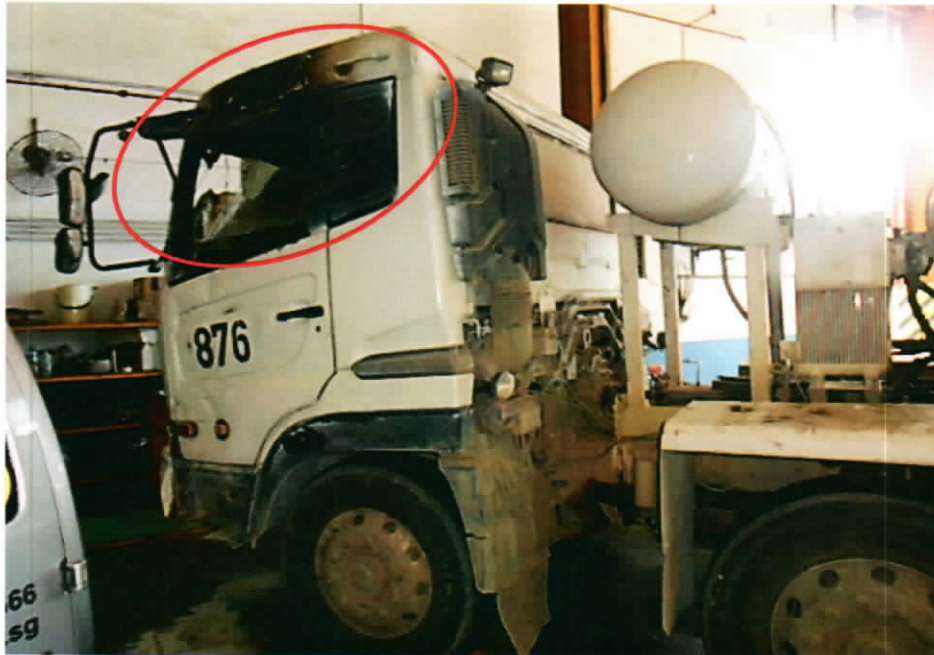
Photo 3 shows the left side view of the Insured Vehicle at the time of our inspection. The fire damage to the Insured Vehicle was confined to its interior compartment. The left side was observed to have been unaffected by the fire except for the left passenger door window (circled).

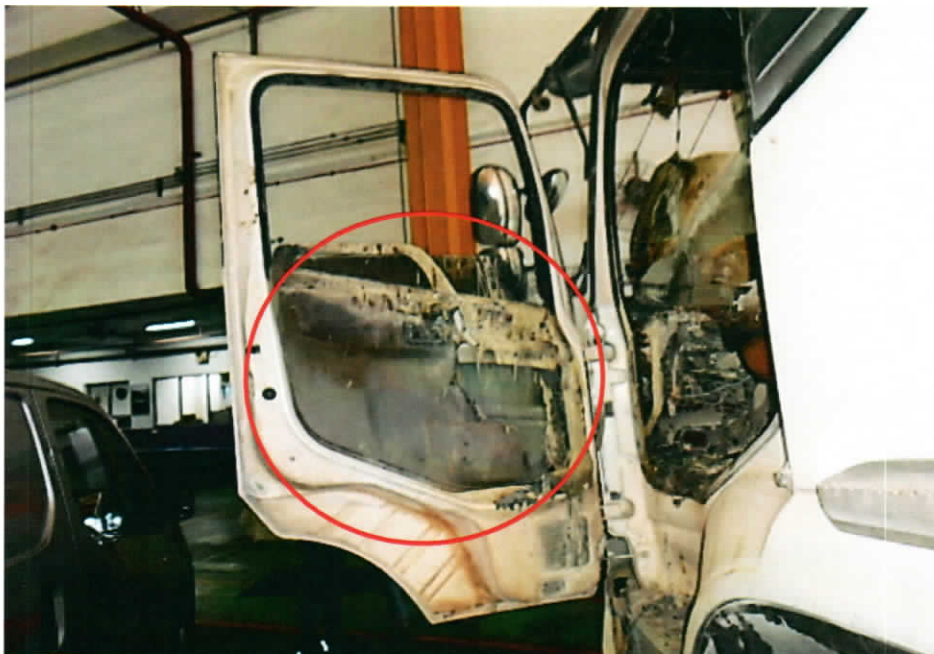
Photo 4 shows a closer view of the interior portion of the left passenger door of the Insured Vehicle at the time of our inspection. The left passenger door was observed to have sustained serious fire damage (circled).

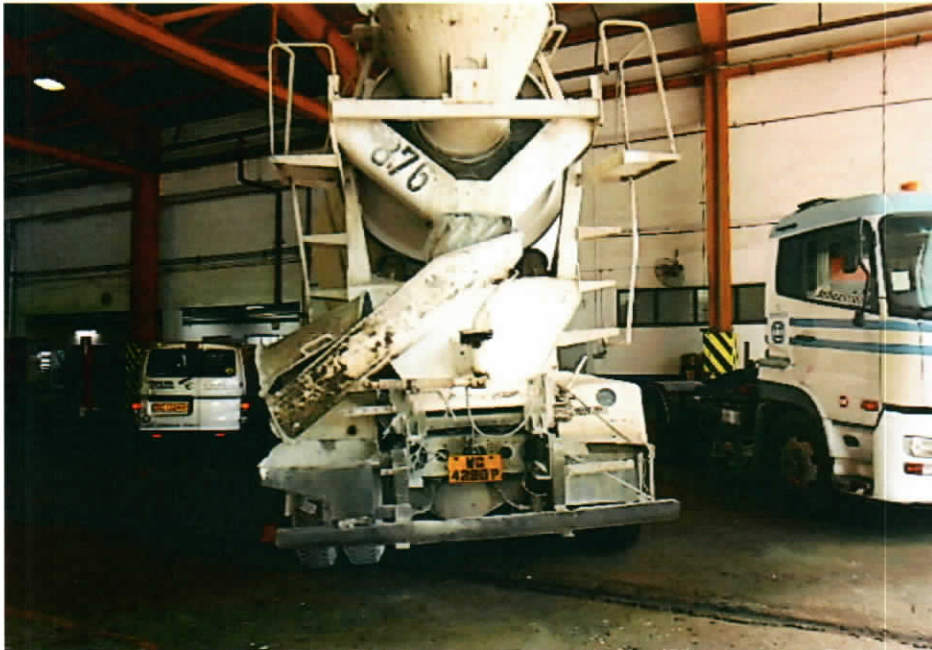
Photo 5 shows the rear view of the Insured Vehicle at the time of our inspection. The fire damage to the Insured Vehicle was confined to its interior compartment. The rear portion was observed to have been unaffected by the fire.

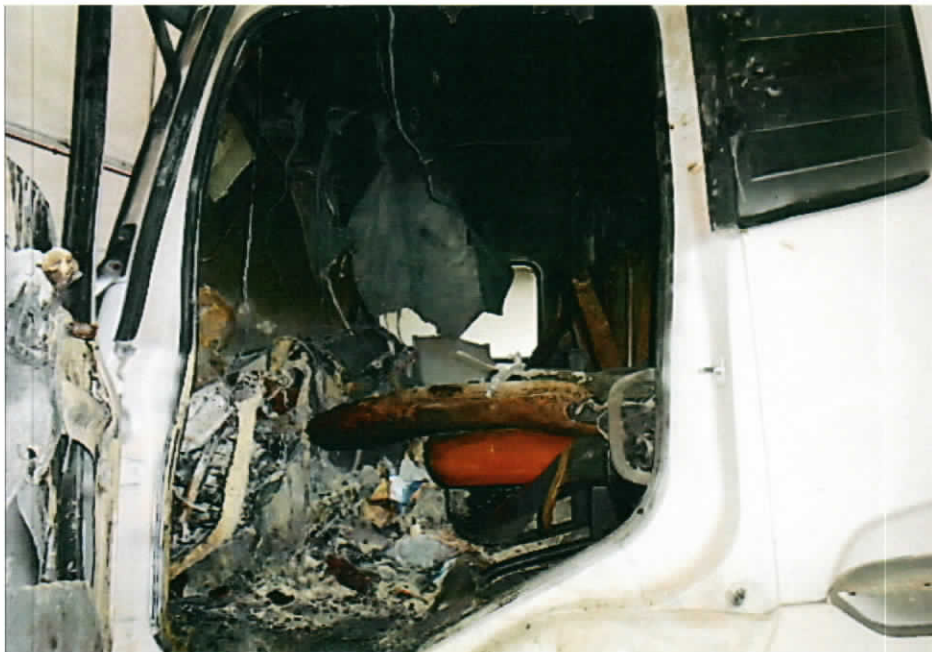
Photo 6 shows the interior compartment of the Insured Vehicle at the time of our inspection. Most of the components in the interior compartment were found to be burnt and/or melted as a result of the fire.

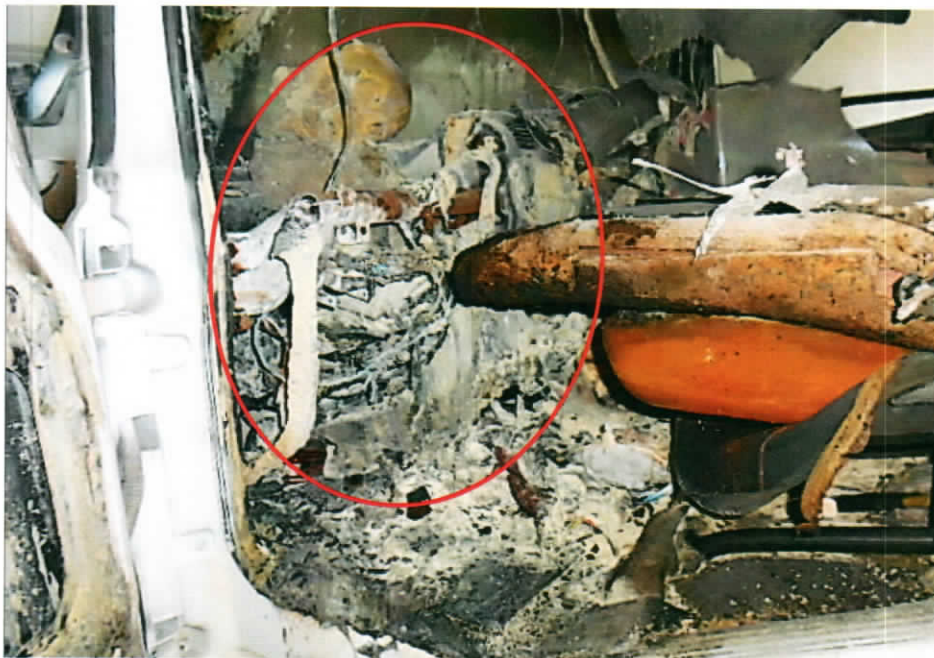
7. For this particular case, the fire appears to have started from the left portion of the dashboard instrument panel. This can be determined basing on the area where the extent of fire damage was most severe which was the left portion of the dashboard instrument panel. Various components of the dashboard instrument panel were observed to have been burnt and/or partly melted from prolonged exposure to high heat intensity which included the glove compartment, upper and central parts of the instrument panel assembly, amongst others. See photos 7 & 8 below.

Photo 7 shows the dashboard instrument panel of the Insured Vehicle. The fire seemed to have originated from the left portion of the dashboard basing on the area where the extent of fire damage was most severe. Various components of the instrument panel were observed to have been burnt and/or partly melted from prolonged exposure to high heat intensity which included the glove compartment, upper and central parts of the instrument panel assembly (circled).

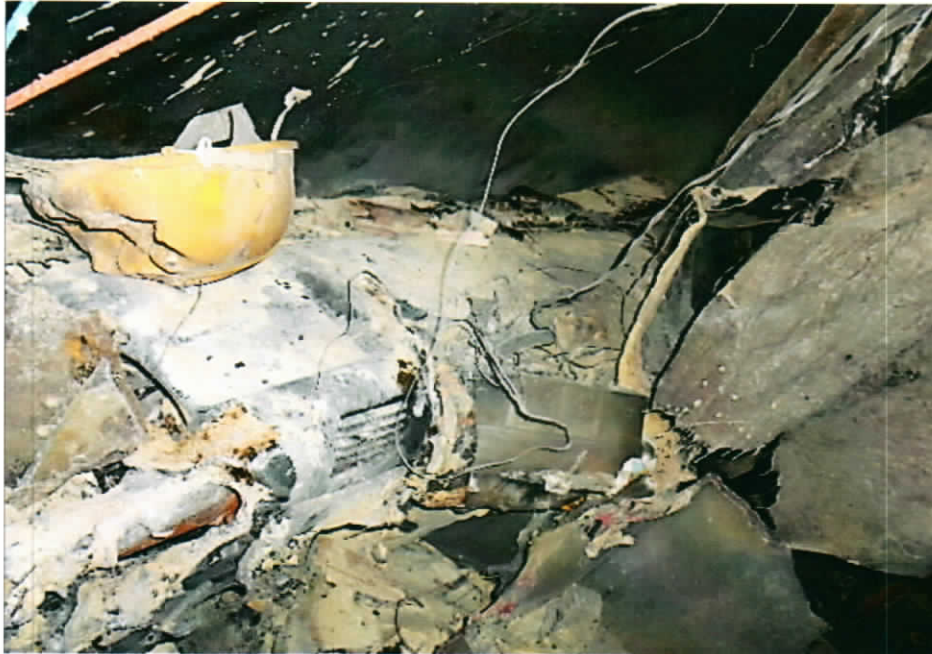
Photo 8 shows a closer view of the centre portion of the instrument panel. Various components of the instrument panel were observed to have been burnt and/or partly melted from prolonged exposure to high heat intensity which included the glove compartment, upper and central parts of the instrument panel assembly.

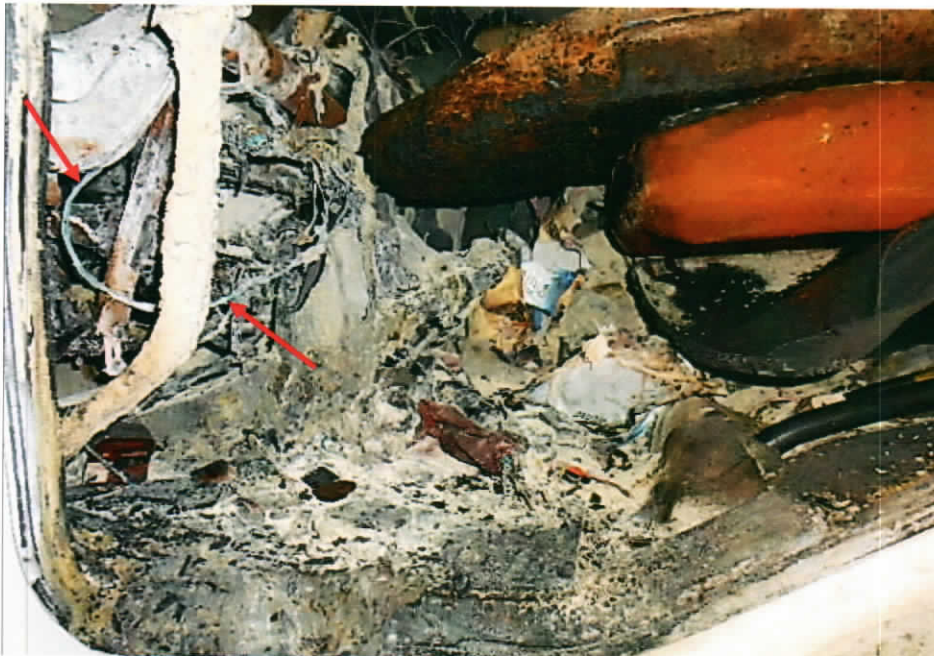
8. Upon closer examination of the various components contained within the glove compartment of the dashboard instrument panel, which was where the fire to the Insured Vehicle had likely started, we had found greenish residue on some of the wirings. The wirings were original factory fitted wirings. The presence of greenish residue indicates internal heating of copper wires, a sign of an electrical short circuit occurring. The greenish residue is normally left behind from oxidation as a result of chemical reaction involving the copper wires. This physical evidence would then appear to suggest that the cause of fire to the Insured Vehicle could have possibly been due to electrical in nature. See photos 9 & 10 below.

Photo 9 shows some original factory fitted wirings within the glove compartment with greenish residue (arrowed). The presence of greenish residue indicates internal heating of copper wires, a sign of an electrical short circuit occurring. The greenish residue is normally left behind from oxidation as a result of chemical reaction involving the copper wires.

24. The possibility of the fire being due to electrical in nature would then seem more likely given that engine overheating and external factors would both seem unlikely. The fire being due to electrical nature is also supported by the condition of the wirings that were found inside the left portion of the dashboard instrument panel of the Insured Vehicle, which was earlier discussed in paragraph 8 above.

26. Having investigated and technically analysed the damages of burnt nature to the Insured Vehicle, we are of the view that the cause of fire to the Insured Vehicle was of electrical in nature. For this particular case, the fire had originated from the wirings within the left portion of the dashboard instrument panel of the Insured Vehicle. The wirings were original factory fitted wirings of the Insured Vehicle.

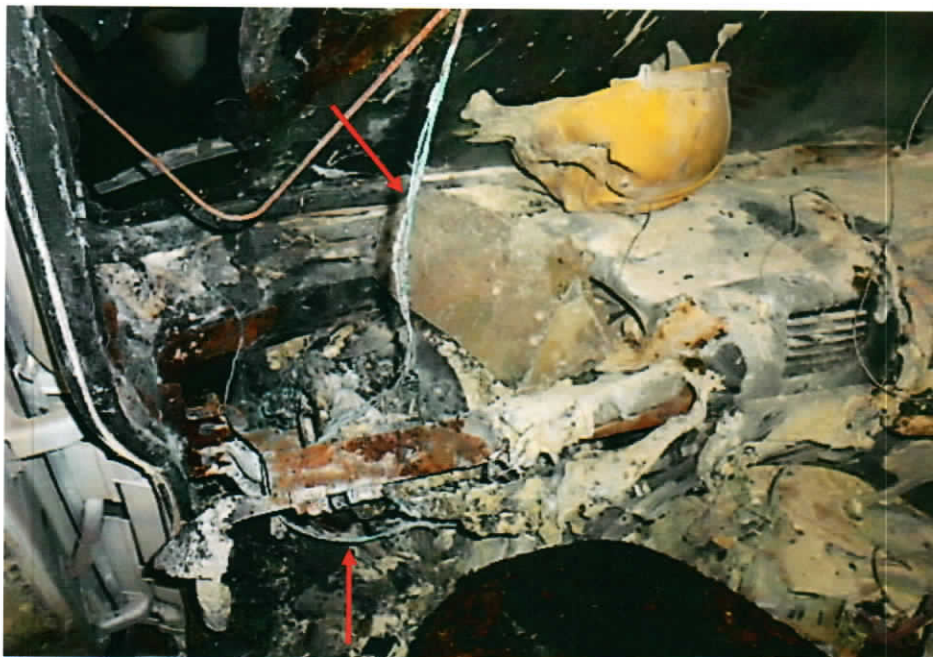
Photo 10 shows a closer view of the original factory fitted wirings within the glove compartment with greenish residue (arrowed). The presence of such greenish residue suggests occurrence of an electrical short circuit.

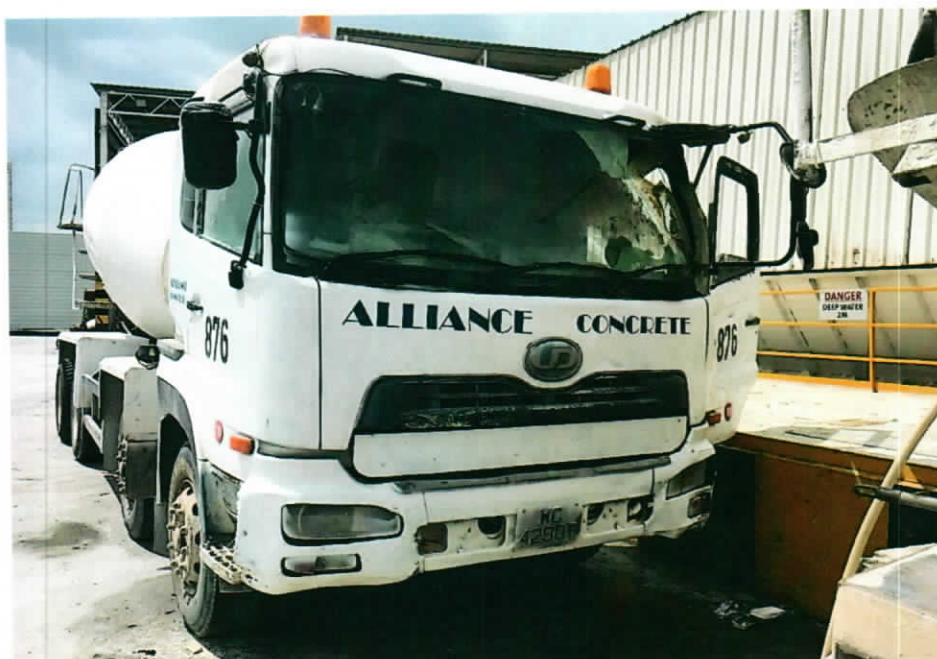
Photo 11 shows the Insured Vehicle after the fire was extinguished by Mr Siva. In general, the information that could be gathered from this photograph had corresponded to the events that were related to us by Mr Siva, which is the fire started from the interior compartment.

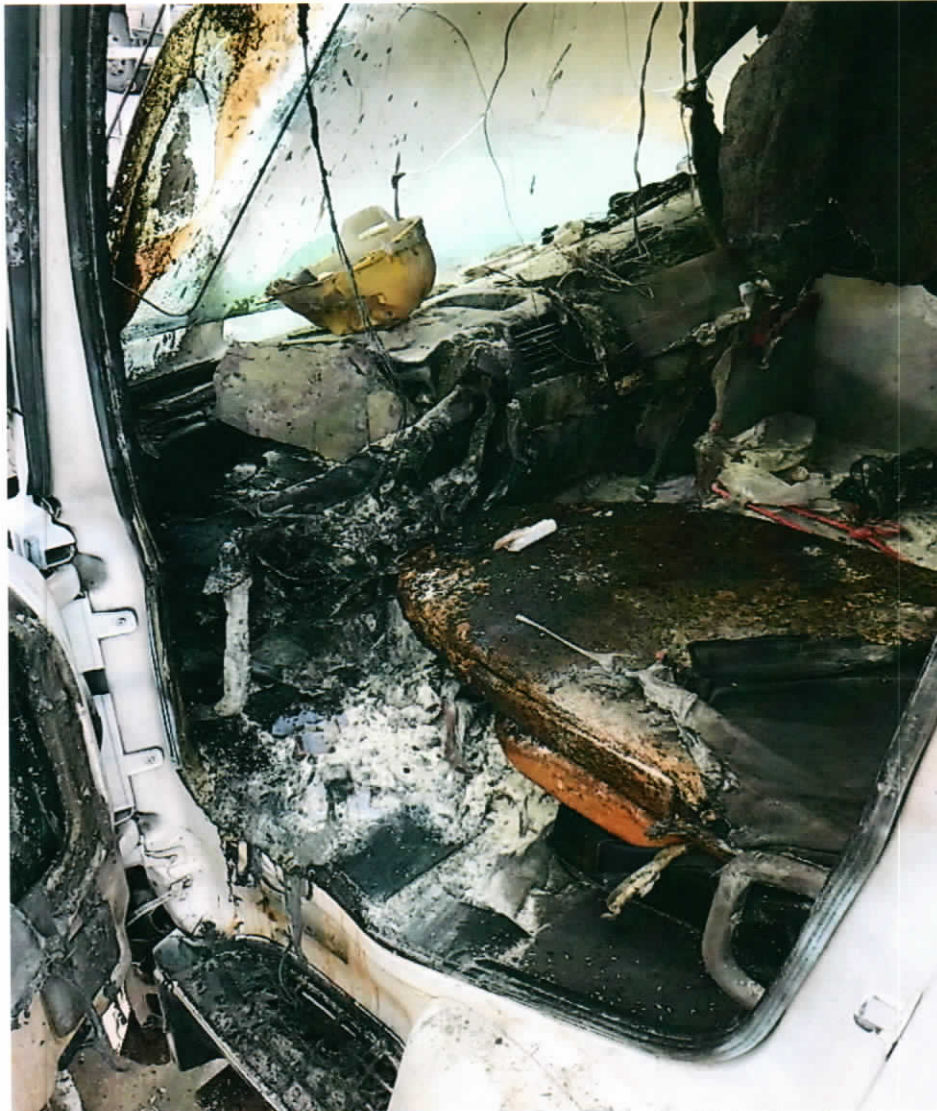
Photo 12 shows the interior compartment of the Insured Vehicle after the fire was extinguished. In general, the extensive damages sustained to the left portion of the dashboard had corresponded to the events that were related to us by Mr Siva, which is the fire started from the left portion of the interior compartment of the Insured Vehicle.
