Your Ref: TP/IP/66301/2018
Our Ref : CI/TPD19002505/Z

18th March 2019

MECHANICAL INSPECTION REPORT OF MOTOR TAXI SHD 2783U

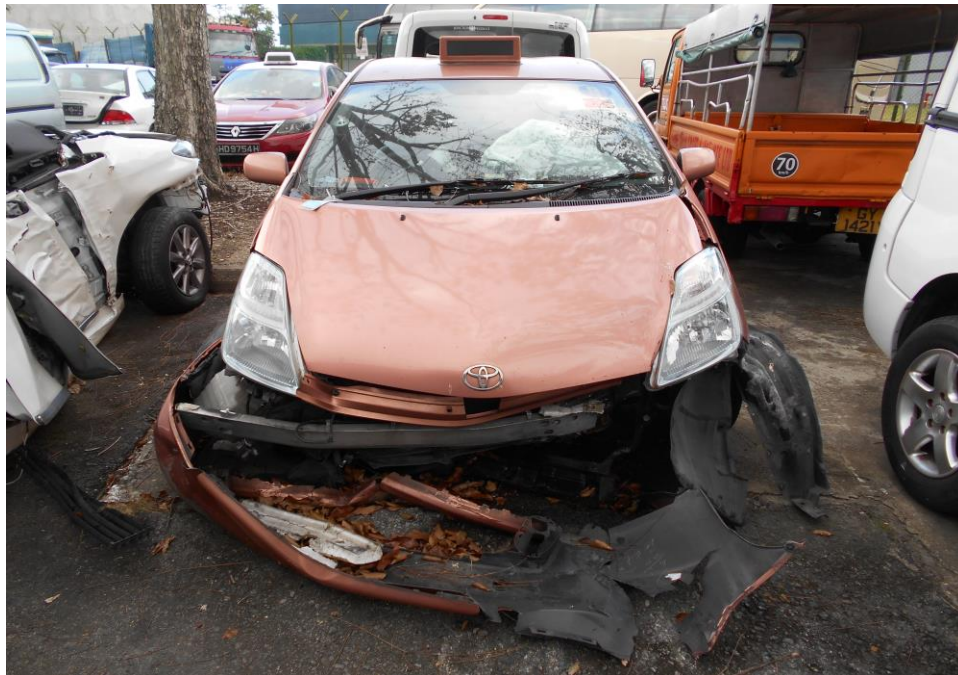
Photo 1 shows a general view of the frontal portion of the Motor Taxi at the time of our inspection. The Motor Taxi was observed to have sustained extensive impact damage at its frontal, left & right portion. The impact force was significant, causing the various parts and components to be damaged as a result of the accident.

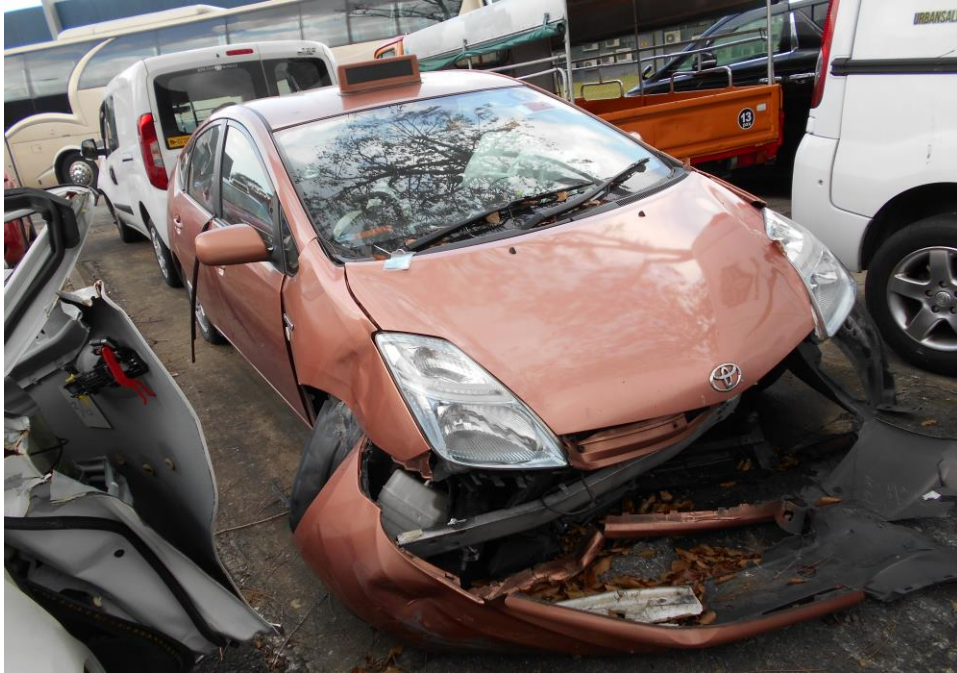
Photo 2 shows a general view of the front right portion of the Motor Taxi at the time of our inspection. The Motor Taxi was observed to have sustained extensive impact damage at its front right portion.

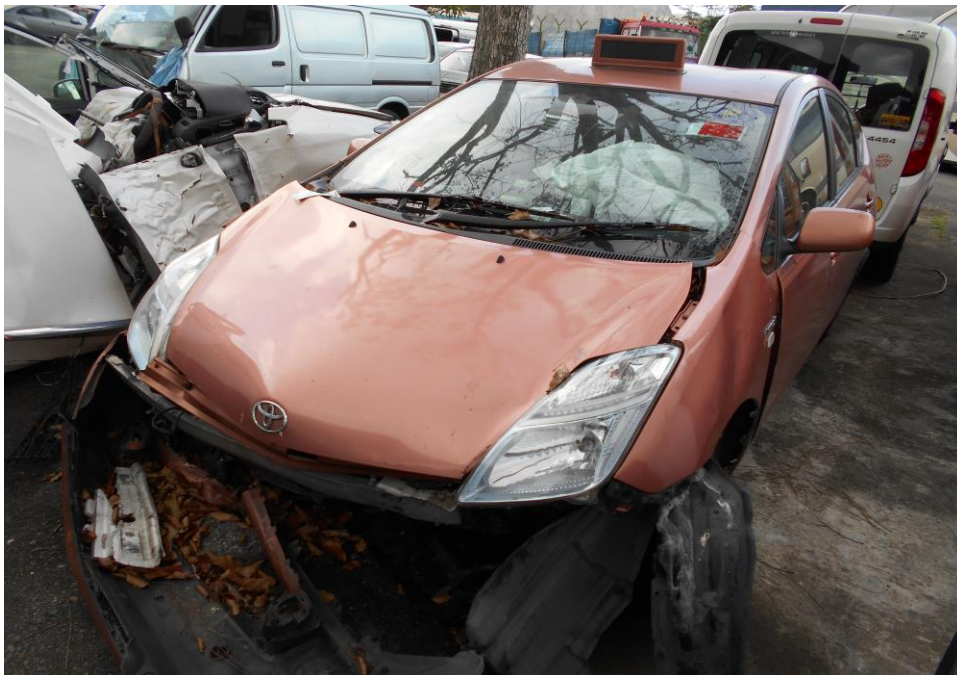
Photo 3 shows a general view of the front left portion of the Motor Taxi at the time of our inspection. The Motor Taxi was observed to have sustained minor impact damage at its front left portion.

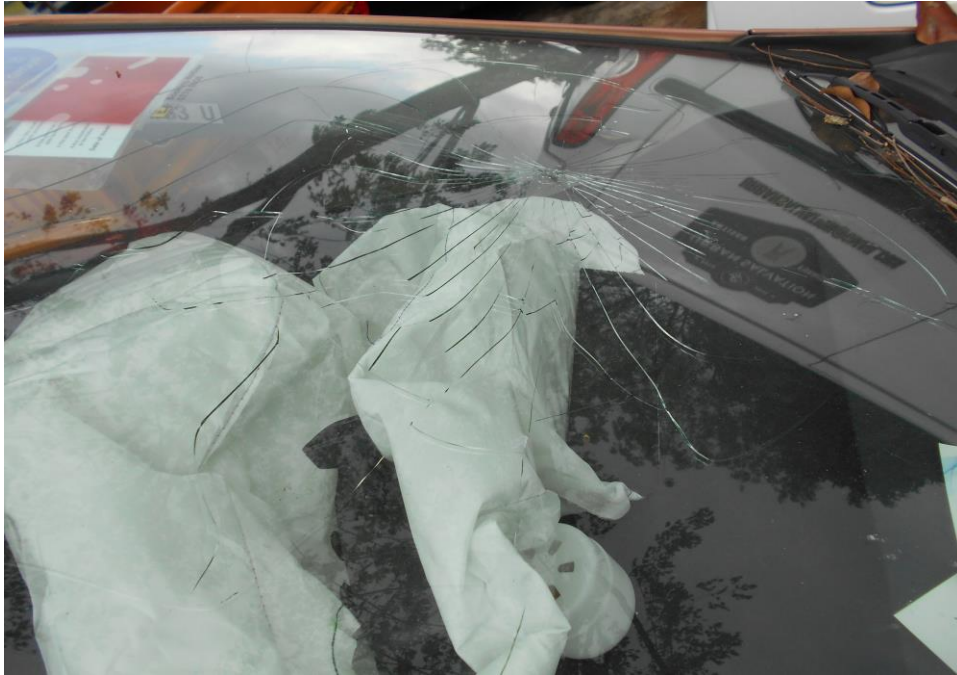
Photo 4 shows a closer view of the damage sustained on the Motor Taxi. The impact force was significant, causing the windshield to sustain cracked due to the accident.

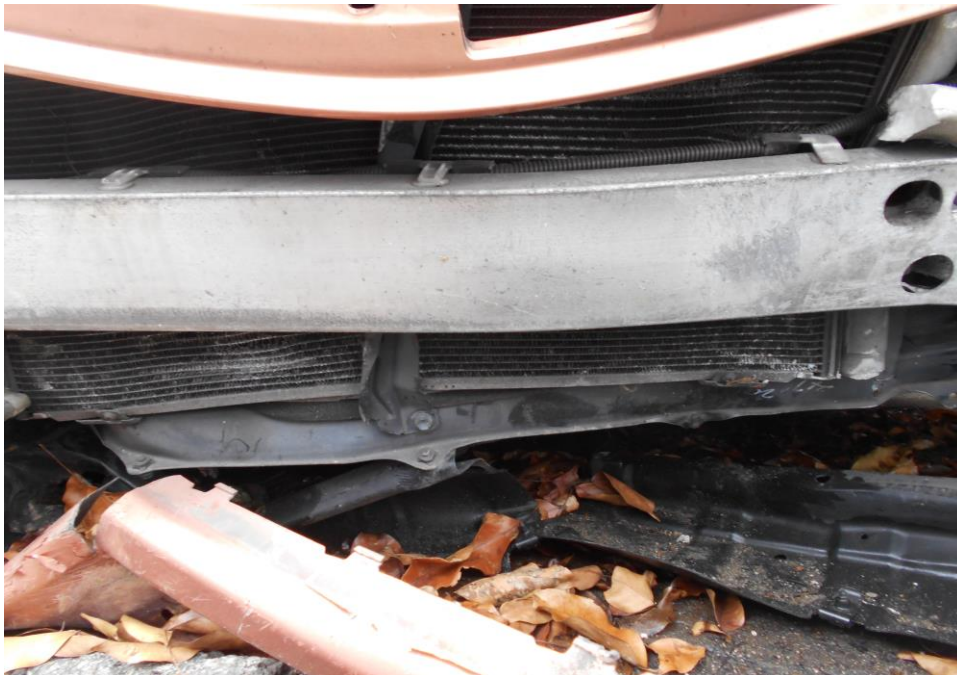
Photo 5 shows a closer view of the damaged radiator tank of the Motor Taxi. The impact force was significant, causing also other various parts and components inside the engine compartment to be damaged as a result of the accident.

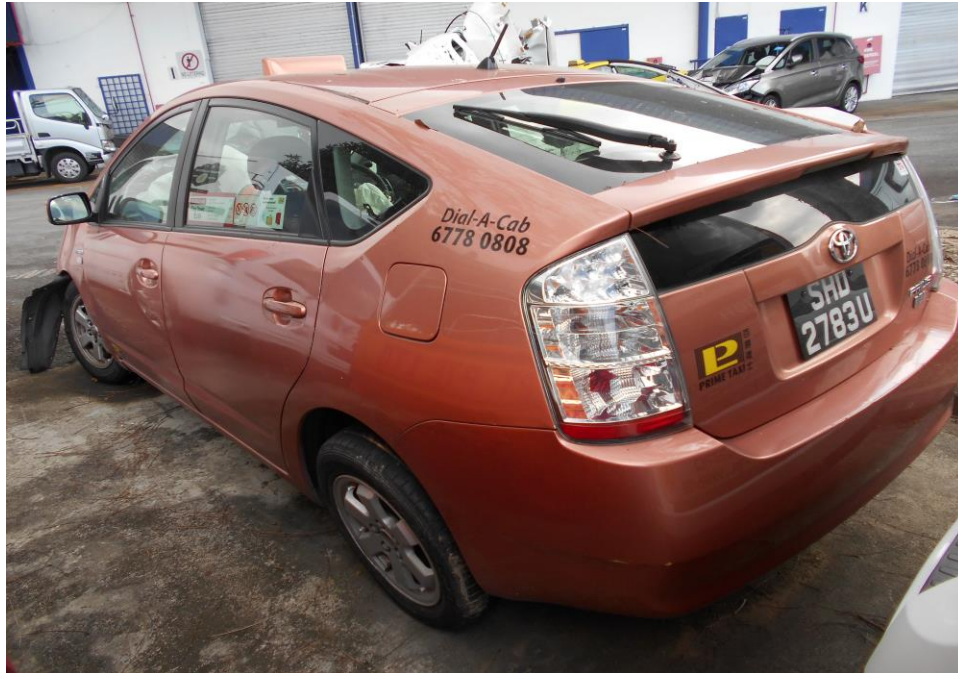
Photo 6 shows a general view of the Motor Taxi rear left portion. It was observed to be unaffected by the accident.

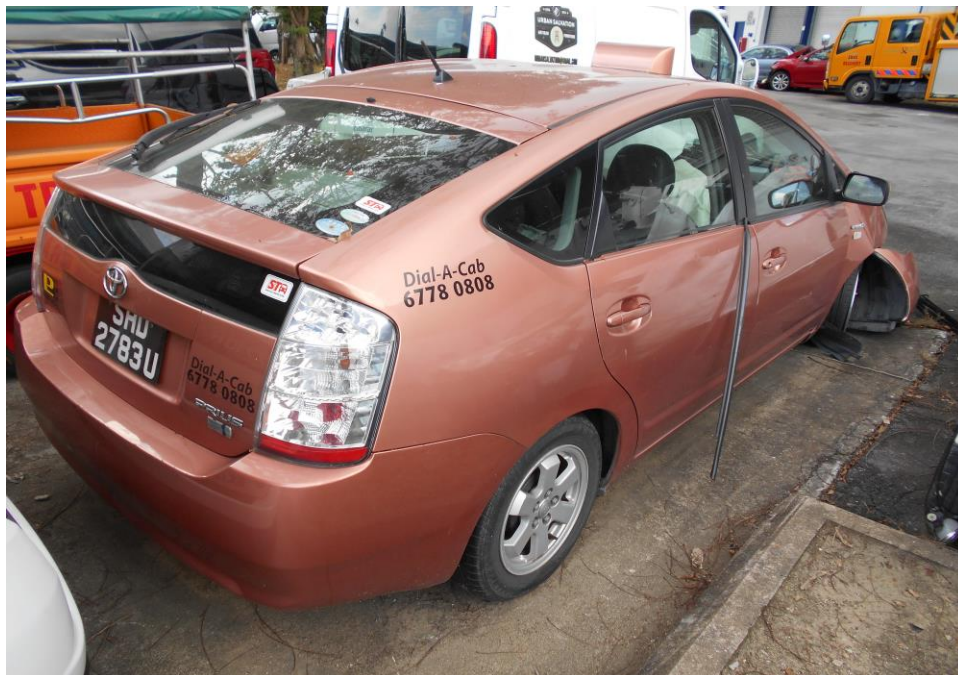
Photo 7 shows a general view of the Motor Taxi rear right portion. It was observed to be unaffected by the accident.

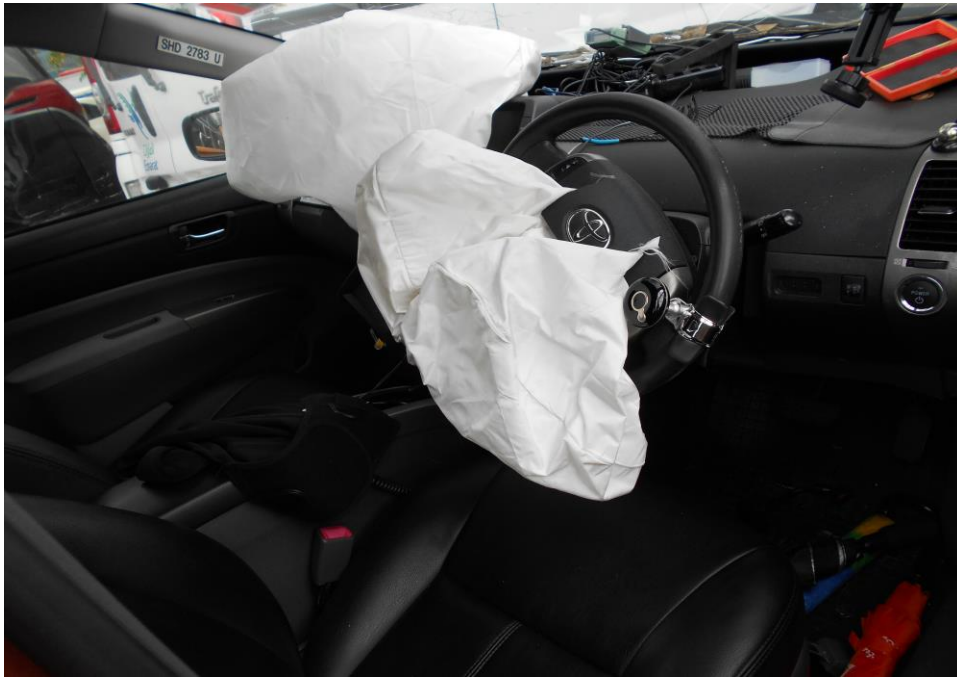
Photo 8 shows the interior portion of the Motor Taxi. The impact force triggered both driver & front passenger's airbag as a result of the accident.

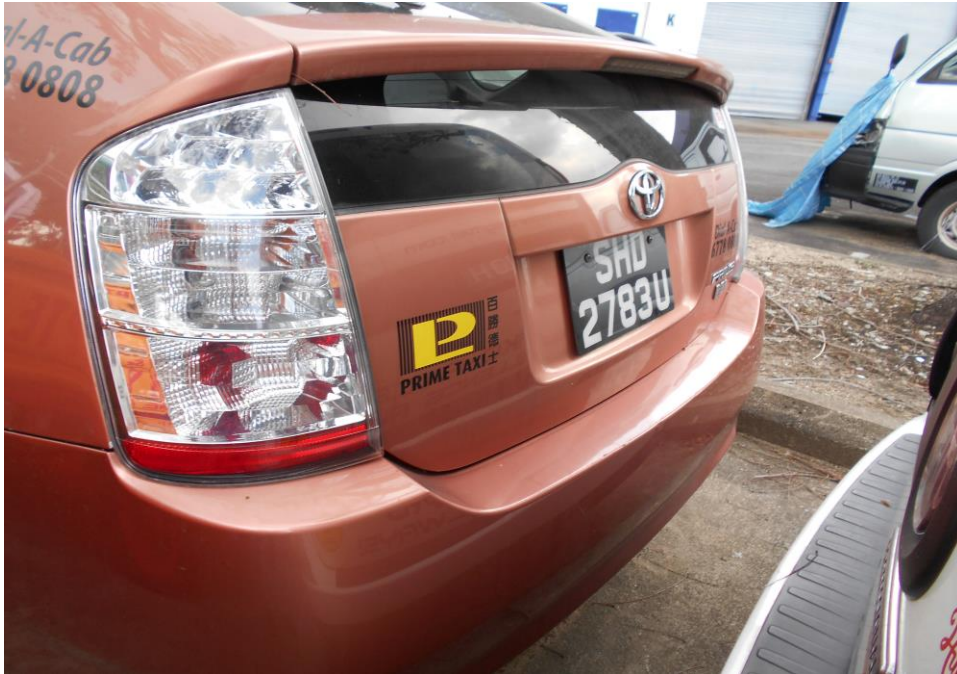
Photo 9 shows a general view of the rear right portion of the Motor Taxi at the time of our inspection. The rear portion was observed to be in good condition unaffected by the accident.

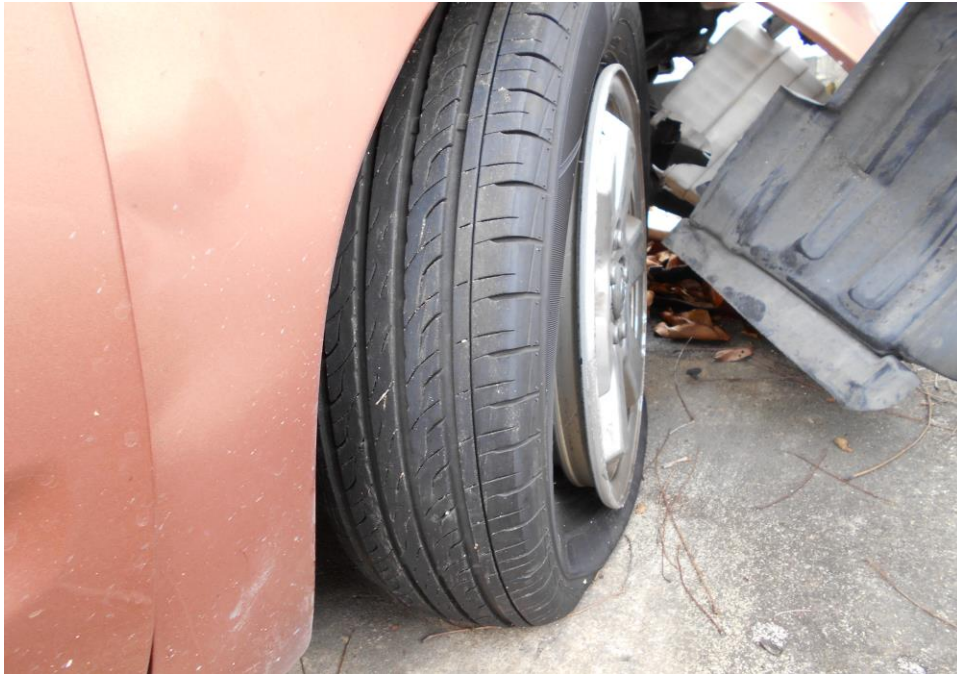
10. As for the front right tyre, it was observed to be deflated due to the accident's impact collision. We did find dent on the outer side of the alloy rim and also a small puncture mark about 15mm in length which was likely caused by the accident.

Photo 10 shows the condition of the front right tyre of the Motor Taxi, which was observed to be deflated (likely due to the accident) which might cause by dented alloy wheel rim.

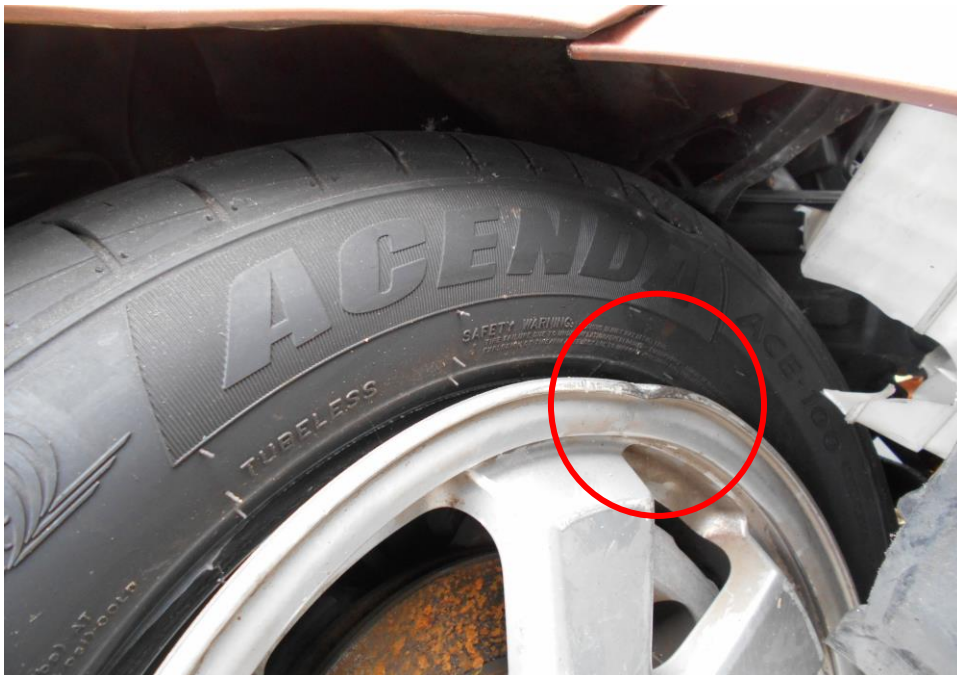
Photo 11 shows the condition of the dented front right wheel rim of the Motor Taxi as a result of the accident.

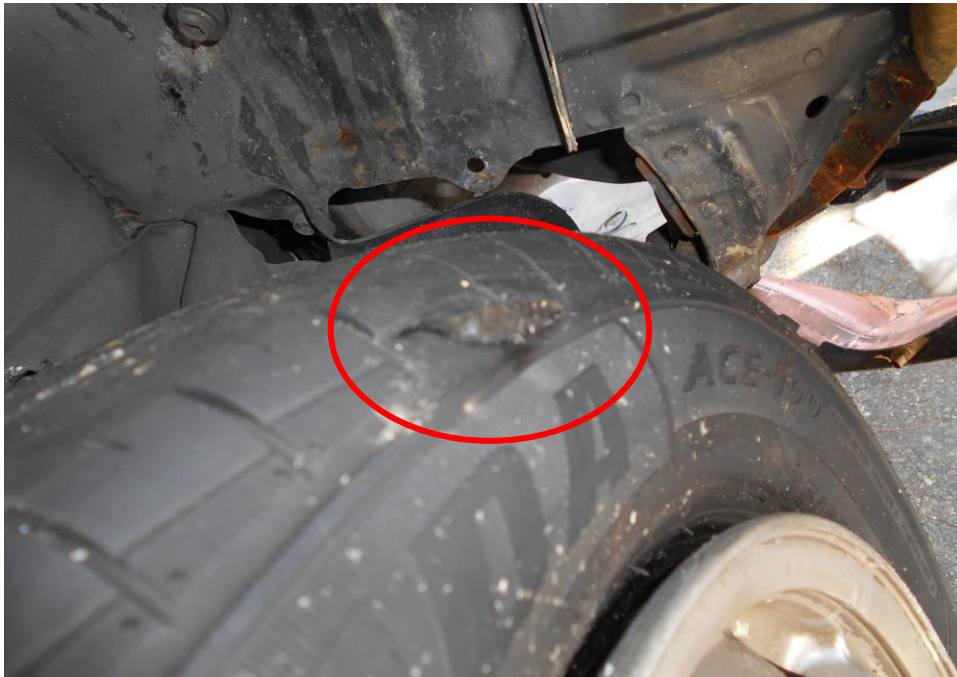
Photo 12 shows the condition of the dented front right wheel rim of the Motor Taxi as a result of the accident.

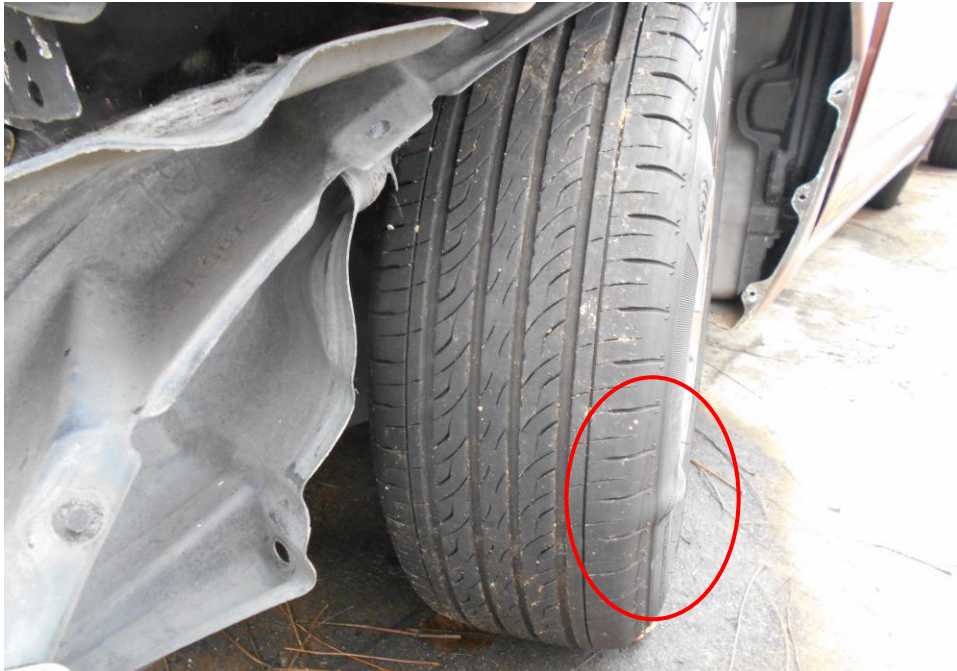
9. The condition of the front left tyre was observed with 2 small bloated marks on the outer wall likely caused by the excessive impact pressure to the front left tyre due to the accident's impact. However, it was observed to be sufficiently inflated for vehicular operation.

Photo 13 shows the condition of the front left tyre of the Motor Taxi, which was observed to be in serviceable condition with remaining tread depth of approximately 5mm. However, 2 small bloated marks were observed on the outer sidewall of the tyre likely due to the accident's impact.

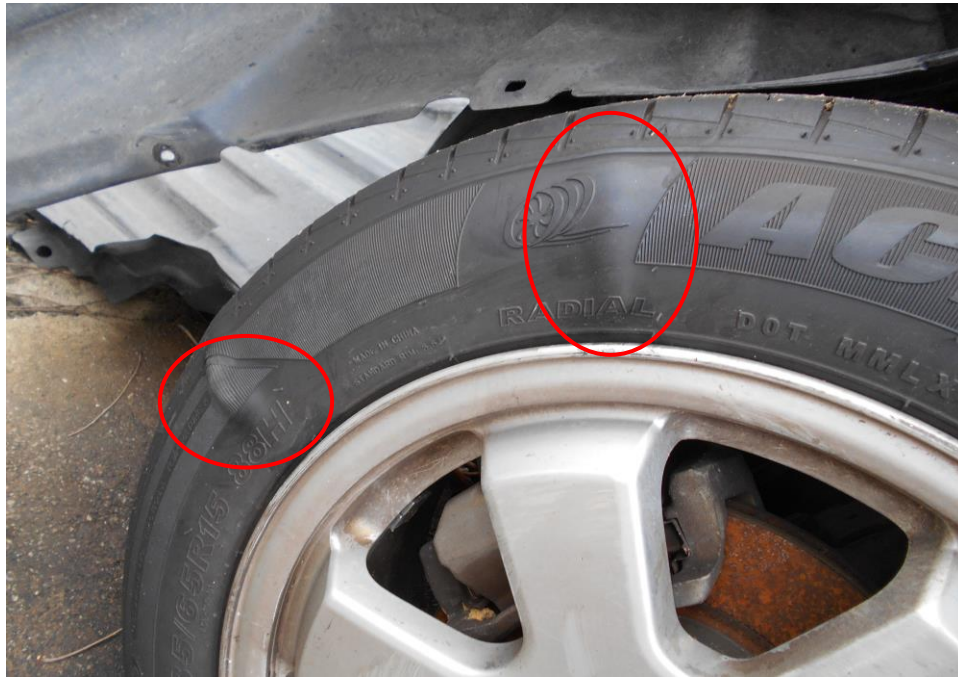
Photo 14 shows the condition of the front left tyre of the Motor Taxi, which was observed to be in serviceable condition with remaining tread depth of approximately 5mm. However, 2 small bloated marks were observed on the outer sidewall of the tyre likely due to the accident.

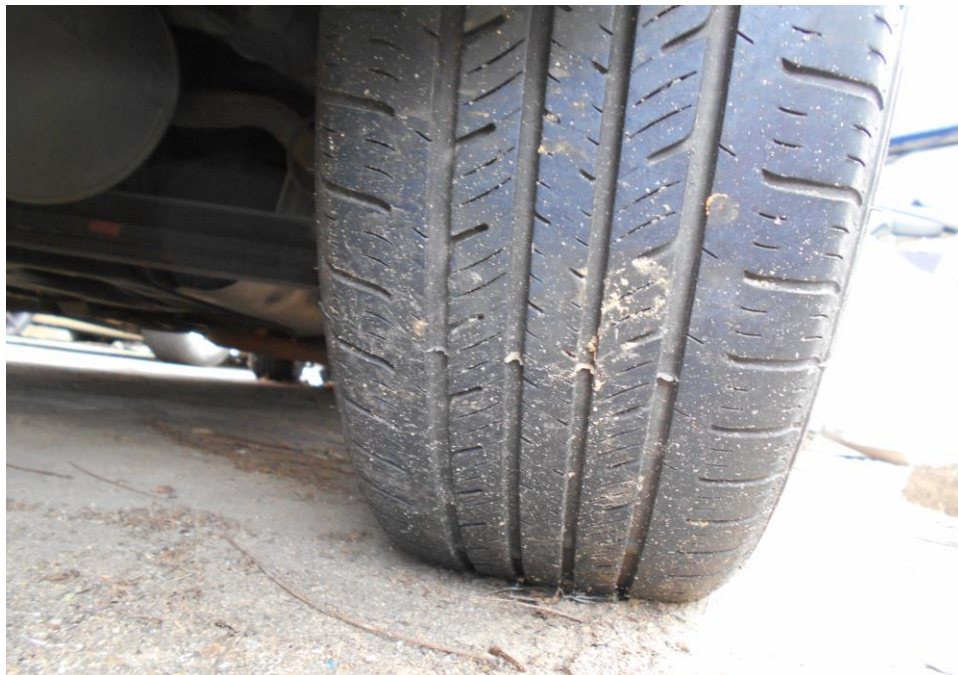
Photo 15 shows the condition of the rear right tyre of the Motor Taxi, which was observed to be in serviceable condition with remaining tread depth of approximately 6mm. There was also no tear, cut or burst mark(s) on the outer and the inner sidewalls as well as across the tread of this tyre.

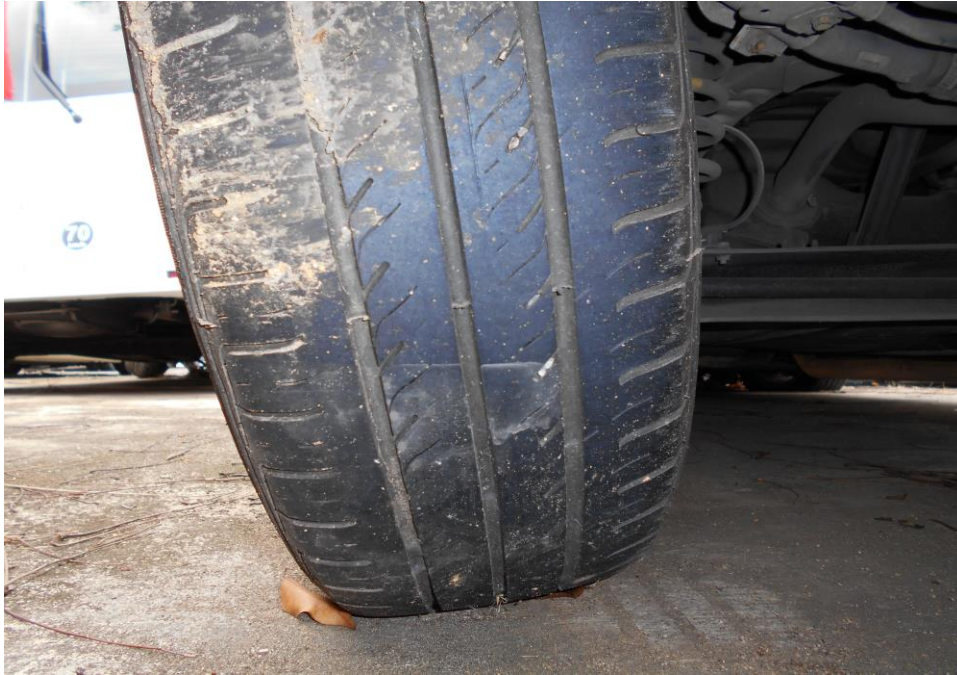
Photo 16 shows the condition of the rear left tyre of the Motor Taxi, which was observed to be in serviceable condition with remaining tread depth of approximately 5mm. There was also no tear, cut or burst mark(s) on the outer and the inner sidewalls as well as across the tread of this tyre.

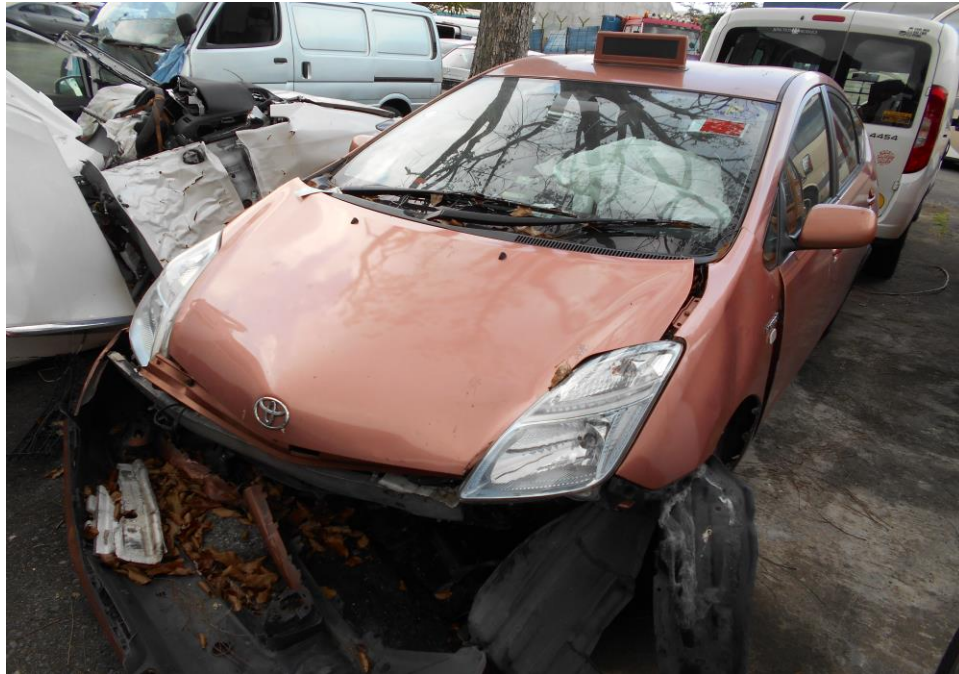
14. The engine compartment of the Motor Taxi was severely affected by the collision. We were unable to access to the engine compartment via the front bonnet. It was observed to be buckled inwards as a result of the accident. From our visual examination at time of the inspection, parts like the radiator, air intake system and exhaust manifold, amongst others were found to be damaged due to the accident's impact collision.

Photo 17 shows a general view of the Motor Car's engine compartment portion. It was observed to be stuck affected by the accident.

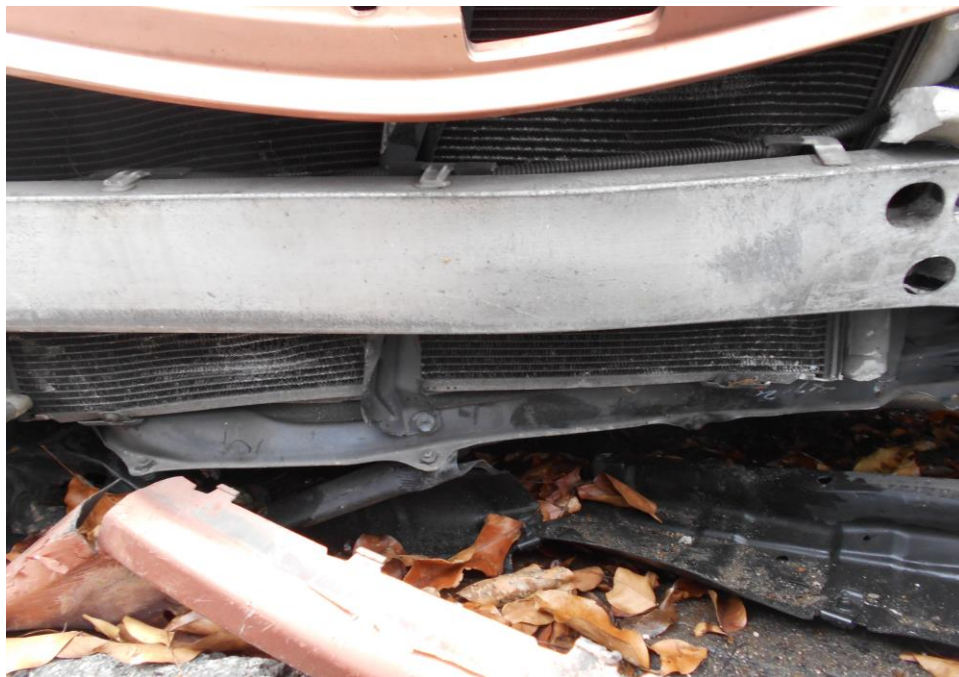
Photo 18 shows the close up view of the radiator tank that was affected by the accident's impact.

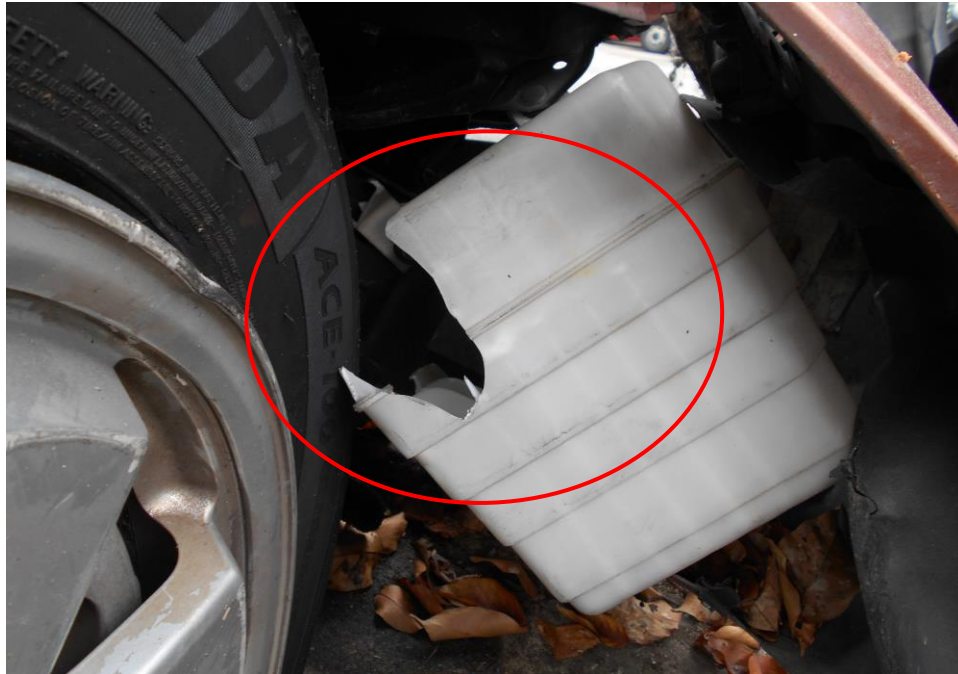
Photo 19 shows the close up view of the wiper washer container that was observed to be damaged (broken) by the accident's impact.

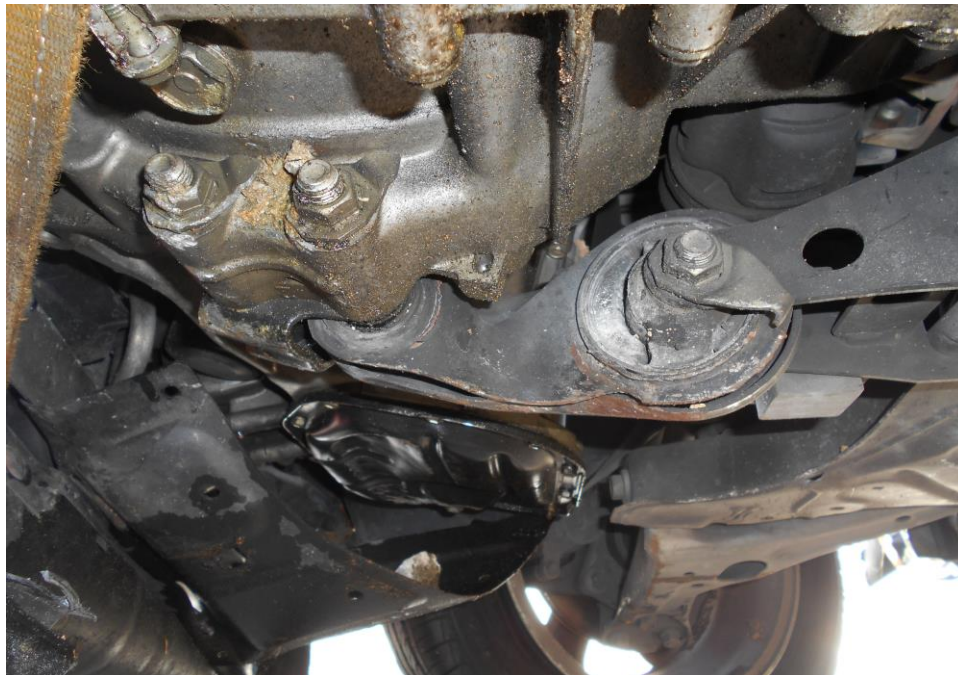
15. Leakage of the various operating fluids like the engine oil and engine coolant fluid was also noted. Given the extent of damages to the engine compartment, the leakages were likely due to the accident. The engine undercarriage was however observed to be covered with fluid, suggesting leakage of fluid. There was no accumulation of dust and/or dirt particles on the engine housing where the fluid stains had formed. This would indicate that the fluid leakage was a fresh leak and likely to be a result of the accident. We were therefore unable to comment whether these operating fluids were of sufficient level and without contamination for vehicular operation prior to the accident See photo 17 – 21 below.

Photo 20 shows the close up view of the undercarriage fluid leakage affected by the accident's impact.

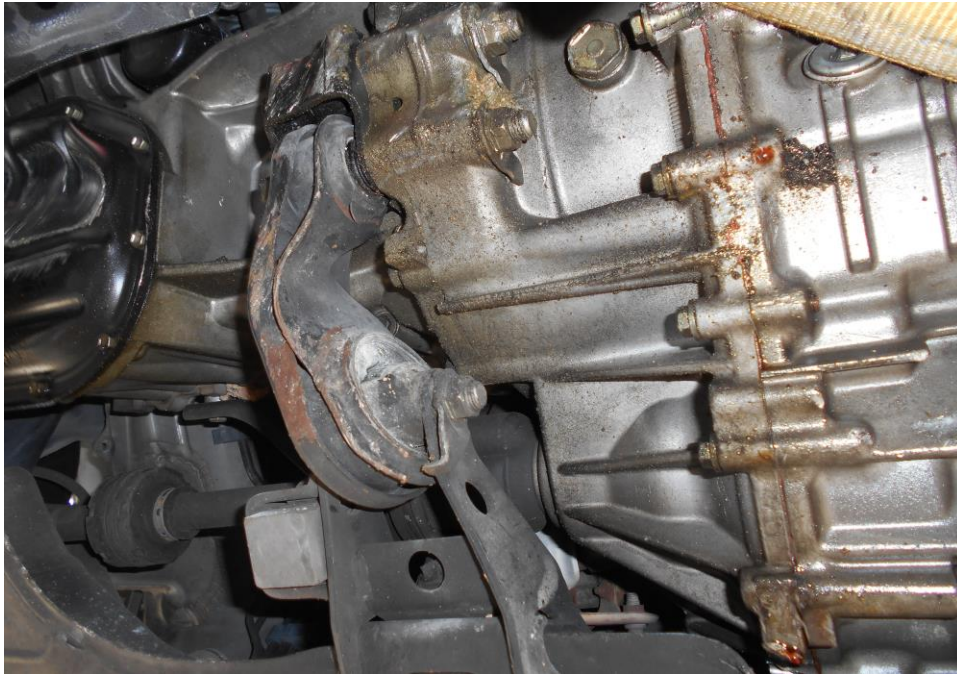
Photo 21 shows the close up view of the undercarriage fluid leakage affected by the accident's impact.

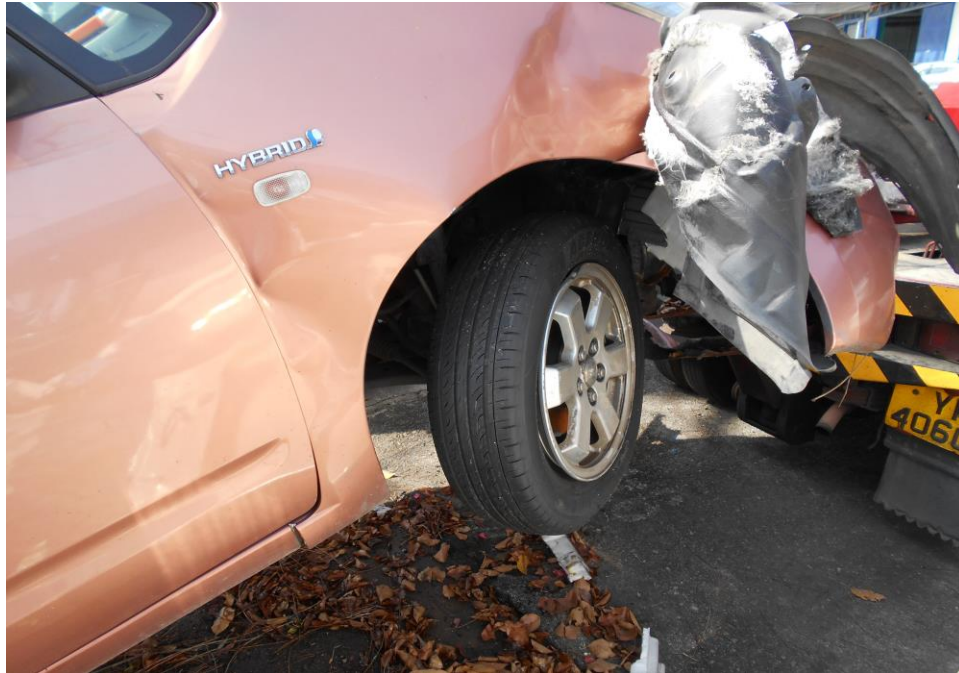
Photo 25 shows the Motor Taxi right tyre. The right wheel had reacted to our steer manoeuvre to the left without abnormality at time of testing.

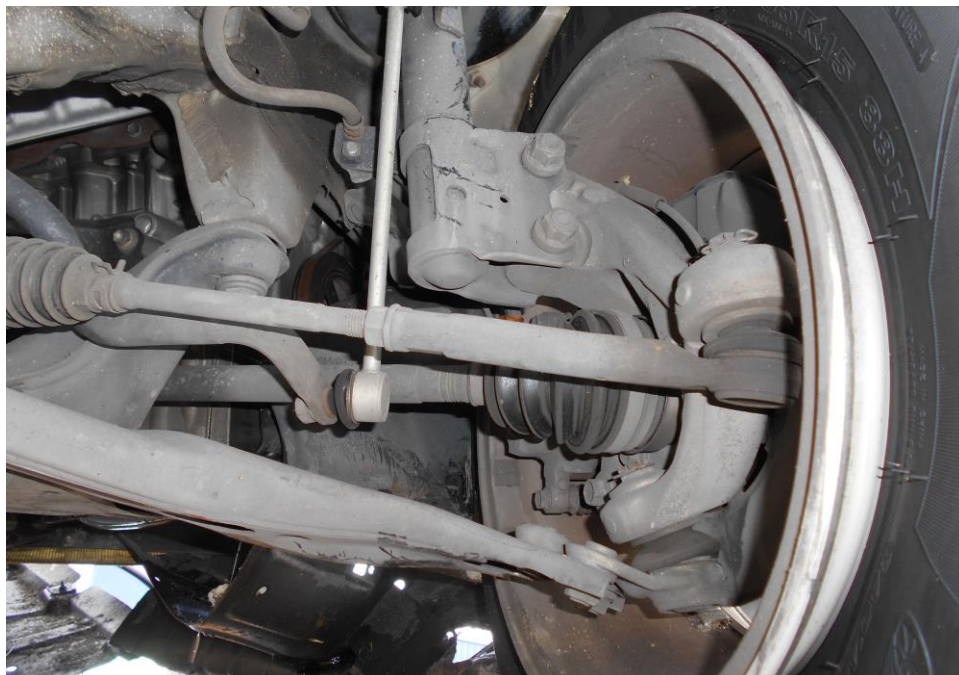
Photo 26 shows the Motor Taxi right wheel steering components which was found to be unaffected by the accident's impact.

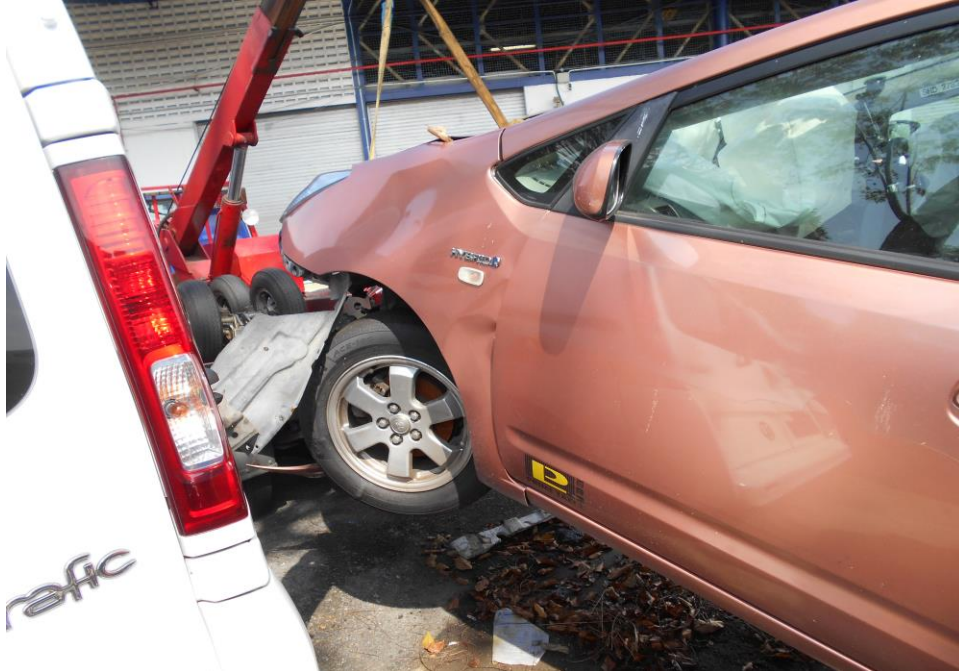
Photo 27 shows the Motor Taxi left tyre. The left wheel had reacted to our steer manoeuvre to the left without abnormality at time of testing.

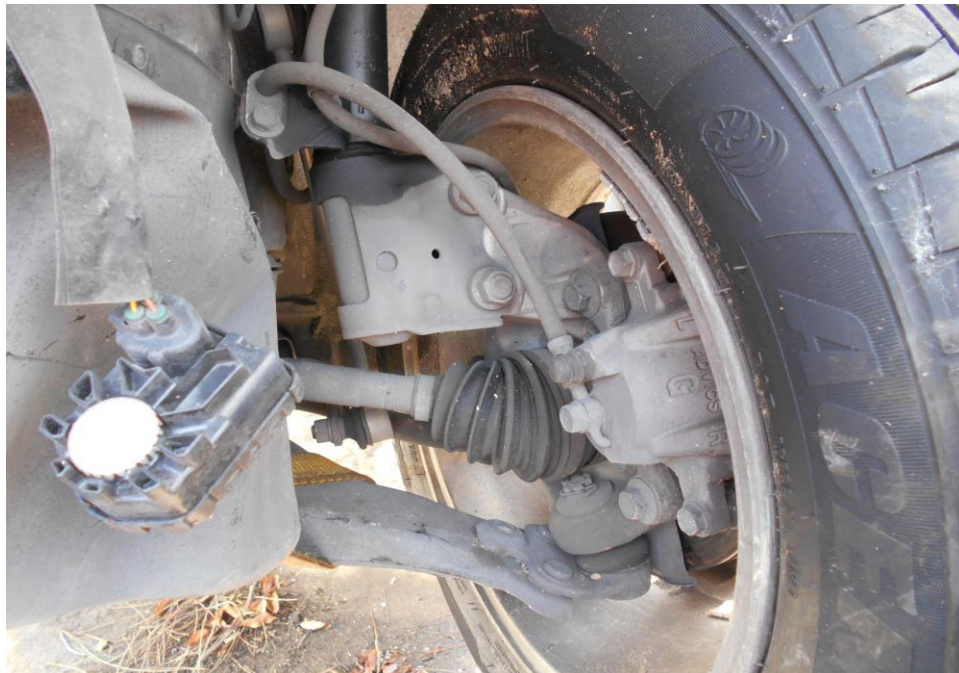
Photo 28 shows the Motor Taxi left wheel steering components which was found to be unaffected by the accident's impact.

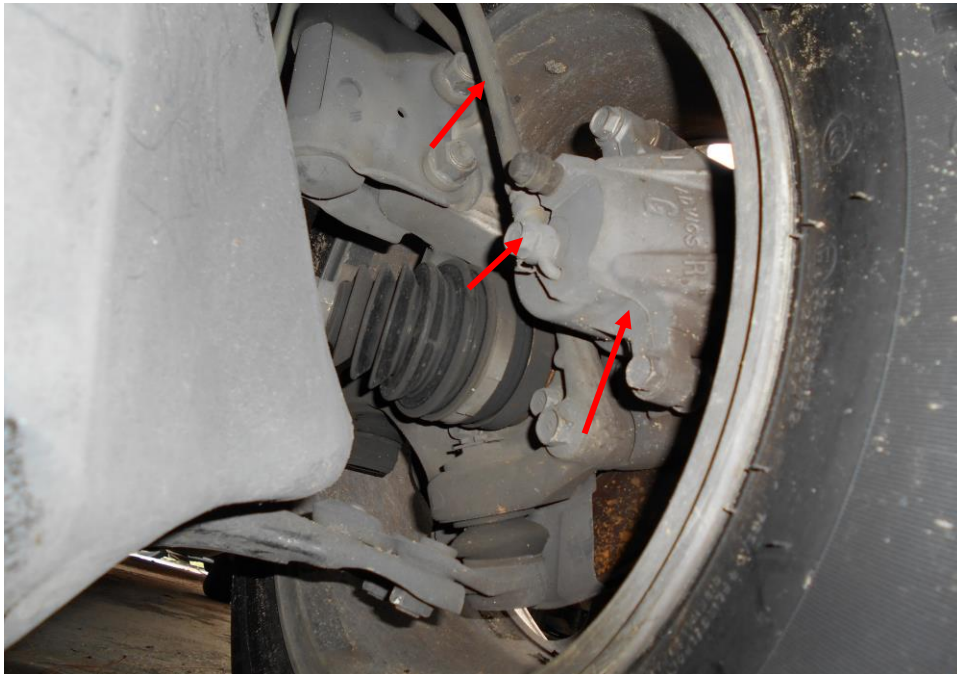
Photo 29 shows the braking components at the front left wheel of the Motor Taxi. We did not observe any leakage of brake fluid at the time of our inspection of the Motor Car.

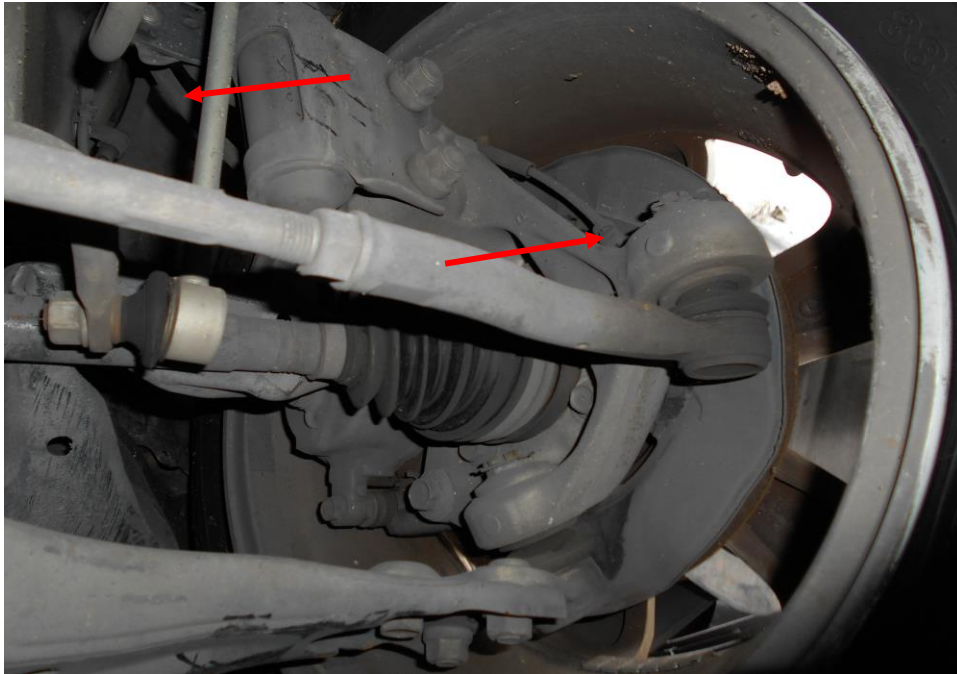
Photo 30 shows the braking components at the front right wheel of the Motor Taxi. We did not observe any leakage of brake fluid at the time of our inspection of the Motor Taxi.

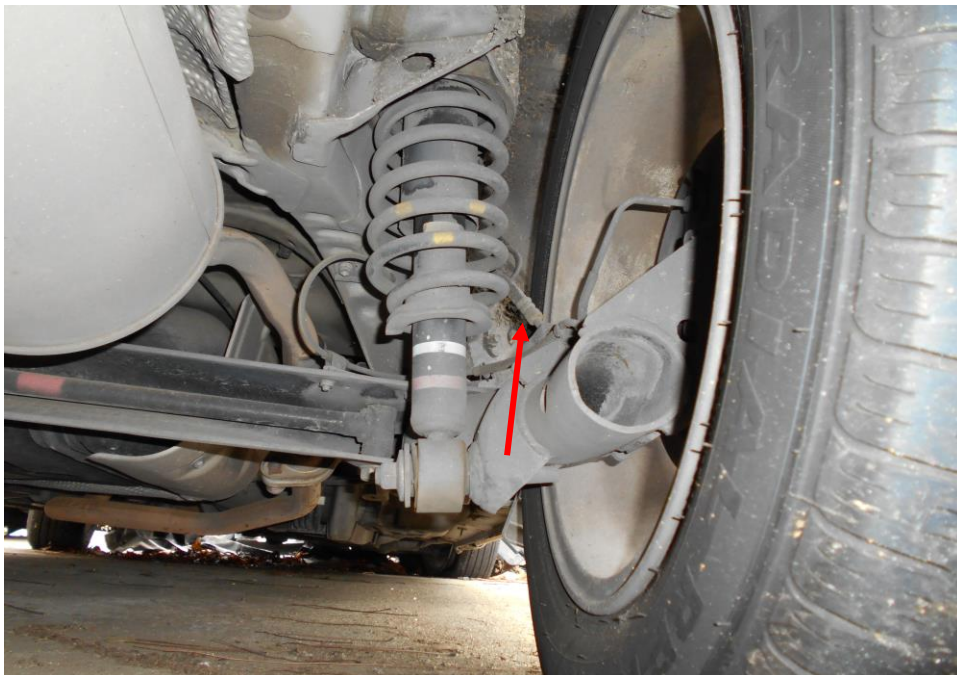
Photo 31 shows the braking components at the rear right wheel of the Motor Taxi. We did not observe any leakage of brake fluid at the time of our inspection of the Motor Taxi.

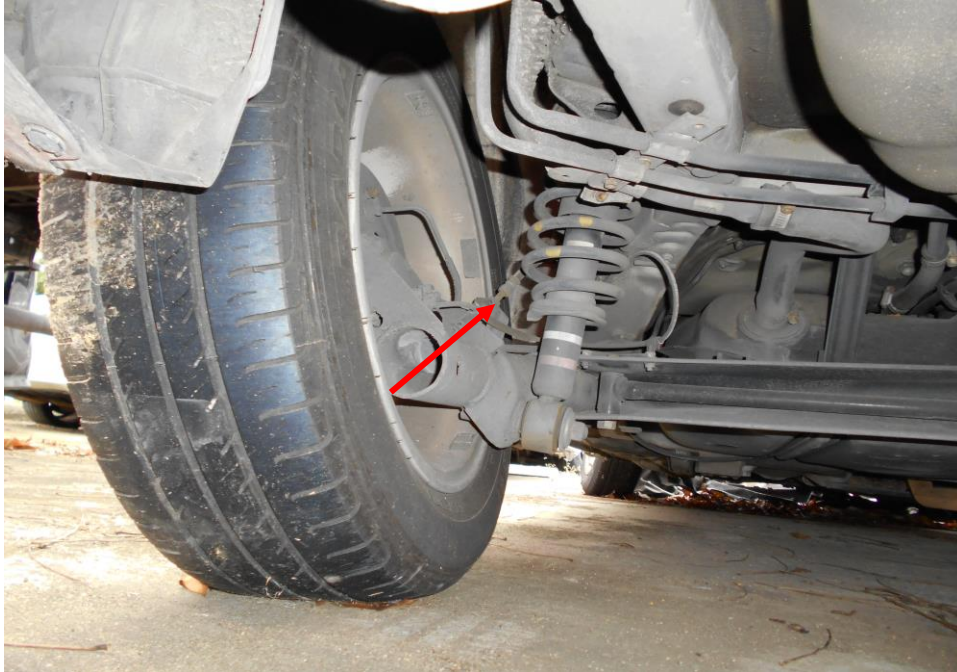
Photo 32 shows the braking components at the rear left wheel of the Motor Taxi. We did not observe any leakage of brake fluid at the time of our inspection of the Motor Taxi.

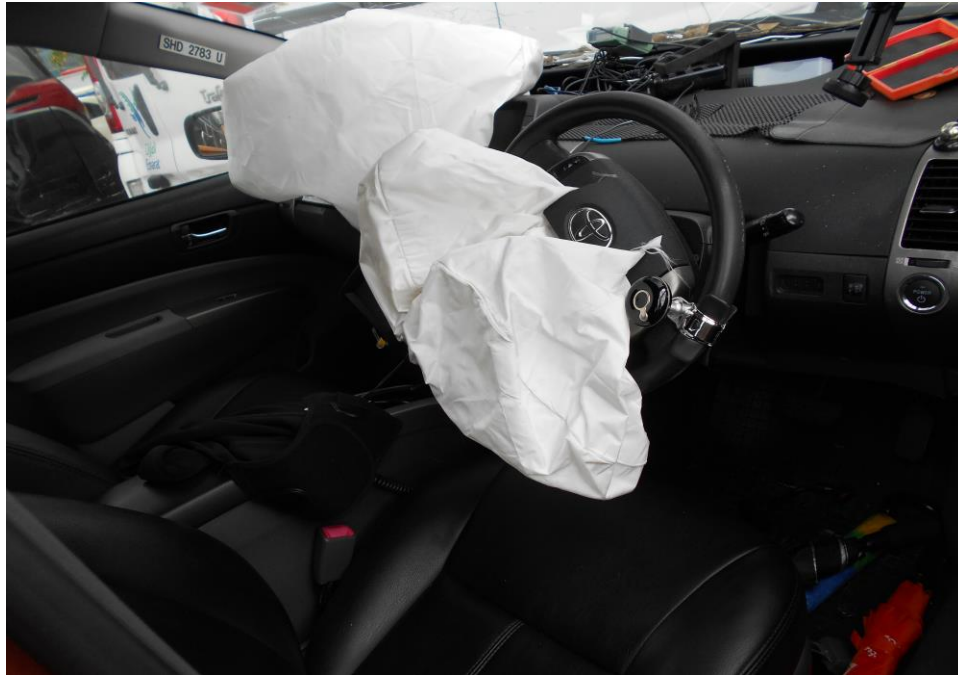
Photo 33 shows the Supplemental Restraint System (SRS) of the Motor Taxi was however likely to be in normal operating condition at the material time of the accident. The evidence of the deployed front driver & passenger's airbag indicates that the impact sensors and control module of the Motor Taxi's SRS were all in serviceable condition at the material time of accident.
