Your Ref: TP/IP/64329/2018
Our Ref : CI/TPD19002507/N

MECHANICAL INSPECTION REPORT OF MOTOR VAN GBH 5120M

1. We refer to your request on 1 February 2019 to conduct a physical inspection of a motor van bearing registration number GBH 5120M (herein referred to as “**Motor Van**”), which was involved in a road traffic accident on 21 November 2018.
2. The objective of this inspection is to determine if there was any possible mechanical failure to the Motor Van that may have contributed to the accident.
3. Following the request, we had carried out a physical inspection of the Motor Van on 29 April 2019 at the premises of Traffic Police vehicle pound, 517 Airport Road Singapore 539942. We now set out below our observations and comments with respect to this inspection.

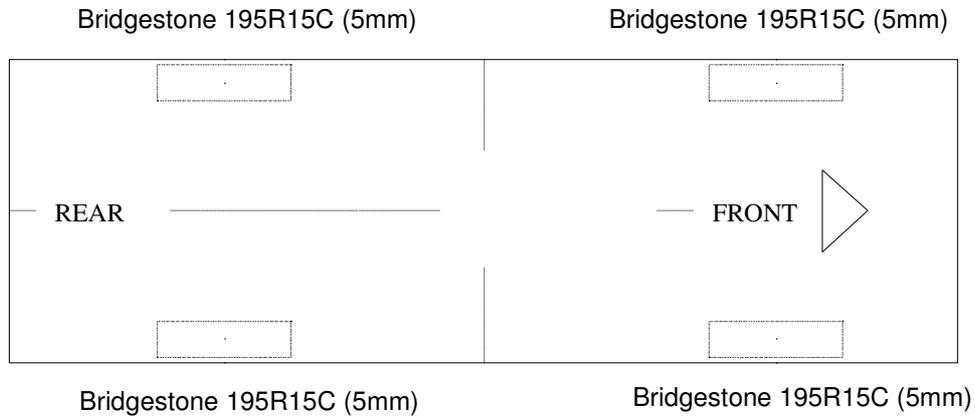
6. The 4 tyres were observed to be in serviceable condition and sufficiently inflated for vehicular operation. We did not find any tear, cut or burst mark(s) on the outer and the inner sidewalls as well as across the tread of the 4 tyres. The tyre brand, tyre size and remaining tread depth of the 4 tyres of the Motor Van were recorded as follows:-

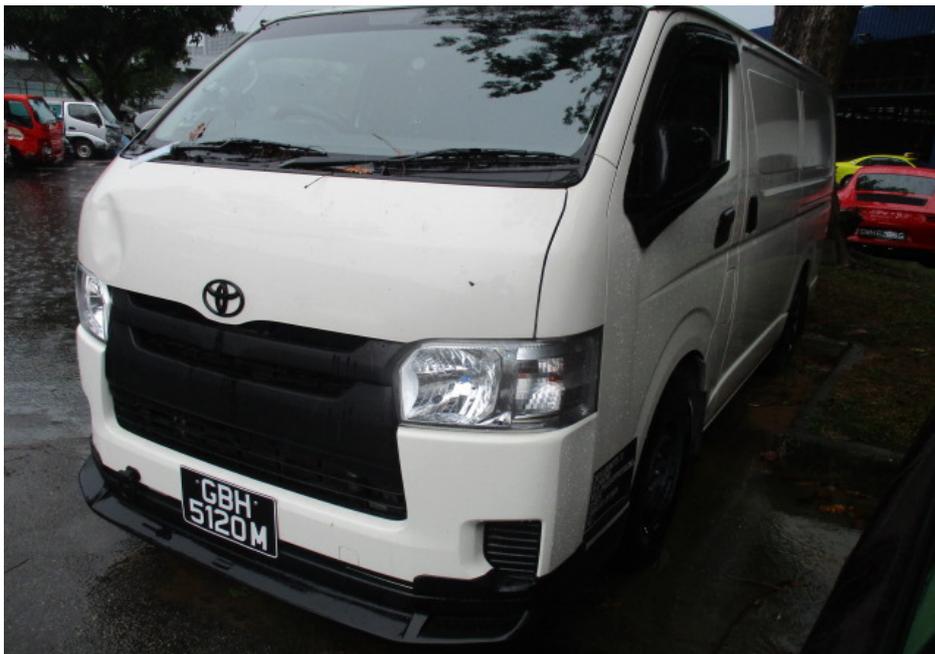
Photo 1 shows a general view of the front left body of the Motor Van at the time of our inspection. The Motor Van was observed to have sustained minimal impact damage that was confined to its right front portion. The mileage of the Motor Van was recorded to be 14, 865km.

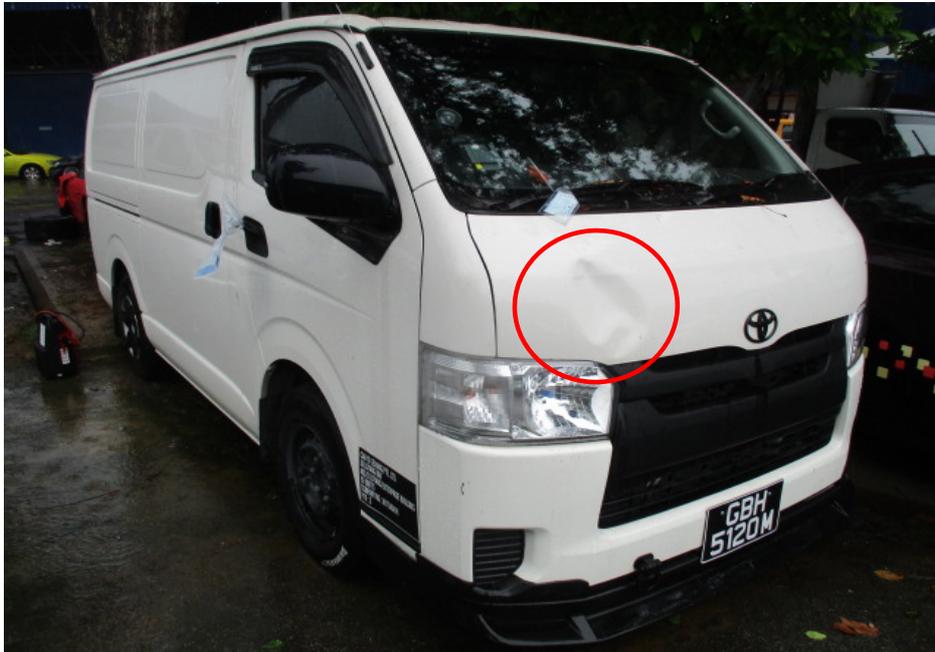
4. The mileage of the Motor Van at the time of our inspection was 14, 865km.
5. The Motor Van was observed to have sustained minimal impact damage at its right front body. Its front bonnet was dented as a result of the accident.

Photo 2 shows a general view of the front right body of the Motor Van at the time of our inspection. The Motor Van was observed to have sustained minimal impact damage that was confined to its right front portion. Its front bonnet was dented as a result of the accident (circled).

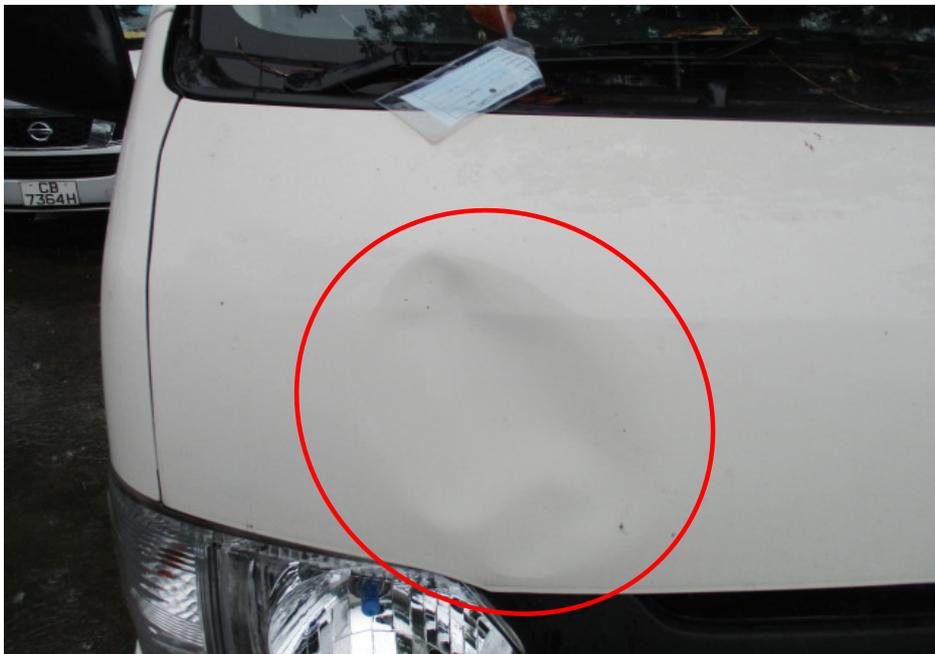
Photo 3 shows a close up view of the dented front bonnet of the Motor Van at the time of our inspection (circled).

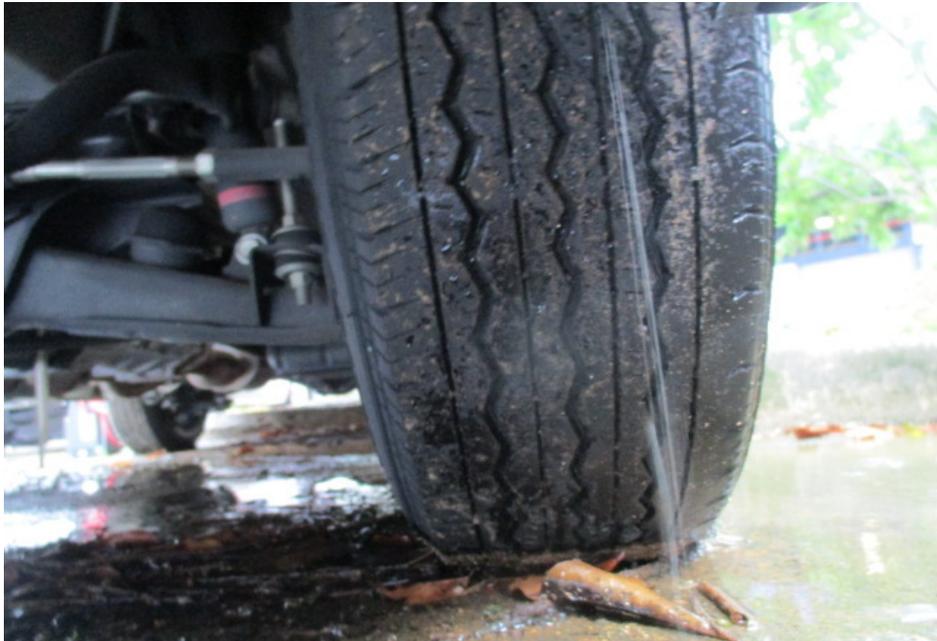
Photo 4 shows the condition of the front left tyre of the Motor Van, which was observed to be in serviceable condition with remaining tread depth of approximately 5mm. The tyre, which was wrapped around standard steel wheel rim, was also observed to be sufficiently inflated for vehicular operation. There was no tear, cut or burst mark(s) on the outer and the inner sidewalls as well as across the tread of the 4 tyres.

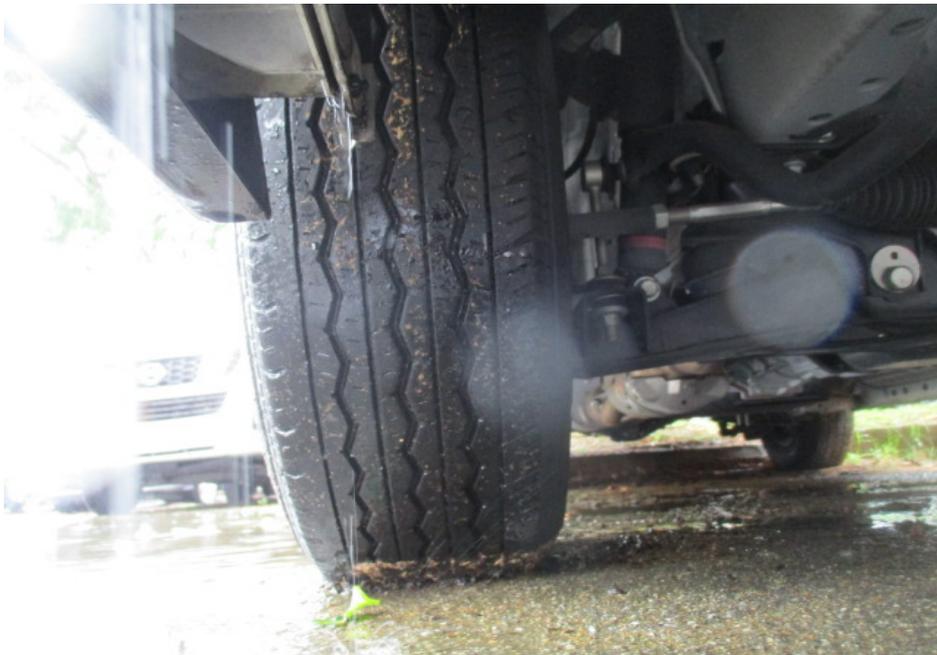
Photo 5 shows the condition of the front right tyre of the Motor Van, which was observed to be in serviceable condition with remaining tread depth of approximately 5mm. The tyre, which was wrapped around standard steel wheel rim, was also observed to be sufficiently inflated for vehicular operation.

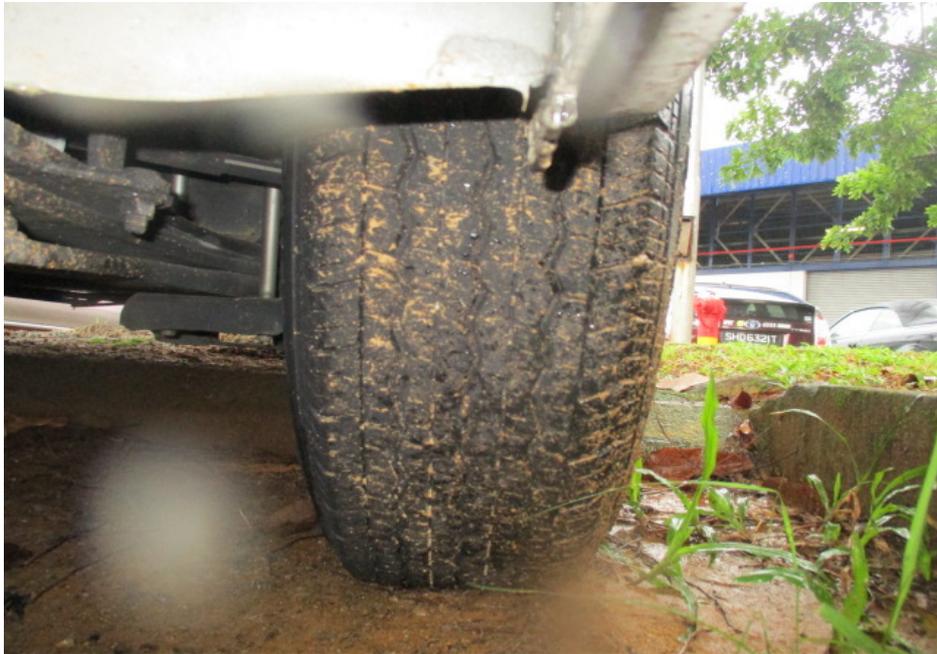
Photo 6 shows the condition of the rear left tyre of the Motor Van, which was observed to be in serviceable condition with remaining tread depth of approximately 5mm. The tyre, which was wrapped around standard steel wheel rim, was also observed to be sufficiently inflated for vehicular operation. There was also no damage found on the 4 wheel rims of the Motor Van.

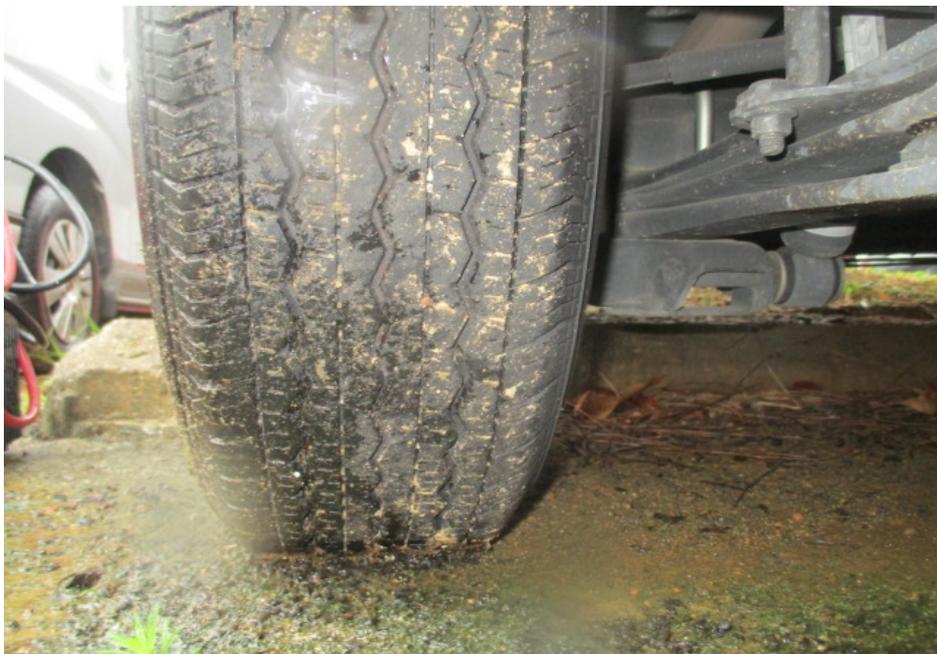
Photo 7 shows the condition of the rear right tyre of the Motor Van, which was observed to be in serviceable condition with remaining tread depth of approximately 5mm. There was also no tear, cut or burst mark(s) on the outer and the inner sidewalls as well as across the tread of the 4 tyres.

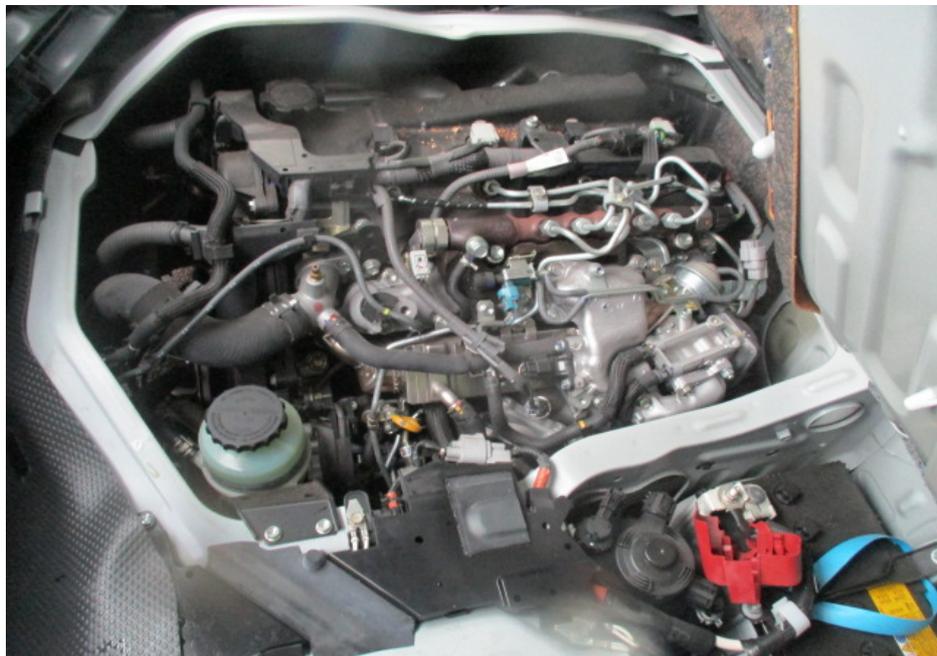
Photo 8 shows a general view of the Motor Van's engine compartment. The various parts and components inside the engine compartment were unaffected by the accident. There was also no sign(s) or indication(s) of fluid leakage and/or fluid stain within the engine compartment. The wirings and cables were all observed to be intact and adequately secured to their respective connectors and/or connecting ports.

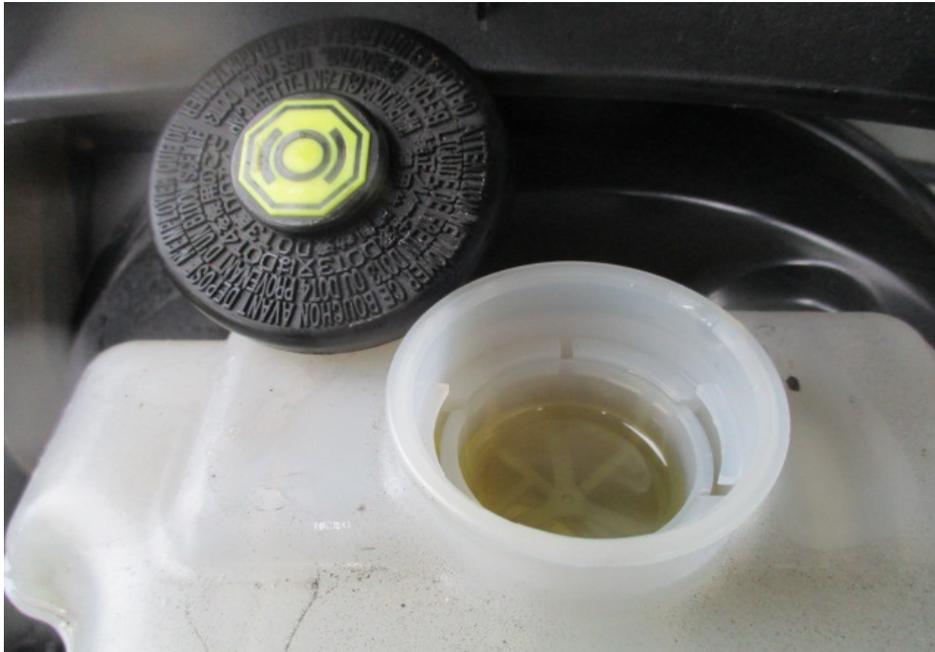
Photo 9 shows the brake fluid reservoir of the Motor Van at the time of our inspection. The brake fluid was observed to be of sufficient level and without any visible contamination.

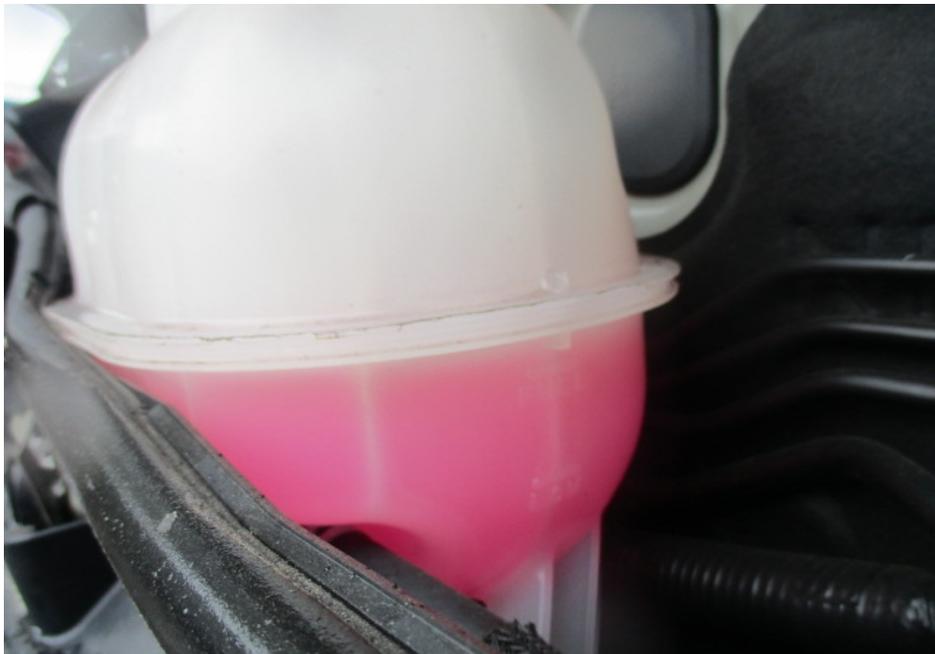
Photo 10 shows the engine coolant reservoir of the Motor Van at the time of our inspection. The engine coolant was observed to be of sufficient level and without any visible contamination.

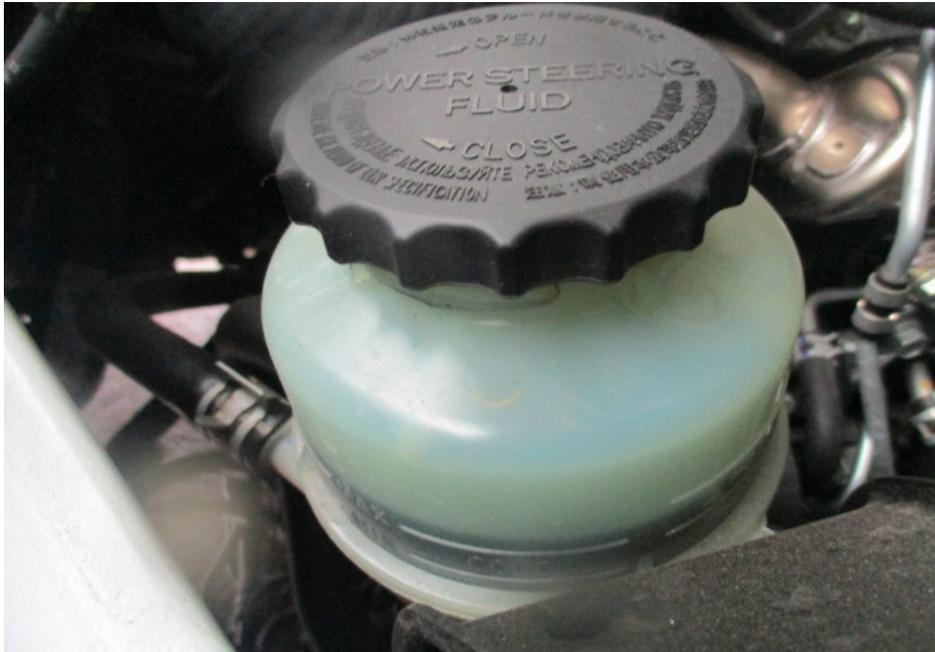
Photo 11 shows the power steering fluid reservoir of the Motor Van at the time of our inspection. The power steering fluid was observed to be of sufficient level and without any visible contamination.

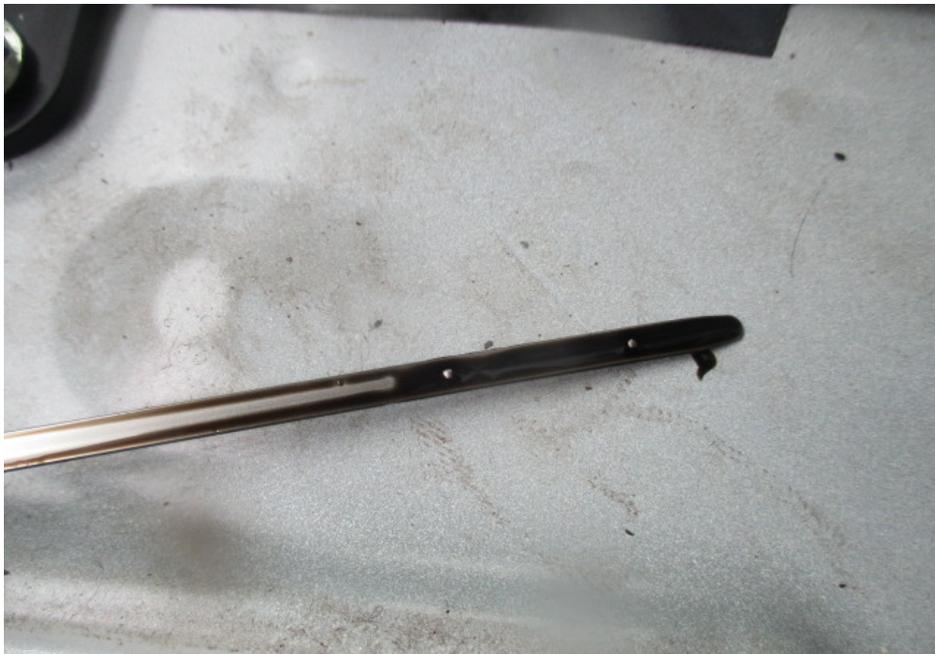
Photo 12 shows the engine dip stick of the Motor Van at the time of our inspection. The engine oil was observed to be of sufficient level and without any visible contamination.

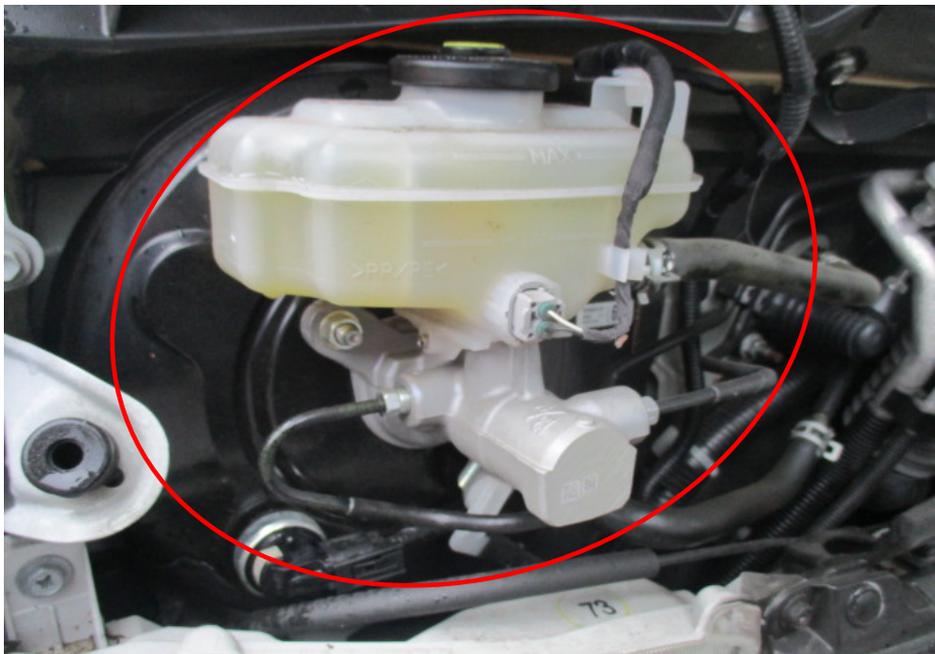
Photo 13 shows the brake master pump, brake reservoir tank, brake booster and brake pipes (circled). These components, which are part of the braking system of the Motor Van, were all observed to be intact, with no sign(s) or indication(s) of brake fluid leakage.

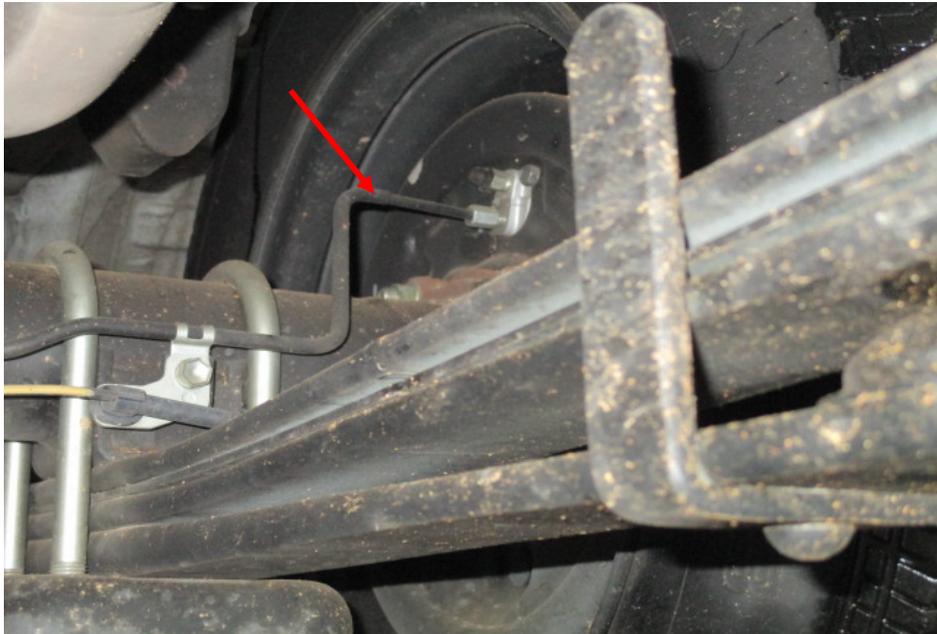
Photo 14 shows the brake pipe (arrowed) at the rear right wheel of the Motor Van. We did not observe any leakage of brake fluid at the time of our inspection of the Motor Van. Our static tests of the Motor Van's braking system had indicated that there was no internal leakage of pressure/vacuum. Hence the braking system was likely to be in serviceable condition at the material time of accident.

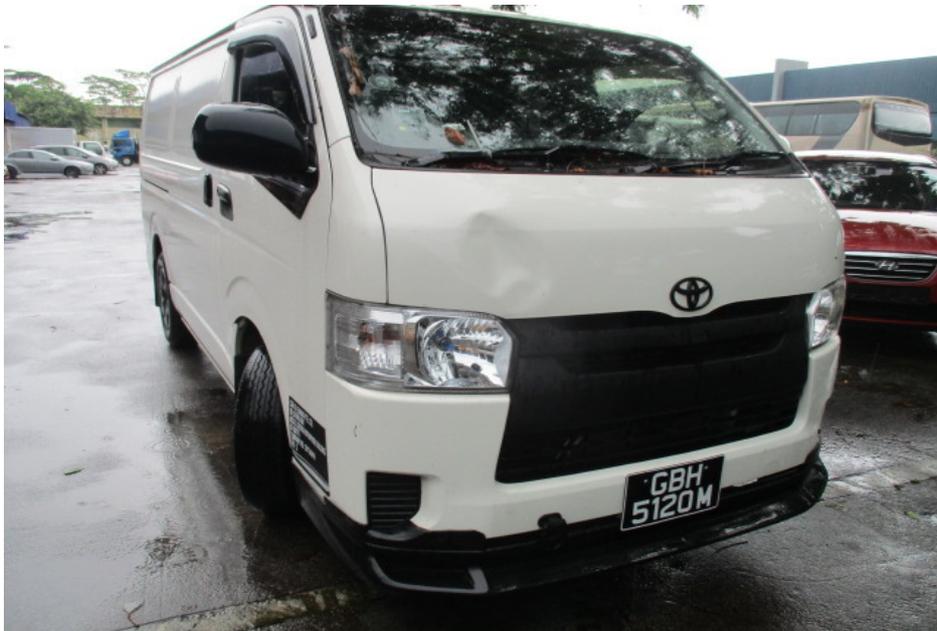
Photo 15 shows the front right wheel of the Motor Van turned to its full right. During our steering system test, we did not experience any abnormal free play and/or resistance when we had turned the steering wheel towards the left and right. This would suggest that the steering system of the Motor Van was likely to be in serviceable condition at the material time of accident.

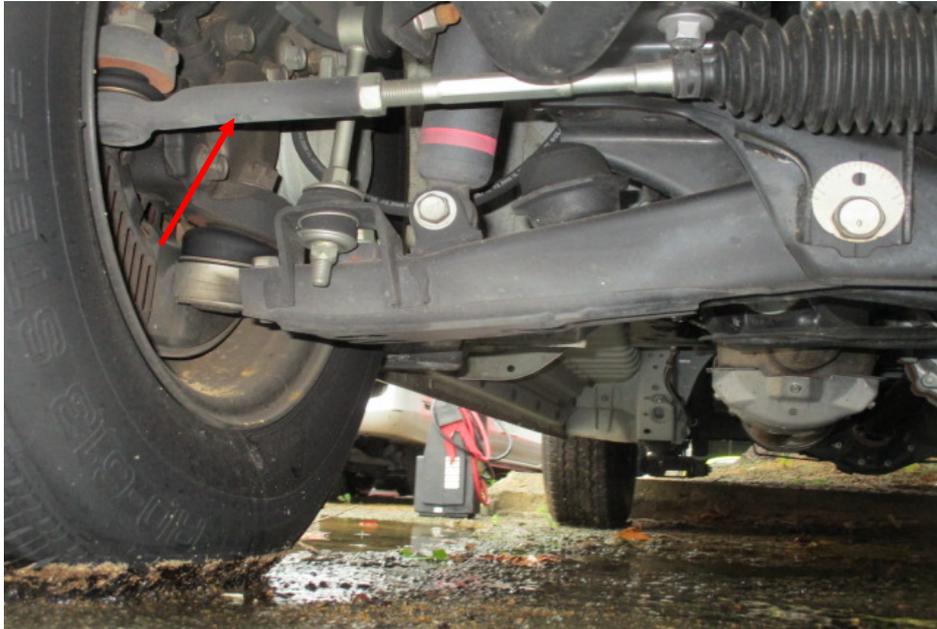
Photo 16 shows the various undercarriage components at the front right wheel of the Motor Van, in particular the steering tie rod (arrowed). The various steering components were all found to be intact, suggesting that the steering system of the Motor Van was likely to be in serviceable condition at the material time of accident. There was also no sign of fluid stain(s) observed on the various undercarriage components.

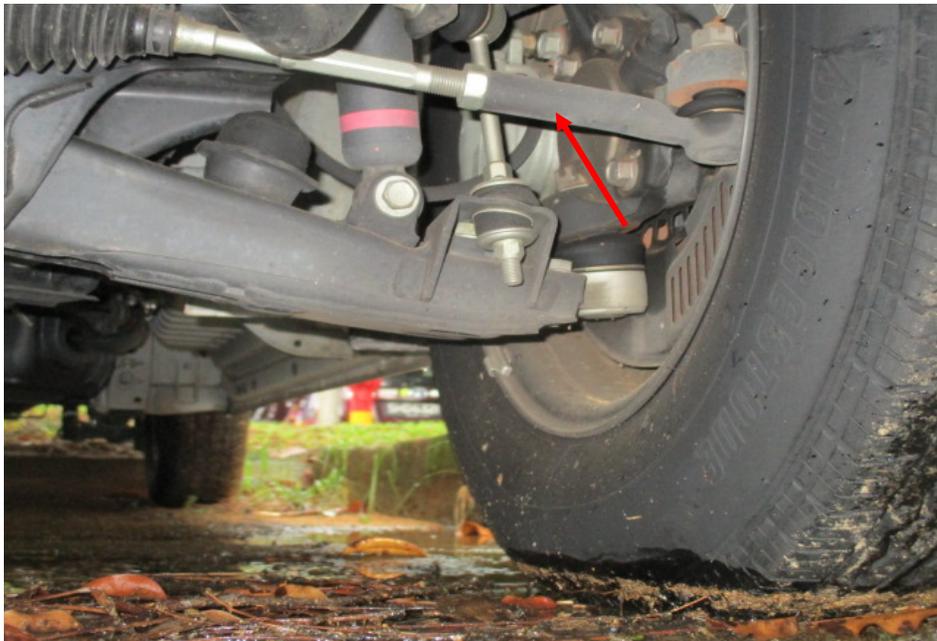
Photo 17 shows the various undercarriage components at the front left wheel of the Motor Van, in particular the steering tie rod (arrowed). The various undercarriage components of the Motor Van were all found to be intact without any visible damage. There was also no sign of fluid stain(s) observed on the various undercarriage components.

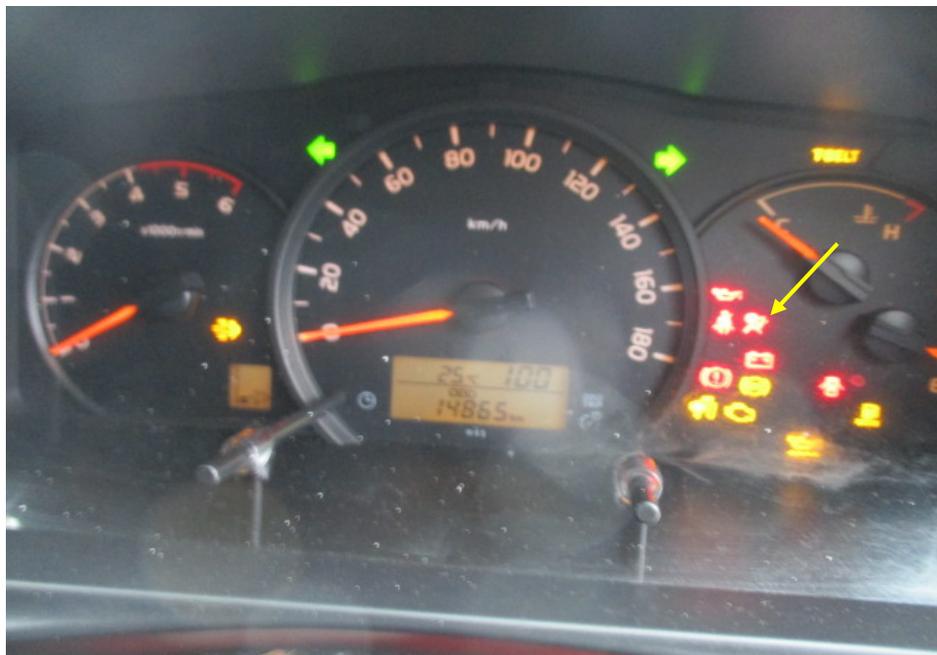
Photo 18 shows the warning lights for the various electronic operating systems of the Motor Van appearing on its instrument panel during the self-test when the engine is cranked, in particular the SRS light (arrowed).

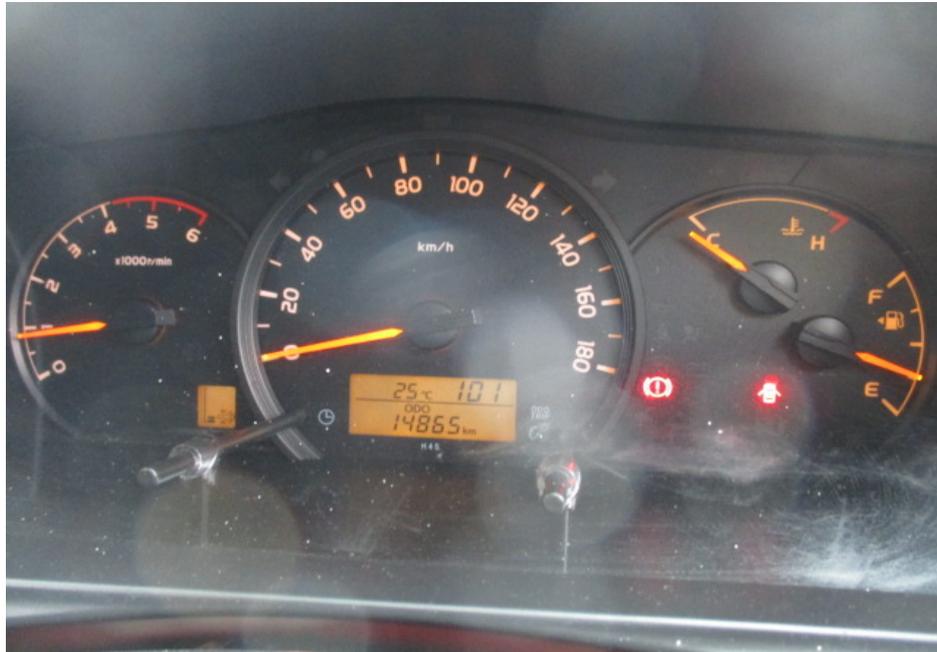
Photo 19 shows no warning lights illuminated on the instrument panel of the Motor Van after the engine was cranked. This would suggest that there was no abnormality to the various electronic operating systems of the Motor Van, like the SRS.
