Your Ref: TP/IP/57195/2018
Our Ref :CI/TPD19002508/Z

Fatal Accident Investigation Team

MECHANICAL INSPECTION REPORT OF MOTORCYCLE JNU 3125

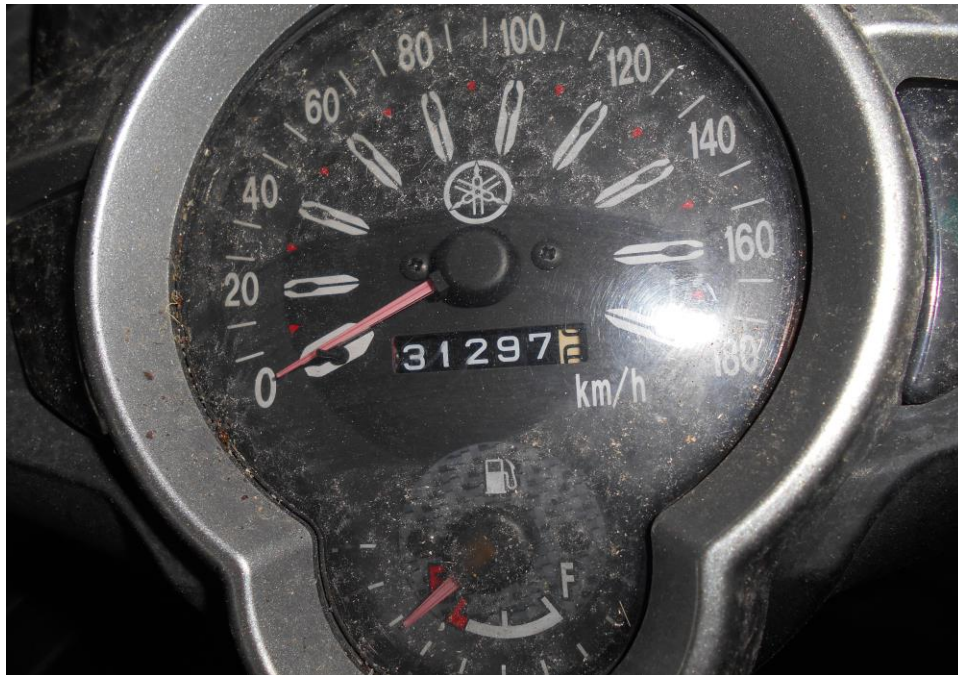
Photo 1 shows a close-up view of the mileage meter at time of our inspection. The mileage was recorded at 312976km.

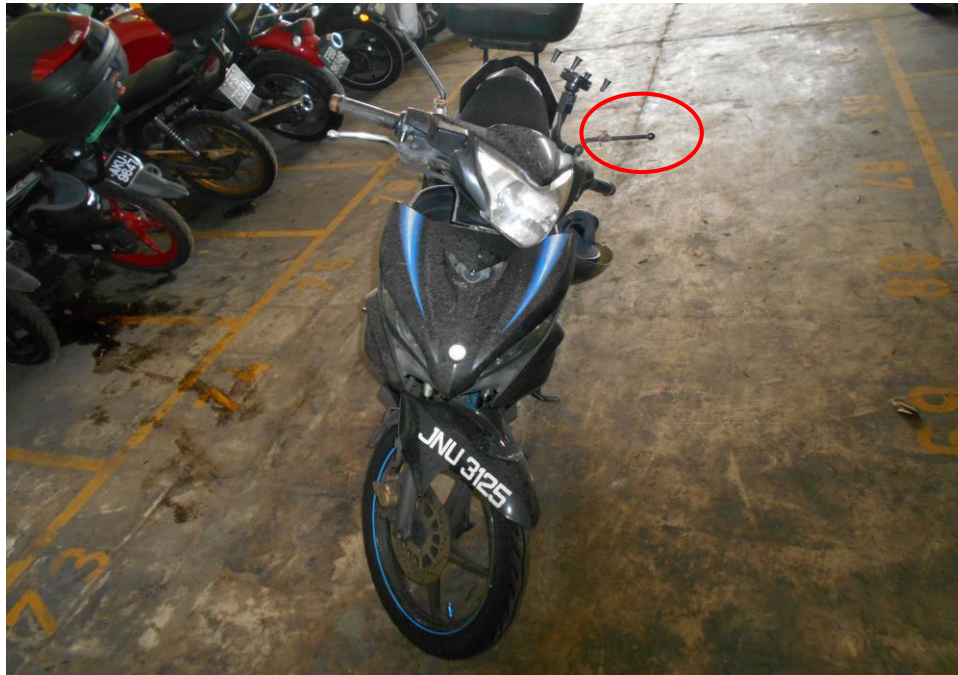
4. The mileage of the Motorcycle recorded at time of our inspection was 312976km.
5. The Motorcycle was observed to have sustained minor damages at the frontal portion. The body parts that were found to have been damaged include its front left wing mirror and foot brake pedal amongst others as a result of the accident.

Photo 2 shows a general view of the front body of the Motorcycle at the time of our inspection. The Motorcycle was observed to have sustained relatively minor damages at time of inspection. The damages were observed to be confined to its frontal & left side of the Motor Cycle.

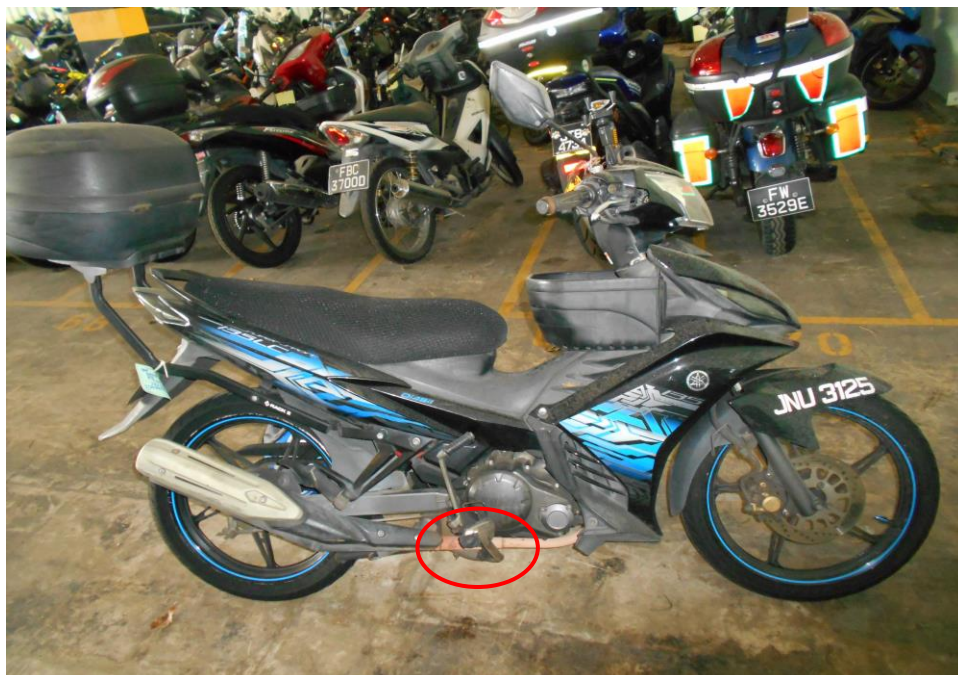
Photo 3 shows a general view of the right body of the Motorcycle at the time of our inspection. The damages were observed to be confined to its frontal & left side of the Motor Cycle.

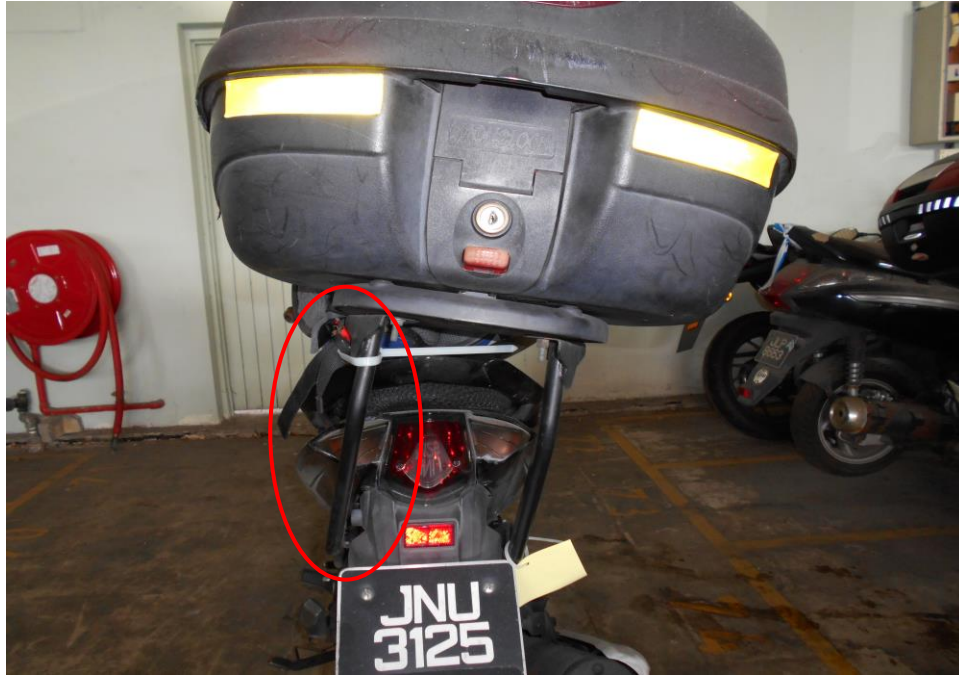
Photo 4 shows a general view of the rear body of the Motorcycle at the time of our inspection. The Motorcycle was observed to have sustained relatively minor damage on the compartment bracket at time of our inspection.

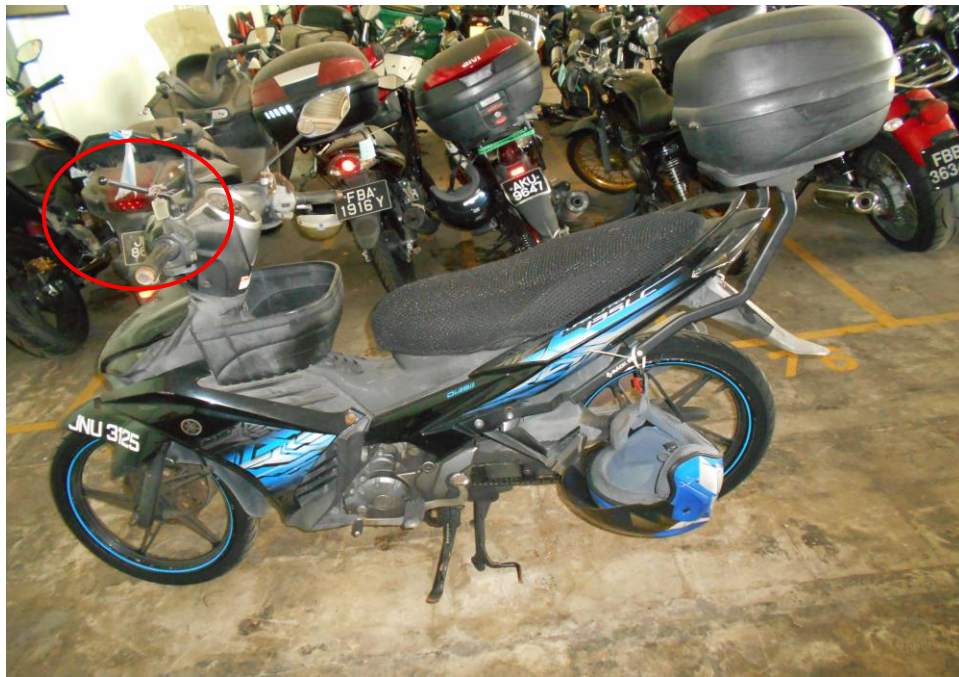
Photo 5 shows a general view of the left body of the Motorcycle at the time of our inspection. The damages were observed to be confined to its frontal & left side of the Motor Cycle at time of our inspection.

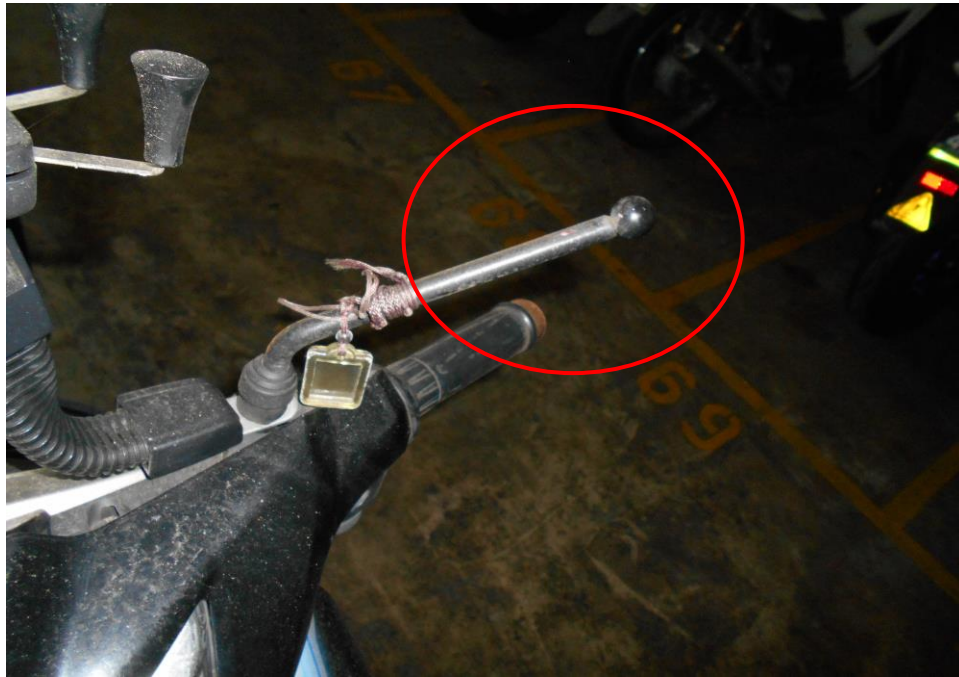
Photo 6 shows a closer view of the front left wing mirror of the Motorcycle at the time of our inspection. The Motorcycle wing mirror was observed to be dislodged due to the accident collision. (Circled)

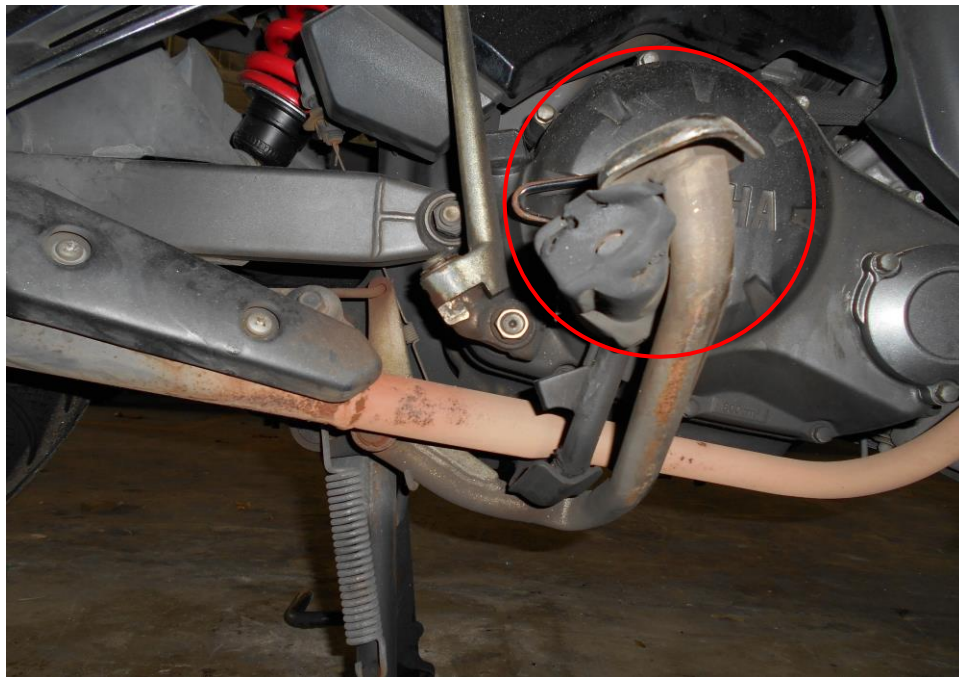
Photo 7 shows a closer view of the rear foot pedal of the Motorcycle at the time of our inspection. It was observed to be stuck to the foot pedal due to the accident collision. (Circled)

16. Basing on our physical inspection of the Motorcycle, it appears that the steering system and braking system (front brake) of the Motorcycle were all in serviceable condition.
17. However, as for the rear brake, it was unable to be tested due to the damage sustained due to the accident (stuck foot brake pedal). However, the rear braking components were found to be unaffected by the accident impact such as rear brake drum, springs and cables which are the supporting components of the rear brake.
18. We did not find any evidence(s) to suggest that there was possible mechanical failure to the Motorcycle that may have caused and/or contributed to the accident.

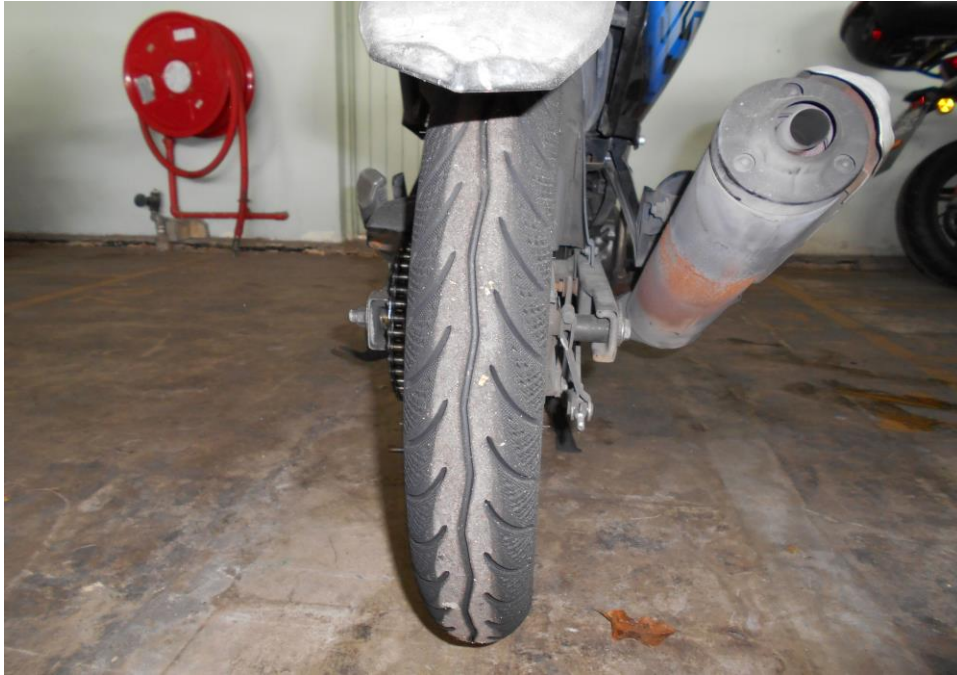
Photo 8 shows the rear tyre of the Motorcycle. The rear tyre was observed to be in serviceable condition with remaining tread depth of approximately 4mm. The tyre was also observed to be sufficiently inflated for vehicular operation.

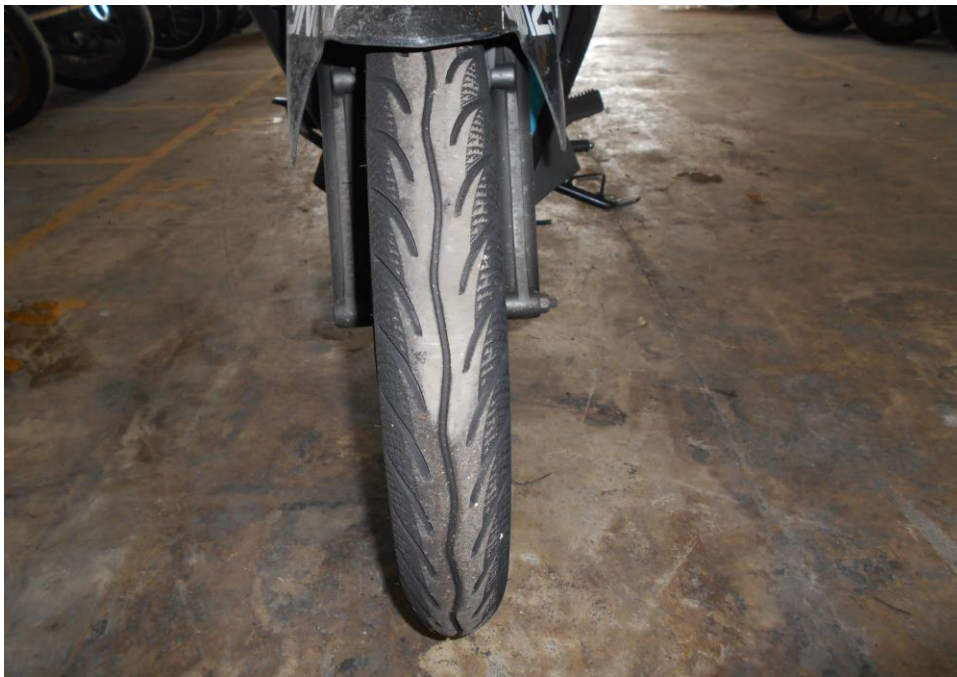
Photo 9 shows the front tyre of the Motorcycle. The front tyre was observed to be in serviceable condition with remaining tread depth of approximately 4mm. The tyre was also observed to be sufficiently inflated for vehicular operation.

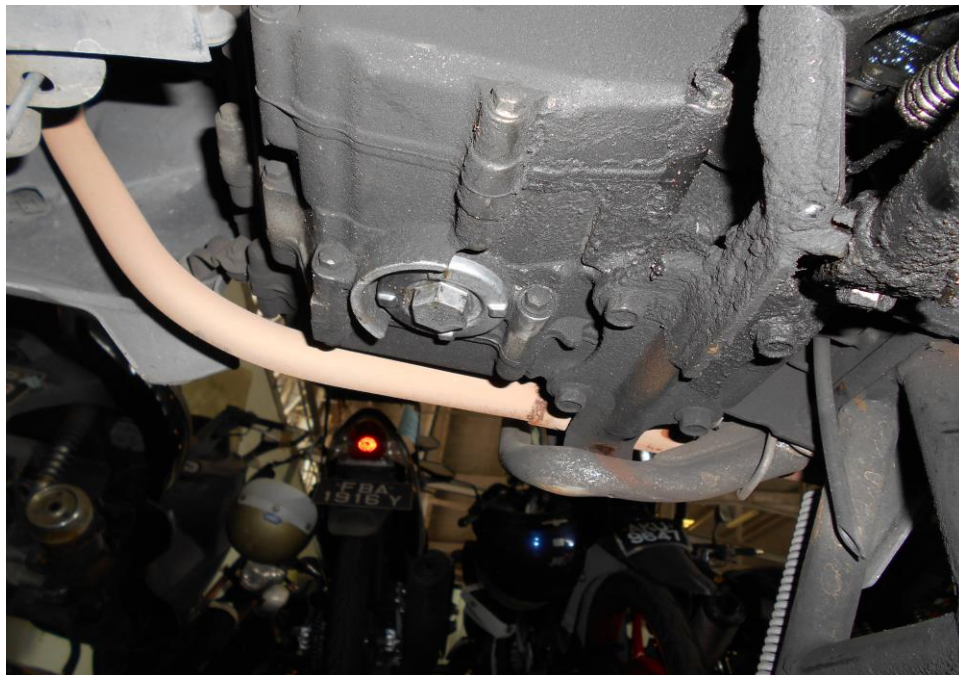
Photo 10 shows no sign(s) or indication(s) of fluid leak observed around the underside of the engine area of the Motorcycle.

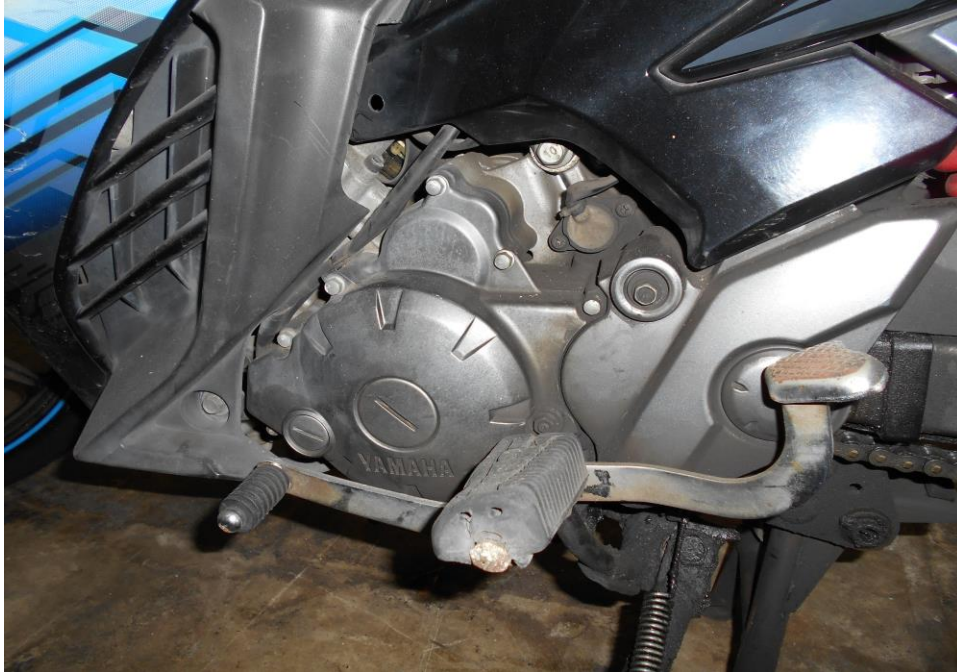
Photo 11 shows no sign(s) or indication(s) of fluid leakage stain observed around the engine area of the Motorcycle.

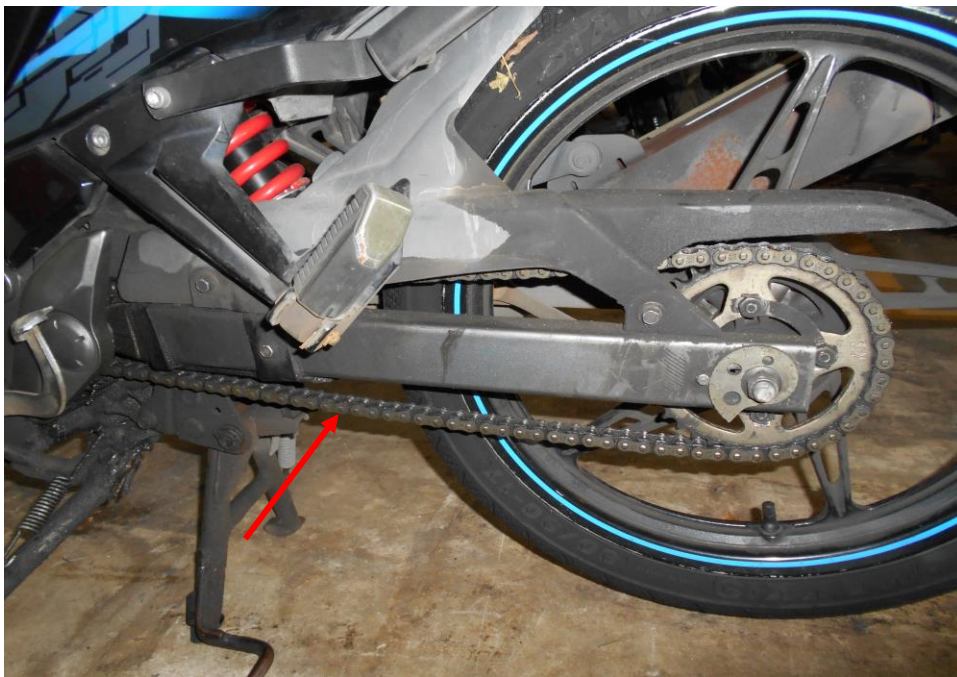
Photo 12 shows the general view of the gear train (arrowed) of the Motorcycle, which was observed to be intact with no misalignment. It was also adequately lubricated for operating purposes.

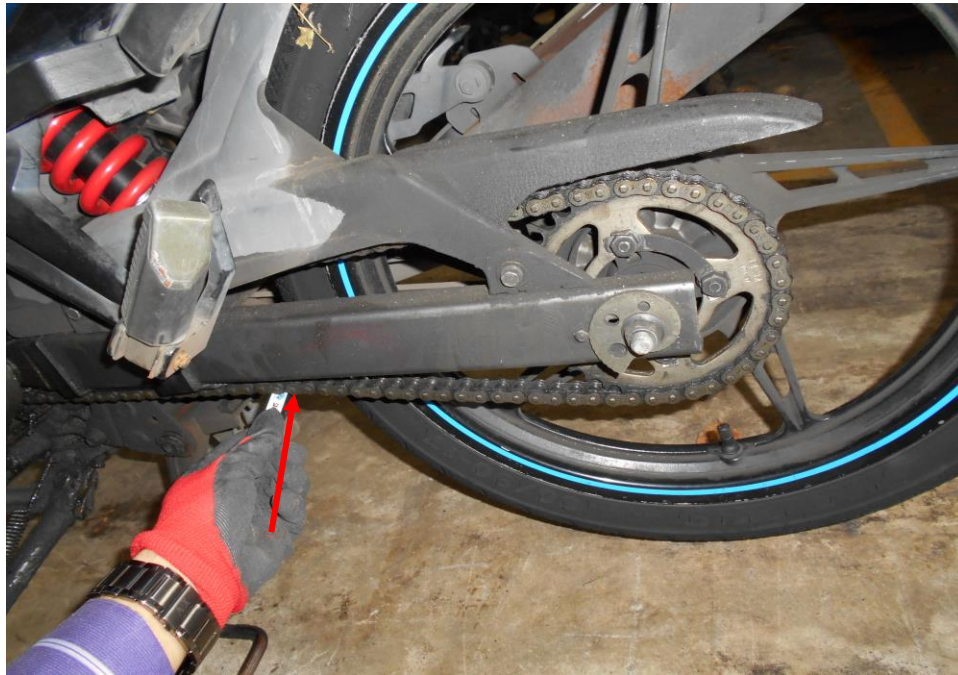
Photo 13 shows the general view of the gear train (arrowed) of the Motorcycle, which was observed to be intact with no misalignment. It was also adequately lubricated for operating purposes. Free play tension was also observed & found adequately acceptable.

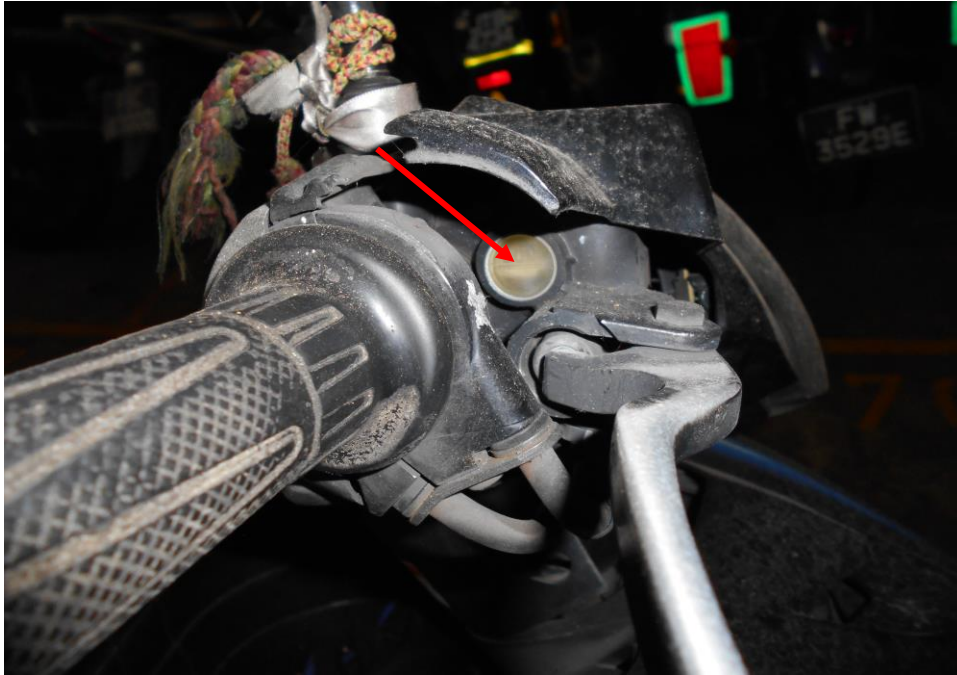
Photo 14 shows our checks on the brake fluid (front) reservoir had also indicated that the brake fluid was of sufficient level for operational purposes, and without contamination.

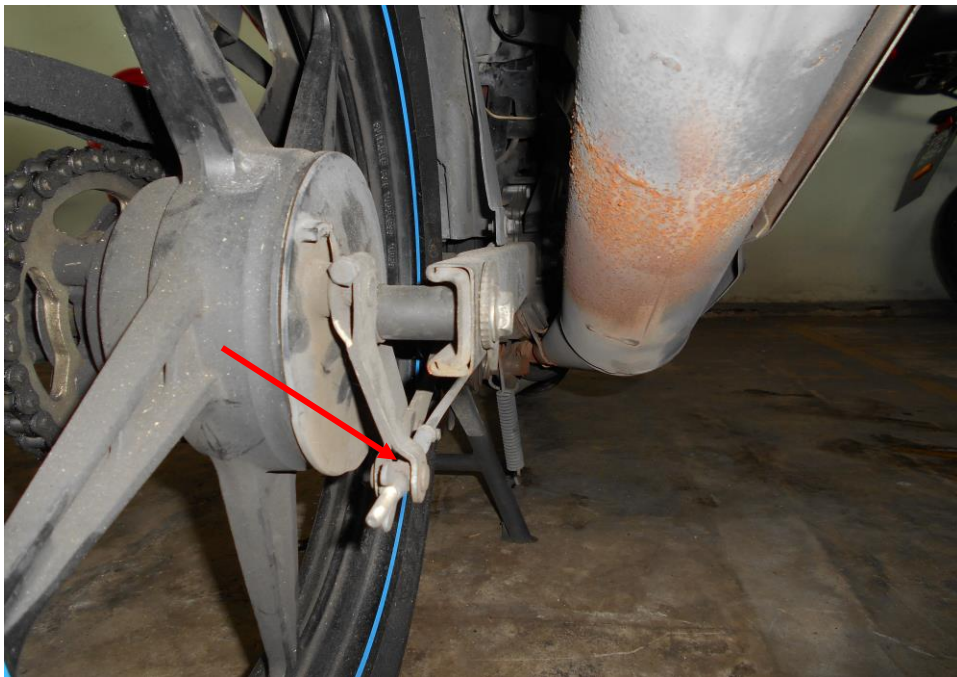
Photo 15 shows our checks on the rear braking system. The rear braking components were found to be unaffected by the accident impact such as rear brake drum, springs and cables which are the supporting components of the rear brake.

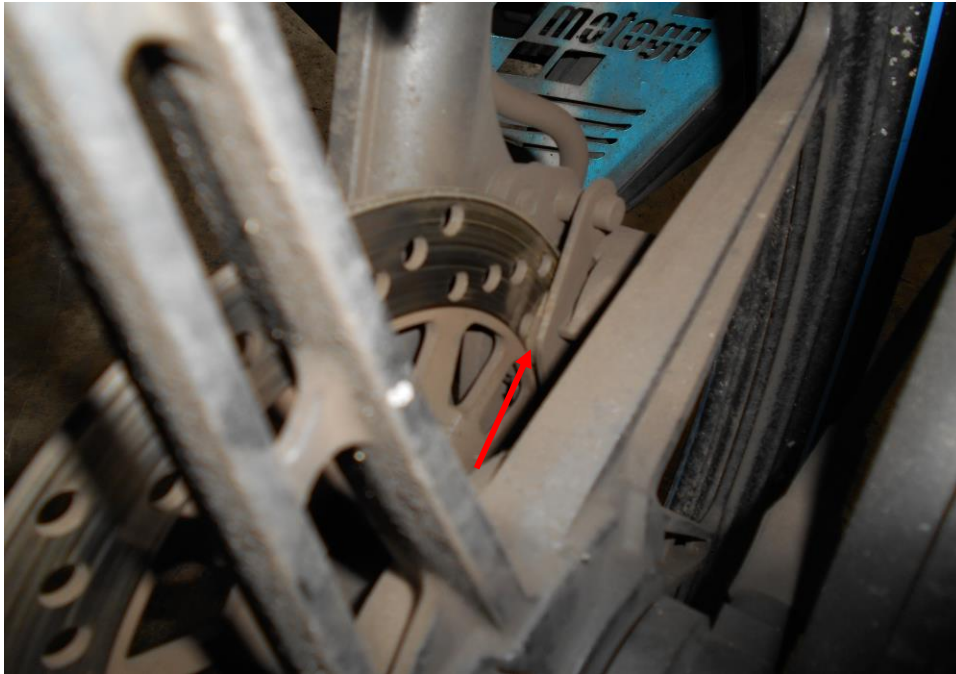
Photo 16 shows the front brake pad at time of our inspection. The frictional material was observed to be sufficient for operational purposes.
