Your Ref: TP/IP/53269/2018
Our Ref : CI/TPD19002512/Z

Fatal Accident Investigation Team

MECHANICAL INSPECTION REPORT OF MOTOR TAXI SHD 9754H

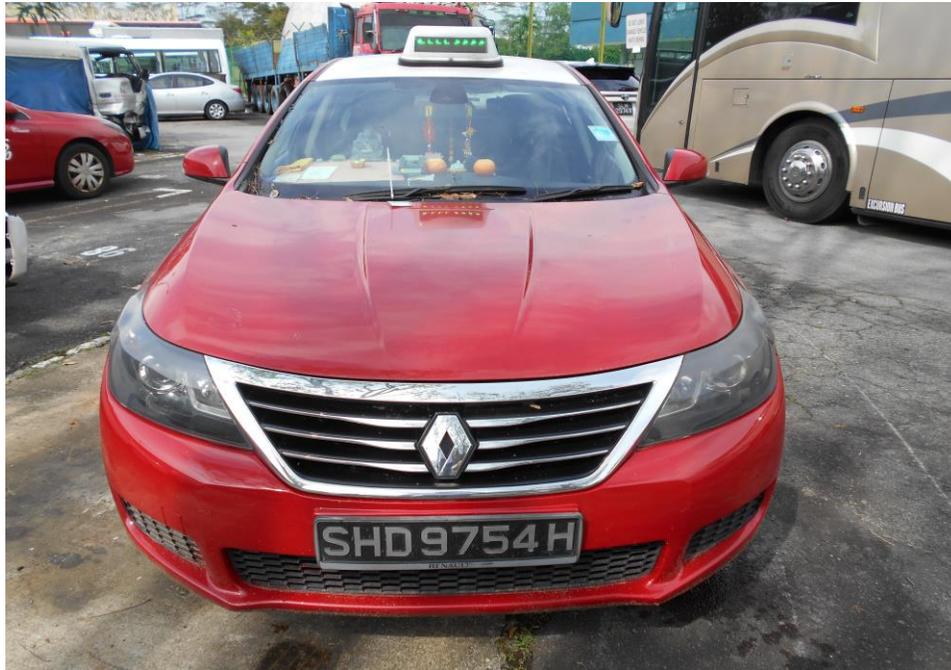
Photo 1 shows a general view of the front body of the Motor Taxi at the time of our inspection. The Motor Taxi was observed to be in good condition at time of our examination (After repair).

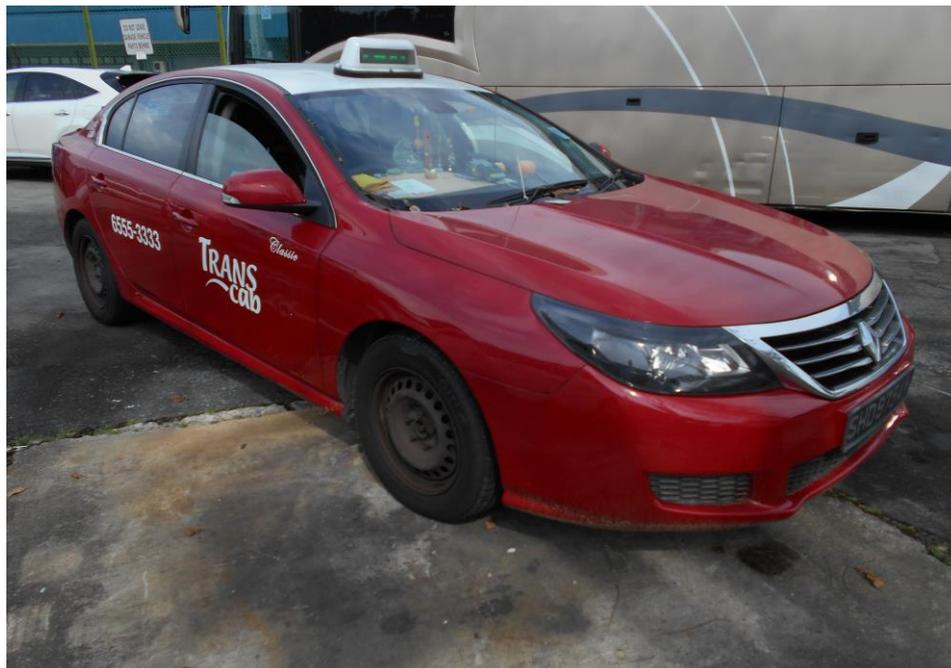
Photo 2 shows a general view of the front right body of the Motor Taxi at the time of our inspection. The Motor Taxi was observed to be in good condition at time of our examination.

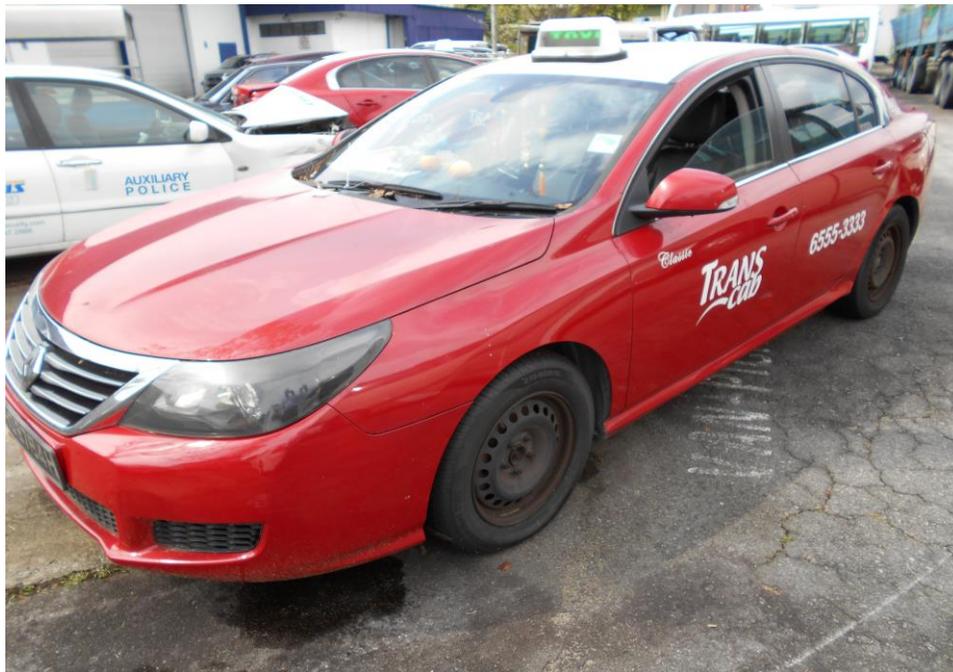
Photo 3 shows a general view of the front right body of the Motor Taxi at the time of our inspection. The Motor Taxi was observed to be in good condition at time of our examination..

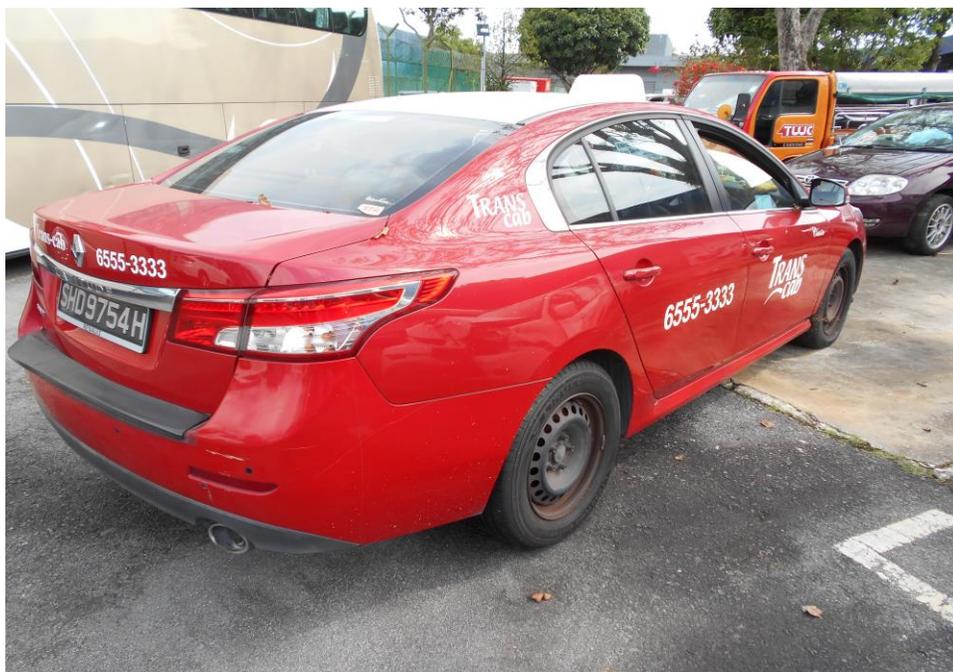
Photo 4 shows a general view of the rear right body of the Motor Taxi at the time of our inspection. The Motor Taxi was observed to have sustained with minor scratches & dent not related to the accident.

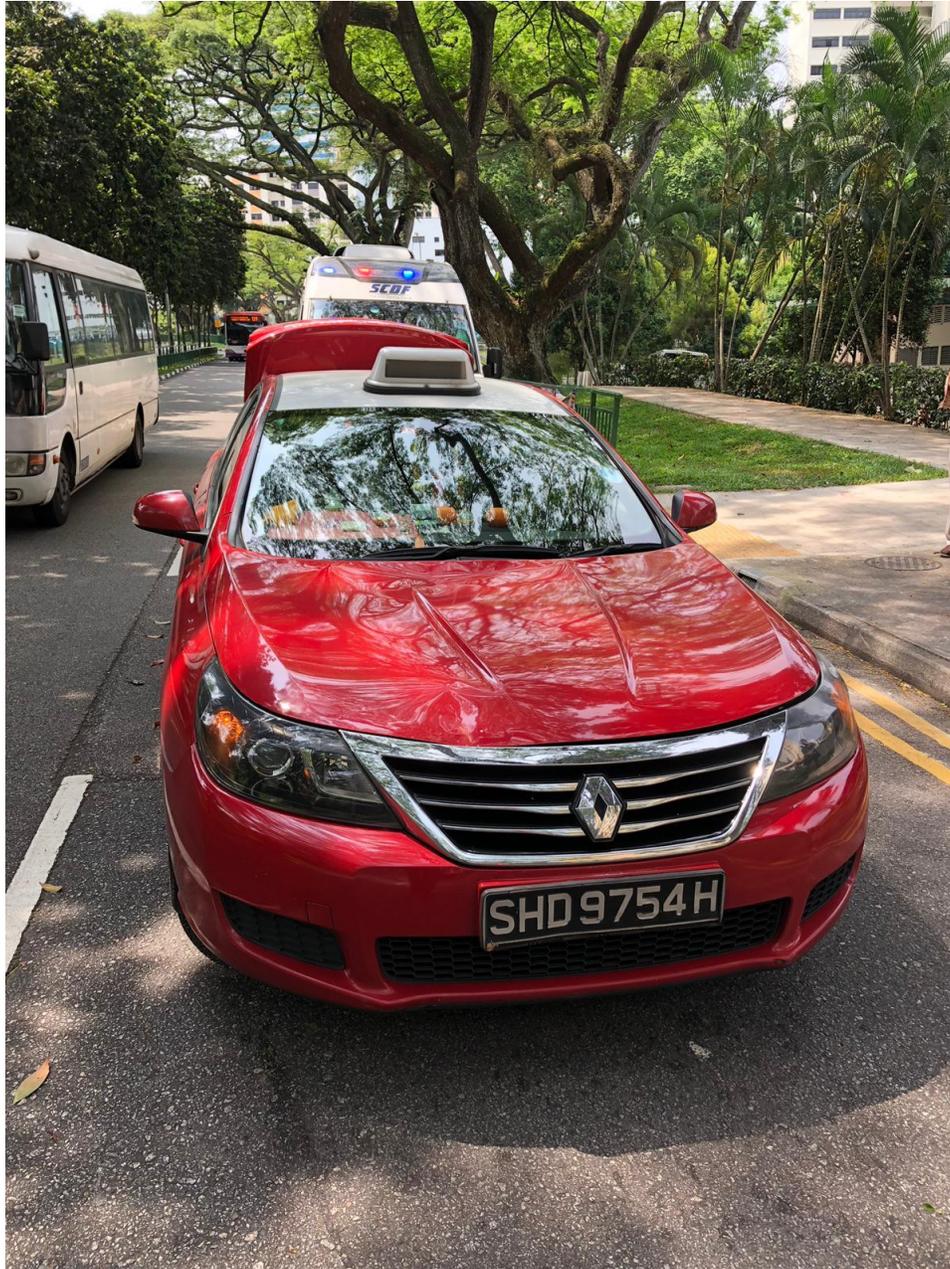
Photo 5 shows a general view of the frontal portion the Motor Taxi at the time of the accident. The Motor Taxi had sustained minor impact damages at the front bonnet as a result of the accident. At scene photo was provided by the SIO in-charge.

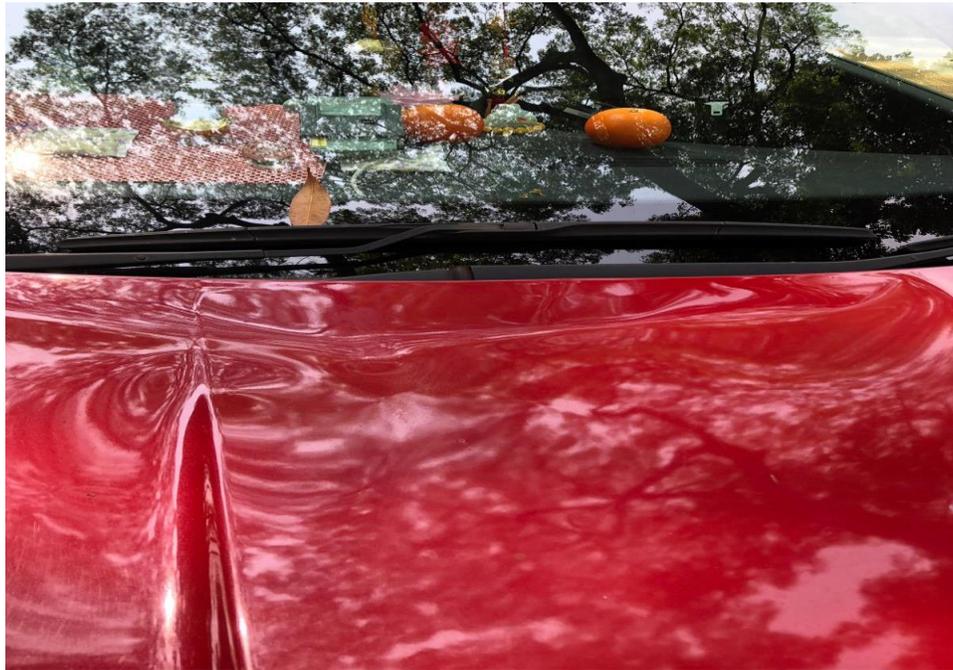
Photo 6 shows a close-up view of the frontal portion the Motor Taxi at the time of the accident. The Motor Taxi had sustained minor impact damages at the front bonnet as a result of the accident. At scene photo was provided by the SIO in-charge.

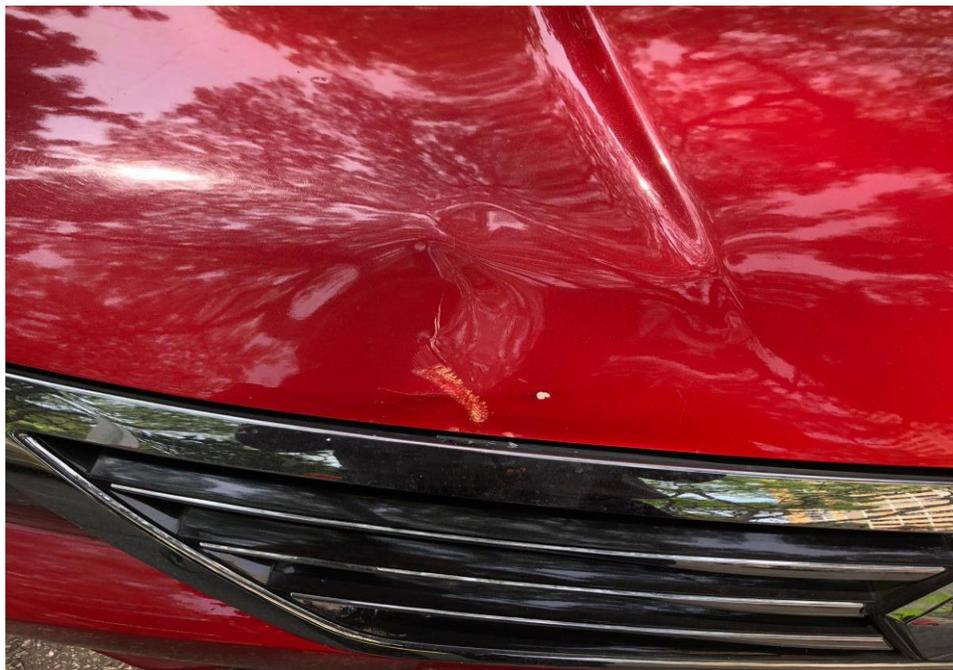
Photo 7 shows a close-up view of the frontal portion the Motor Taxi at the time of the accident. The Motor Taxi had sustained minor impact damages at the front bonnet as a result of the accident. At scene photo was provided by the SIO in-charge.

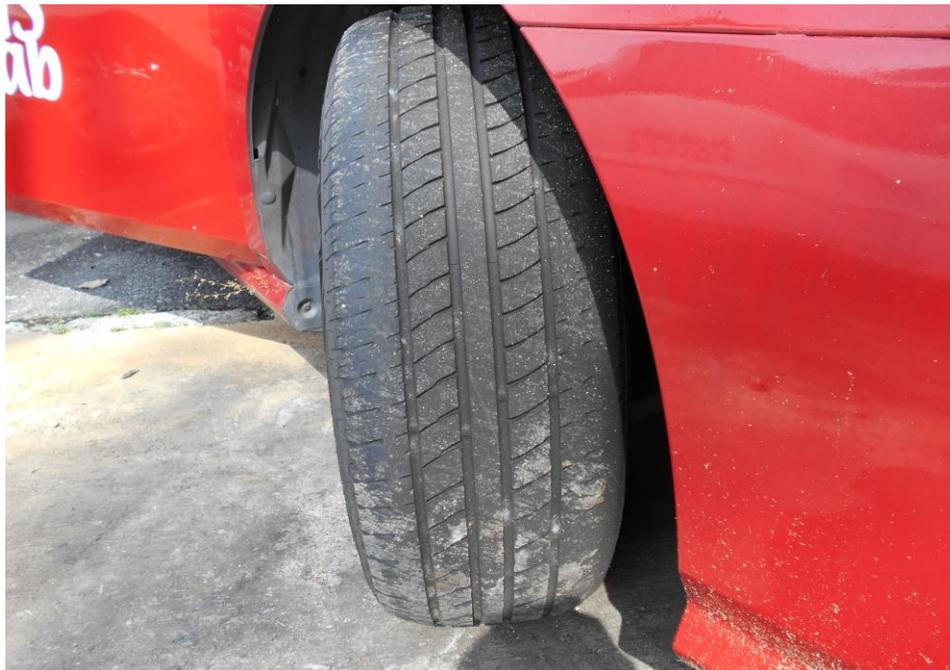
Photo 8 shows the condition of the front right tyre of the Motor Taxi, which was observed to be in serviceable condition with remaining tread depth of approximately 6mm. There was no tear, cut or burst mark(s) on the outer and the inner sidewalls.

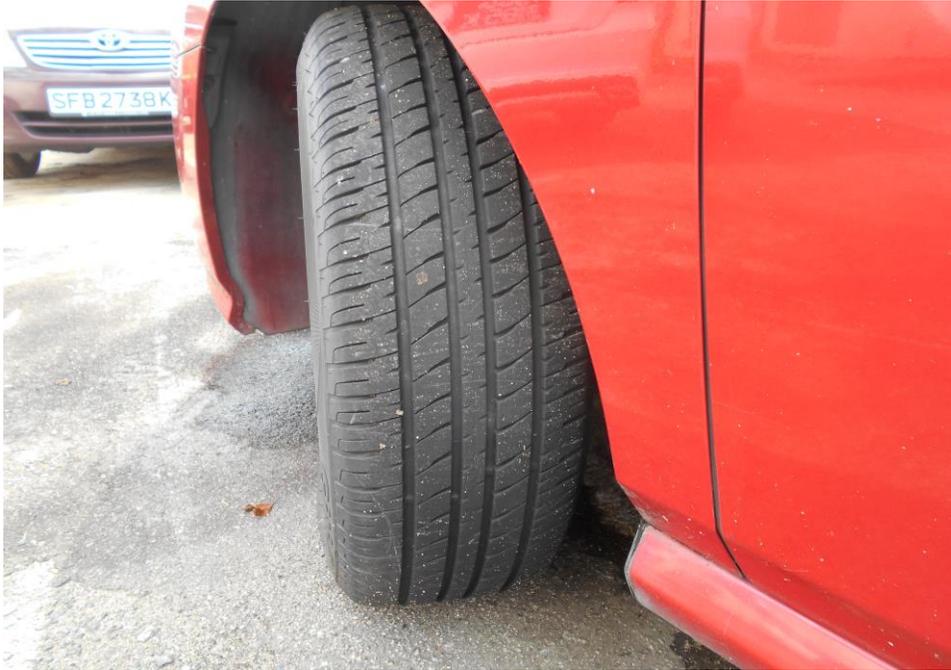
Photo 9 shows the condition of the front left tyre of the Motor Taxi, which was observed to be in serviceable condition with remaining tread depth of approximately 6mm. The tyre, which was wrapped around alloy wheel rim, was also observed to be sufficiently inflated for vehicular operation.

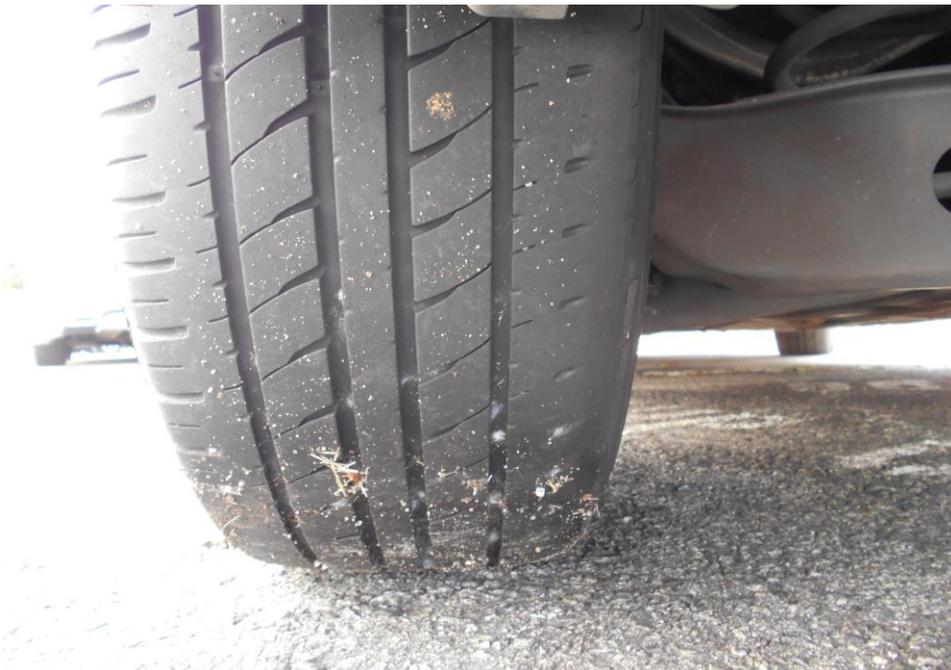
Photo 10 shows the condition of the rear left tyre of the Motor Taxi, which was observed to be in serviceable condition with remaining tread depth of approximately 7mm.

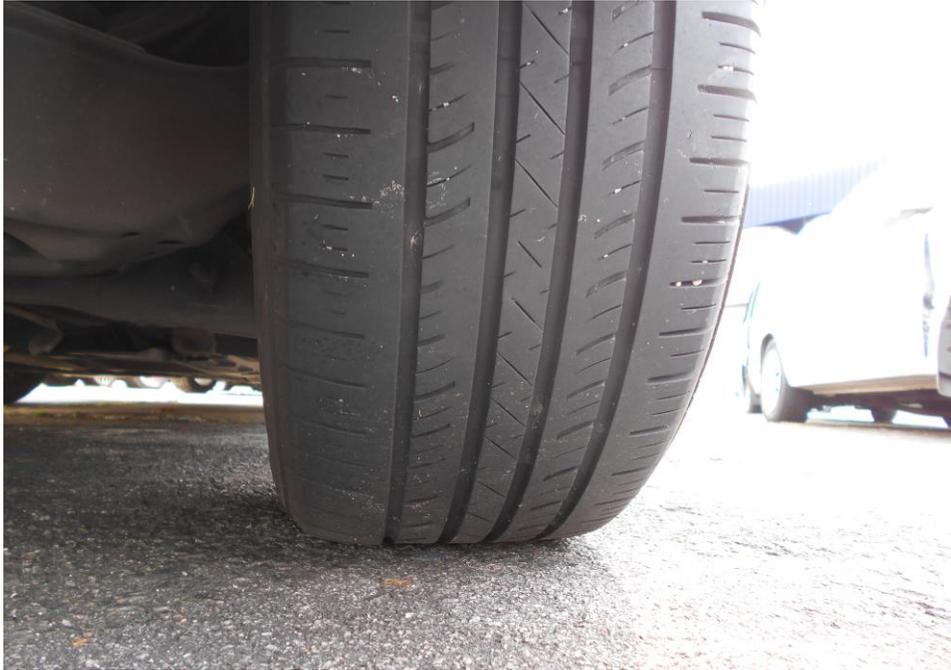
Photo 11 shows the condition of the rear right tyre of the Motor Taxi, which was observed to be in serviceable condition with remaining tread depth of approximately 7mm.

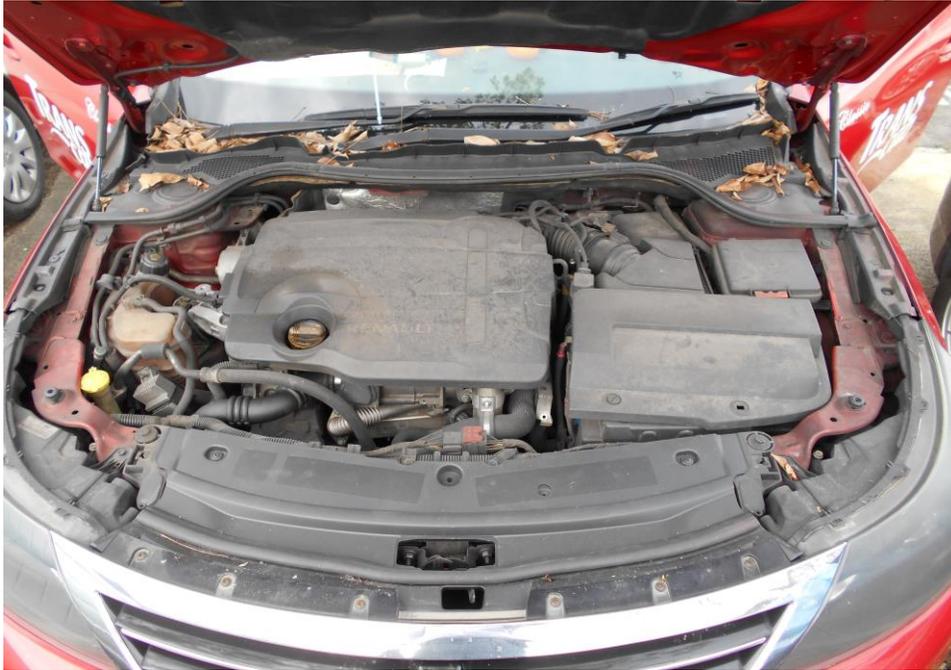
Photo 12 shows a general view of the Motor Car's engine compartment. The various parts and components inside the engine compartment were unaffected by the accident. There was also no sign(s) or indication(s) of fluid leakage and/or fluid stain within the engine compartment.

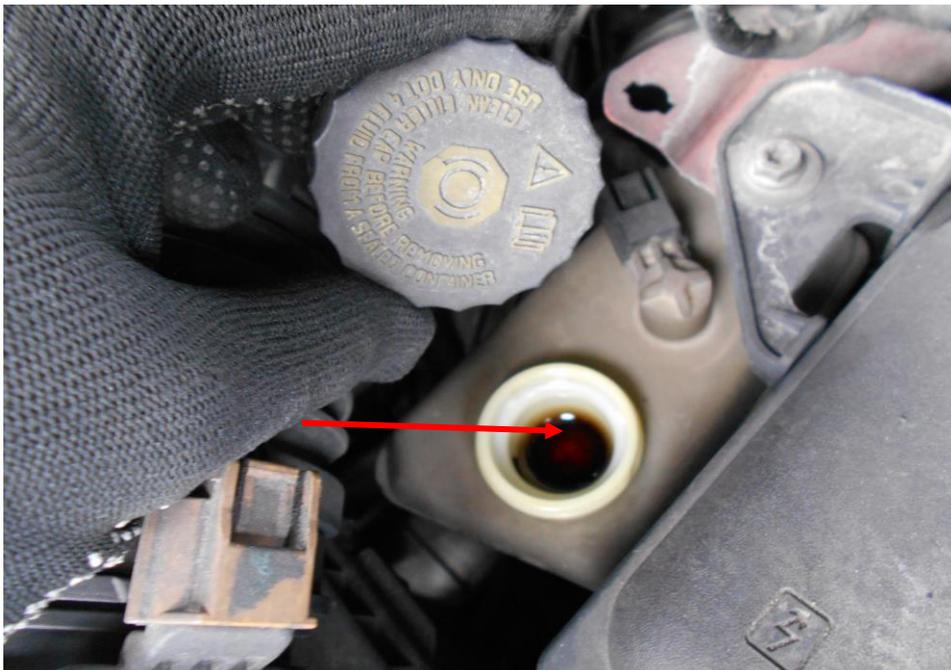
Photo 13 shows the brake fluid reservoir of the Motor Taxi at the time of our inspection. The brake fluid was observed to be of sufficient level (arrowed) and without any visible contamination.

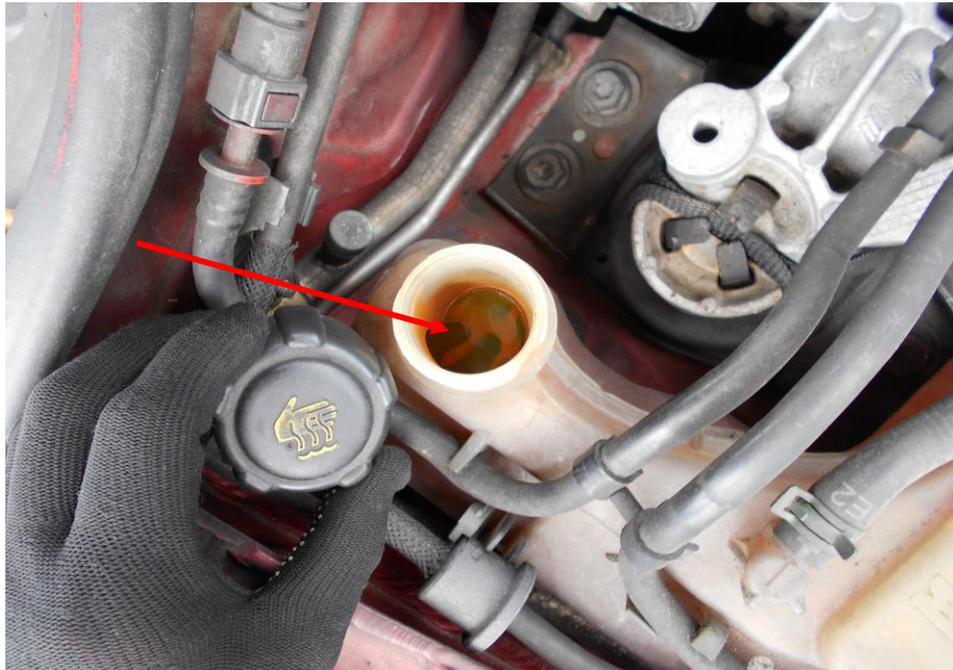
Photo 14 shows the engine coolant fluid reservoir of the Motor Taxi at the time of our inspection. The engine coolant fluid was observed to be of sufficient level and without any visible contamination.

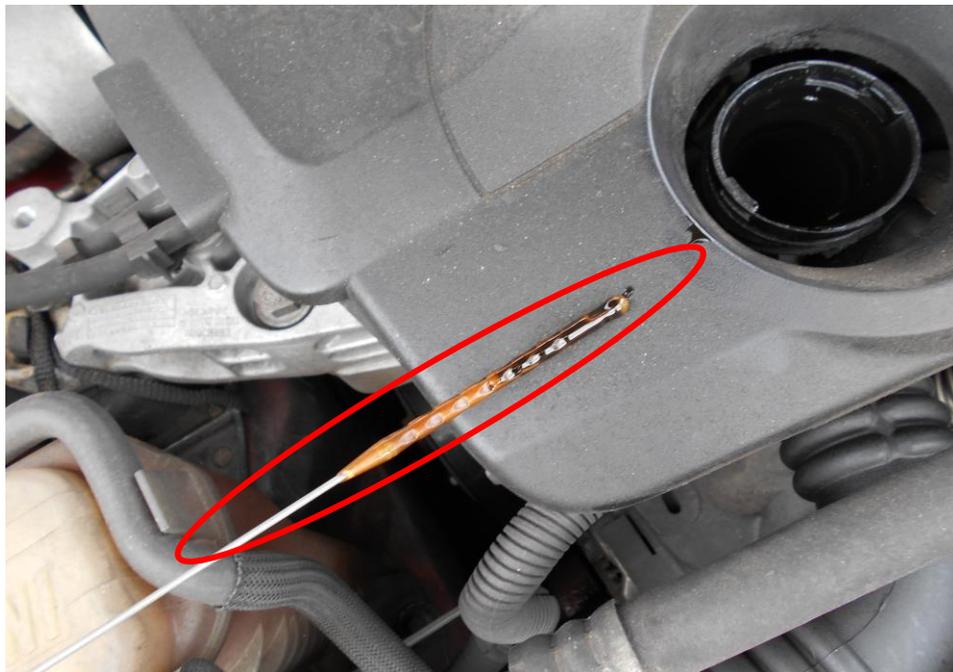
Photo 15 shows the engine oil dip stick of the Motor Taxi at the time of our inspection. The engine oil was observed to be of sufficient level and without any visible contamination.

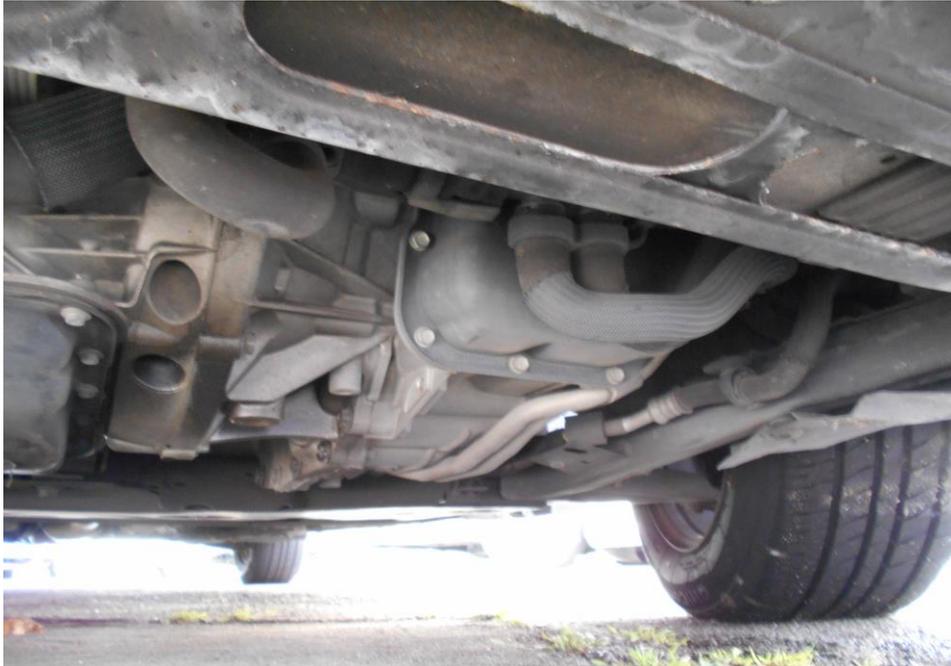
11. Our subsequent checks on the underside of the Motor Taxi revealed fluid stain observed to be pre-existed prior the accident looking at the dust accumulated with it. Our checks on the engine fluid had also indicated that the engine fluid was of sufficient level for operational purposes, and without contamination. Visually, the various undercarriage components of the Motor Taxi were all observed to be intact and without any visible damage. See photo 12 – 16 below.

Photo 16 shows the engine underside of the Motor Taxi engine at the time of our inspection. The engine was observed to be with a pre-existed oil stain prior the accident. This was based on the dust that associated with the fluid stain.

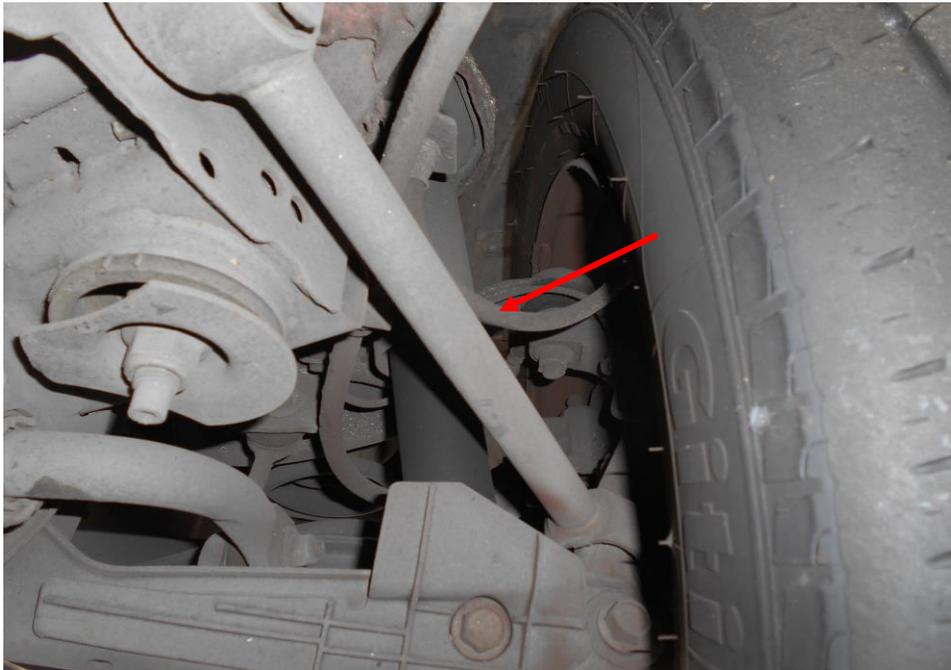
Photo 17 shows the brake hose (arrowed) at the rear left wheel of the Motor Taxi. We did not observe any leakage of brake fluid at the time of our inspection of the Motor Taxi. Our visual inspection of the various mechanical components of the Motor Taxi's braking system revealed all to be intact without visible damage.

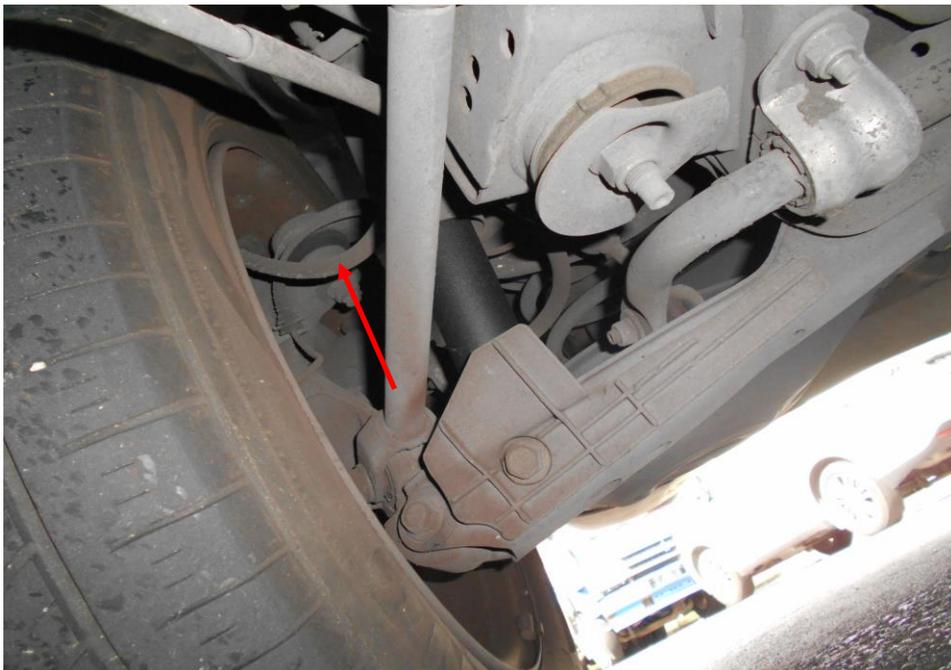
Photo 18 shows the brake hose (arrowed) at the rear right wheel of the Motor Taxi. We did not observe any leakage of brake fluid at the time of our inspection of the Motor Taxi. Our visual inspection of the various mechanical components of the Motor Taxi's braking system revealed all to be intact without visible damage.

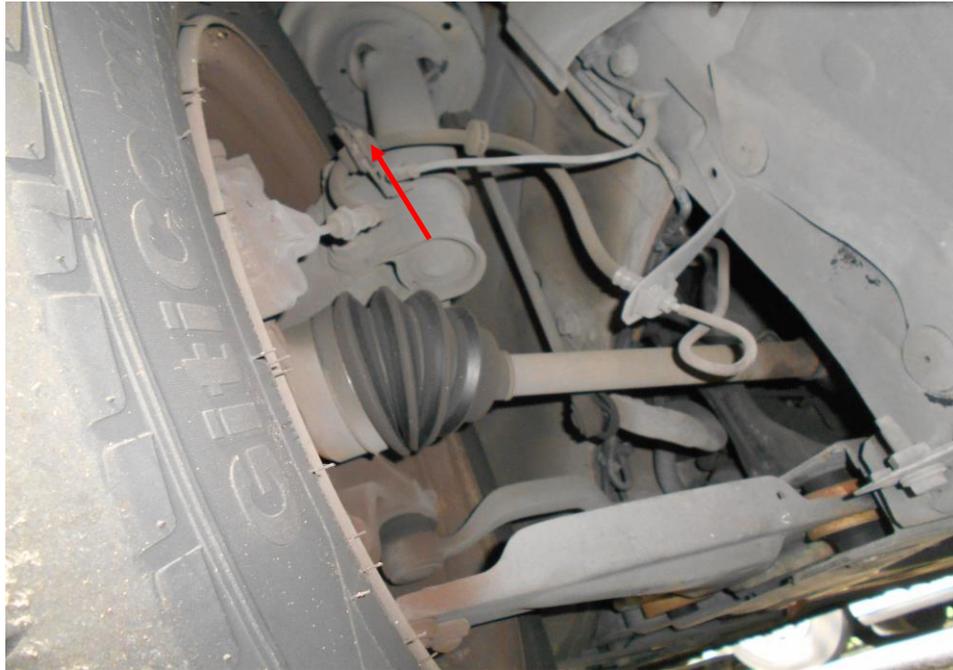
Photo 19 shows the various undercarriage components at the front right wheel of the Motor Taxi, in particular the steering tie rod (arrowed). The various steering components were all found to be intact, suggesting that the steering system of the Motor Taxi was likely to be in serviceable condition.

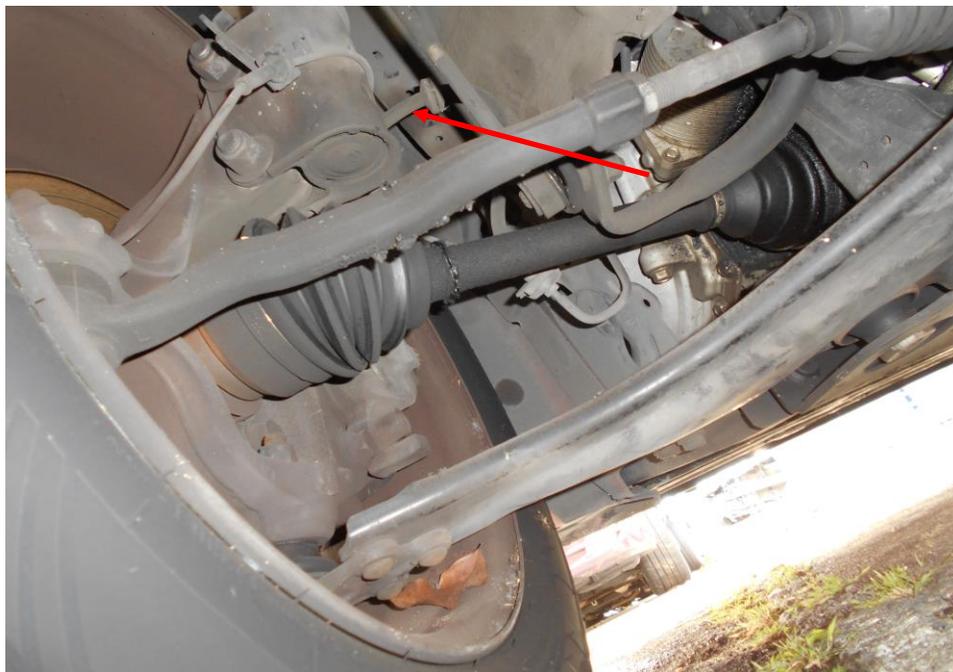
Photo 20 shows the various undercarriage components at the front left wheel of the Motor Taxi. We did not observe any leakage of brake fluid (arrowed) at the time of our inspection of the Motor Taxi. Our visual inspection of the various mechanical components of the Motor Taxi's braking system revealed all to be intact and without visible damage, indicating that the braking system was likely to be in serviceable condition at the material time of accident.

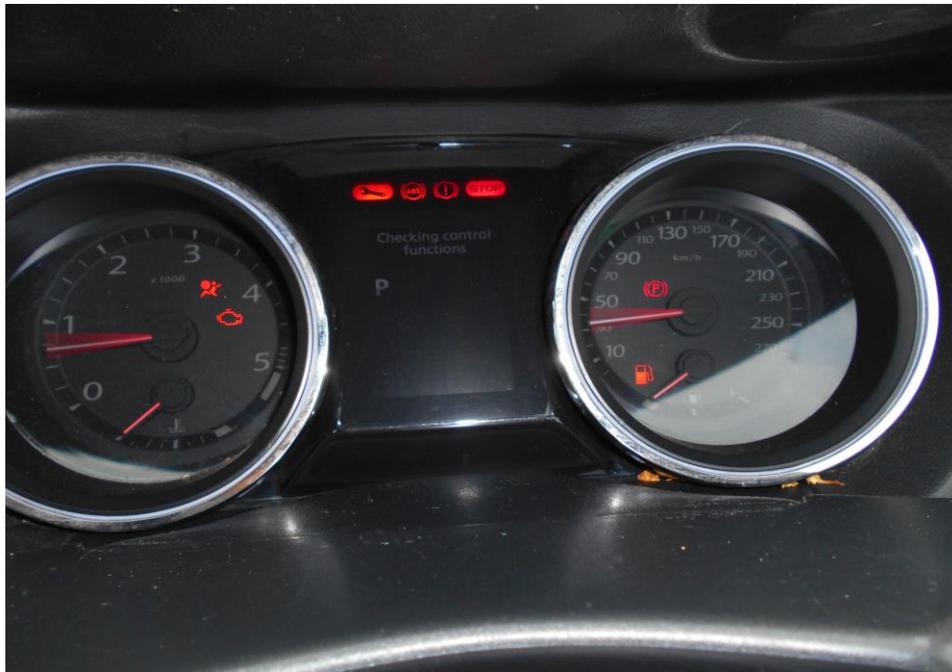
Photo 21 shows the warning lights for the various electronic operating systems of the Motor Taxi appearing on its instrument panel during the self-test when the engine is cranked, in particular the ABS light, SRS light, engine check light, parking light and fuel check light amongst others.

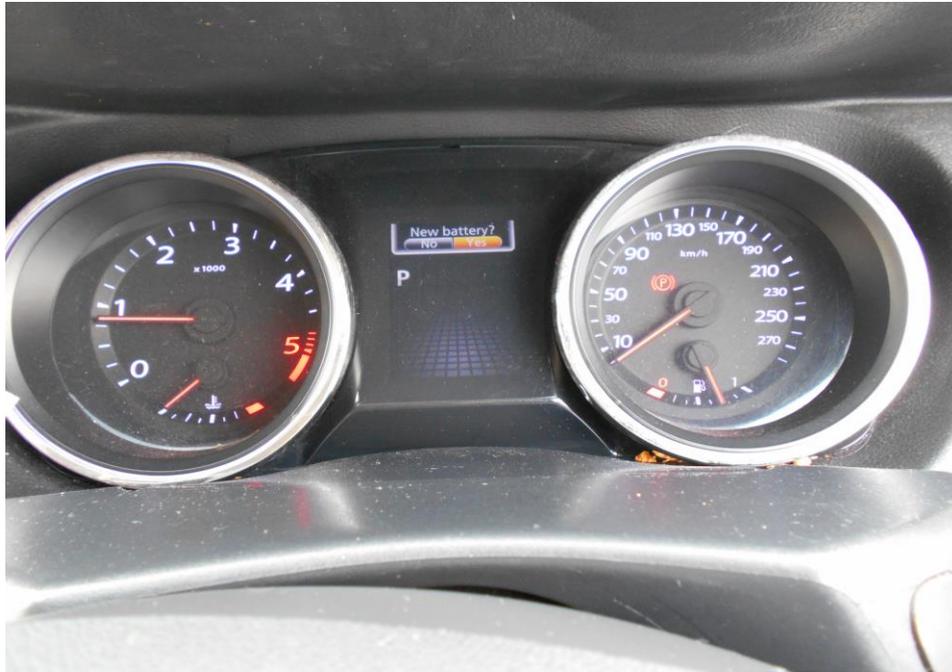
Photo 22 shows no warning lights illuminated on the instrument panel of the Motor Taxi after the engine was cranked. This would suggest that there was no abnormality to the various electronic operating systems of the Motor Taxi.

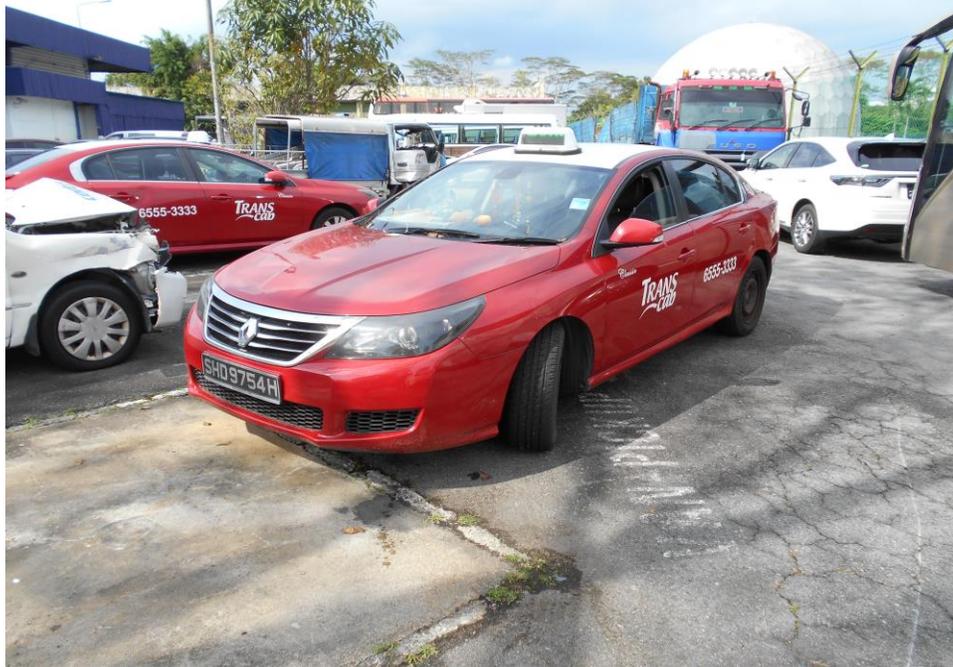
Photo 23 shows an operational test of the Motor Taxi. We were able to move the vehicle reverse, forward and backward normally.

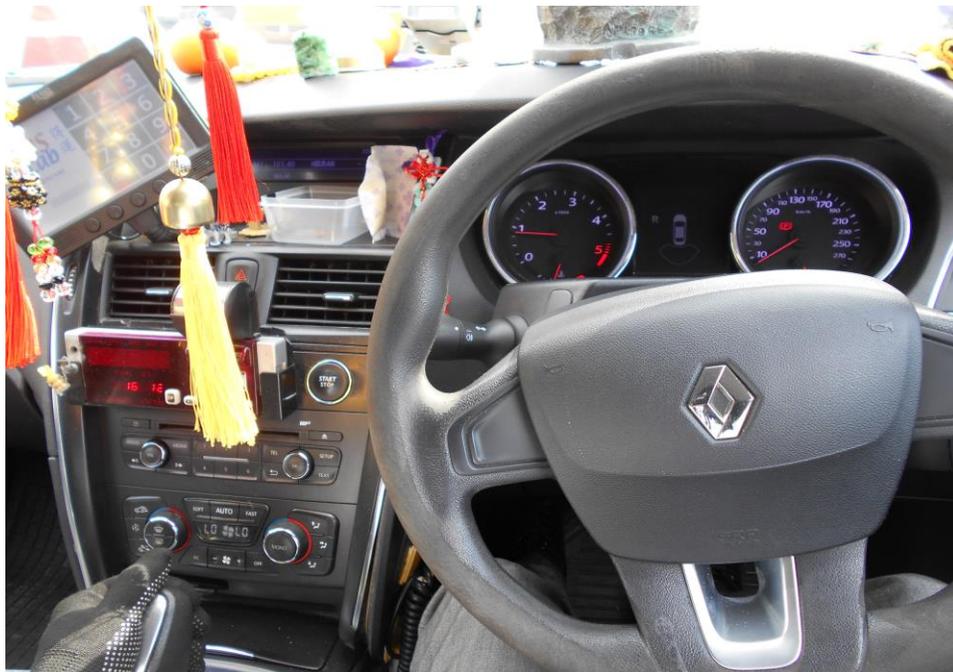
Photo 24 shows an operational test of the Motor Taxi. We were able to move the vehicle reverse, forward and backward normally.
