MECHANICAL INSPECTION REPORT OF MOTOR TAXI SHA 8661P

1. We refer to your request on 1 February 2019 to conduct a physical inspection of a motor taxi bearing registration number SHA 8661P (herein referred to as "**Motor Taxi**"), which was involved in a fatal road traffic accident on 5 December 2018.
2. The objective of the inspection is to determine if there was any possible mechanical failure to the Motor Taxi that may have contributed to the accident.
3. Following the request, we had carried out a physical inspection of the Motor Taxi on 2 May 2019 at the premises of Traffic Police vehicle pound, 517 Airport Road Singapore 539942. We now set out below our observations and comments with respect to this inspection.

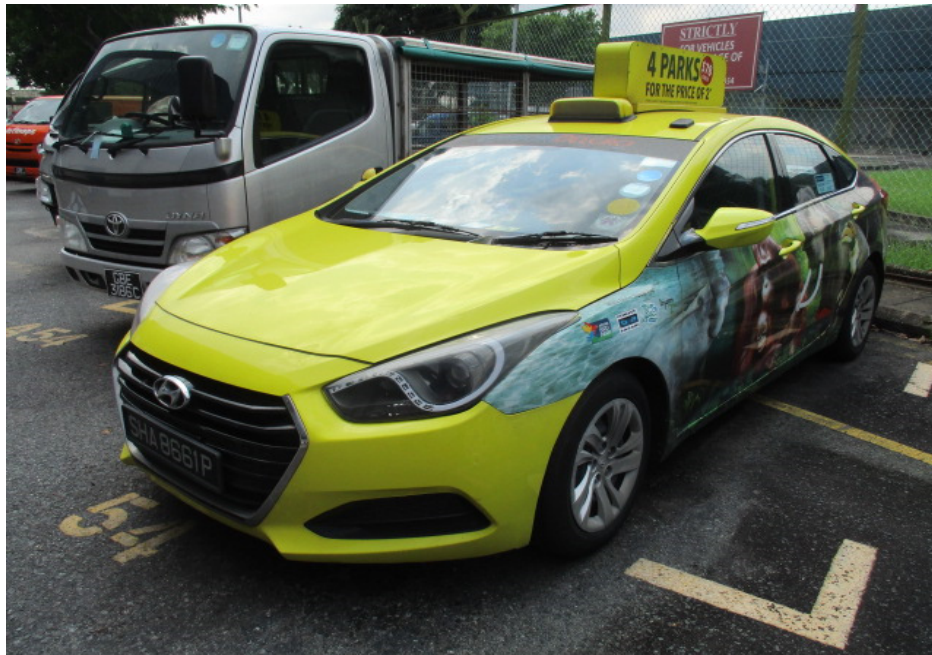
Photo 1 shows a general view of the front left body of the Motor Taxi at the time of our inspection. The Motor Taxi was observed to be in good general condition except for some relatively minor impact damage at its frontal portion. The mileage of the Motor Taxi was recorded to be 315, 415km.

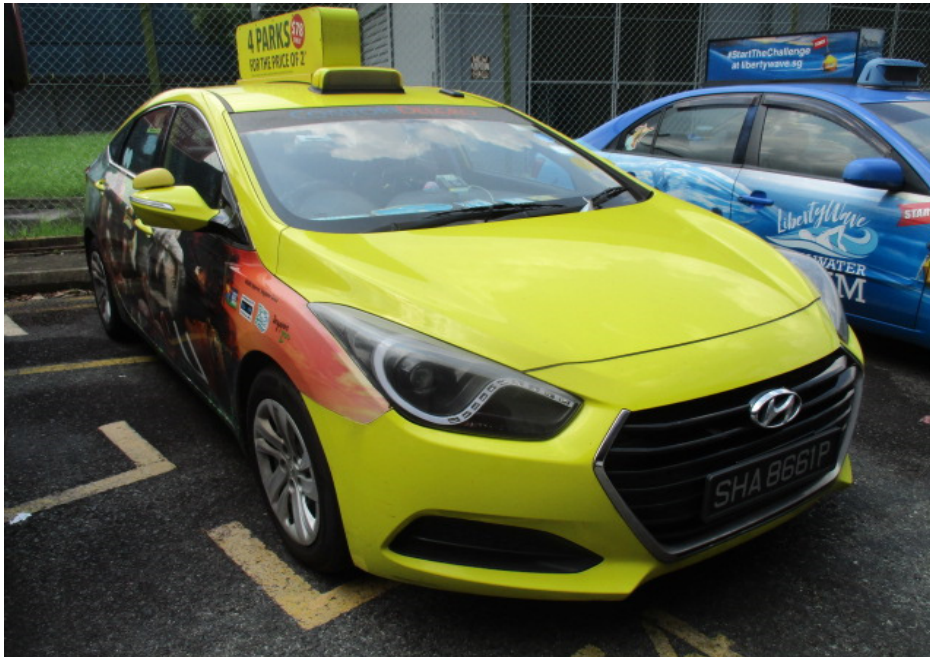
4. The mileage of the Motor Taxi at the time of our inspection was 315, 415km.
5. The Motor Taxi had sustained relatively minor impact damage that was confined to its frontal portion. Paint scratches were observed on its front bumper, front bumper grille and front bumper lower grille.

Photo 2 shows a general view of the front right body of the Motor Taxi at the time of our inspection. The Motor Taxi was observed to be in good general condition. However we had observed relatively minor impact damage that was confined to its frontal portion. Paint scratches were observed on its front bumper, front bumper grille and front bumper lower grille.

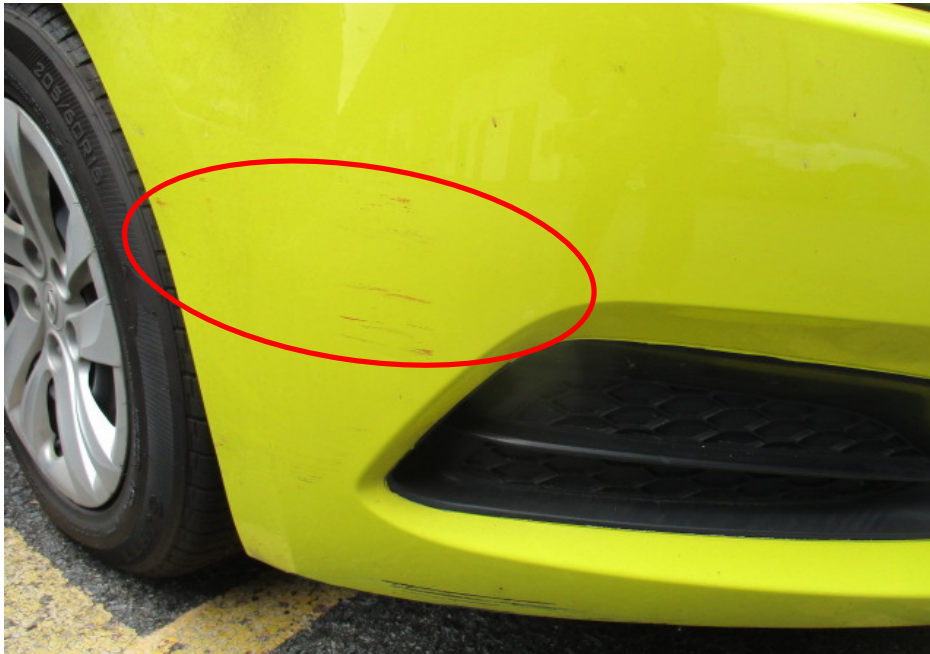
Photo 3 shows a closer view of the paint scratches on the front bumper of the Motor Taxi at the time of our inspection (circled).

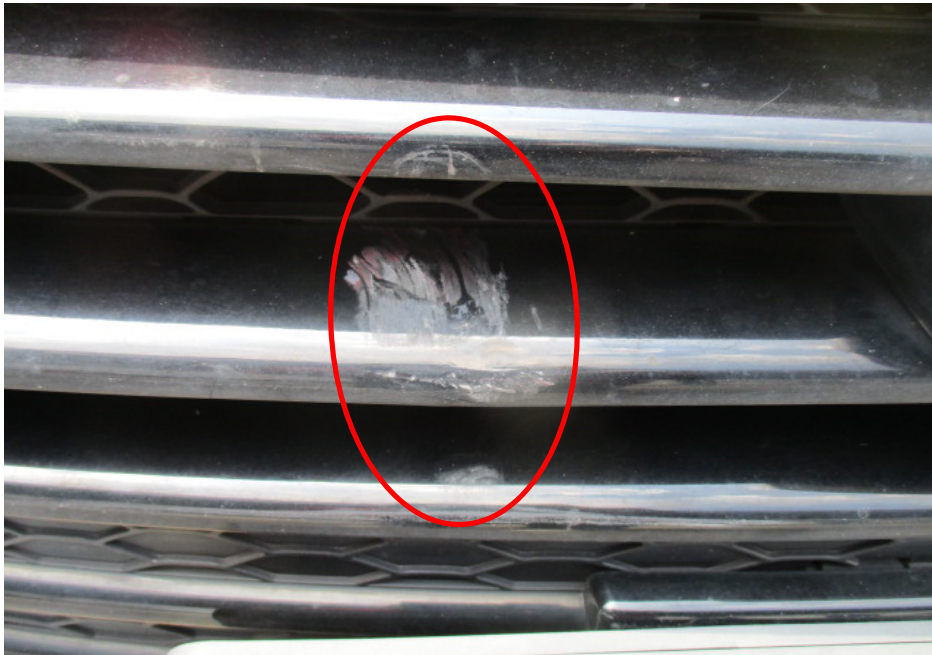
Photo 4 shows a closer view of the scratches on the front bumper grille of the Motor Taxi at the time of our inspection (circled).

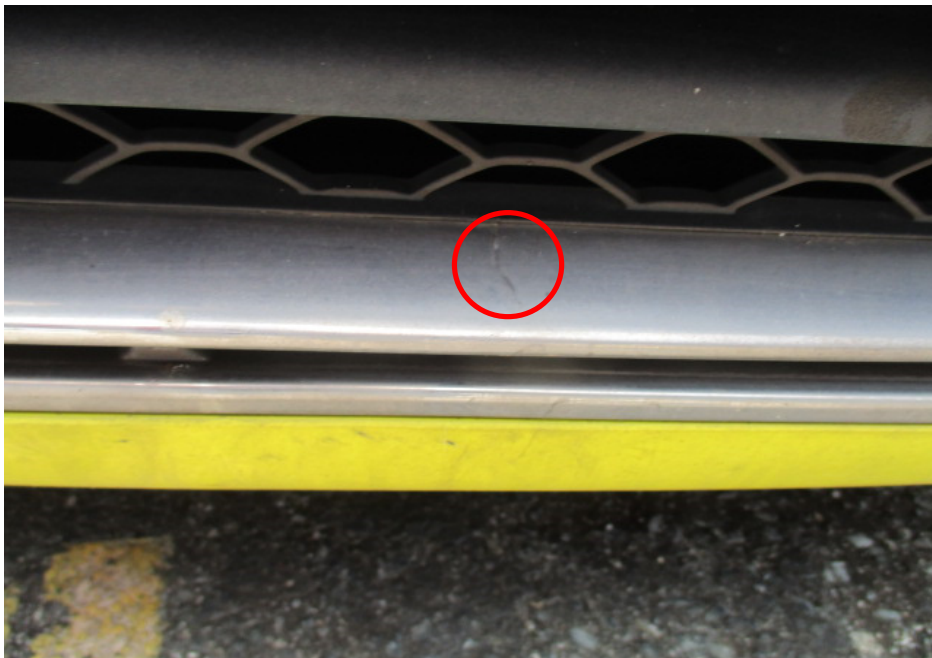
Photo 5 shows a closer view of the scratches on the front bumper lower grille of the Motor Taxi at the time of our inspection (circled).

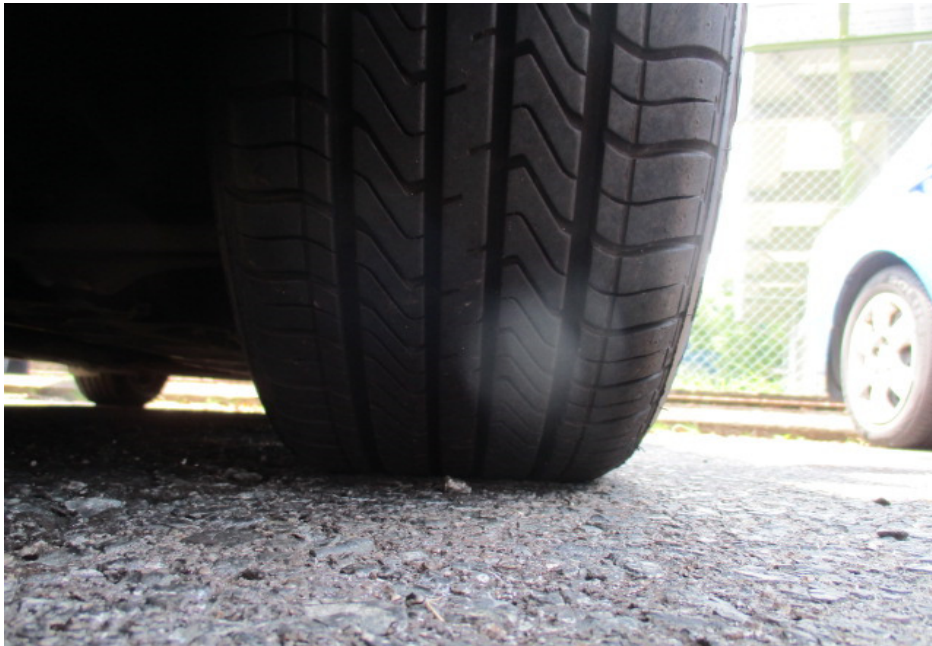
Photo 6 shows the condition of the front left tyre of the Motor Taxi, which was observed to be in serviceable condition with remaining tread depth of approximately 6mm. The tyre, which was wrapped around alloy wheel rim, was also observed to be sufficiently inflated for vehicular operation. There was no tear, cut or burst mark(s) on the outer and the inner sidewalls as well as across the tread of the 4 tyres.

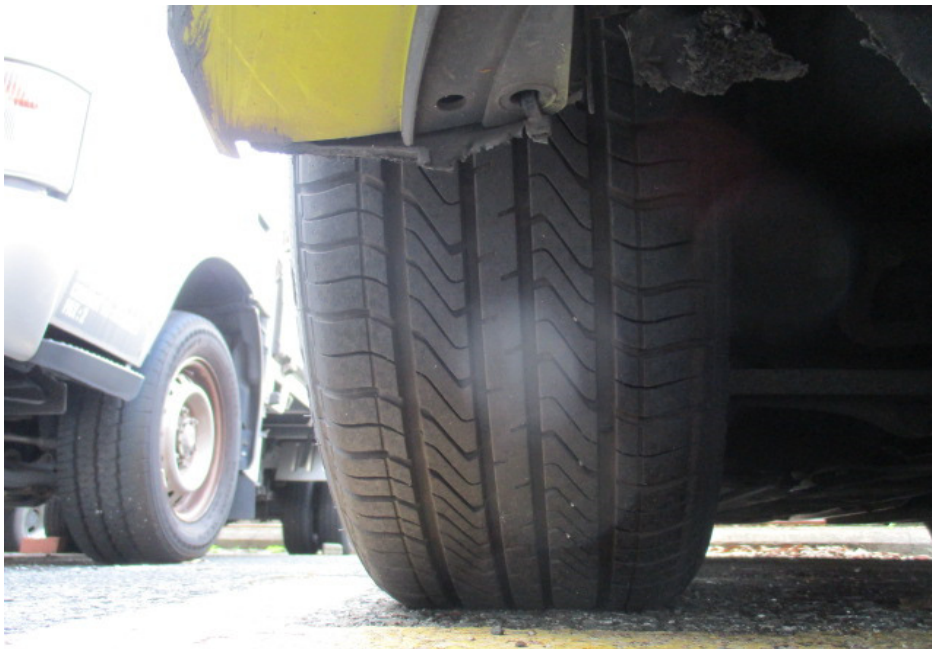
Photo 7 shows the condition of the front right tyre of the Motor Taxi, which was observed to be in serviceable condition with remaining tread depth of approximately 6mm. The tyre, which was wrapped around alloy wheel rim, was also observed to be sufficiently inflated for vehicular operation.

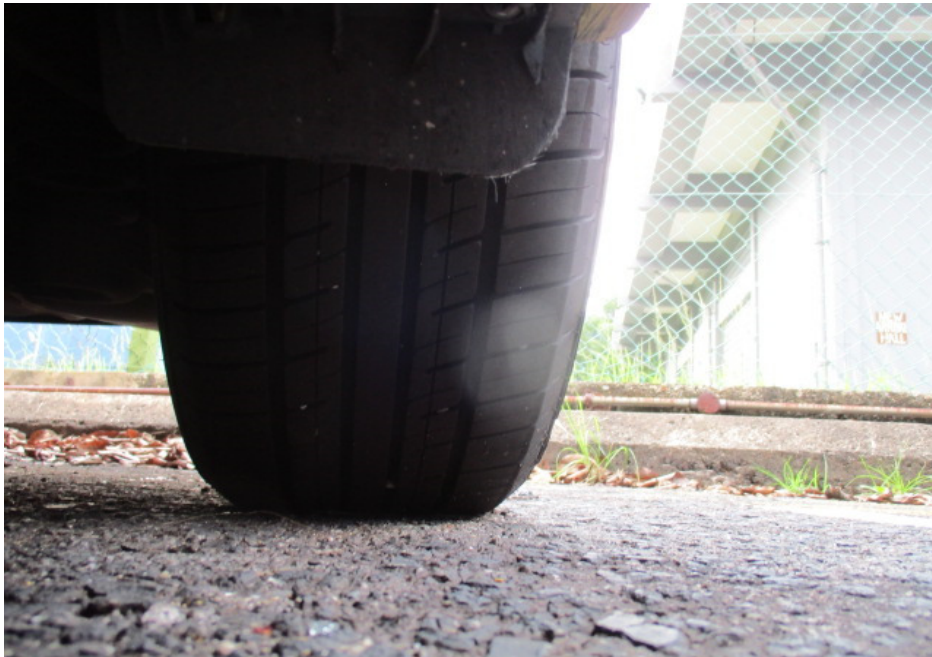
Photo 8 shows the condition of the rear left tyre of the Motor Taxi, which was observed to be in serviceable condition with remaining tread depth of approximately 7mm. The tyre, which was wrapped around alloy wheel rim, was also observed to be sufficiently inflated for vehicular operation. There was also no damage found on the 4 wheel rims of the Motor Taxi.

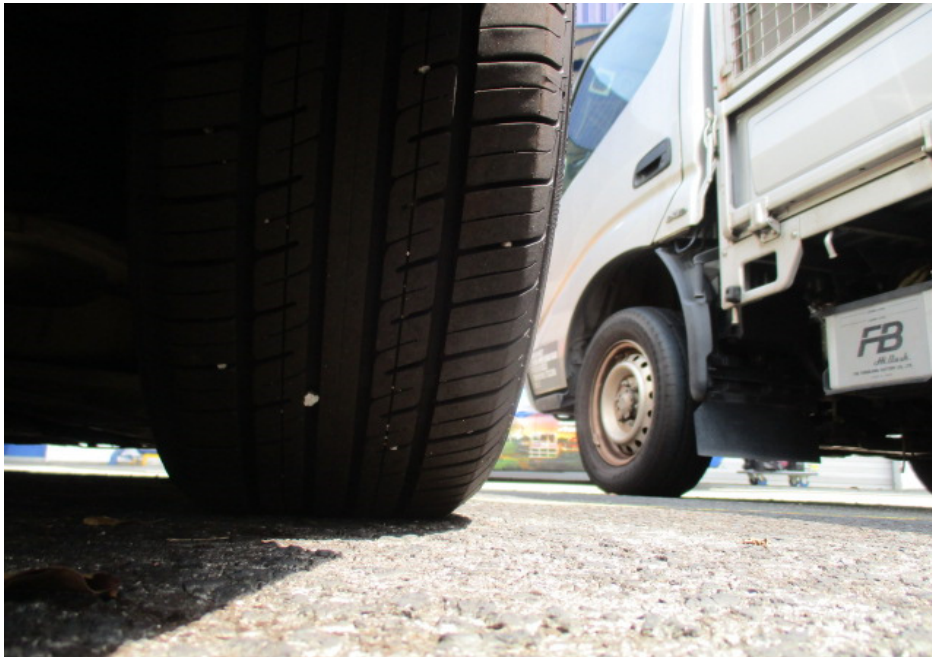
Photo 9 shows the condition of the rear right tyre of the Motor Taxi, which was observed to be in serviceable condition with remaining tread depth of approximately 7mm. There was also no tear, cut or burst mark(s) on the outer and the inner sidewalls as well as across the tread of the 4 tyres.

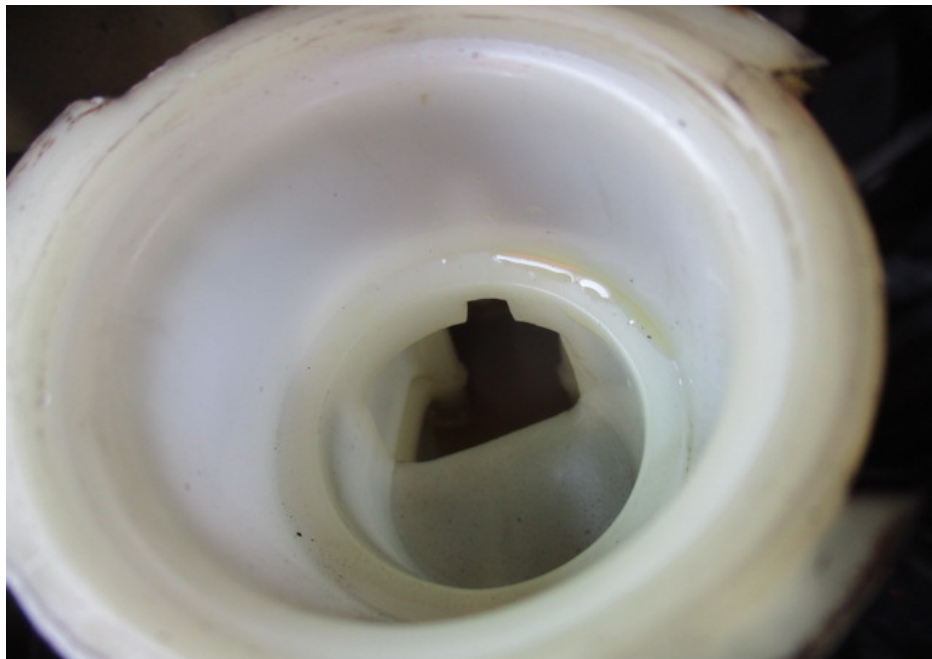
Photo 10 shows the brake fluid reservoir of the Motor Taxi at the time of our inspection. The brake fluid was observed to be of sufficient level and without any visible contamination.

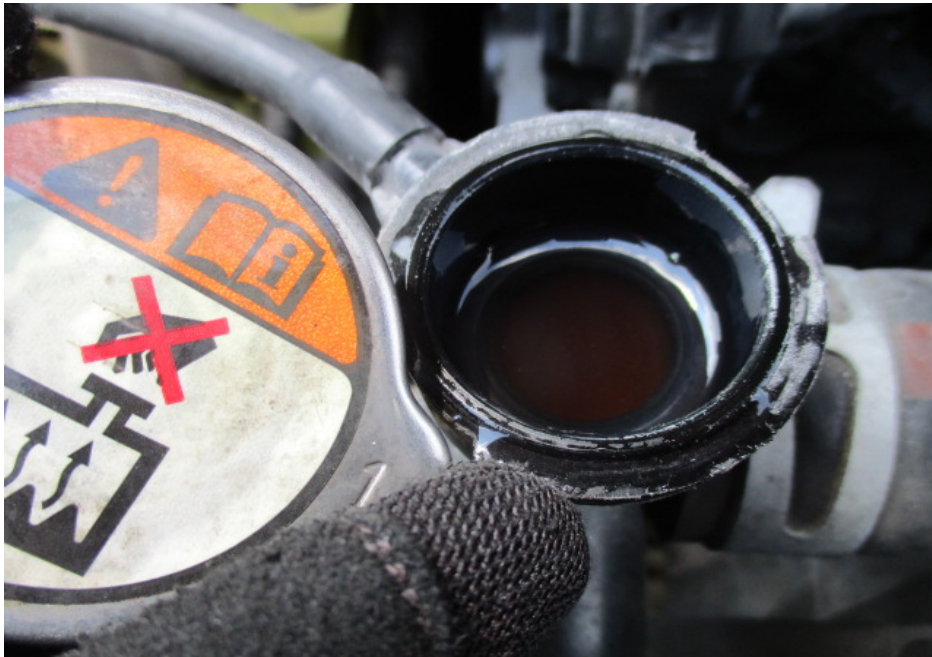
Photo 11 shows checks being carried out to the engine coolant of the Motor Taxi at the time of our inspection. The engine coolant was observed to be of sufficient level and without any visible contamination.

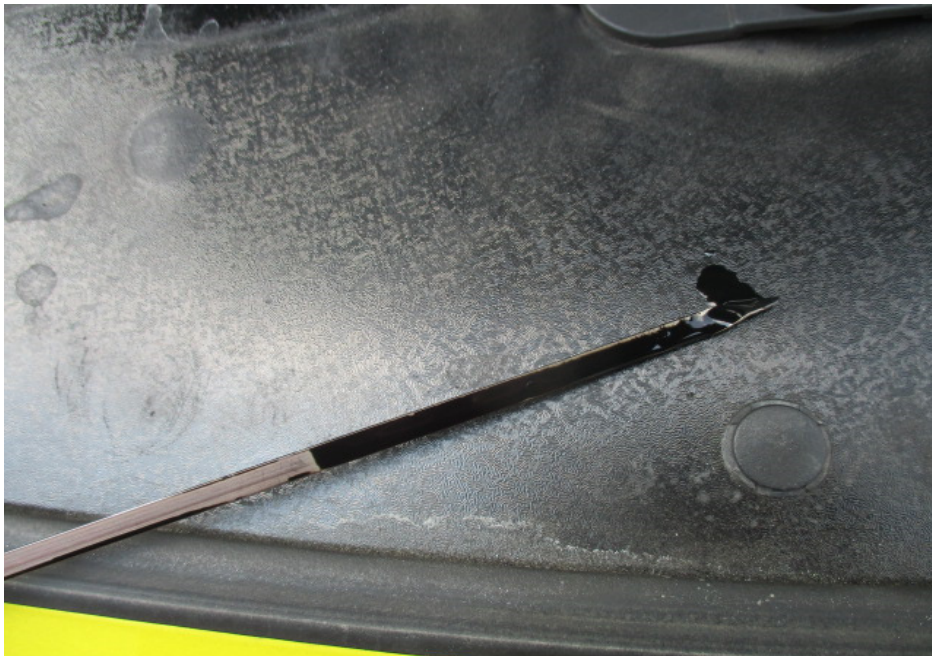
Photo 12 shows the engine oil dip stick of the Motor Taxi at the time of our inspection. The engine oil was observed to be of sufficient level and without any visible contamination.

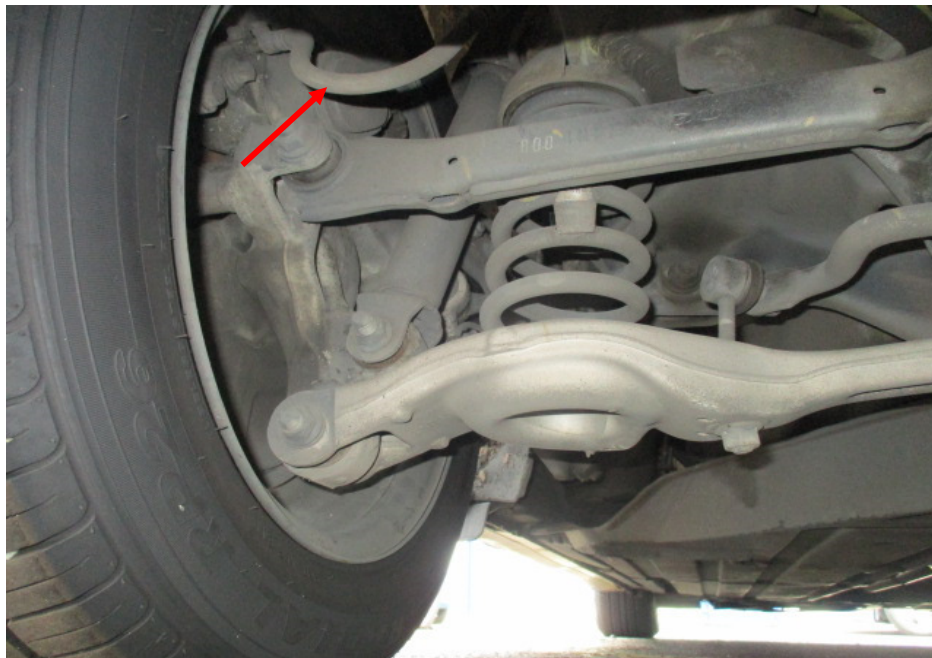
Photo 13 shows the brake hose/pipe (arrowed) at the rear left wheel of the Motor Taxi. We did not observe any leakage of brake fluid at the time of our inspection of the Motor Taxi. Static tests of the Motor Taxi's braking system had indicated that there was no internal leakage of pressure/vacuum. Hence the braking system was likely to be in serviceable condition at the material time of accident. The undercarriage components of the Motor Taxi were also all found to be intact and without any visible damage.

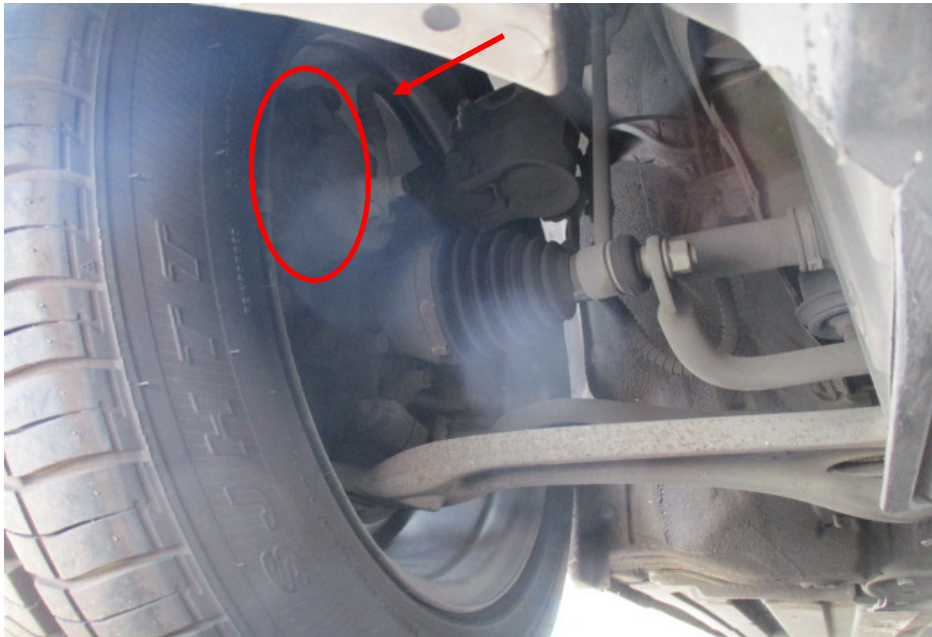
Photo 14 shows the brake hose/pipe (arrowed) at the front right wheel of the Motor Taxi. No leakage of brake fluid was observed. Visual examination of the various components of the braking system like the brake caliper (circled), brake pedal etc. had revealed all to be intact and without visible damage.

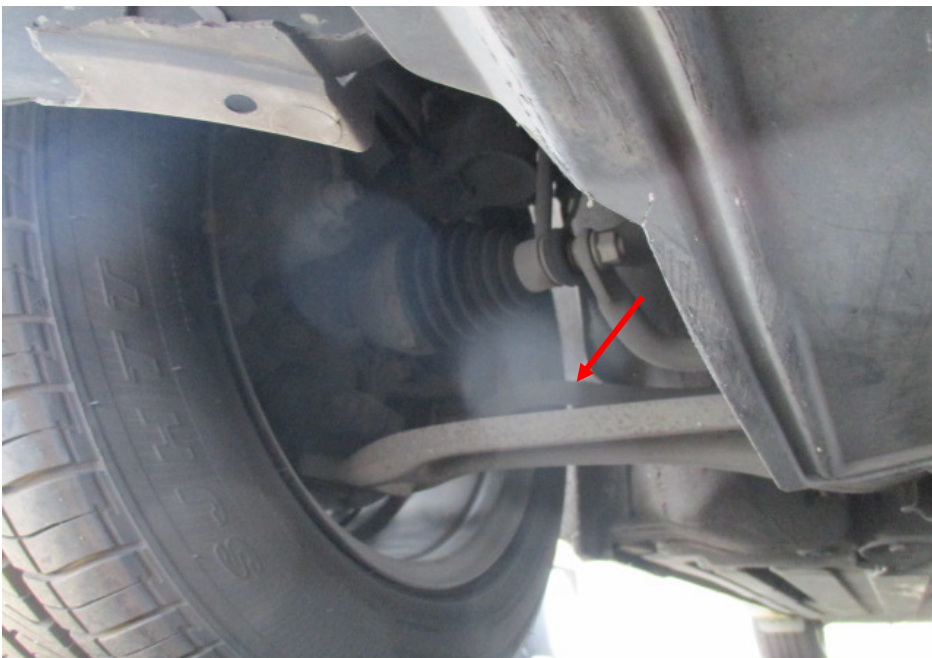
Photo 15 shows the various undercarriage components at the front right wheel of the Motor Taxi, in particular the steering tie rod (arrowed). The various steering components were all found to be intact, suggesting that the steering system of the Motor Taxi was likely to be in serviceable condition at the material time of accident. There was also no sign of fluid stain observed on the various undercarriage components at the front right wheel of the Motor Taxi.

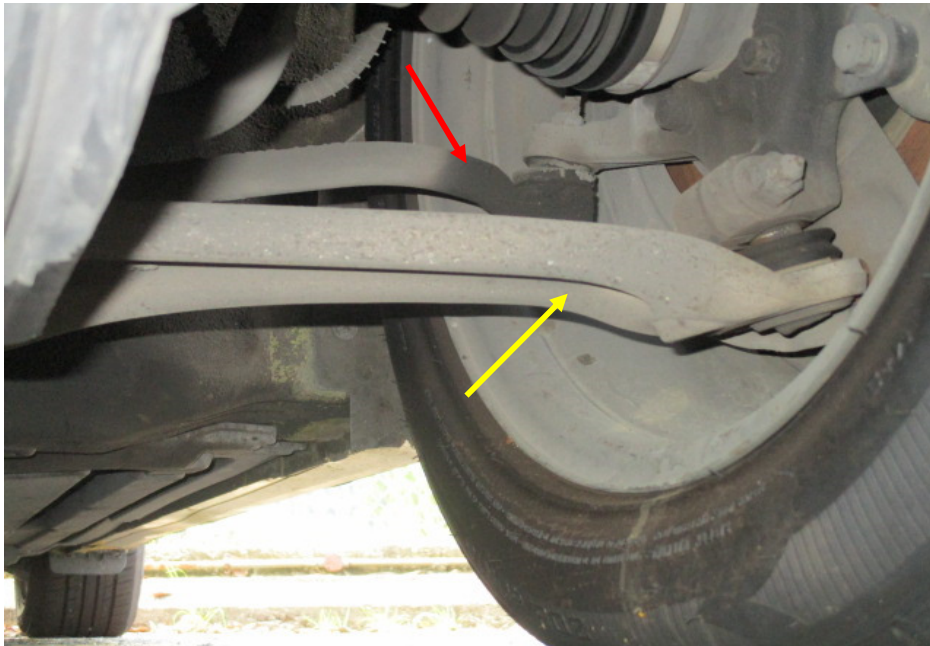
Photo 16 shows the various undercarriage components at the front left wheel of the Motor Taxi, which had included the steering tie rod (red arrow) and left drive shaft (yellow arrow). The various undercarriage components of the Motor Taxi were all found to be intact without any visible damage.

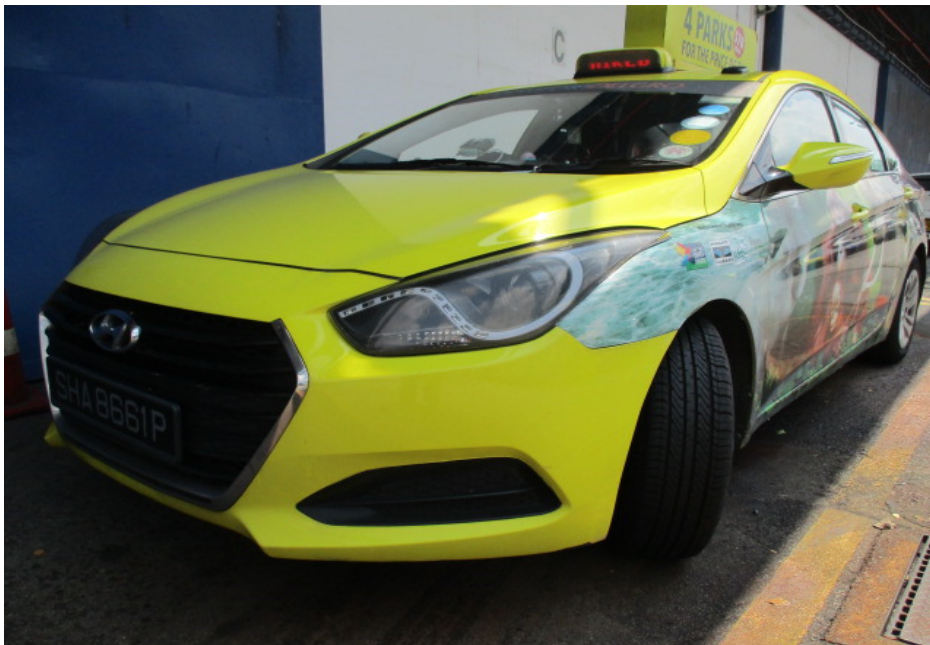
Photo 17 shows the front left wheel of the Motor Taxi turned to its full left. During our steering system test, we did not experience any abnormal free play and/or resistance when we had turned the steering wheel towards the left and right. This would suggest that the steering system of the Motor Taxi was likely to be in serviceable condition at the material time of accident.

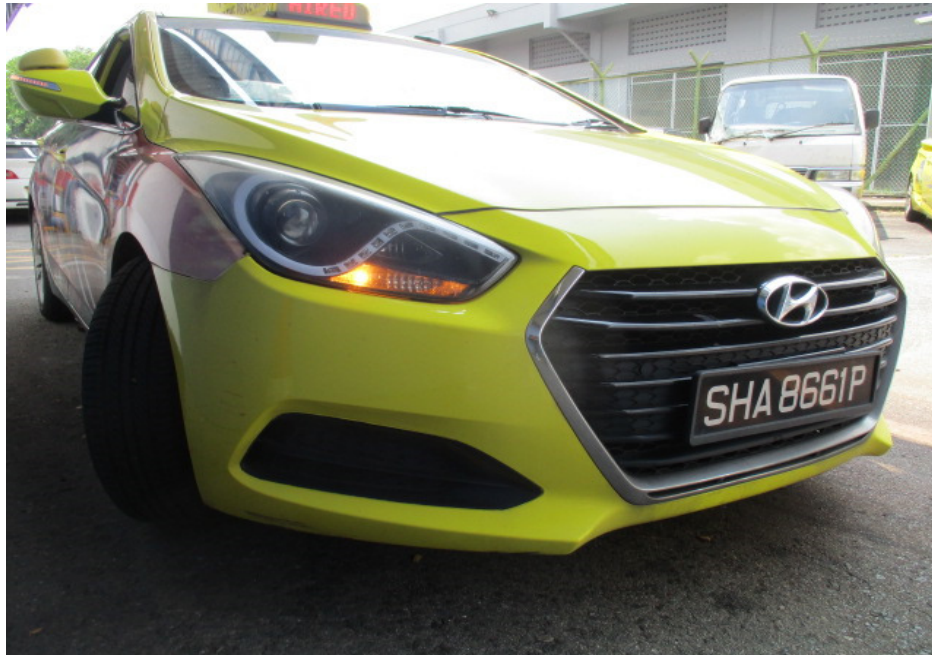
Photo 18 shows the front right wheel of the Motor Taxi turned to its full right. During our steering system test, we did not experience any abnormal free play and/or resistance when we had turned the steering wheel towards the left and right. This would suggest that the steering system of the Motor Taxi was likely to be in serviceable condition at the material time of accident.

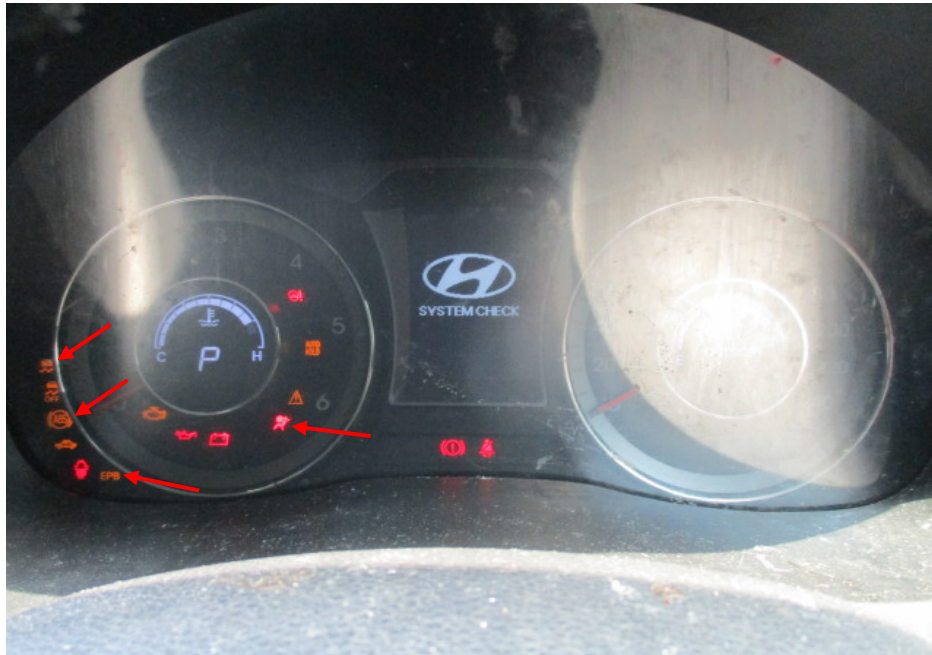
Photo 19 shows the warning lights for the various electronic operating systems of the Motor Taxi appearing on its instrument panel during the self-test when the engine is cranked, in particular the EPS light, ABS light, ESC light and SRS light (arrowed).

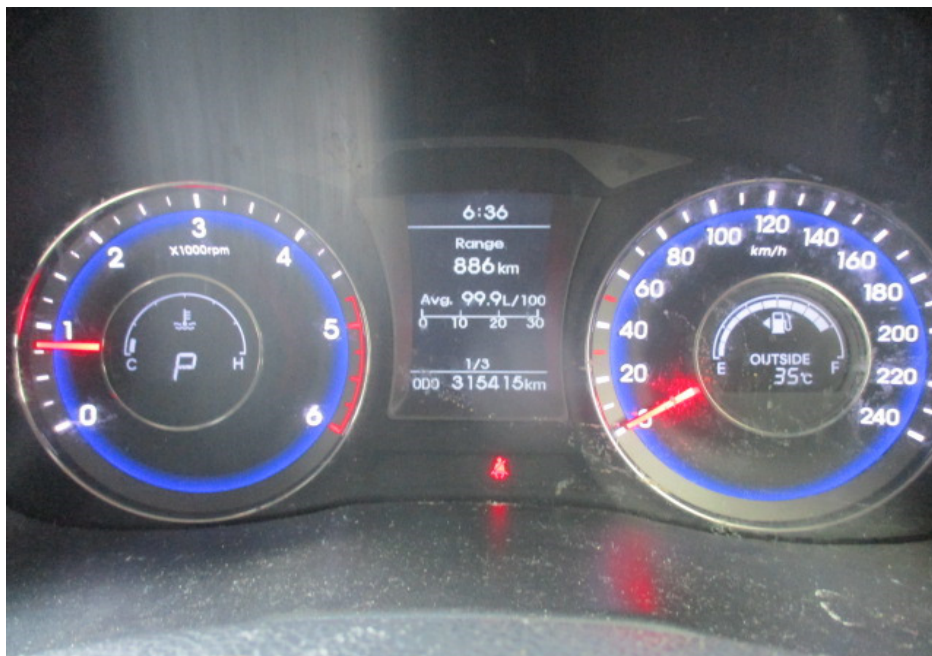
Photo 20 shows no warning lights illuminated on the instrument panel of the Motor Taxi after the engine was cranked. This would suggest that there was no abnormality to the various electronic operating systems of the Motor Taxi, like the EPS, ABS, ESC and SRS etc.
