Your Ref: TP/IP/70101/2018  
Our Ref : CI/TPD19002519/N

3 May 2019

**MECHANICAL INSPECTION REPORT OF MOTOR CAR SLW 9010Z**

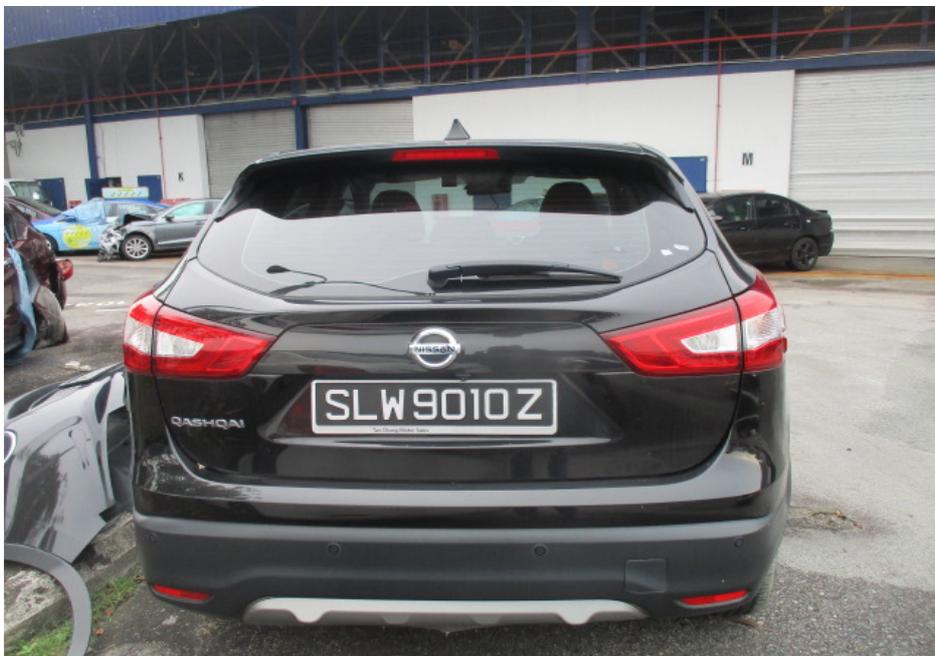
**Photo 1** shows a general view of the rear body of the Motor Car at the time of our inspection. The Motor Car was observed to be in good general condition except for some relatively moderate impact damage at its frontal portion. The mileage of the Motor Car was recorded to be 26, 090km.

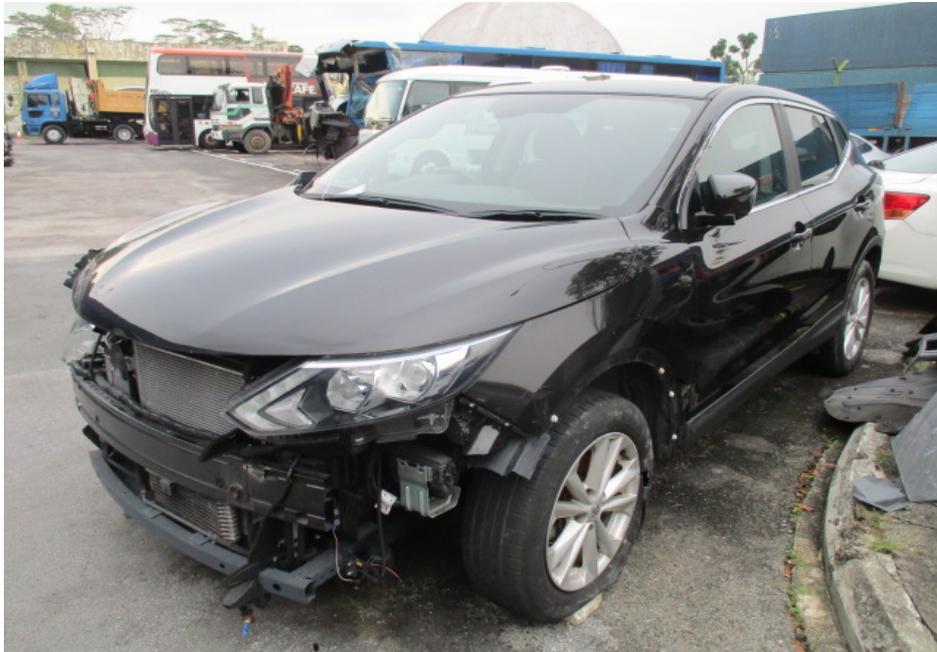
**Photo 2** shows a general view of the front left body of the Motor Car at the time of our inspection. The Motor Car was observed to be in good general condition except for some relatively moderate impact damage at its frontal portion.

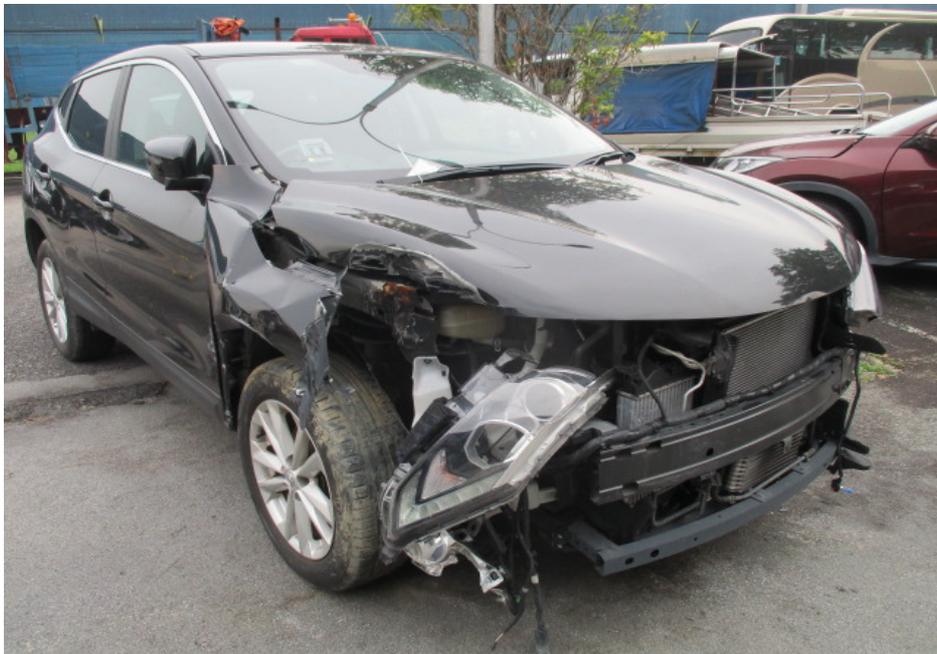
4. The mileage of the Motor Car at the time of our inspection was 26, 090km.
5. The Motor Car had sustained relatively moderate impact damage that was confined to its frontal portion. Its front bumper was observed to be dislodged; its front bonnet as well as right front fender was observed to have been dented while its right headlight was observed to be cracked.

**Photo 3** shows a general view of the front right body of the Motor Car at the time of our inspection. We had observed relatively moderate impact damage that was confined to its frontal portion. Its front bumper was observed to be dislodged; its front bonnet as well as right front fender was observed to have been dented while its right headlight was observed to be cracked.

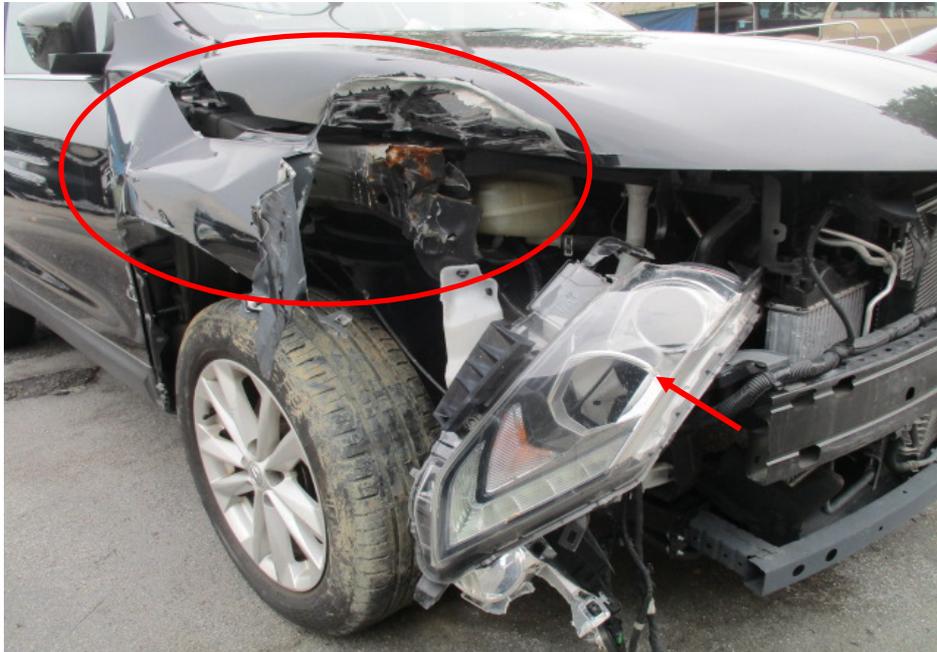
**Photo 4** shows a closer view of the dented front bonnet and left front fender (circled) as well as the cracked right headlight (arrowed) of the Motor Car at the time of our inspection.

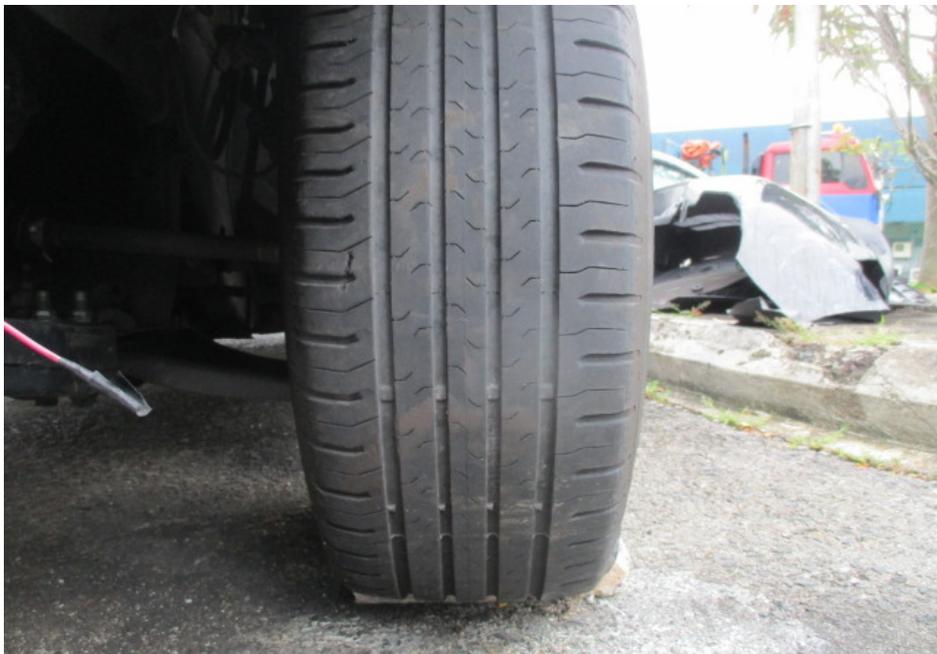
**Photo 5** shows the condition of the front left tyre of the Motor Car, which was observed to be in serviceable condition with remaining tread depth of approximately 5mm.

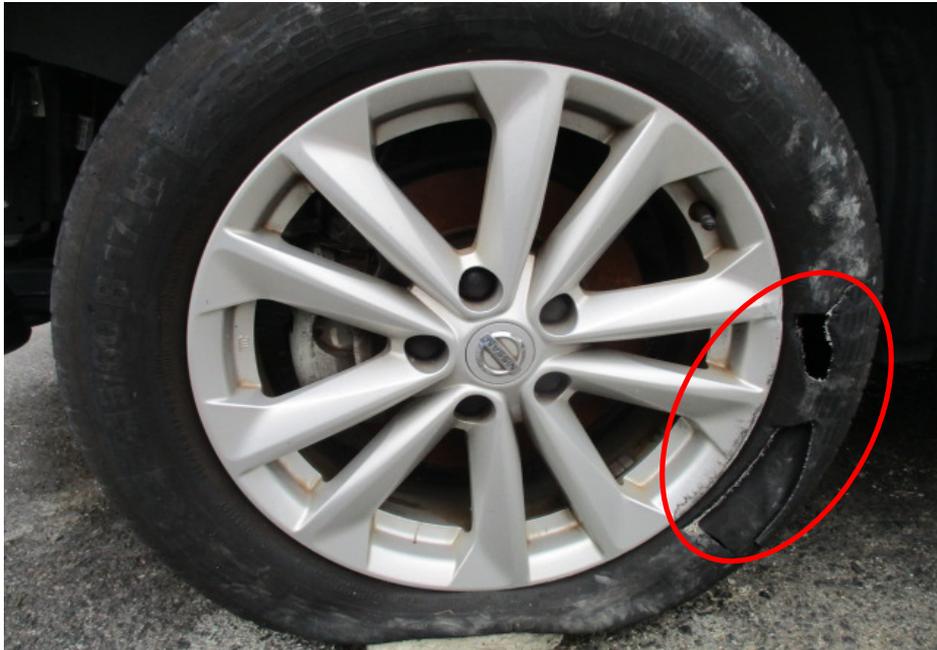
7. We observed a cut/tear on the outer sidewall of the front left tyre. The remaining tread depth of this tyre was approximately 5mm, similar to the other 3 tyres. We had also found some relatively minor marks of grazing nature on the edges of the front left wheel rim. See photos 1 – 9 below.

**Photo 6** shows the condition of the front left tyre of the Motor Car. We observed a cut/tear on the outer sidewall of the front left tyre. We had also found some relatively minor marks of grazing nature on the edges of the front left wheel rim (circled).

19. The 4 tyres of the Motor Car were found to be in serviceable condition with remaining tread depth of approximately 5mm each. This had included the front left tyre where a cut/tear on its outer side wall area was observed. This cut/tear was a result of the accident and did not occur prior to the accident.

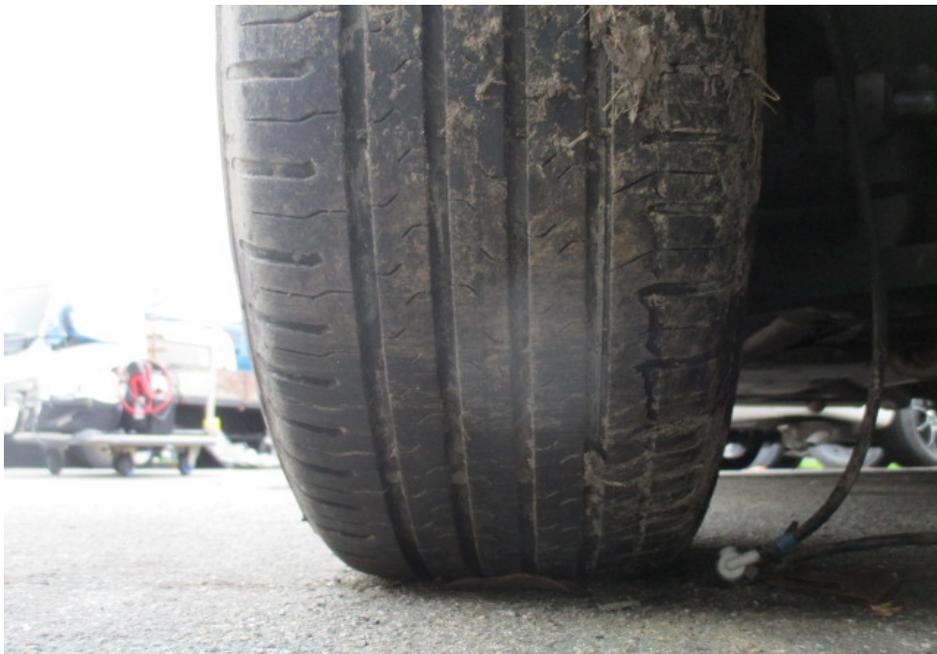
**Photo 7** shows the condition of the front right tyre of the Motor Car, which was observed to be in serviceable condition with remaining tread depth of approximately 5mm. The tyre, which was wrapped around alloy wheel rim, was also observed to be sufficiently inflated for vehicular operation.

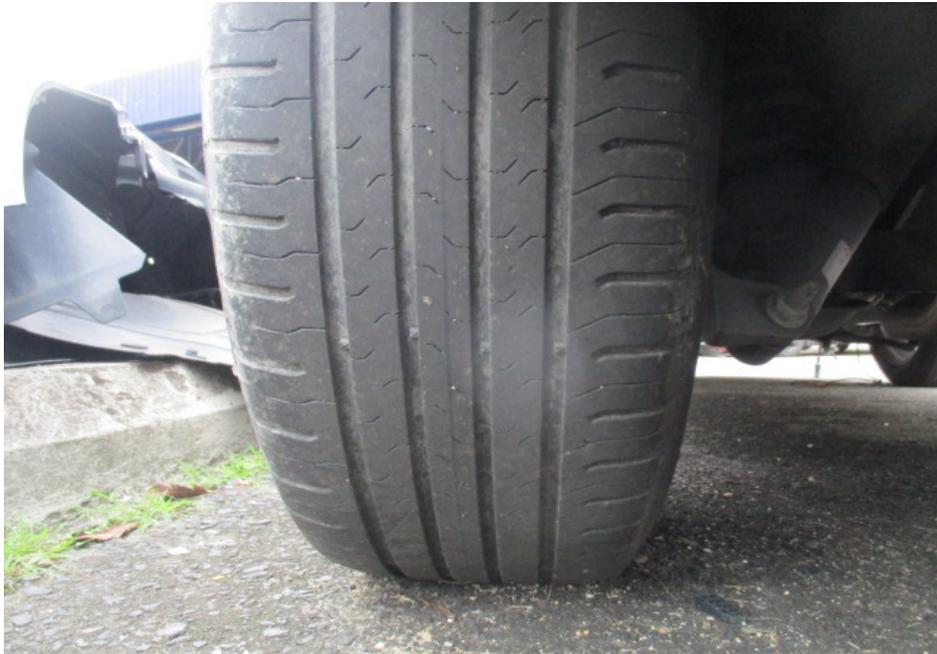
**Photo 8** shows the condition of the rear left tyre of the Motor Car, which was observed to be in serviceable condition with remaining tread depth of approximately 4mm. The tyre, which was wrapped around an alloy wheel rim, was also observed to be sufficiently inflated for vehicular operation.

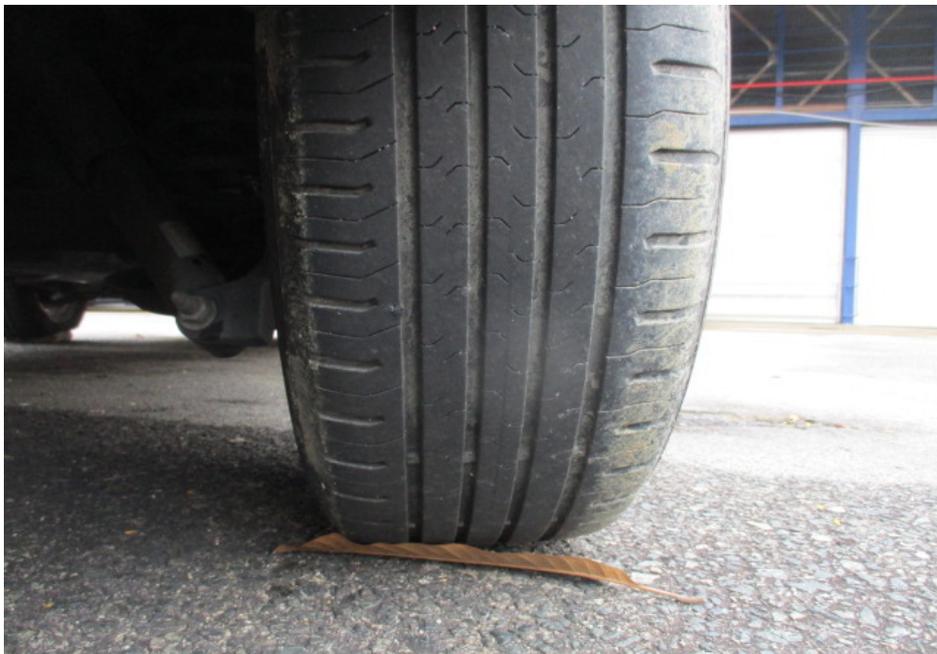
**Photo 9** shows the condition of the rear right tyre of the Motor Car, which was observed to be in serviceable condition with remaining tread depth of approximately 5mm. There was also no tear, cut or burst mark(s) on the outer and the inner sidewalls as well as across the tread of the 4 tyres.

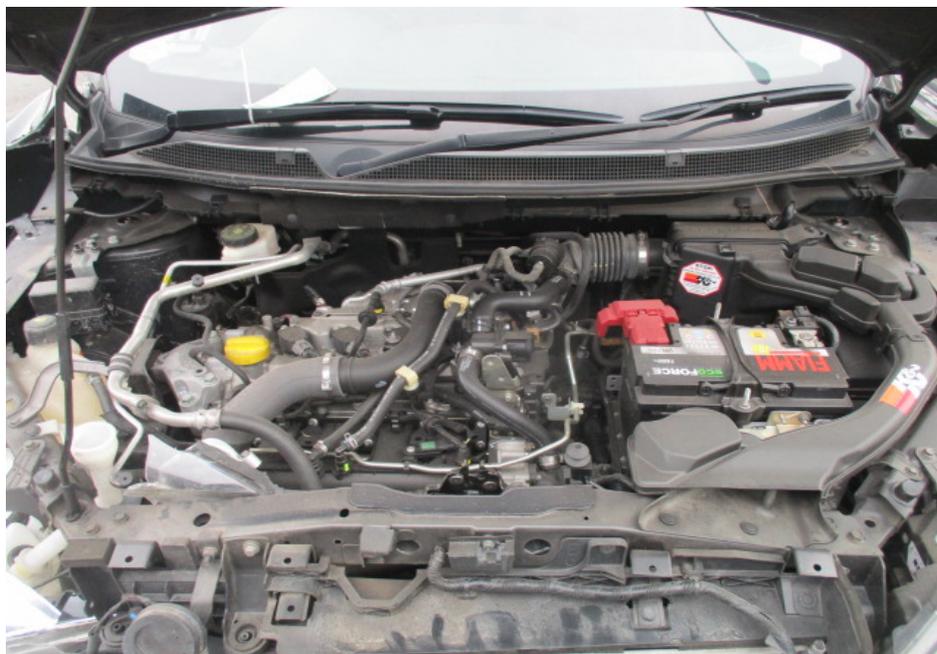
**Photo 10** shows a general view of the Motor Car's engine compartment. The various parts and components inside the engine compartment were unaffected by the accident. There was also no sign(s) or indication(s) of fluid leakage and/or fluid stain within the engine compartment.

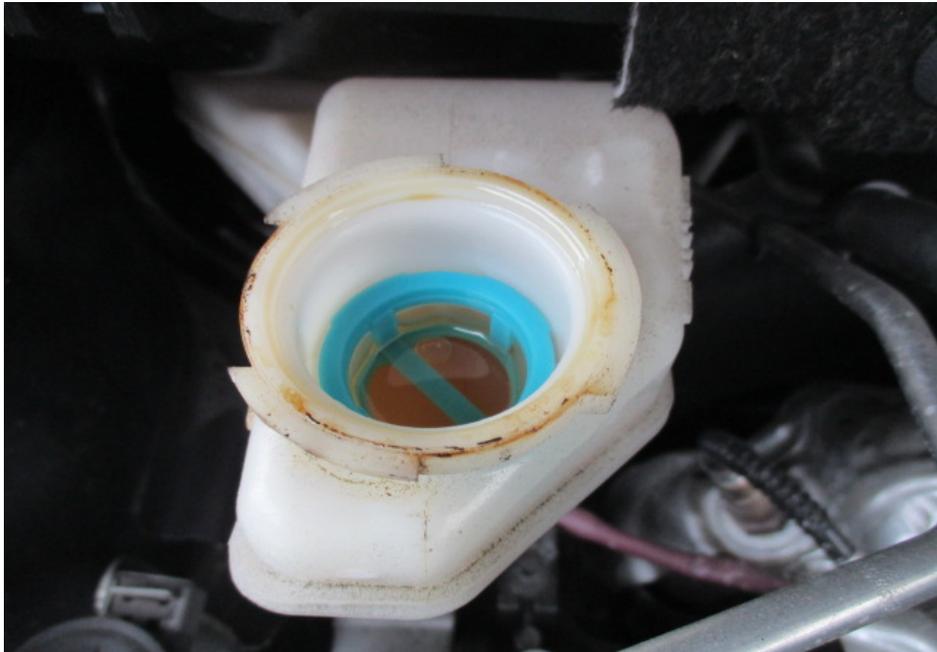
**Photo 11** shows the brake fluid reservoir of the Motor Car at the time of our inspection. The brake fluid was observed to be of sufficient level and without any visible contamination.

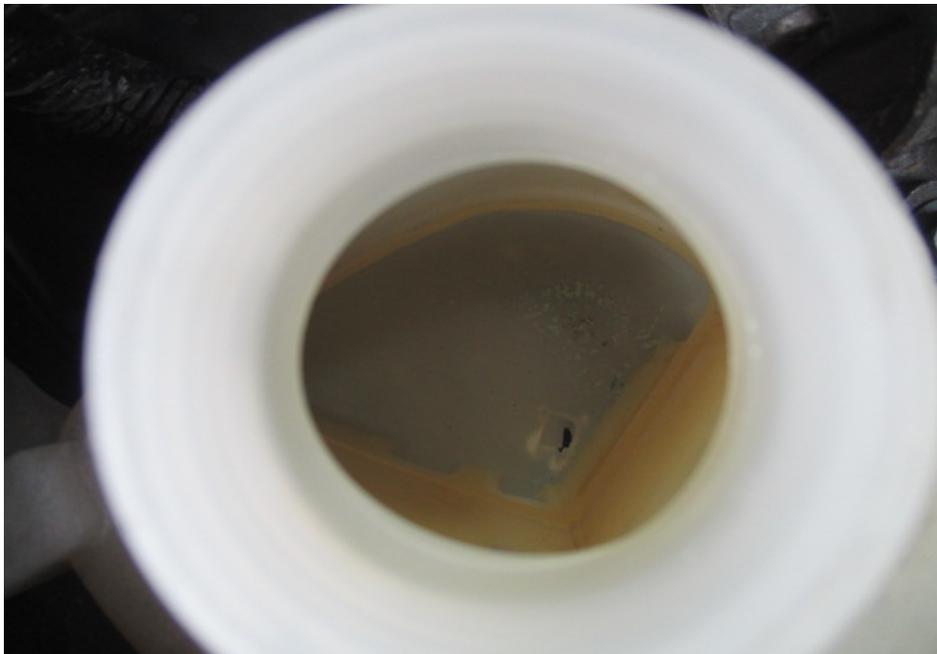
**Photo 12** shows checks being carried out to the engine coolant of the Motor Car at the time of our inspection. The reserve engine coolant reservoir was observed to be empty.

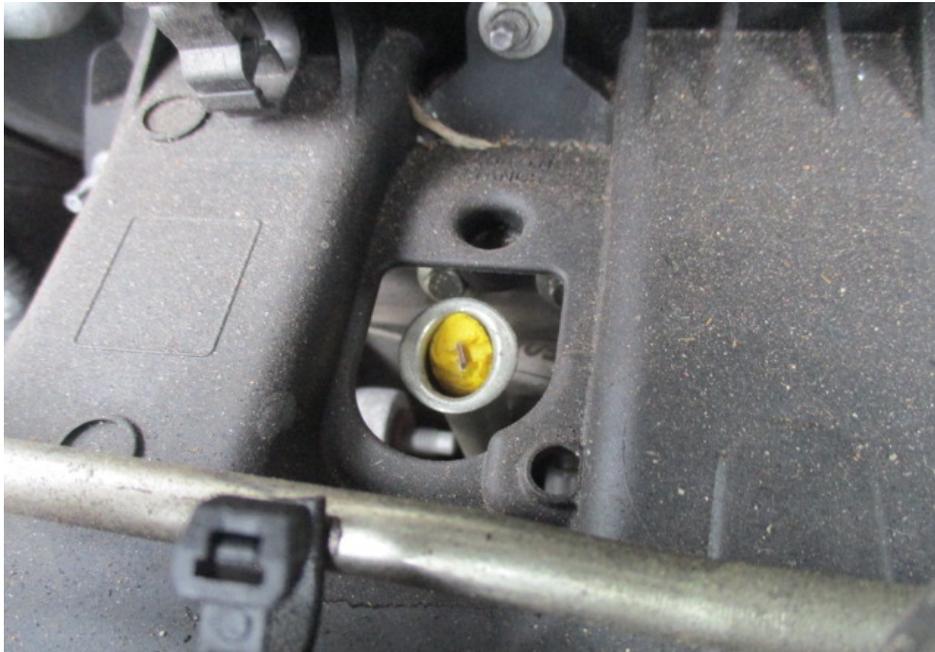
**Photo 13** shows the engine oil dip stick of the Motor Car at the time of our inspection. The top portion of the engine oil dipstick had broken off.

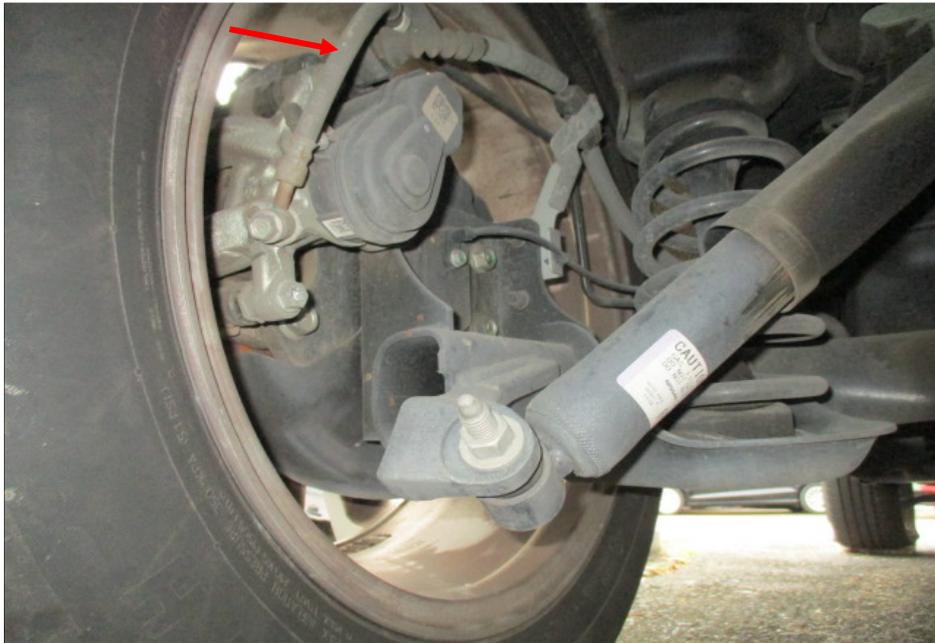
**Photo 14** shows the brake hose/pipe (arrowed) at the rear left wheel of the Motor Car. We did not observe any leakage of brake fluid at the time of our inspection of the Motor Car. Static tests of the Motor Car's braking system had indicated that there was no internal leakage of pressure/vacuum. Hence the braking system was likely to be in serviceable condition at the material time of accident. The undercarriage components of the Motor Car were also all found to be intact and without any visible damage.

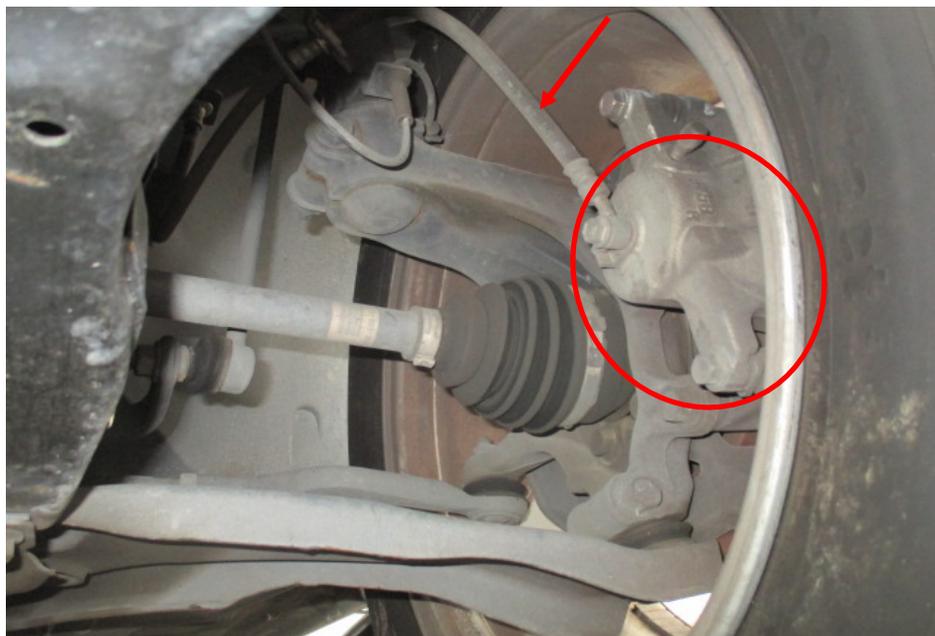
**Photo 15** shows the brake hose/pipe (arrowed) at the front left wheel of the Motor Car. No leakage of brake fluid was observed. Visual examination of the various components of the braking system like the brake caliper (circled), brake pedal etc. had revealed all to be intact and without visible damage.

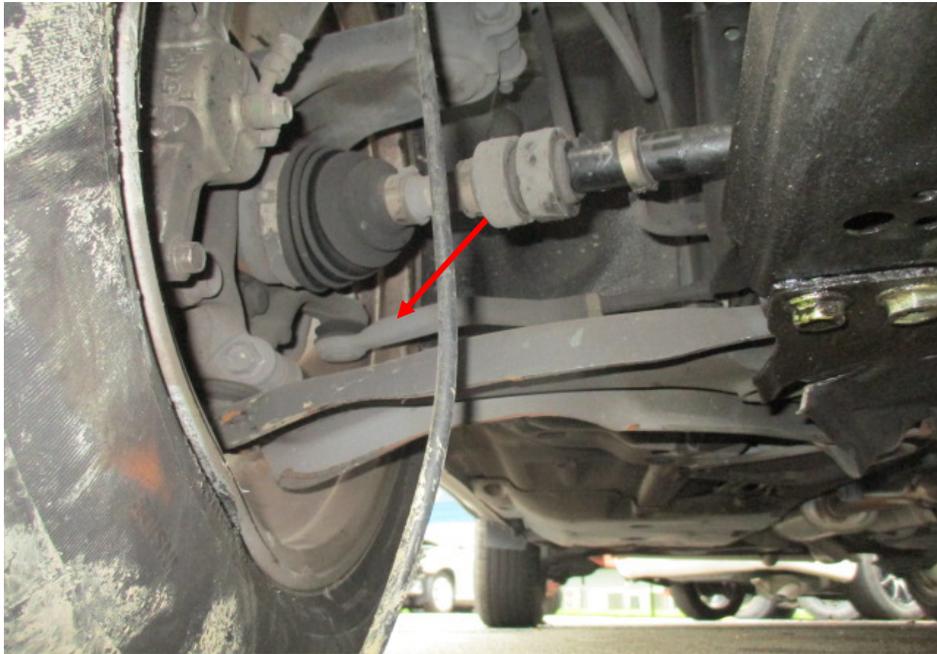
**Photo 16** shows the various undercarriage components at the front right wheel of the Motor Car, in particular the steering tie rod (arrowed). The various steering components were all found to be intact, suggesting that the steering system of the Motor Car was likely to be in serviceable condition at the material time of accident. There was also no sign of fluid stain observed on the various undercarriage components at the front right wheel of the Motor Car.

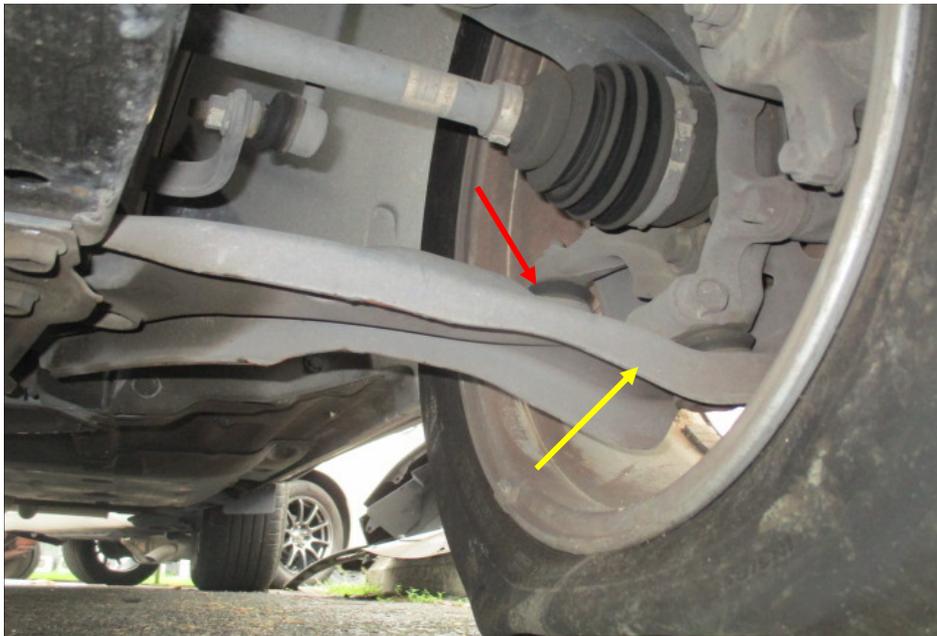
**Photo 17** shows the various undercarriage components at the front left wheel of the Motor Car, which had included the steering tie rod (red arrow) and left drive shaft (yellow arrow). The various undercarriage components of the Motor Car were all found to be intact without any visible damage.

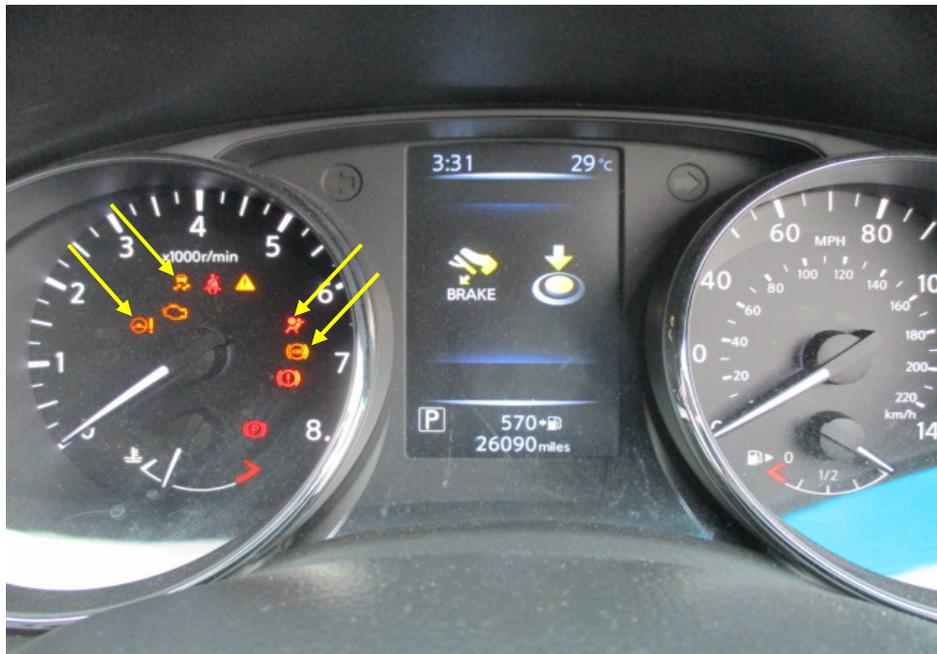
**Photo 18** shows the warning lights for the various electronic operating systems of the Motor Car appearing on its instrument panel during the self-test when the engine is cranked, in particular the EPS light, ABS light, ESC light and SRS light (arrowed).

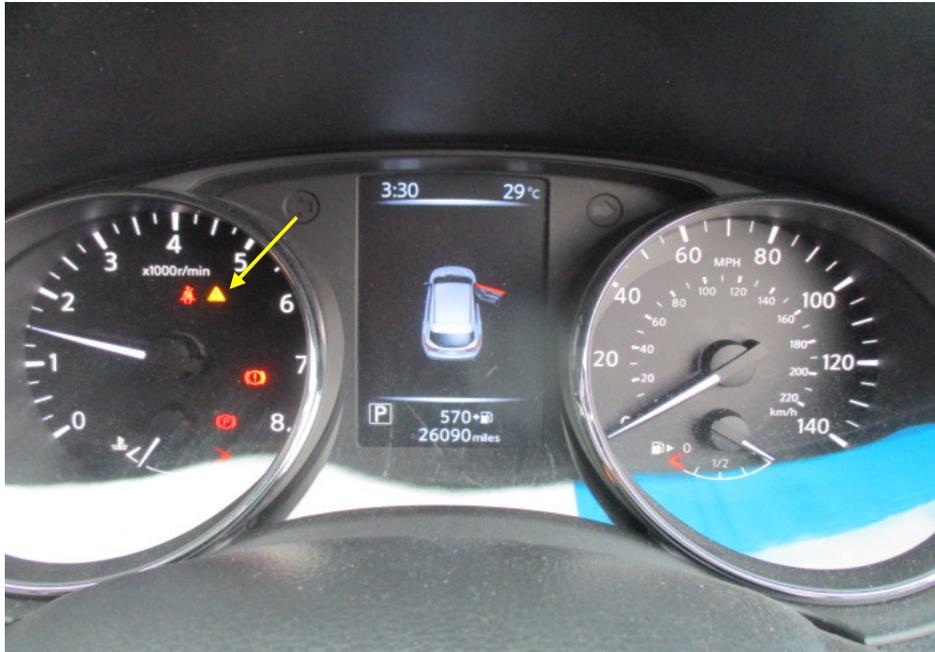
**Photo 19** shows no warning lights illuminated on the instrument panel of the Motor Car after the engine was cranked. This would suggest that there was no abnormality to the various electronic operating systems of the Motor Car, like the ABS, EPS, ESC and SRS etc. The master warning light had however remained illuminated after the self-test (arrowed).
