Your Ref: TP/IP/66301/2018
Our Ref : CI/TPD19002521/P

17th May 2019

MECHANICAL INSPECTION REPORT OF MOTOR CAR SJH 9201S

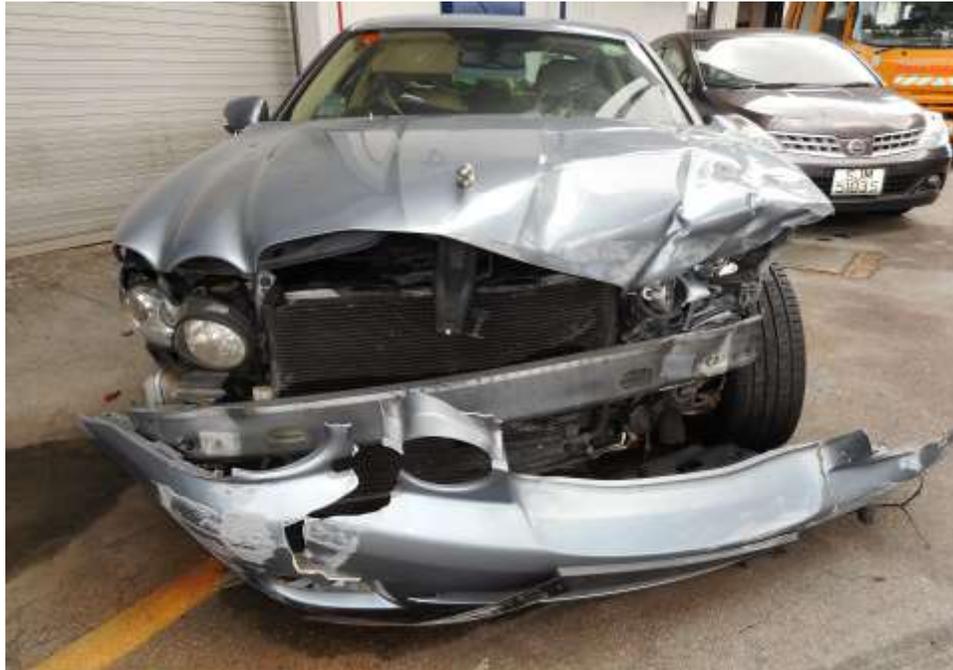
Photo 1 shows a general view of the front portion of the Motor Car at the time of my inspection. The Motor Car was also observed to have sustained extensive impact damage at its frontal portion. Its front bumper, front bonnet, front bonnet lock mechanism, engine system and radiator were amongst the body parts that were observed to have been damaged as a result of the accident.

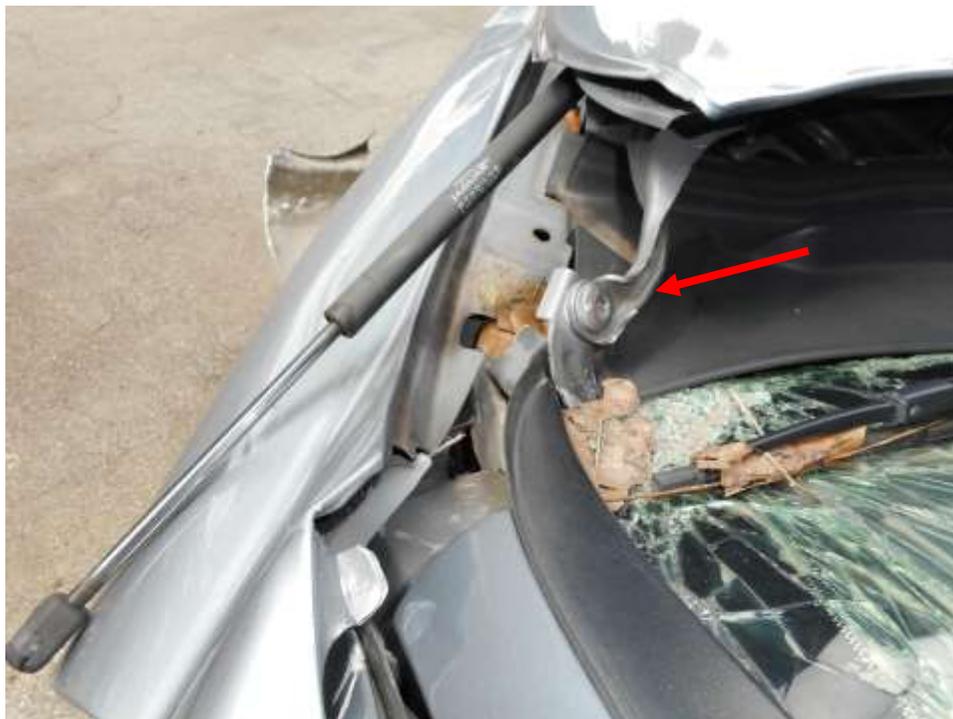
Photo 2 shows a close up view of the left bonnet hinge of the Motor Car at the time of my inspection. The left bonnet hinge of the Motor Car was observed to have been damaged as a result of the accident rendering the bonnet unable to be opened (arrowed)

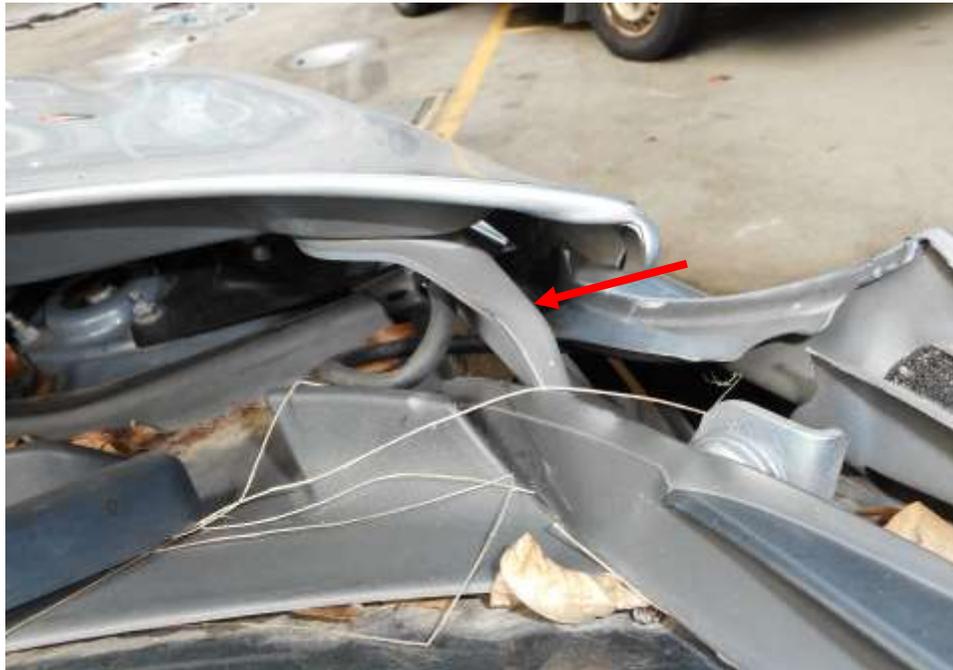
Photo 3 shows a close up view of the right bonnet hinge of the Motor Car at the time of my inspection. The left bonnet hinge of the Motor Car was observed to have been damaged as a result of the accident rendering the bonnet unable to be opened (arrowed)

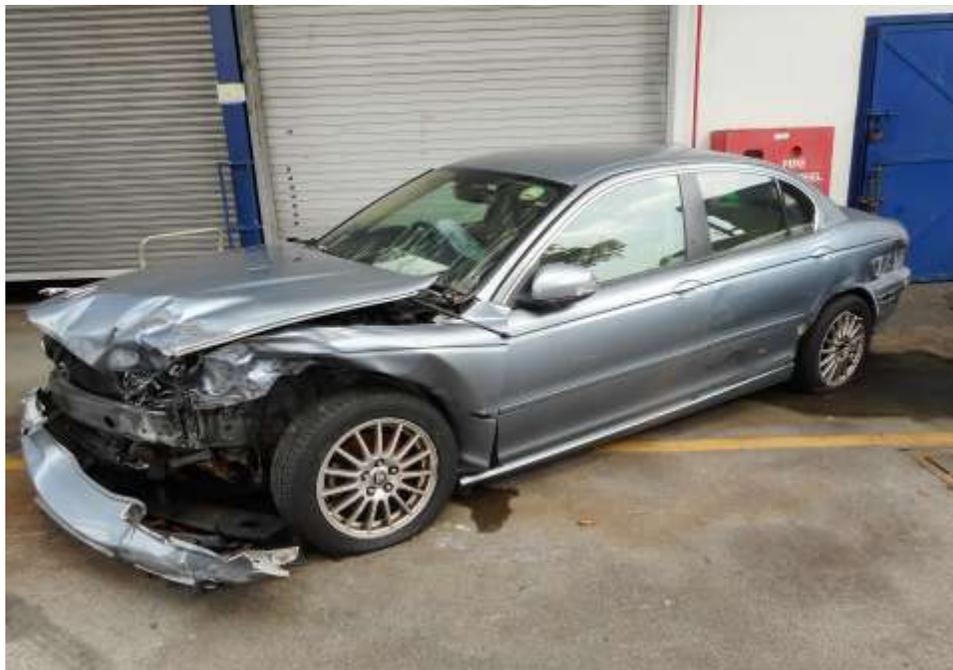
Photo 4 shows a general view of the left portion of the Motor Car at the time of my inspection. The left side fender, front windscreen and the rear portion of the Motor Car was observed to have been damaged as a result of the accident.

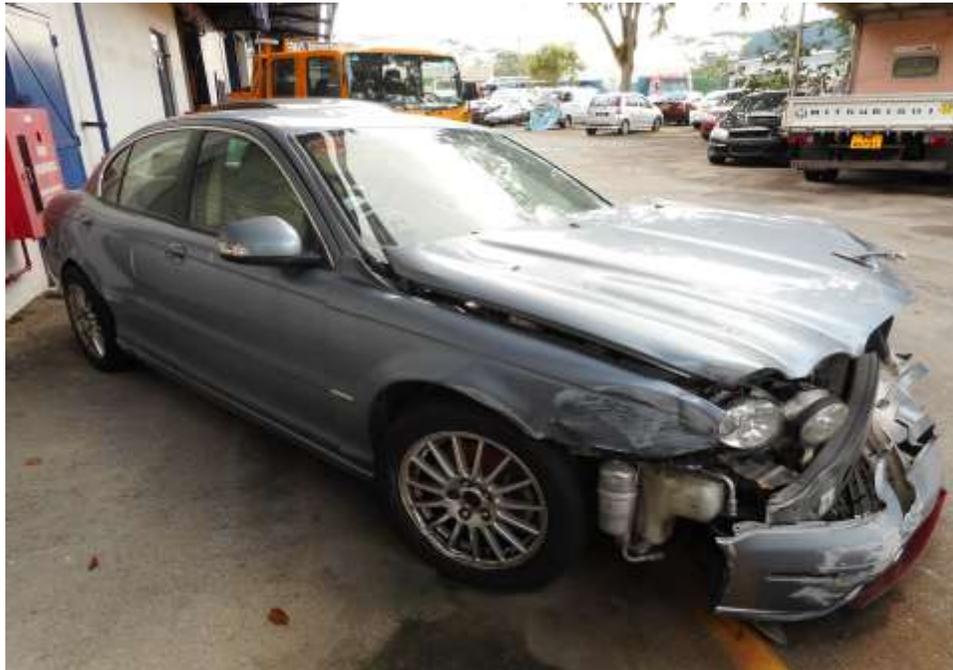
Photo 5 shows a general view of the right portion of the Motor Car at the time of my inspection. The right side fender of the Motor Car was observed to have been damaged as a result of the accident.

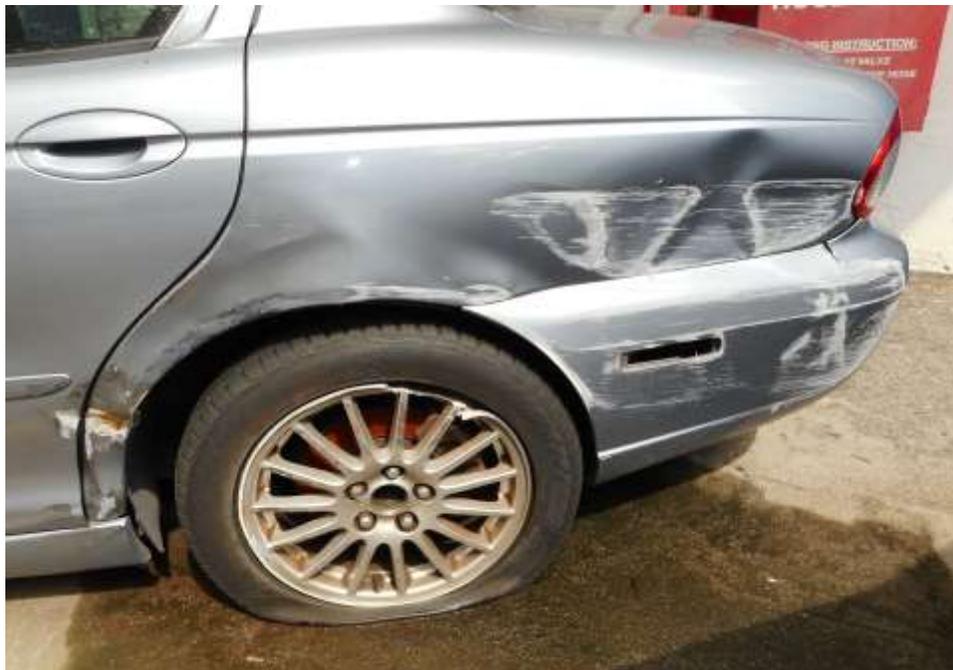
Photo 6 shows a general view of the rear portion of the Motor Car at the time of my inspection. The rear portion of the Motor Car was observed to have been damaged as a result of the accident.

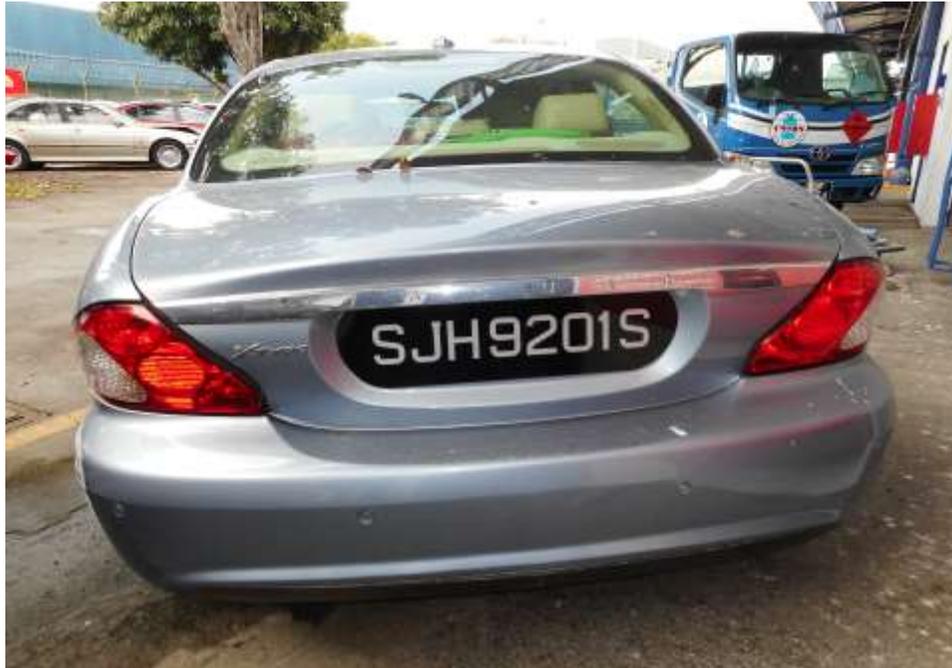
Photo 7 shows a general view of the rear portion of the Motor Car at the time of my inspection. The rear portion of the Motor Car was observed to have been unaffected by the accident.

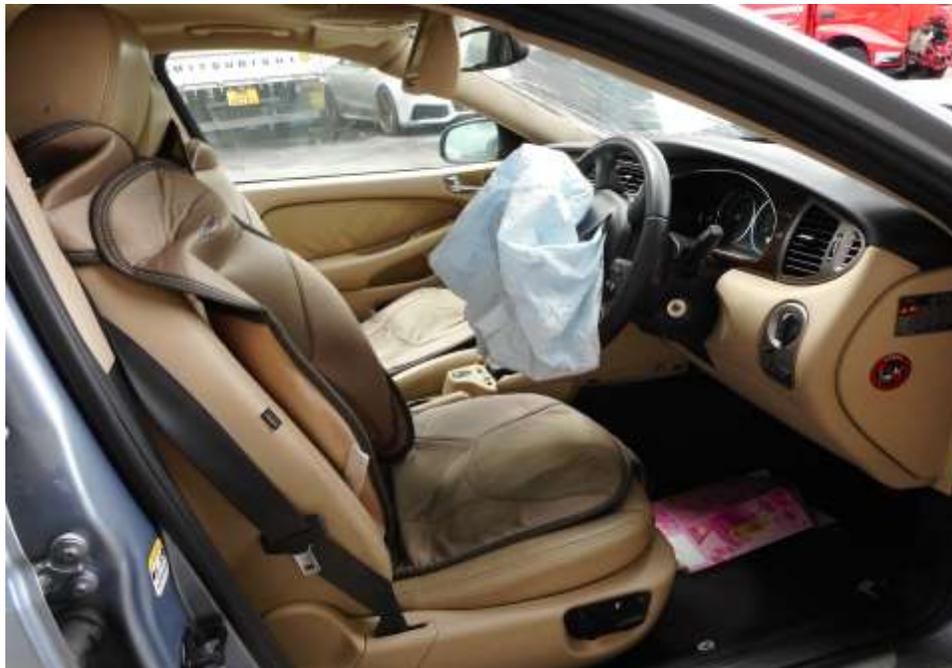
Photo 8 shows a general view of the Motor Car's interior compartment. The driver's air bag, were also deployed as a result of the accident.

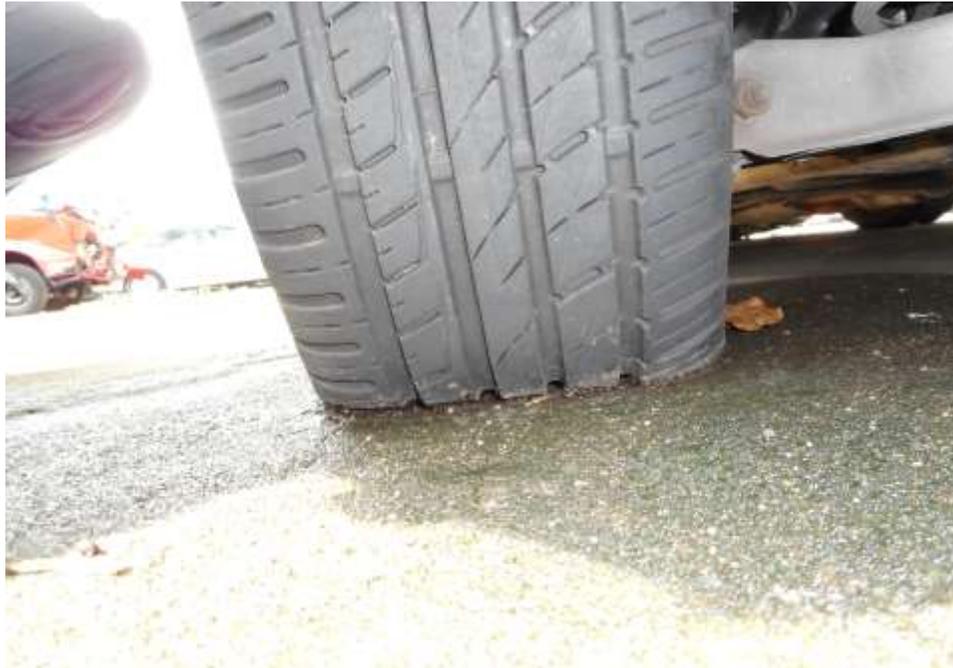
Photo 9 shows the condition of the rear left tyre of the Motor Car, which was observed to be in serviceable condition with remaining tread depth of approximately 5.1mm. There was no tear, cut or burst mark(s) on the outer and the inner sidewalls as well as across the tread of this tyre, however observed to be deflated due to damage to the rims.

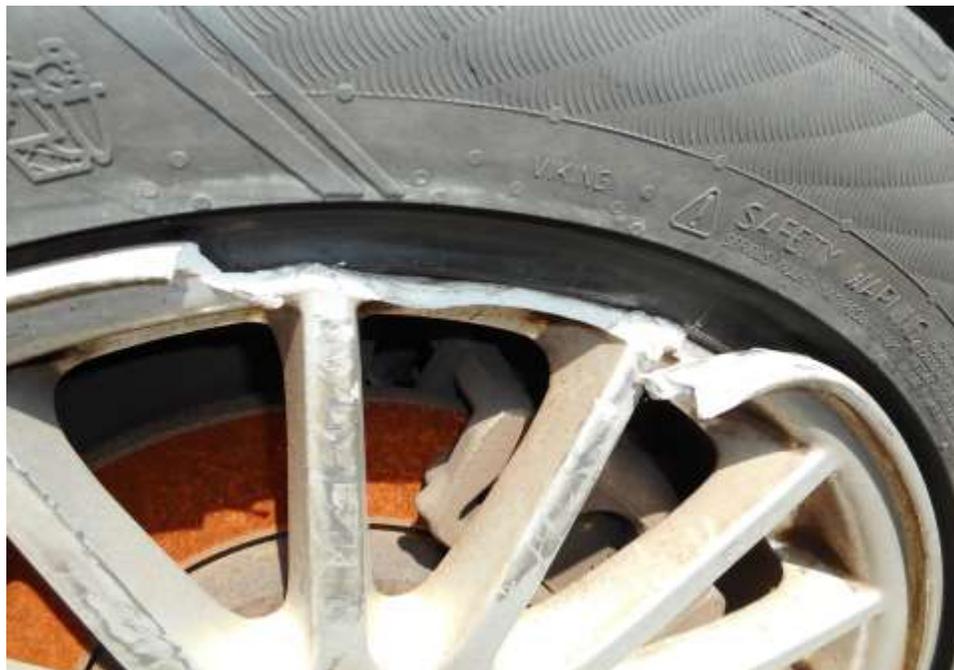
Photo 10 shows the condition of the rear left wheel rim of the Motor Car, The tyre, which was wrapped around alloy wheel rim which was observed to be cracked as a result of the accident.

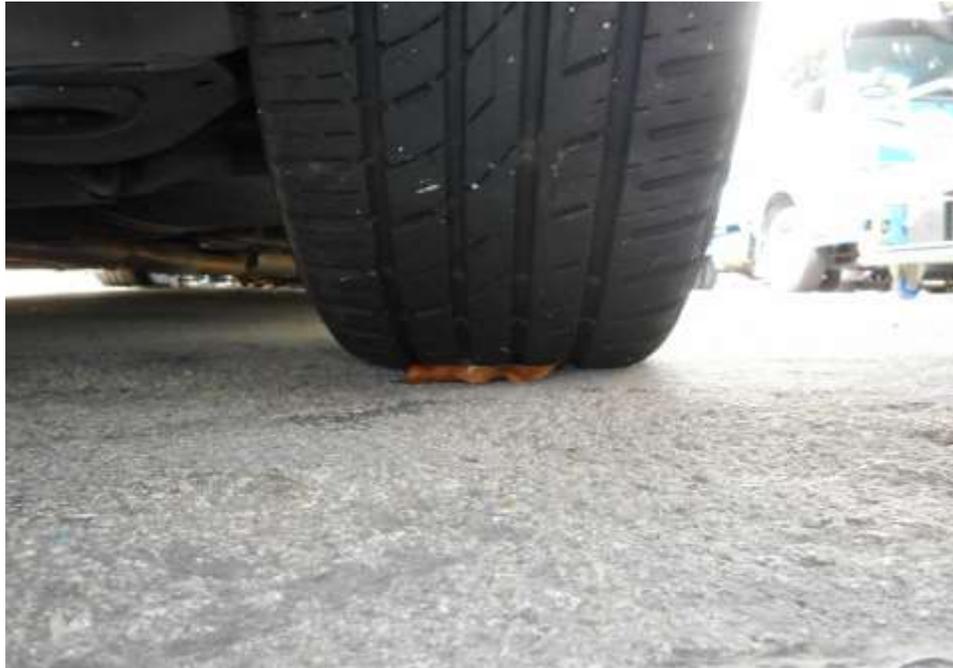
Photo 11 shows the condition of the rear right tyre of the Motor Car, which was observed to be in serviceable condition with remaining tread depth of approximately 5.2mm. There was no tear, cut or burst mark(s) on the outer and the inner sidewalls as well as across the tread of this tyre, however observed to be deflated due to damage to the rims.

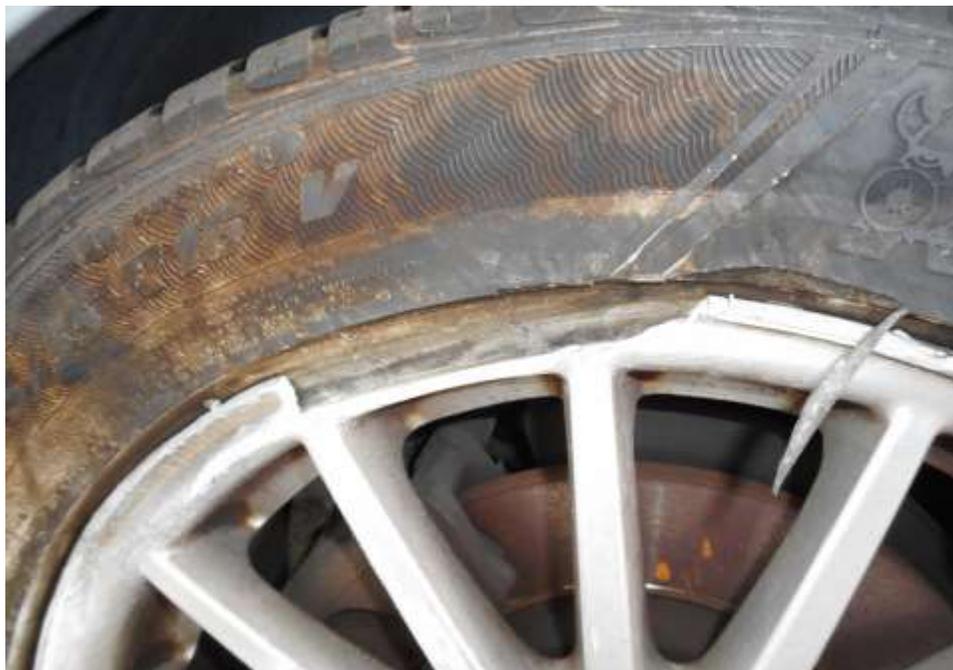
Photo 12 shows the condition of the rear right wheel rim of the Motor Car, The tyre, which was wrapped around alloy wheel rim which was observed to be cracked as a result of the accident.

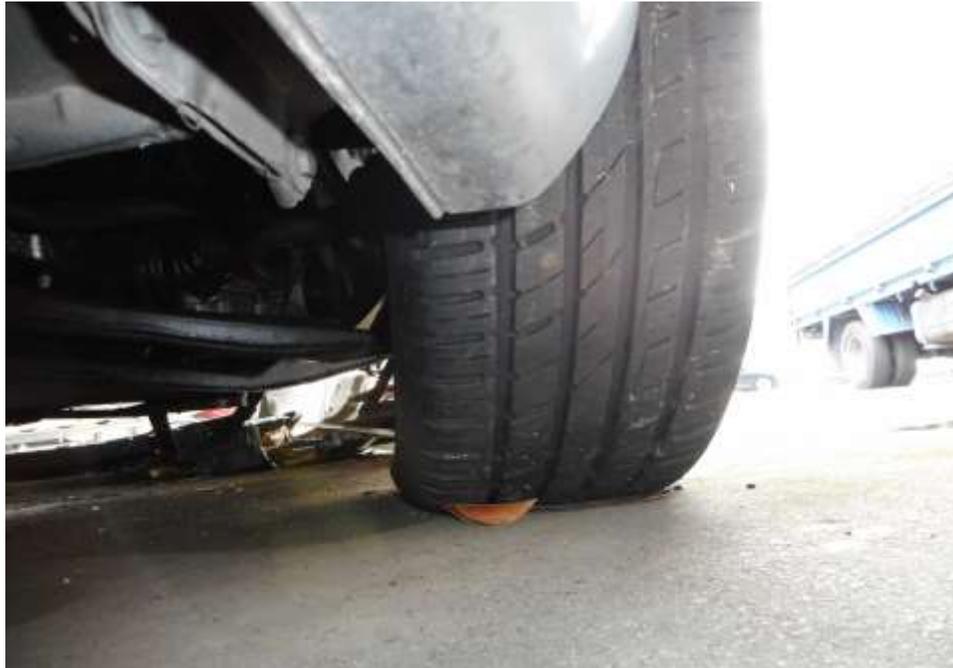
Photo 13 shows the condition of the front right tyre of the Motor Car, which was observed to be in serviceable condition with remaining tread depth of approximately 6.9mm. There was no tear, cut or burst mark(s) on the outer and the inner sidewalls as well as across the tread of this tyre, however observed to be deflated due to damage to the rims.

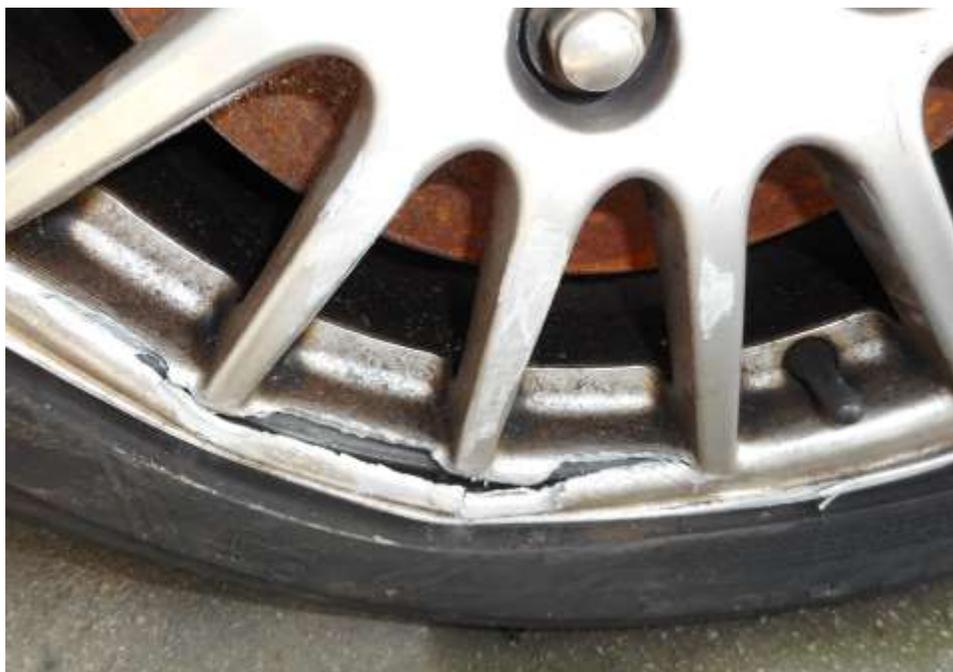
Photo 14 shows the condition of the front right wheel rim of the Motor Car, The tyre, which was wrapped around alloy wheel rim which was observed to be cracked as a result of the accident.

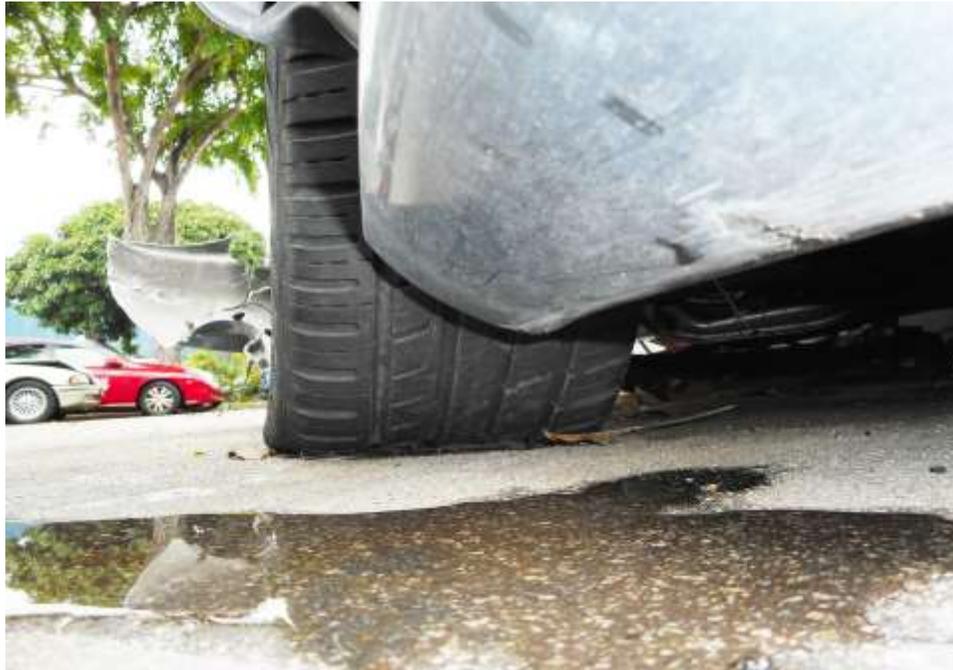
Photo 15 shows the condition of the front left tyre of the Motor Car, which was observed to be in serviceable condition with remaining tread depth of approximately 6.3mm. There was no tear, cut or burst mark(s) on the outer and the inner sidewalls as well as across the tread of this tyre, however observed to be deflated due to damage to the rims.

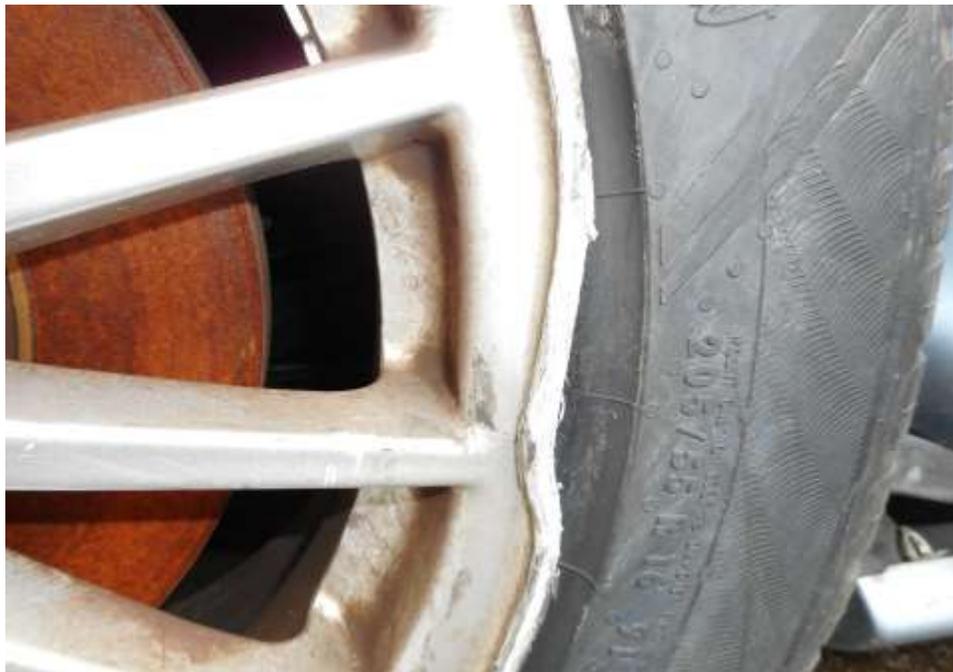
Photo 16 shows the condition of the rear right wheel rim of the Motor Car, The tyre, which was wrapped around alloy wheel rim which was observed to be dented as a result of the accident.

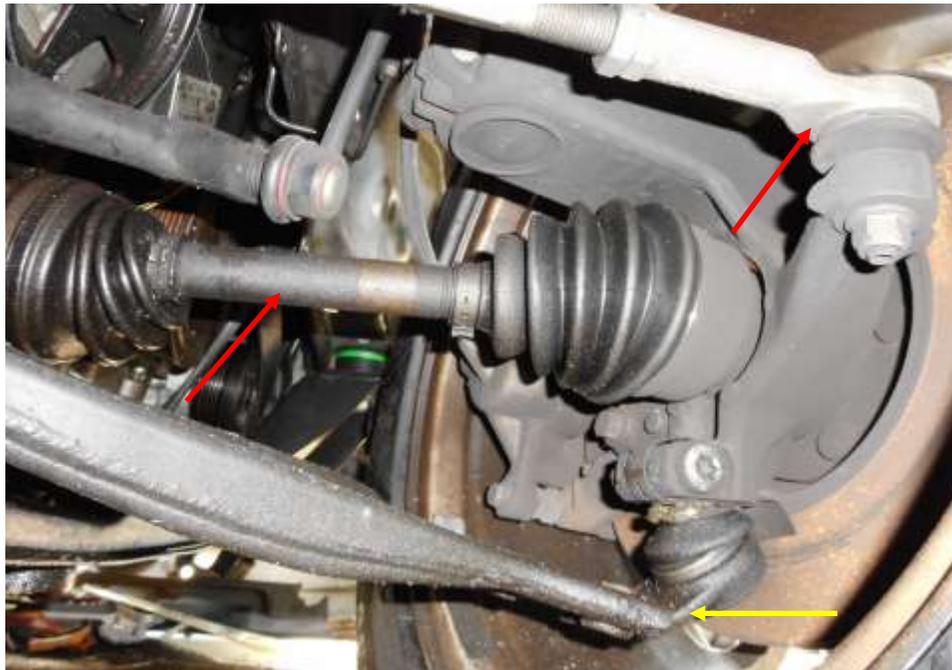
Photo 17 shows the undercarriage components at the front right wheel of the Motor Car. My checks on the underside of the Motor Car revealed damage to the various undercarriage components, the steering rack and pinion, tie rods, tie rod ends and ball joints (red arrow) revealed that these components were all generally in good condition. However, the front right lower arm (yellow arrow) of the Motor Car was damaged.

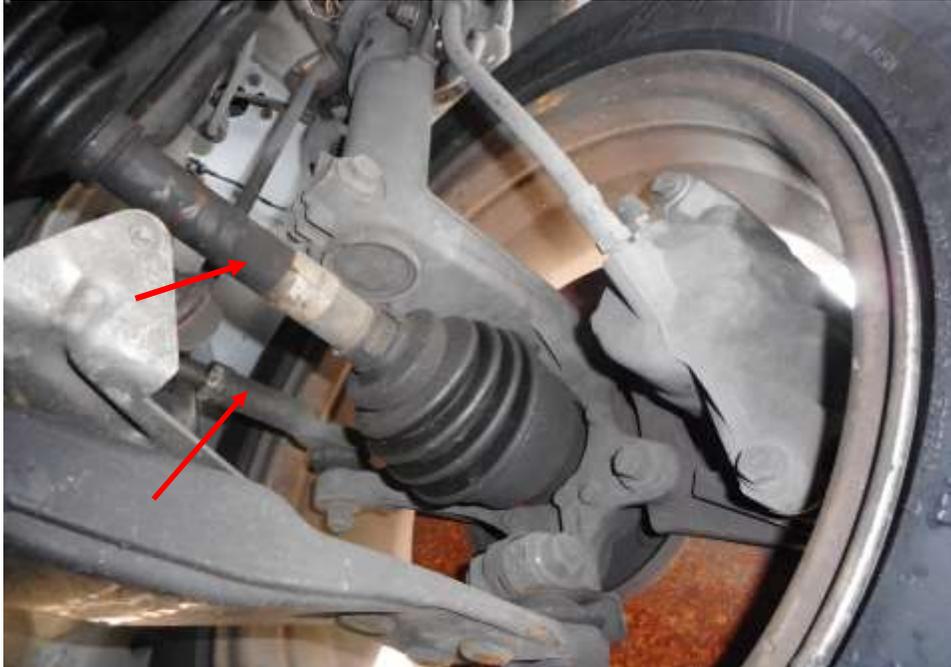
Photo 18 shows the various undercarriage components at the front left wheel of the Motor Car, which had included the steering tie rod (arrow) and front left drive shaft (arrowed). The various undercarriage components of the Motor Car were all found to be intact without any visible damage.

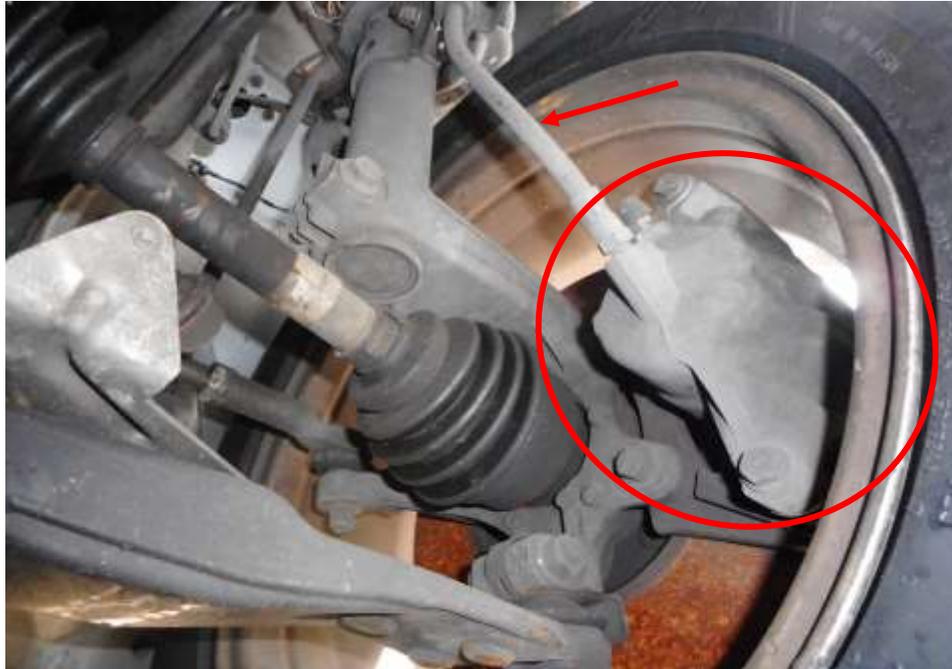
Photo 18 shows the brake hose (arrowed) at the front left wheel of the Motor Car. I did not observe any leakage of brake fluid at the 4 wheels of the Motor Car. My visual inspection of the various mechanical components of the Motor Car's braking system, including its brake caliper (circled), revealed all to be intact and without visible damage, indicating that the braking system was likely to be in serviceable condition at the material time of accident.

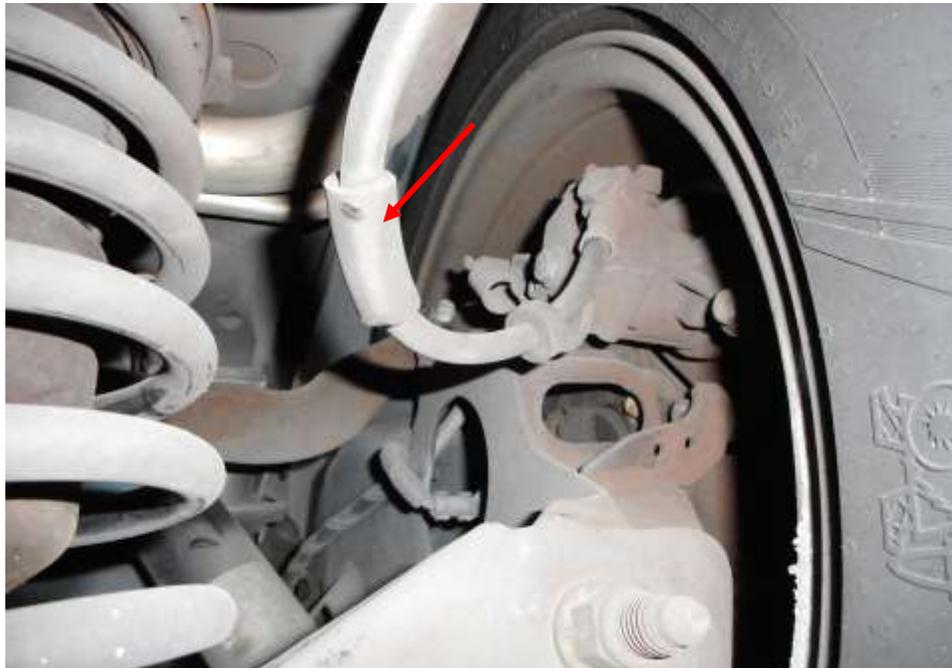
Photo 19 shows the various undercarriage components at the rear right wheel of the Motor Car, in particular the brake hose (arrowed). I did not observe any leakage of brake fluid at the 4 wheels of the Motor Car. My visual inspection of the various mechanical components of the Motor Car's braking system revealed all to be intact and without visible damage, indicating that the braking system was likely to be in serviceable condition at the material time of accident.
