Your Ref: TP/IP/70099/2018  
Our Ref : CI/TPD19002522/N

22 April 2019

**Fatal Accident Investigation Team**

**INSPECTION REPORT OF MOTORCYCLE FX 8854C**

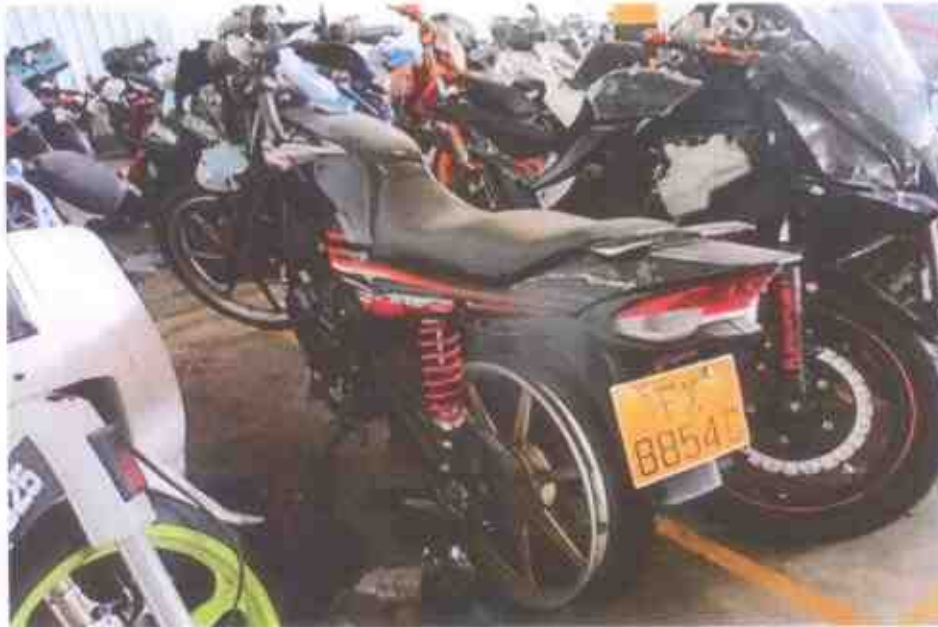
4. The mileage of the Motorcycle at the time of our inspection was 15,505km.
5. The Motorcycle was observed to have sustained damages along its left side. The body parts that were found to have been damaged include its headlamp assembly, front left signal lamp, left side mirror, clutch lever, left handlebar end, front mudguard, gear shift rod, gear shift pedal, left front footrest, left front footrest bracket, left rear side cover, rear wheel rim and rear tyre amongst others.

Photo 1 shows a general view of the left rear body of the Motorcycle at the time of our inspection. The Motorcycle was observed to have sustained damages along its left side. The mileage at the time of inspection was recorded to be 15,505km.

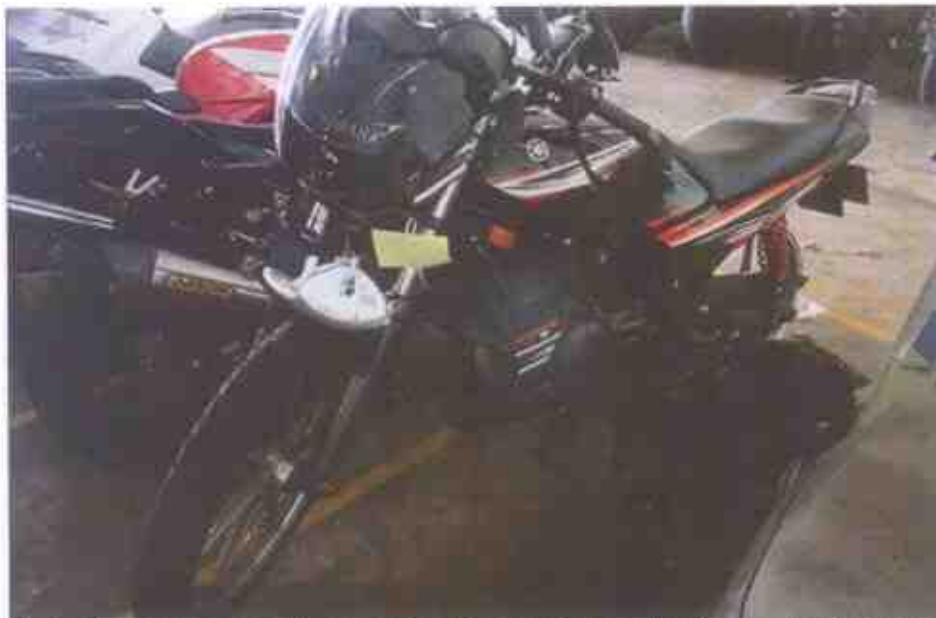
Photo 2 shows a general view of the left front body of the Motorcycle at the time of our inspection. The Motorcycle was observed to have sustained damages along its left side. Amongst the body parts that were found to have been damaged include its headlamp assembly, front left signal lamp, left side mirror, clutch lever, left handlebar end, front mudguard, gear shift rod, gear shift pedal, left front footrest, left front foot rest bracket, left rear side cover, rear wheel rim and rear tyre amongst others.

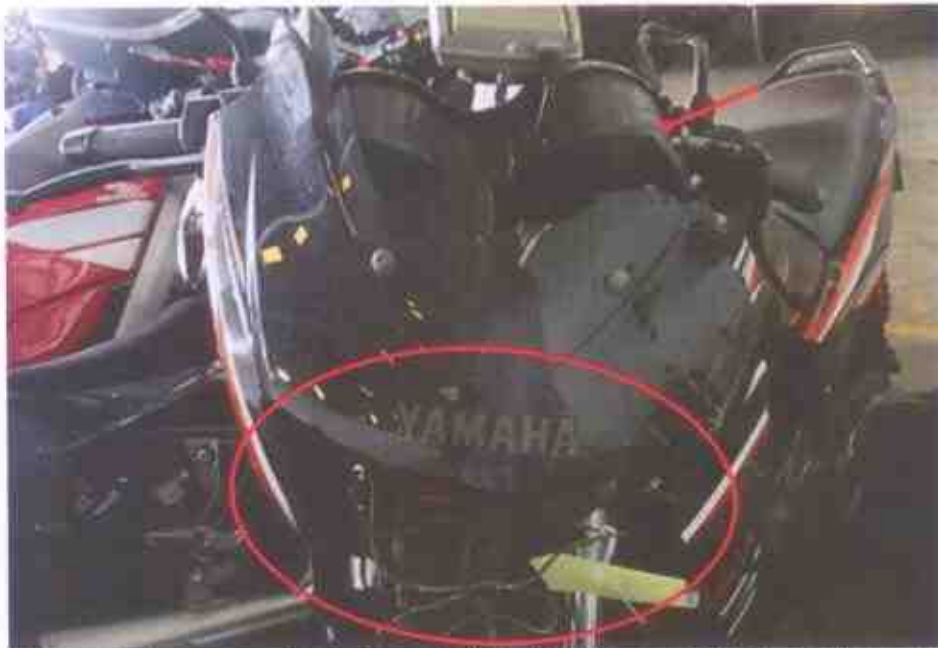
**Photo 3** shows a closer view of the headlamp assembly (circled) and speedometer (arrowed) which were amongst the body parts at the front body of the Motorcycle that had sustained damage as a result of the accident.

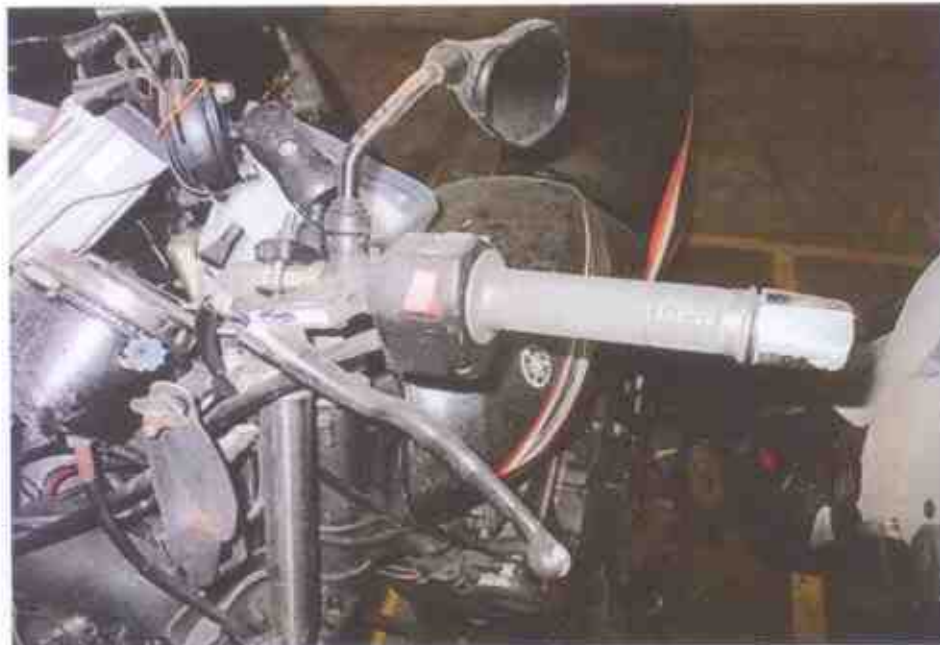
**Photo 4** shows a close up view of the left side mirror, clutch lever and left handlebar end of the Motorcycle. These parts were amongst the body parts of the Motorcycle which were damaged as a result of the accident.

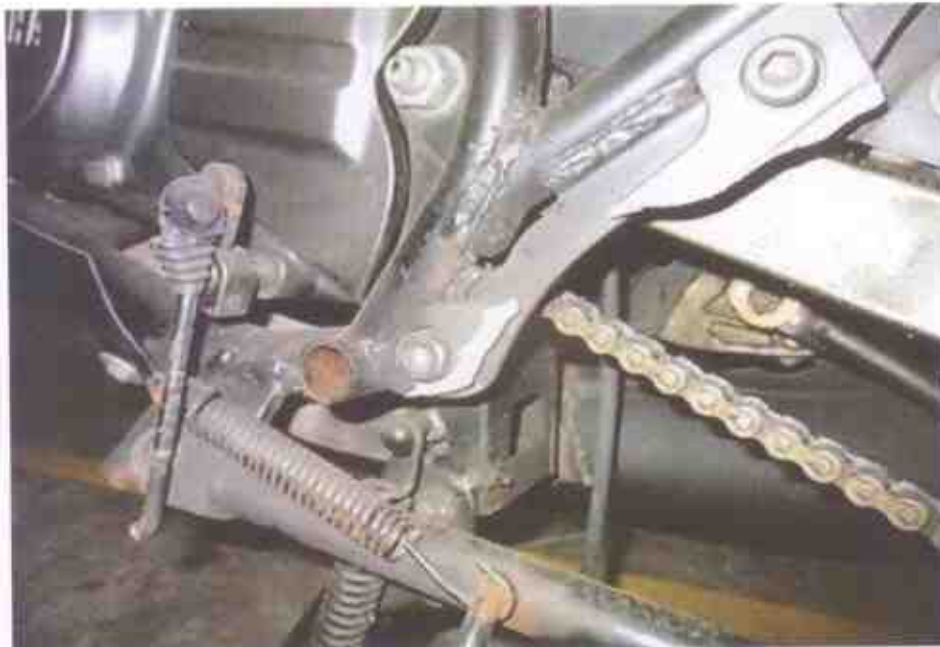
Photo 5 shows a closer view of the gear shift rod, gear shift pedal, left front footrest and left front footrest bracket, which were amongst the body parts of the Motorcycle that had sustained damage as a result of the accident.

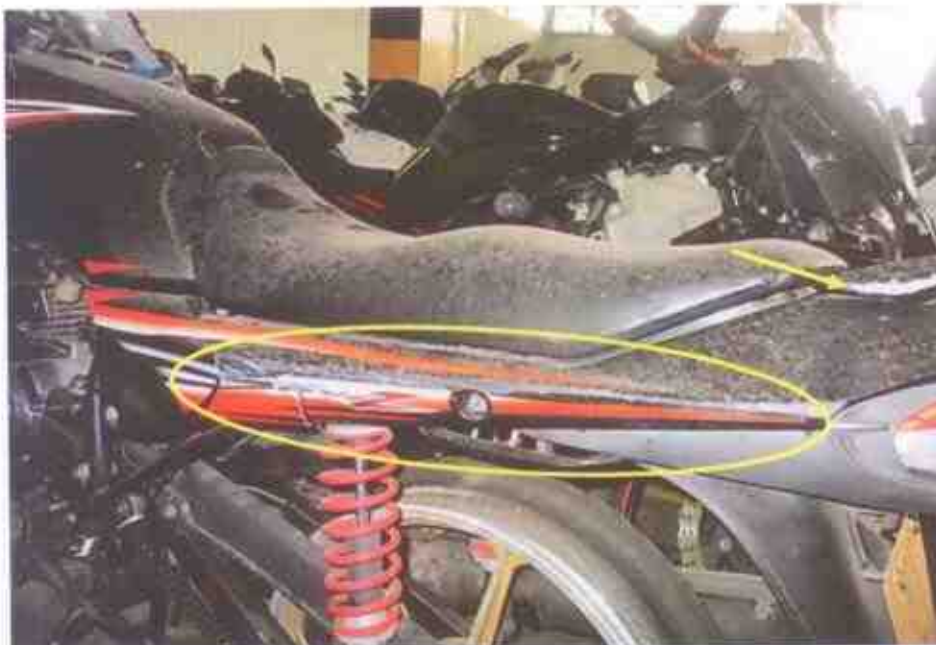
Photo 6 shows the damaged left rear side cover (circled) and pillion grab bar (arrowed) which were amongst the body parts of the Motorcycle that had sustained damage as a result of the accident.

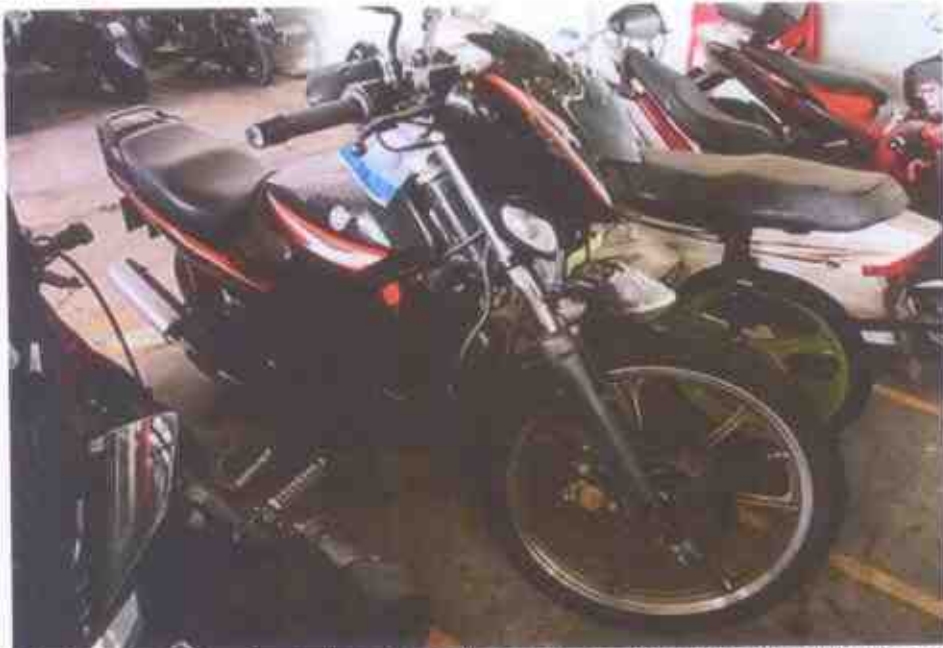
**Photo 7** shows the front wheel rim and front tyre of the Motorcycle at the time of our inspection. The front tyre was observed to be in serviceable condition with remaining tread depth of approximately 5mm. The tyre was also observed to be sufficiently inflated for vehicular operation. There was no significant damage observed on the front wheel rim.

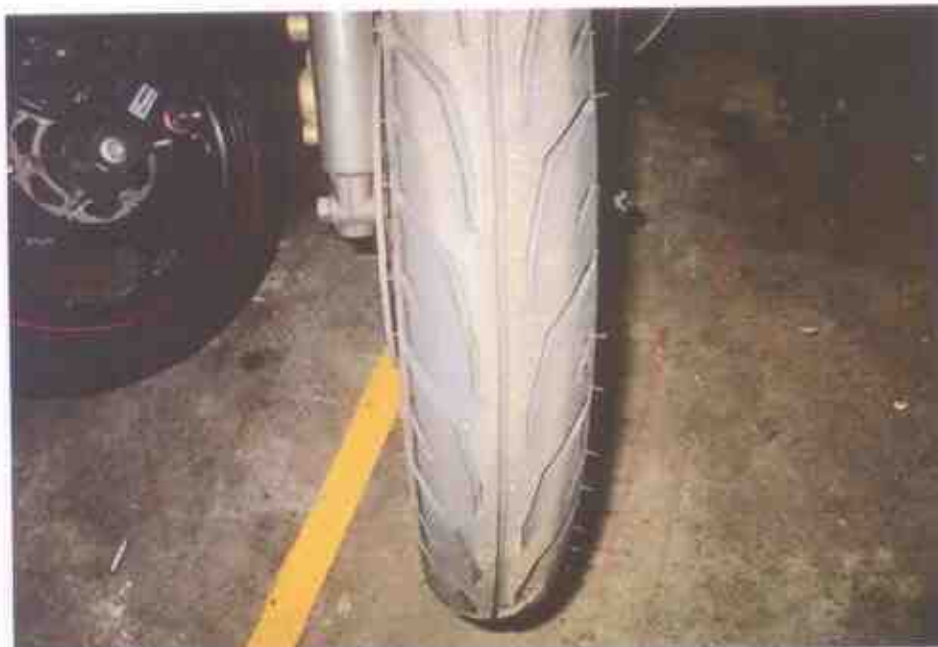
**Photo 8** shows the front tyre of the Motorcycle at the time of our inspection. The front tyre was observed to be in serviceable condition. The pattern of the tread was also clearly visible. There was no tear, burst mark(s) and/or punctured hole(s) on the sidewalls as well as across the tread of the front tyre.

17. The front tyre of the Motorcycle was found to be in serviceable condition. There was no tear, cut or burst mark(s) on the outer and the inner sidewalls as well as across its tread. The front tyre was sufficiently inflated for vehicular operation with remaining tread depth of approximately 5mm.

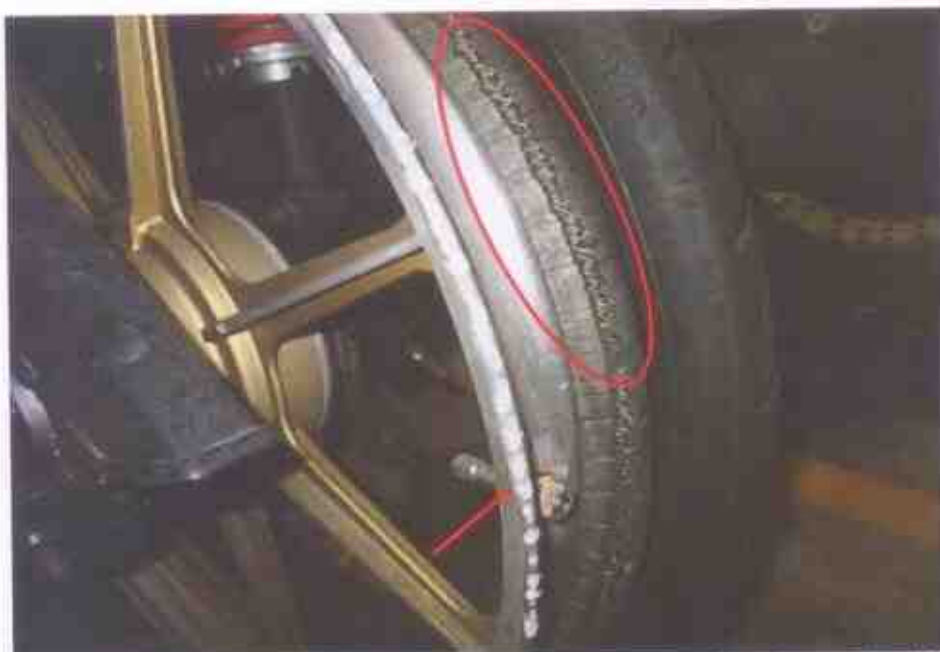
Photo 9 shows the rear tyre of the Motorcycle at the time of our inspection. We observed that the left sidewall of the rear tyre had burst (circled). The tread pattern of the rear tyre was clearly visible with remaining tread depth of approximately 5mm. The rear rim had sustained significant damage due to the burst left sidewall of the rear tyre (arrowed).

15. We were not able to conduct any operational test(s) on the Motorcycle's rear braking system due to the damage of its rear tyre and rim. The left sidewall of the rear tyre had burst and caused significant damage to the rear rim. As a result of this, we could not release the Motorcycle from its main stand to conduct the operational test on the Motorcycle's rear braking system. See photos 16 - 19 below.

18. The rear tyre on the other hand was observed to have burst at the left outer sidewall as a result of the accident. The rear tyre had sufficient remaining tread depth of approximately 5mm.

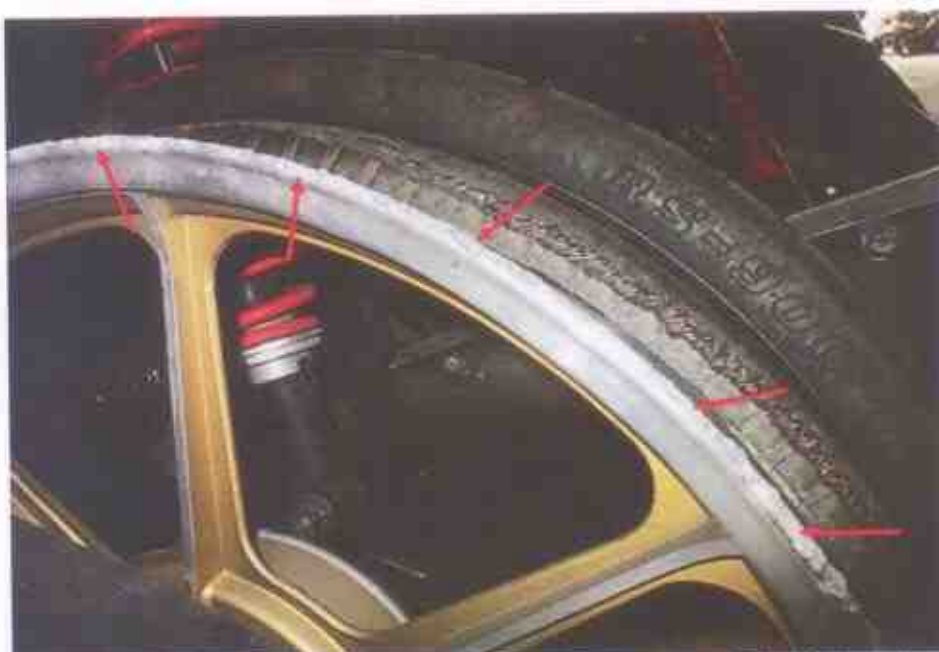
9. The 2 tyres were wrapped around alloy wheel rims. At the time of our inspection, we did not observe any visible damage on the front wheel rim of the Motorcycle. We had however found some relatively minor marks of grazing nature on the edges of the rear wheel rim, at the left side of the Motorcycle. See photos 1 – 11 below

Photo 10 shows the left side of the rear wheel rim and tyre of the Motorcycle at the time of our inspection. Some relatively minor marks of grazing nature were observed on the edges of the rear wheel rim (arrowed).

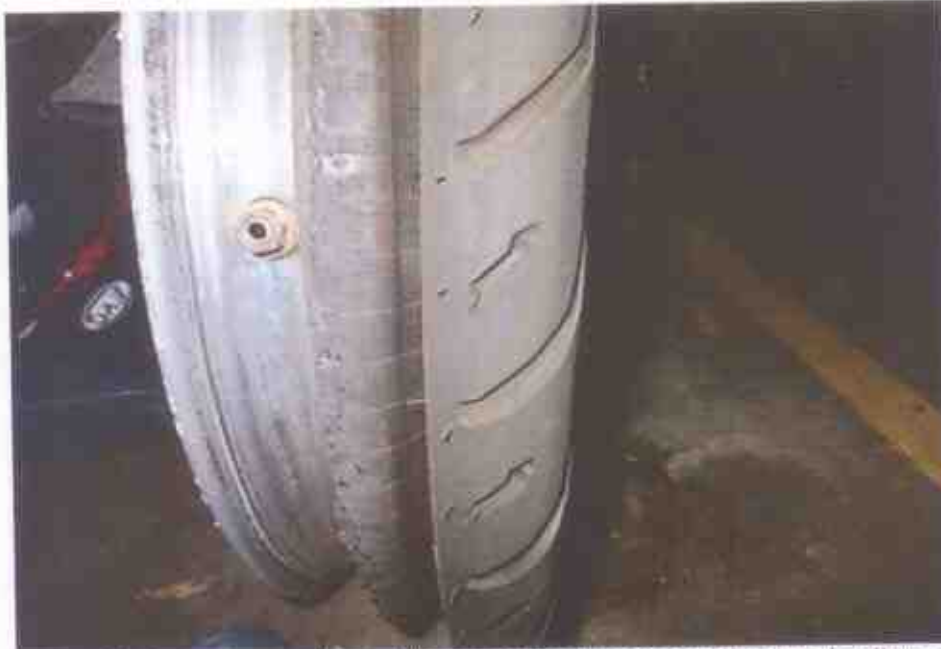
**Photo 11** shows the condition of the Motorcycle's rear tyre. The tread pattern of the rear tyre was clearly visible with remaining tread depth of approximately 5mm.

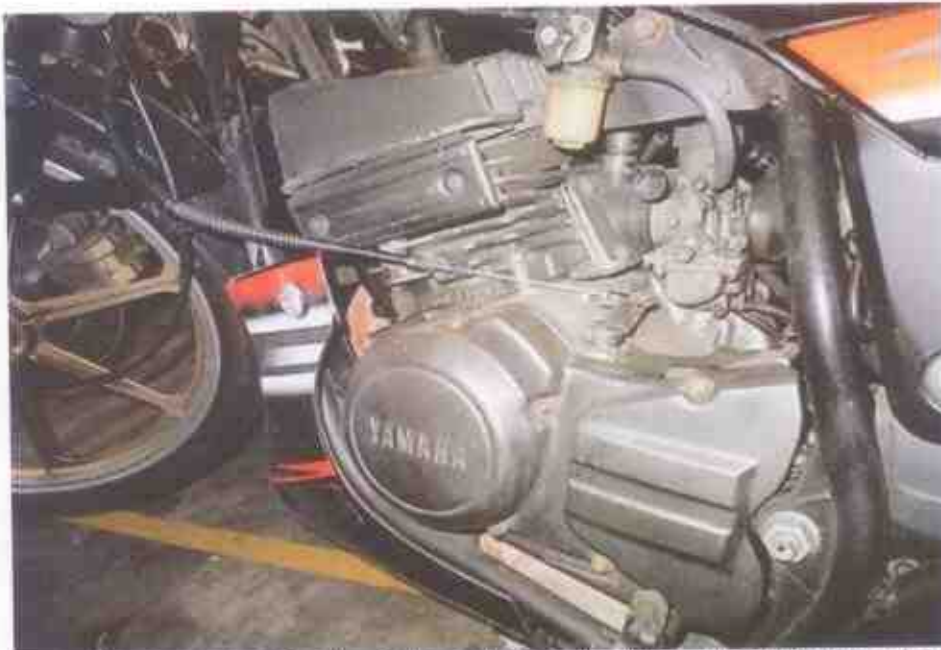
**Photo 12** shows the left side of the engine of the Motorcycle at the time of our inspection. The various engine related parts and components were found to be intact with no visible damage. There was also no sign(s) or indication(s) of fluid leak observed around the left engine area of the Motorcycle.

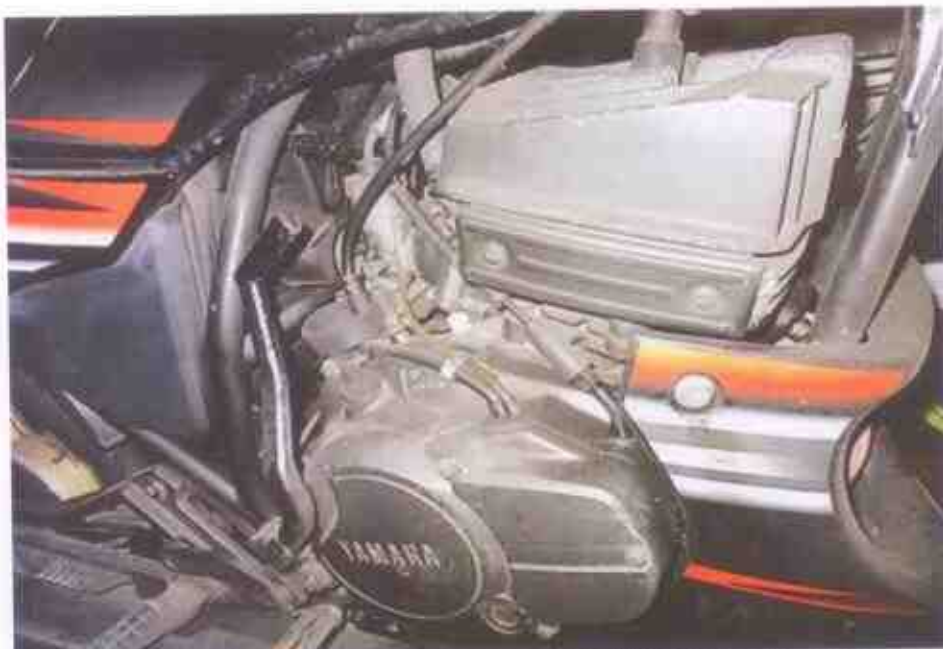
**Photo 13** shows the right side of the engine of the Motorcycle at the time of our inspection. The various engine related parts and components were found to be intact with no visible damage. There was also no sign(s) or indication(s) of fluid leak observed around the right engine area of the Motorcycle.

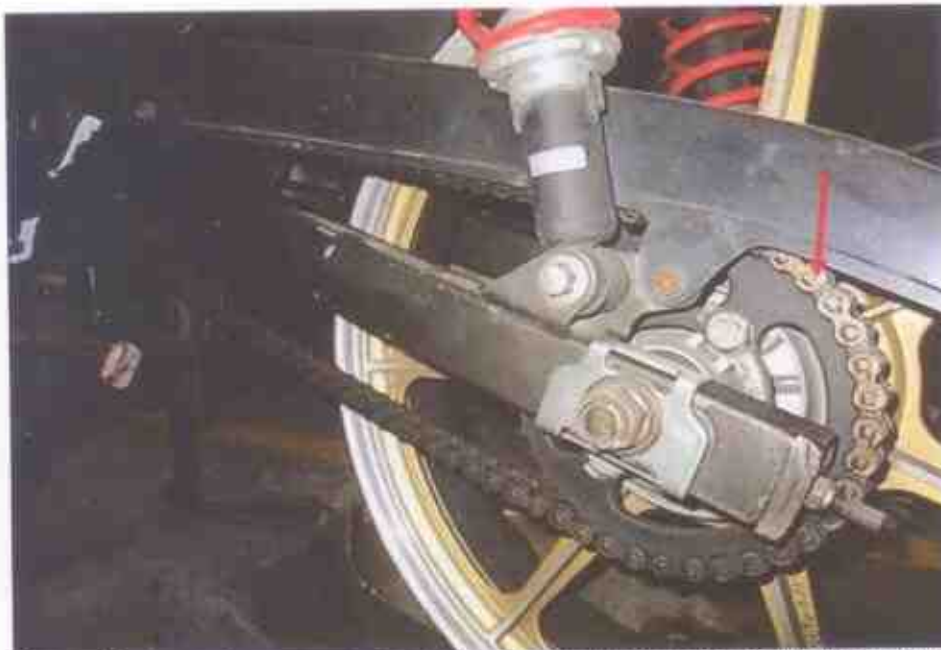
**Photo 14** shows the general view of the gear train (arrowed) of the Motorcycle, which was observed to be intact with no misalignment. It was also adequately lubricated for operating purposes.

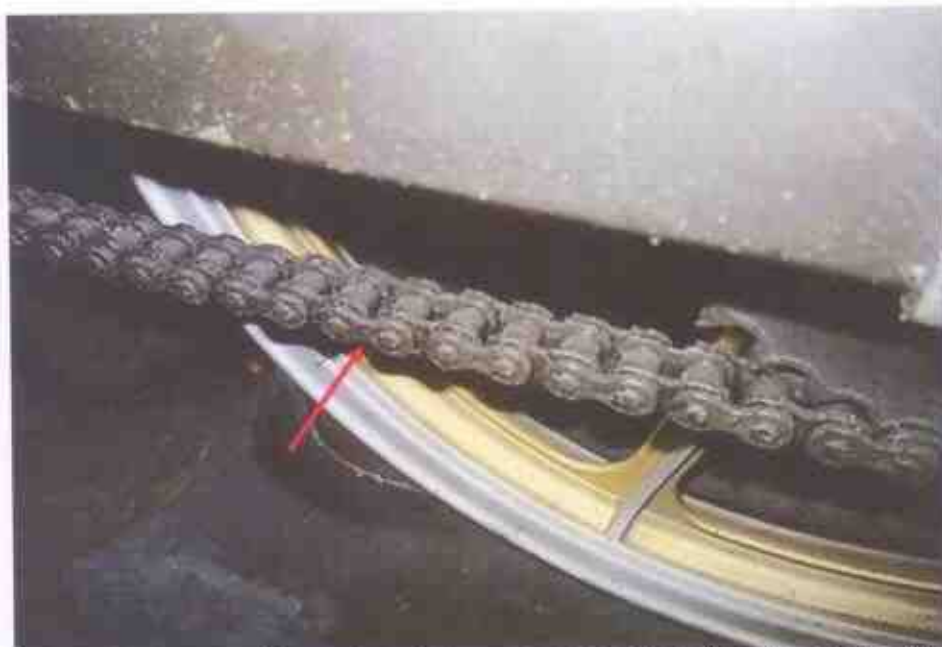
**Photo 15** shows a closer view of the gear train (arrowed) of the Motorcycle, which was observed to be intact with no misalignment. It was also adequately lubricated for operating purposes.

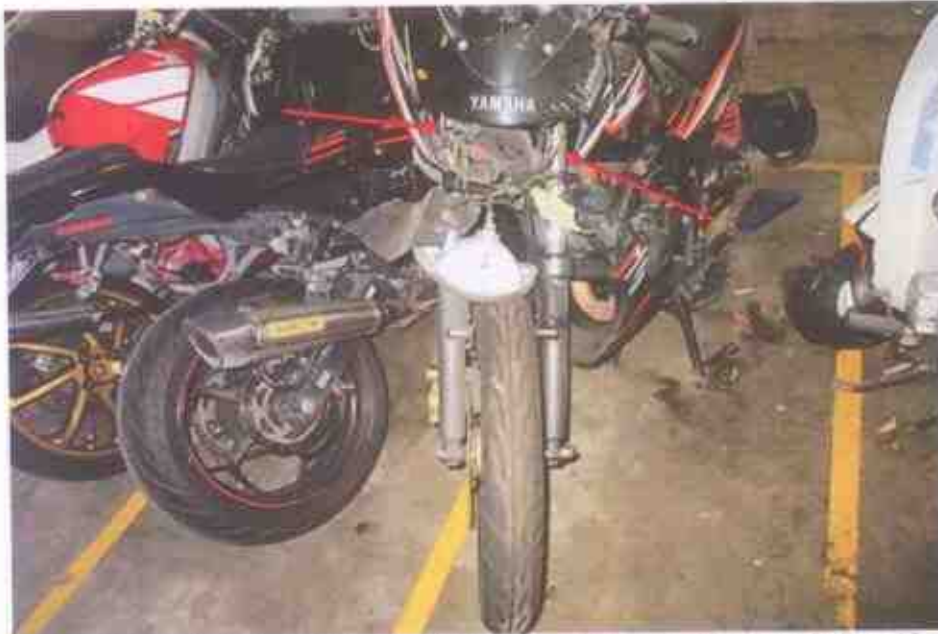
12. Our checks on the various steering components of the Motorcycle revealed that its steering system was in serviceable condition. Its front fork was found to be intact and undamaged. Turning the handle bar towards the left and right also did not produce any abnormal free play and/or resistance.

**Photo 16** shows the front fork (arrowed) of the Motorcycle. The front fork and fork bracket of the Motorcycle were both found to be intact and undamaged. Turning the Motorcycle's handle bar towards the left and right did not produce any abnormal free play and/or resistance. The steering system of the Motorcycle was in serviceable condition at the time of our inspection.

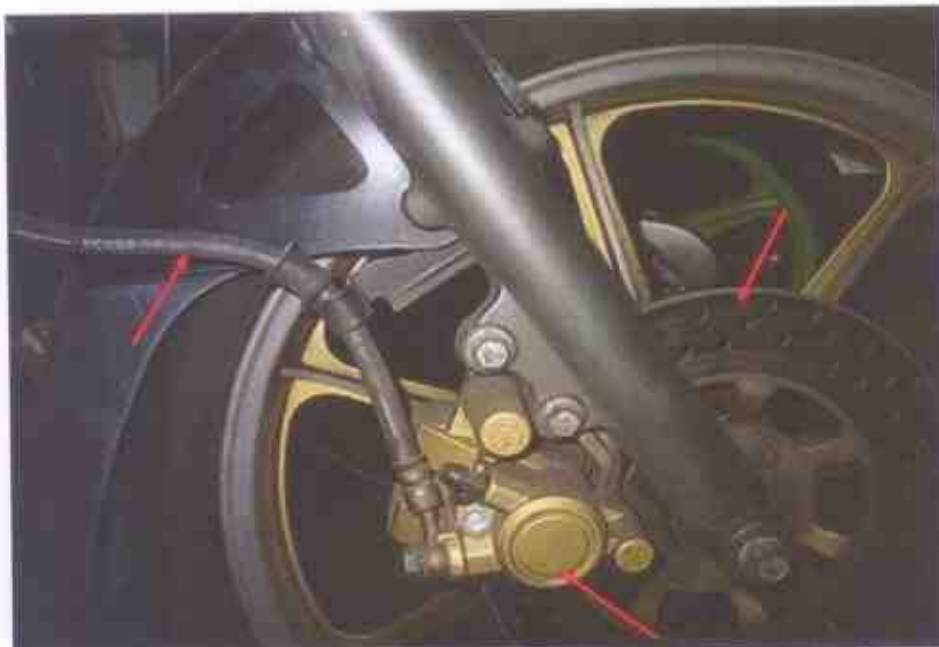
**Photo 17** shows a close up view of the front brake caliper, front brake disc and front brake hose (arrowed) of the Motorcycle, which are all part of the components in the hydraulic front brake system of the Motorcycle. Our visual checks of these various components had revealed all to be intact with no visible damage. No leakage of brake fluid was also observed.

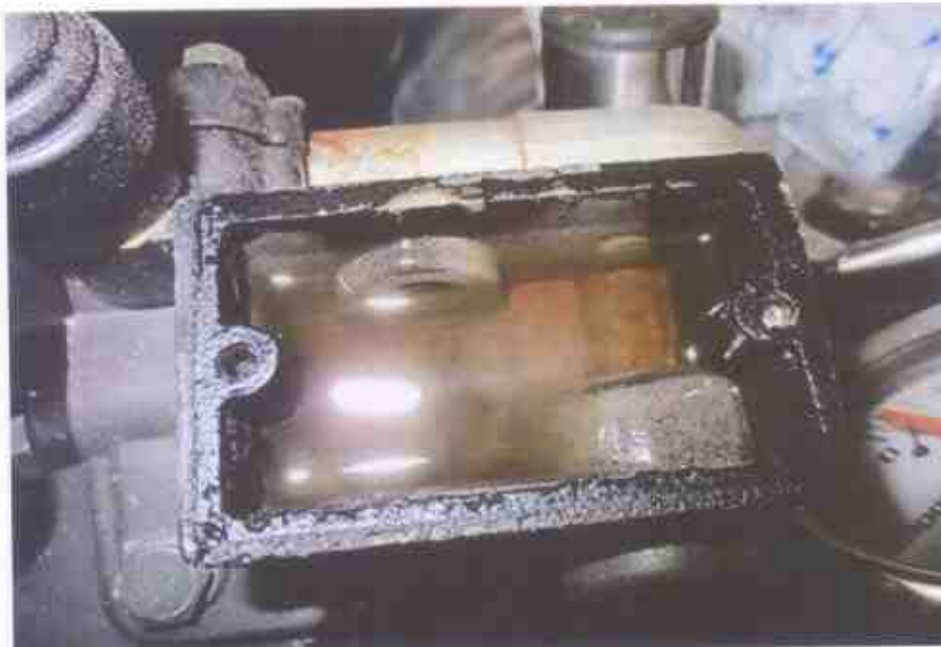
**Photo 18** shows the brake fluid reservoir for the front brake of the Motorcycle. The brake fluid was observed to be of sufficient level and without contamination for operational purposes.

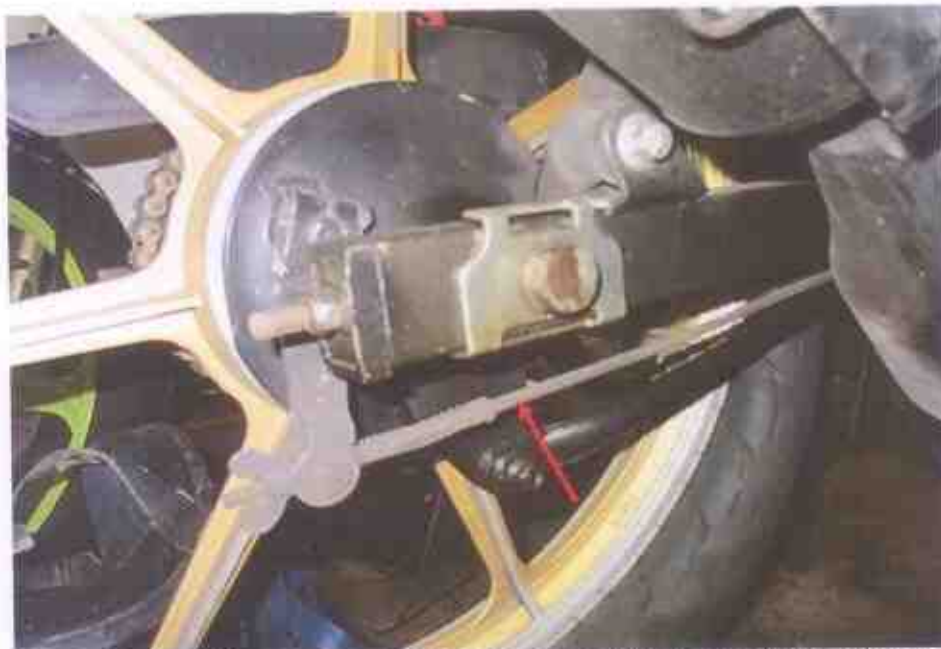
**Photo 19** shows the rear wheel of the Motorcycle. The type of brake system for the rear wheel was of a mechanical type, controlled by the brake foot pedal of the Motorcycle. Our checks of the cable (arrowed), spring and drum which are all part of the components in the rear brake system of the Motorcycle reveal all to be intact and without damage.
