Your Ref: TP/IP/70407/2018
Our Ref : CI/TPD19002525/N

Fatal Accident Investigation Team

MECHANICAL INSPECTION REPORT OF MOTOR CAR SJM 5556T

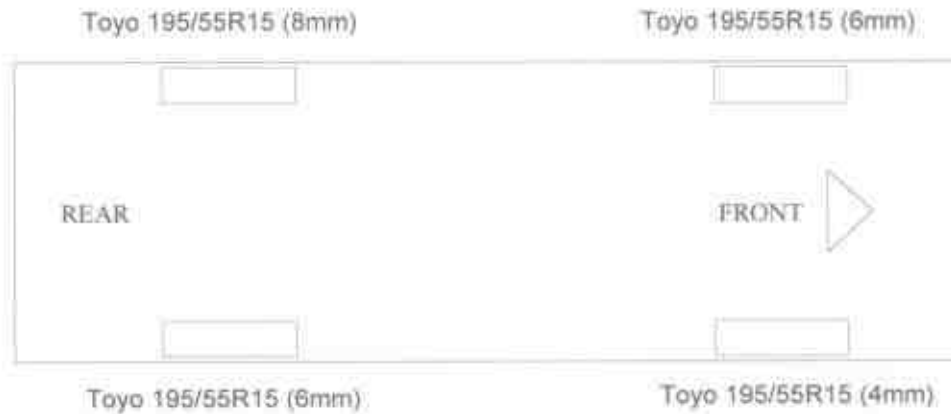
6. The condition of the Motor Car's 4 tyres was observed to be in serviceable condition. We did not find any tear, cut or burst mark(s) on the outer and the inner sidewalls as well as across the tread of the 4 tyres. The 4 tyres were also observed to be sufficiently inflated for vehicular operation. The tyre brand, tyre size and remaining tread depth of the 4 tyres were recorded as follows:-

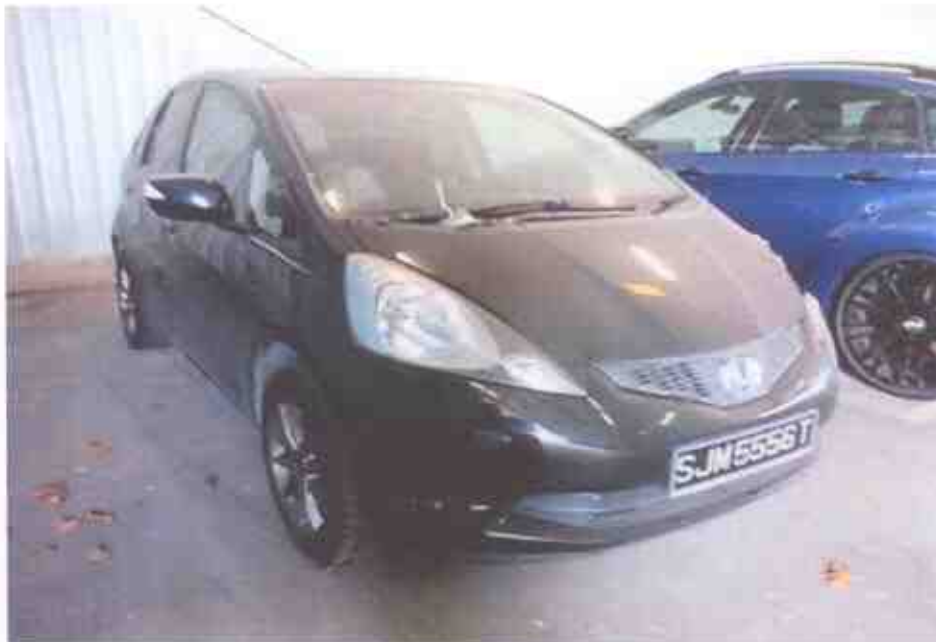
Photo 1 shows a general view of the front right body of the Motor Car at the time of our inspection. The Motor Car was observed to be in good general condition except for some relatively minor impact damage at its left frontal portion. The mileage of the Motor Car was recorded to be 118, 914km.

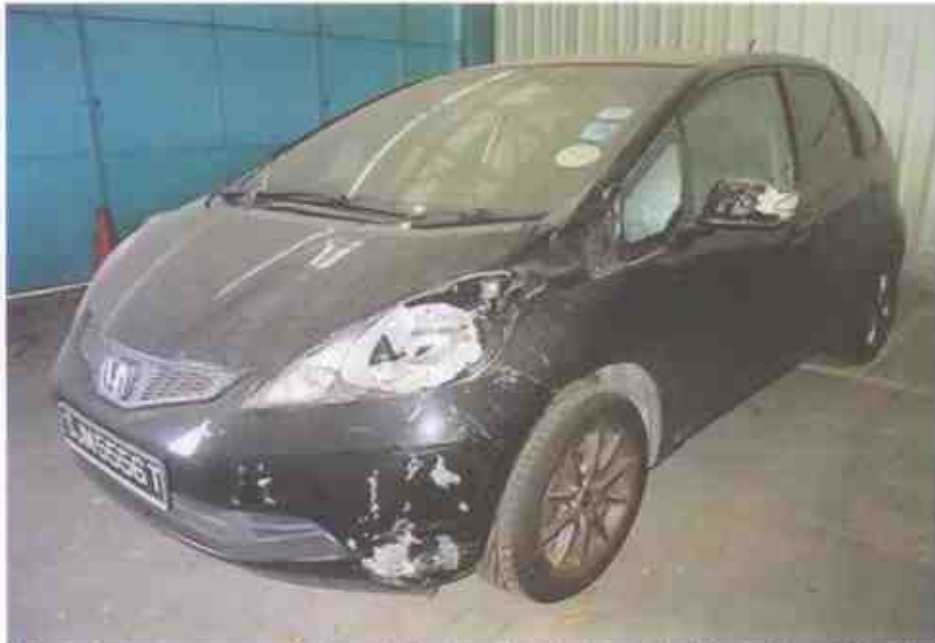
4. The mileage of the Motor Car at the time of our inspection was 118, 914km.
5. The Motor Car had sustained relatively minor impact damage that was confined to its left frontal portion. Its front bonnet and left front fender was observed to have been dented; its front bumper was observed to have cracked; its left front door quarter glass was observed to have shattered while its left side mirror cover was observed to be missing.

Photo 2 shows a general view of the front left body of the Motor Car at the time of our inspection. The Motor Car was observed to be in good general condition. However we had observed relatively minor impact damage that was confined to its left frontal portion. Its front bonnet and left front fender was observed to have been dented at the left portion; its front bumper was observed to have cracked; its left front door quarter glass was observed to be shattered while its left side mirror cover was observed to be missing.

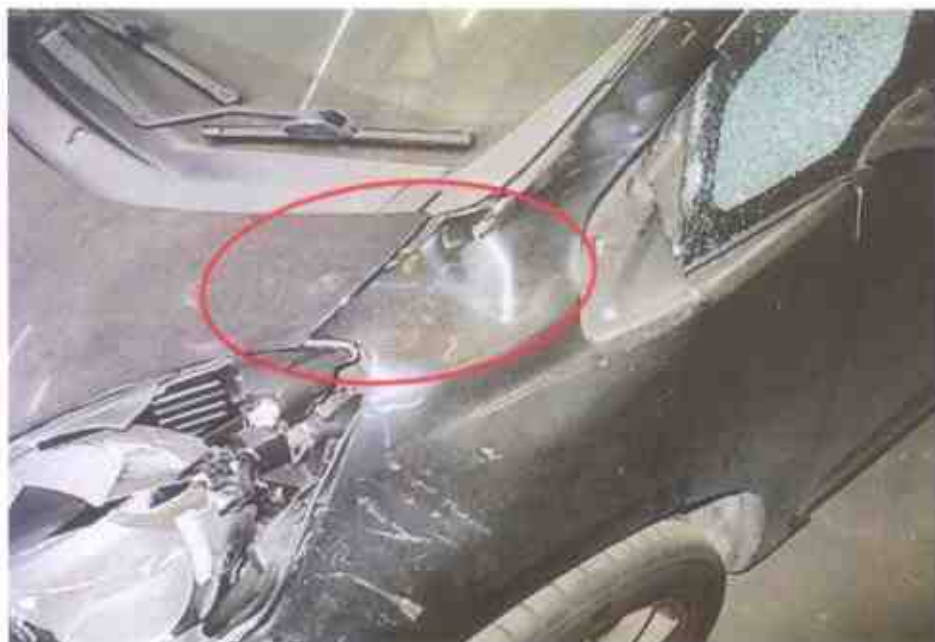
Photo 3 shows a closer view of the dented front bonnet and left front fender of the Motor Car at the time of our inspection (circled).

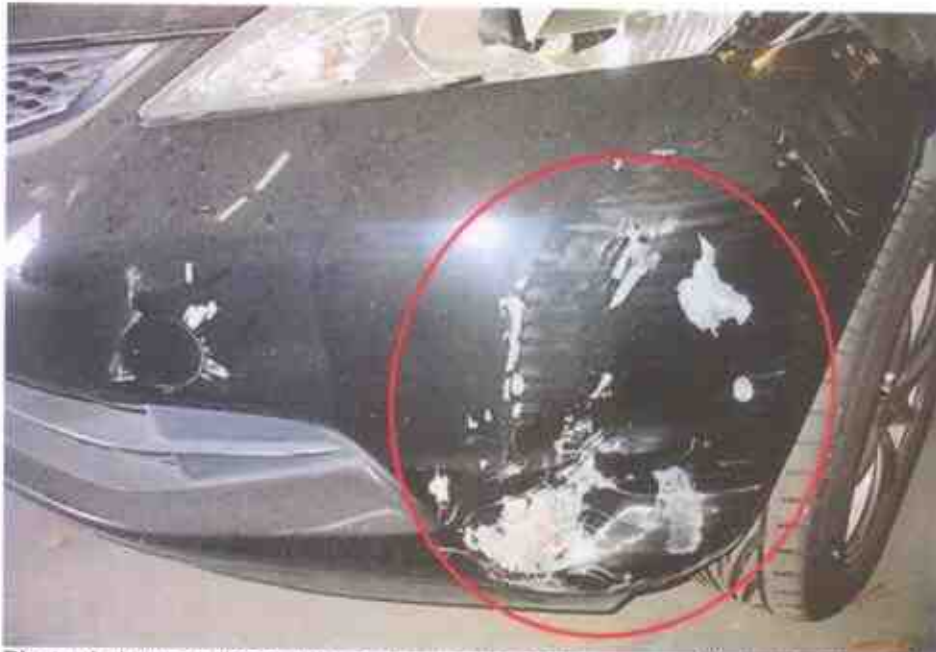
Photo 4 shows a closer view of the cracked front bumper of the Motor Car at the time of our inspection (circled).

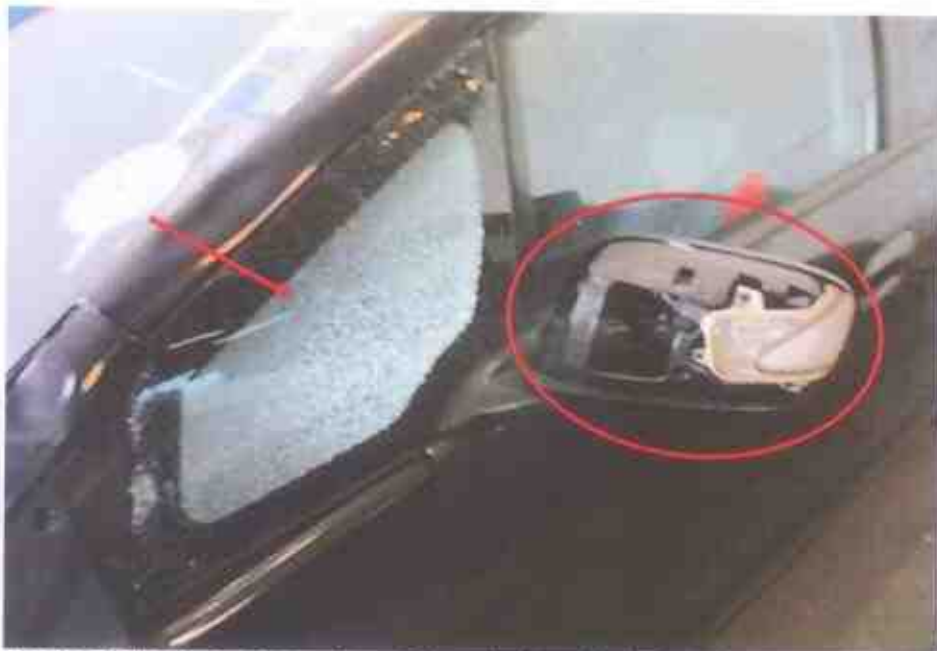
Photo 5 shows a closer view of the shattered left front door quarter glass (arrowed) as well as the missing left side mirror cover (circled) of the Motor Car at the time of our inspection.

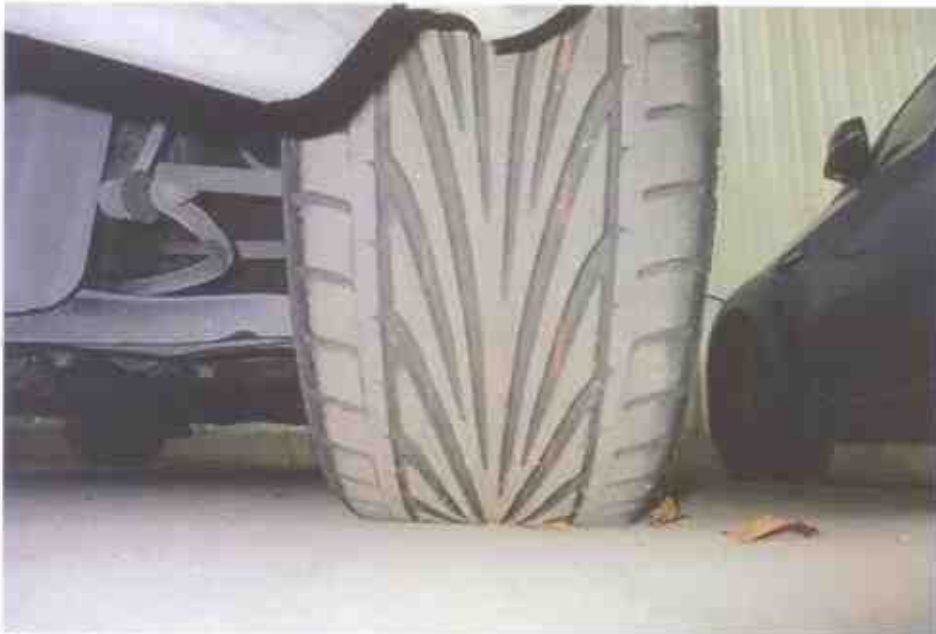
Photo 6 shows the condition of the front left tyre of the Motor Car, which was observed to be in serviceable condition with remaining tread depth of approximately 6mm. The tyre, which was wrapped around alloy wheel rim, was also observed to be sufficiently inflated for vehicular operation. There was no tear, cut or burst mark(s) on the outer and the inner sidewalls as well as across the tread of the 4 tyres.

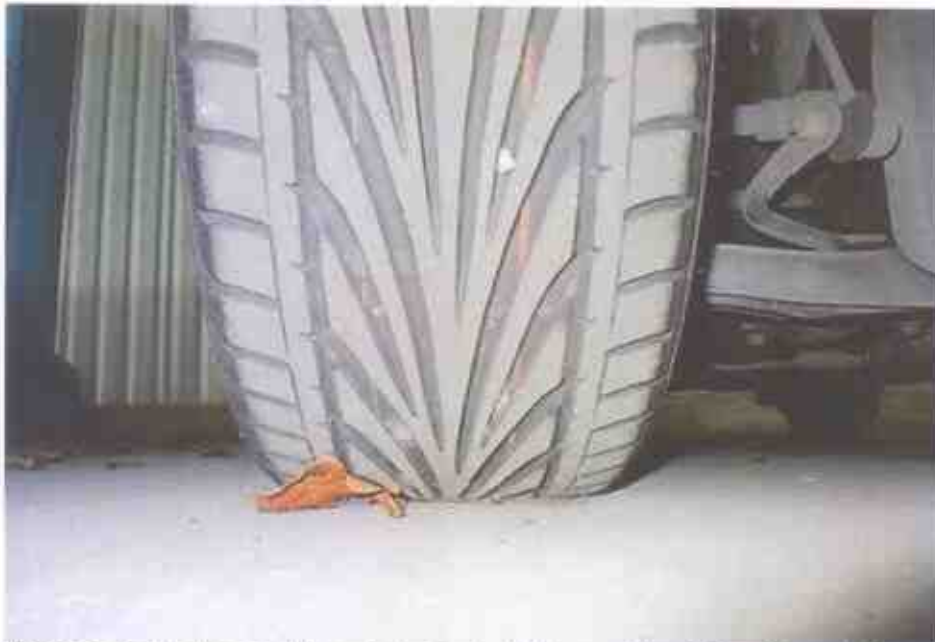
Photo 7 shows the condition of the front right tyre of the Motor Car, which was observed to be in serviceable condition with remaining tread depth of approximately 4mm. The tyre, which was wrapped around alloy wheel rim, was also observed to be sufficiently inflated for vehicular operation.

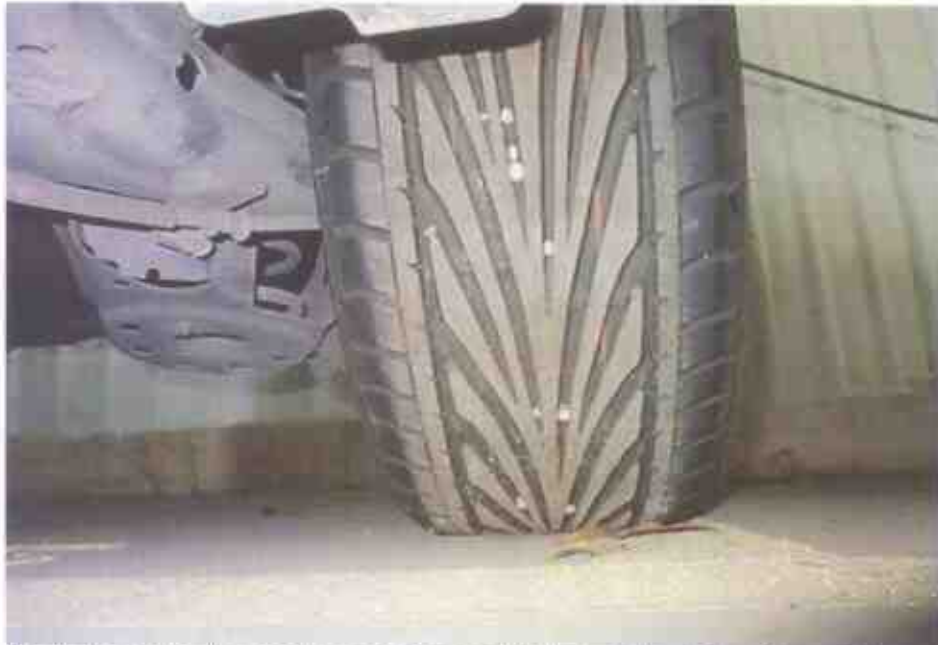
Photo 8 shows the condition of the rear left tyre of the Motor Car, which was observed to be in serviceable condition with remaining tread depth of approximately 8mm. The tyre, which was wrapped around alloy wheel rim, was also observed to be sufficiently inflated for vehicular operation. There was also no damage found on the 4 wheel rims of the Motor Car.

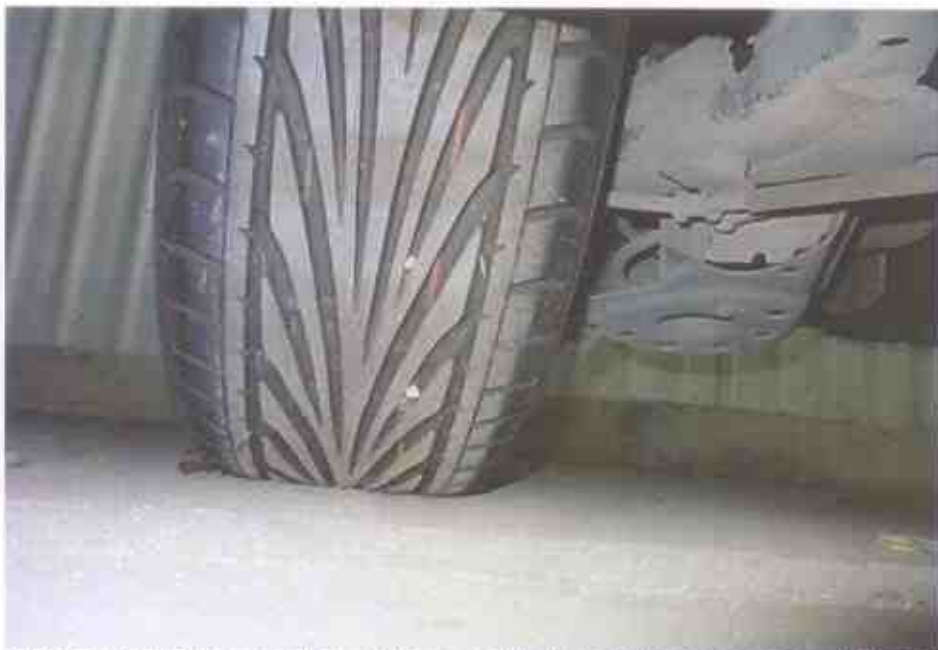
Photo 9 shows the condition of the rear right tyre of the Motor Car, which was observed to be in serviceable condition with remaining tread depth of approximately 6mm. There was also no tear, cut or burst mark(s) on the outer and the inner sidewalls as well as across the tread of the 4 tyres.

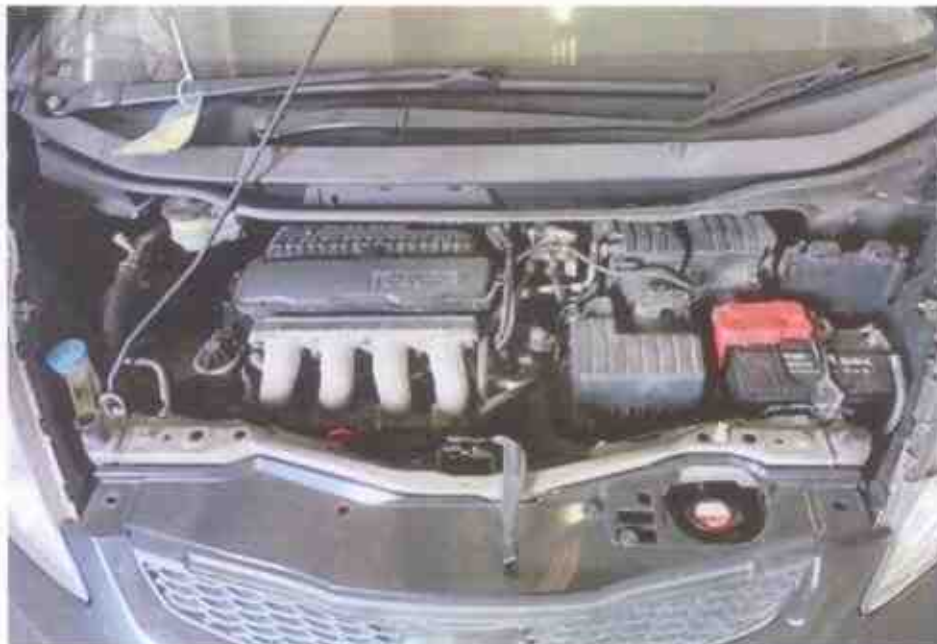
Photo 10 shows a general view of the Motor Car's engine compartment. The various parts and components inside the engine compartment were unaffected by the accident. There was also no sign(s) or indication(s) of fluid leakage and/or fluid stain within the engine compartment.

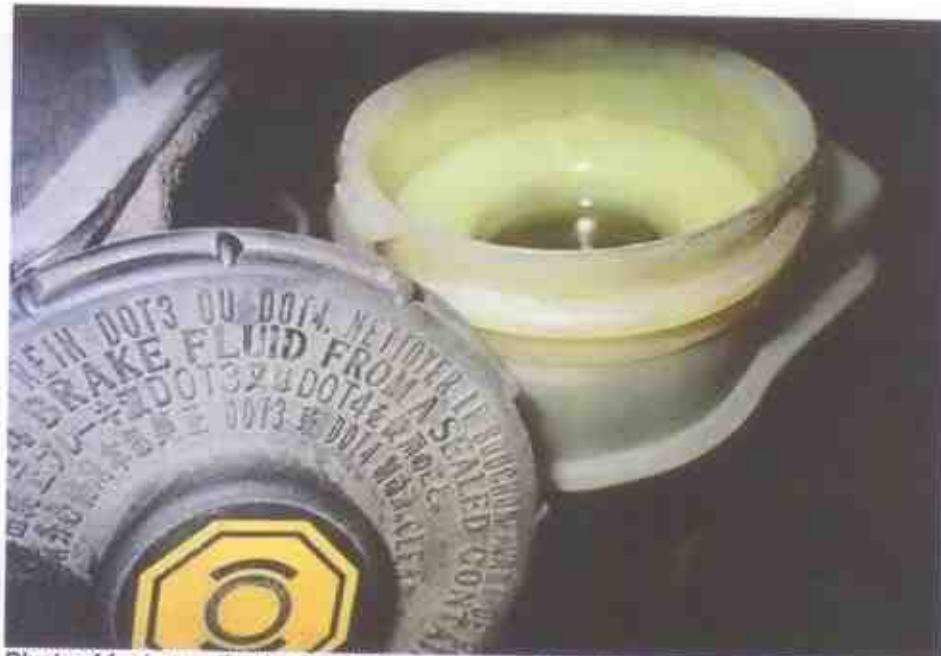
Photo 11 shows the brake fluid reservoir of the Motor Car at the time of our inspection. The brake fluid was observed to be of sufficient level and without any visible contamination.

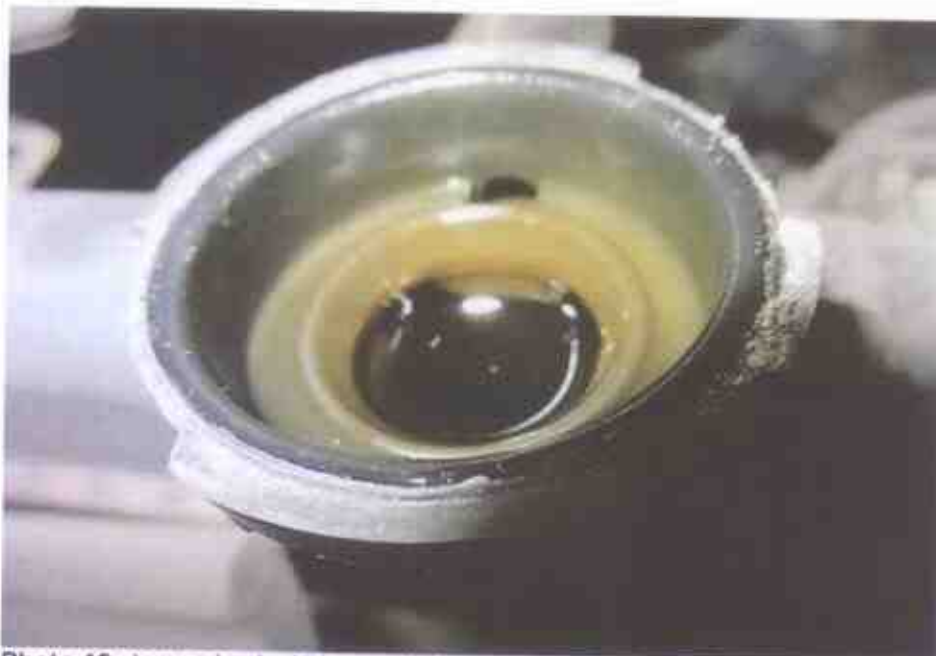
Photo 12 shows checks being carried out to the engine coolant of the Motor Car at the time of our inspection. The engine coolant was observed to be of sufficient level and without any visible contamination.

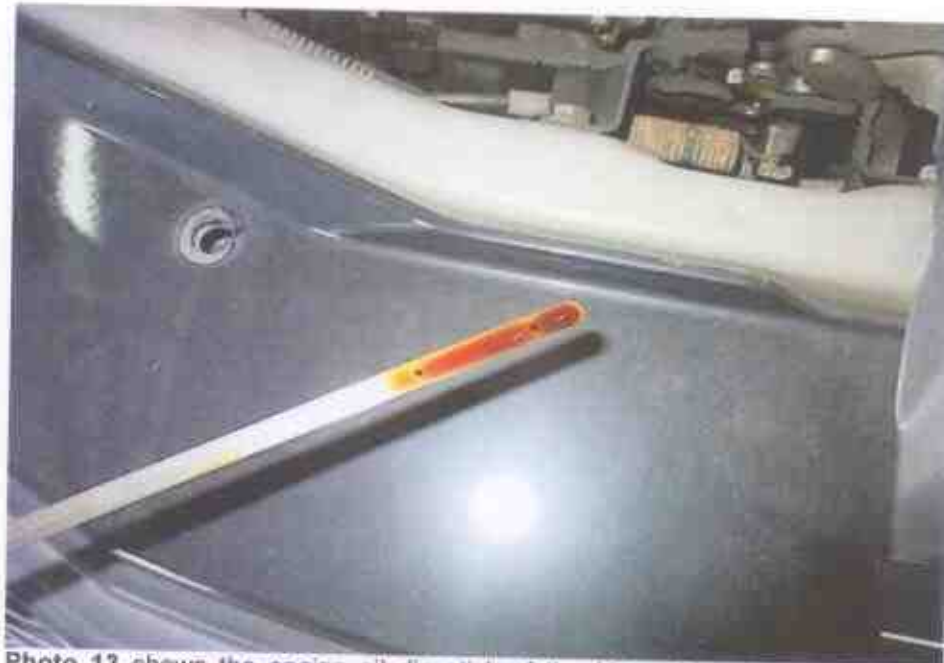
Photo 13 shows the engine oil dip stick of the Motor Car at the time of our inspection. The engine oil was observed to be of sufficient level and without any visible contamination.

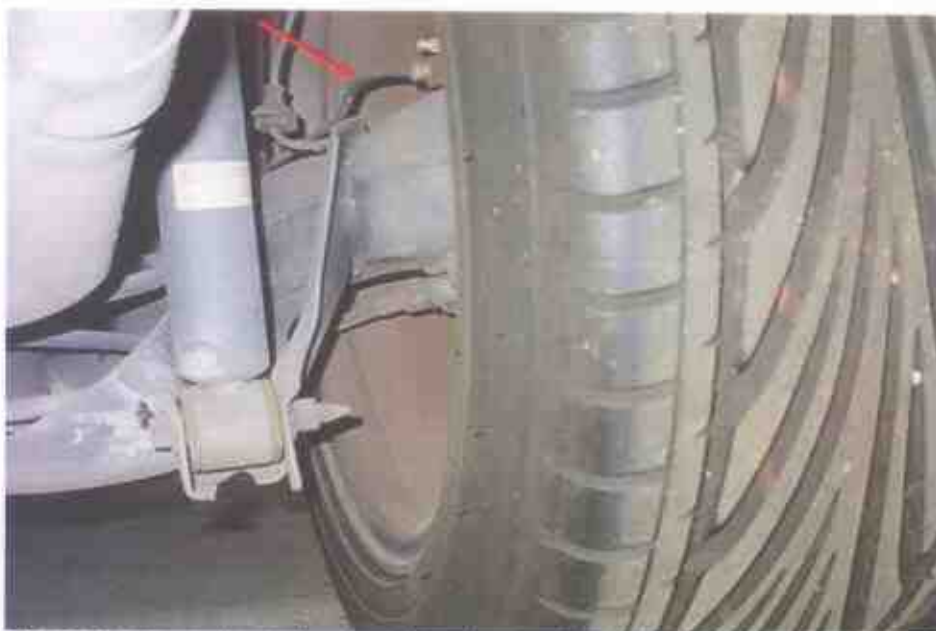
11. Static brake tests conducted on the Motor Car revealed no abnormality. There was no abnormal movement of the brake pedal when it was depressed. In general, the static brake tests had suggested that there was no internal leakage of pressure/vacuum in the braking system of the Motor Car. The braking system of the Motor Car was likely to be in serviceable condition at the material time. This was taking into consideration that the brake fluid was of sufficient level, and also that there was no sign(s) of brake fluid leakage along the brake hoses and brake pipes.

Photo 14 shows the brake hose/pipe (arrowed) at the rear right wheel of the Motor Car. We did not observe any leakage of brake fluid at the time of our inspection of the Motor Car. Static tests of the Motor Car's braking system had indicated that there was no internal leakage of pressure/vacuum. Hence the braking system was likely to be in serviceable condition at the material time of accident. The undercarriage components of the Motor Car were also all found to be intact and without any visible damage.

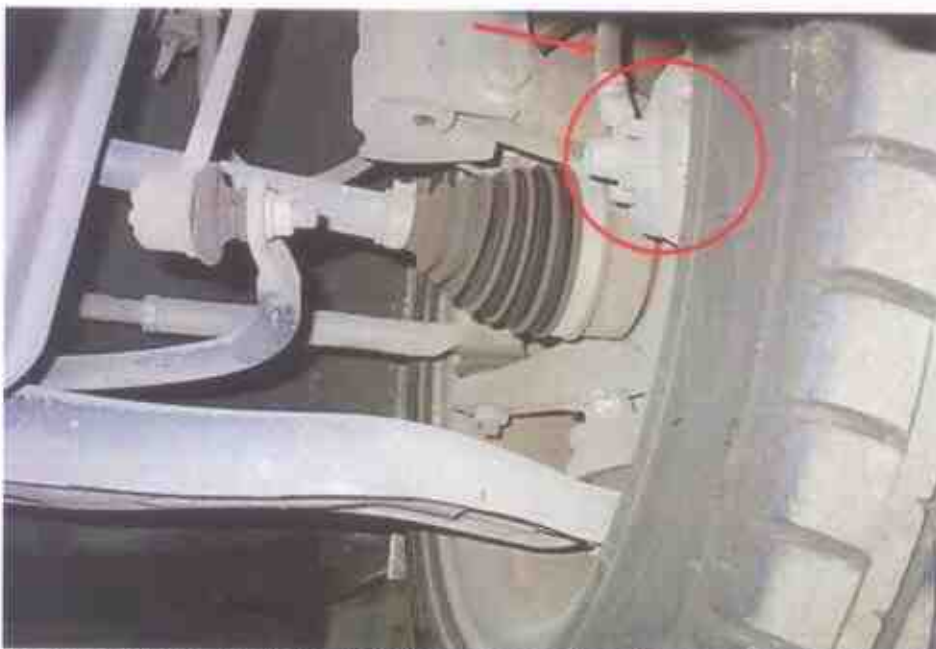
Photo 15 shows the brake hose/pipe (arrowed) at the front left wheel of the Motor Car. No leakage of brake fluid was observed. Visual examination of the various components of the braking system like the brake caliper (circled), brake pedal etc. had revealed all to be intact and without visible damage.

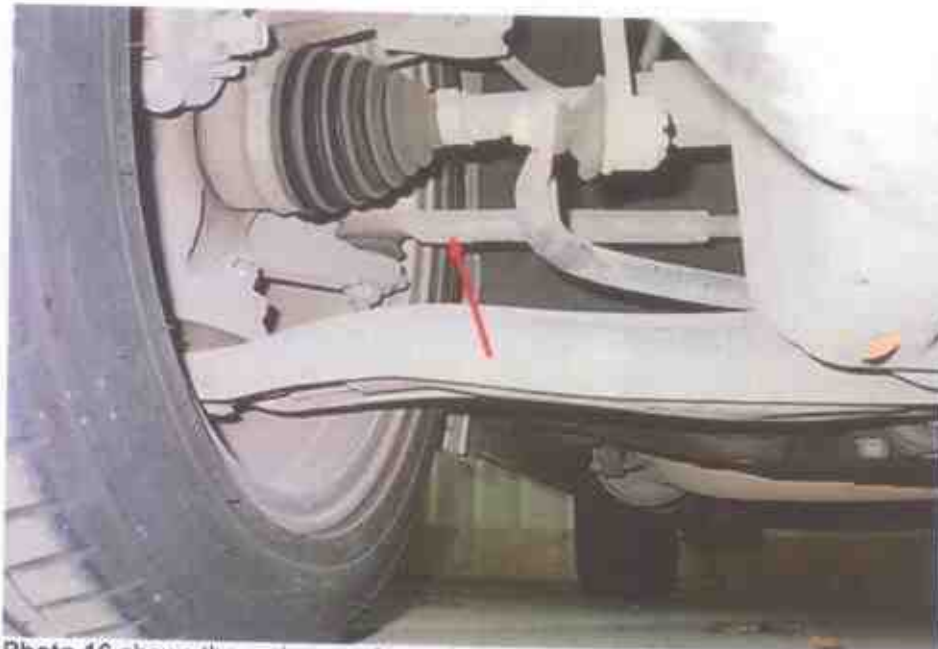
Photo 16 shows the various undercarriage components at the front right wheel of the Motor Car, in particular the steering tie rod (arrowed). The various steering components were all found to be intact, suggesting that the steering system of the Motor Car was likely to be in serviceable condition at the material time of accident. There was also no sign of fluid stain observed on the various undercarriage components at the front right wheel of the Motor Car.

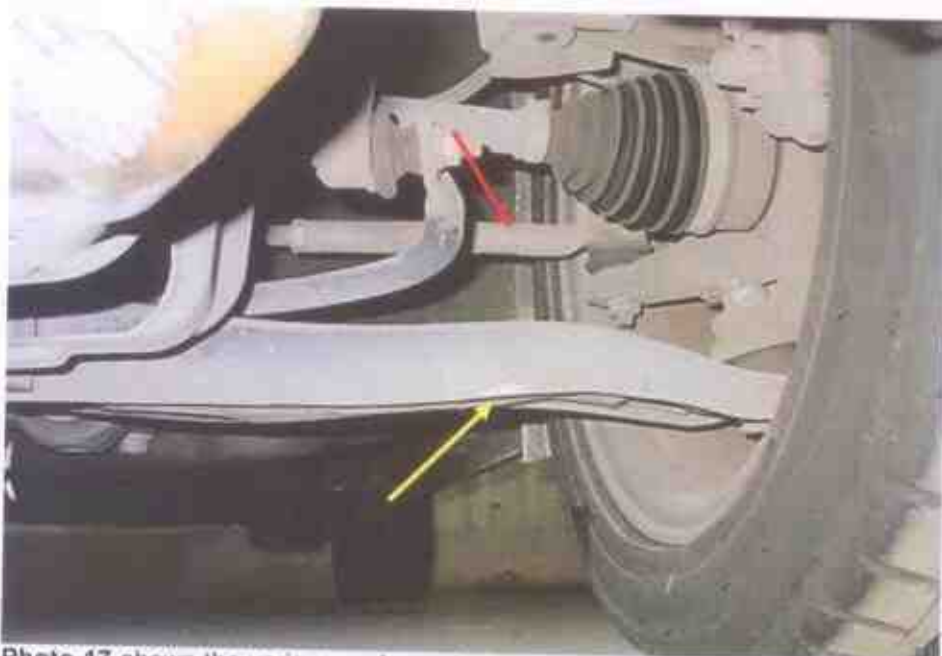
Photo 17 shows the various undercarriage components at the front left wheel of the Motor Car, which had included the steering tie rod (red arrow) and left drive shaft (yellow arrow). The various undercarriage components of the Motor Car were all found to be intact without any visible damage.

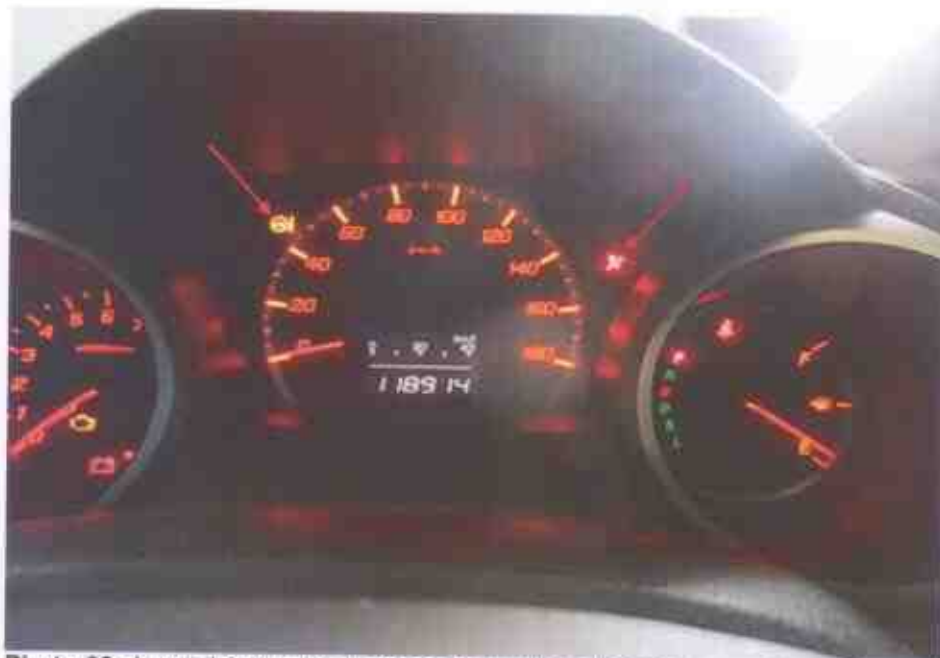
Photo 20 shows the warning lights for the various electronic operating systems of the Motor Car appearing on its instrument panel during the self-test when the engine is cranked, in particular the EPS light and SRS light (arrowed).

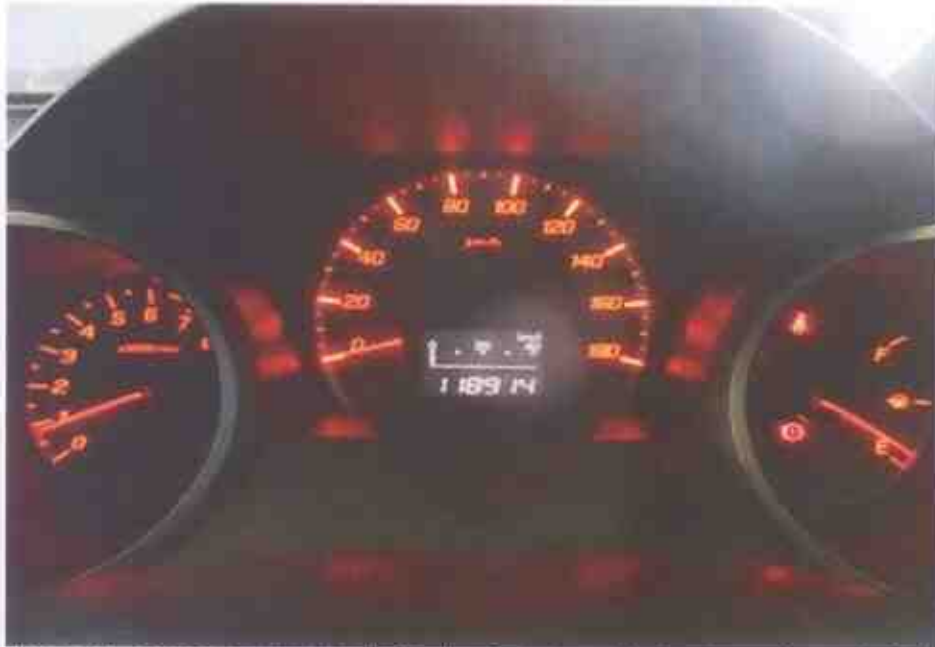
Photo 21 shows no warning lights illuminated on the instrument panel of the Motor Car after the engine was cranked. This would suggest that there was no abnormality to the various electronic operating systems of the Motor Car, like the EPS and SRS etc.
