CS/INC19003030/Dgd302

OD / TP / WS / TP RES / OD RES / EVA / INV / MV / CSTo Inspect Vehicle No: SHD 6752H Insured: SMP 6915Kat Workshop m/s Chunni Tel: 65425119of BLK 10 AMC #03-19Policy No: \_\_\_\_\_ Claim No: MT-1032145-002

### 4. Description of Damages

## ADJUSTMENT ON REPAIR COST FOR VEHICLE NO. SHD 6752H

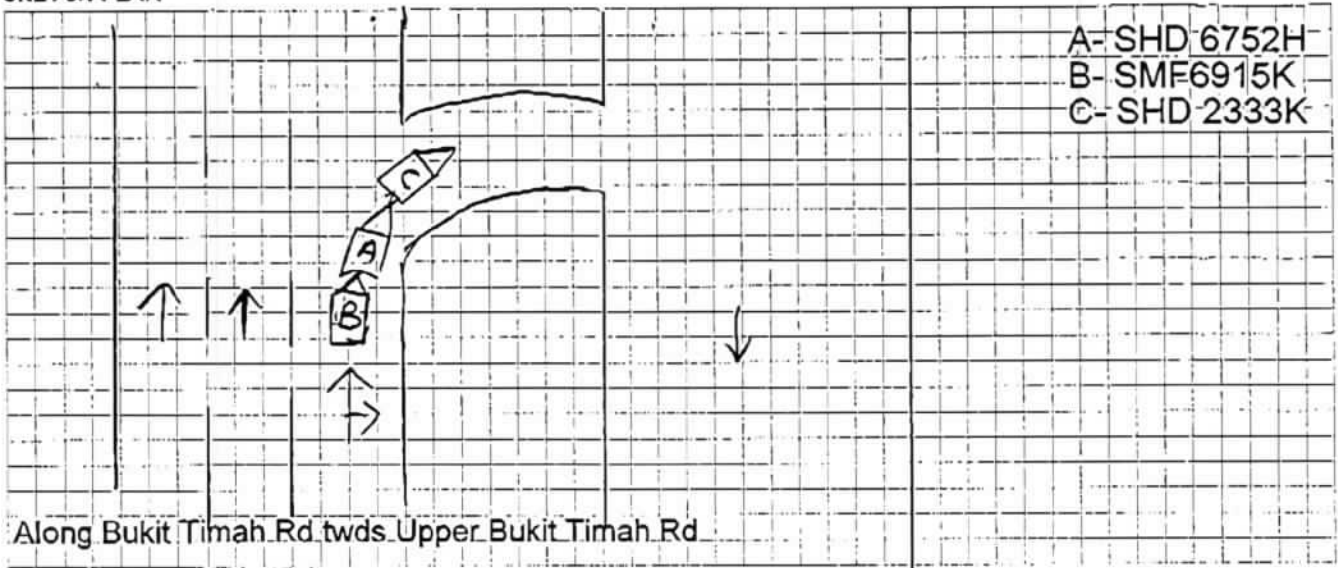
## SKETCH PLAN

As I was waiting for the veh(C) SHD 2333K slow down and stopped and I followed too. Suddenly Veh(B) SMF 6915K hit onto my vehicle rear portion and caused my vehicle to surge forward and hit veh(C) SHD 2333K
