DAMAGED VEHICLE (GBE 6905 A) INSPECTION REPORT (WITHOUT PREJUDICE)

ASSESSMENT OF REPAIRS AND SPARE PARTS COSTS FOR VEHICLE NO: GBE 6905 A

1. Policy Particulars :- THIRD PARTY CLAIM				
Insured Veh.	YN 6171E	Veh. Inspected	GBE 6905A	
Policy No.		Coverage (\$)	0.00	
Claim No.	18/18/18/VC00/021178	Excess (\$)	0.00	
Assign From	ONG LI LI	Assign Date	05/12/2018

ADJUSTMENT ON REPAIR COST FOR VEHICLE NO. GBE 6905A

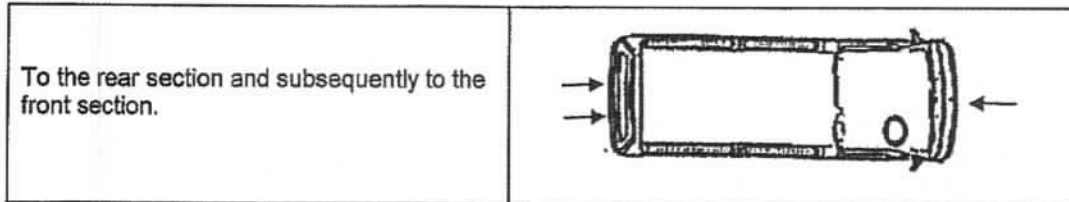
(E) Point of Impact

The impact of the collision has damaged/affected the rear LH door, rear RH door, rear bumper, front bumper and etc.

Our adjusted cost of lump sum repair is **\$13,000.00** and an estimated **10** days is required to repair the vehicle. Please refer to the Annex for a detailed account of the cost estimates.
