VEHICLE APPRAISAL REPORT

Registration No.	: SMD 6488L	Chassis Frame No.	: WAUZZZ8F6BN004566
Make / Model	: Audi A5 Cabriolet 2.0 TFSI Quattro	Engine No. (Logcard)	: CDN146096
Year of Manufacture/Reg	: 2010	Odometer Reading	: 137,752 KM
Colour	: Pink		
Class / Type	: Convertible

Affiliated to Federation Internationale Des Experts En Automobile			
LONPAC INSURANCE BHD		Ref : CS3/LPC19000449/Jvd3n2-1	
300 BEACH ROAD #17-04/07 THE CONCOURSE SINGAPORE 199555		Date : 22-02-2019

ADJUSTMENT ON REPAIR COST FOR VEHICLE NO. SMD 6488L

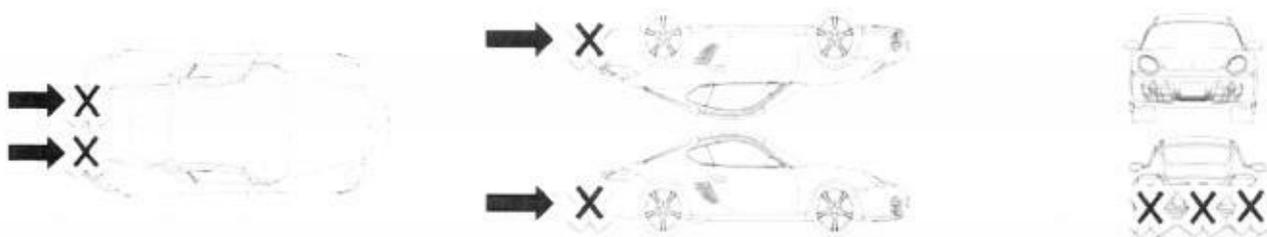
Damages sustained were consistent with the subject vehicle being involved in a collision with another vehicle and the impact was delivered **Squarely to the Rear** portion of the vehicle.

The general area of damages is at the **Rear portion**
(Please refer to the parts list and photographs as attached for more information)

The estimated repair costs submitted by Messrs **Graffiti Garage SG Pte Ltd** is \$ 11,317.47 .
We have adjusted the cost to \$ 9,726.75 and the repairer has agreed to undertake the repairs at a **Contract Lump Sum of \$ 7,800.00** to a acceptable quality and standards.
However, we have not given authorization and instruction to the repairer to proceed with the repairs.

The repairs should be completed within a reasonable period of **5** working days.
