Your Ref: TP/IP/07873/2019
Our Ref : CI/TPD19003318/Z

Fatal Accident Investigation Team

MECHANICAL INSPECTION REPORT OF MOTOR CAR SKK 34P

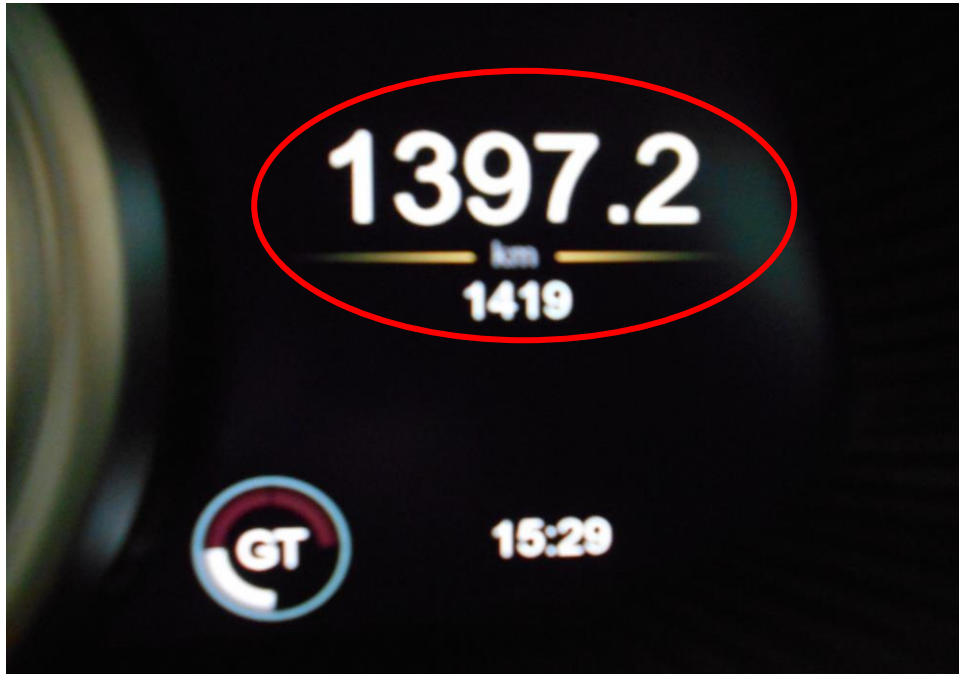
4. The mileage of the Motor Car at the time of our inspection was recorded at 1397.2km.
5. The Motor Car had sustained a relatively minor impact damages that was confined to its frontal left portion. It's lower left bonnet, left side fender, left hand headlamp and lower left windshield was observed to be damaged likely due to the accident.

Photo 1 shows the mileage of the Motor Car at the time of our inspection was recorded at 1397.2km.

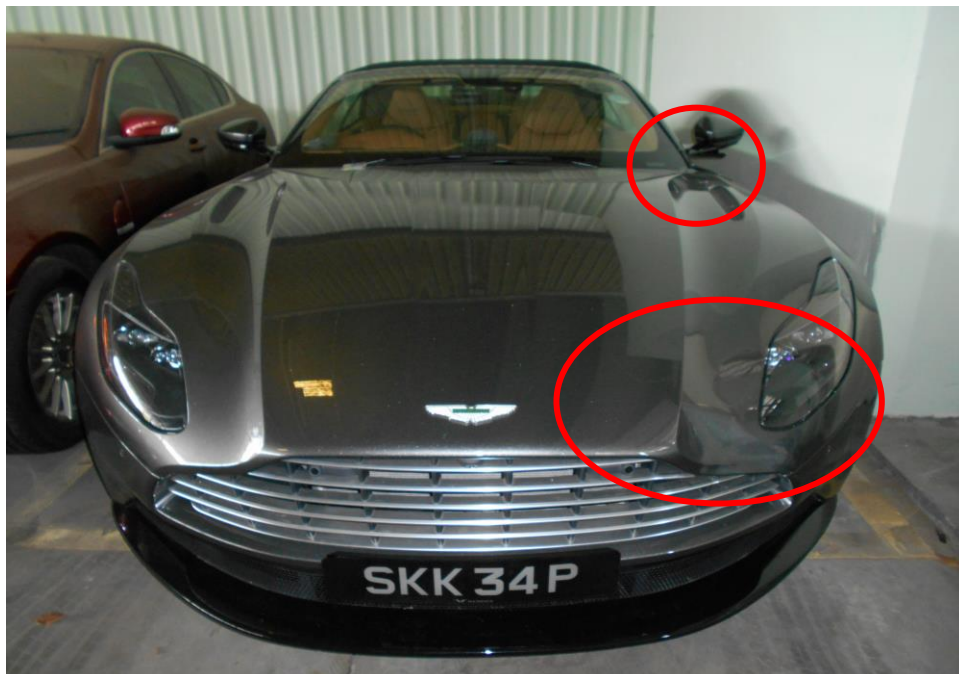
Photo 2 shows a general view of the front body of the Motor Car at the time of our inspection. The Motor Car was observed to have sustained a relatively minor impact damages that was confined to its front left portion. Its lower left bonnet, left side fender and lower left windshield was observed to be damaged likely due to the accident.

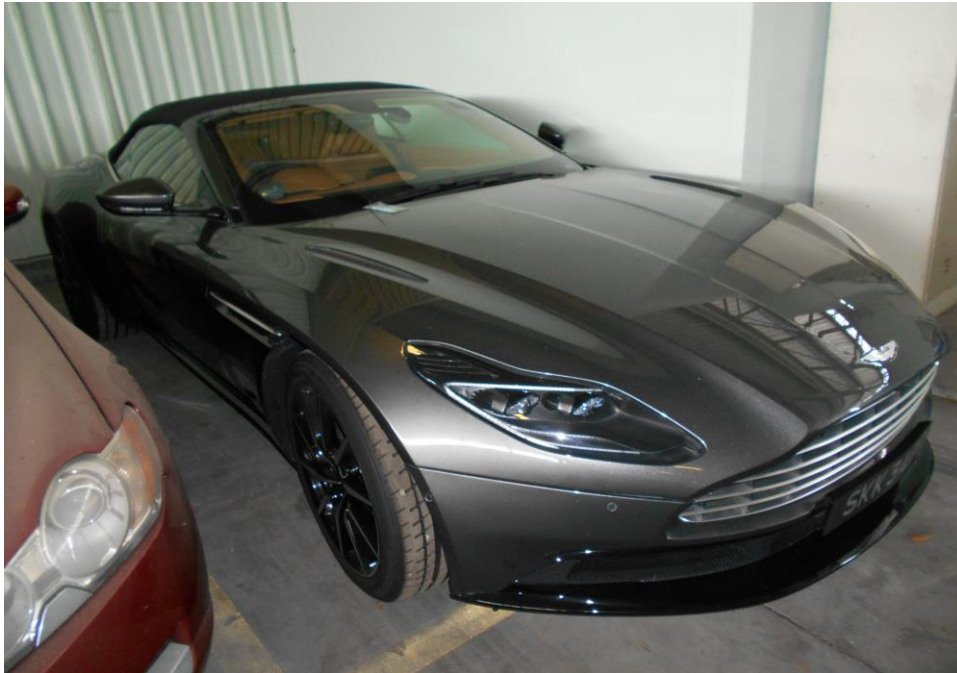
Photo 3 shows a general view of the front right body of the Motor Car at the time of our inspection. The Motor Car was observed to be in good condition.

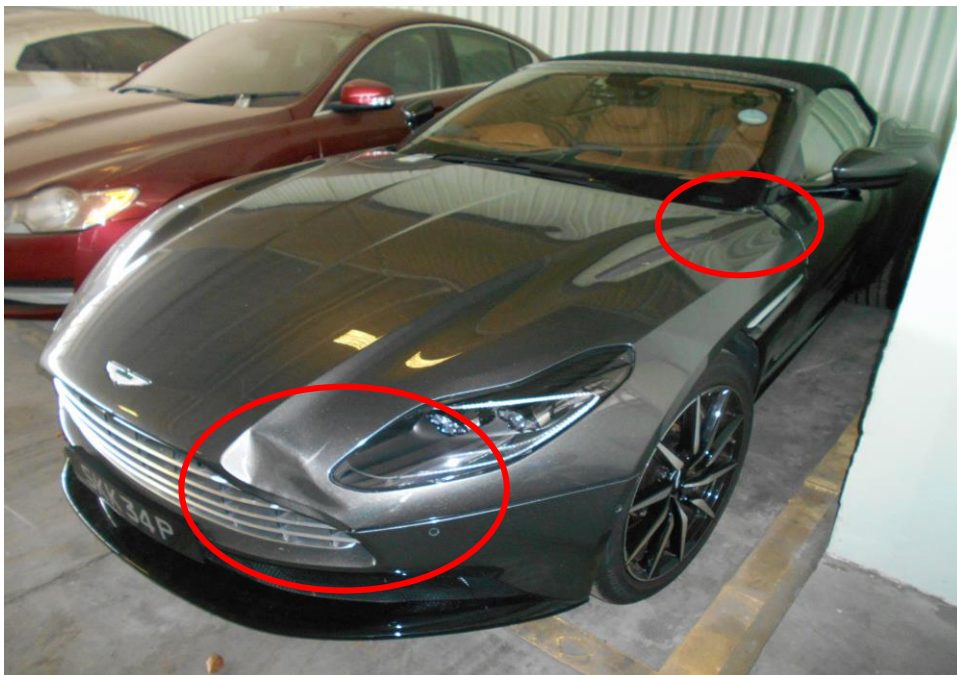
Photo 4 shows a general view of the front left body of the Motor Car at the time of our inspection. The Motor Car was observed to have sustained a relatively minor impact damages that was confined to its front left portion.

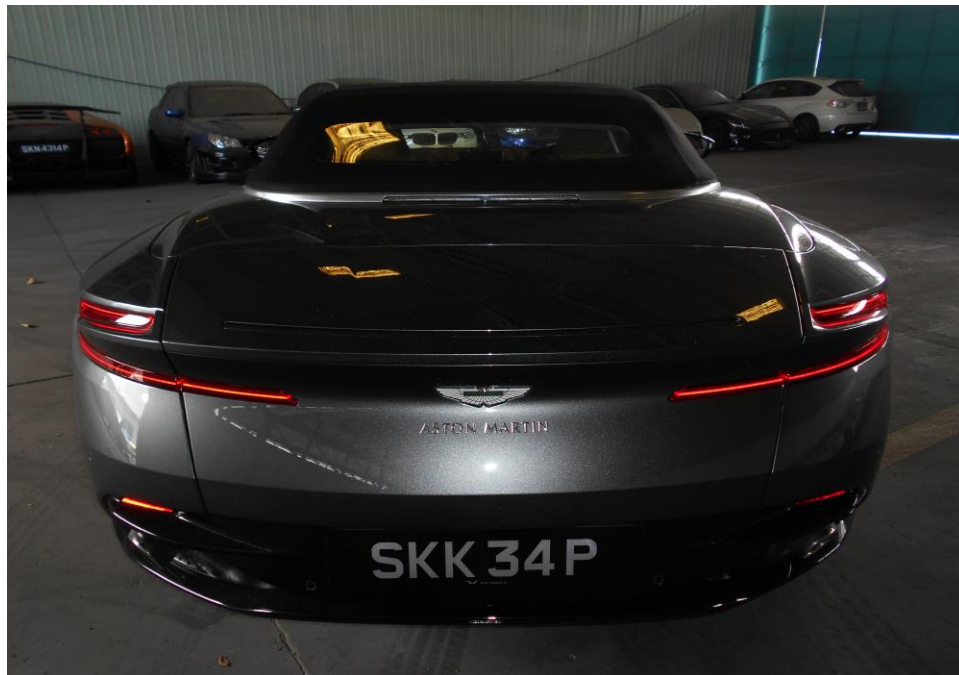
Photo 5 shows a general view of the rear body of the Motor Car at the time of our inspection. The Motor Car was observed to be in good general condition.

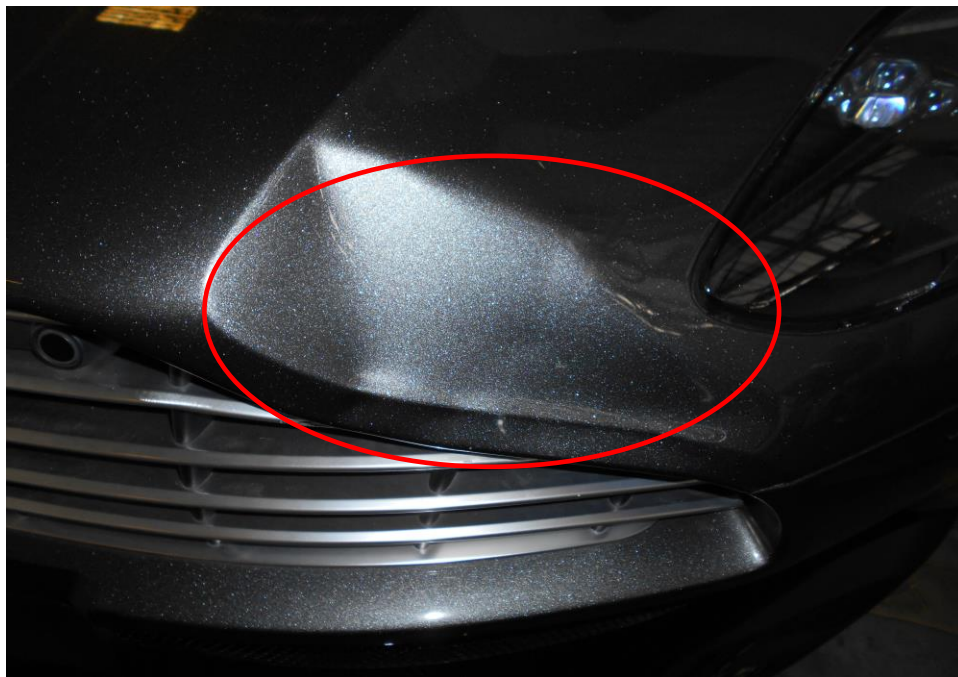
Photo 6 shows a close up view of the front left lower bonnet of the Motor Car at the time of our inspection. The Motor Car had sustained relatively minor damages at the front lower bonnet of the Motor Car.

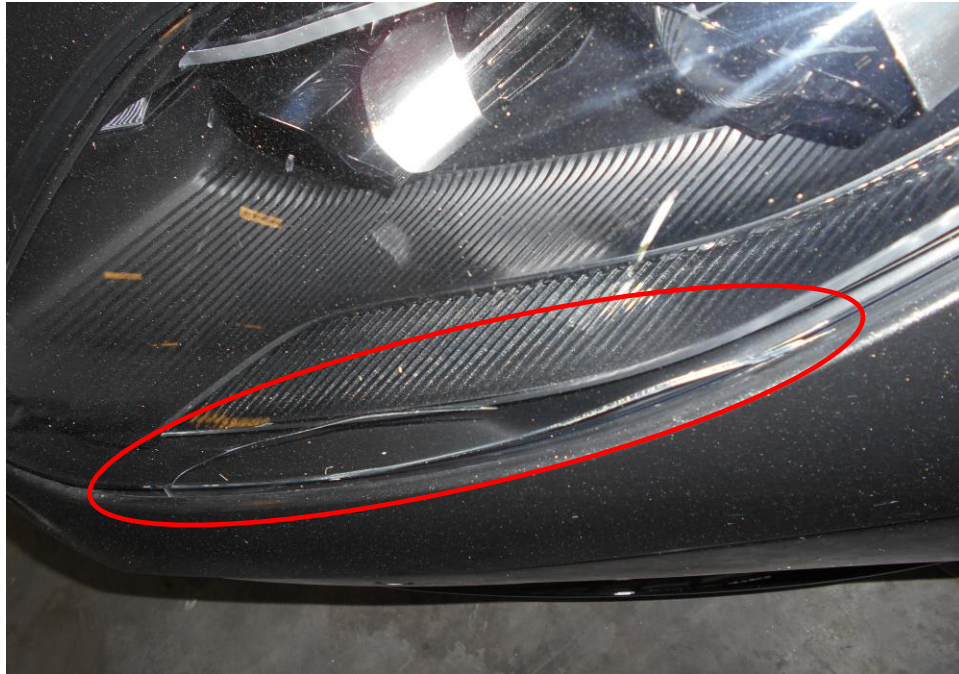
Photo 7 shows a close up view of the front left headlamp of the Motor Car at the time of our inspection. The Motor Car had sustained relatively minor scratches at the headlamp of the Motor Car.

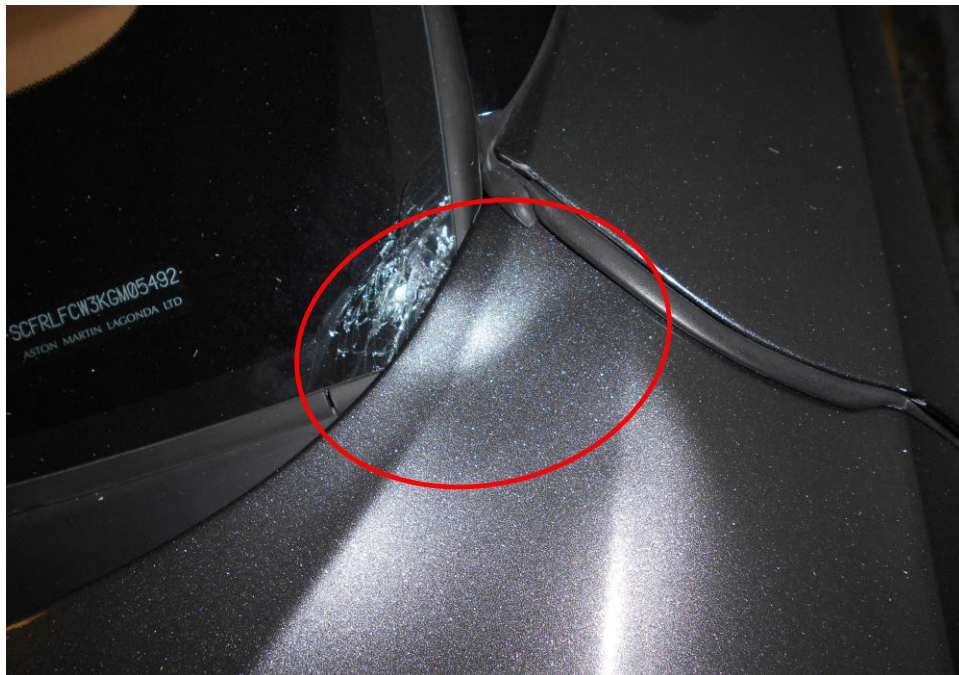
Photo 8 shows a close up view of the front left lower windshield and upper left portion of the front bonnet of the Motor Car at the time of our inspection. The Motor Car had sustained relatively minor damages as a result of the accident.

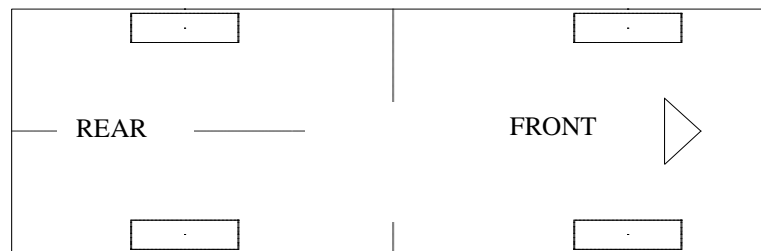
7. The condition of the Motor Car's 4 tyres was observed to be in serviceable condition; we did not find any tear, cut or burst mark(s) on the outer and the inner sidewalls as well as across the tread of the 4 tyres. The 4 tyres were also observed to be sufficiently inflated for vehicular operation. The remaining tread depth of the 4 tyres was approximately between 6mm. The tyre brand, tyre size and remaining tread depth of the 4 tyres were recorded as follows:-

Bridgestone Potenza S007 295/35ZR20 (7mm)

Bridgestone Potenza S007 255/40ZR20 (7mm)

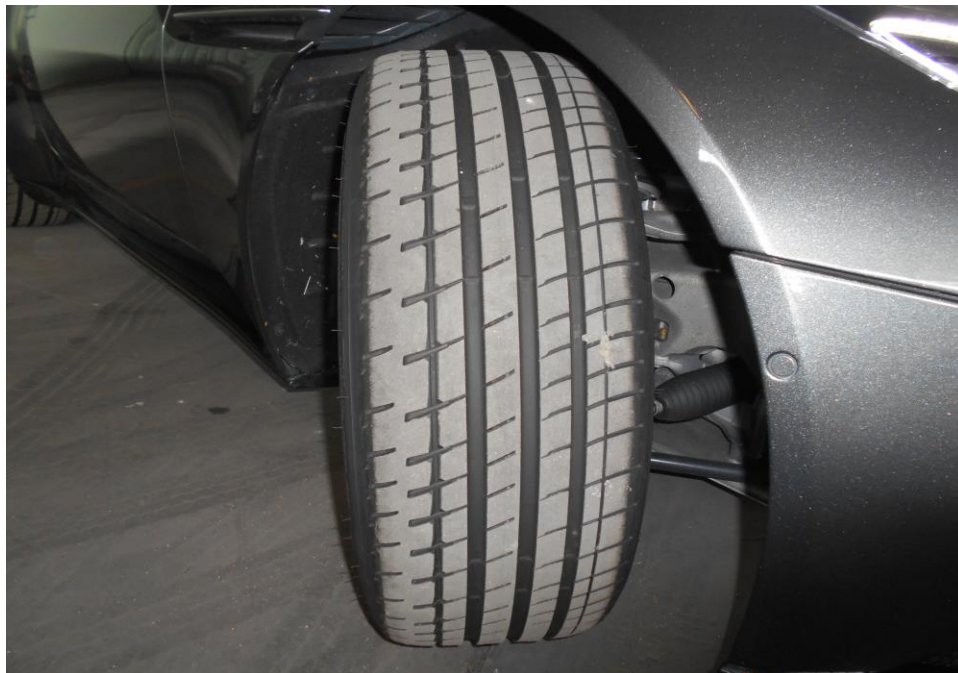
Photo 9 shows the condition of the front right tyre of the Motor Car, which was observed to be in serviceable condition with remaining tread depth of approximately 7mm. The tyre, which was wrapped around alloy wheel rim, was also observed to be sufficiently inflated for vehicular operation.

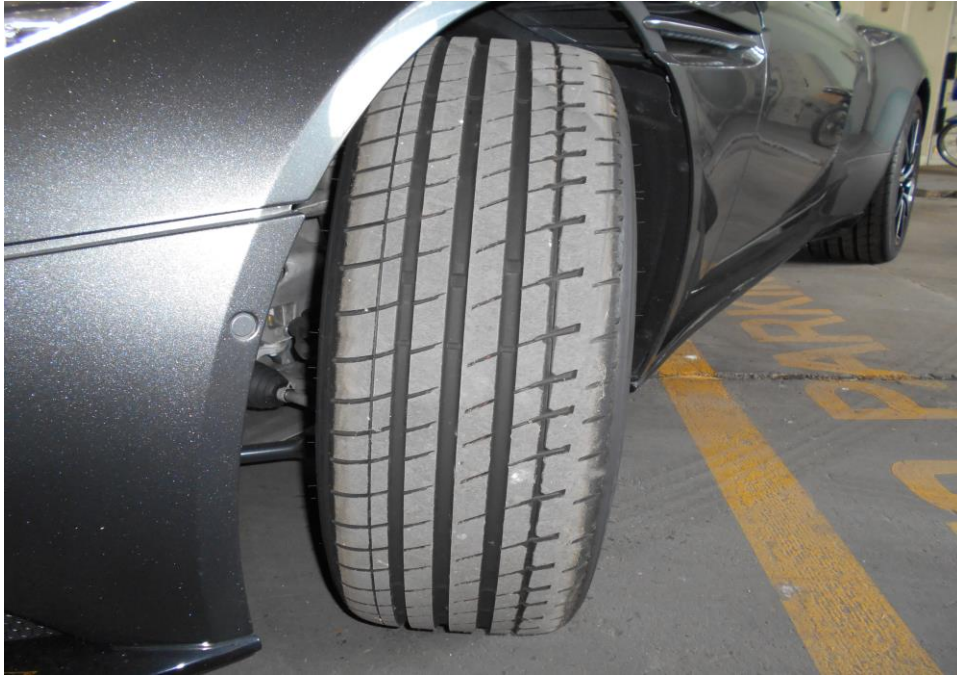
Photo 10 shows the condition of the front left tyre of the Motor Car, which was observed to be in serviceable condition with remaining tread depth of approximately 7mm. The tyre, which was wrapped around alloy wheel rim, was also observed to be sufficiently inflated for vehicular operation.

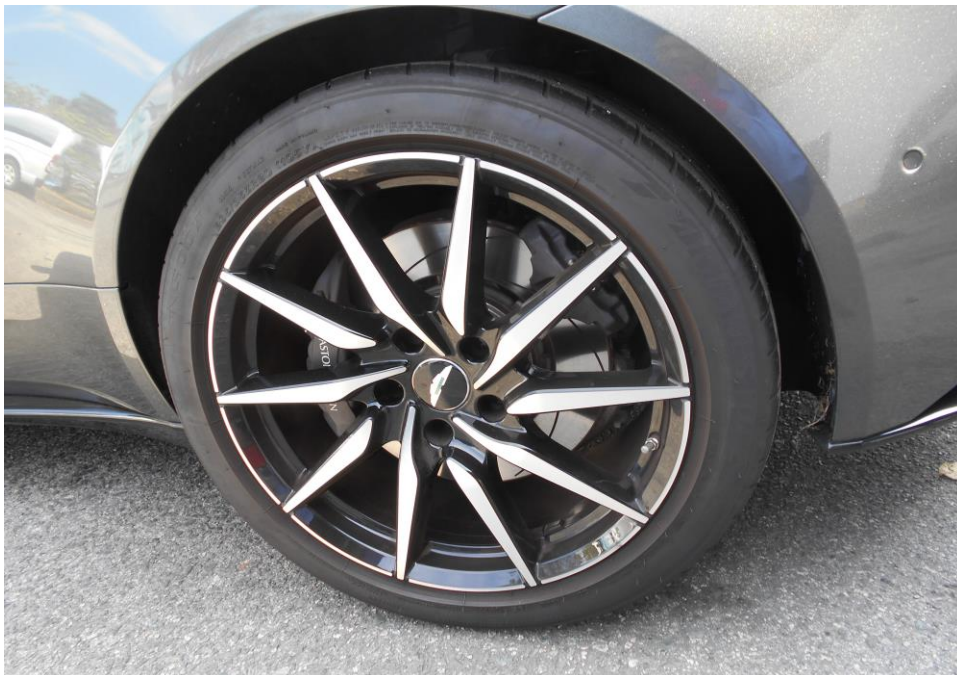
Photo 11 shows the condition of the rear left tyre of the Motor Car, which was observed to be in serviceable condition with remaining tread depth of approximately 7mm.

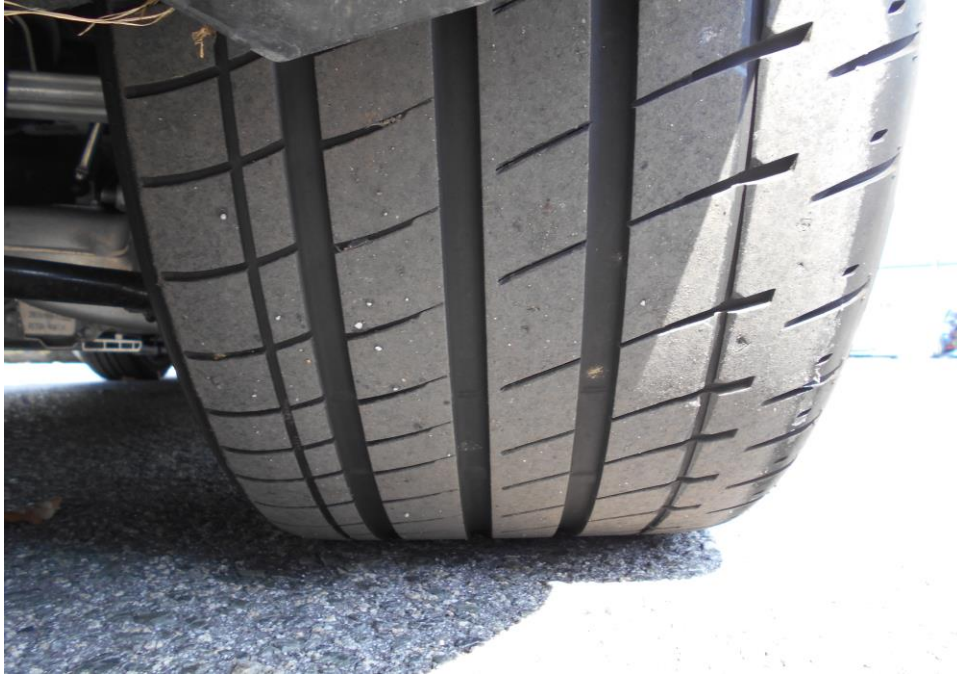
Photo 12 shows the condition of the rear right tyre of the Motor Car, which was observed to be in serviceable condition with remaining tread depth of approximately 7mm.

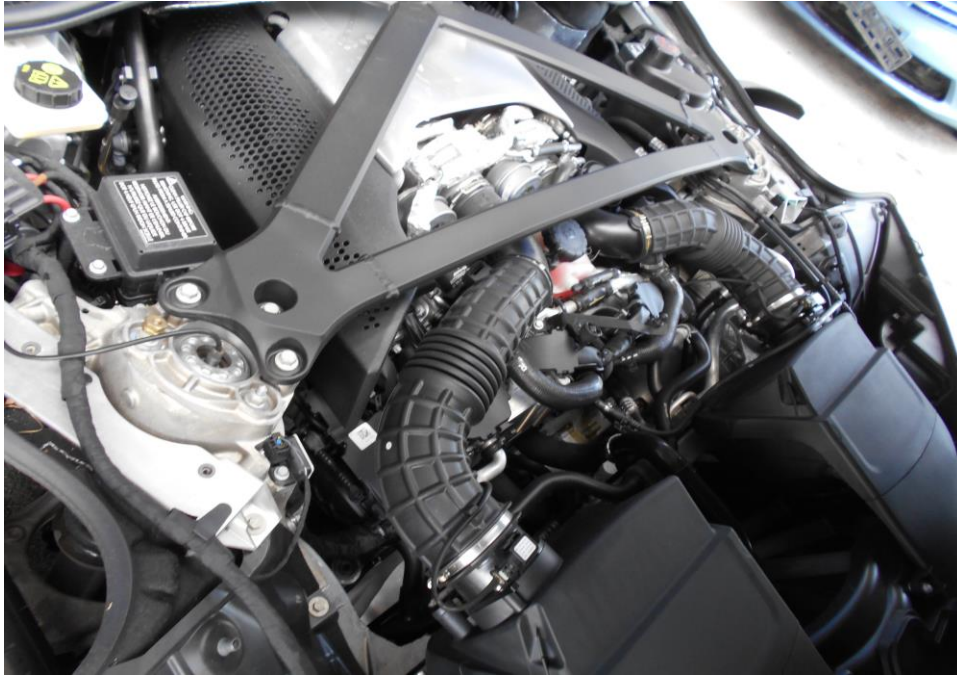
Photo 13 shows a general view of the Motor Car's engine compartment. The various parts and components inside the engine compartment were unaffected by the accident. There was also no sign(s) or indication(s) of fresh fluid leakage and/or fluid stain within the engine compartment.

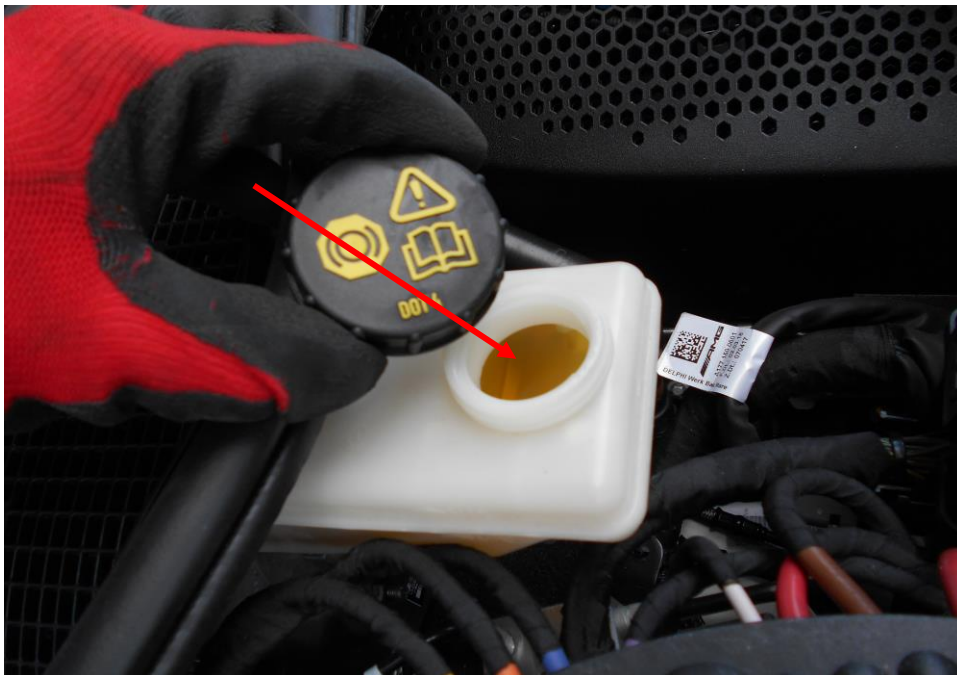
Photo 14 shows the brake fluid reservoir of the Motor Car at the time of our inspection. The brake fluid was observed to be of sufficient level (arrowed) and without any visible contamination.

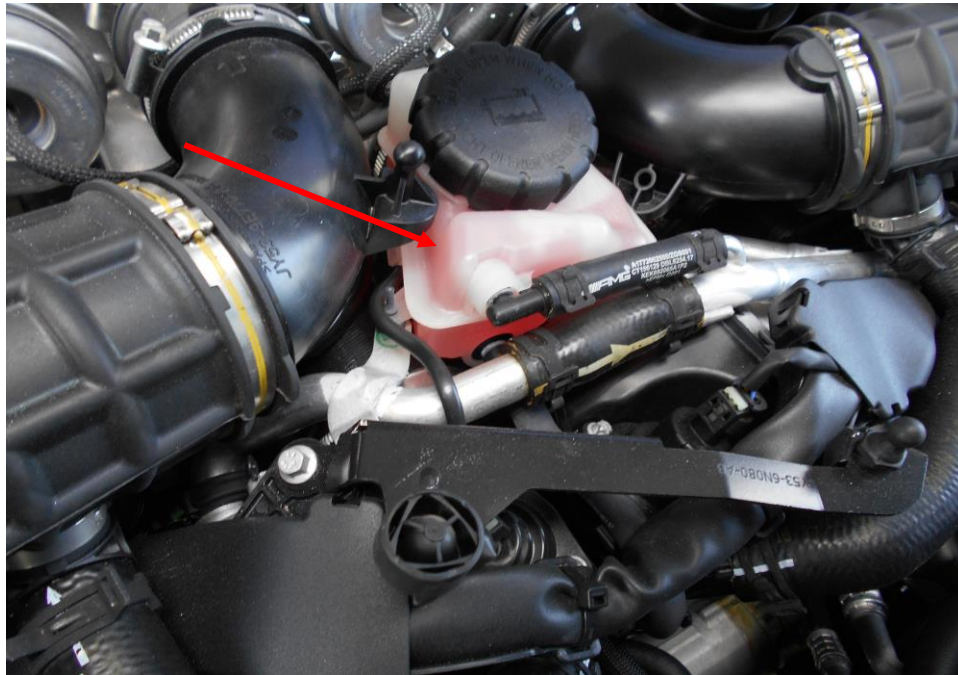
Photo 15 shows the engine coolant fluid reservoir of the Motor Car at the time of our inspection. The engine coolant fluid was observed to be of sufficient level and without any visible contamination.

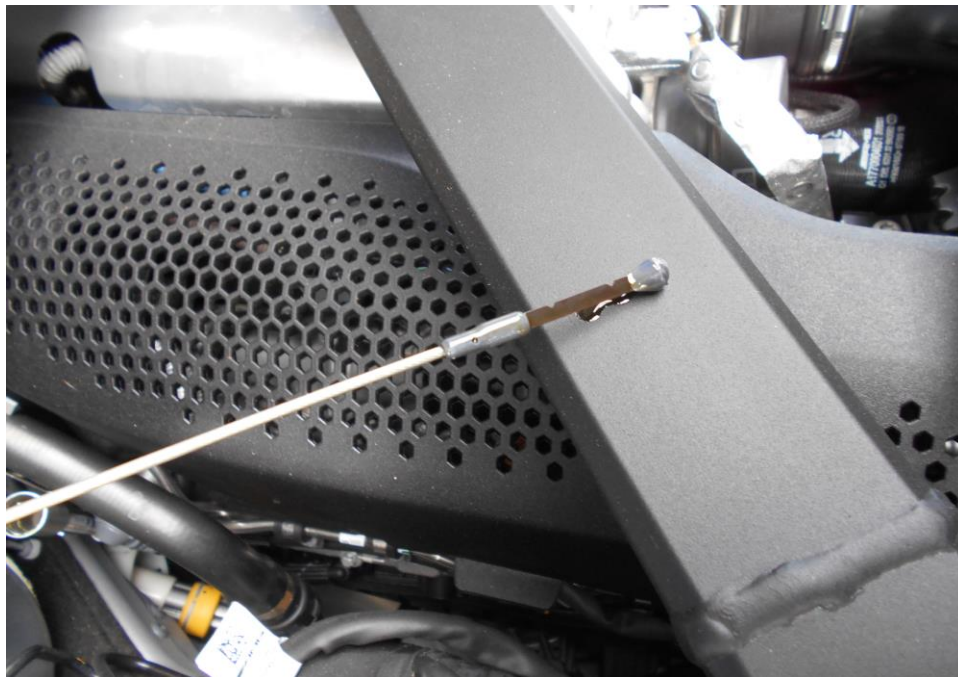
Photo 16 shows the engine fluid dipstick of the Motor Car at the time of our inspection. The engine oil was observed to be of sufficient level and without any contamination at time of our examination.

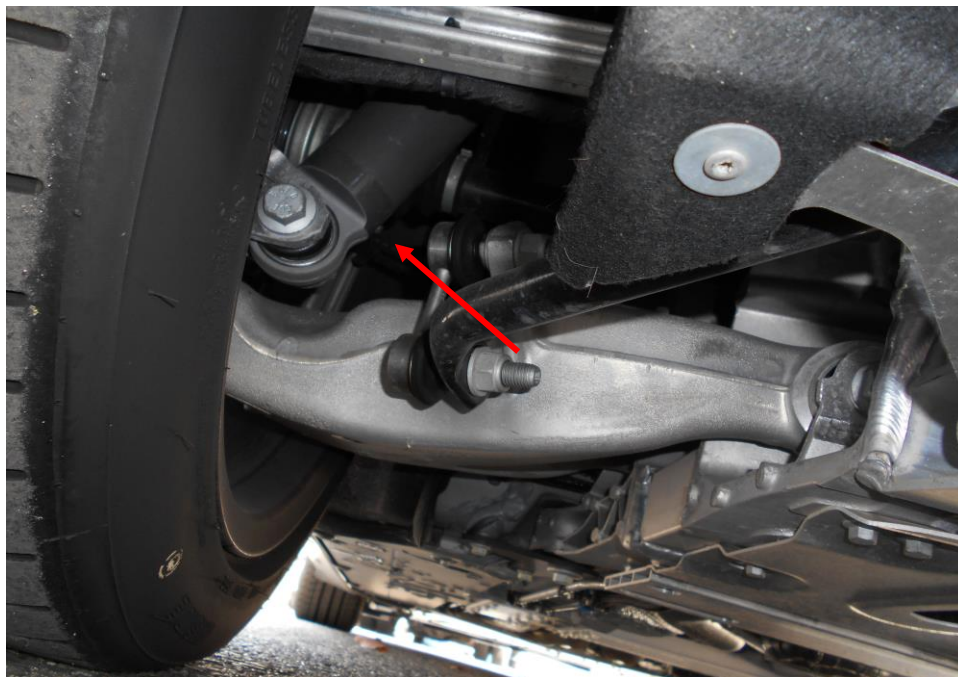
Photo 17 shows the brake hose (arrowed) at the rear left wheel of the Motor Car. We did not observe any leakage of brake fluid at the time of our inspection of the Motor Car. Our visual inspection of the various mechanical components of the Motor Car's braking system revealed all to be intact without visible damage.

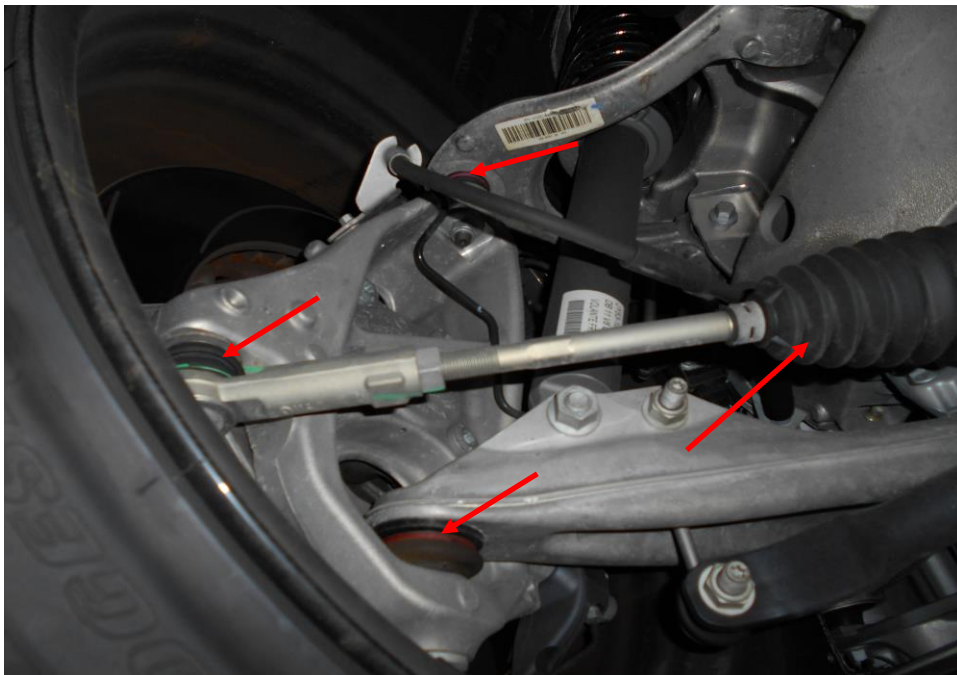
Photo 19 shows the various undercarriage components at the front right wheel of the Motor Car, in particular the steering tie rod (arrowed). The various steering components were all found to be intact, suggesting that the steering system of the Motor Car was likely to be in serviceable condition.

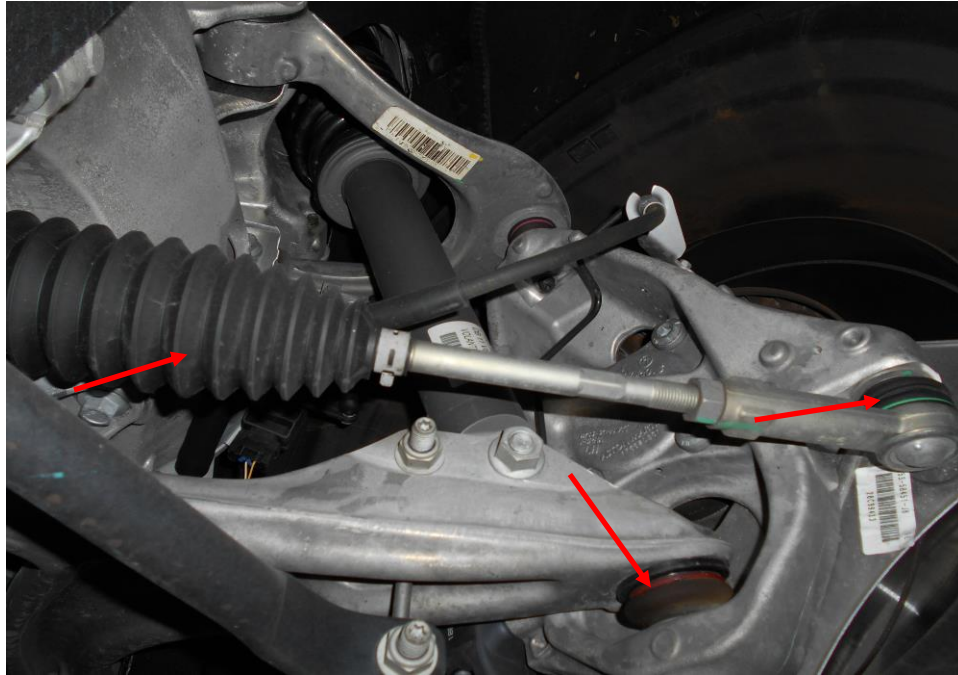
Photo 20 shows the various undercarriage components at the front left wheel of the Motor Car. We did not observe any leakage of brake fluid (arrowed) at the time of our inspection of the Motor Car. Our visual inspection of the various mechanical components of the Motor Car's braking system revealed all to be intact and without visible damage, indicating that the braking system was likely to be in serviceable condition at the material time of accident.

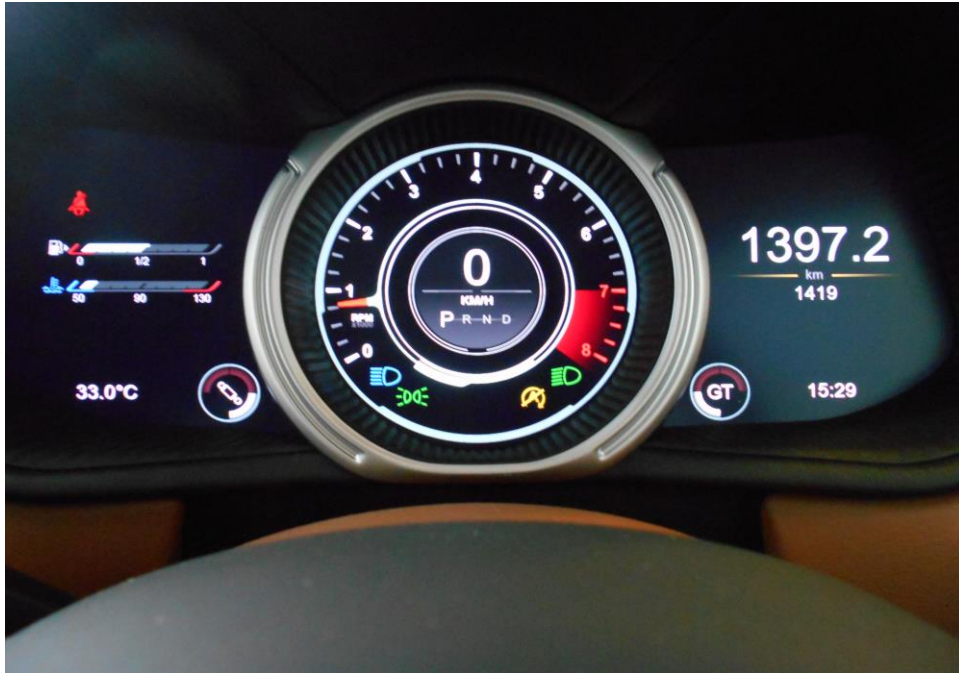
14. The Motor Car's automatic self-test of the functionality of its various electronic operating systems like the Anti-Brake Lock System (ABS), parking light, battery light, engine check light and during cranking of the engine had indicated that these systems were in working condition and without abnormality. This can be established from the warning lights disappearing from the instrument panel after the self-test. See photo 21 below.

Photo 21 shows most warning lights disappearing from the instrument panel of the Motor Car after the engine was cranked.

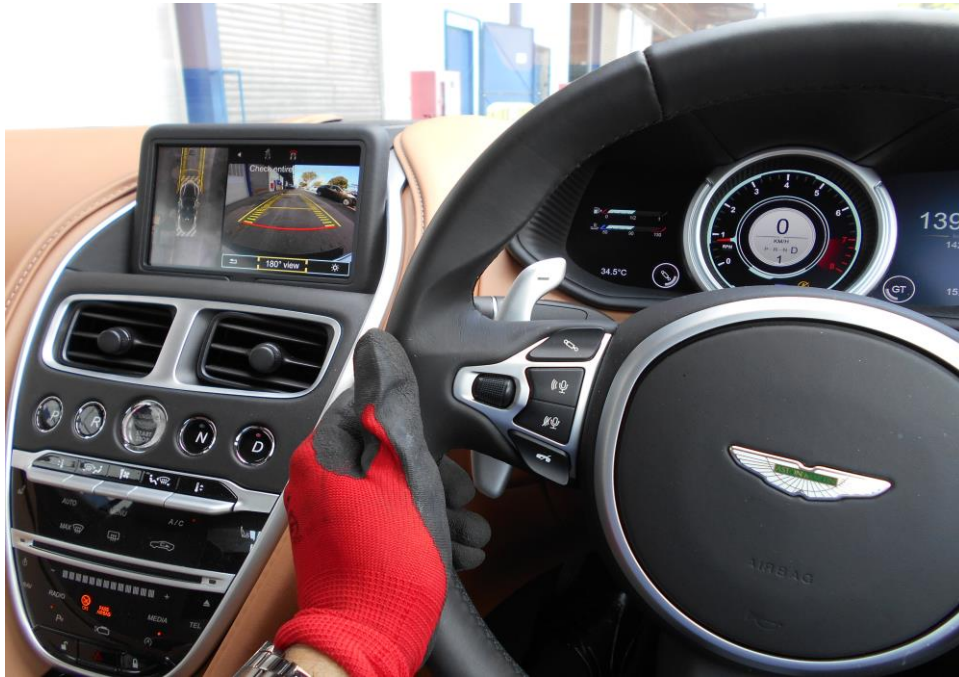
Photo 22 shows we conducted an operational test on the Motor Car. Reverse mode were engaged at time of our test. There was no abnormality observed at time of testing.

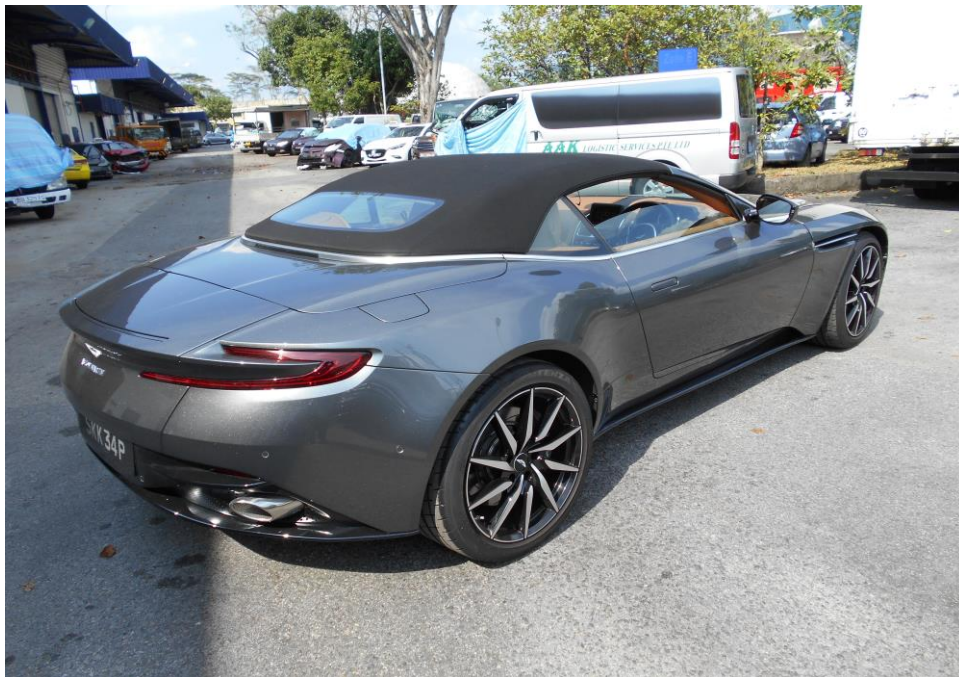
Photo 23 shows we conducted an operational test on the Motor Car. Drive mode, Reverse mode & Neutral mode were engaged at time of our test. Brake pedal was also engaged to a complete stop. There was no abnormality observed at time of testing.
