**Preliminary Advice**

Vehicle No	: SME9645A	Accident Date	: 16/02/2019
Make	: BLUECAR BLUECAR	Policy No.	: 29112616MCY
Assignment Date	: 20/03/2019	Excess	: S\$2,000.00
Date of Inspection	: 22/02/2019	Est. Duration of Repair	: 5 days
Inspection At	: Indeco Engineers Pte Ltd (Defu) No. 39 Defu Lane 12 Singapore 539315

## VEHICLE DAMAGE INSPECTION REPORT

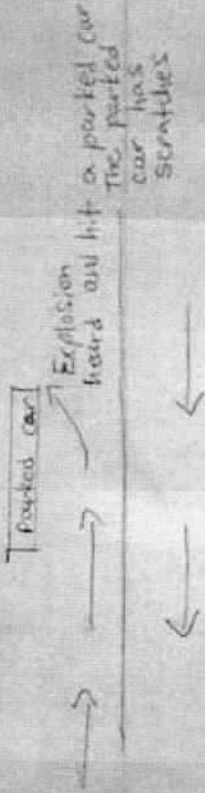
SKETCH PLAN

I was travelling along 72 Joo Chiat place at a very slow speed. I heard a loud sound the car swayed and hit a parked car. I got down the car and saw the whole tyre flat and car has come off. The stick which held the front left tyre has dropped out.
