Your Ref: BMW 523i  
(chassis number WBAJL120X0BE46952)  
Our Ref : CI/TP19003398/D

23 February 2019

**INSPECTION REPORT OF AN UNREGISTERD BMW 523i MOTOR CAR WITH CHASSIS NUMBER WBAJL120X0BE46952**

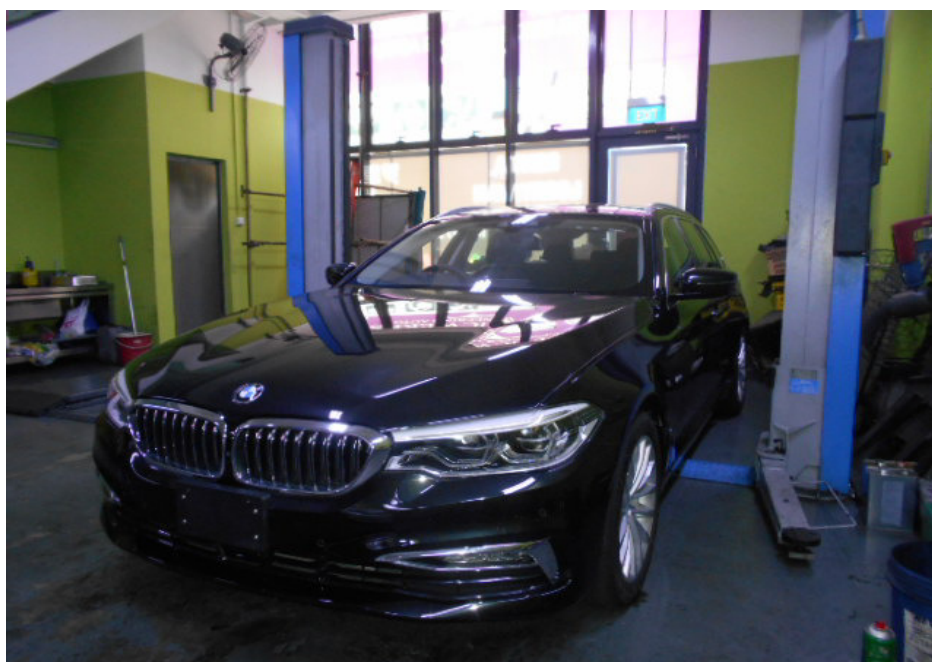
**Photo 1** shows a general view of the front left body of the Motor Car at the time of my inspection. The Motor Car was observed to be in relatively good general condition with no loose exterior fittings observed.

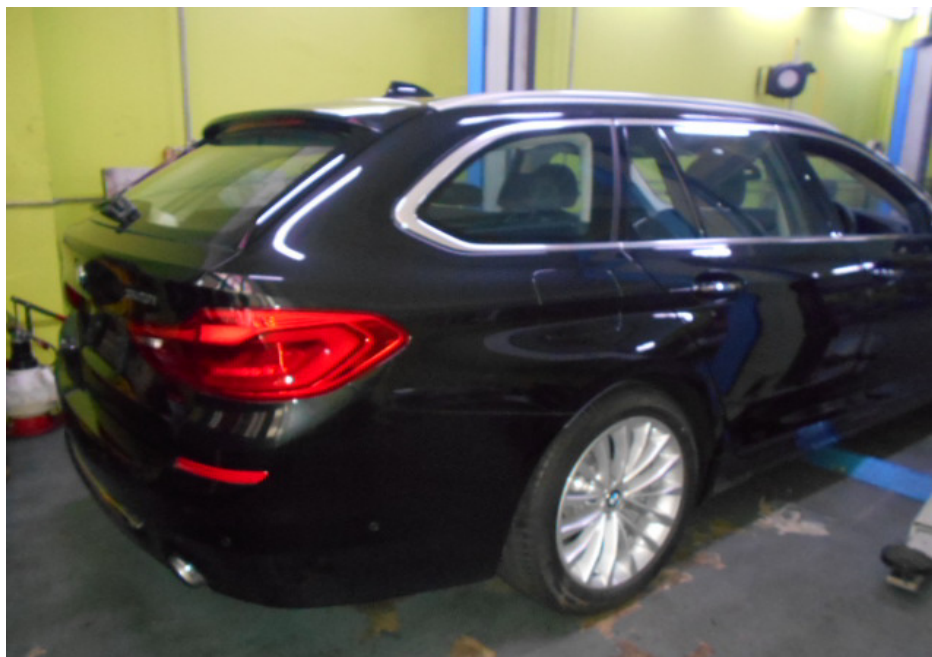
**Photo 2** shows a general view of the rear right body of the Motor Car at the time of my inspection. The Motor Car was observed to be in relatively good general condition with no loose exterior fittings observed.

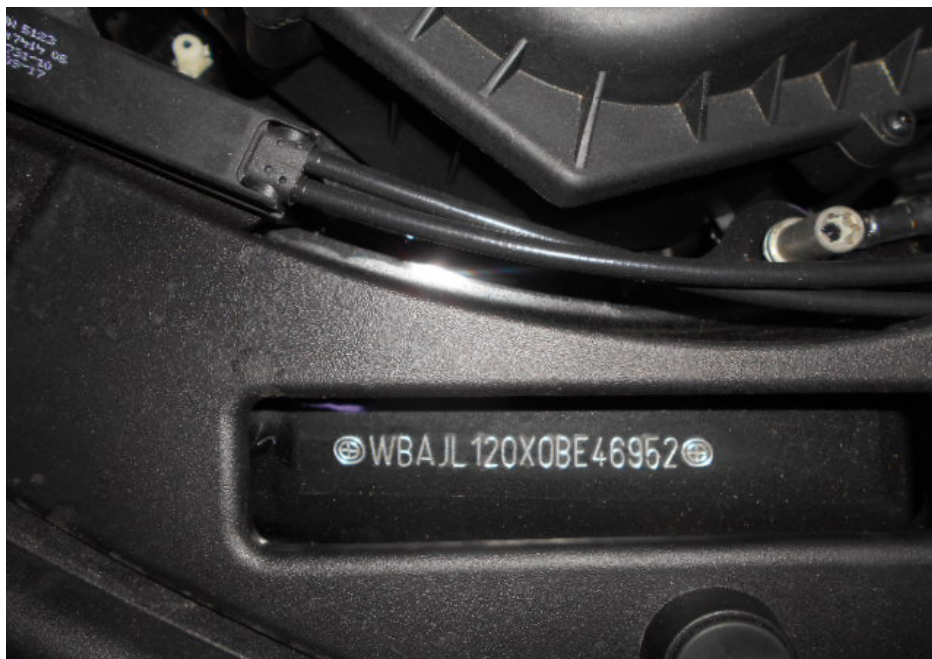
**Photo 3** shows the chassis number of the Motor Car. The chassis number recorded was WBAJL120X0BE46952.

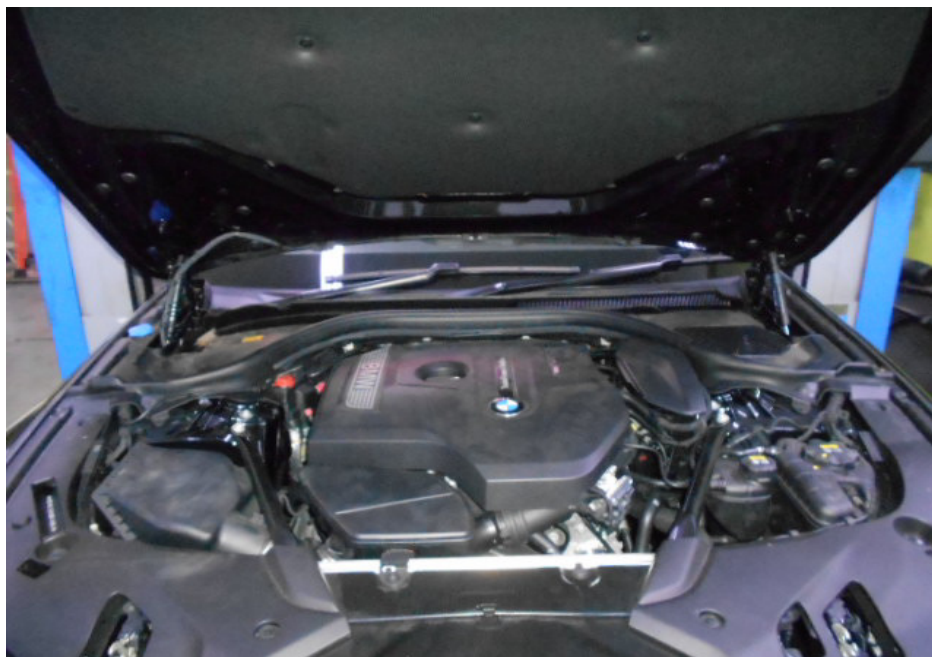
12. My examination of the engine compartment of the Motor Car revealed that the various parts and components inside the engine compartment were all intact and properly fitted. The engine oil, transmission fluid, brake fluid and engine coolant were all found to be of sufficient level for operating purposes. Visually, there was also no contamination found to these fluids.
13. My checks on the underside of the Motor Car revealed no sign(s) or indication(s) of fluid leakage and/or fluid stain(s). The engine block and automatic transmission assembly were both secured properly. They were not mounted onto the chassis body or any integral body part of the Motor Car. All undercarriage components of the Motor Car were also observed to be intact and secured in an appropriate manner.

**Photo 4** shows a general view of the engine compartment of the Motor Car at the time of my inspection. The various parts and components inside the engine compartment were all observed to be intact and properly fitted. There was also no sign(s) or indication(s) of fluid leak and/or fluid stain found inside the engine compartment.

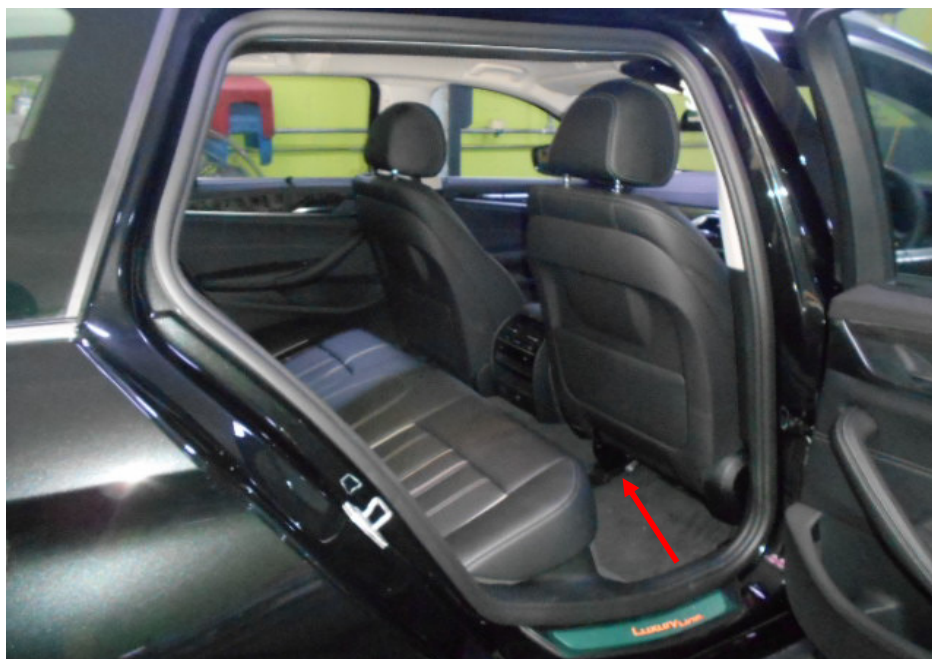
10. The seats of the Motor Car were found to be secured to the floor board of the Motor Car via seat rails bolted onto the floor board. Retractable seat belt reels and pre-tensioners were fitted on all seats of the Motor Car. The seat belt reels were able to be fastened securely to the respective pre-tensioner that is fixed to the side of all the seats.

**Photo 5** shows the seats of the Motor Car, which were secured via seat rails (arrowed) to the floor board. All the seats of the Motor Car were fitted with a retractable seat belt reel and pre-tensioner. The seat belts were also able to be fastened to the pretension that were fitted on the side of each individual seat.

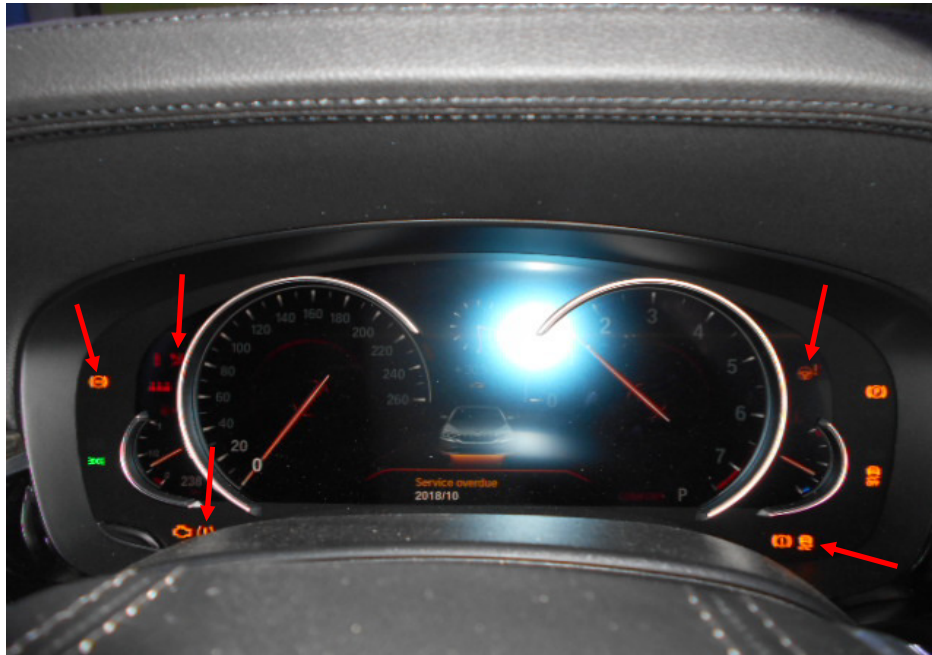
**Photo 6** shows the warning lights for the various electronic safety features appearing on the instrument panel of the Motor Car during its self-test when the engine is cranked, in particular the ABS, SRS, IAS, TPM and DSC lights (arrowed).

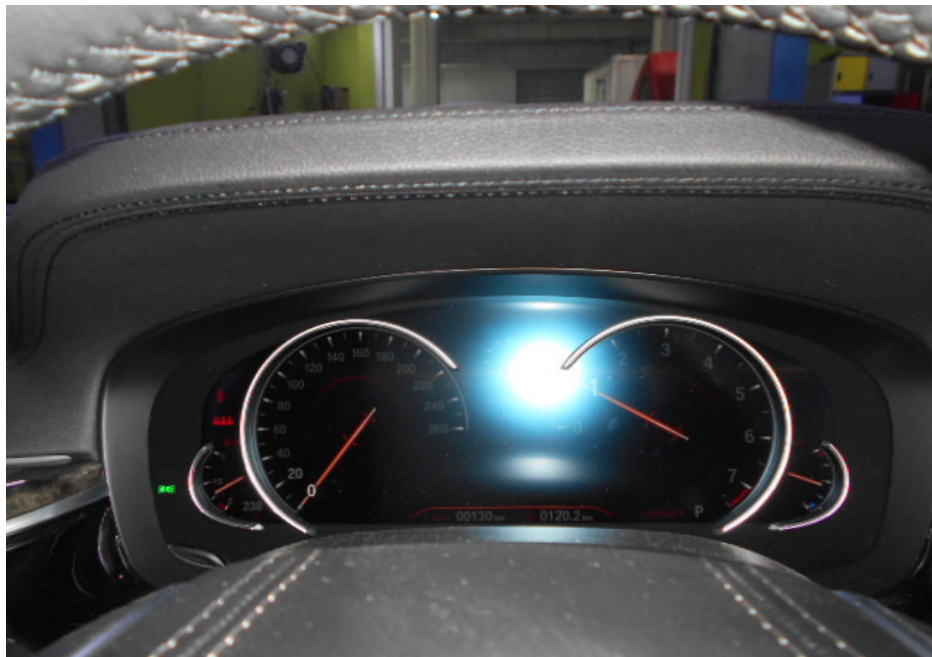
11. The Motor Car's automatic self-test of the functionality of its various electronic safety features like the Anti-Brake Lock System (ABS), Supplemental Restraint System (SRS), Integral Active Steering (IAS), Tyre Pressure Monitor (TPM) and Dynamic Stability Control (DSC) during cranking of the engine had indicated that these electronic systems were in working condition. This was determined from the respective warning lights disappearing from the instrument panel after the self-test.

**Photo 7** shows the respective warning lights no longer illuminated, indicating that there is no fault detected to the ABS, SRS, IAS, TPM and DSC systems of the Motor Car during the self-test. These electronic systems were hence in working condition at the time of my inspection.

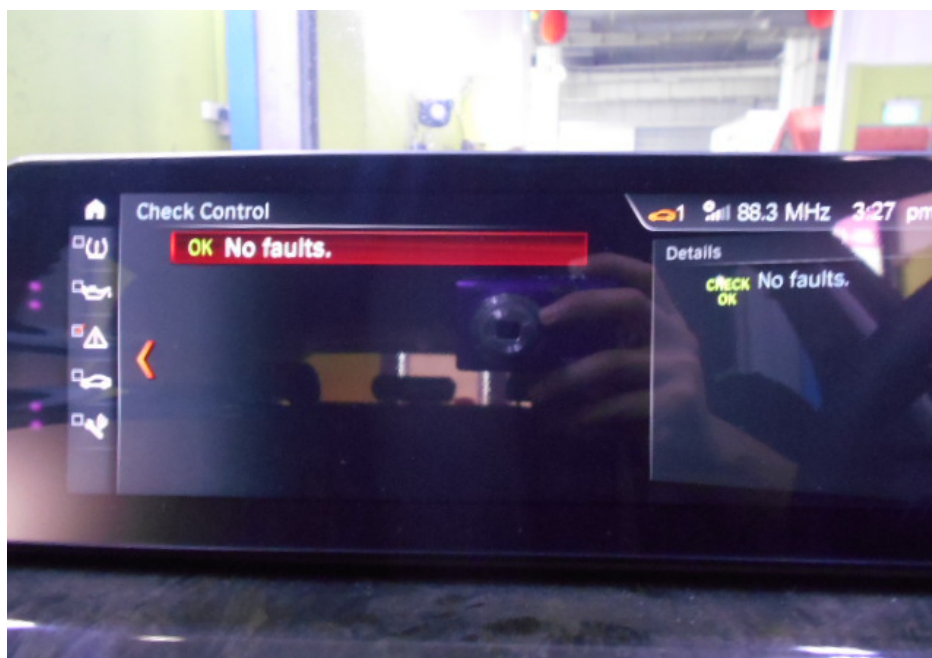
19. An on-board self-diagnostic check on the various controls and systems of the Motor Car was initiated during my inspection, and at the end of the check, there was no fault(s) found.

**Photo 8** shows no fault(s) was detected to the various controls and systems of the Motor Car after my initiation of the Motor Car's on-board self-diagnostic check.

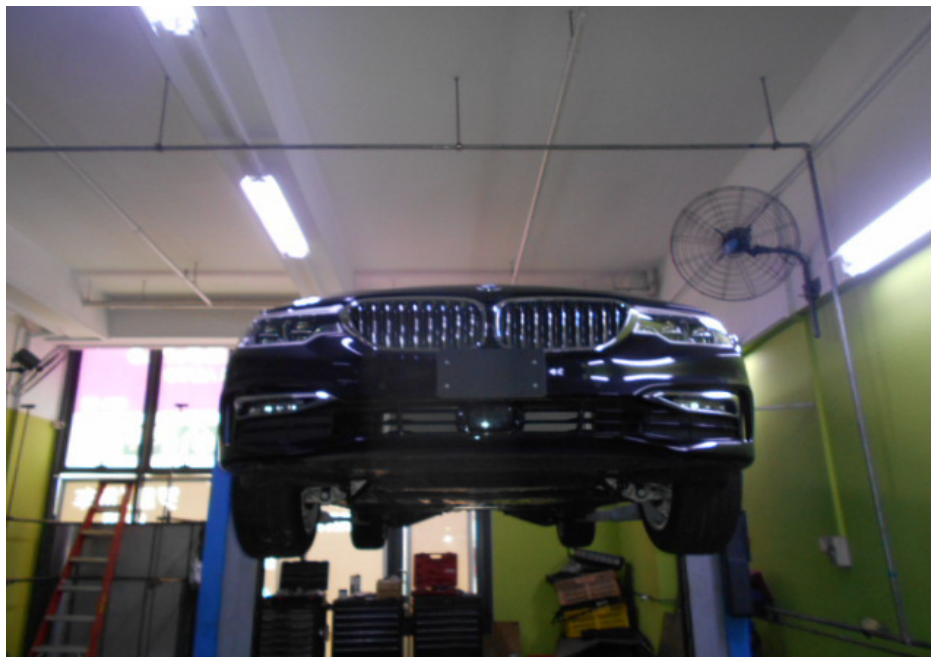
**Photo 9** shows the Motor Car hoisted up for checks on its undercarriage. There was no sign(s) or indication(s) of fluid leakage and/or fluid stain(s). The undercarriage components of the Motor Car were also all observed to be intact and secured in an appropriate manner.

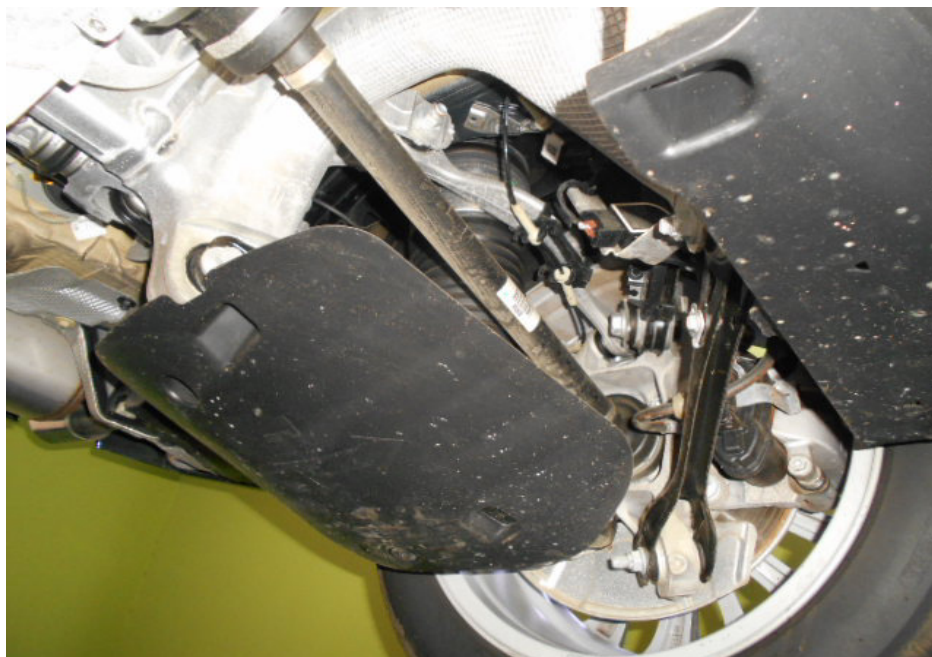
**Photo 10** shows a general view of the control arms and linkages at the rear left wheel of the Motor Car. I did not observe any fluid leak and/or fluid stain on the underside of the Motor Car. All of the Motor Car's undercarriage components were observed to be intact and secured in an appropriate manner.

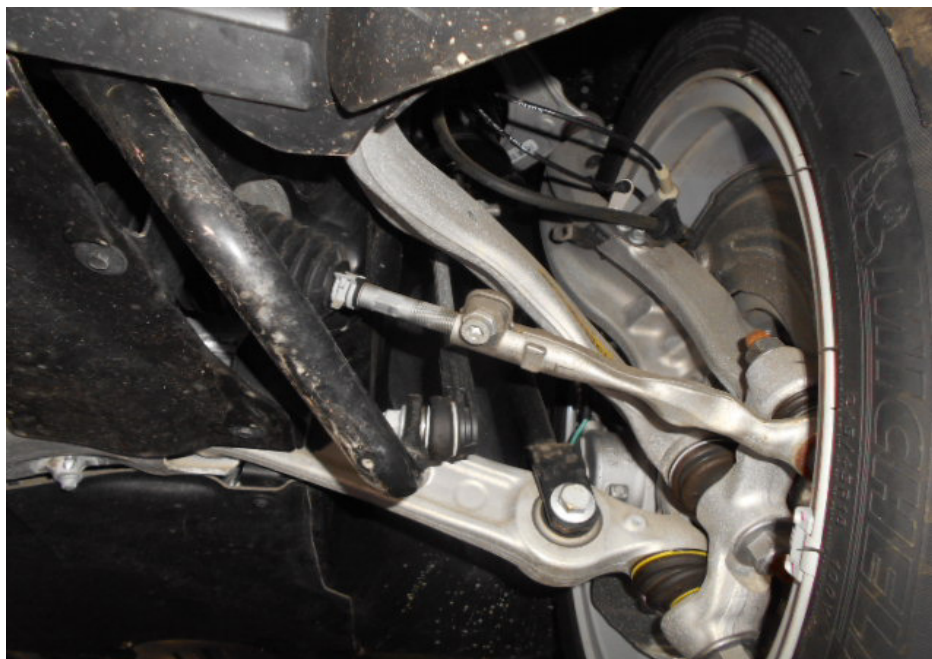
**Photo 11** shows the various undercarriage components at the front left wheel of the Motor Car. The mechanical components, control arms and linkages were all found to be intact and secured in an appropriate manner.

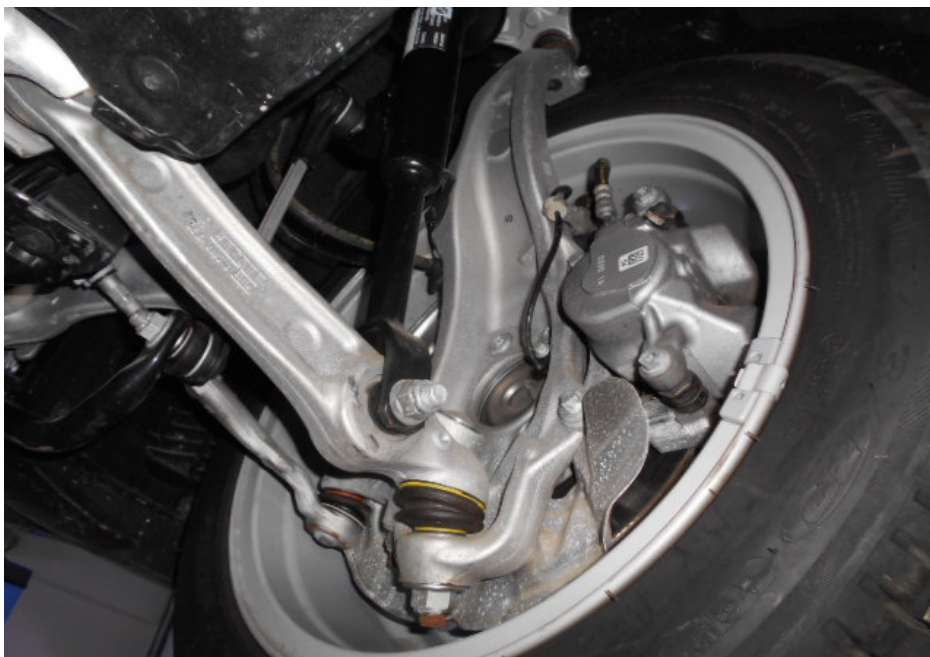
**Photo 12** shows the various undercarriage components at the front right wheel of the Motor Car. The mechanical components, control arms and linkages were all found to be intact and secured in an appropriate manner.

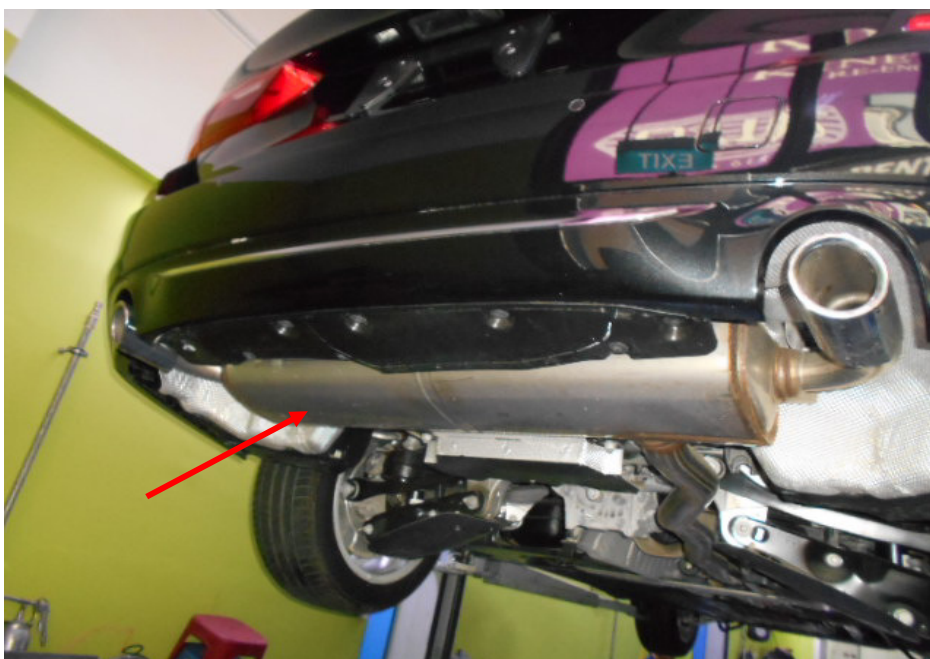
**Photo 13** shows the Motor Car's rear exhaust muffler (arrowed). My examination of the Motor Car's exhaust system revealed no sign(s) or indication(s) of any cut or weld marks along its exhaust pipes and on its rear mufflers.

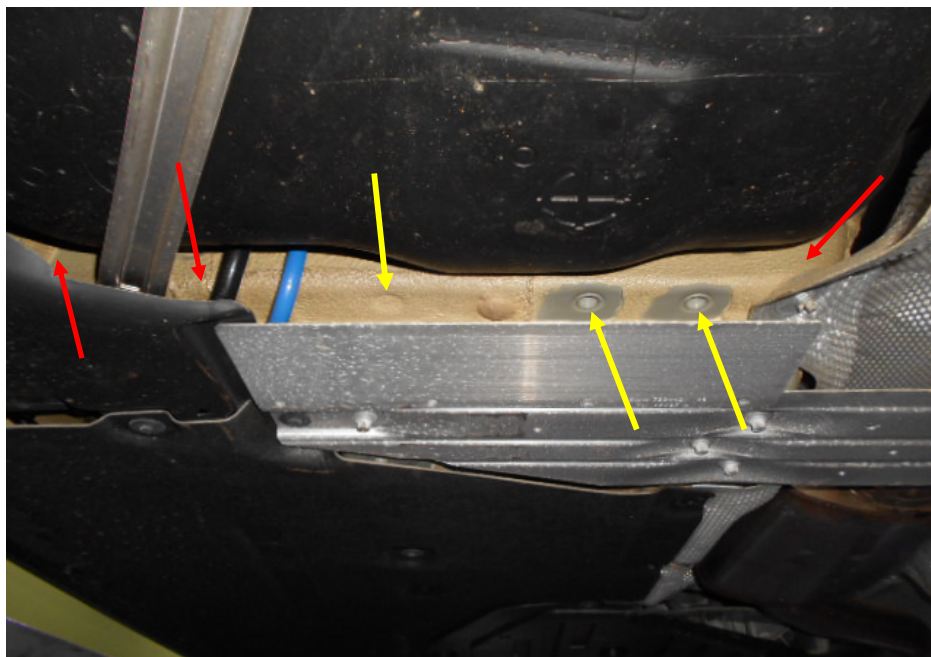
9. Visually, I did not find any weld marks, other than the original spot weld marks, on the chassis body of the Motor Car. The original factory sealant at the joints along the chassis body was also untouched, again indicating that no replacement of the chassis body was carried out; and that the chassis body was originally fitted.

**Photo 14** shows the structural body at the underside left centre of the Motor Car. Visually, I did not find any weld marks other than original spot weld marks (yellow arrow) on the chassis body of the Motor Car. The original factory sealant (red arrow) at the joints along the chassis body was also untouched, indicating no work was done on the chassis body of the Motor Car and that the chassis body was originally fitted.

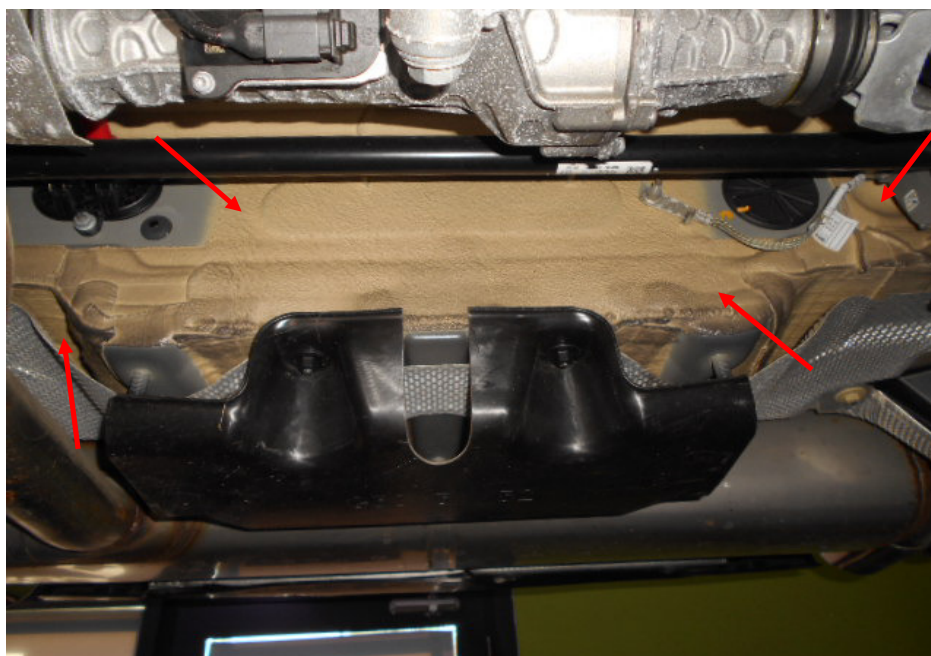
**Photo 15** shows the structural body at the underside rear centre of the Motor Car. Visually, The original factory sealant (arrowed) at the joints along the chassis body was untouched, indicating no work was done on the chassis body of the Motor Car and that the chassis body was originally fitted.

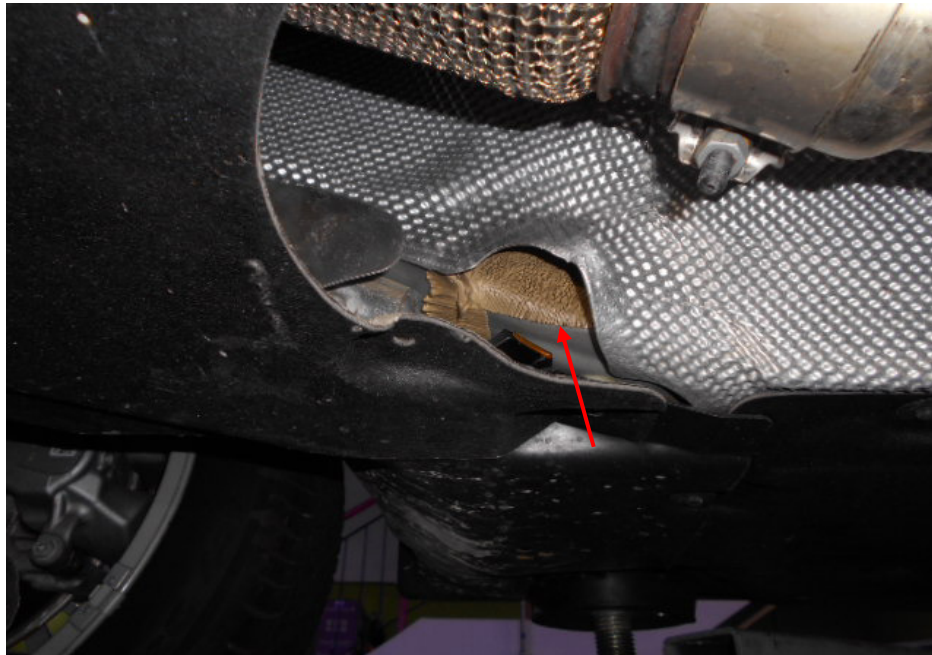
**Photo 16** shows the structural body at the underside right front of the Motor Car. The original factory sealant (arrowed) at the joints along the chassis body was untouched, indicating no work was done on the chassis body of the Motor Car and that the chassis body was originally fitted.
