Your Ref : S9M01DFF
Our Ref : CS/ASM19003408/N

21 March 2019

**TECHNICAL INVESTIGATION REPORT OF FIRE INCIDENT INVOLVING THE
INSURED MOTORCYCLE FBH 9728J ON 6 FEBRUARY 2019**

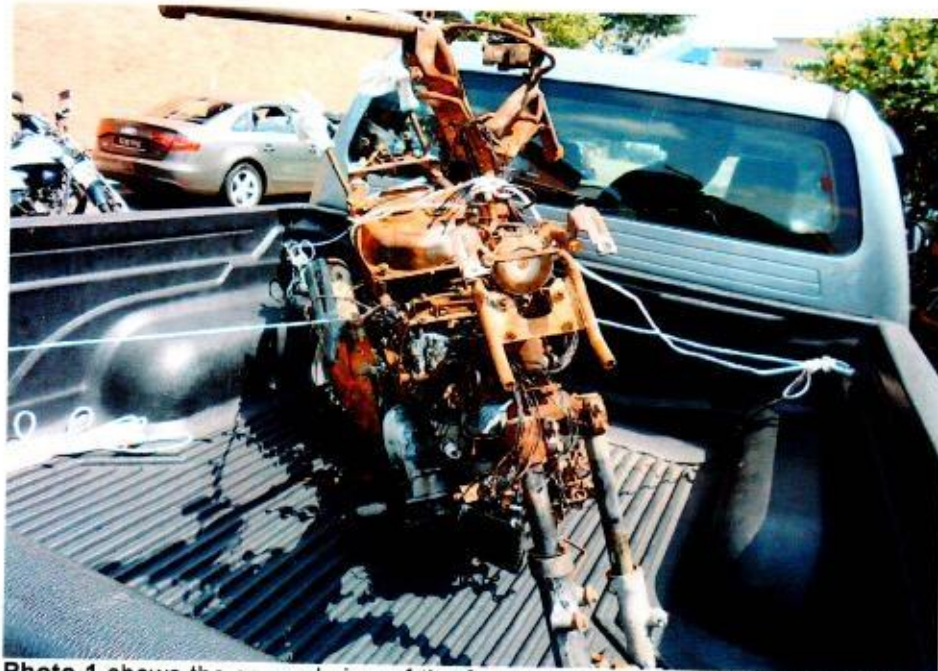
Photo 1 shows the general view of the front portion of the Insured Motorcycle at the time of our inspection. The Insured Motorcycle was observed to have sustained extensive fire damage all around. Rust had accumulated all over the Insured Motorcycle as a result of exposure to environmental condition for a period of time.

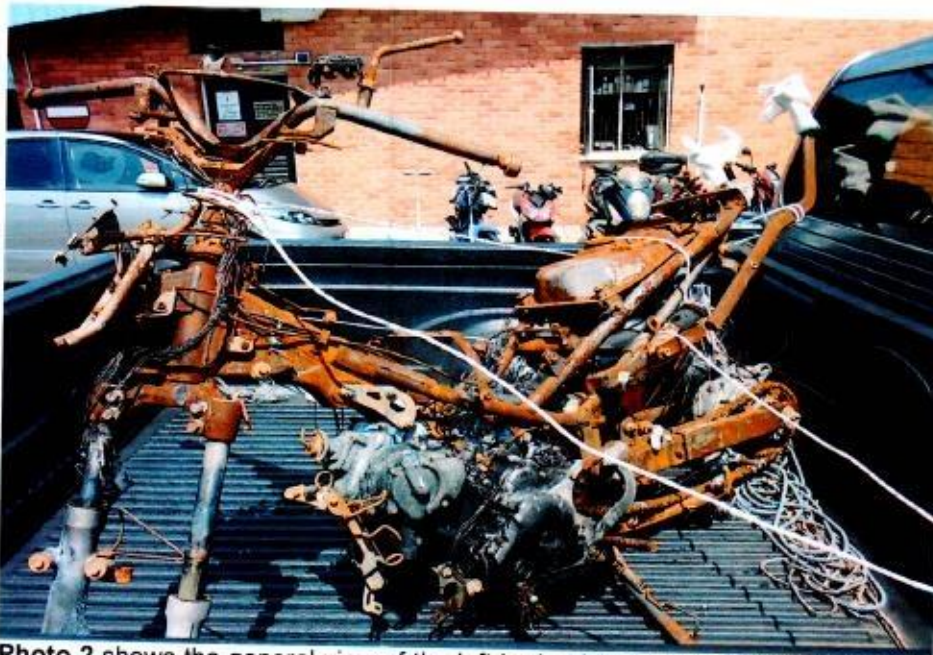
Photo 2 shows the general view of the left body of the Insured Motorcycle at the time of our inspection. The Insured Motorcycle was observed to have sustained extensive fire damage all around. Rust had accumulated all over the Insured Motorcycle as a result of exposure to environmental condition for a period of time.

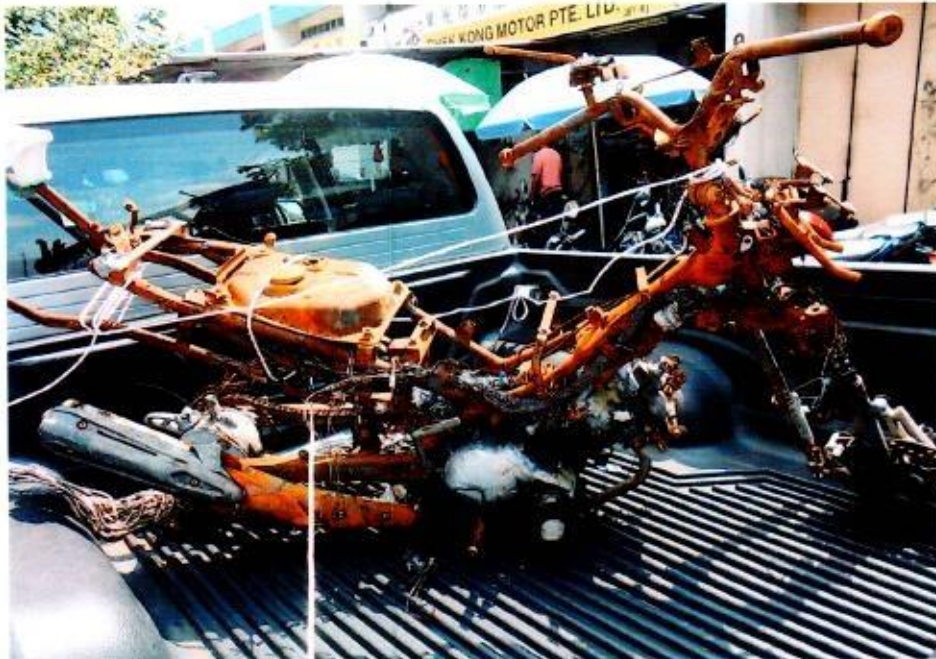
Photo 3 shows the general view of the right body of the Insured Motorcycle at the time of our inspection. The Insured Motorcycle was observed to have sustained extensive fire damage all around. Rust had accumulated all over the Insured Motorcycle as a result of exposure to environmental condition for a period of time.

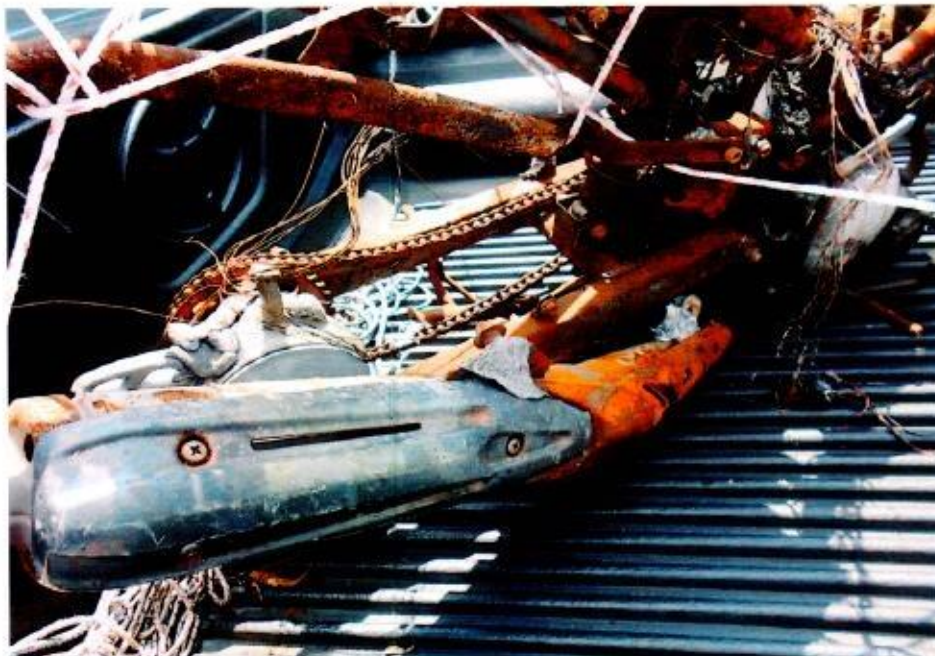
Photo 4 shows the general view of the right rear body of the Insured Motorcycle at the time of our inspection. The Insured Motorcycle was observed to have sustained extensive fire damage all around. Rust had accumulated all over the Insured Motorcycle as a result of exposure to environmental condition for a period of time.

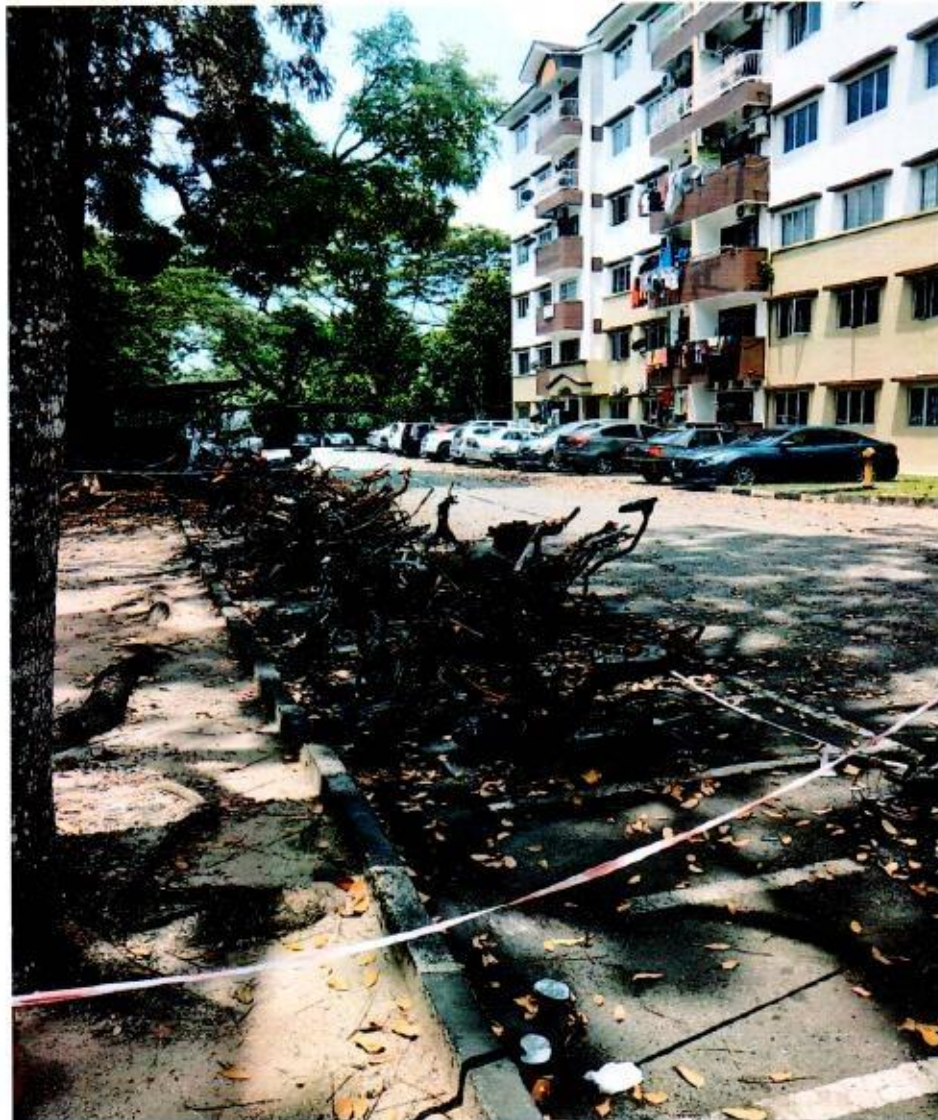
Photo 5 shows the motorcycles which were badly burnt by the fire which had included the Insured Motorcycle. The parked motorcycles were observed to be burnt completely, with rust developing on their structural bodies. In general, the information that could be gathered from this photograph had corresponded to the events that were related to us by Mr Tan, which is the fire had occurred at the parking lots of Mr Tan's home premises.

16. From our analysis of the incident scene photographs, it would appear that the fire to the Insured Motorcycle was due to an external source, where flames from the origin had spread to the Insured Motorcycle.
17. Our checks with both local and international bodies and associations had also revealed that at the time of writing this report, there is no manufacturer recall of similar make and model motorcycle as the Insured Motorcycle that may possibly pose a fire risk.

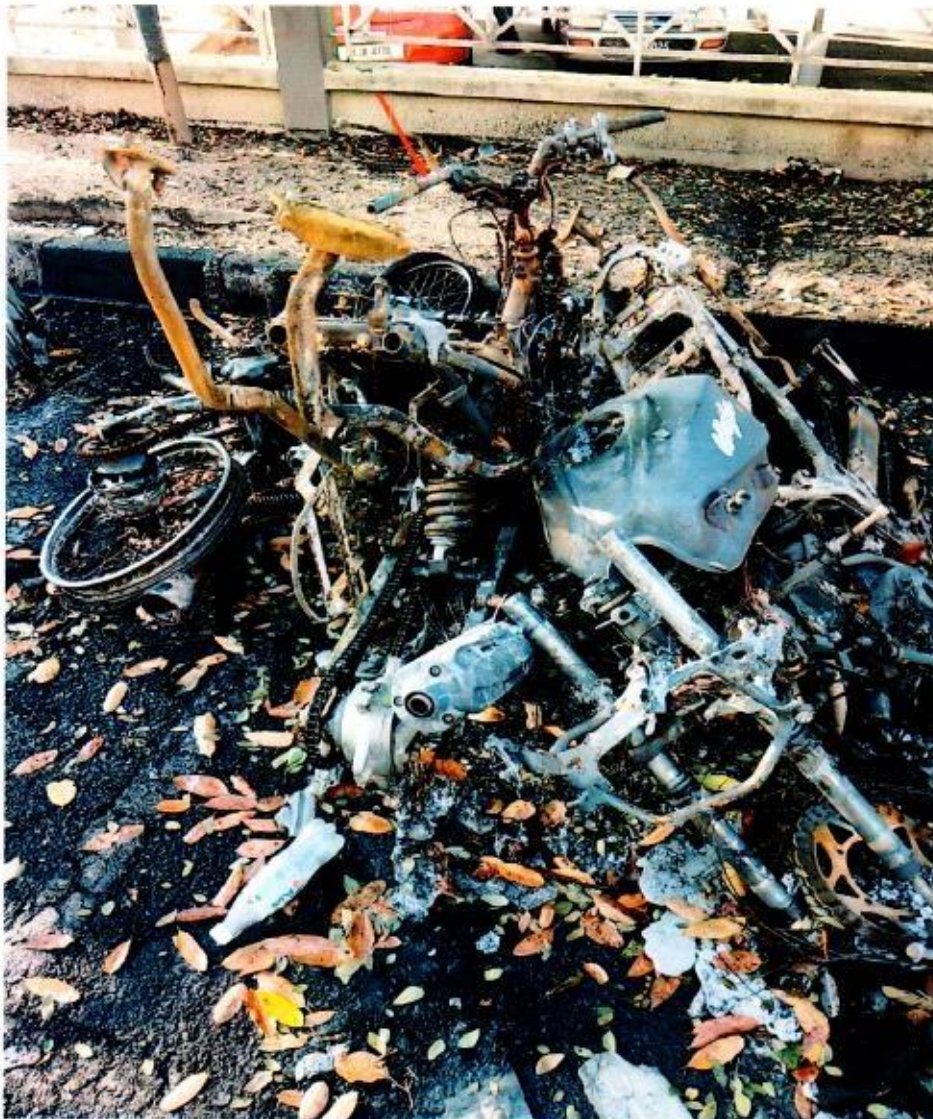
Photo 6 shows a closer view of the Insured Motorcycle (arrowed) which was amongst the few motorcycles found completely burnt by the fire at the parking lot of Mr Tan's home premises.

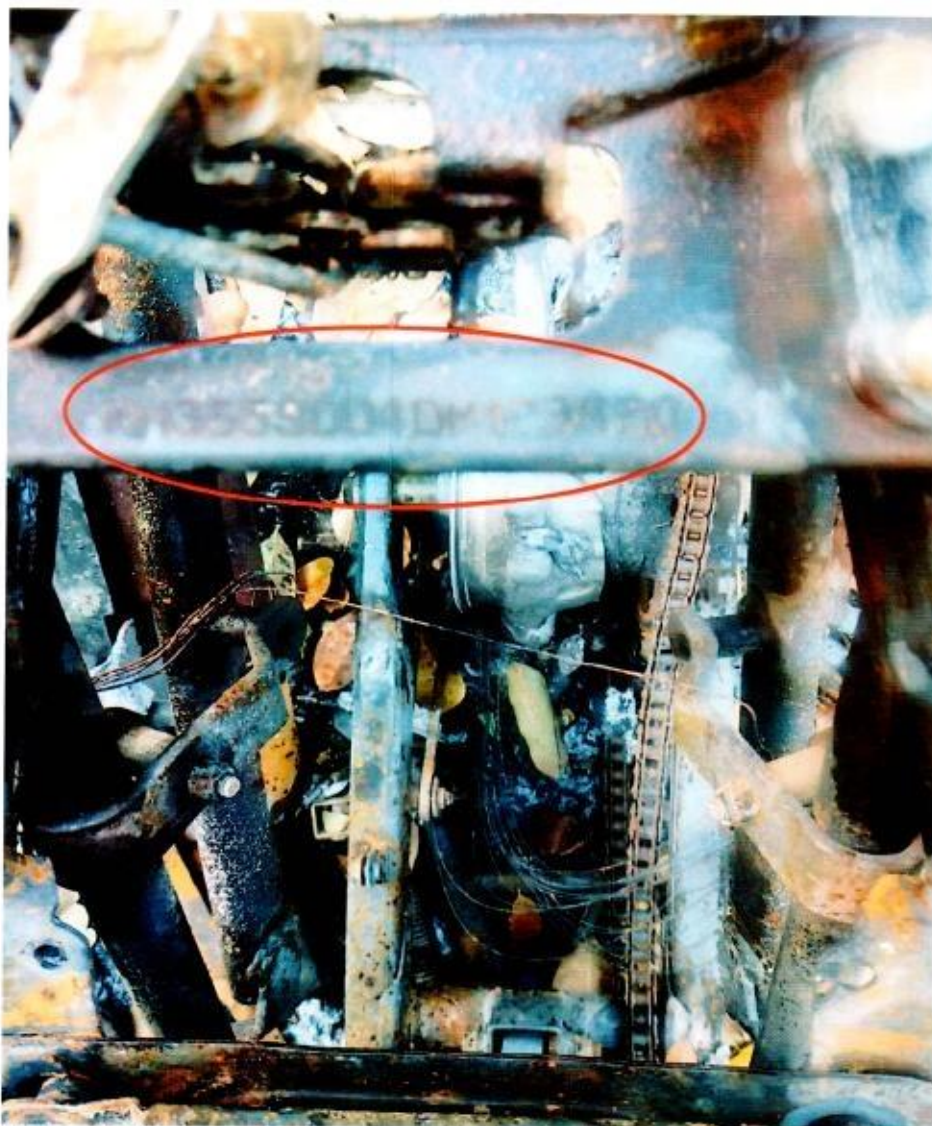
Photo 7 shows a close up view of the structural remains of the Insured Motorcycle (arrowed) which was amongst the few motorcycles that were badly burnt by the fire at the parking lots of Mr Tan's home premises. The chassis number **MH355S004DK123820** on the frame matches that of the Insured Motorcycle (circled).
