## Preliminary Advice

Insured Vehicle No	: SGW3642Z	Accident Date	: 22/02/2019
TP Vehicle No	: SHC6155L	Assignment Date	: 26/02/2019
Make	: KIA OPTIMA	Est. Duration of Repair	: 10 days
Date of Inspection	: 27/02/2019		
Inspection At	: Premier Automotive Services Pte Ltd (HQ) 23 Changi South Ave 2, #01-02 Singapore 486443

## VEHICLE DAMAGE INSPECTION REPORT

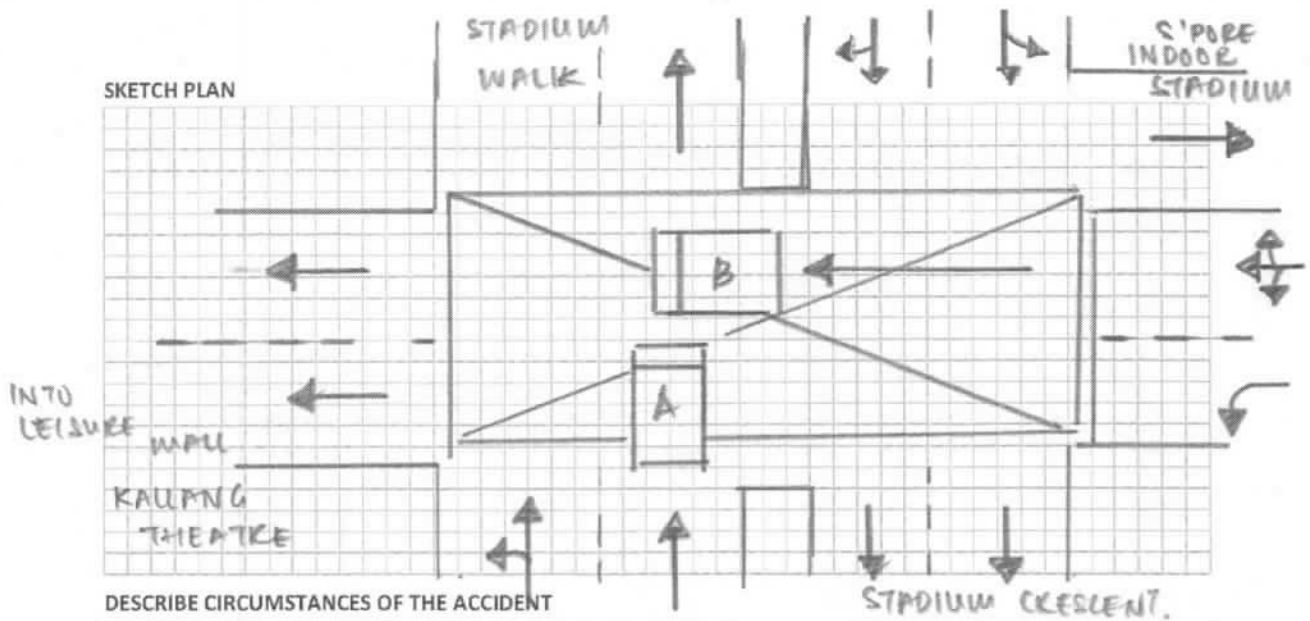
Sketch Plan Pg. 2

WHILE I WAS MOVING STRAIGHT AHEAD – WITHIN MY LANE, SUDDENLY VEHICLE B ( SGW 3642 Z – HONDA CIVIC/WHITE ) WHICH WAS EXITING FROM CARPARK @ SINGAPORE INDOOR STADIUM (ON MY RIGHT) – FAILED TO KEEP FOR PROPER LOOK OUT & FAILED TO STOP TO GIVE WAY TO ONCOMING VEHICLES APPROACHING FROM MY ROUTE, HAD ENCROACHED ONTO MY PATH ON MY FRONT ABRUPTLY.

AS SUCH, THE LEFT FRONT OF VEHICLE B COLLIDED ONTO THE FRONT PORTION OF MY TAXI – WHILE HE WAS MOVING OFF AHEAD INTO THE DRIVEWAY OF LEISURE MALL/KALLANG THEATRE.

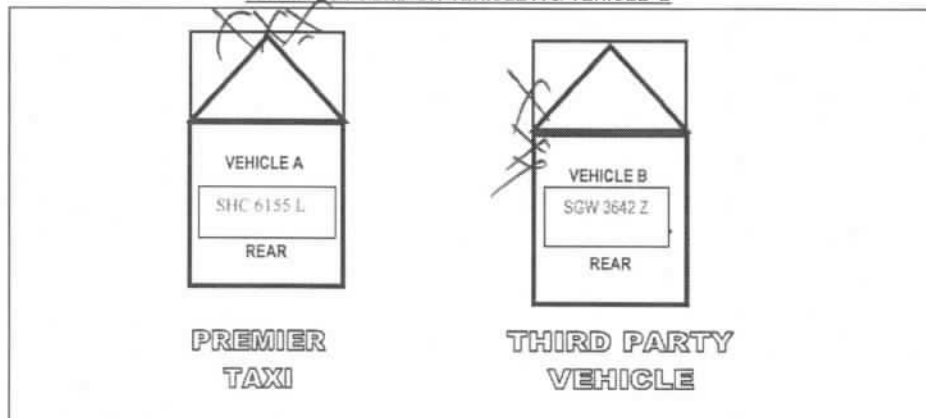
DAMAGES FOUND ON VEHICLE A & VEHICLE B

DUE TO THE IMPACT, MY TAXI HAD DAMAGES ON THE FRONT PORTION AND VEHICLE B HAD DAMAGES ON THE LEFT FRONT PORTION.
