Our ref: CS/FCI19003713/Dvd3

**INITIAL INSPECTION REPORT OF VEHICLE NO SHA 1909Y**

| Affiliated to Federation Internationale Des Experts En Automobile | | | | |
|---|---|---|---|---|
| MS FIRST CAPITAL INSURANCE LTD | | Ref : CS/FCI19003713/Dvd3n2 | | |

## ADJUSTMENT ON REPAIR COST FOR VEHICLE NO. SHA 1909Y

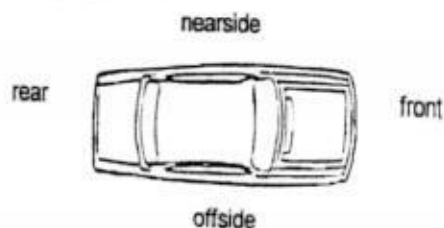
The vehicle sustained damages at the o/s rear portion

Comments/Present Status:  
Damages Consistent
