Inspected Vehicle No: GX 4716 H

PRE-REPAIR INSPECTION REPORT				
CHINA TAIPING INSURANCE (S) PTE LTD		Ref: CS3/CTI19003714/R1cd3e2		
3 ANSON ROAD #16-00 SPRINGLEAF TOWER		Date: 08-05-2019		
SINGAPORE 079909		Code: CTI ✓

4. Description of Damages				
THE VEHICLE SUSTAINED DAMAGES AT THE REAR PORTION.				
5. General Information				
Accident Date	14/02/2019 ✓	Inspect Date / Time	27/02/2019 (04:41 PM) ✓	
Survey held at	RAN CAR REPAIRS BLK 1001 #01-49 BUKIT MERAH LANE 3 ALEXANDRA VILLAGE SINGAPORE 159718			
5a. Remarks

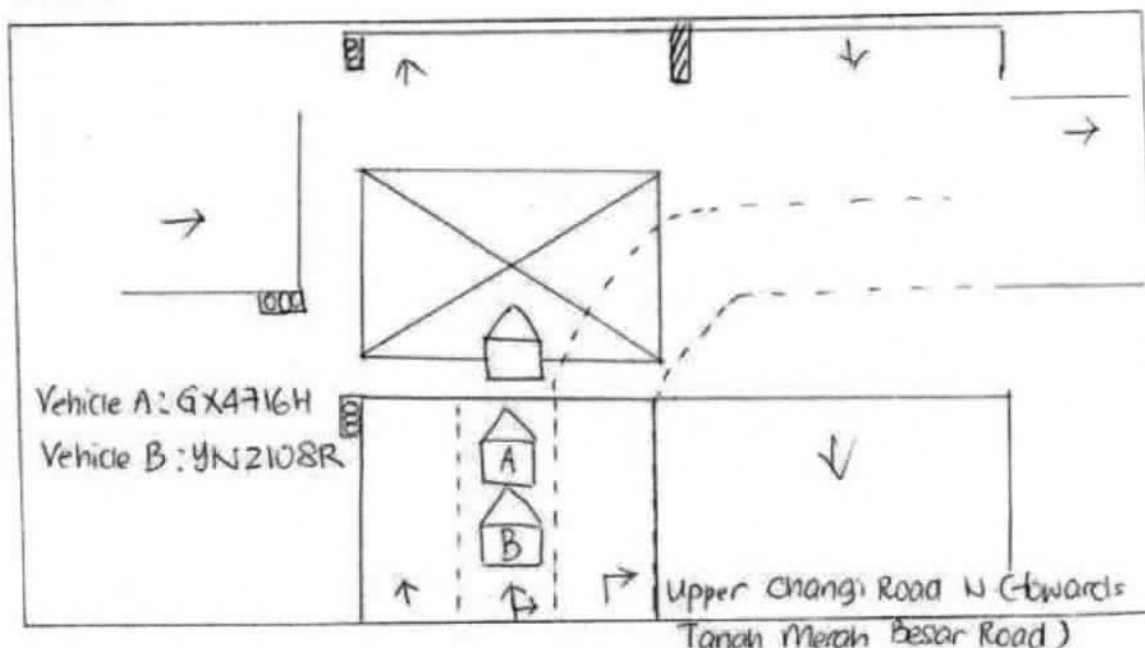
Sketch Plan

I was travelling along Upper Changi Road N. (towards Tanah Merah Besar Road) on 14/02/19 at about 8.5 am.

Traffic was slow and heavy. The vehicles in front stopped so I followed. Few seconds later, Vehicle B came from behind and hit onto me.
