Our ref: CS/FCI19003802/Dvd3

**INITIAL INSPECTION REPORT OF VEHICLE NO SHC 988P**

VEHICLE NO : SHC 988P (Supplementary)

## ADJUSTMENT ON REPAIR COST FOR VEHICLE NO. SHC 988P

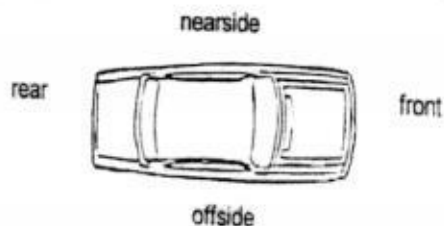
The vehicle sustained damages at the front and rear portion

Comments/Present Status:  
Damages Consistent
