Re : Third Party Claim For Vehicle Registration No. SLL2906T

VEHICLE INSPECTION REPORT

Registration no.	: SLL2906T	Odometer	: 100830 km
Make / Model	: Mazda 3 4-Door Sedan 1.5L SP.6EA	Chassis no.	: JM6BN22A8H0140802
Regn. date	: 20 Feb 2017	Engine no.	: P520428640
Body colour	: Blue	Engine cap.	: 1496 cc

ADJUSTMENT ON REPAIR COST FOR VEHICLE NO. SLL 2906T

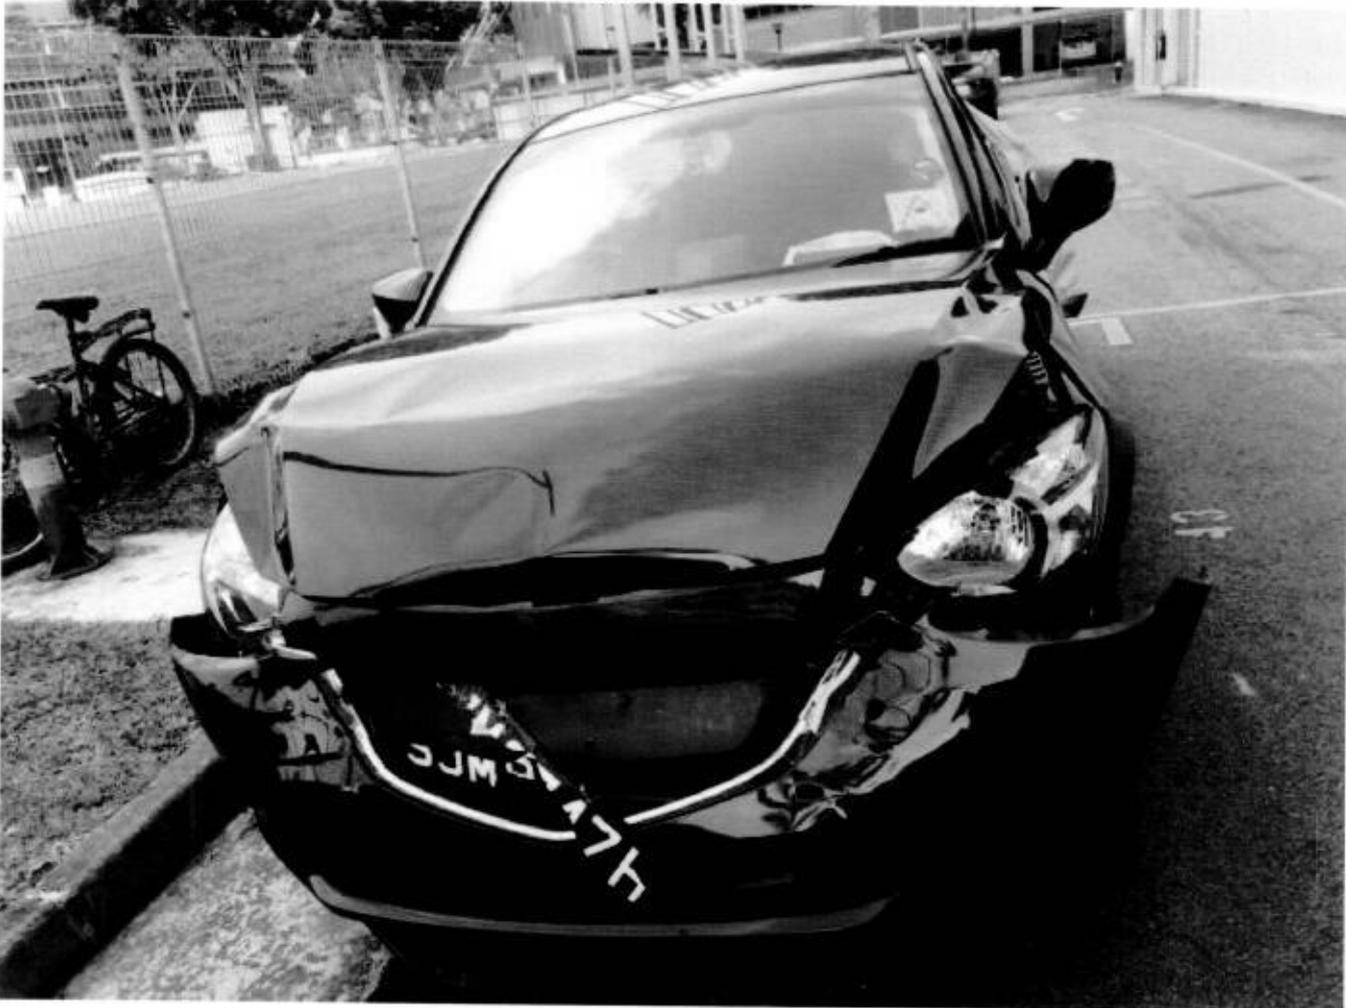
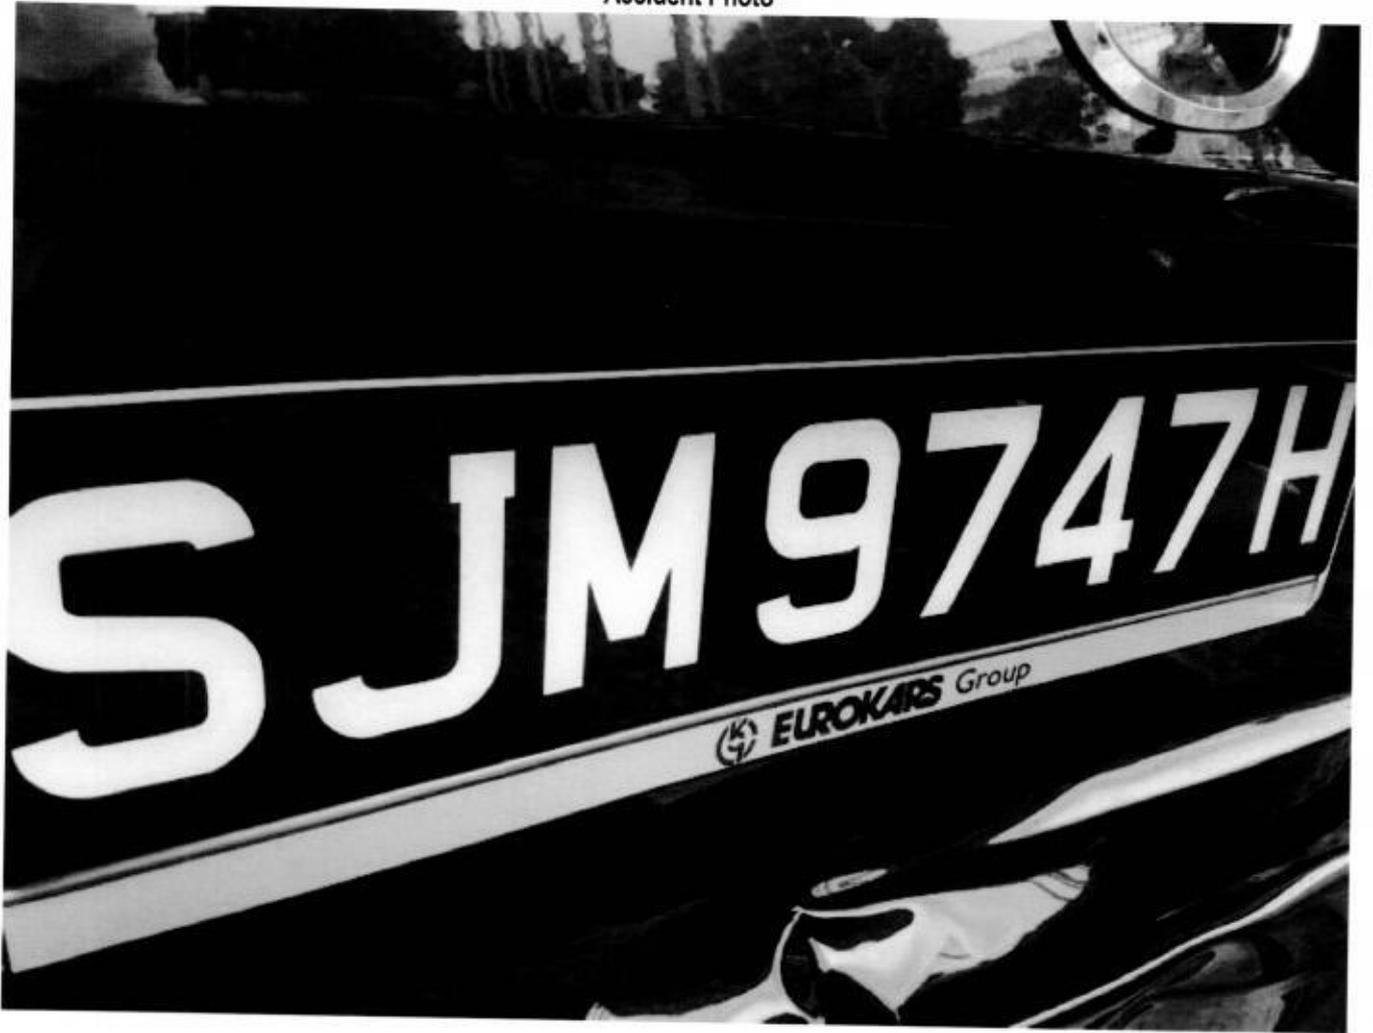
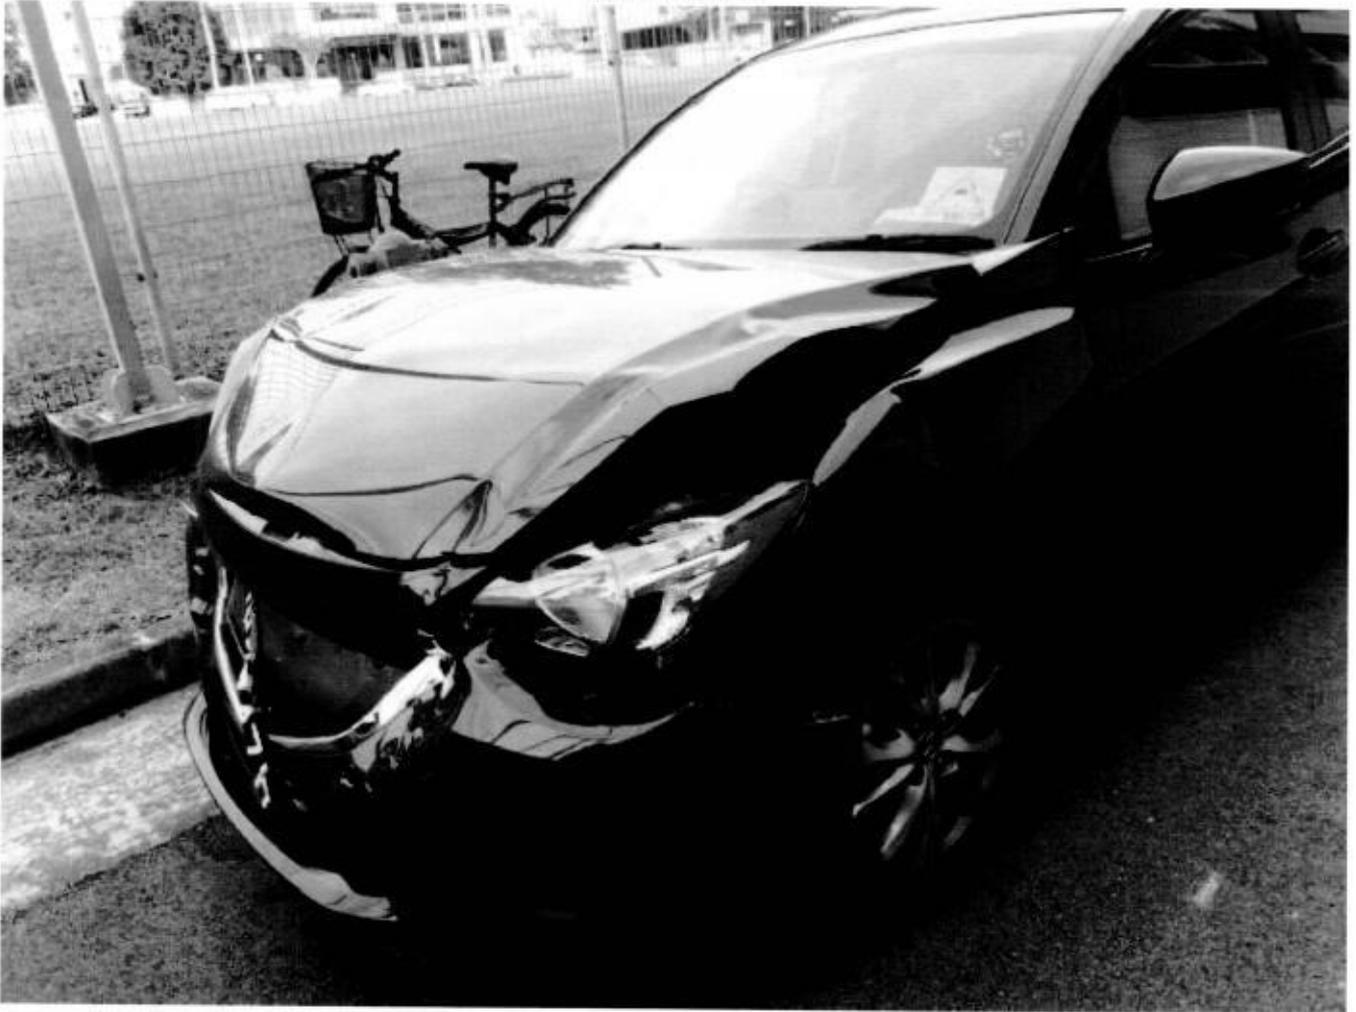
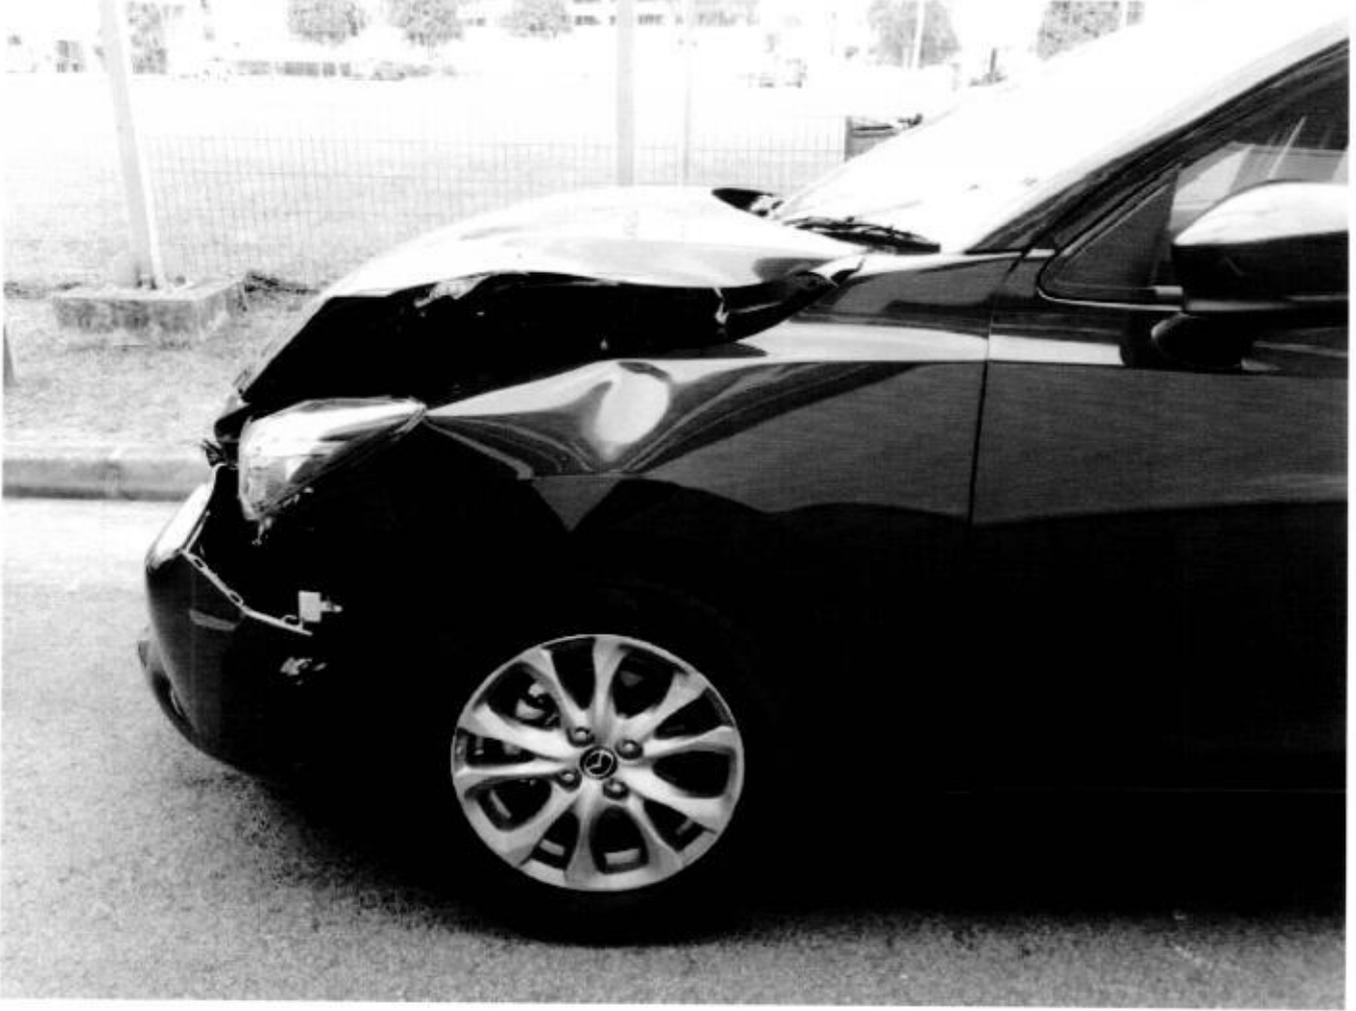
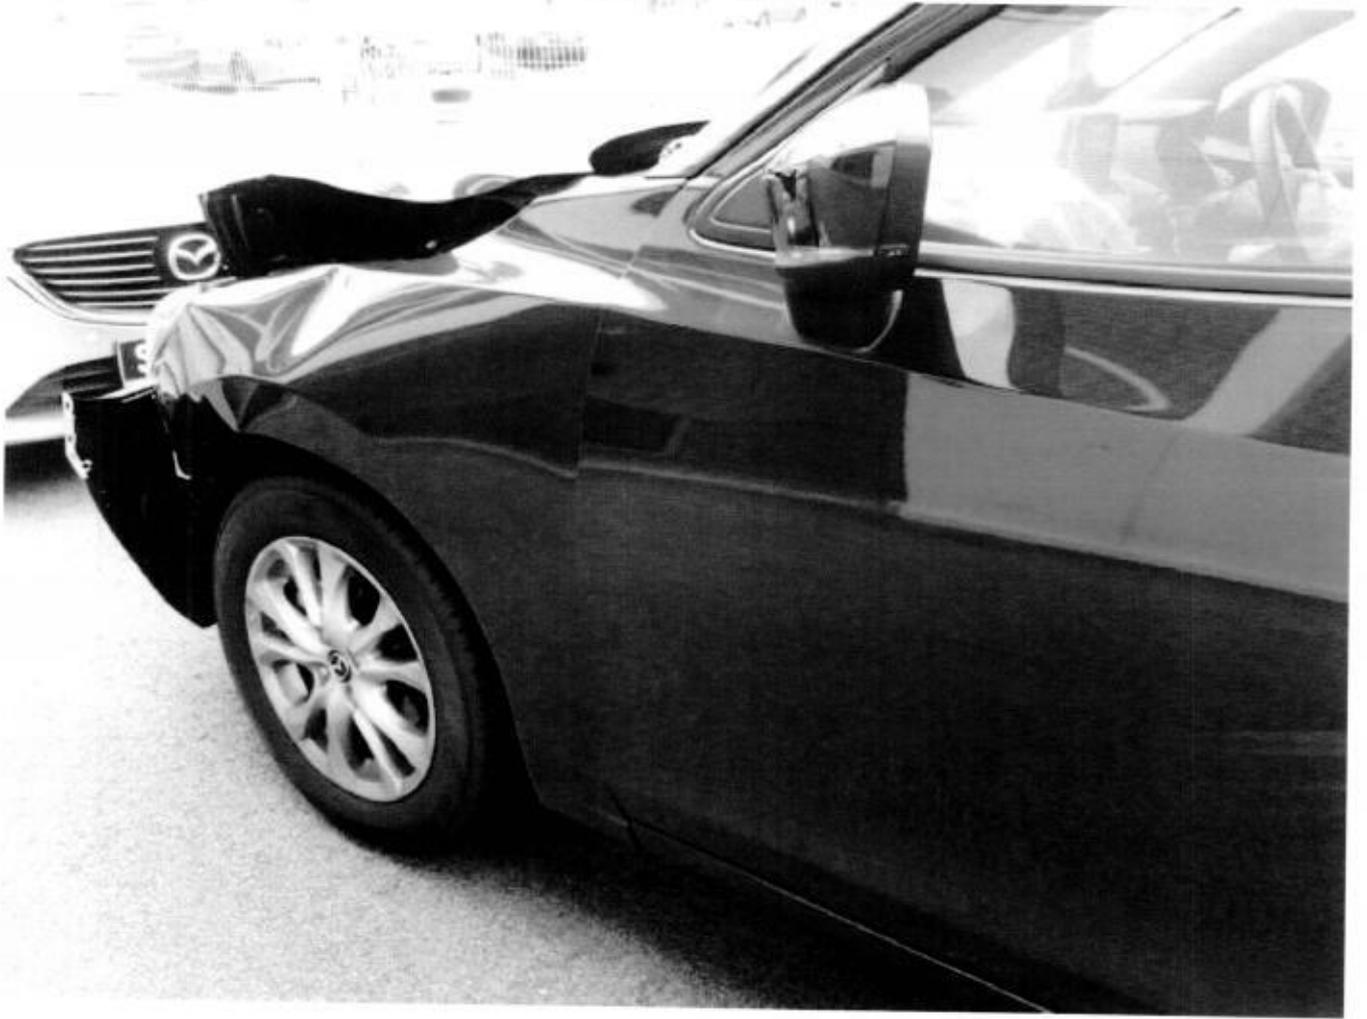
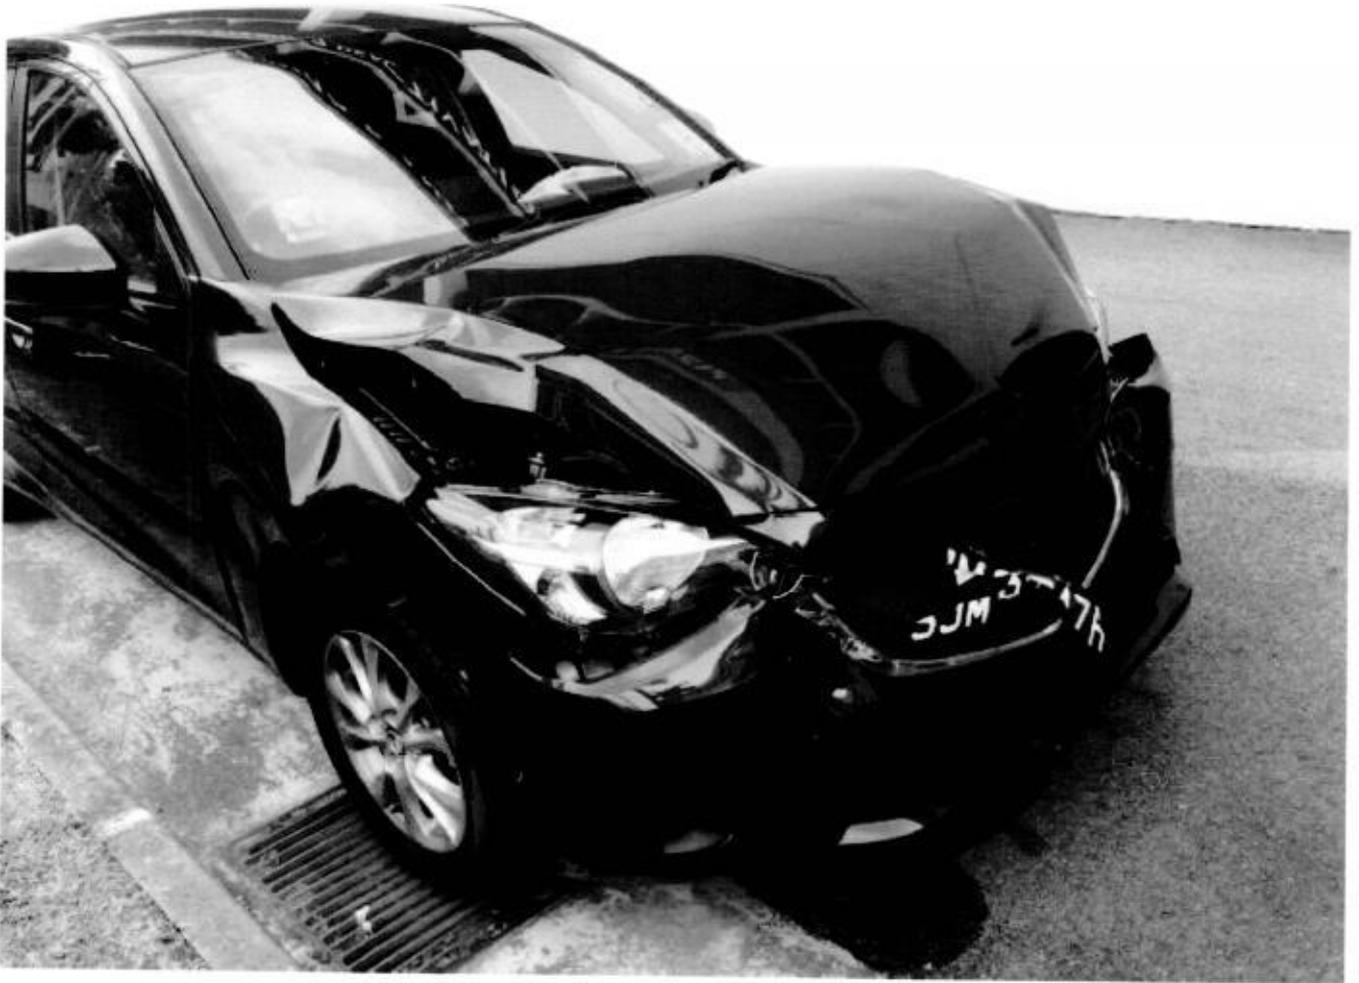
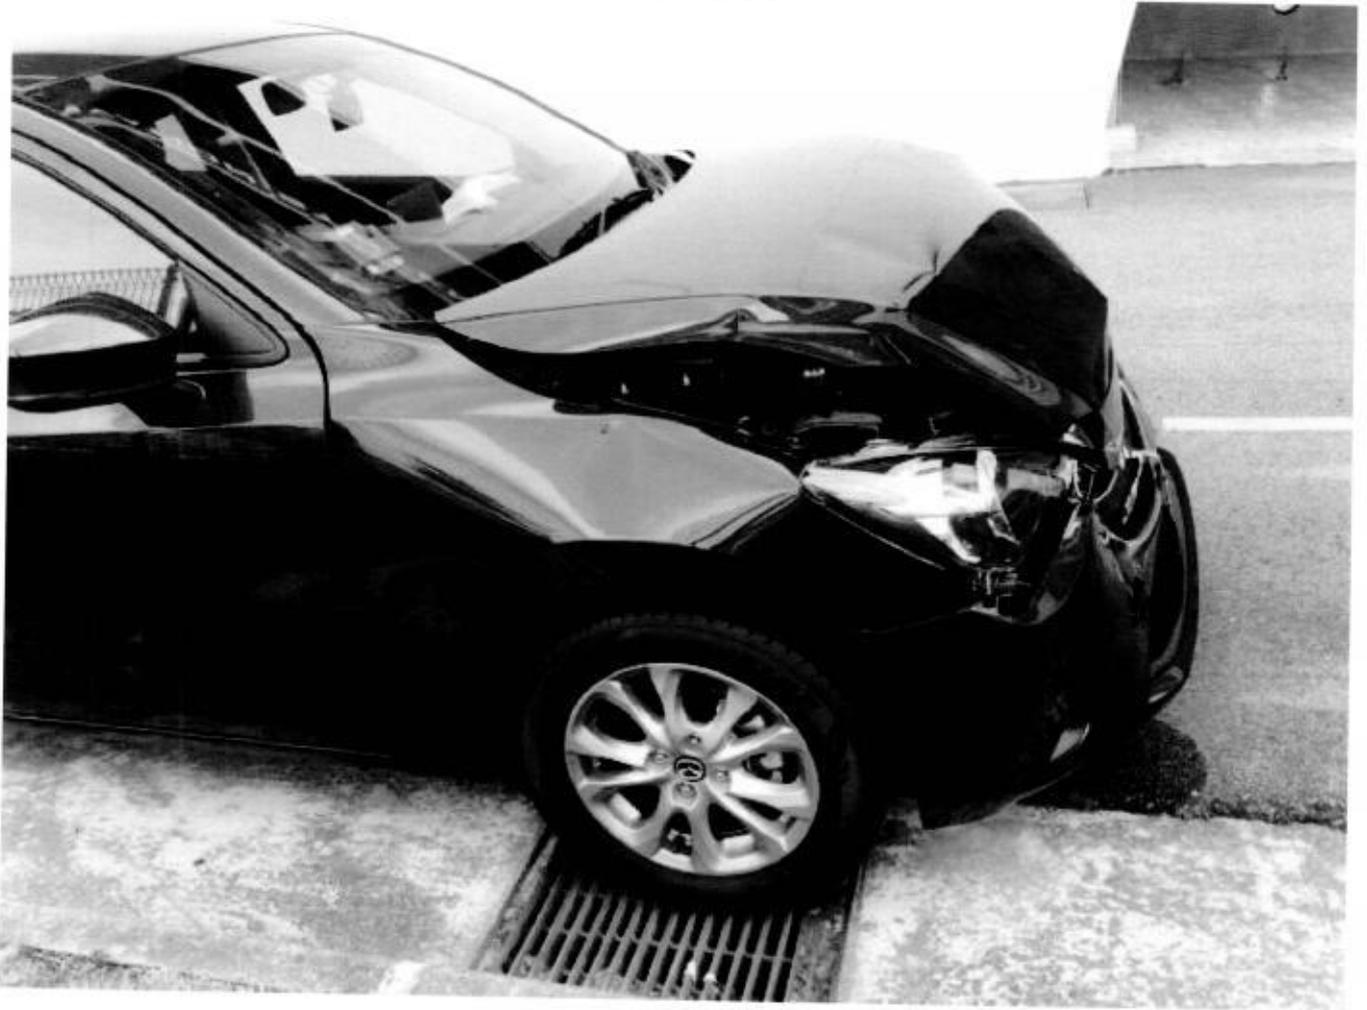
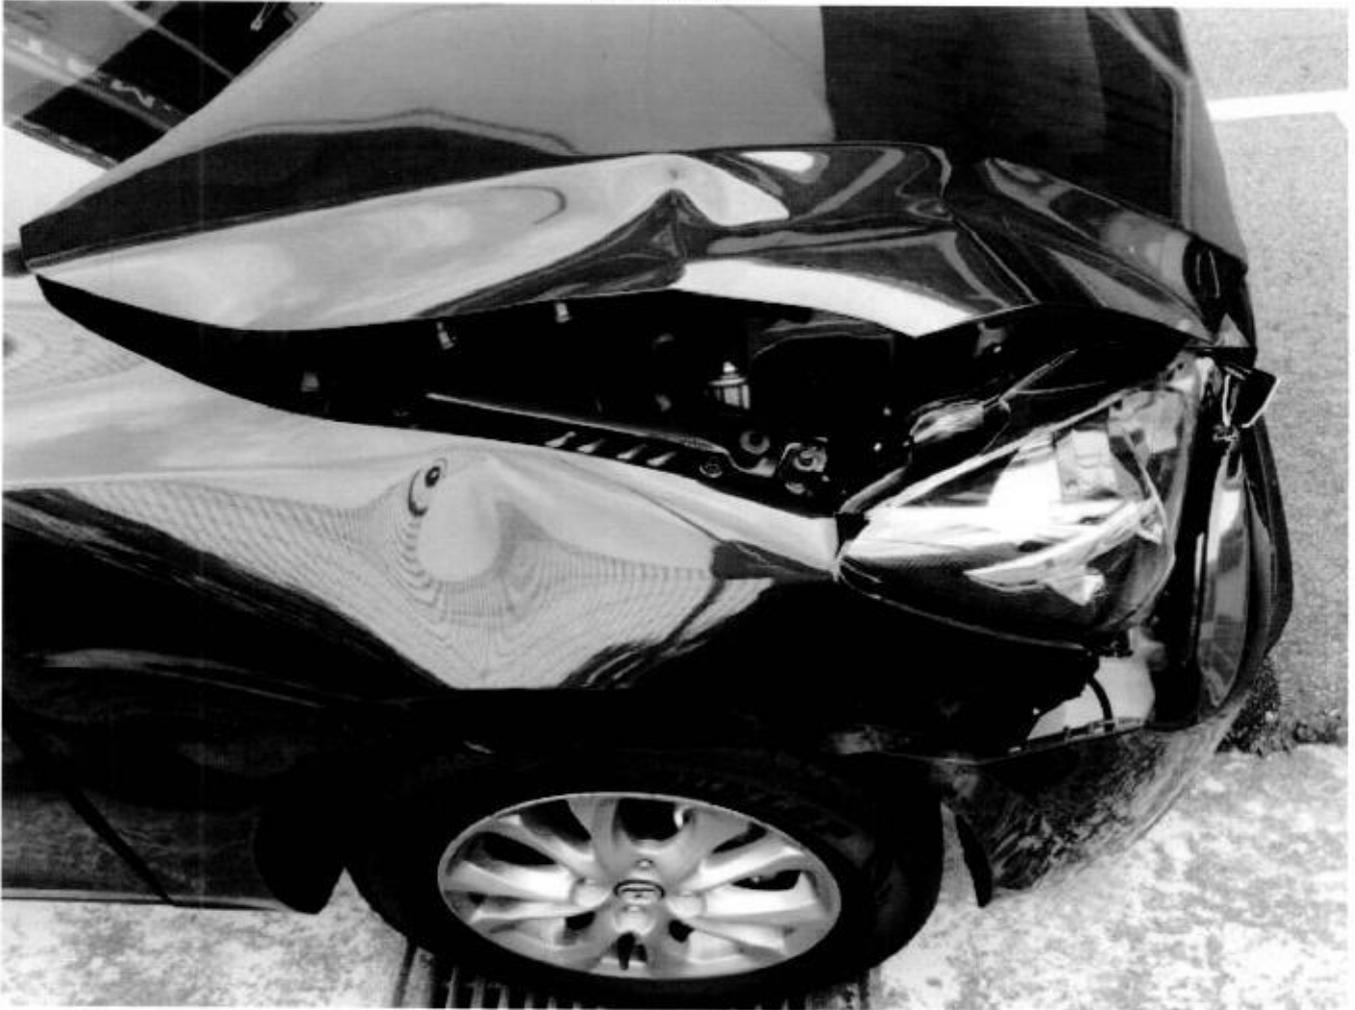
Accident Photo

POINT OF IMPACT

On the rear and front portion in the direction from rear to front causing vehicle surge forward and collided onto front vehicle.

The impact of the collision has damaged / affected the bootlid, rear bumper, rear end panel, exhaust pipe, taillamp, bonnet, front bumper, headlamp and etc...
