Your Ref: TP/IP/01847/2019  
Our Ref : CI/TPD19004300/P

**Accident Enquiry & Investigation Team**

**MECHANICAL INSPECTION REPORT OF MOTOR CAR SCK 1726P**

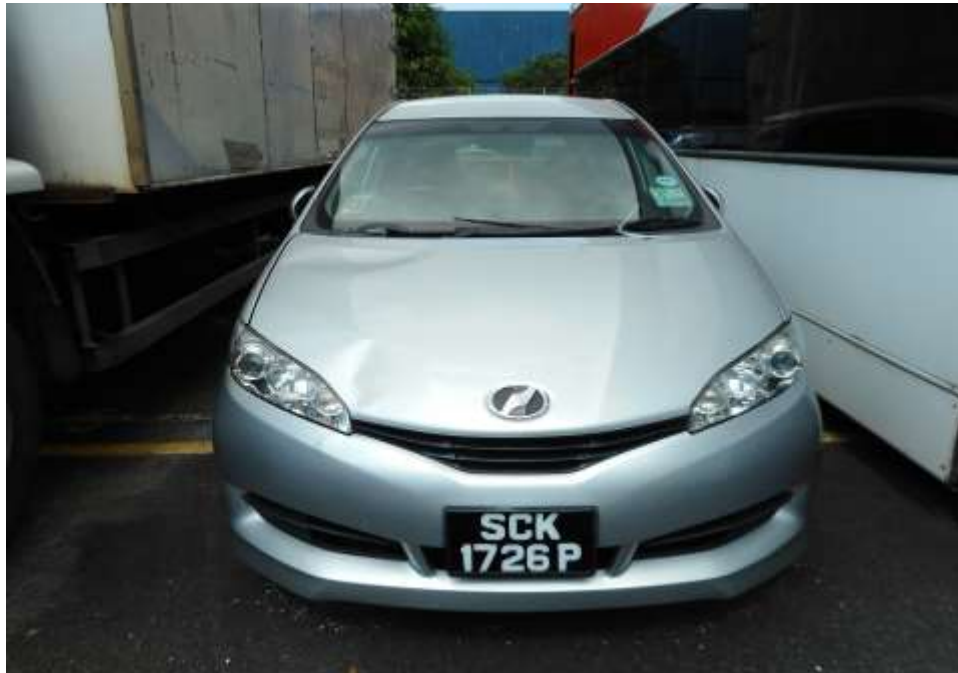
4. The mileage of the Motor car at the time of my inspection was 153,092km.
5. The Motor car was observed to have sustained relatively minor damage at its frontal portion. Its front windscreen, right windscreen wiper, bonnet and bumper were amongst the body parts that were damaged as a result of the accident.

**Photo 1** shows a general view of the front right body of the Motor Car at the time of my inspection. The Motor car was observed to have sustained relatively minor damage at its frontal portion. Its front windscreen, right windscreen wiper, bonnet and bumper were amongst the body parts that were damaged as a result of the accident. The mileage of the Motor Car at the time of my inspection was recorded to be 153,092km.

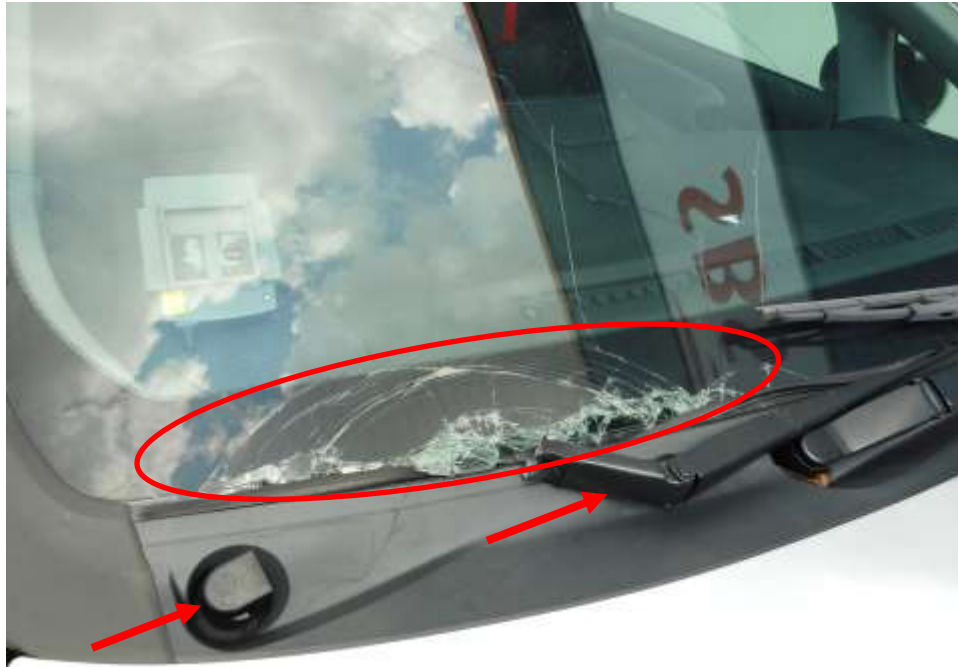
**Photo 2** shows a close up view of the damaged front windscreen (circled) and right windscreen wiper (arrowed) of the Motor Car. The mileage of the Motor Car at the time of my inspection was recorded to be 111,492km.

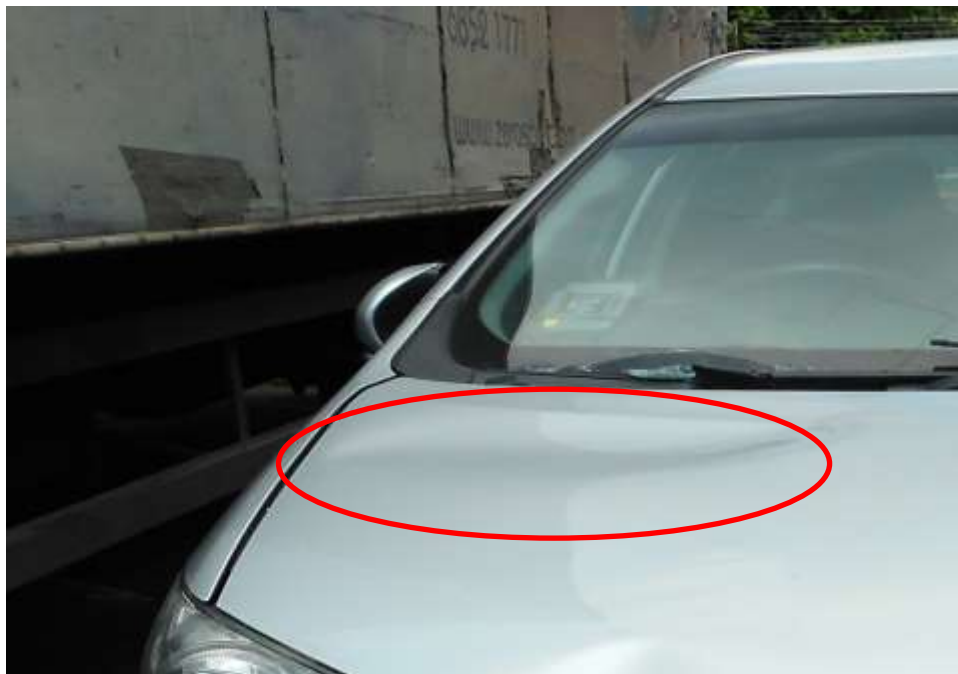
**Photo 3** shows a close up view of the Motor car's bonnet. Its front bonnet (circled) was damaged as a result of the accident.

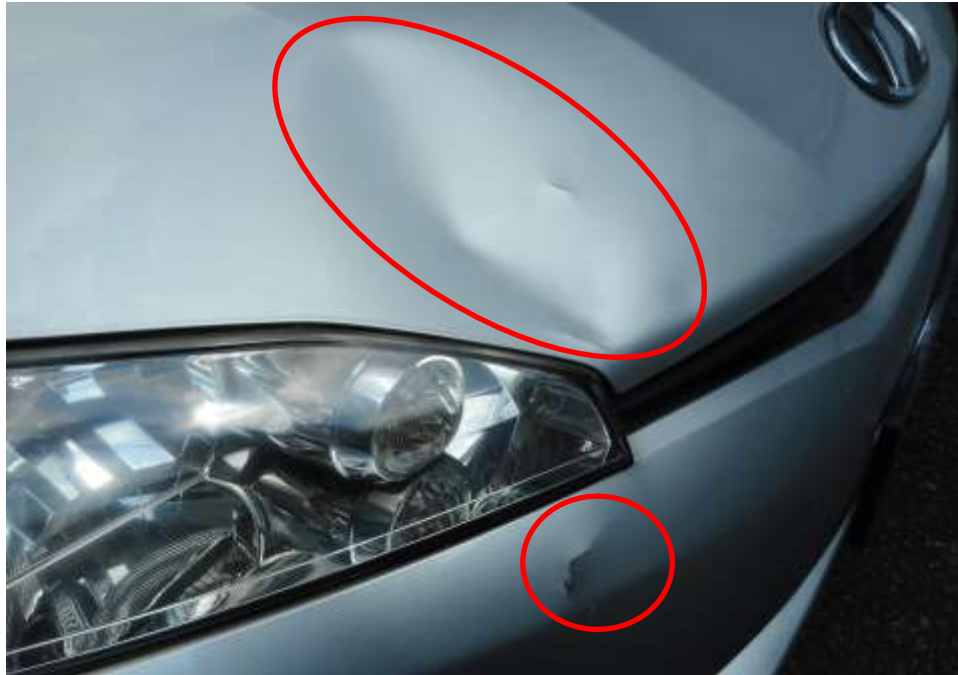
**Photo 4** shows a close up view of the front body of the Motor Car at the time of my inspection. The Motor Car was observed to have sustained relatively minor damage at its frontal portion. Its front bonnet and bumper (circled) were damaged as a result of the accident.

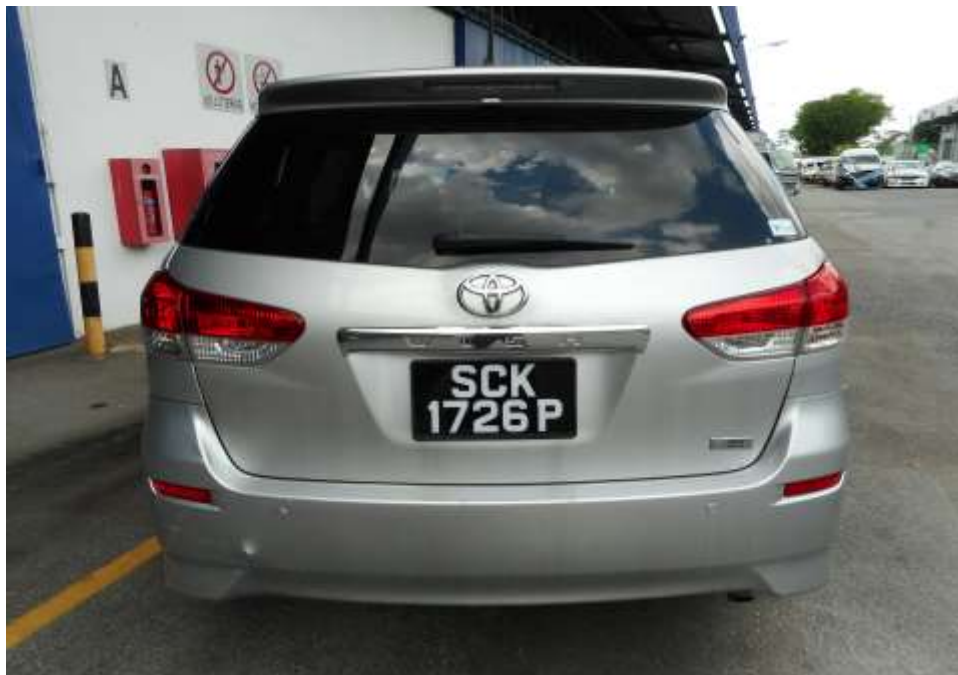
**Photo 5** shows a general view of the Motor Car's rear left body at the time of my inspection. The rear portion of the Motor Car was observed to have been unaffected by the accident.

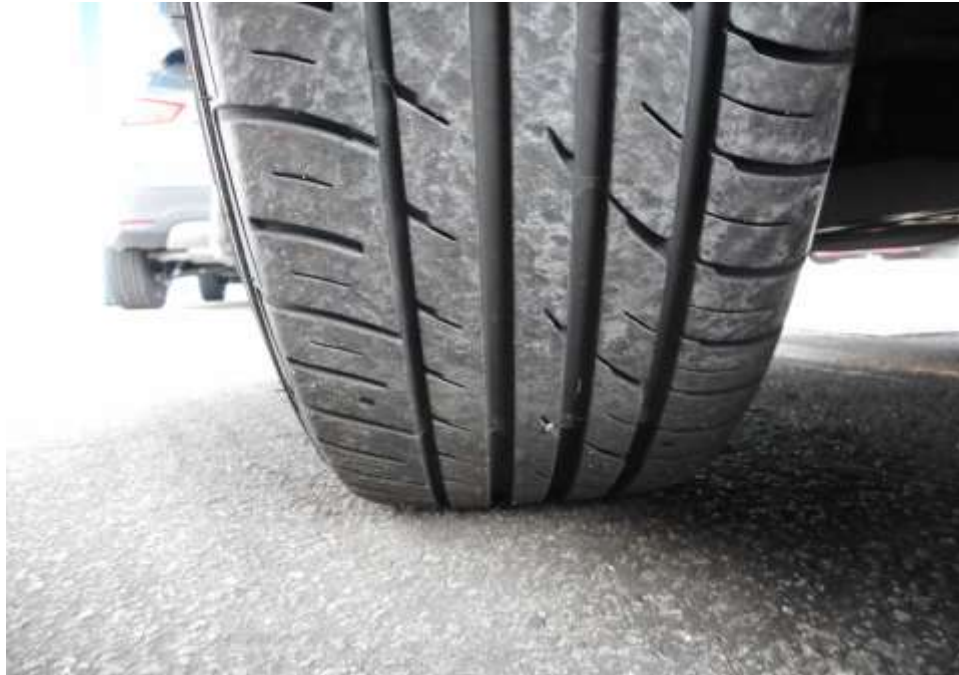
**Photo 6** shows the condition of the front left tyre of the Motor Car, which was observed to be in serviceable condition with remaining tread depth of approximately 6.1mm. The tyre was sufficiently inflated for vehicular operation with no tear, cut or burst mark(s) on the outer and the inner sidewalls as well as across the tread. The 4 tyres of the Motor Car were wrapped around standard alloy wheel rims without any damage.

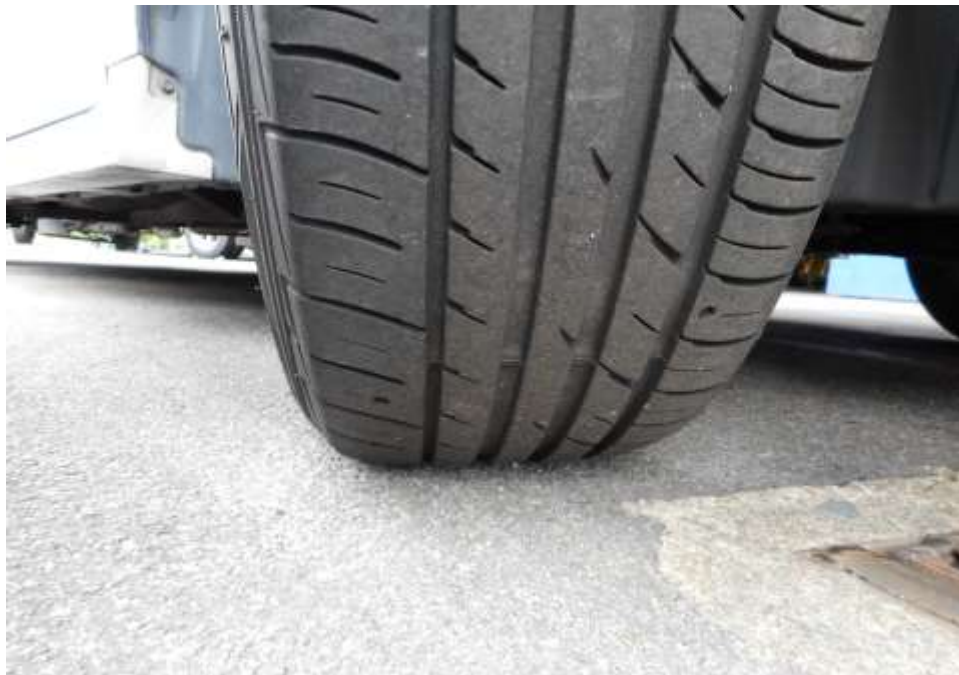
**Photo 7** shows the condition of the front right tyre of the Motor Car, which was observed to be in serviceable condition with remaining tread depth of approximately 6.1mm. The tyre was also observed to be sufficiently inflated for vehicular operation with no tear, cut or burst mark(s).

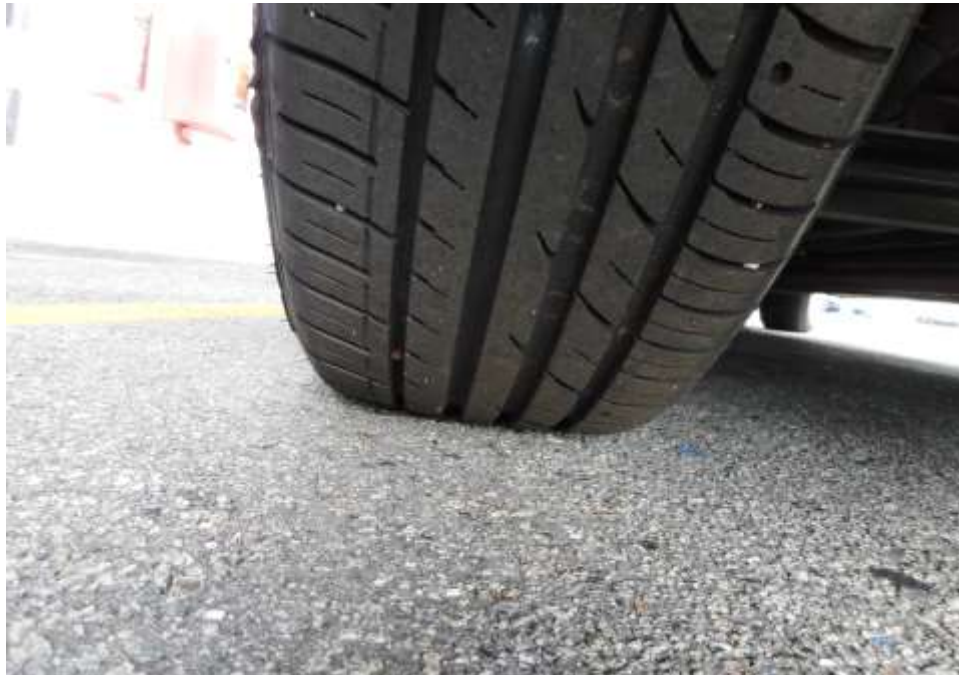
**Photo 8** shows the condition of the rear left tyre of the Motor Car, which was observed to be in serviceable condition with remaining tread depth of approximately 7mm. The tyre, which was wrapped around alloy wheel rim, was also observed to be sufficiently inflated for vehicular operation. The 4 tyres of the Motor Car were wrapped around standard alloy wheel rims that were without any significant damage apart for some relatively minor kerb grazing type of damage on the outer side of the wheel rims

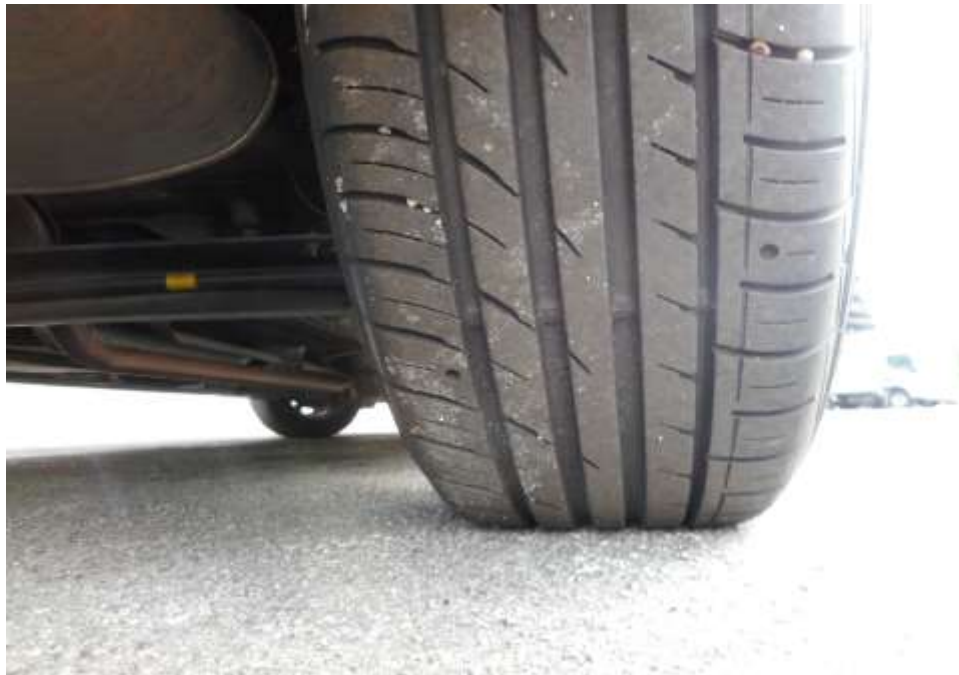
**Photo 9** shows the condition of the rear right tyre of the Motor Car, which was observed to be in serviceable condition with remaining tread depth of approximately 7mm. There was also no tear, cut or burst mark(s) on the outer and the inner sidewalls as well as across the tread of the Motor Car's 4 tyres.

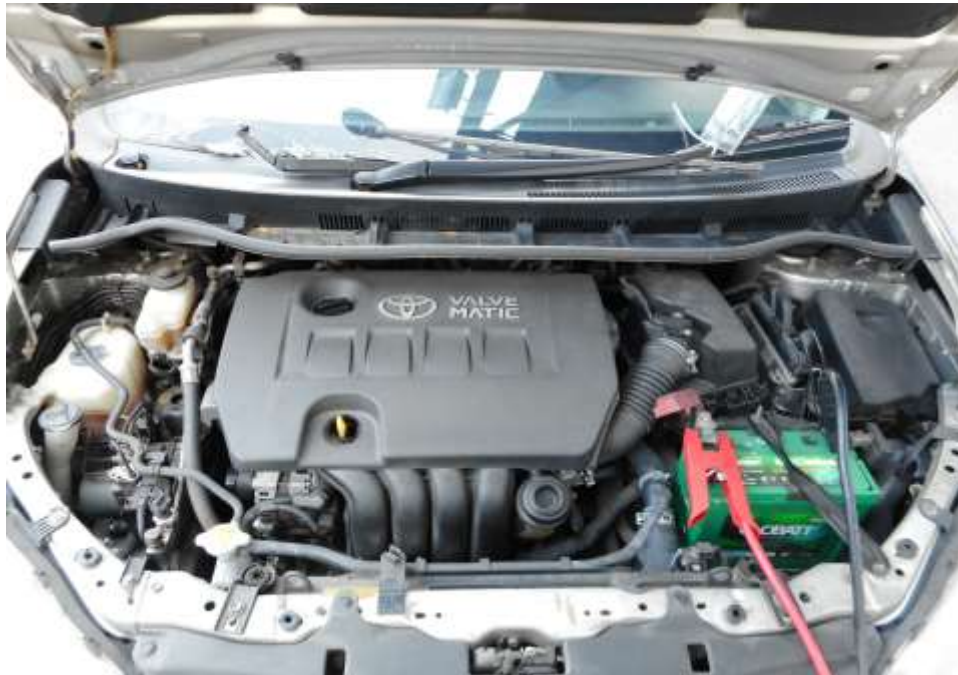
**Photo 10** shows a general view of the Motor Car's engine compartment. The various parts and components inside the engine compartment were unaffected by the accident. There was also no sign(s) or indication(s) of fluid leakage and/or fluid stain within the engine compartment.

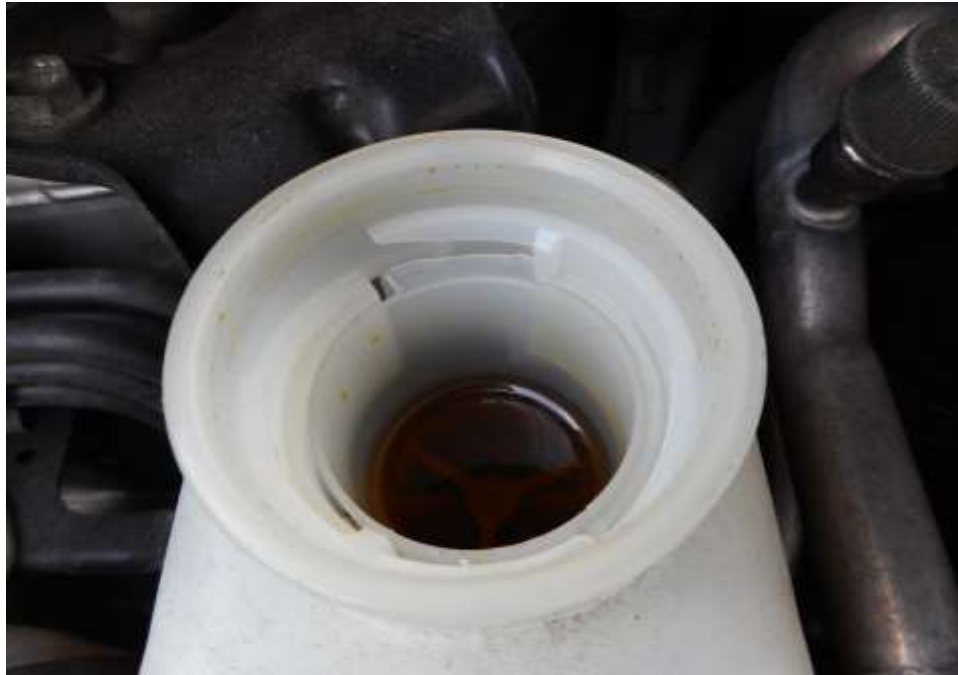
**Photo 11** shows the brake fluid reservoir of the Motor Car at the time of my inspection. The brake fluid was observed to be of sufficient level and without any visible contamination.

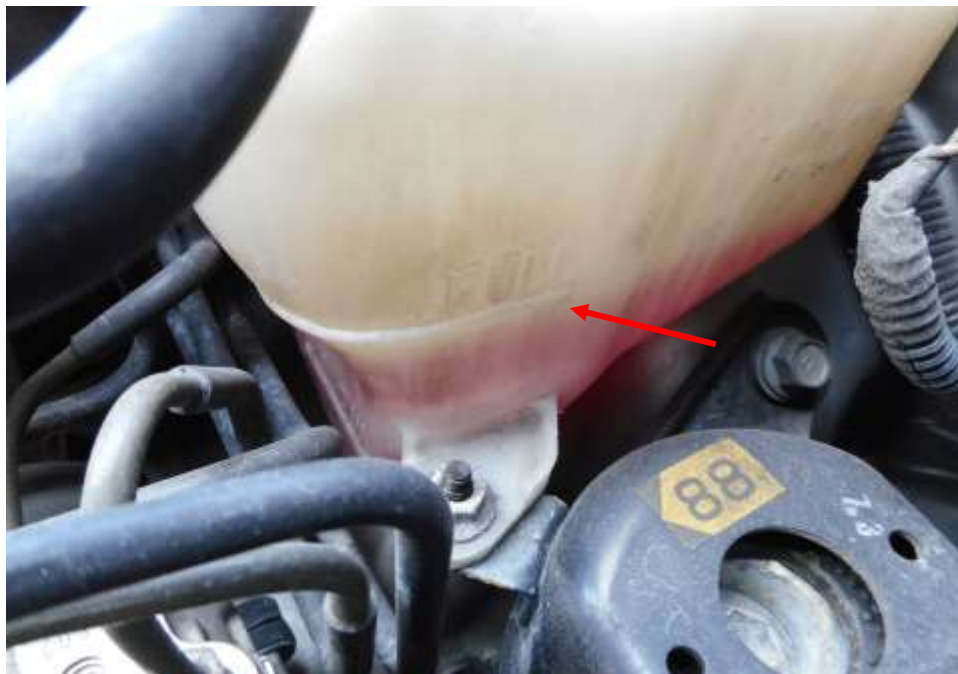
**Photo 12** shows checks being carried out to the engine coolant of the Motor Car at the time of my inspection. The engine coolant was observed to be of sufficient level (arrowed) and without any visible contamination.

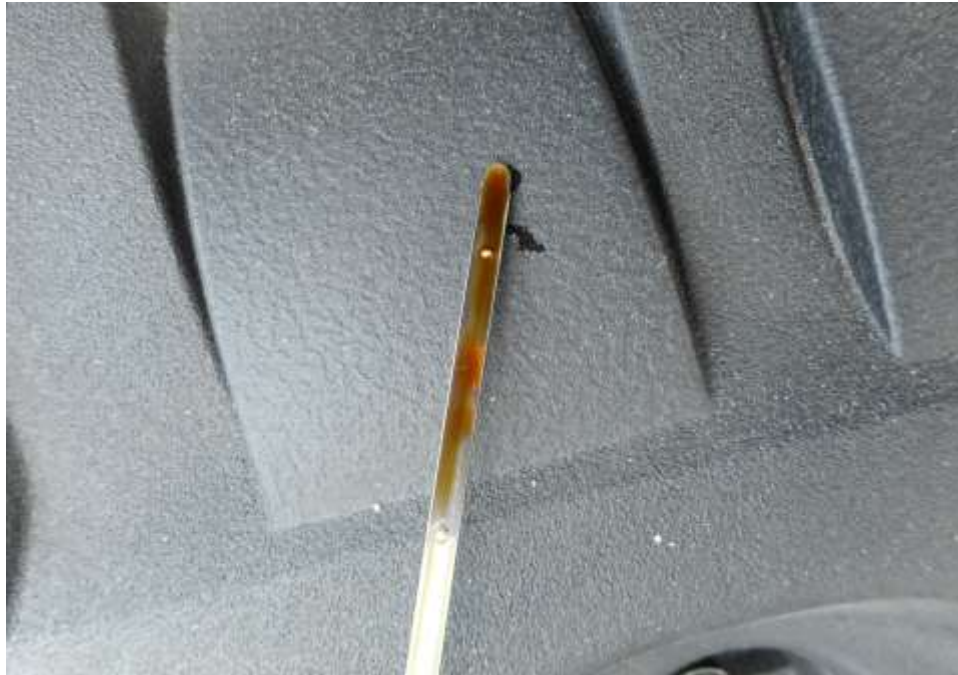
**Photo 13** shows the engine oil dip stick of the Motor Car at the time of my inspection. The engine oil was observed to be of sufficient level and without any visible contamination.

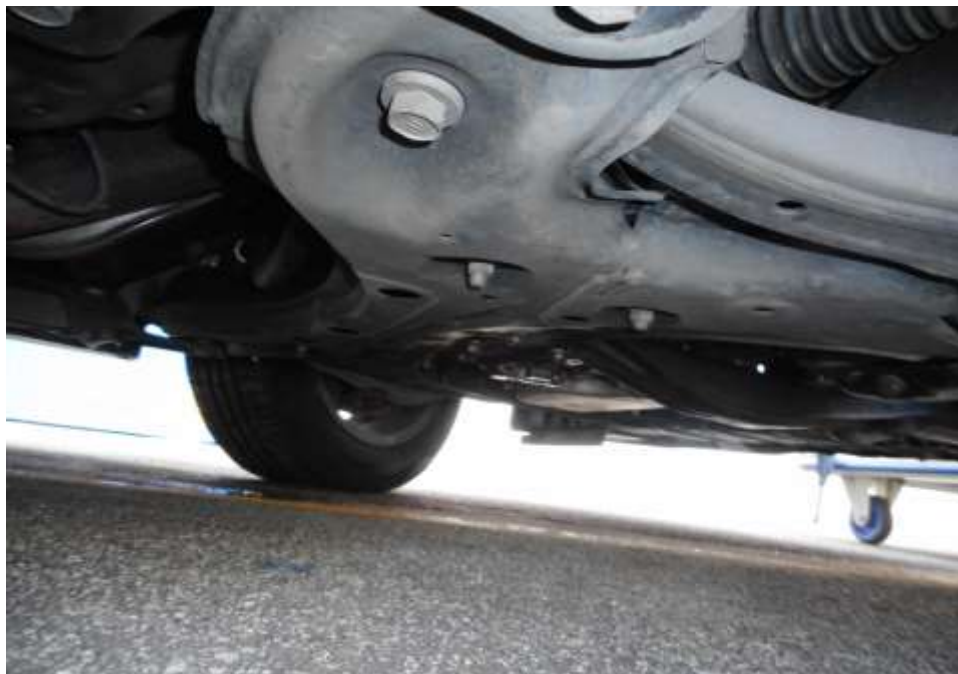
**Photo 14** shows the undercarriage of the Motor Car, at the area where the engine housing and transmission housing are located. I did not find any sign(s) or indication(s) of fluid leak and/or fluid stain(s) on the underside of the Motor Car.

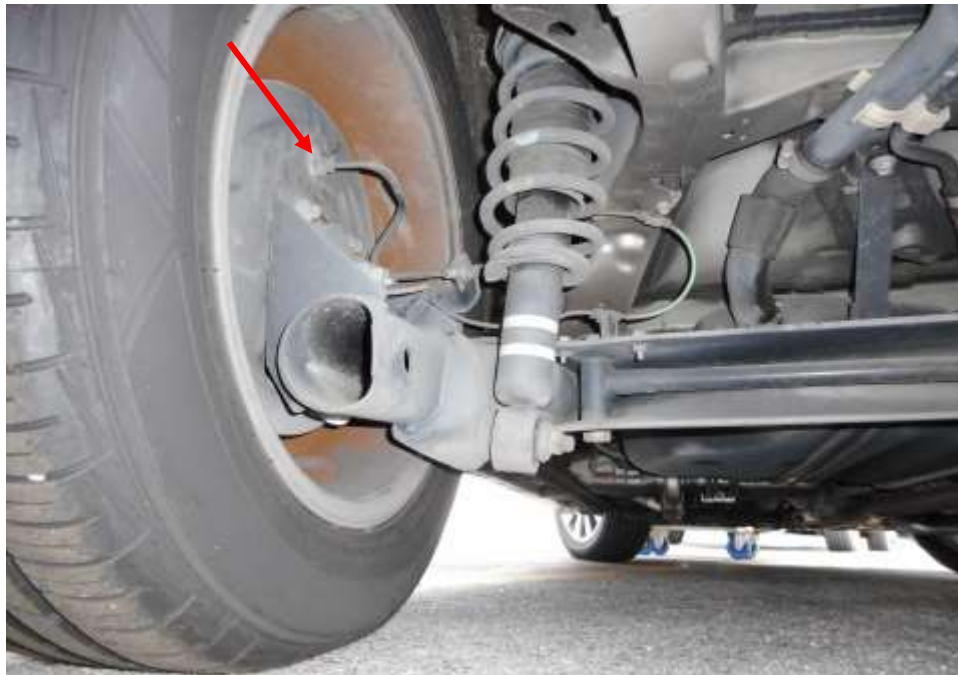
**Photo 15** shows the brake hose/pipe (arrowed) at the rear left wheel of the Motor Car. I did not observe any leakage of brake fluid at the time of my inspection of the Motor Car. Static tests of the Motor Car's braking system had indicated that there was no internal leakage of pressure/vacuum. The undercarriage components of the Motor Car were also all found to be intact and without any visible damage.

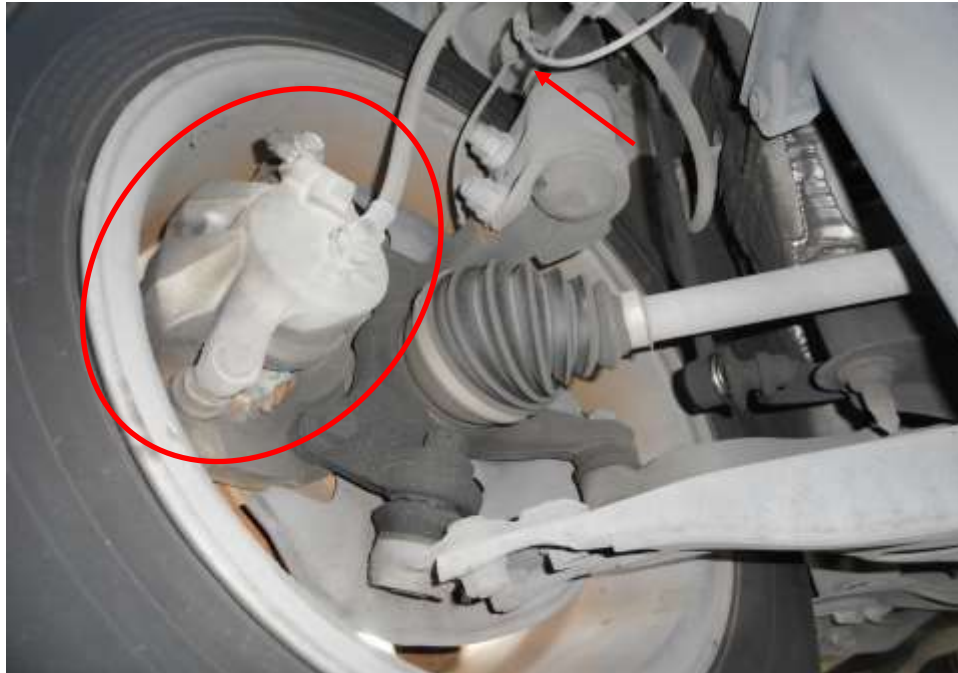
**Photo 16** shows the brake hose/pipe (arrowed) at the front right wheel of the Motor Car. No leakage of brake fluid was observed. Visual examination of the various components of the braking system like the brake caliper (circled), brake booster, brake pedal etc had revealed all to be intact and without visible damage.

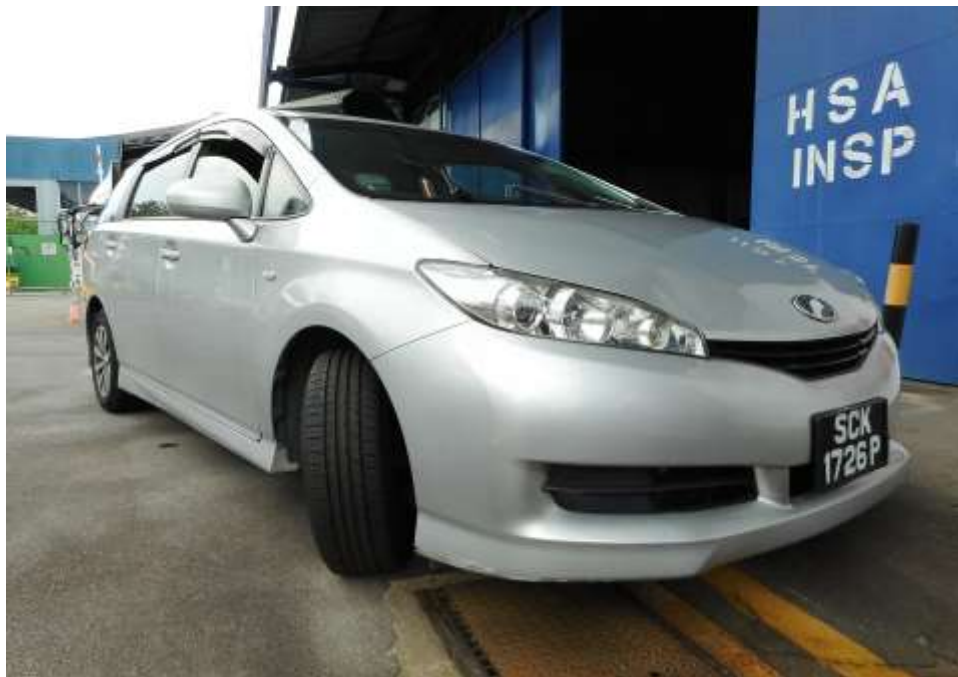
**Photo 17** shows the front right wheel of the Motor Car turned to its full right. During my steering system test, I did not experience any abnormal free play and/or resistance when I had turned the steering wheel towards the left and right. This would suggest that the steering system of the Motor Car was likely to be in serviceable condition at the material time of accident.

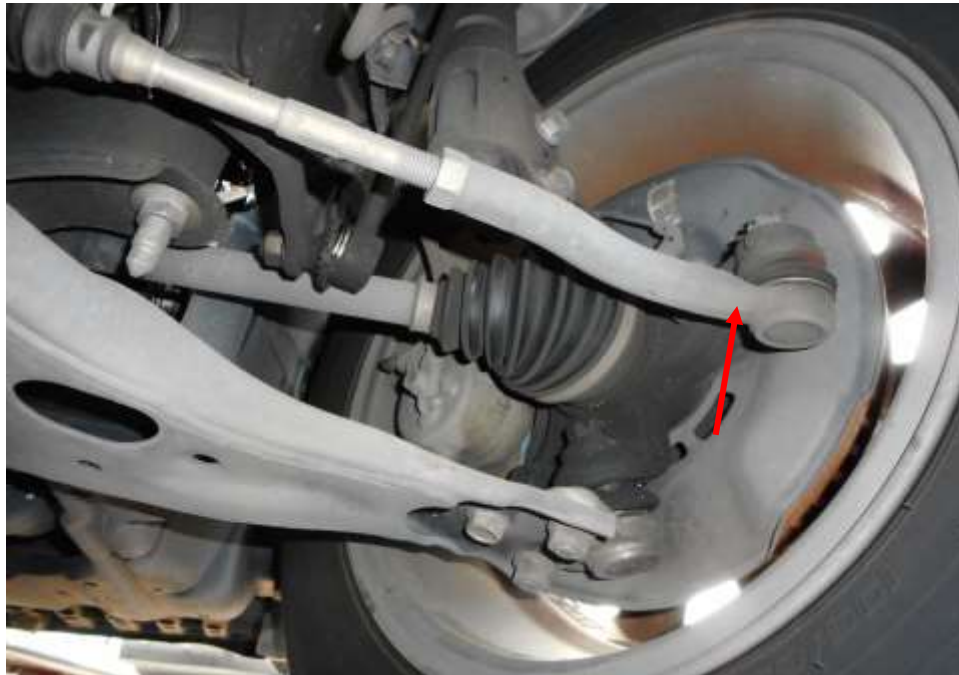
**Photo 18** shows the various undercarriage components at the front right wheel of the Motor Car, in particular the steering tie rod (arrowed). The various steering components were all found to be intact, suggesting that the steering system of the Motor Car was likely to be in serviceable condition at the material time of accident. There was also no sign of fluid stain observed on the various undercarriage components at the front right wheel of the Motor Car.

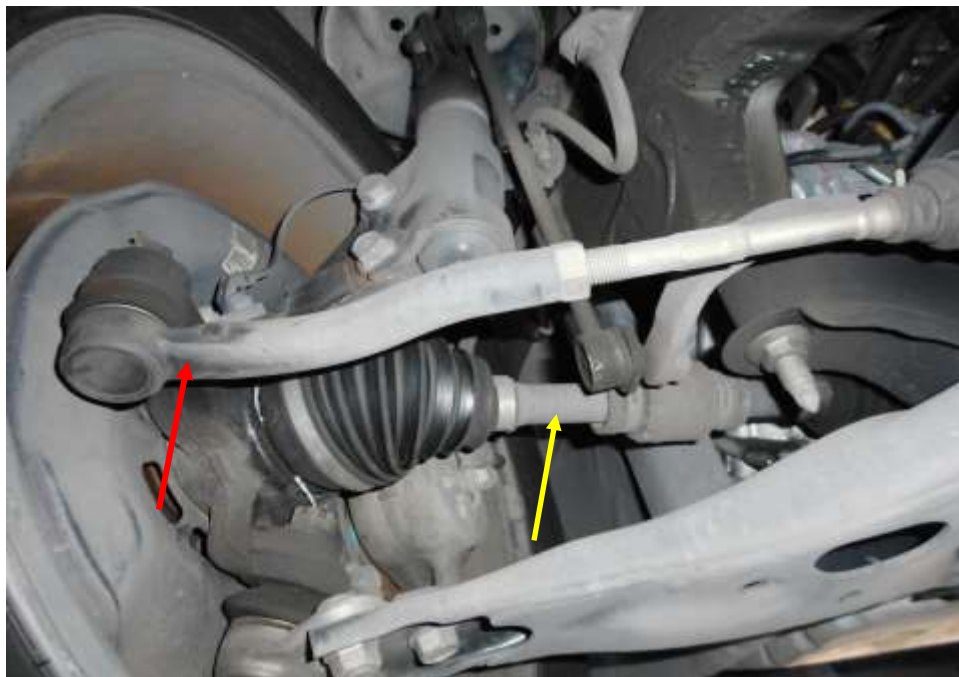
**Photo 19** shows the various undercarriage components at the front left wheel of the Motor Car, which had included the steering tie rod (red arrow) and front left drive shaft (yellow arrow). The various undercarriage components of the Motor Car were all found to be intact without any visible damage.

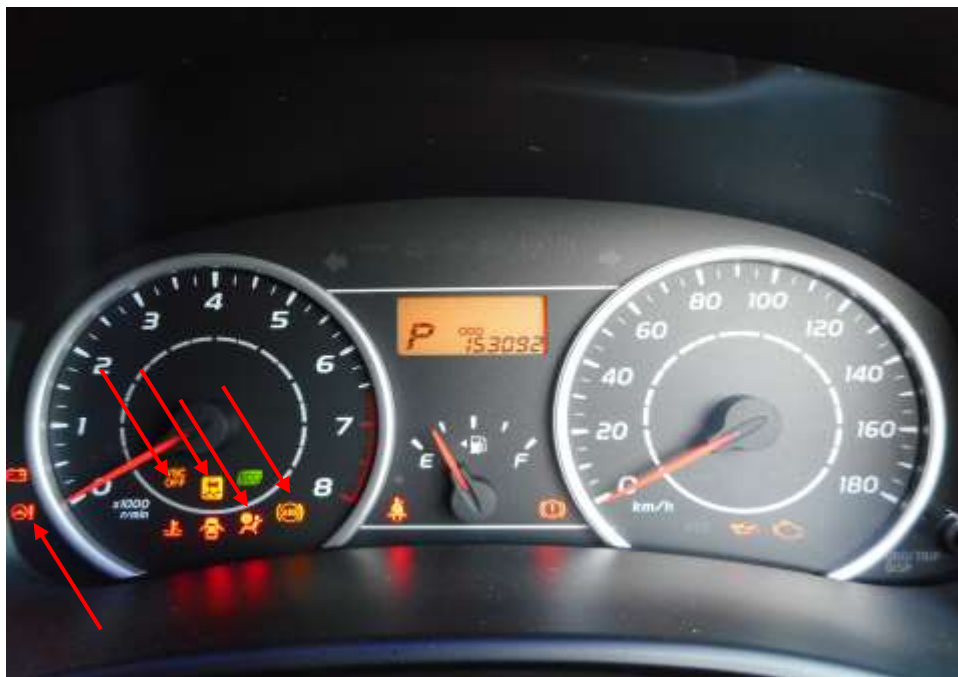
**Photo 20** shows the warning light for Anti-Lock Brake System (ABS), Electric Power Steering System (EPS), Traction Control (TC) and Supplemental Restraint System (SRS) appearing on the instrument panel of the Motor Car during the self-test of its various electronic operating systems when its engine was cranked.

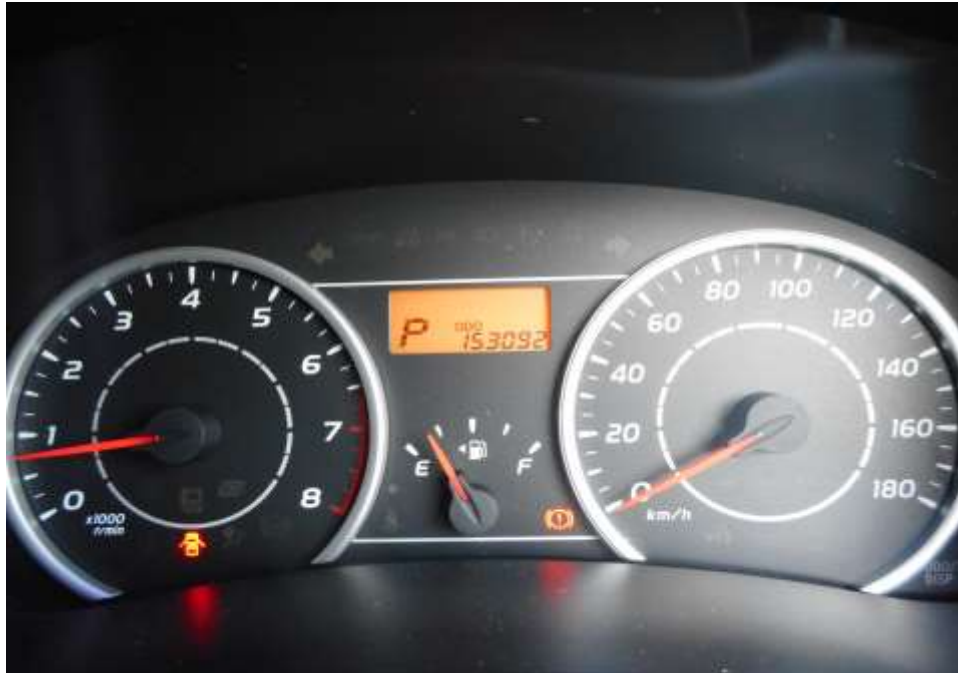
**Photo 21** shows no warning lights illuminated on the instrument panel of the Motor Car after the engine was cranked. This would suggest that there was no abnormality to the various electronic operating systems of the Motor Car, like the ABS, EPS, TC and SRS etc.
