Your Ref: TP/IP/69903/2018
Our Ref: CI/TPD19004301/P

24th April 2019

MECHANICAL INSPECTION REPORT OF MOTORCYCLE FBE 8770H

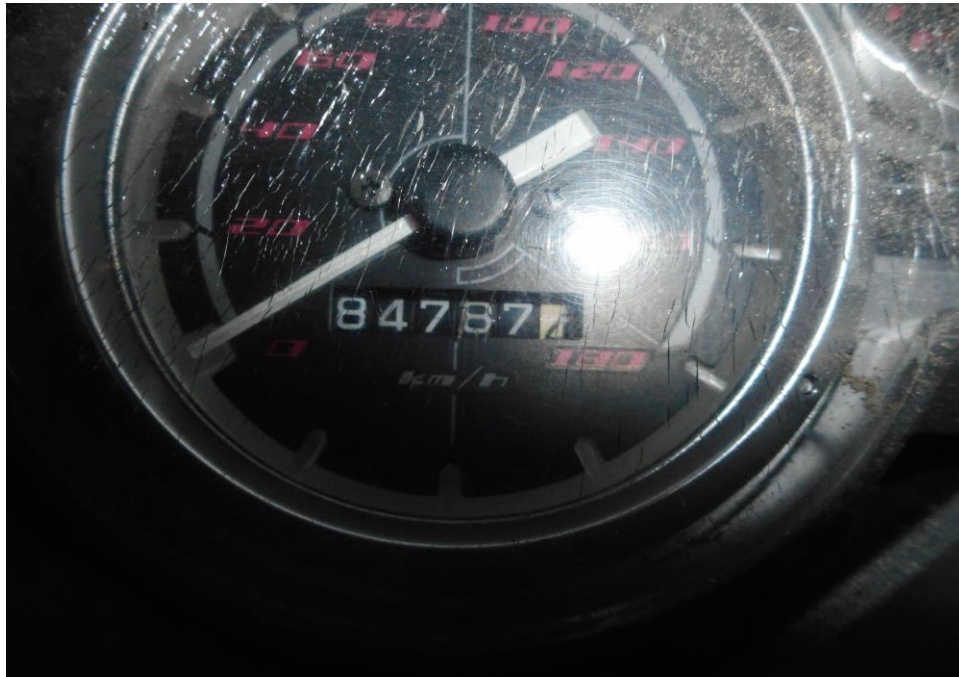
4. The mileage of the Motorcycle was 84,787km recorded at time of our inspection.
5. The Motorcycle was observed to have sustained minor damages at the frontal portion. The body parts that were found to have been damaged include its front number plate, front cowling, brake lever, and exhaust muffler. See Photo 1- 6.

Photo 1 shows a general view of the mileage 84,787KM at the time of our inspection.

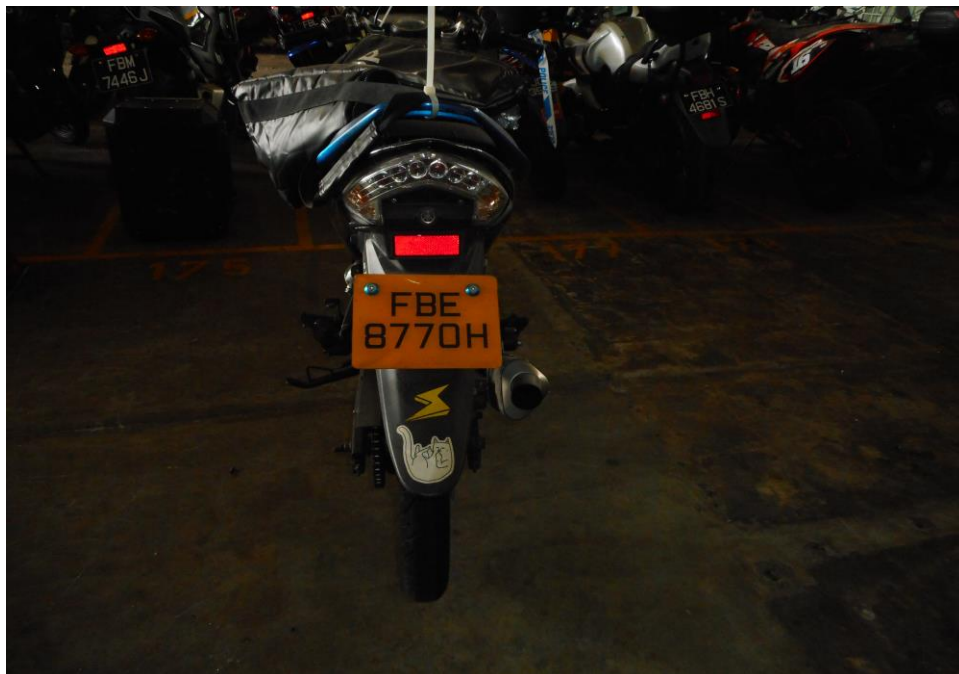
Photo 2 shows the rear of the number plate. The rear of the Motor Cycle was observed to not have sustained any damage at the time of inspection.

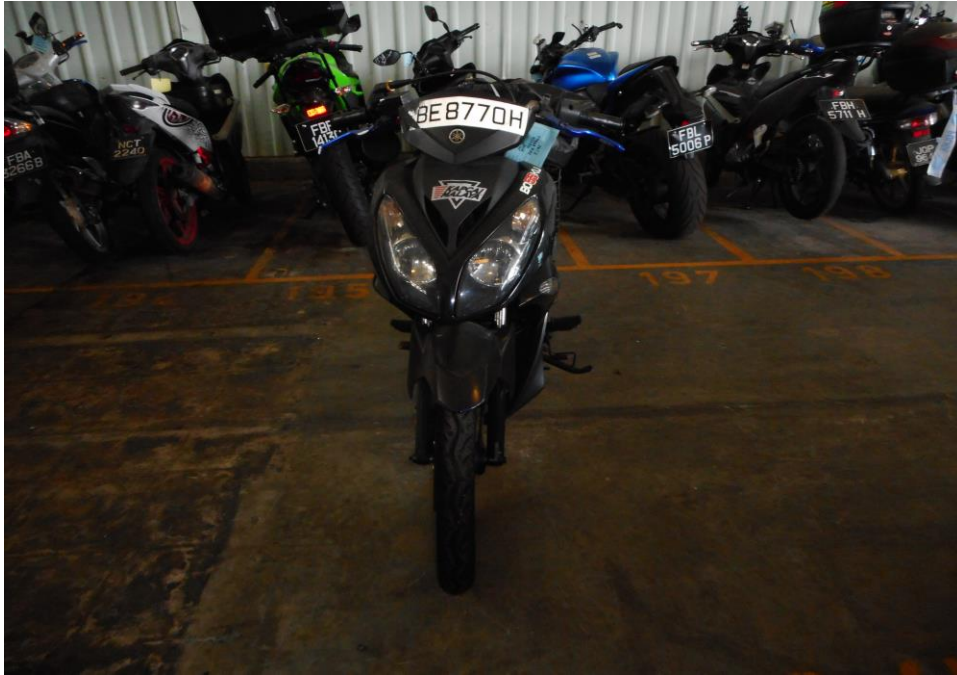
Photo 3 shows a general view of the front body of the Motorcycle at the time of our inspection. The Motorcycle was observed to have sustained relatively minor damages at time of inspection.

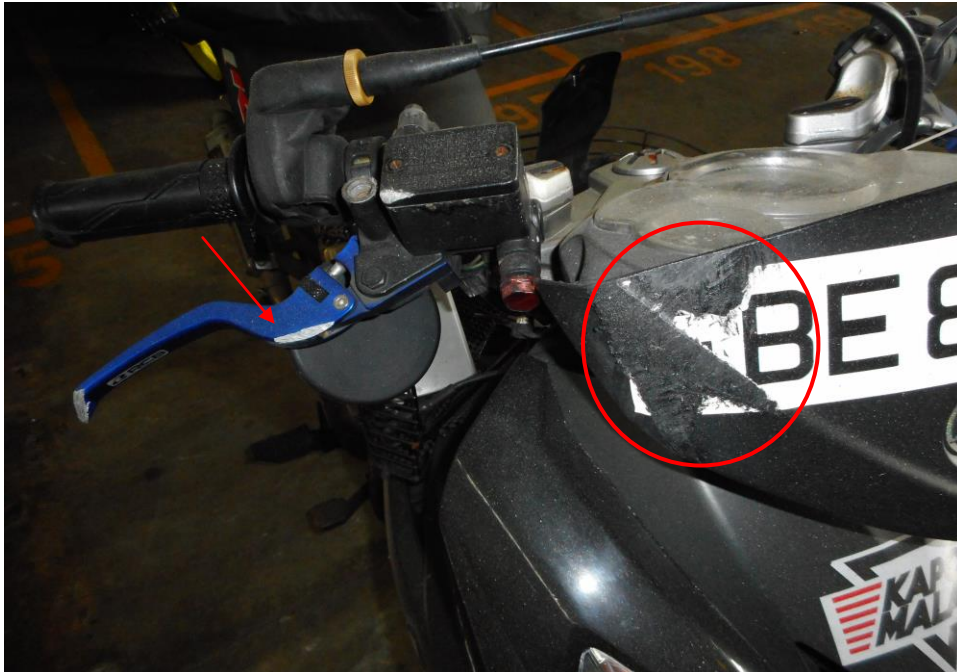
Photo 4 shows a close up view of the front body of the Motorcycle at the time of our inspection. The Motorcycle was observed to have sustained relatively minor damages at time of inspection. The damages were observed to be confined to its number plate and brake lever of the Motorcycle.

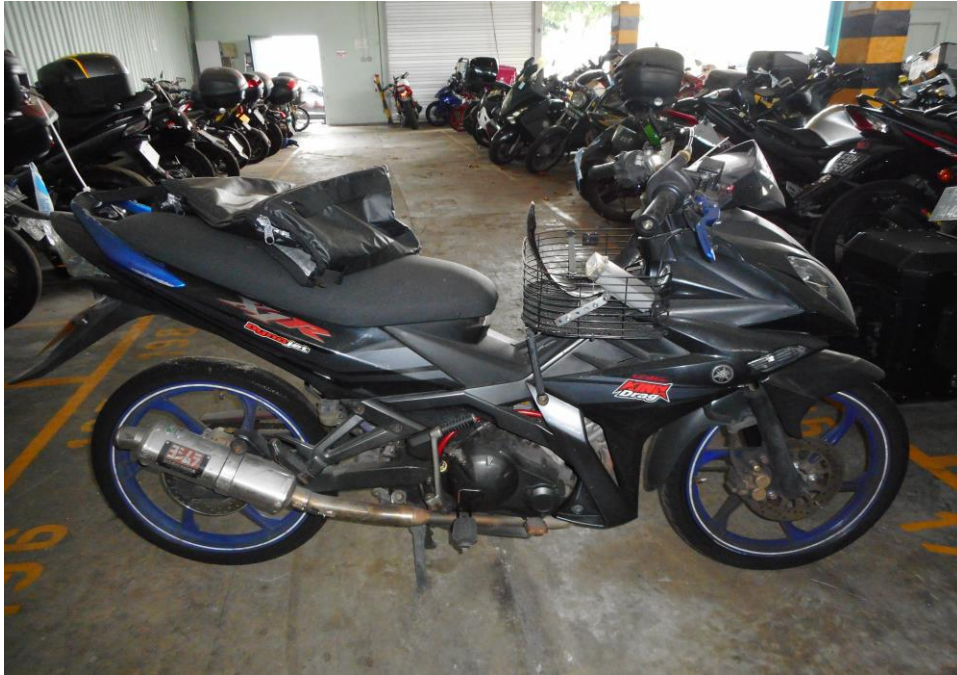
Photo 5 shows a general view of the right side body of the Motorcycle at the time of our inspection. The Motorcycle was observed to have not sustained any major damages at time of inspection.

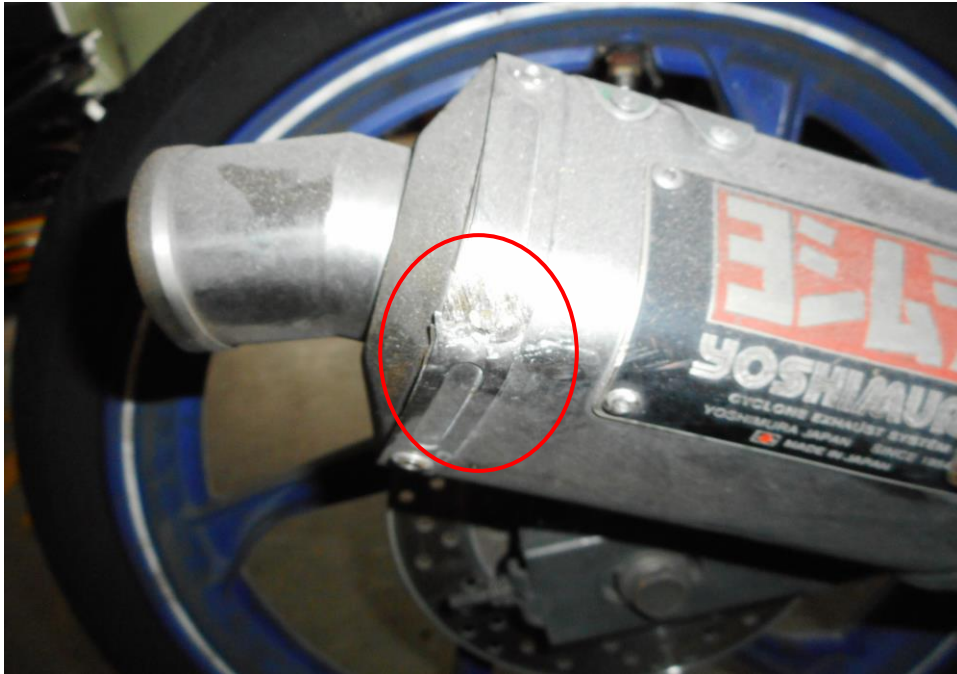
Photo 6 shows a close up view of the exhaust muffler of the Motorcycle at the time of our inspection. The Motorcycle was observed to have sustained relatively minor damages at time of inspection.

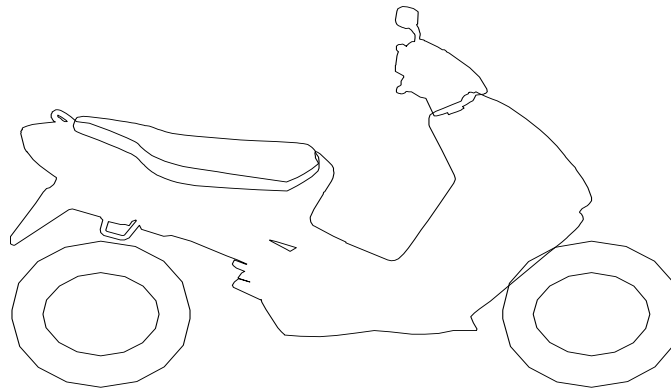
6. The condition of the Motorcycle's 2 tyres was observed to be in serviceable condition. The tread pattern of the 2 tyres was clearly visible. We did not observe any tear, burst mark(s) and/or punctured hole(s) on the sidewalls as well as across the tread of the 2 tyres. The 2 tyres were both observed to be sufficiently inflated for vehicular operation. The tyre brand, tyre size and remaining tread depth of the 2 tyres were recorded as follows:-

Maxxis Volans
70/ 90 - 17 (1.6mm)

Maxxis Volans
70/90 - 17 (3.5mm)

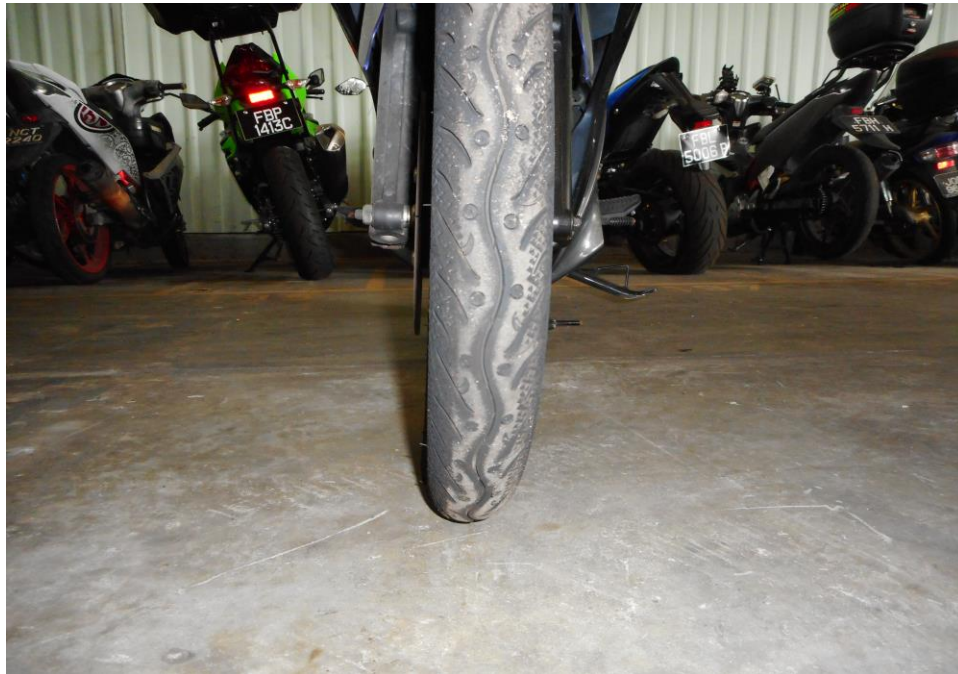
Photo 7 shows the front tyre of the Motorcycle. The front tyre was observed to be in serviceable condition with remaining tread depth of 3.5mm. The tyre was also observed to be sufficiently inflated for vehicular operation. See photo above.

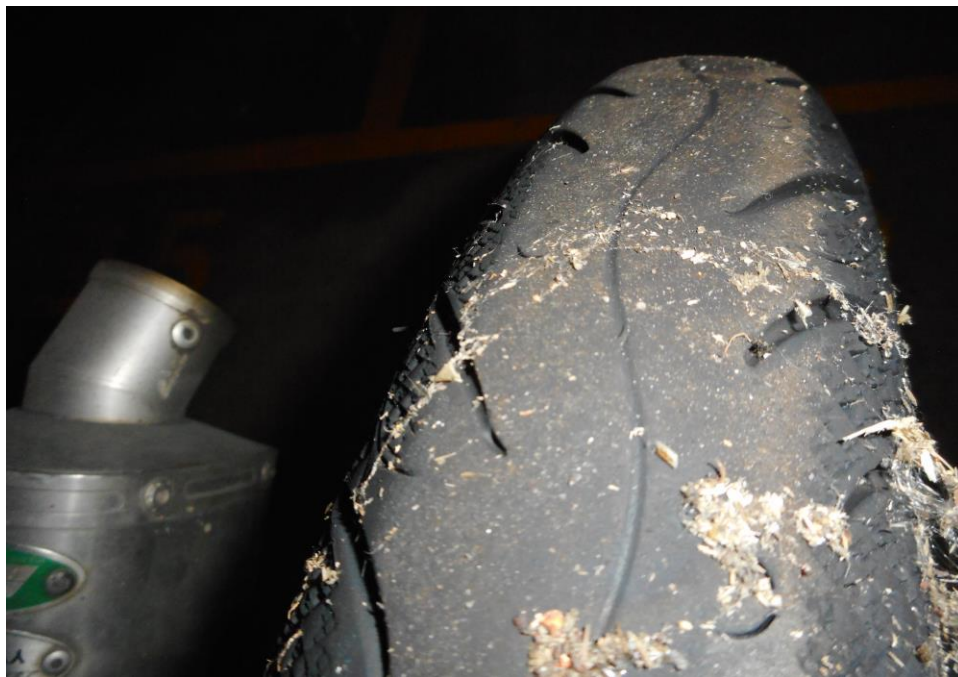
Photo 8 shows the rear tyre of the Motorcycle. The rear tyre was observed to be in serviceable condition with remaining tread depth of 1.6mm. The tyre was also observed to be sufficiently inflated for vehicular operation. See above.

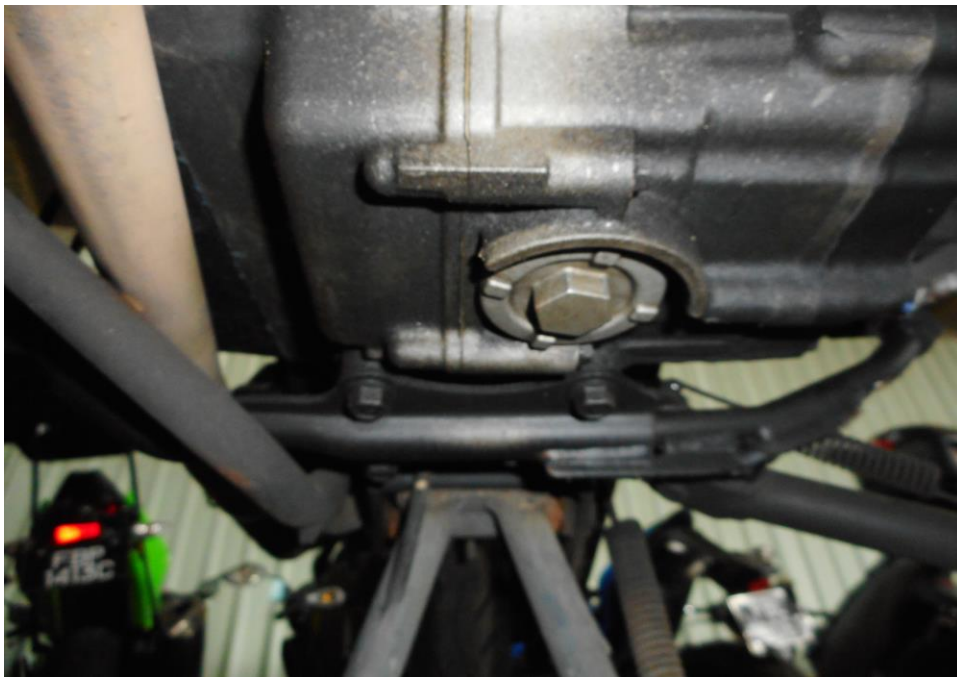
Photo 9 shows no sign(s) or indication(s) of fluid leak observed around the undercarriage of the engine area of the Motorcycle.

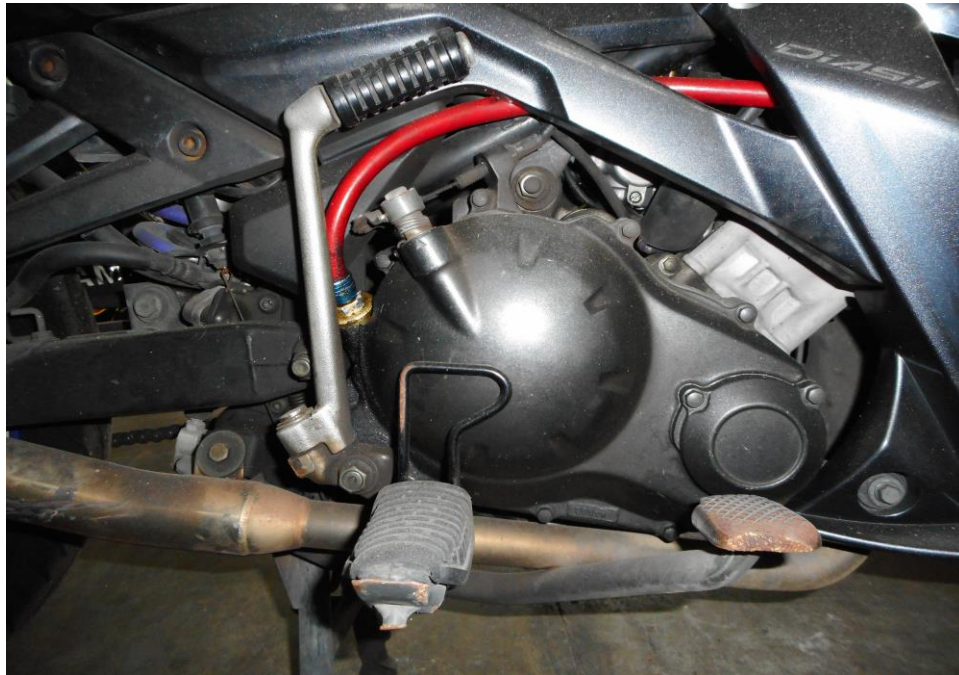
Photo 10 shows no sign(s) or indication(s) of fluid leakage stain observed around the engine area of the Motorcycle.

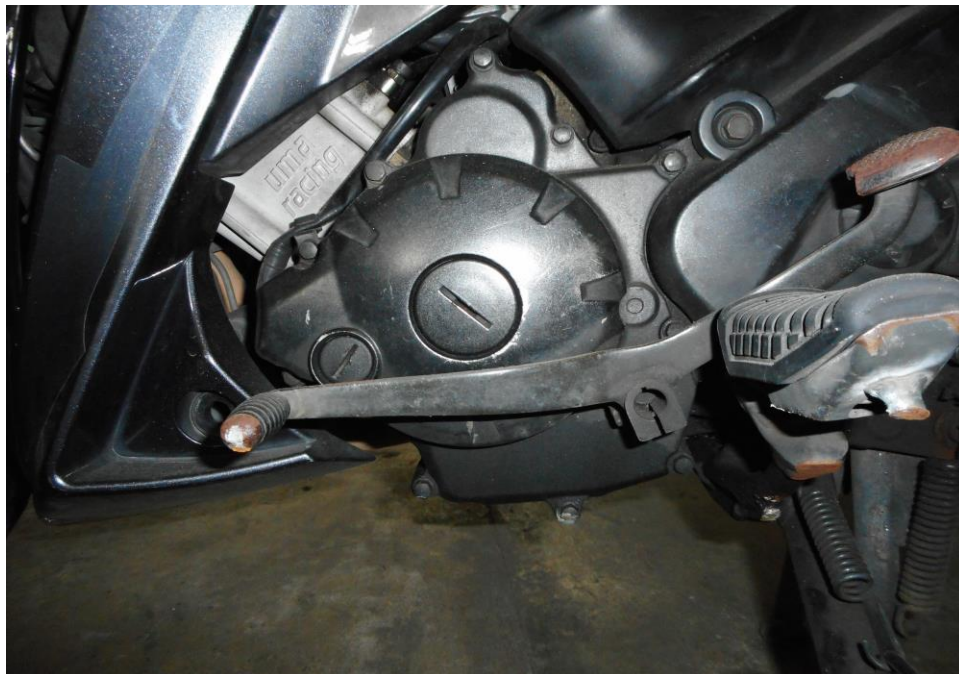
Photo 11 shows no sign(s) or indication(s) of fluid leakage stain observed around the engine area of the Motorcycle.

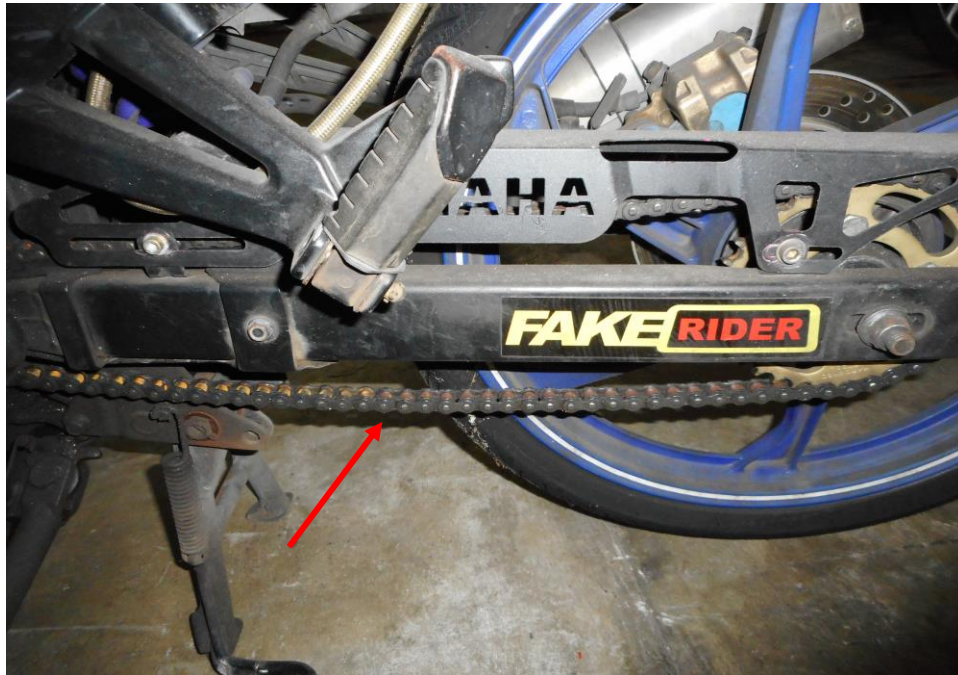
Photo 12 shows the general view of the gear train (arrowed) of the Motorcycle, which was observed to be intact with no misalignment. It was also adequately lubricated for operating purposes. Free play tension was observed & found adequately acceptable.

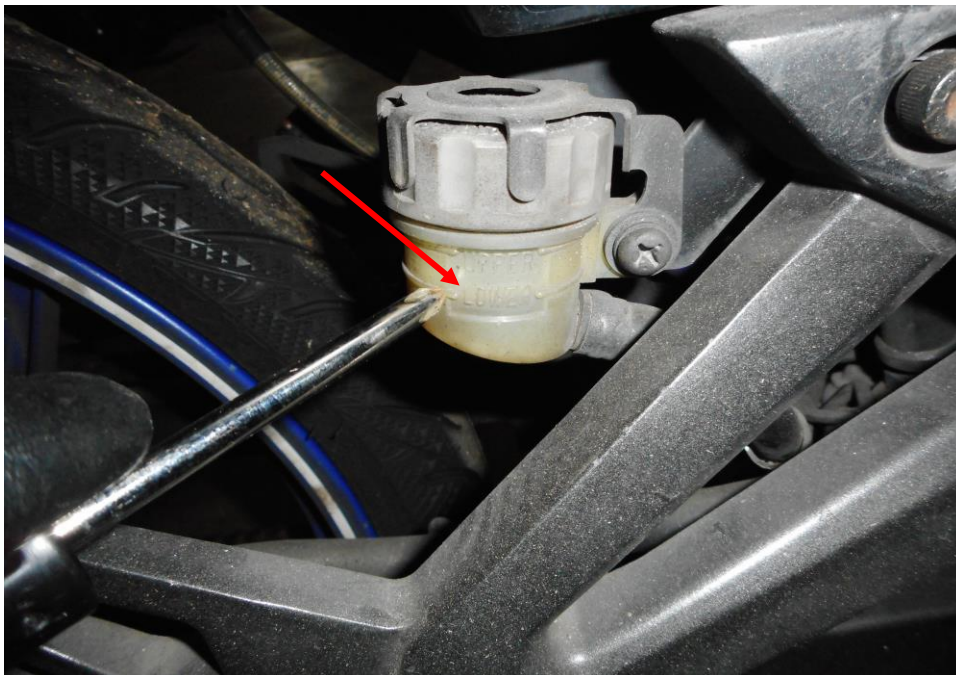
Photo 13 shows our checks on the brake fluid reservoir had also indicated that the brake fluid was of sufficient level for operational purposes, and without contamination.

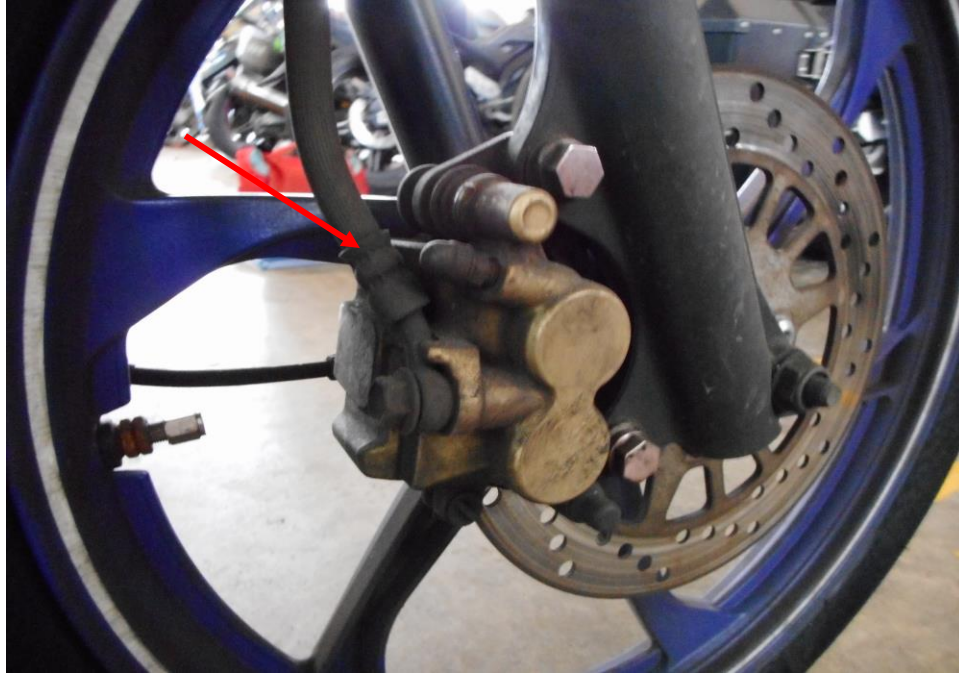
Photo 14 shows our checks on the brake callipers housing (front). There was also no sign(s) or indication(s) of fluid leak observed around the Motorcycle.

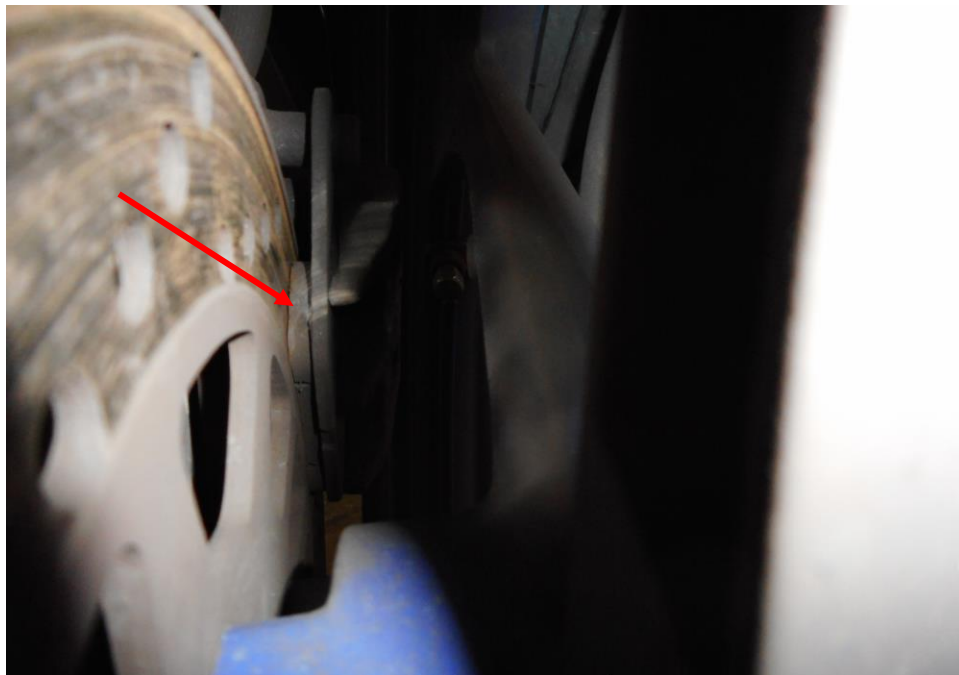
Photo 15 shows a close-up view our checks on the brake pad (front). The frictional material was observed to be in a sufficient level for operational purposes.

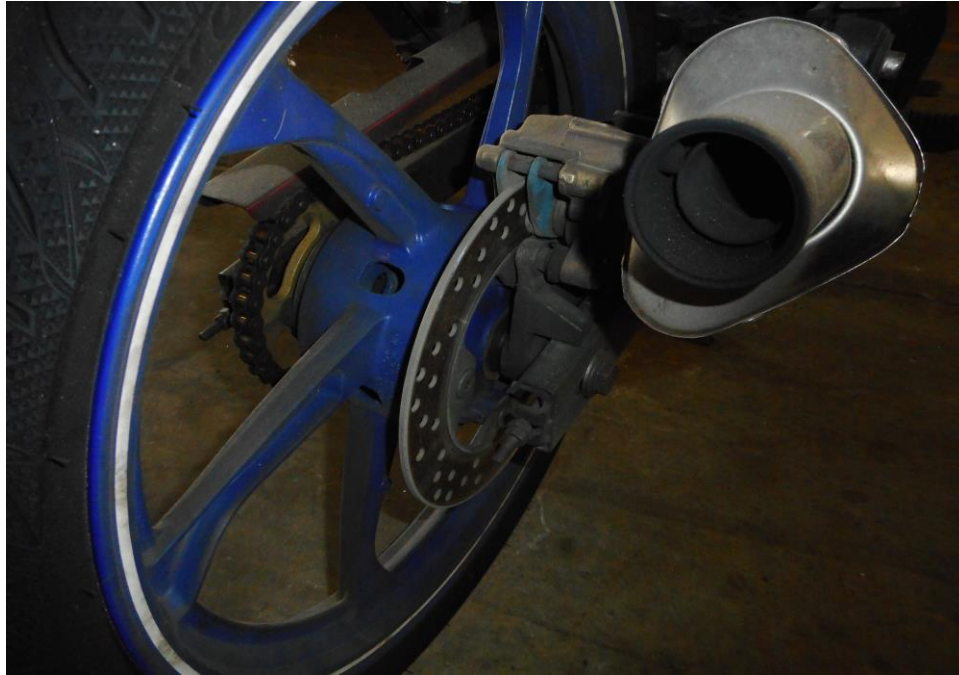
Photo 16 shows a general of the brake calliper (rear) no leakage or fluids is present around it, and without contamination.

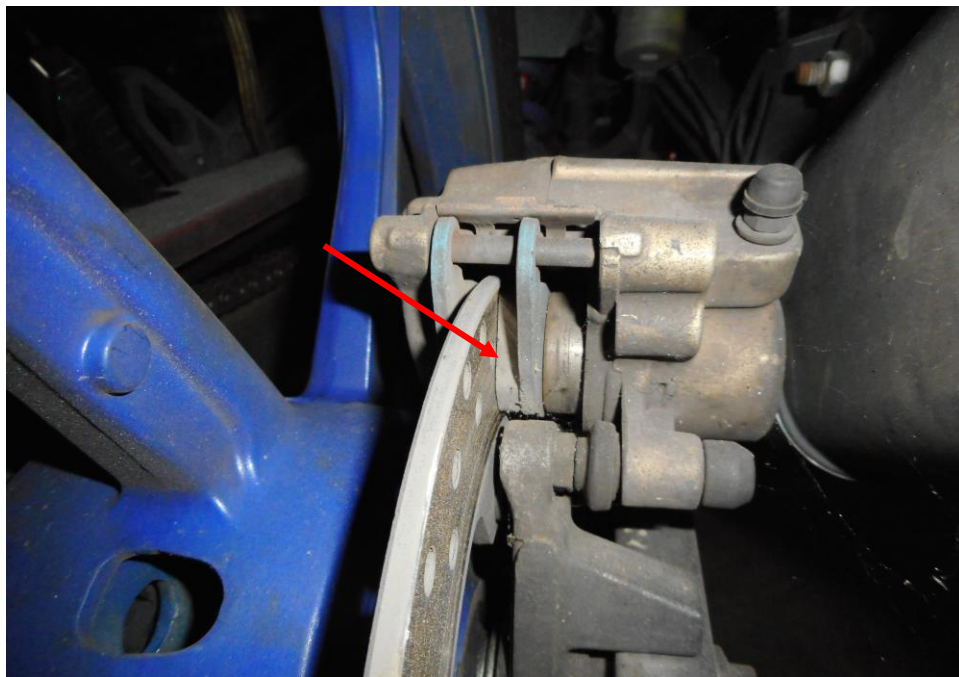
Photo 17 shows a close-up view our checks on the brake pad (rear). The frictional material was observed to be in a sufficient level for operational purposes.

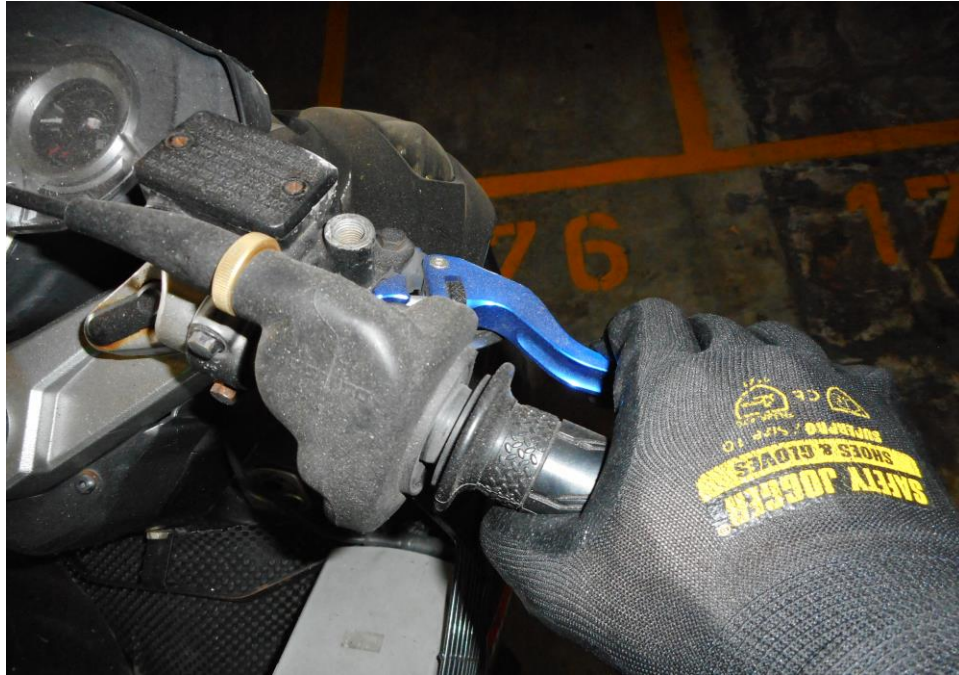
Photo 18 shows testing of the braking of the front brake in progress. The braking force was felt upon pressing the brake lever. The brakes are in serviceable condition.

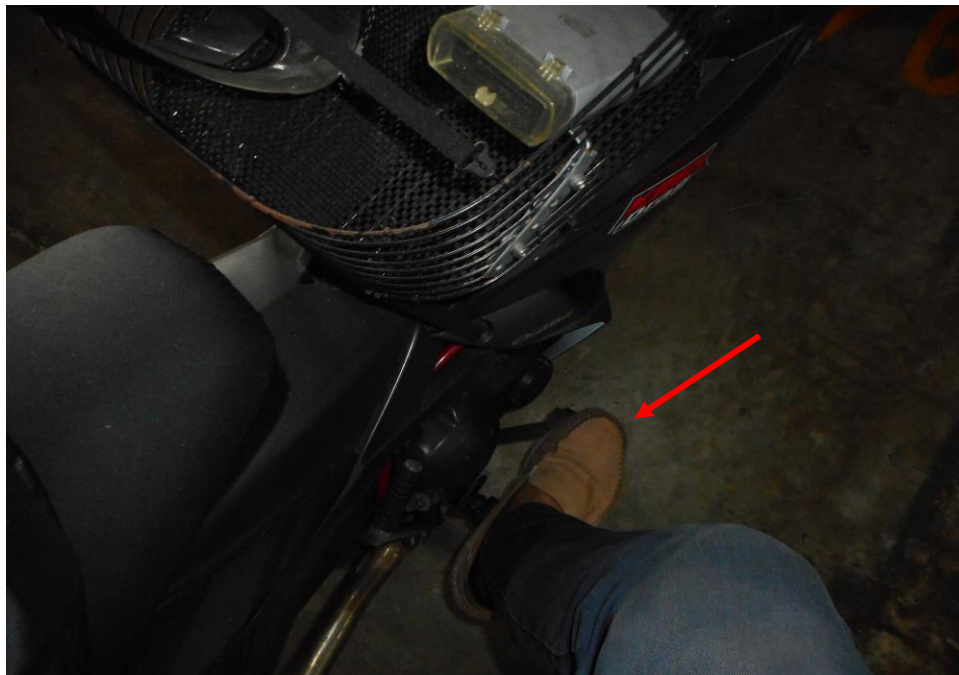
Photo 19 shows testing of the braking of the rear brake in progress. The braking force was felt upon stepping on the brake lever. The brakes are in serviceable condition
