Your Ref: TP/IP/00599/2019
Our Ref : CI/TPD19004303/P

Accident Enquiry & Investigation Team

MECHANICAL INSPECTION REPORT OF POLICE MOTOR CAR QX 327E

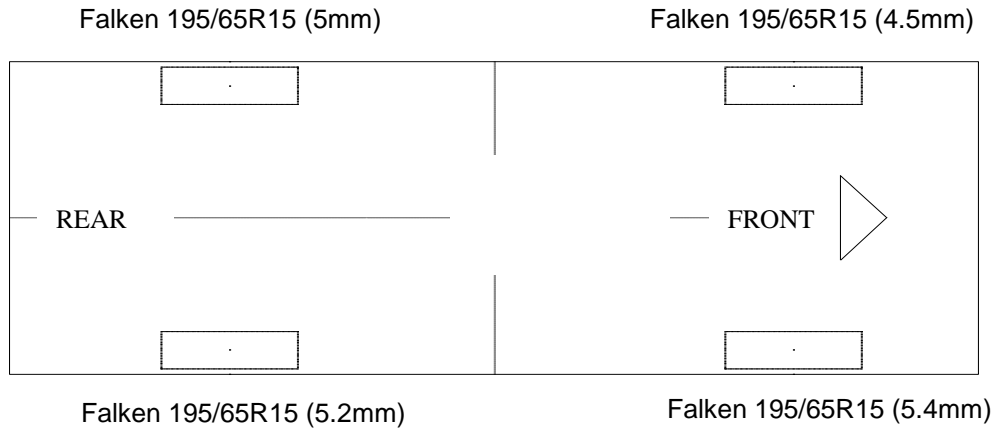
6. The condition of the Police Car's 4 tyres was observed to be in serviceable condition. I did not find any tear, cut or burst mark(s) on the outer and the inner sidewalls as well as across the tread of the 4 tyres. The 4 tyres were also observed to be sufficiently inflated for vehicular operation. The tyre brand, tyre size and remaining tread depth of the 4 tyres were recorded as follows:-

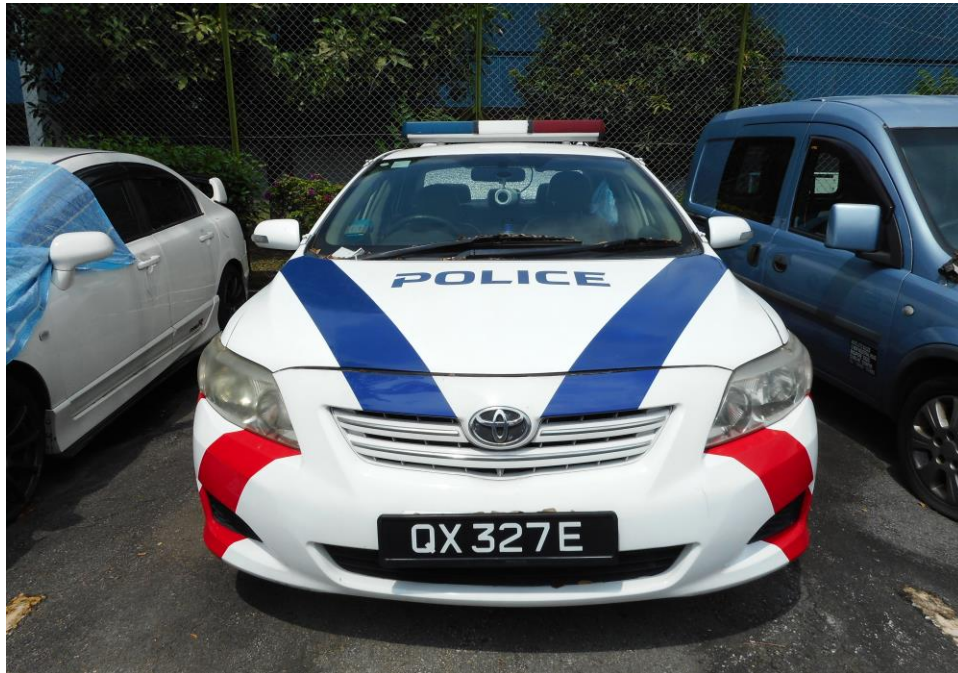
Photo 1 shows a general view of the Police Car's front body at the time of my inspection. The front portion of the Police Car was observed to have been unaffected by the accident.

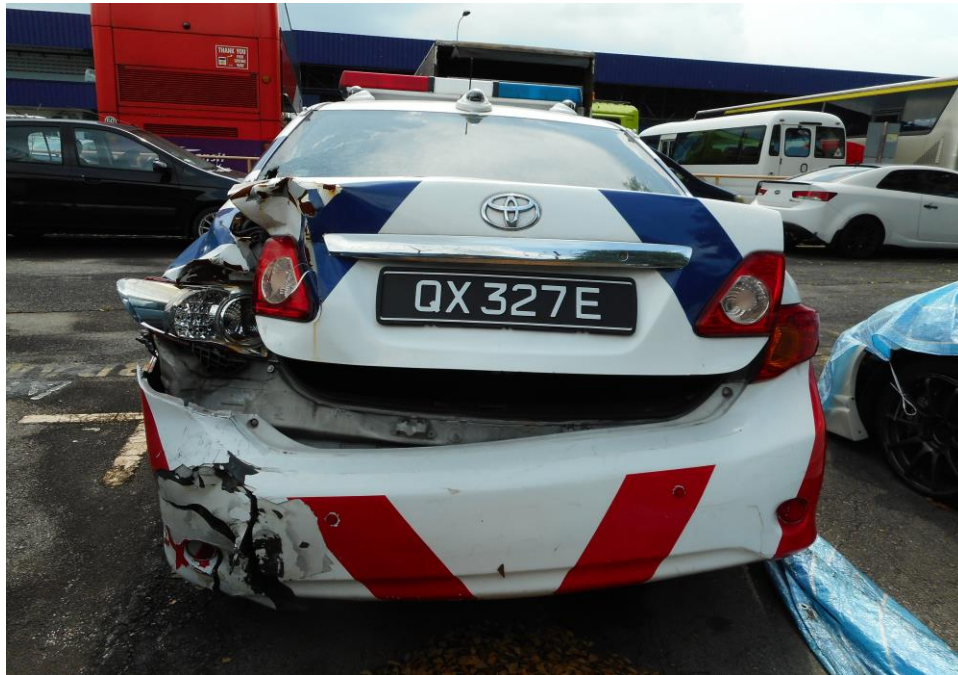
4. The mileage of the Police Car at the time of my inspection was 312,139km.
5. The Police Car was observed to have sustained relatively moderate damage at its rear portion. Its rear windscreen, rear bonnet, rear bumper, rear left body panel, rear headlamp and rear bumper were amongst the body parts that were damaged as a result of the accident.

Photo 2 shows a general view of the front body of the Police Car at the time of my inspection. The Police Car was observed to have sustained relatively moderate damage at its rear portion. Its rear windscreen, rear bonnet, rear bumper, rear left headlamp, rear left body panel and rear bumper were observed to have been damaged as a result of the accident. The mileage of the Police Car at the time of my inspection was recorded to be 312,139km.

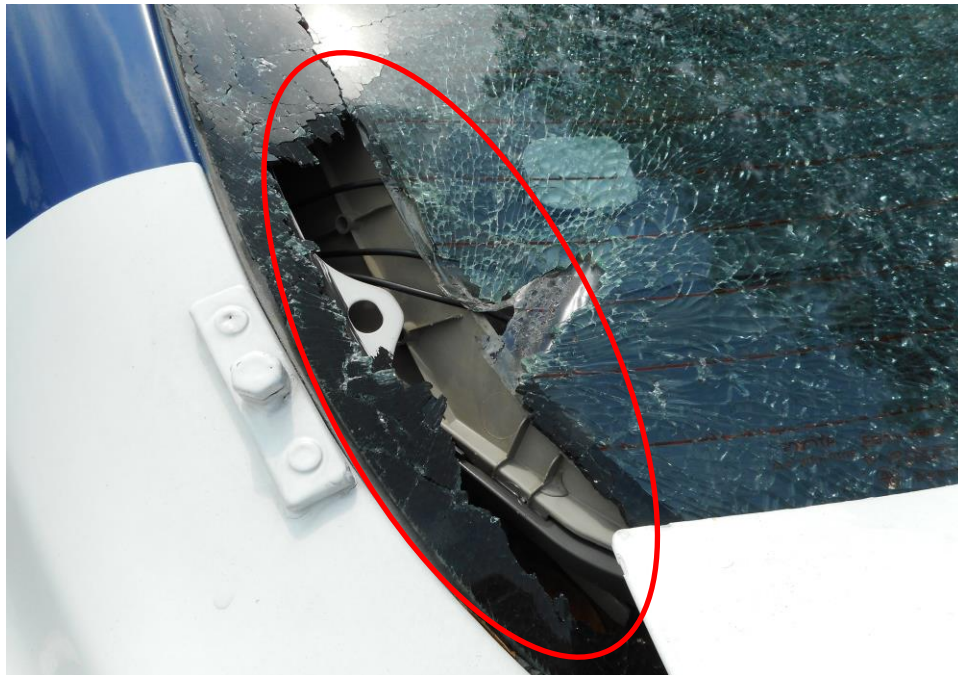
Photo 2 shows a close up view of the damaged rear windscreen of the Police Car (circled) was damaged as a result of the accident.

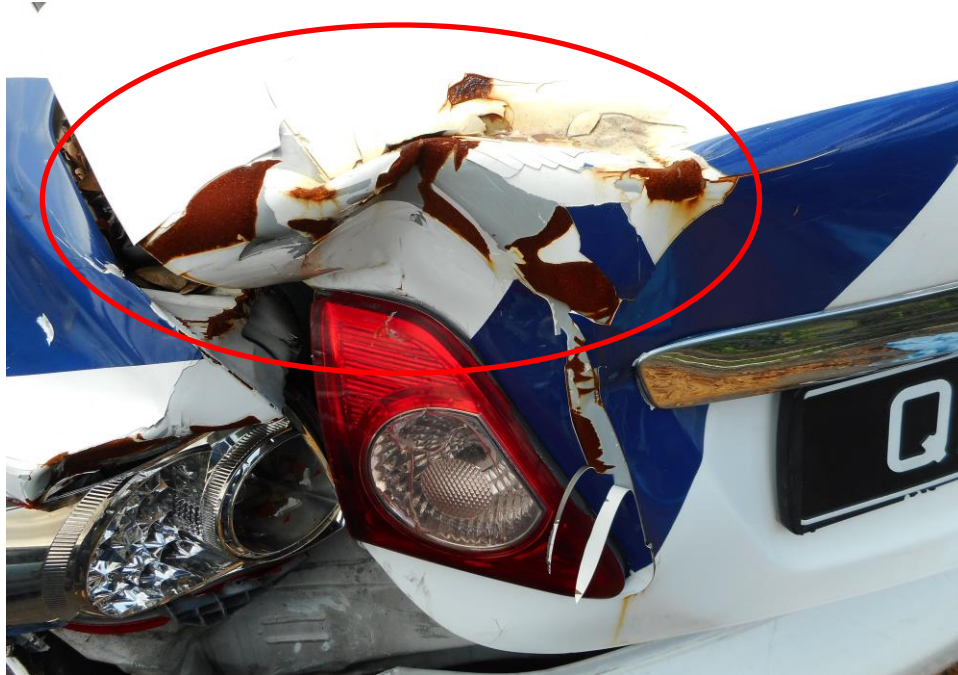
Photo 4 shows a close up view of the damaged rear windscreen of the Police Car (circled) was damaged as a result of the accident.

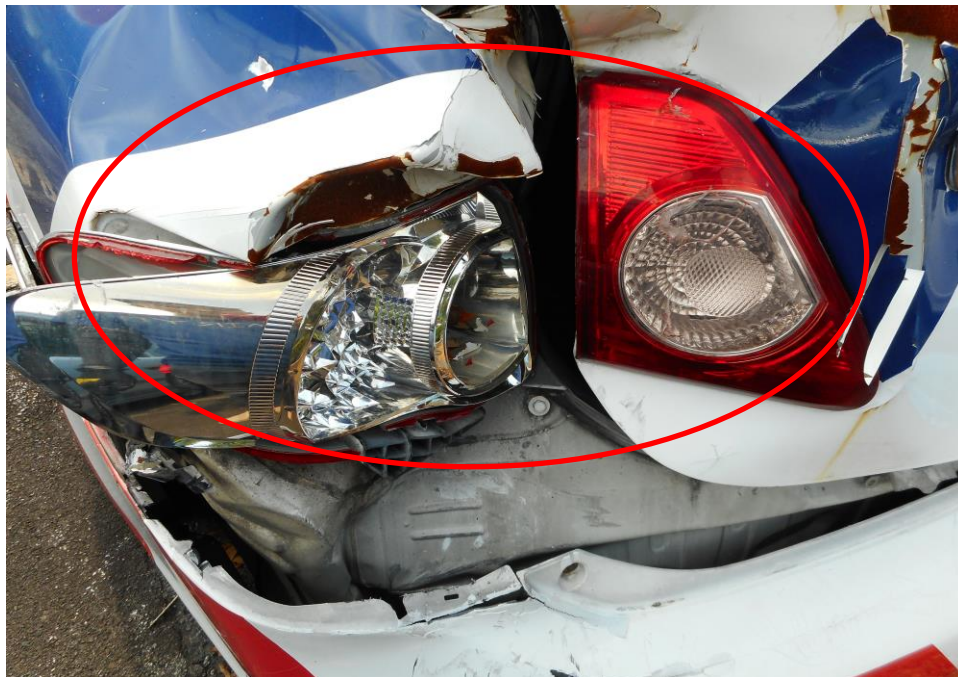
Photo 5 shows a close up view of the damaged rear left headlamp of the Police Car (circled) was damaged as a result of the accident.

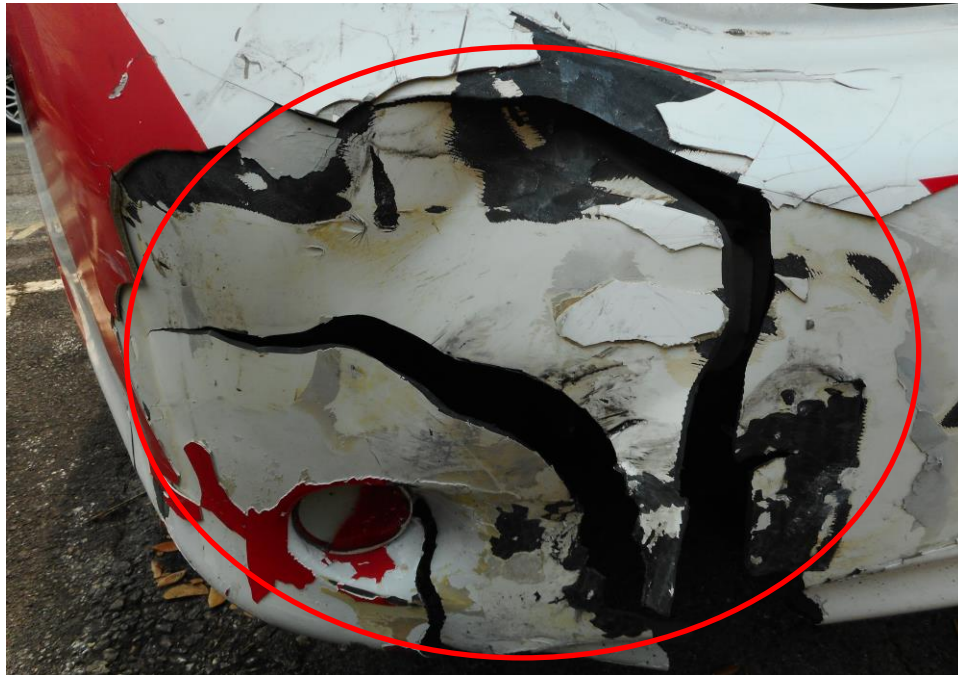
Photo 6 shows a close up view of the damaged rear bumper of the Police Car (circled) was damaged as a result of the accident.

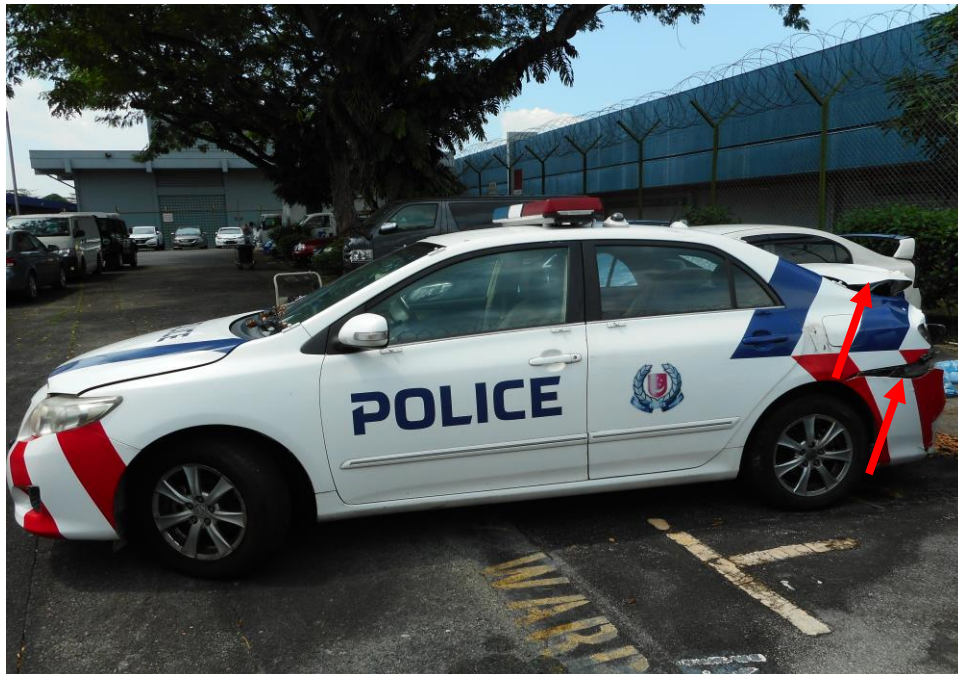
Photo 7 shows a general view of the Police Car's left body at the time of my inspection. The left portion of the Police Car was observed to have been unaffected by the accident, other than the damage at the rear bonnet and bumper (arrowed)

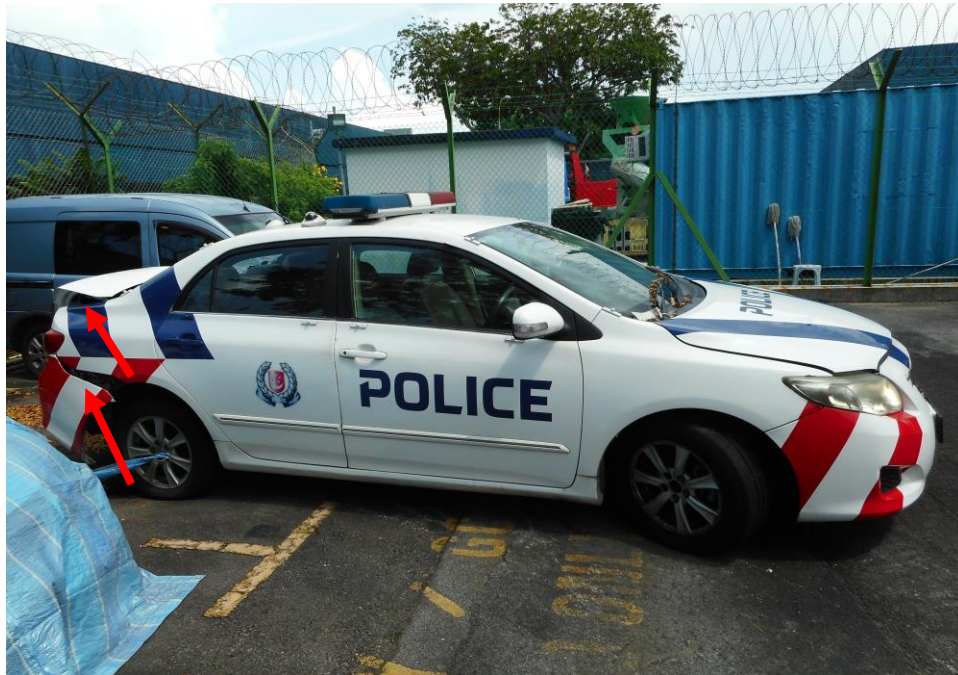
Photo 8 shows a general view of the Police Car's right body at the time of my inspection. The right portion of the Police Car was observed to have been unaffected by the accident, other than the damage at the rear bonnet and bumper (arrowed)

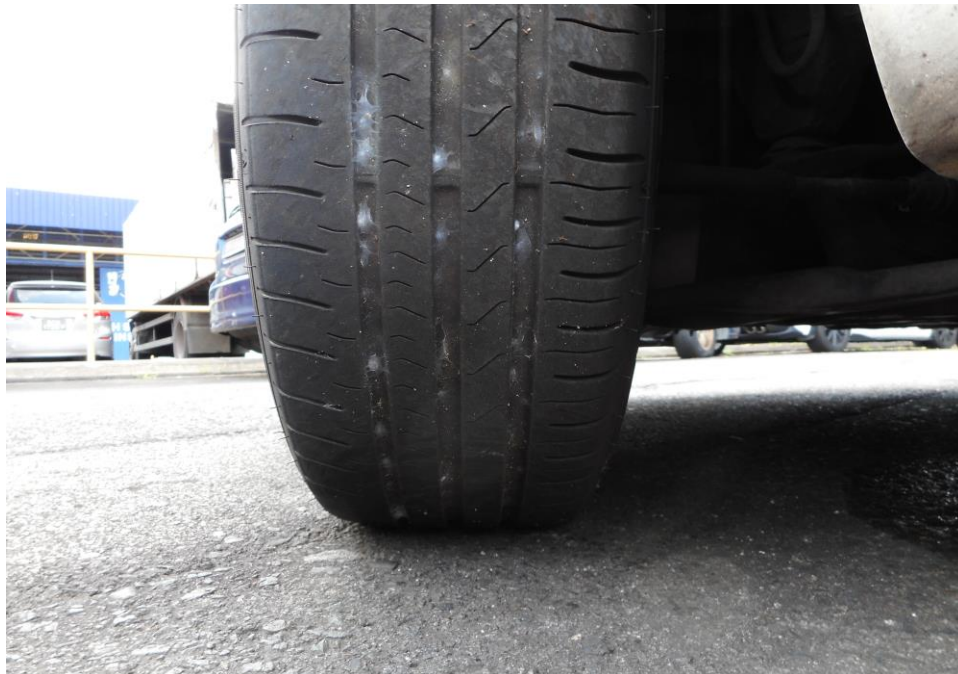
Photo 9 shows the condition of the front left tyre of the Police Car, which was observed to be in serviceable condition with remaining tread depth of approximately 4.5mm. The tyre was sufficiently inflated for vehicular operation with no tear, cut or burst mark(s) on the outer and the inner sidewalls as well as across the tread. The 4 tyres of the Police Car were wrapped around standard alloy wheel rims that were without any significant damage apart for some relatively minor kerb grazing type of damage on the outer side of the wheel rims.

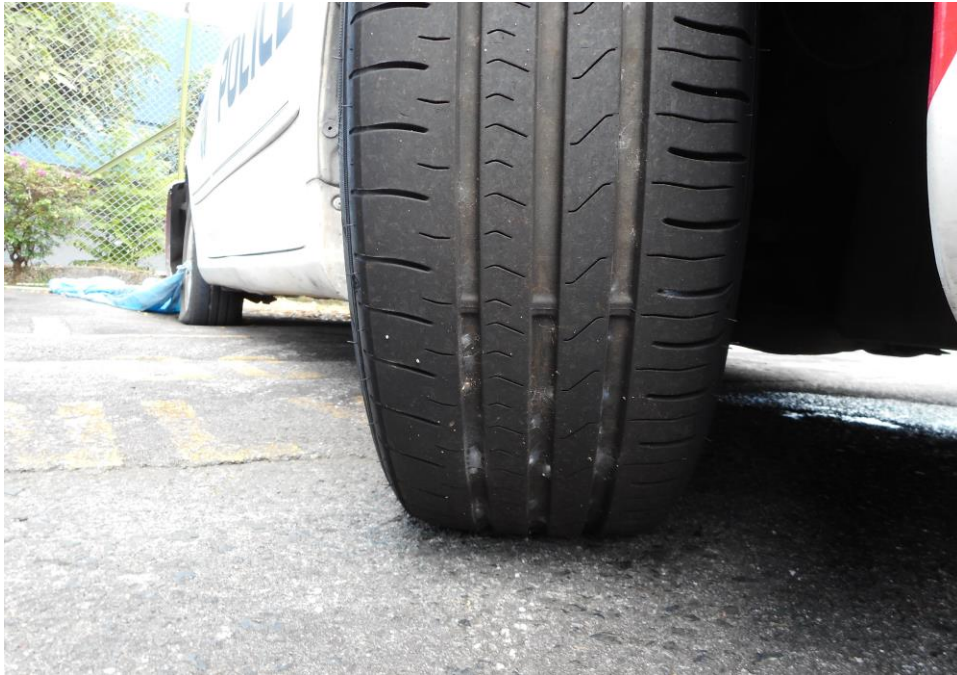
Photo 10 shows the condition of the front right tyre of the Police Car, which was observed to be in serviceable condition with remaining tread depth of approximately 5.4mm. The tyre was also observed to be sufficiently inflated for vehicular operation with no tear, cut or burst mark(s).

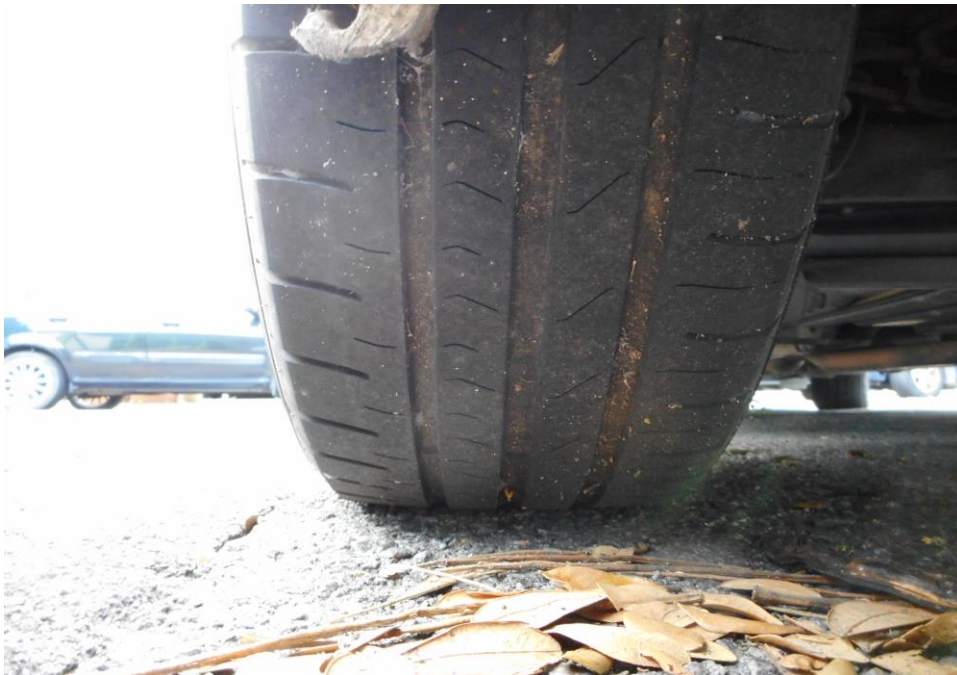
Photo 11 shows the condition of the rear left tyre of the Police Car, which was observed to be in serviceable condition with remaining tread depth of approximately 5mm. The tyre, which was wrapped around alloy wheel rim, was also observed to be sufficiently inflated for vehicular operation.

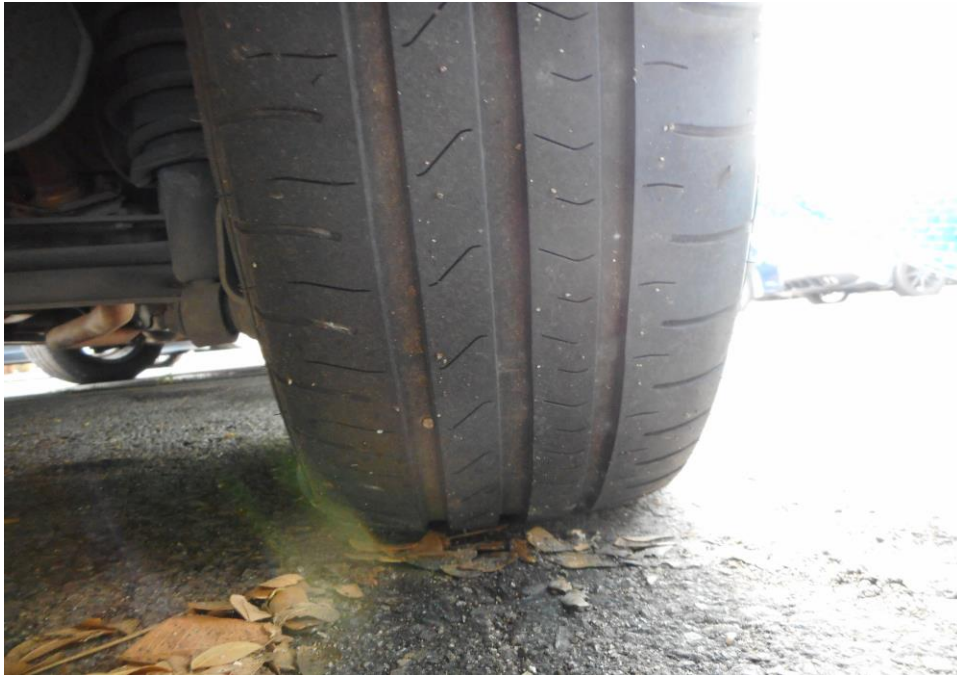
Photo 12 shows the condition of the rear right tyre of the Police Car, which was observed to be in serviceable condition with remaining tread depth of approximately 5.2mm. There was also no tear, cut or burst mark(s) on the outer and the inner sidewalls as well as across the tread of the Police Car's 4 tyres.

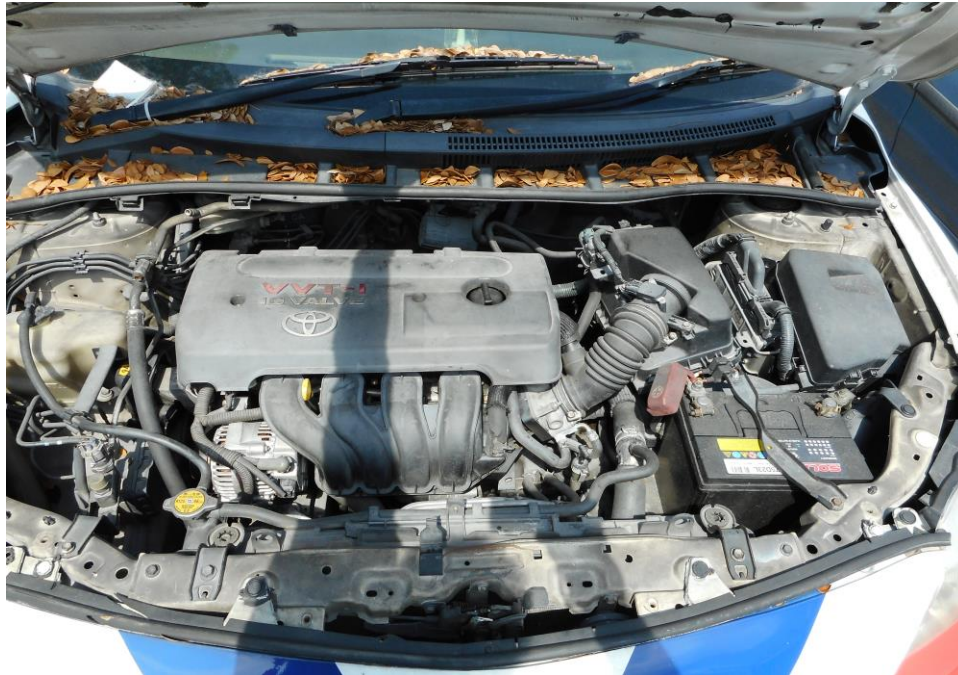
Photo 13 shows a general view of the Police Car's engine compartment. The various parts and components inside the engine compartment were unaffected by the accident. There was also no sign(s) or indication(s) of fluid leakage and/or fluid stain within the engine compartment.

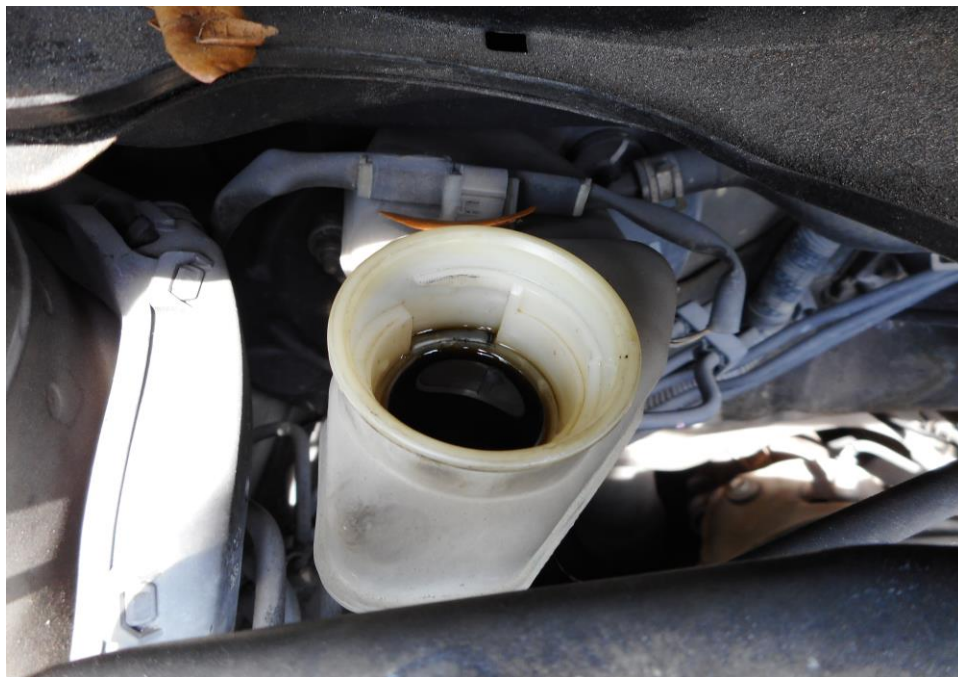
Photo 14 shows the brake fluid reservoir of the Police Car at the time of my inspection. The brake fluid was observed to be of sufficient level and without any visible contamination.

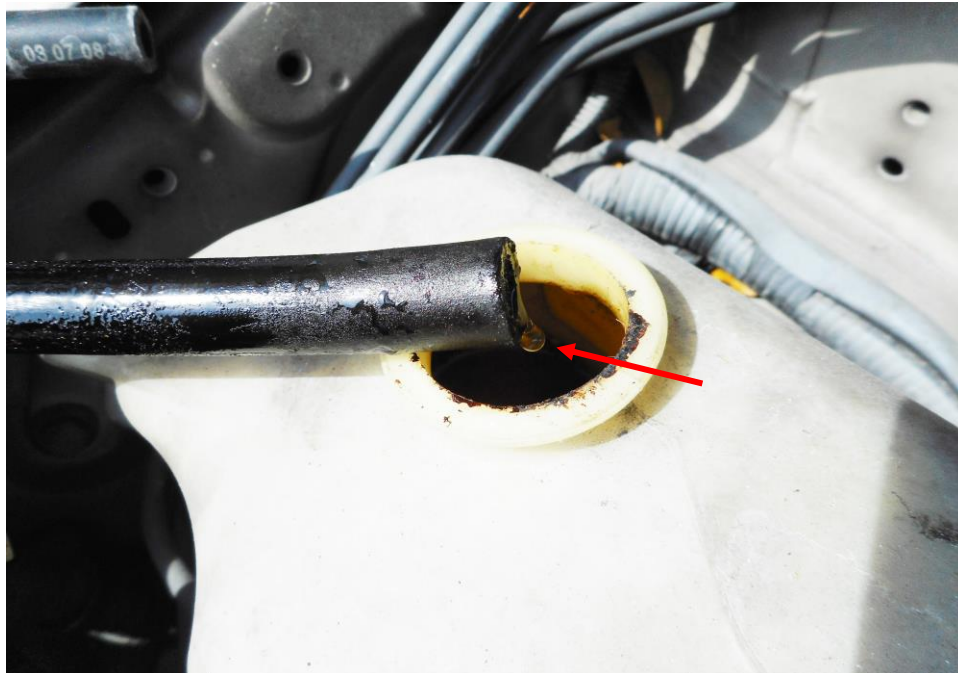
Photo 15 shows checks being carried out to the engine coolant of the Police Car at the time of my inspection. The engine coolant was observed to be of sufficient level (arrowed) and without any visible contamination.

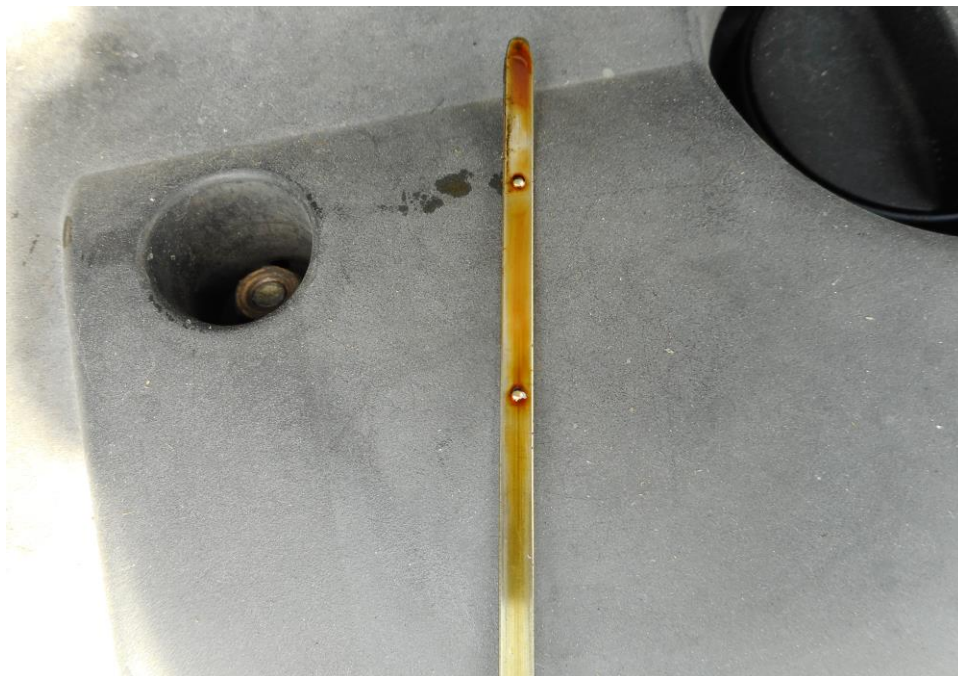
Photo 16 shows the engine oil dip stick of the Police Car at the time of my inspection. The engine oil was observed to be of sufficient level and without any visible contamination.

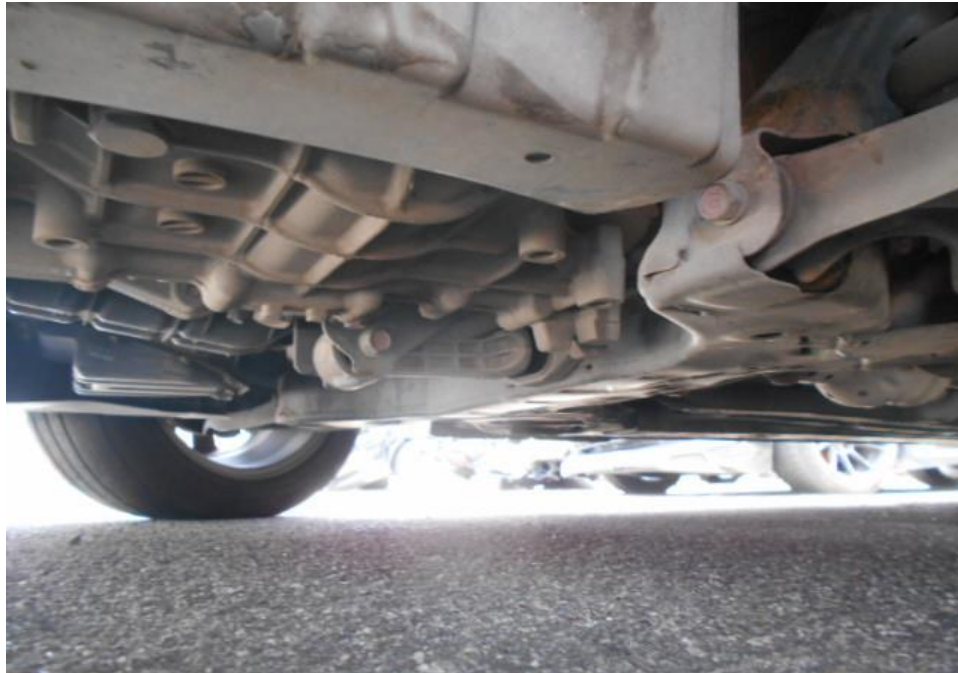
Photo 17 shows the undercarriage of the Police Car, at the area where the engine housing and transmission housing are located. I did not find any sign(s) or indication(s) of fluid leak and/or fluid stain(s) on the underside of the Police Car.

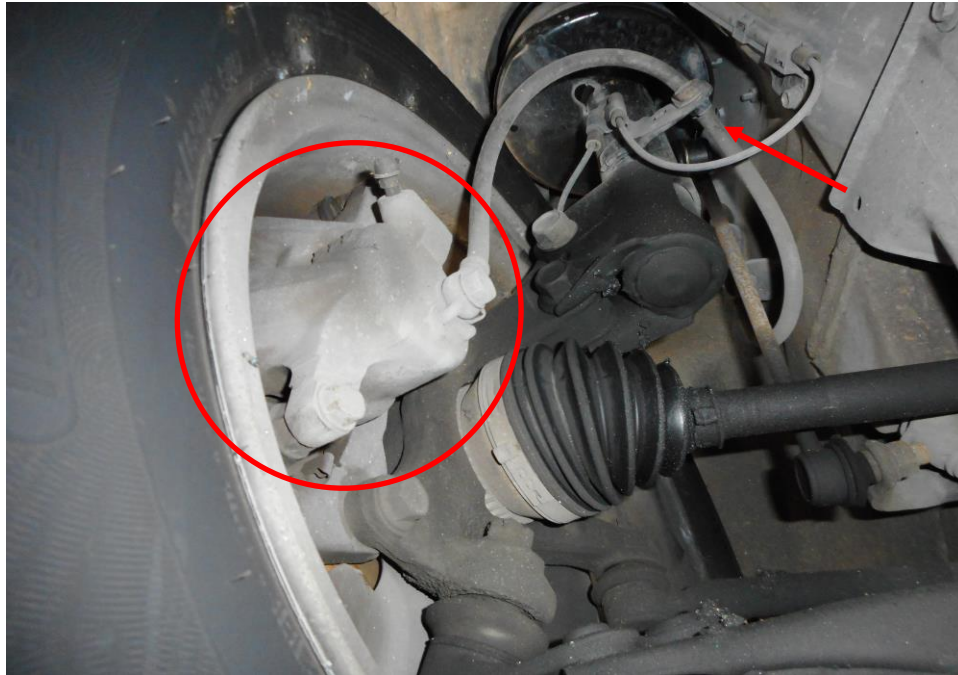
Photo 18 shows the brake hose/pipe (arrowed) at the front right wheel of the Police Car. No leakage of brake fluid was observed. Visual examination of the various components of the braking system like the brake caliper (circled), brake booster, brake pedal etc had revealed all to be intact and without visible damage.

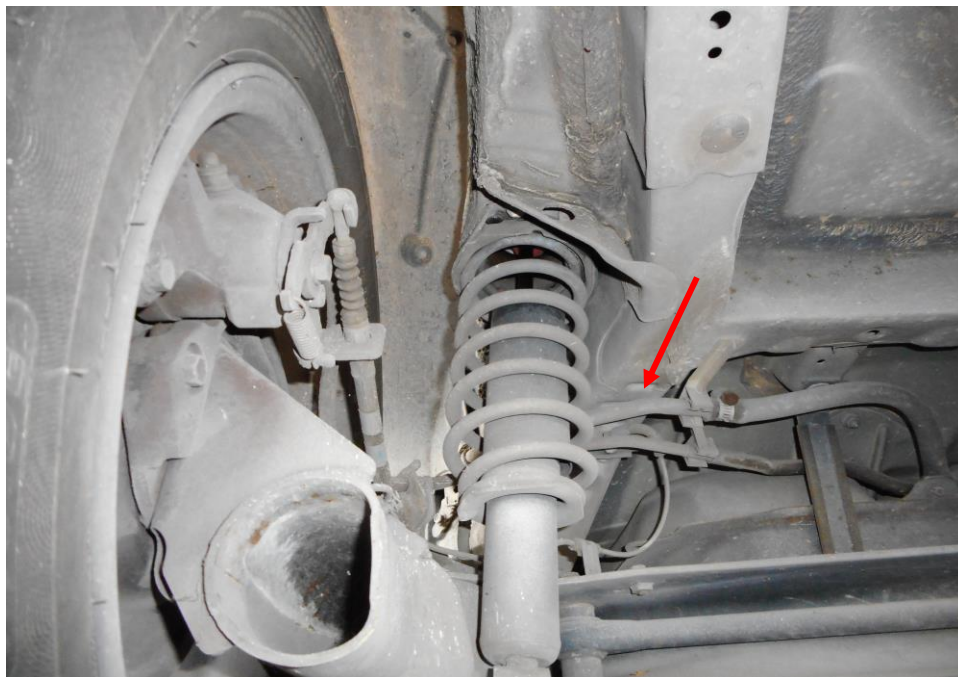
Photo 19 shows the brake hose/pipe (arrowed) at the rear left wheel of the Police Car. I did not observe any leakage of brake fluid at the time of my inspection of the Police Car. Static tests of the Police Car's braking system had indicated that there was no internal leakage of pressure/vacuum. The undercarriage components of the Police Car were also all found to be intact and without any visible damage.

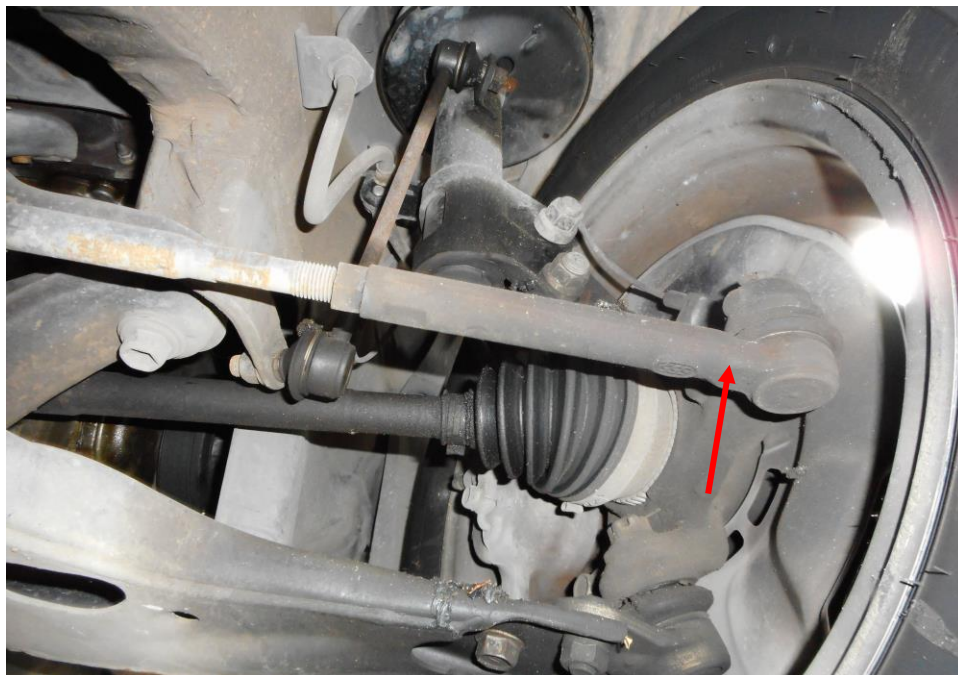
Photo 21 shows the various undercarriage components at the front right wheel of the Police Car, in particular the steering tie rod (arrowed). The various steering components were all found to be intact, suggesting that the steering system of the Police Car was likely to be in serviceable condition at the material time of accident. There was also no sign of fluid stain observed on the various undercarriage components at the front right wheel of the Police Car.

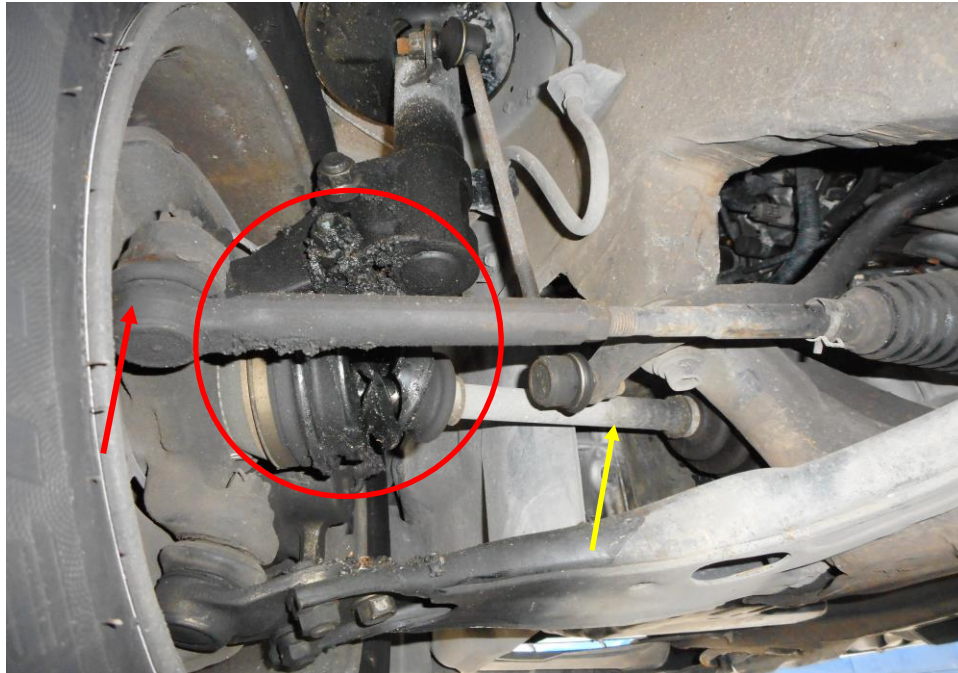
Photo 22 shows the various undercarriage components at the front left wheel of the Police Car, which had included the steering tie rod (red arrow) and front left drive shaft (yellow arrow) was inspected to be in good condition, other than the broken boot rubber of the outer CV joint (circled). The various undercarriage components of the Police Car were all found to be intact without any visible damage.

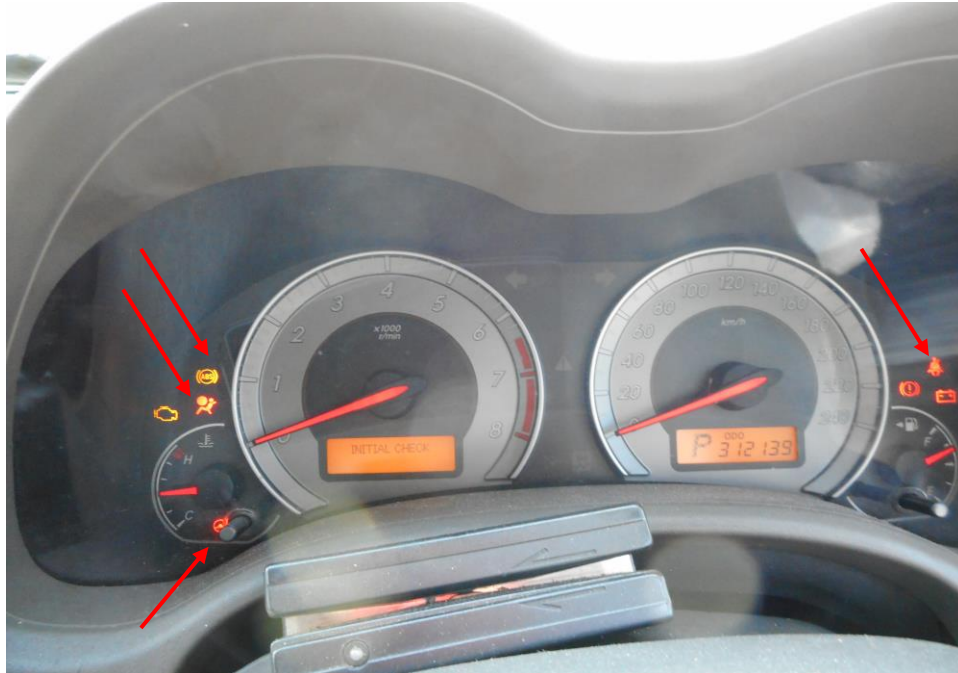
Photo 23 shows the warning light for Anti-Lock Brake System (ABS), Electric Power Steering System (EPS), Traction Control (TC) and Supplemental Restraint System (SRS) appearing on the instrument panel of the Police Car during the self-test of its various electronic operating systems when its engine was cranked.

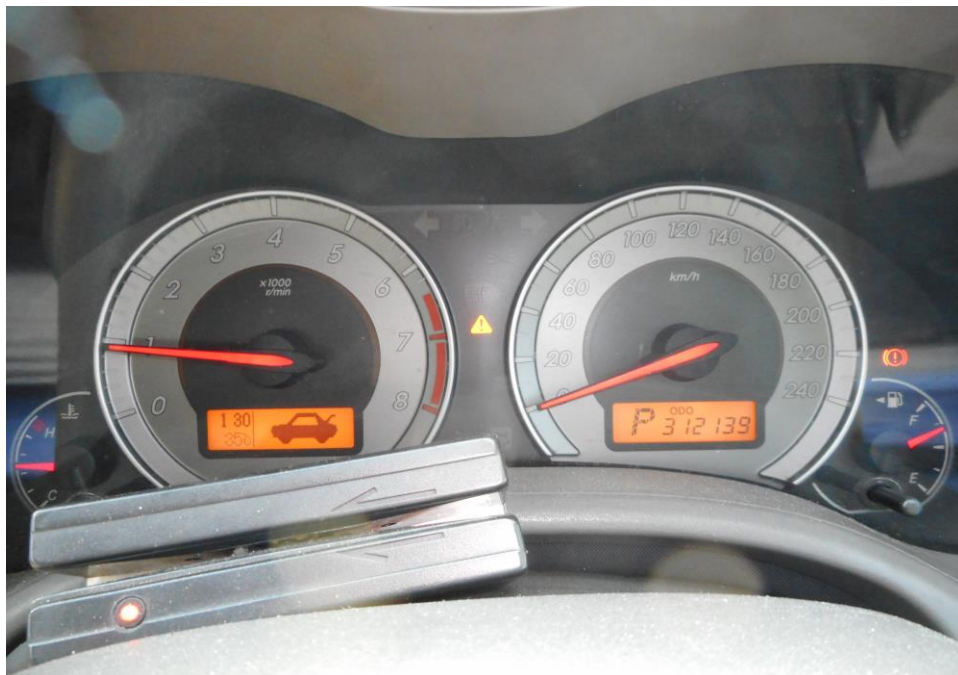
Photo 24 shows no warning lights illuminated on the instrument panel of the Police Car after the engine was cranked. This would suggest that there was no abnormality to the various electronic operating systems of the Police Car, like the ABS, EPS, TC and SRS etc.
