Your Ref: TP/IP/03829/2019  
Our Ref : CI/TPD19004305/P

### **Fatal Accident Investigation Team**

### **MECHANICAL INSPECTION REPORT OF MOTOR LORRY XD 3396H**

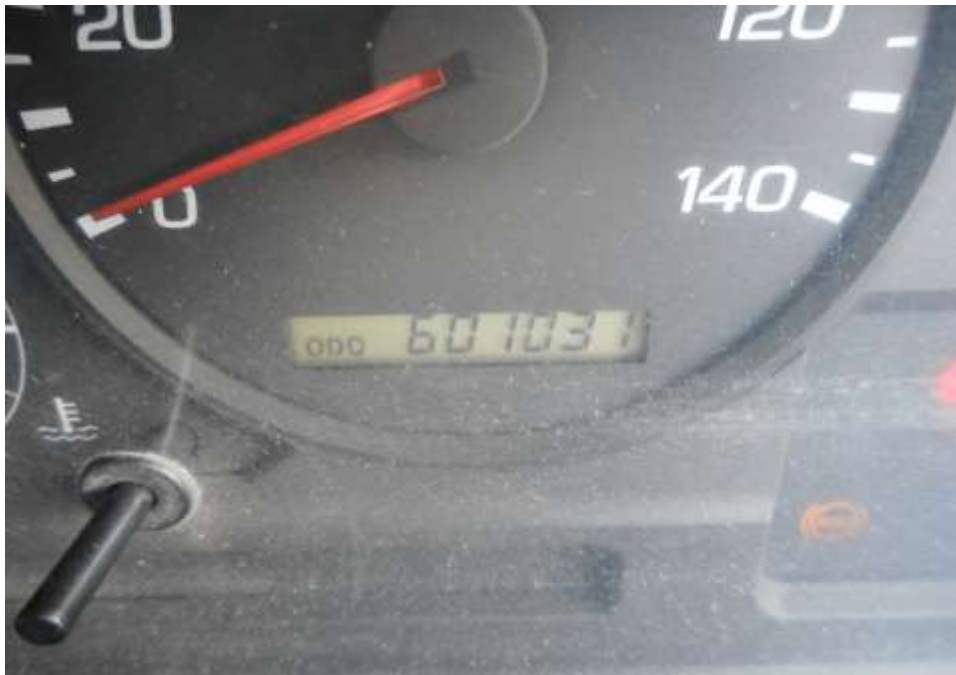
4. The mileage of the Motor Lorry at the time of my inspection was 601,031km.
5. The Motor Lorry was observed to have sustained minor damages at its frontal portion. Its front bumper was damage as a result of the accident at the time of my inspection.

**Photo 1** shows a general view of the instrument cluster of the Motor Lorry at the time of my inspection. The mileage of the Motor Lorry was 601,103km

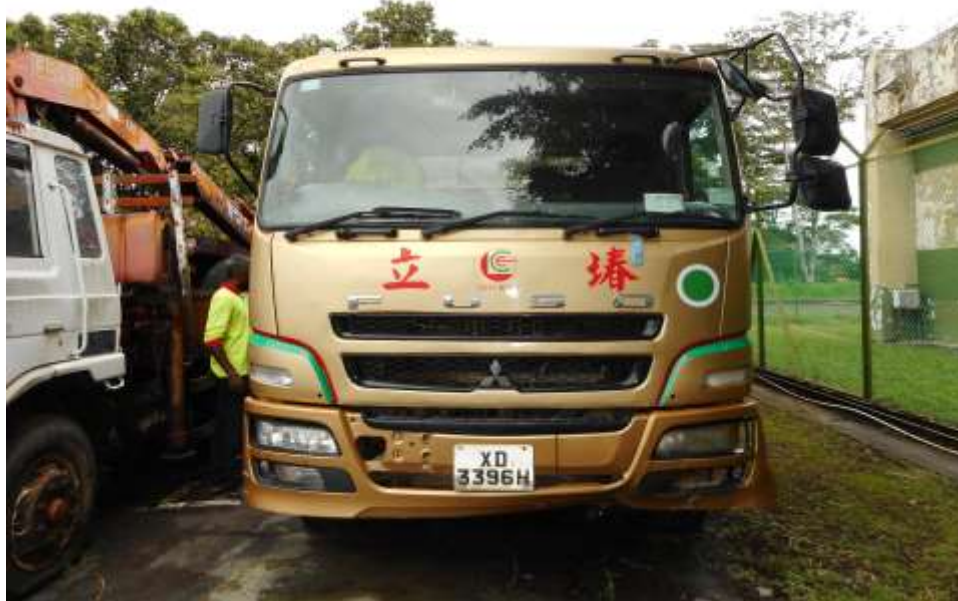
**Photo 2** shows a general view of the front body of the Motor Lorry at the time of my inspection. The Motor Lorry was observed to have sustained minor damage to its frontal portion; its front bumper was damaged as a result of the accident.

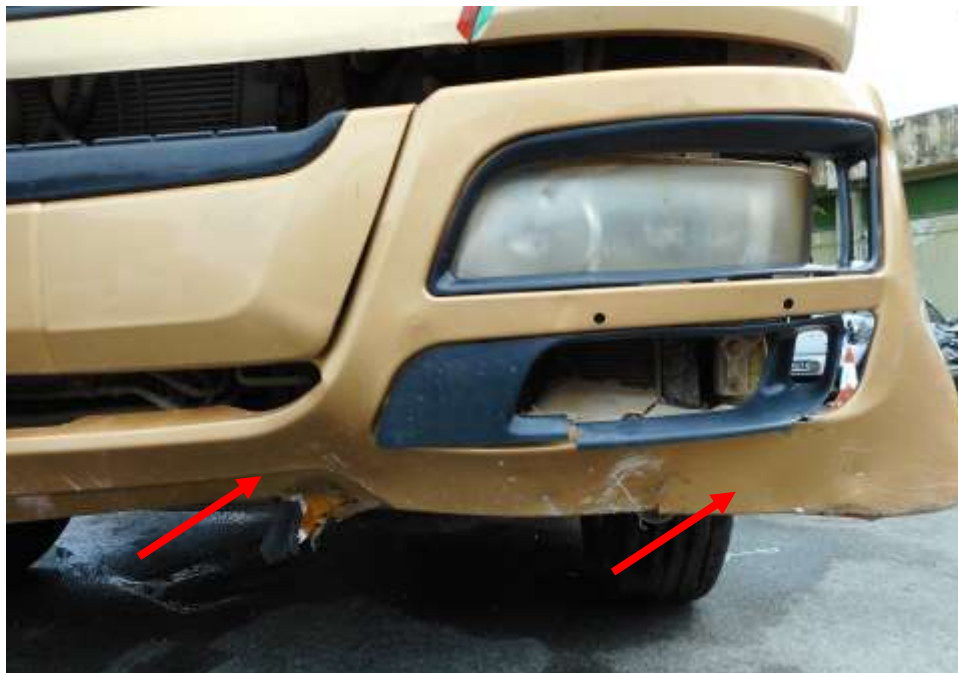
**Photo 3** shows a close up view of the front body of the Motor Lorry at the time of my inspection. The Motor Lorry was observed to have sustained minor damage to its frontal portion; its front bumper was damaged (arrowed) as a result of the accident.

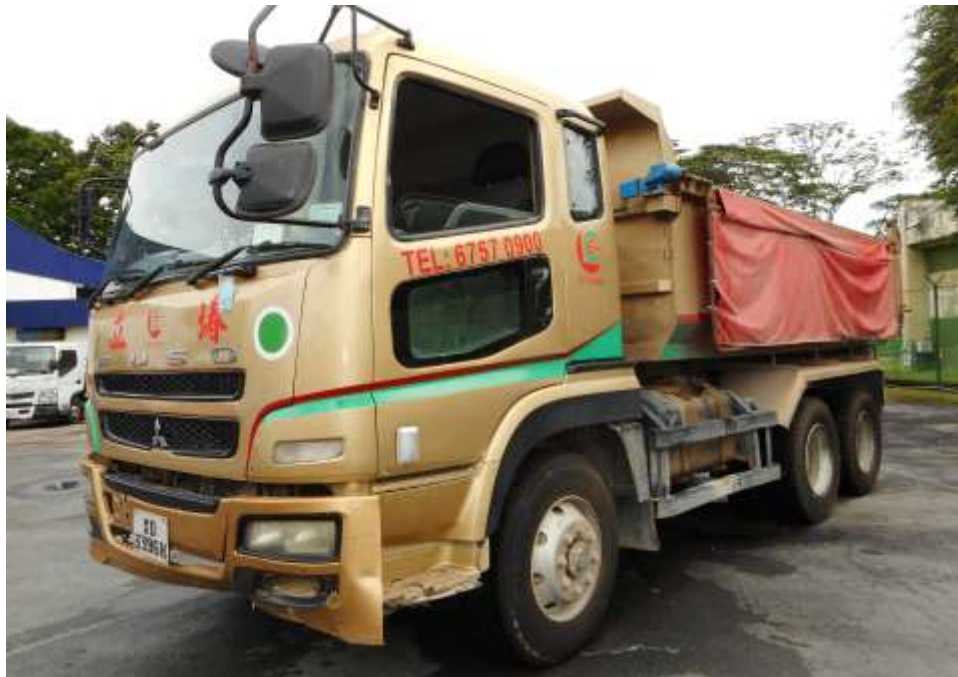
**Photo 4** shows a general view of the left body of the Motor Lorry at the time of my inspection. The Motor Lorry was observed to be in good general condition.

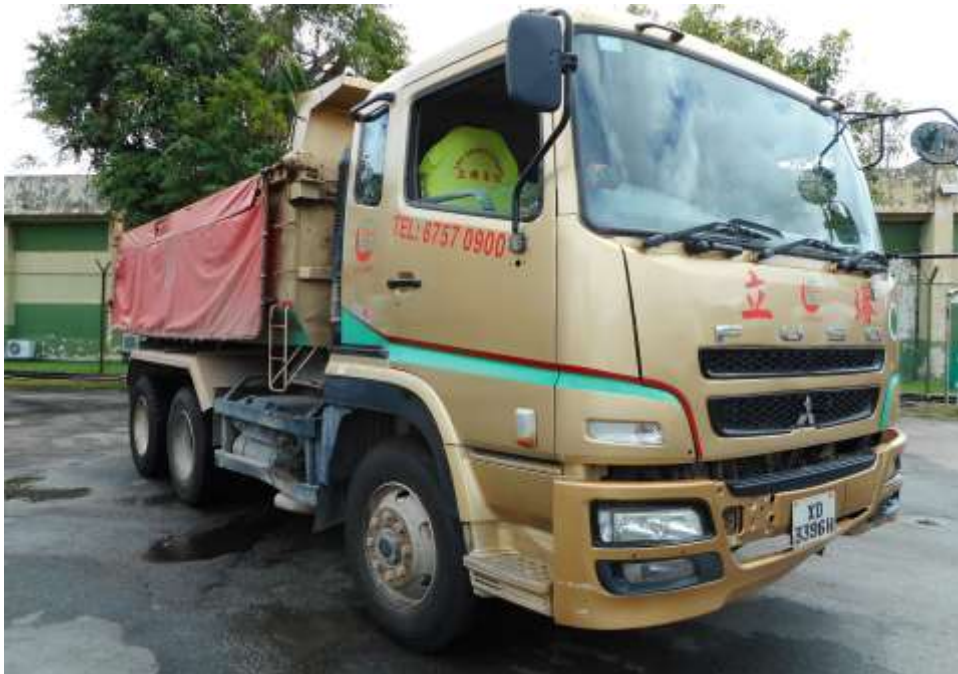
**Photo 5** shows a general view of the front right body of the Motor Lorry at the time of my inspection. The Motor Lorry was observed to be in good general condition.

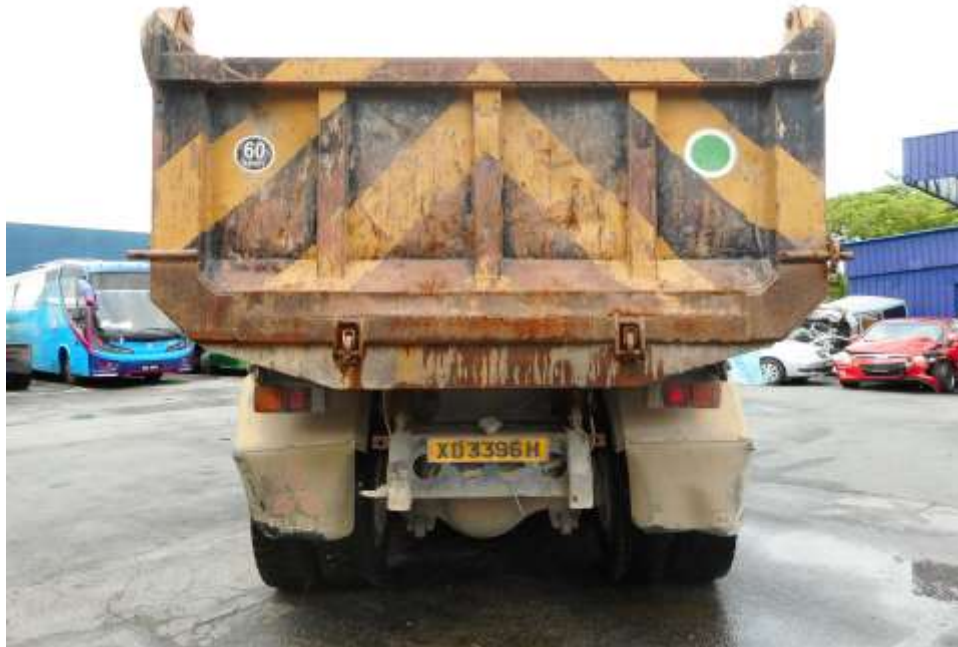
**Photo 6** shows a general view of the Motor Lorry's rear left body at the time of my inspection. There was no damage found to the rear portion of the Motor Lorry.

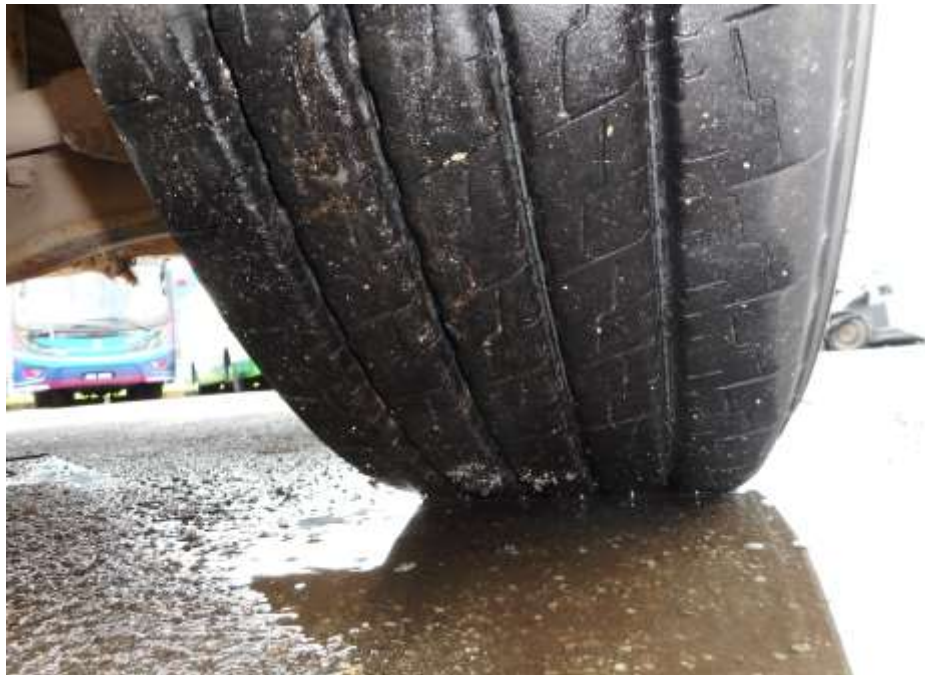
**Photo 7** shows the condition of the front right tyre of the Motor Lorry, which was observed to be in serviceable condition with remaining tread depth of approximately 11 mm. The tyre, which was wrapped around standard steel wheel rim, was also observed to be sufficiently inflated for vehicular operation. There was no tear, cut or burst mark(s) on the outer and the inner sidewalls as well as across the tread of the 6 tyres that were fitted on the Motor Lorry.

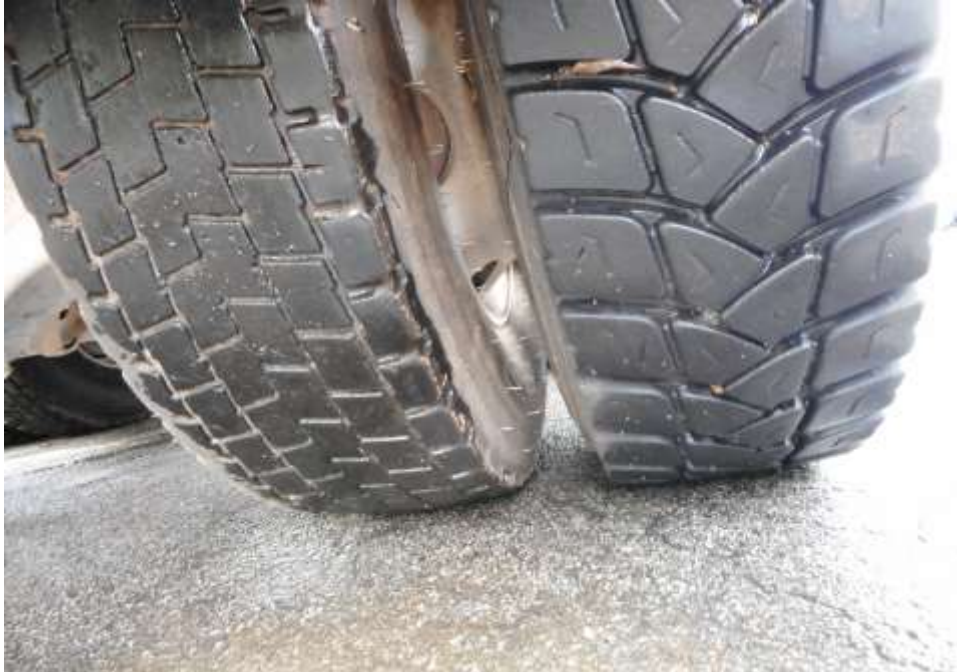
**Photo 8** shows the condition of the rear right tyre of the Motor Lorry, which was observed to be in serviceable condition with remaining tread depth of approximately 8.7mm. The tyre, which was wrapped around standard steel wheel rim, was also observed to be sufficiently inflated for vehicular operation.

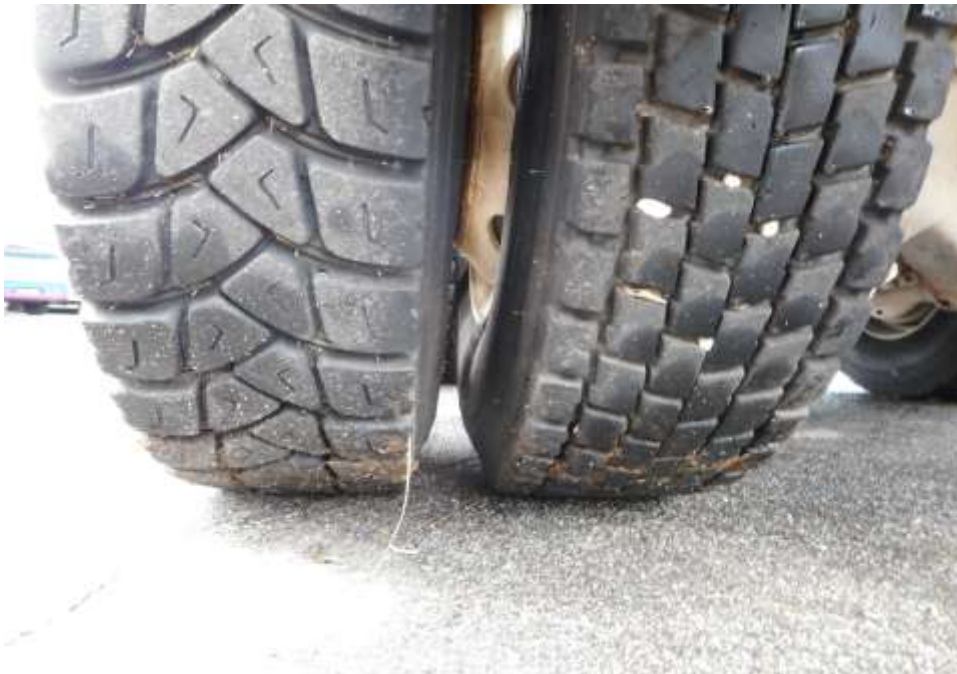
**Photo 9** shows the condition of the rear left tyres of the Motor Lorry, which was observed to be in serviceable condition with remaining tread depth of approximately 9.1mm. The tyres, which were wrapped around standard steel wheel rim, were also observed to be sufficiently inflated for vehicular operation. There was also no damage found on all 6 steel wheel rims of the Motor Lorry.

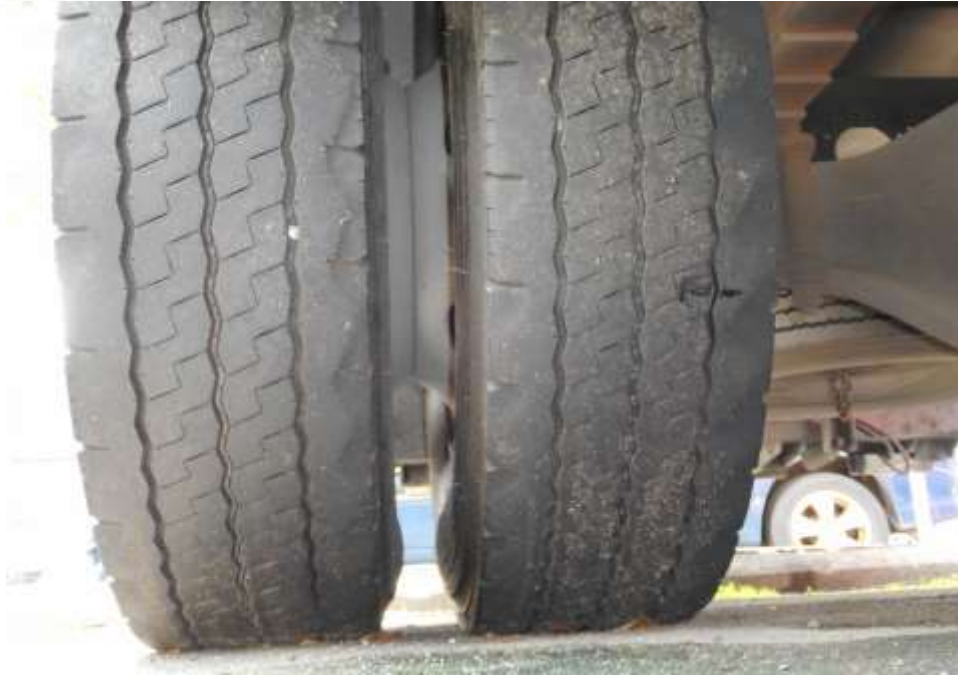
**Photo 10** shows the condition of the front left tyres of the Motor Lorry, which were observed to be in serviceable condition with remaining tread depth of approximately 10.3mm. There was also no tear, cut or burst mark(s) on the outer and the inner sidewalls as well as across the tread of the 6 tyres that were fitted on the Motor Lorry.

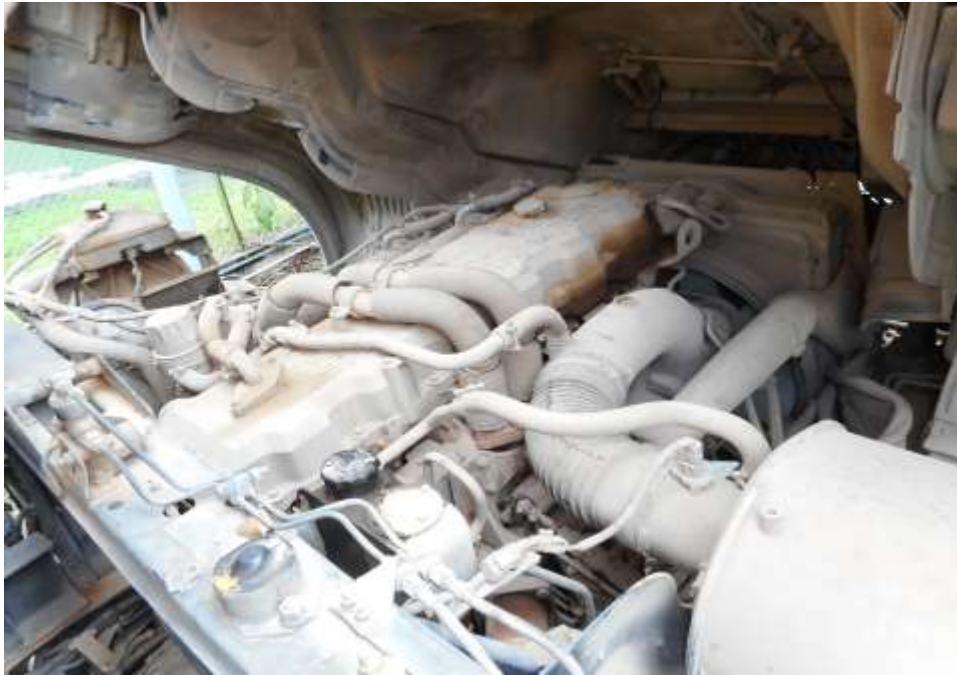
**Photo 11** shows a general view of the Motor Lorry's engine compartment, which was accessed by lifting the front cabin of the Motor Lorry. The various parts and components inside the engine compartment were unaffected by the accident. There was also no sign(s) or indication(s) of fresh fluid leakage and/or fluid stain within the engine compartment (photograph shows the engine compartment as viewed from the right front side of the Motor Lorry).

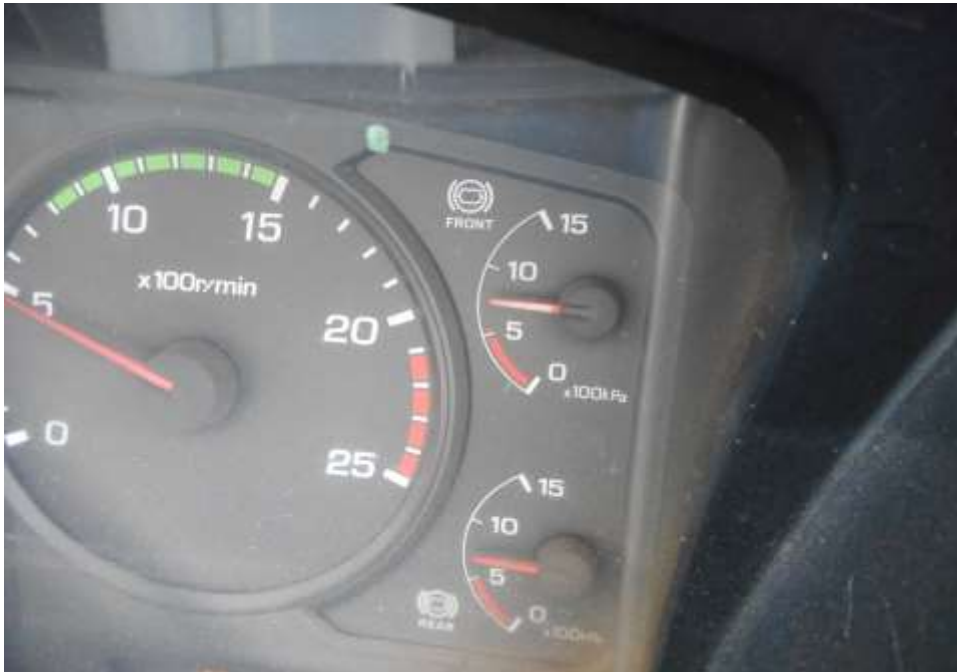
**Photo 12** shows the air in the air brake cylinder of the Motor Lorry at the time of my inspection. The air in the cylinder was observed to be of sufficient level & serviceable at the time of the accident.

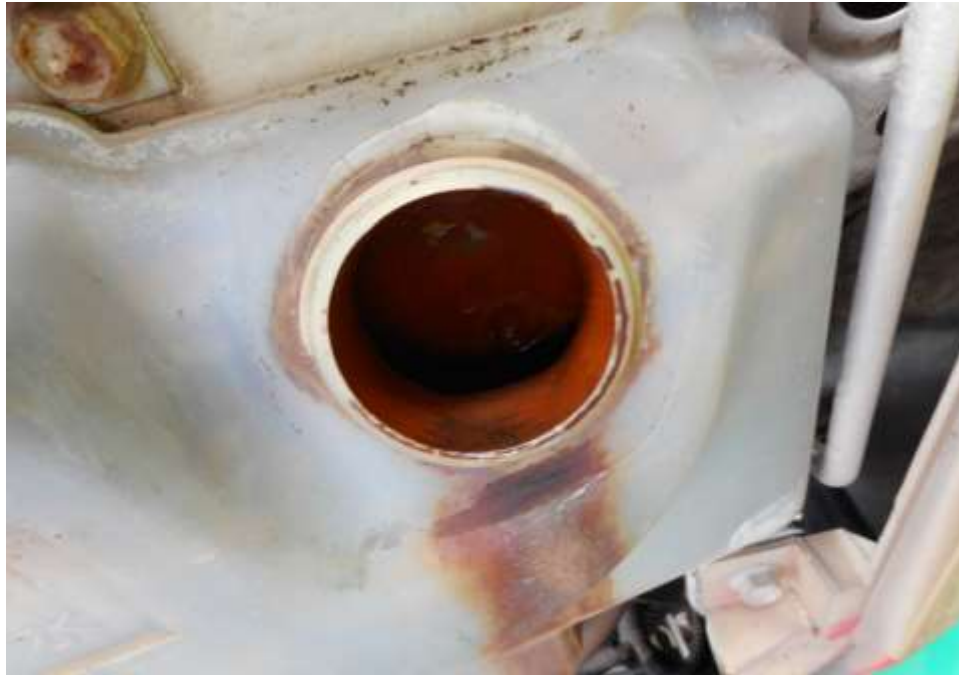
**Photo 13** shows the engine coolant reservoir of the Motor Lorry at the time of my inspection. The engine coolant was observed to be of sufficient level and without any visible contamination.

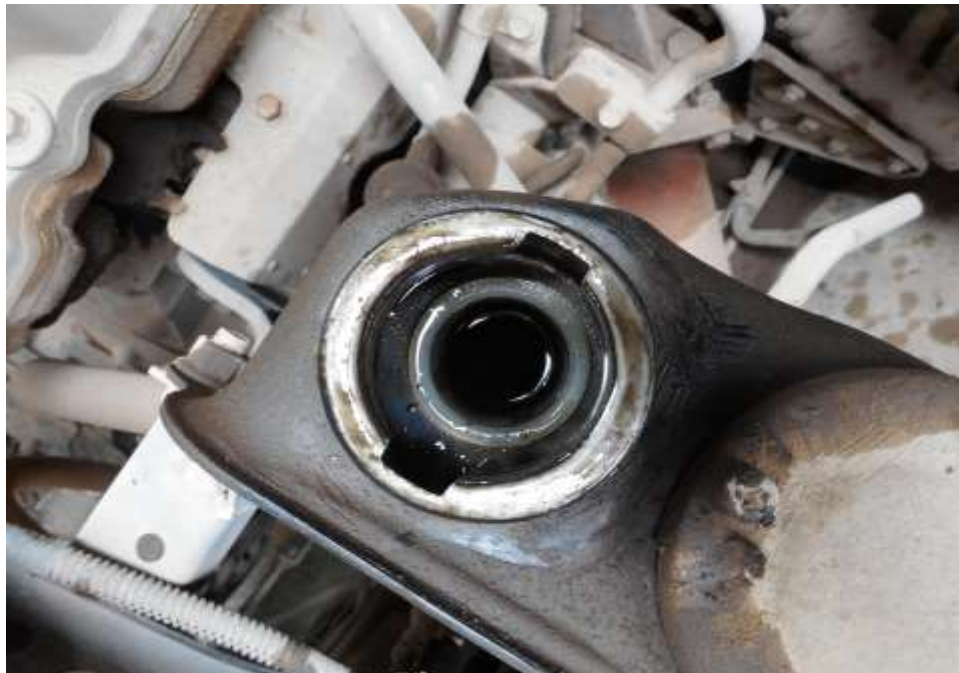
**Photo 14** shows the power steering fluid reservoir of the Motor Lorry at the time of my inspection. The power steering fluid was observed to be of sufficient level and without any visible contamination.

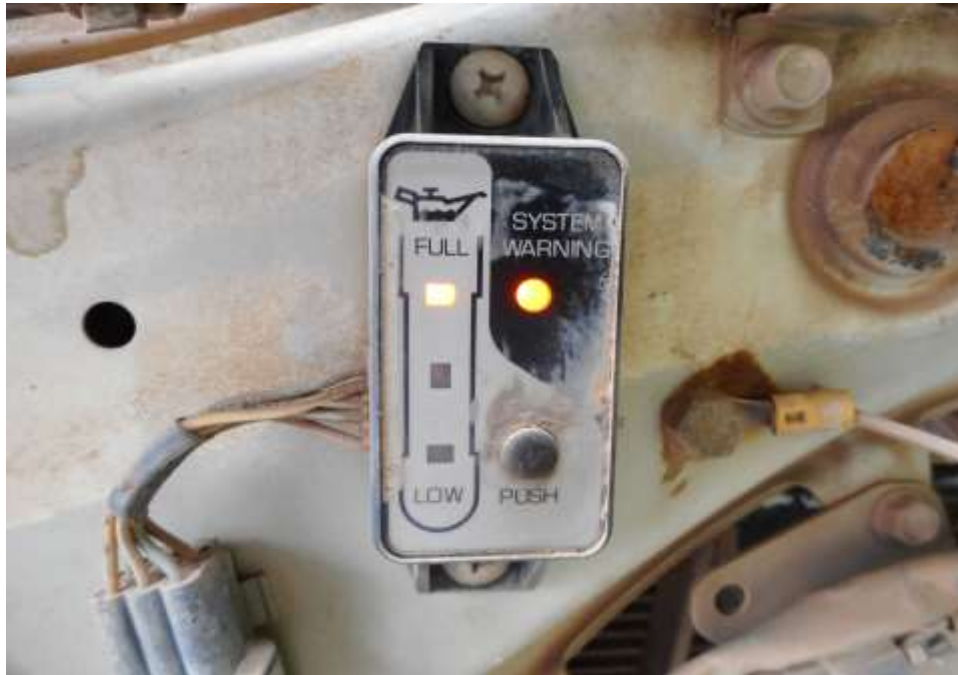
**Photo 15** shows the engine oil dip stick system of the Motor Lorry at the time of my inspection. The engine oil was observed to be of sufficient level and without any visible contamination.

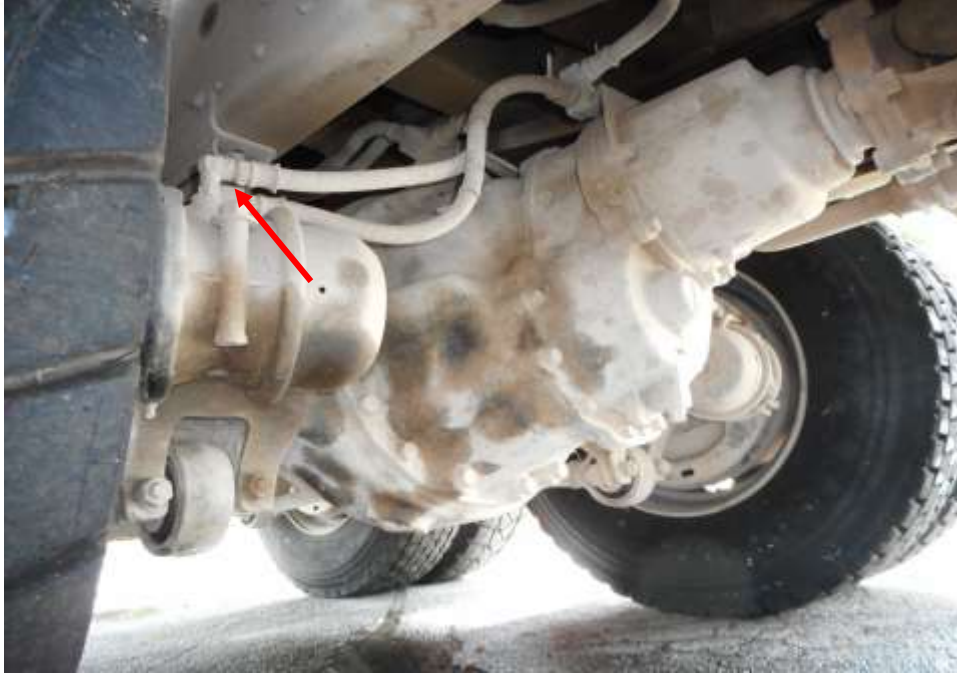
**Photo 16** shows the brake pipe (arrowed) at the rear right wheel of the Motor Lorry. I did not observe any leakage of brake fluid at the time of my inspection of the Motor Lorry. My static tests of the Motor Lorry's braking system, along with my visual examination of the various mechanical components in the braking system, had indicated that there was no internal leakage of pressure/vacuum. Hence the braking system of the Motor Lorry was likely to be in serviceable condition at the material time of accident.

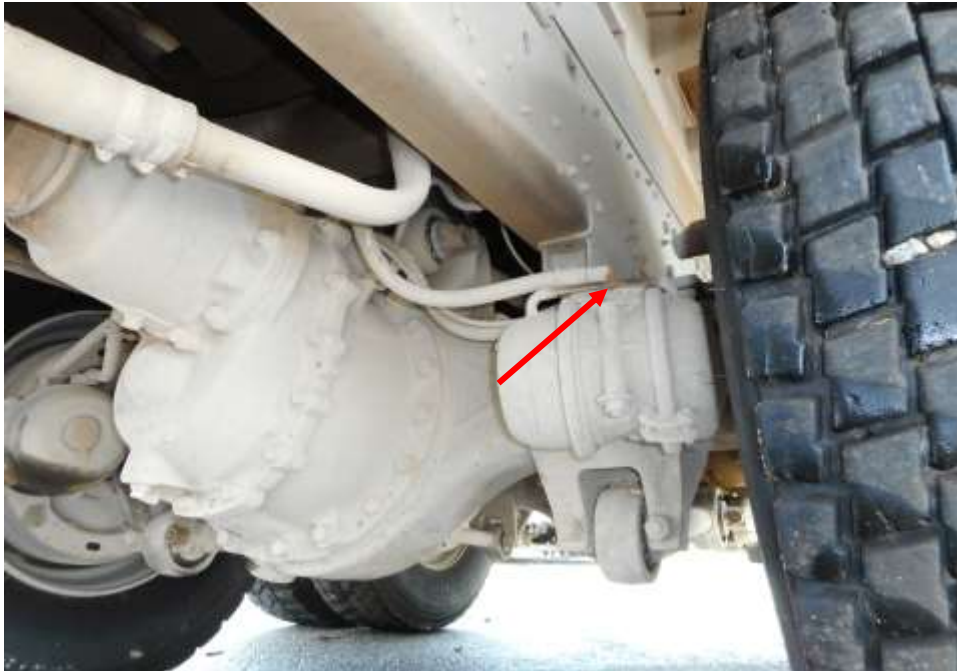
**Photo 17** shows the brake pipe (arrowed) at the rear left wheel of the Motor Lorry. I did not observe any leakage of brake fluid at the time of my inspection of the Motor Lorry. My static tests of the Motor Lorry's braking system, along with my visual examination of the various mechanical components in the braking system, had indicated that there was no internal leakage of pressure/vacuum. Hence the braking system of the Motor Lorry was likely to be in serviceable condition at the material time of accident.

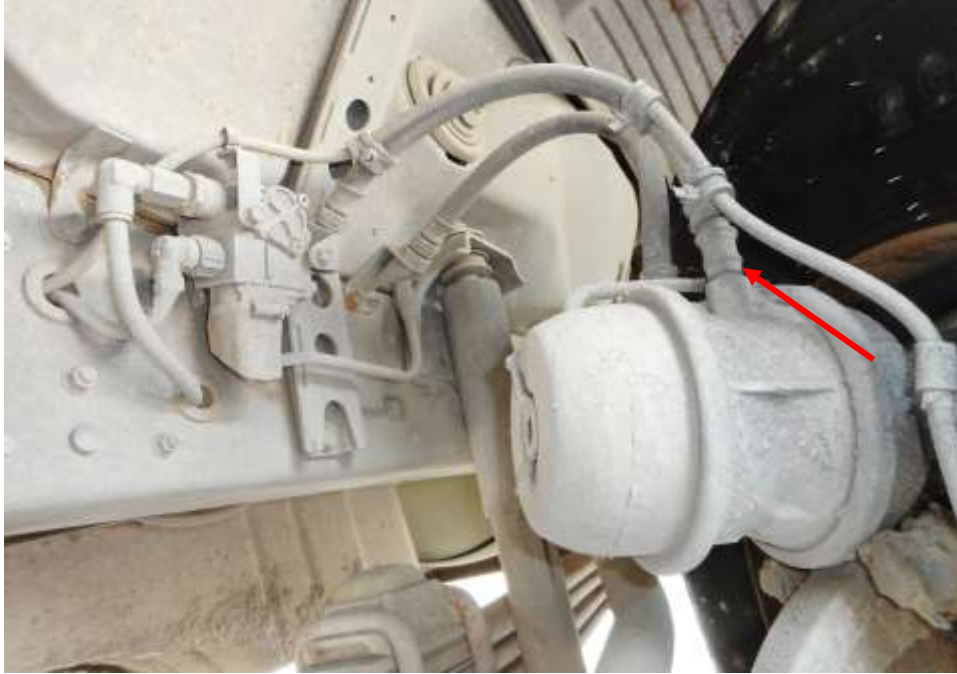
**Photo 18** shows the brake pipe (arrowed) at the front right wheel of the Motor Lorry. I did not observe any leakage of brake fluid at the time of my inspection of the Motor Lorry. My static tests of the Motor Lorry's braking system, along with my visual examination of the various mechanical components in the braking system, had indicated that there was no internal leakage of pressure/vacuum. Hence the braking system of the Motor Lorry was likely to be in serviceable condition at the material time of accident.

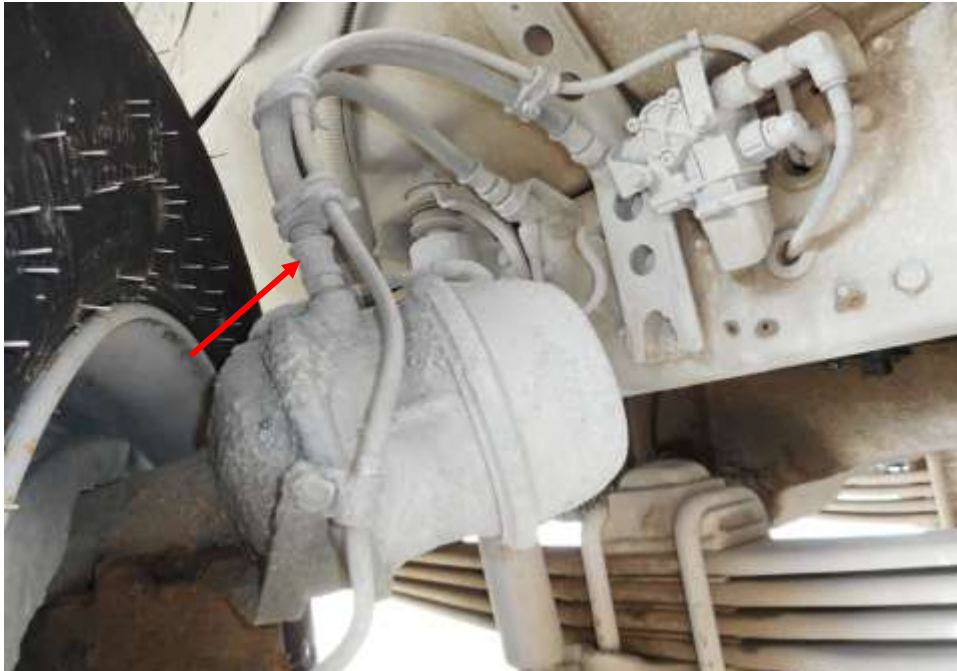
**Photo 19** shows the brake pipe (arrowed) at the front left wheel of the Motor Lorry. I did not observe any leakage of brake fluid at the time of my inspection of the Motor Lorry. My static tests of the Motor Lorry's braking system, along with my visual examination of the various mechanical components in the braking system had indicated that there was no internal leakage of pressure/vacuum. Hence the braking system of the Motor Lorry was likely to be in serviceable condition at the material time of accident.

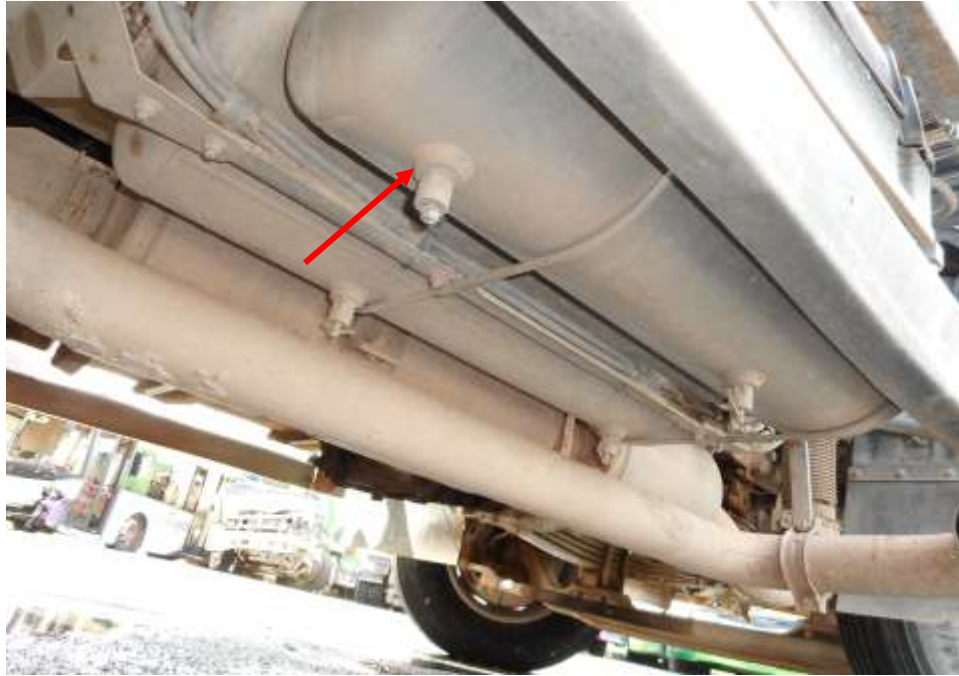
**Photo 20** shows the air brake cylinder (arrowed) at the undercarriage of the Motor Lorry. I did not observe any leakage of air brake fluid at the time of my inspection of the Motor Lorry. My static tests of the Motor Lorry's braking system, along with my visual examination of the various mechanical components in the braking system had indicated that there was no internal leakage of pressure/vacuum. Hence the braking system of the Motor Lorry was likely to be in serviceable condition at the material time of accident.

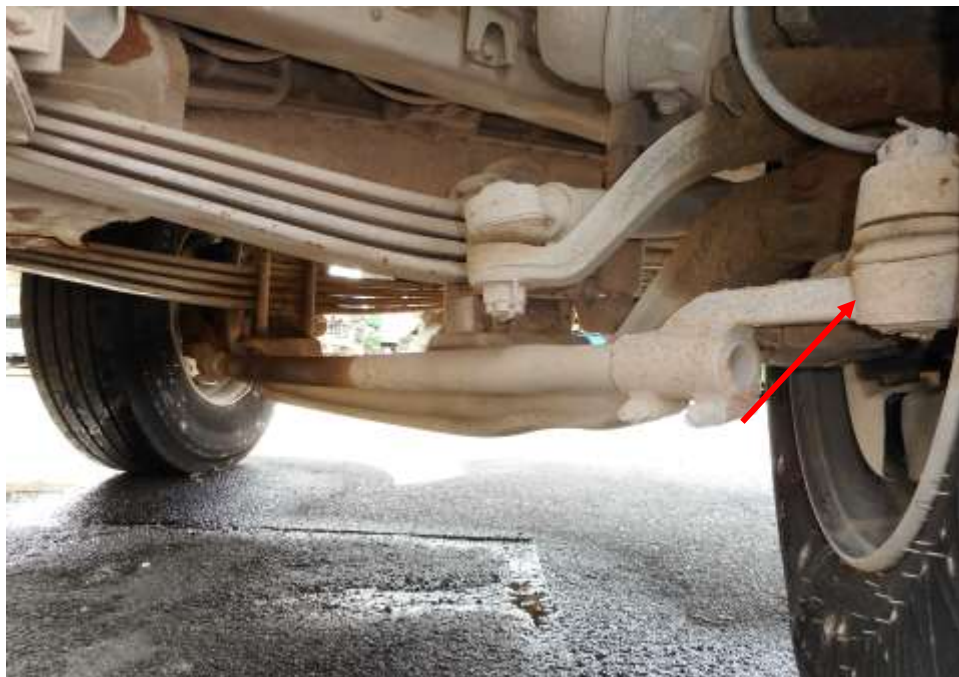
**Photo 21** shows the various undercarriage components at the front right wheel of the Motor Lorry, in particular the steering tie rod end (arrowed). The various steering components were all found to be intact, suggesting that the steering system of the Motor Lorry was likely to be in serviceable condition at the material time of accident. There was also no sign of fluid stain(s) observed on the various undercarriage components.

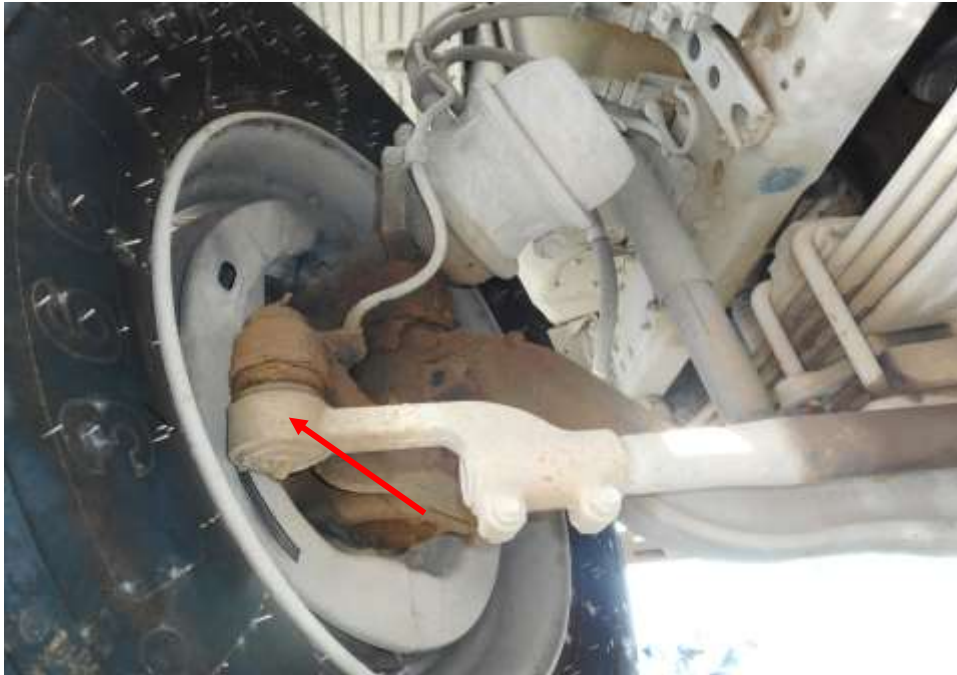
**Photo 22** shows the various undercarriage components at the front left wheel of the Motor Lorry, in particular the steering tie rod end (arrowed). The various undercarriage components of the Motor Lorry were all found to be intact without any visible damage. There was also no sign of fluid stain(s) observed on the various undercarriage components.

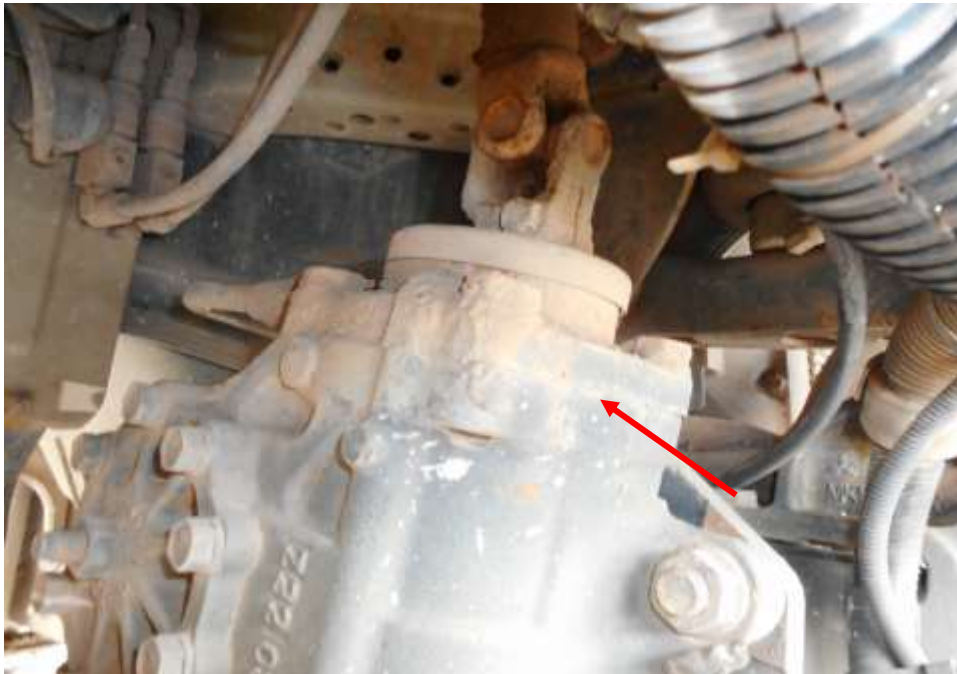
**Photo 23** shows the steering box component (arrowed) at the undercarriage of the Motor Lorry was found to be intact without any visible damage. There was also no sign of fluid stain(s) observed on the various undercarriage components.

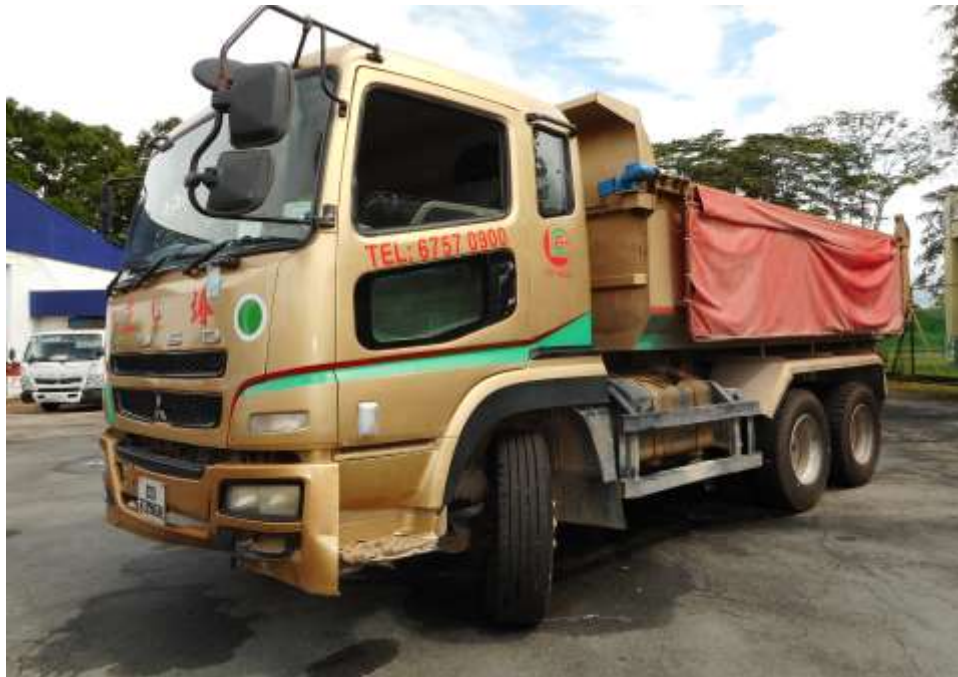
**Photo 24** shows the front left wheel of the Motor Lorry turned to its full left. During my steering system test, I did not experience any abnormal free play and/or resistance when I had turned the steering wheel towards full left and full right. This would suggest that the steering system of the Motor Lorry was likely to be in serviceable condition at the material time of accident.

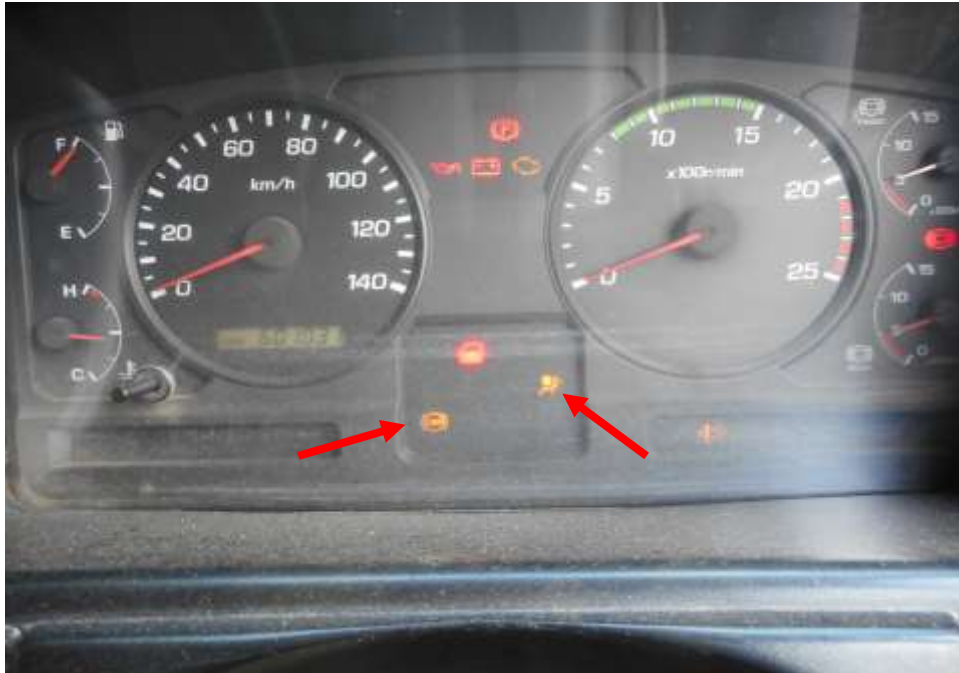
13. The Motor Lorry automatic self-test of the functionality of its various electronic operating systems like the Anti-Lock Brake System (ABS) & Safety Restraint System (SRS) during cranking of the engine had indicated that these systems were in working condition and without abnormality. However the Anti-Lock Brake System (ABS) and the Safety Restraint System (SRS) remained illuminated after cranking of the engine. See photo 25 & 26.

**Photo 25** shows the warning light for Anti-Lock Brake System (ABS) and Safety Restraint System (SRS) (arrowed) appearing on the instrument panel of the Motor Lorry during the self-test of its various electronic operating systems when its engine was cranked.

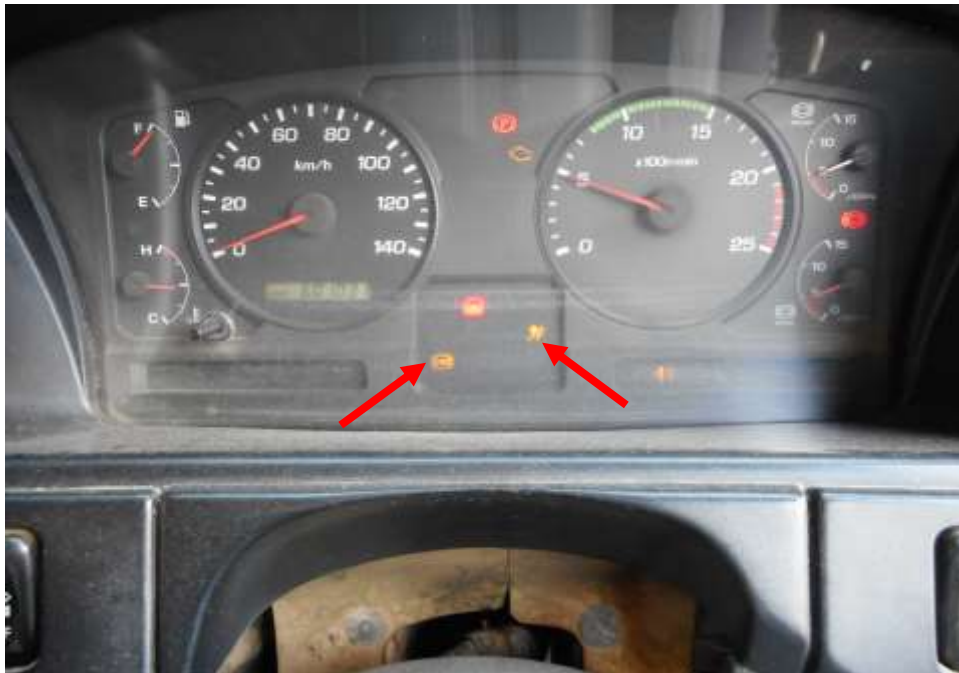
**Photo 26** shows the warning lights for Anti-Lock Brake System (ABS) and Safety Restraint System (SRS) (arrowed) stayed illuminated on the instrument panel of the Motor Lorry after the engine was cranked.
