Your Ref: TP/IP/03829/2019
Our Ref : CI/TPD19004306/N

15 April 2019

MECHANICAL INSPECTION REPORT OF MOTORCYCLE FBB 8585S

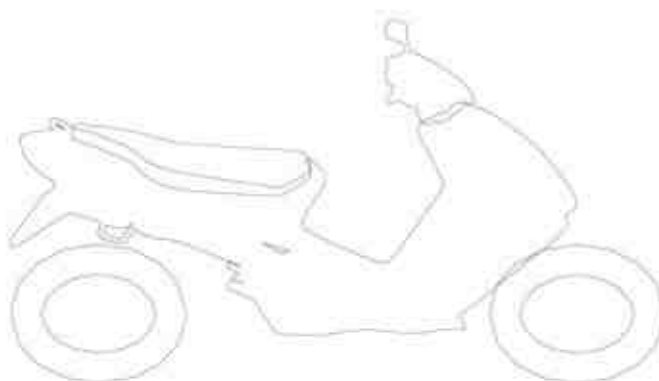
6. The condition of the 2 tyres of the Motorcycle was observed to be in serviceable condition. We did not observe any tear, burst mark(s) and/or punctured hole(s) on the sidewalls as well as across the tread of the 2 tyres. Both the tyres were observed to be sufficiently inflated for vehicular operation. The tyre brand, tyre size and remaining tread depth of the 2 tyres of the Motorcycle were recorded as follows:-

Bridgestone 180/55 R17 (4mm)

Bridgestone 120/70 R17 (3mm)

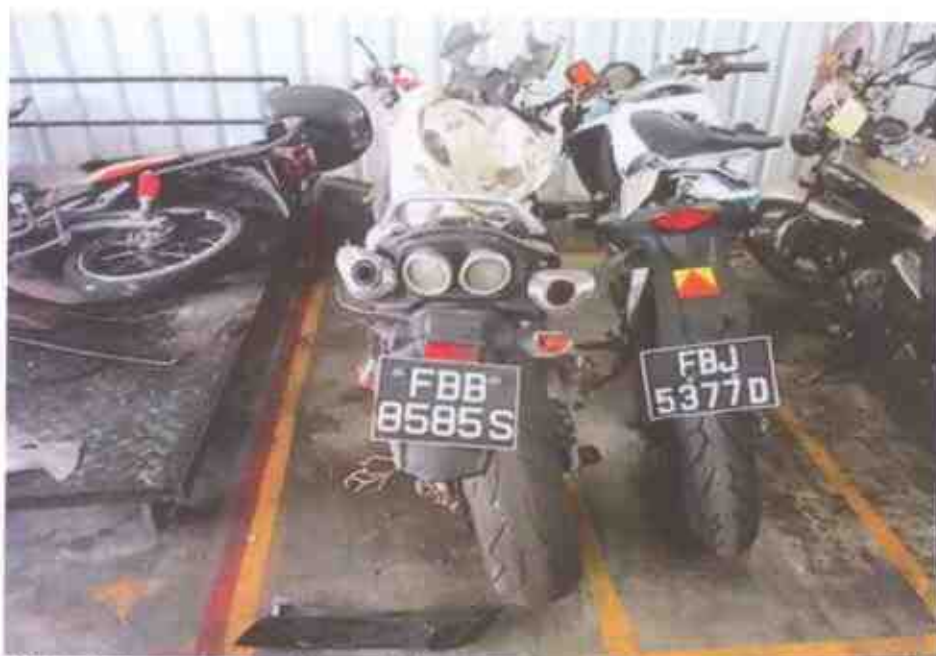
Photo 1 shows a general view of the rear body of the Motorcycle at the time of our inspection. The Motorcycle had sustained damages all around, significantly at its front portion and left body. The mileage of the Motorcycle was not recorded at the time of our inspection due to the damage sustained to the odometer display screen as a result of the accident.

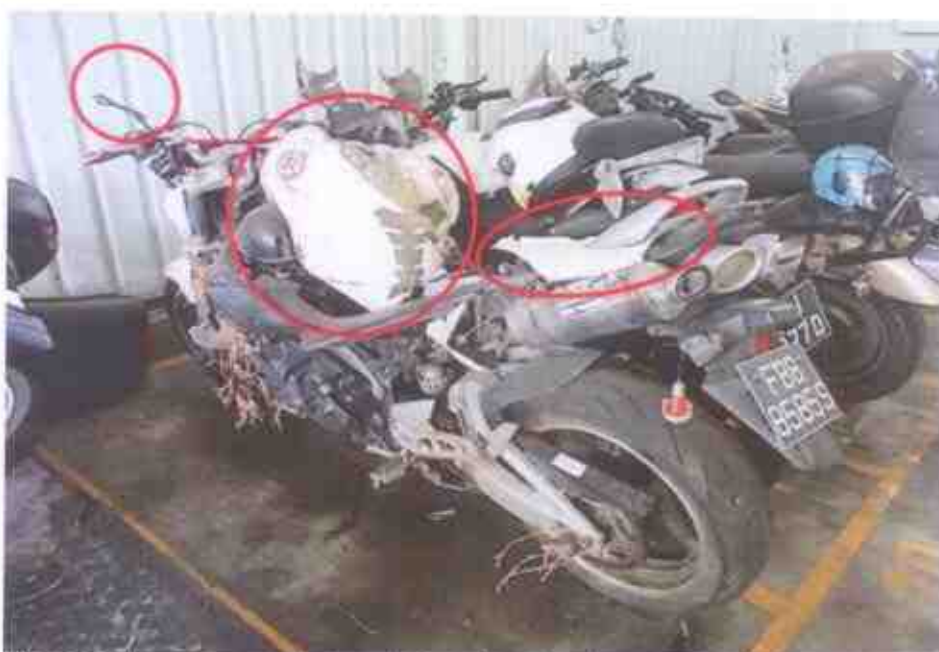
Photo 2 shows a general view of the left body of the Motorcycle at the time of our inspection. Body parts that were found to have been damaged include its left side mirror, fuel tank and left rear side cover (circled).

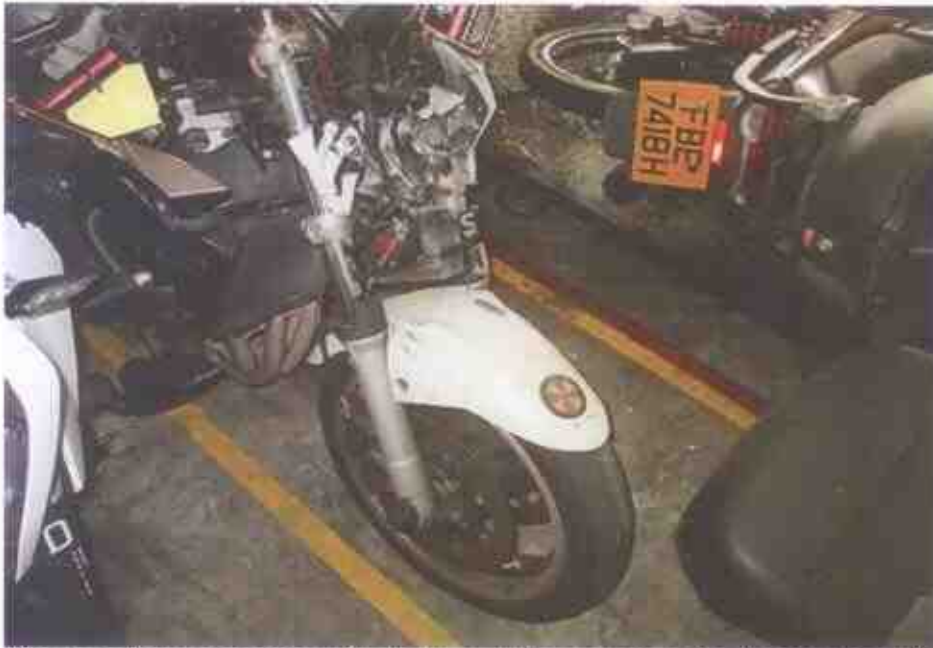
Photo 3 shows a general view of the right front body of the Motorcycle at the time of our inspection. Body parts that were found to have been damaged include its headlamp assembly, speedometer, front mudguard, left side mirror, clutch lever, right side mirror, front brake lever, front brake fluid reservoir, petrol tank, rear right footrest, left exhaust muffler and left rear side cover amongst others.

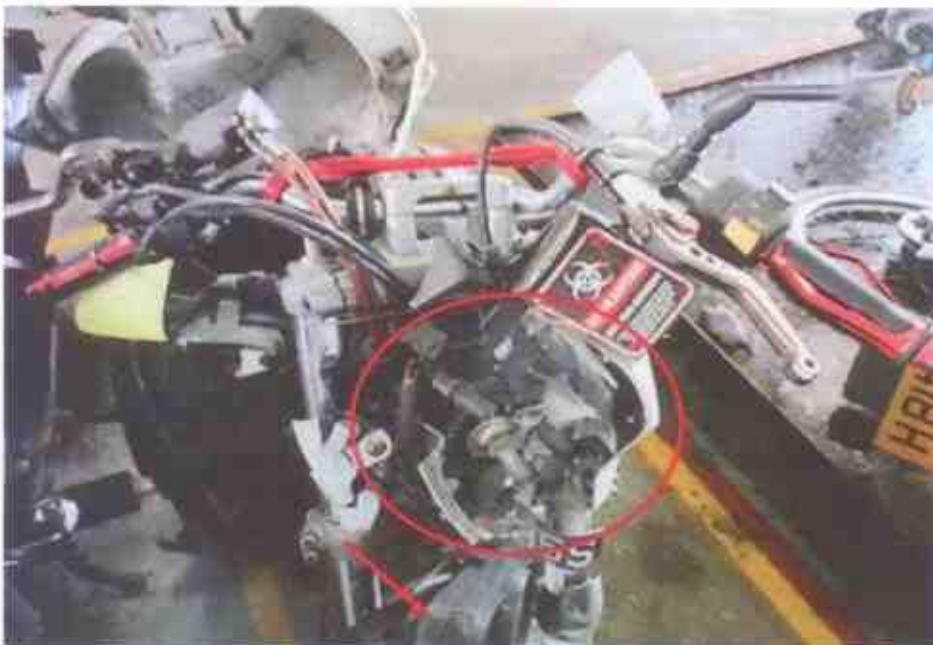
Photo 4 shows a closer view of the headlamp assembly (circled) and speedometer (arrowed) which were amongst the body parts at the front body of the Motorcycle that had sustained damage as a result of the accident.

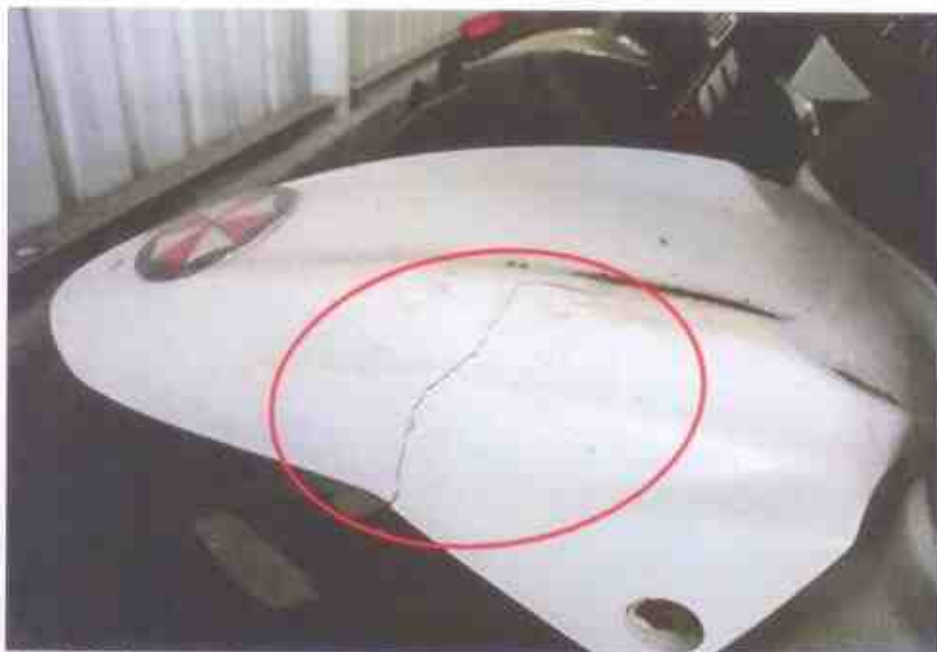
Photo 5 shows a closer view of the front mudguard (circled) which was amongst the body parts at the front body of the Motorcycle that had sustained damage as a result of the accident.

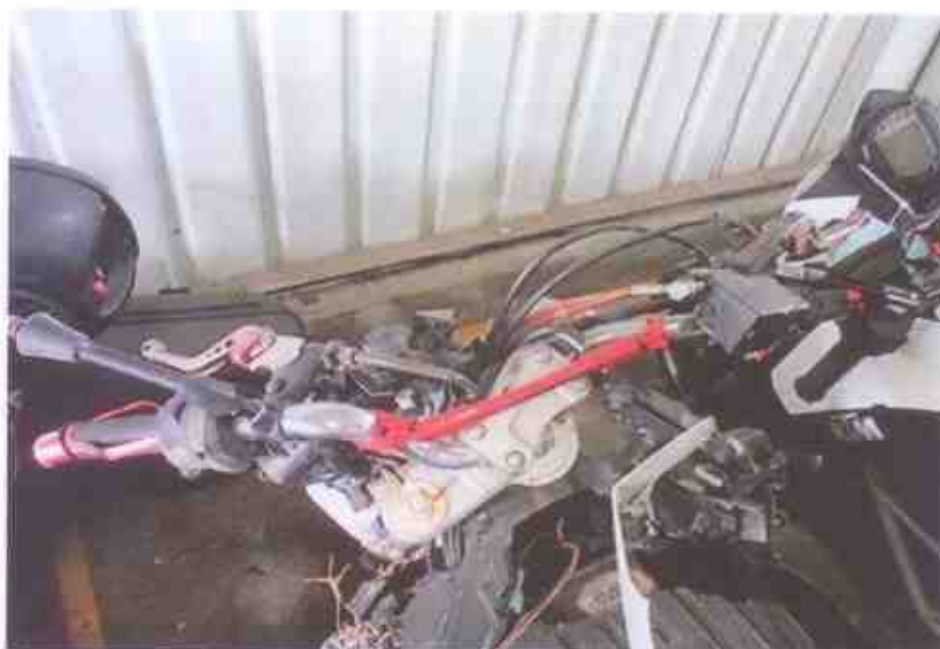
Photo 6 shows a close up view of the front brake lever, front brake fluid reservoir, left side mirror, clutch lever, left handlebar grip and left handlebar end of the Motorcycle. These parts were amongst the body parts of the Motorcycle which were damaged as a result of the accident.

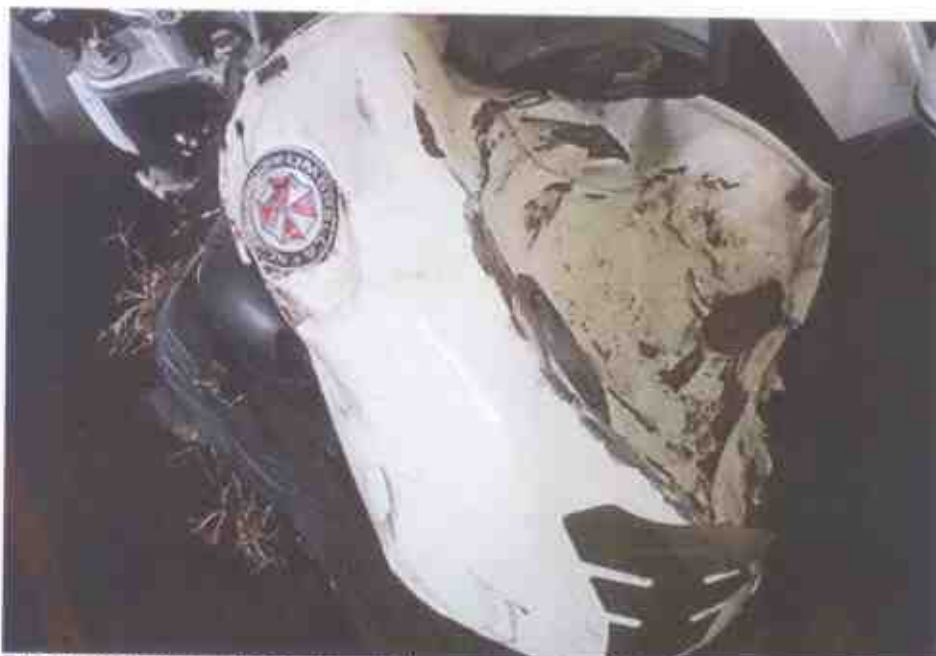
Photo 7 shows a closer view of the petrol tank, which was amongst the body parts of the Motorcycle that had sustained damage as a result of the accident.

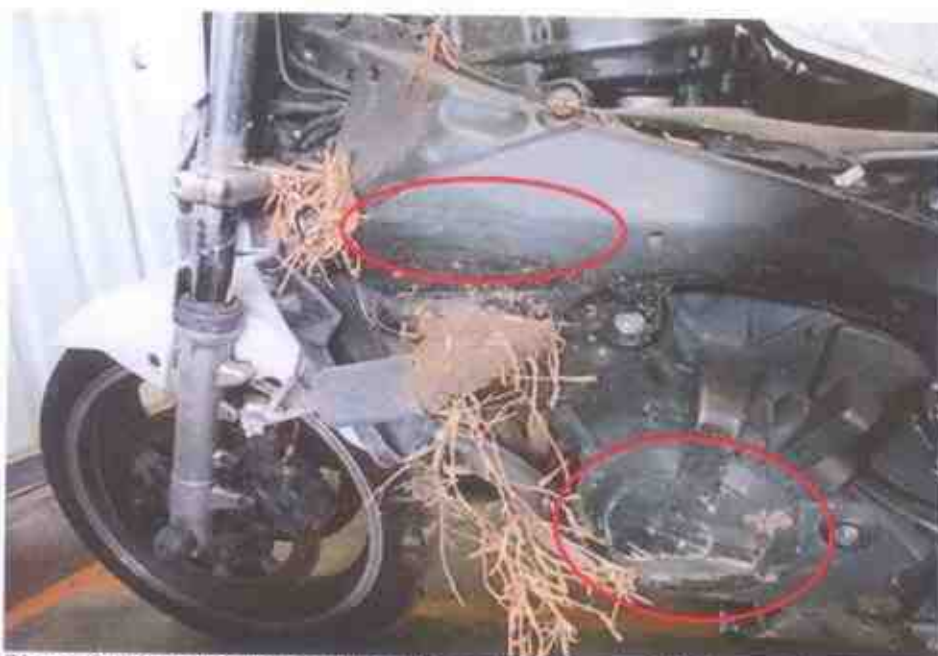
Photo 8 shows the damaged left side engine cover and left frame (circled) of the Motorcycle. The damage sustained at the left frame of the Motorcycle was mainly of grazing nature.

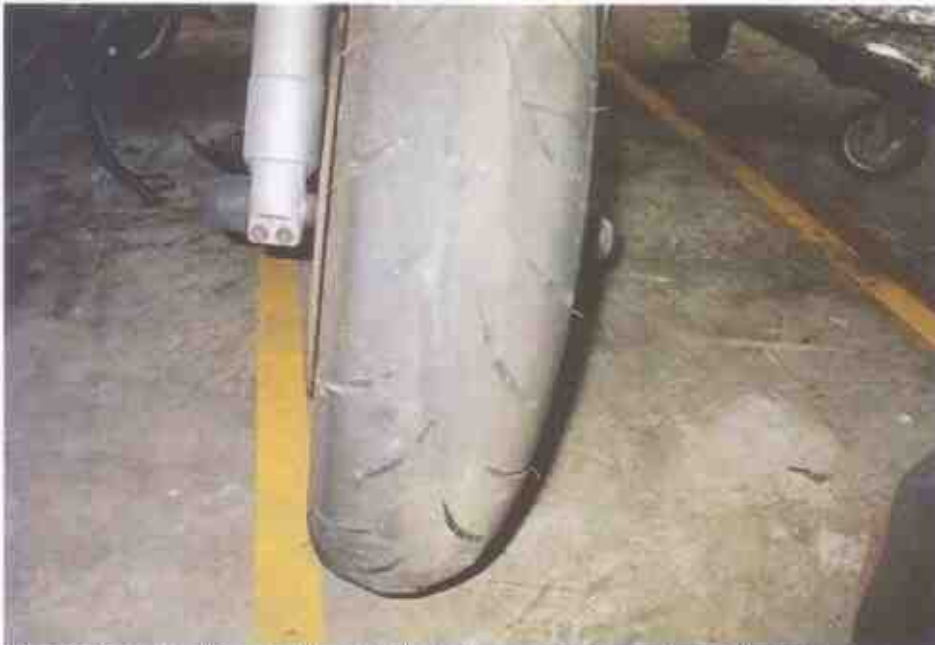
Photo 9 shows the condition of the Motorcycle's front tyre. The front tyre was observed to be in serviceable condition with remaining tread depth of approximately 3mm. The tyre was also observed to be sufficiently inflated for vehicular operation. We did not observe any tear, burst mark(s) and/or punctured hole(s) on the sidewalls as well as across the tread of the front tyre.

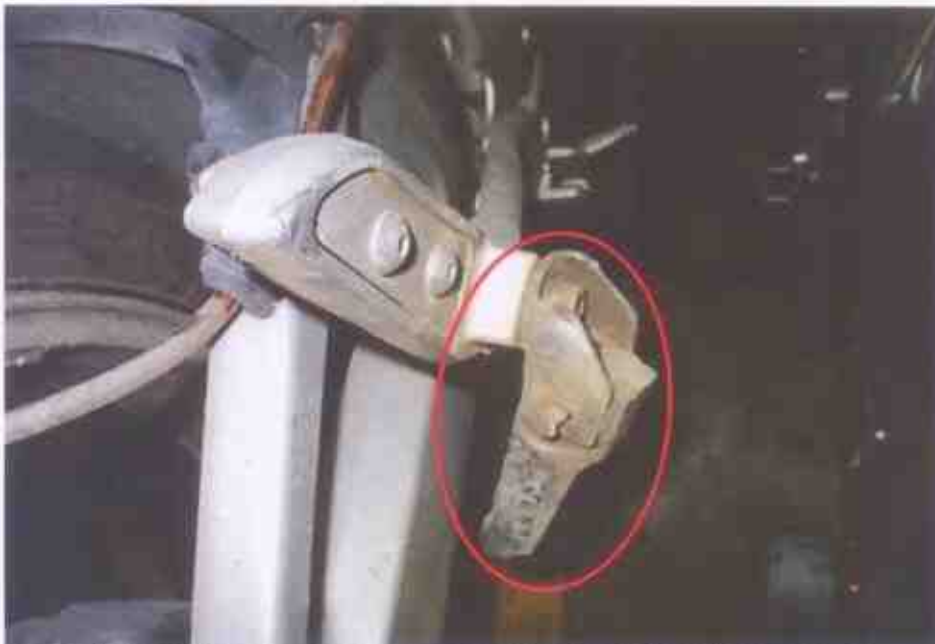
Photo 10 shows the damaged right rear footrest (circled) of the Motorcycle.

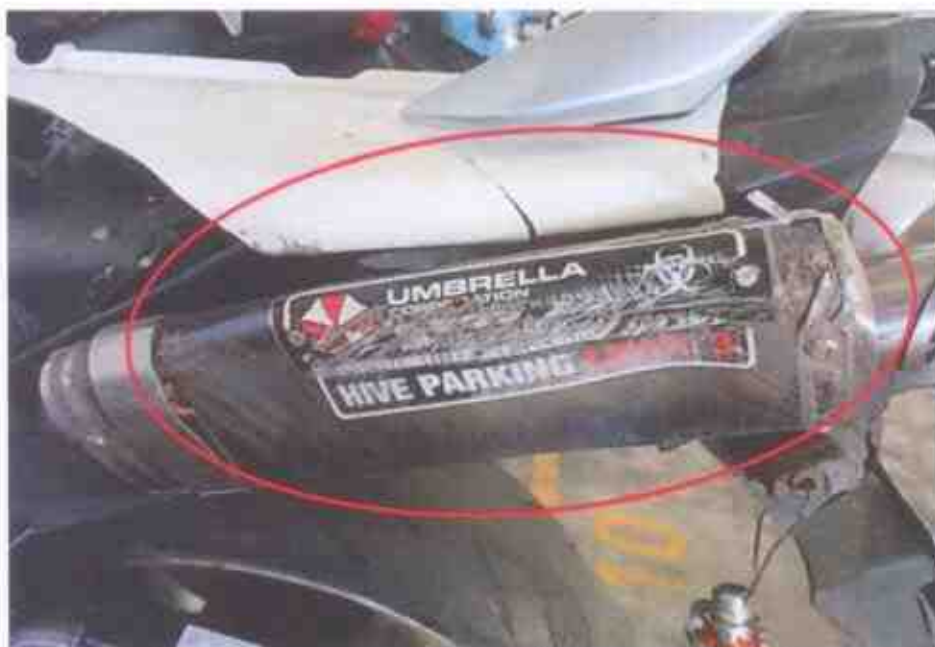
Photo 11 shows the damaged left rear side cover and left exhaust muffler (circled) of the Motorcycle as a result of the accident.

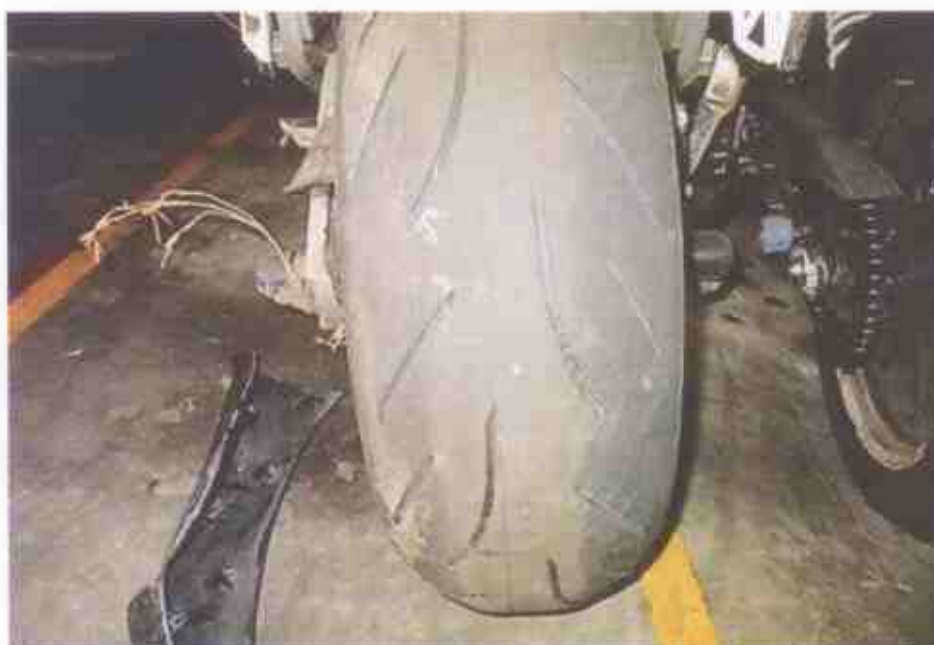
Photo 12 shows the condition of the Motorcycle's rear tyre. The rear tyre was observed to be in serviceable condition with remaining tread depth of approximately 4mm. The tyre was also observed to be sufficiently inflated for vehicular operation. We did not observe any tear, burst mark(s) and/or punctured hole(s) on the sidewalls as well as across the tread of the rear tyre.

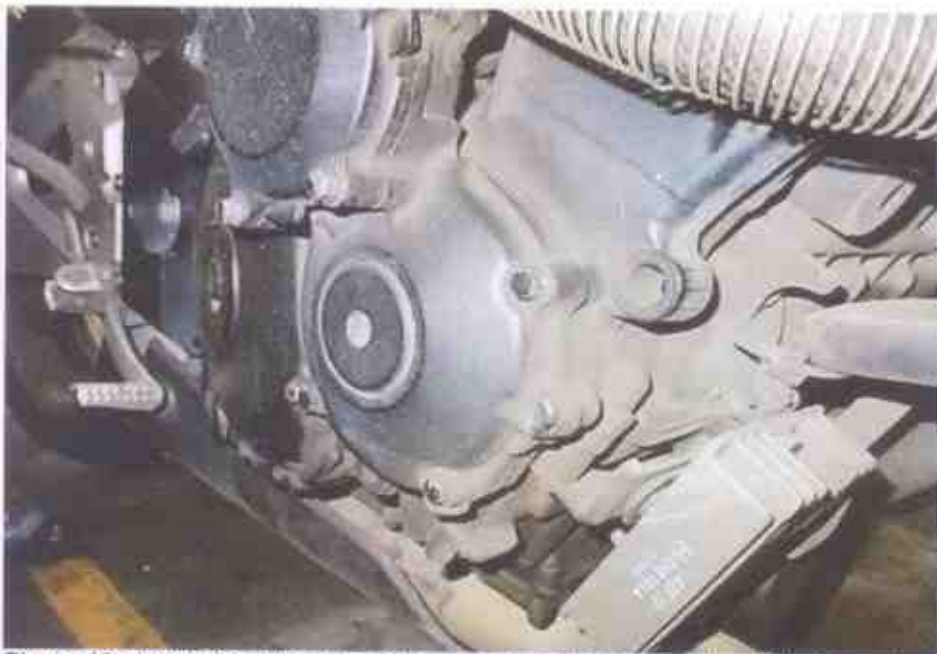
Photo 13 shows the right side of the engine of the Motorcycle at the time of our inspection. The various engine related parts and components were found to be intact with no visible damage. There was also no sign(s) or indication(s) of fluid leak observed around the right engine area of the Motorcycle.

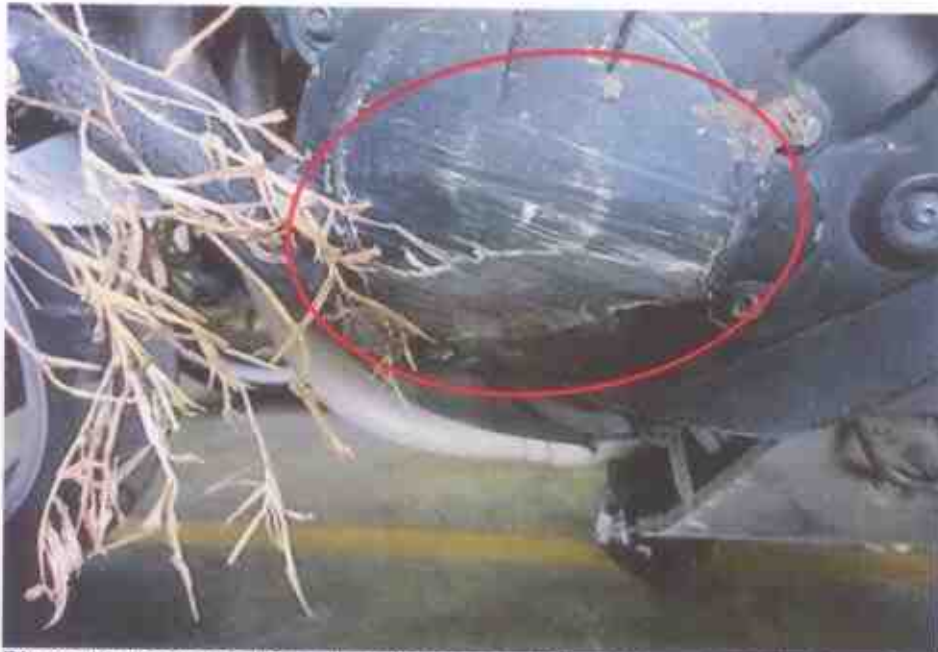
Photo 14 shows the left side of the engine of the Motorcycle at the time of our inspection. The various left engine components had sustained damage of grazing nature as a result of the accident (circled) however the engine components were still intact. There was also no fluid leak and/or fluid stain found around the left engine area of the Motorcycle.

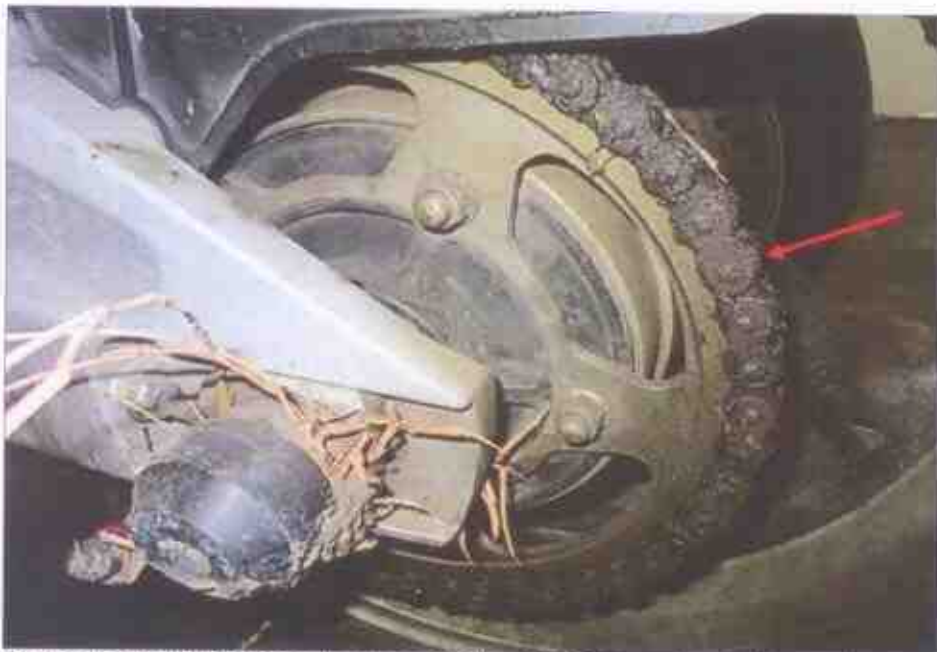
Photo 15 shows the gear chain (arrowed) of the Motorcycle, which was observed to be intact with no misalignment. It was also adequately lubricated for operating purposes. The gear chain rotates the rear wheel of the Motorcycle.

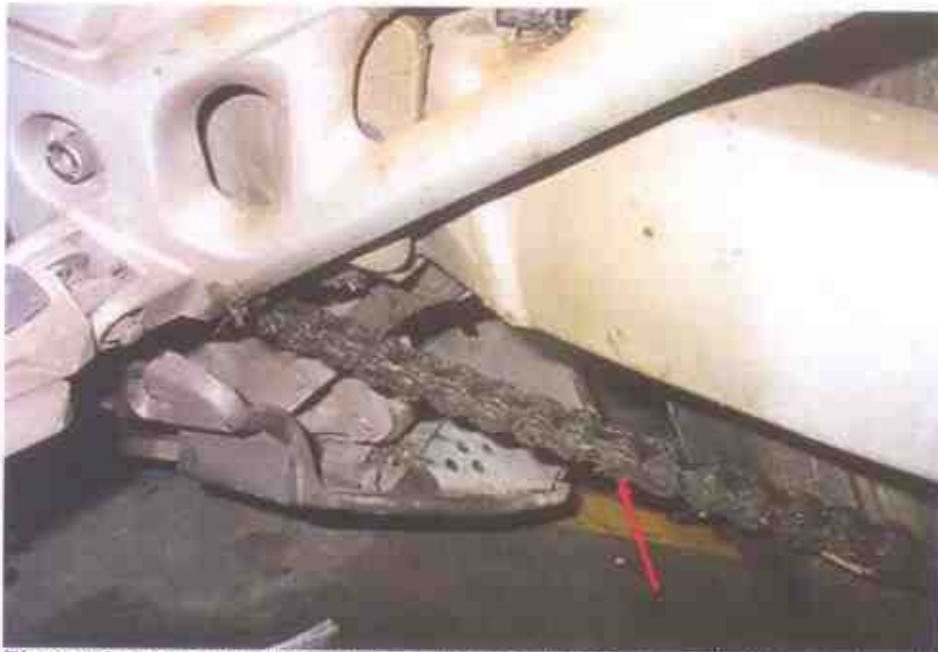
Photo 16 shows the closer view of the gear chain (arrowed) of the Motorcycle, which was observed to be intact with no misalignment. It was also adequately lubricated for operating purposes.

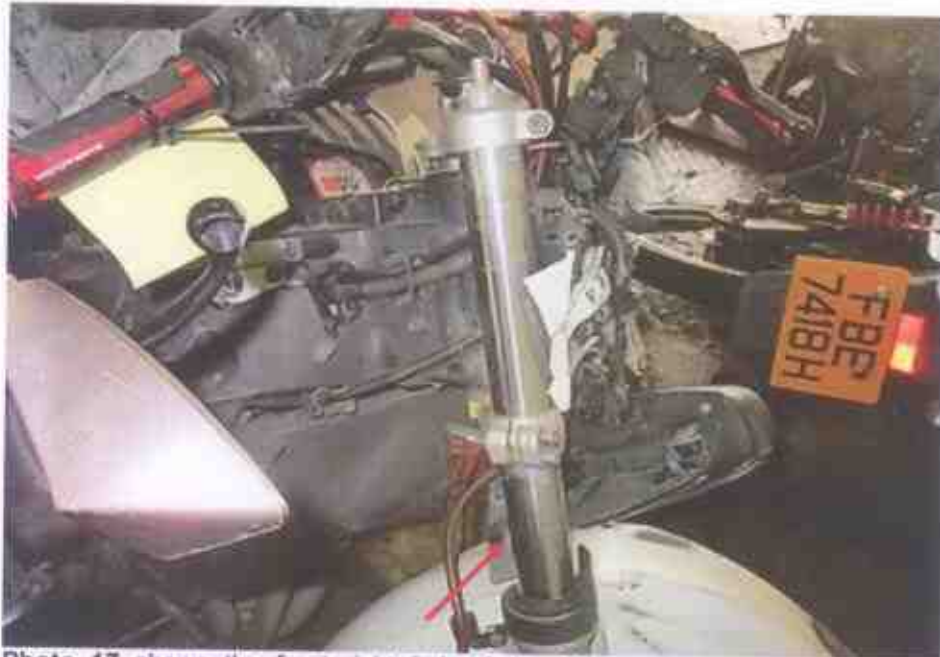
10. For this case, we were not able to conduct any test(s) on the steering system of the Motorcycle due to the damage of its front fork. The front fork was found to be bent inwards as a result of the accident.

Photo 17 shows the front right fork of the Motorcycle. The front right fork (arrowed) was observed to be bent inwards as a result of the accident. We were hence not able to conduct any tests on the steering system of the Motorcycle.

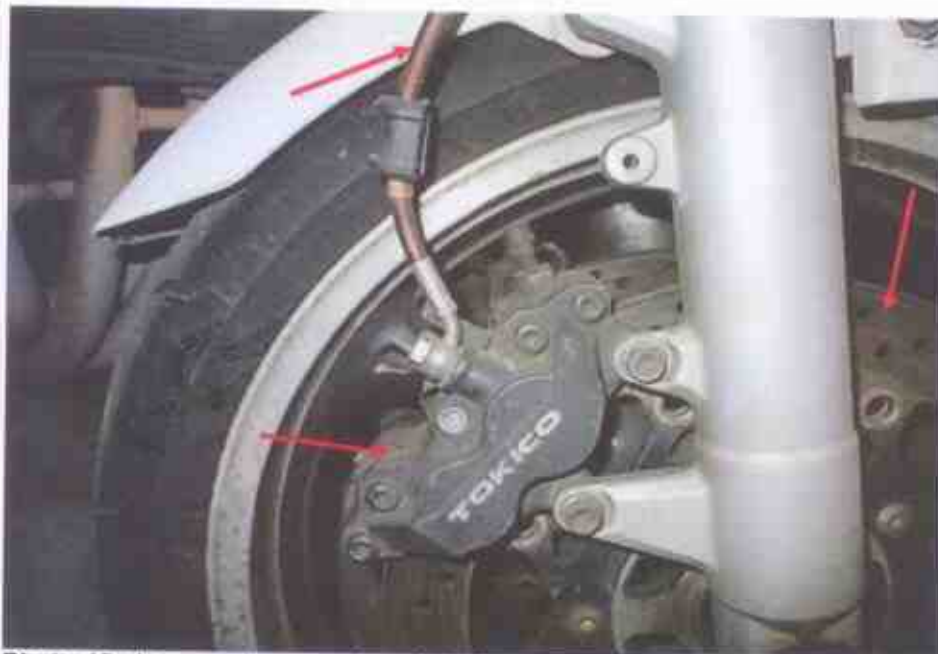
Photo 18 shows a close up view of the front brake caliper, front brake disc and front brake hose (arrowed) of the Motorcycle, which are all part of the components in the hydraulic front brake system of the Motorcycle. Our visual checks of these various components had revealed all to be intact with no visible damage. No leakage of brake fluid was also observed.

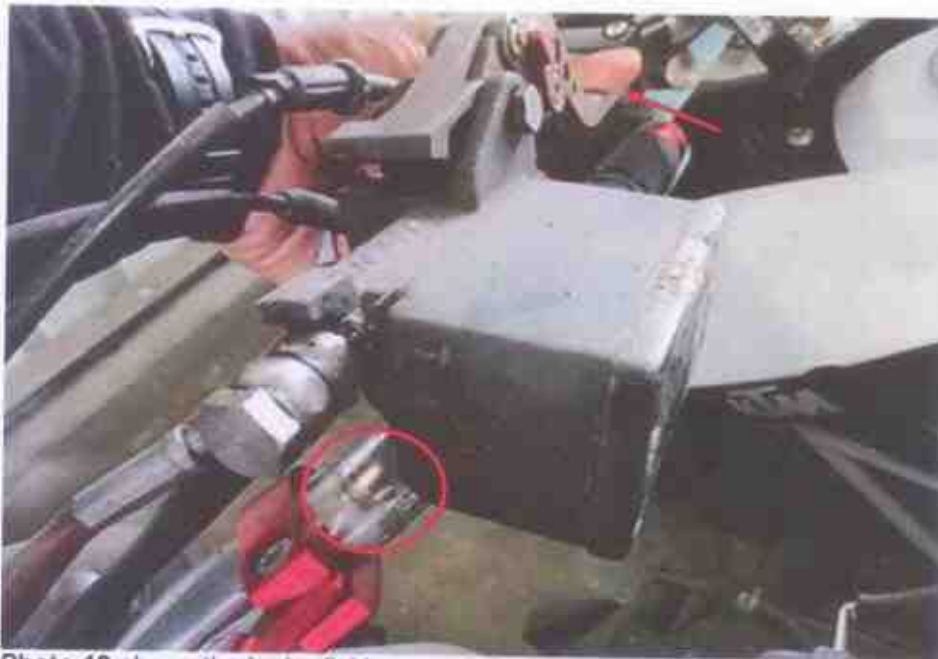
13. Our visual examination of the various components in the Motorcycle's braking system like the brake discs, brake calipers, brake lever, brake foot pedal and brake hoses revealed all to be intact and without damage. The brake fluid for the front brake and rear brake was also found to be of sufficient level and without any contamination. There was no leakage of brake fluid observed along the brake hoses. This was from the respective brake fluid reservoirs to the front brake caliper and rear brake caliper of the Motorcycle. However a leakage of brake fluid from the front brake fluid reservoir was observed when the front brake lever was depressed. The leakage of brake fluid from the front brake fluid reservoir could have been due to the accident as the front brake fluid reservoir was found to be bent inwards causing a crack to the front brake fluid reservoir.

Photo 19 shows the brake fluid reservoir for the front brake of the Motorcycle. A leakage of brake fluid from the front brake fluid reservoir was observed (circled) when the front brake lever was depressed (arrowed).

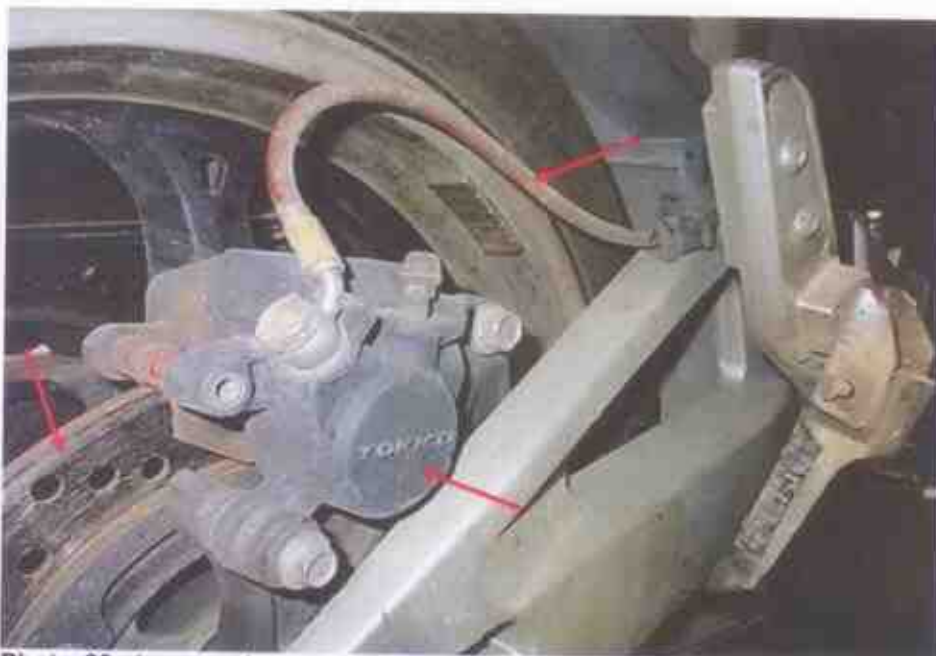
14. Static brake tests conducted on the Motorcycle had appear to indicate that the rear brake system of the Motorcycle was in serviceable condition. There was some resistance felt (spongy like feel) upon pressing the brake pedal. This would indicate that there no leakage of pressure/vacuum in the brake system. Our checks on the brake fluid had also indicated that the brake fluid was of sufficient level for operational purposes, and without contamination.

Photo 20 shows a close up view of the rear brake caliper, rear brake disc and rear brake hose (arrowed) of the Motorcycle, which are all part of the components in the hydraulic rear brake system of the Motorcycle. Our visual checks of these various components revealed all to be intact with no visible damage. No leakage of brake fluid was also observed.
