Your Ref: TP/IP/05309/2019
Our Ref :CI/TPD19004308/N

Fatal Accident Investigation Team

INSPECTION REPORT OF MOTORCYCLE FBJ 1912K

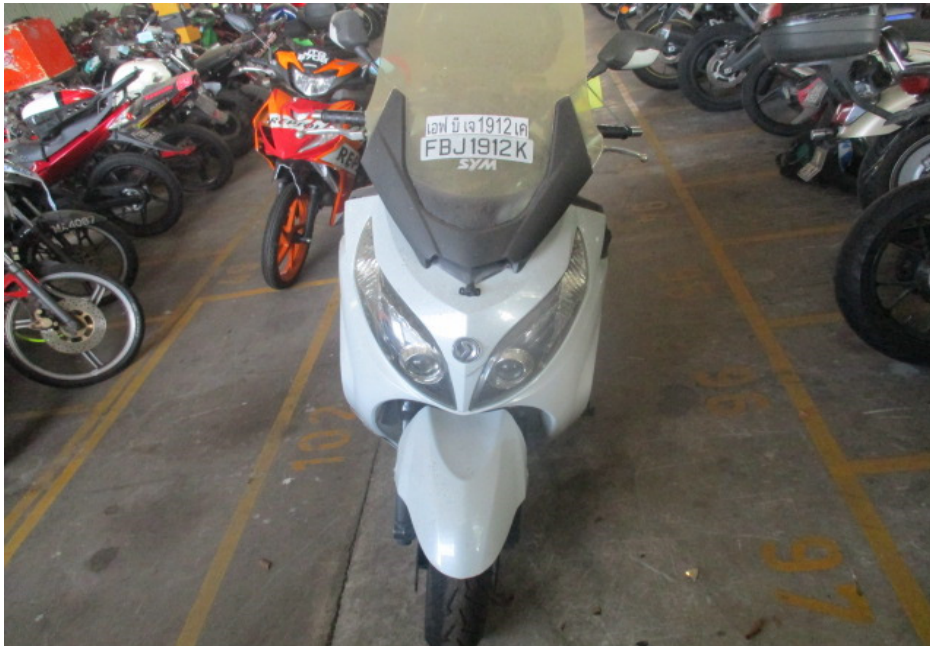
Photo 1 shows a general view of the front body of the Motorcycle at the time of our inspection. The Motorcycle was observed to have sustained minor damages at the frontal and right portion. The body parts that were found to have been damaged include its front windshield, front brake lever, right cowling, right rear side cover, right pillion foot rest and exhaust muffler, amongst others as a result of the accident.

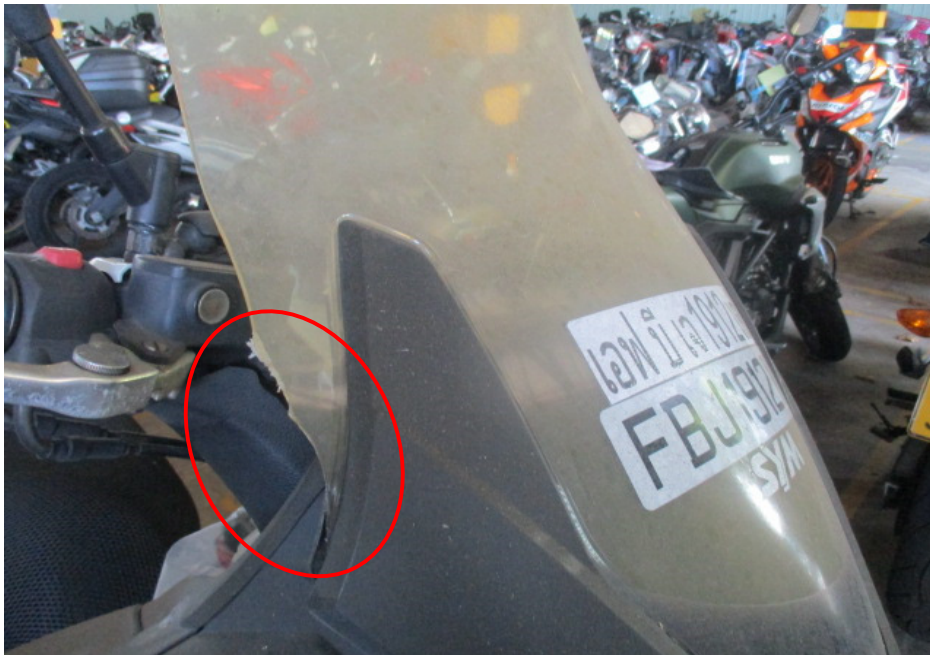
Photo 2 shows a closer view of the front windshield (circled) which was amongst the body parts at the front body of the Motorcycle that had sustained damage as a result of the accident.

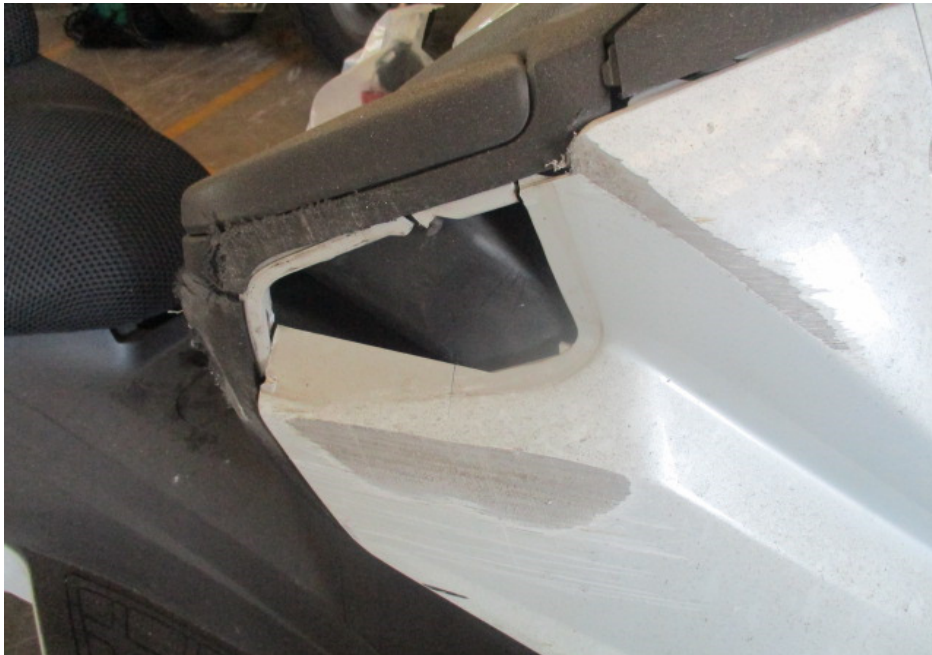
Photo 3 shows a closer view of the right cowling which was amongst the body parts at the front body of the Motorcycle that had sustained damage as a result of the accident.

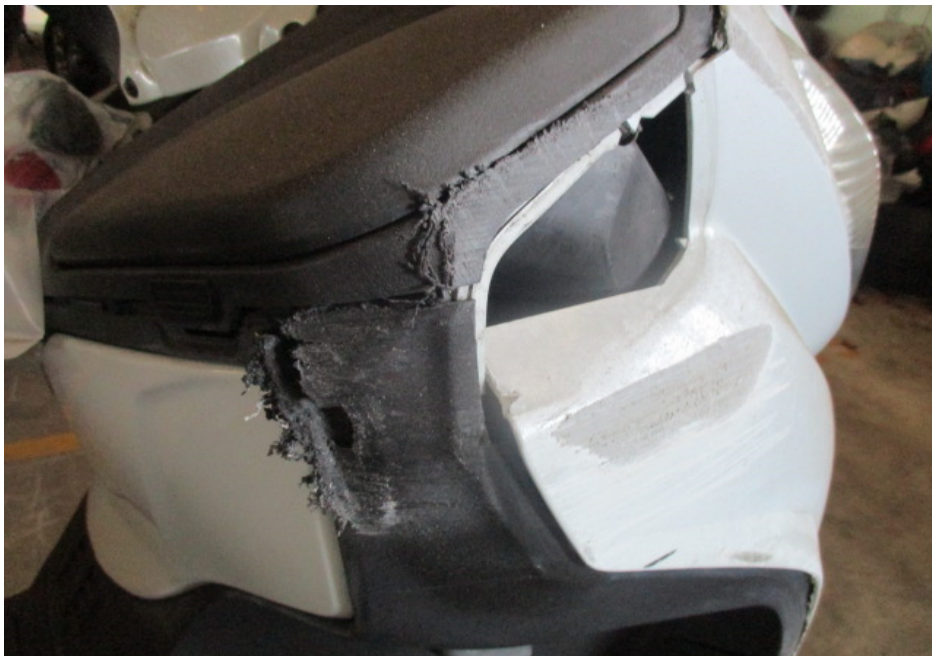
Photo 4 shows a closer view of the right inner cowling which was amongst the body parts at the front body of the Motorcycle that had sustained damage as a result of the accident.

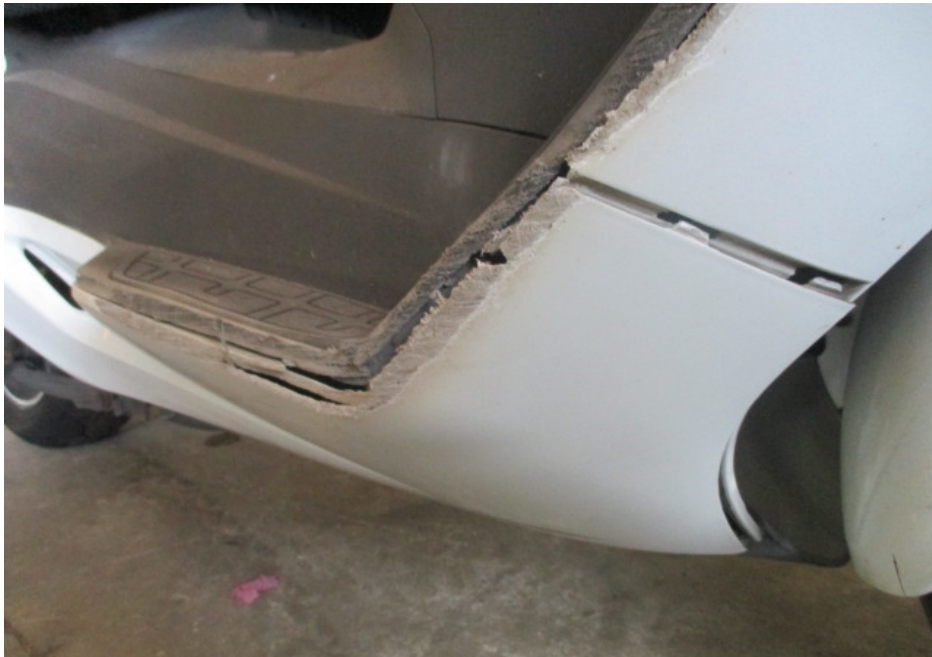
Photo 5 shows a closer view of the right bottom cowling of the Motorcycle which was observed to be damaged due to the accident.

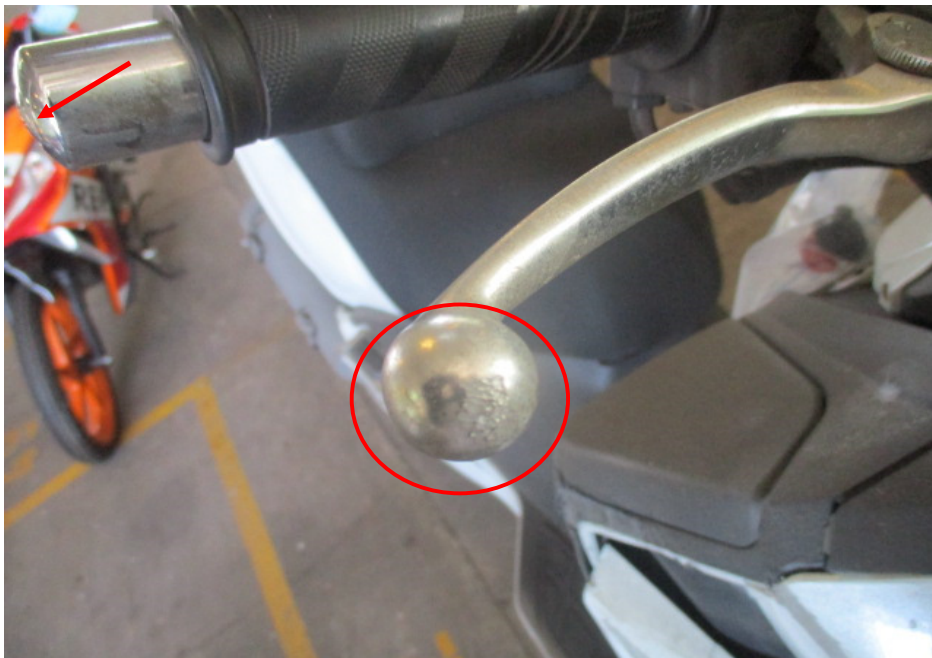
Photo 6 shows a closer view of the front brake lever (circled) and right handlebar end (arrowed) of the Motorcycle which were observed to be damaged due to the accident

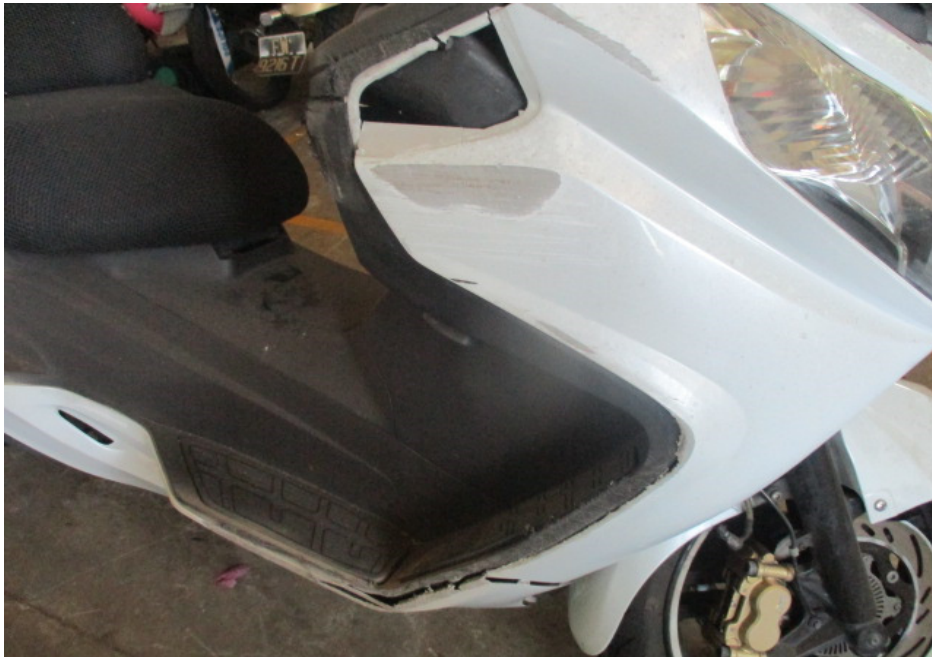
Photo 7 shows a close-up view of the right front portion of the Motorcycle at the time of our inspection. The right cowling sustained damages of grazing nature due to the accident.

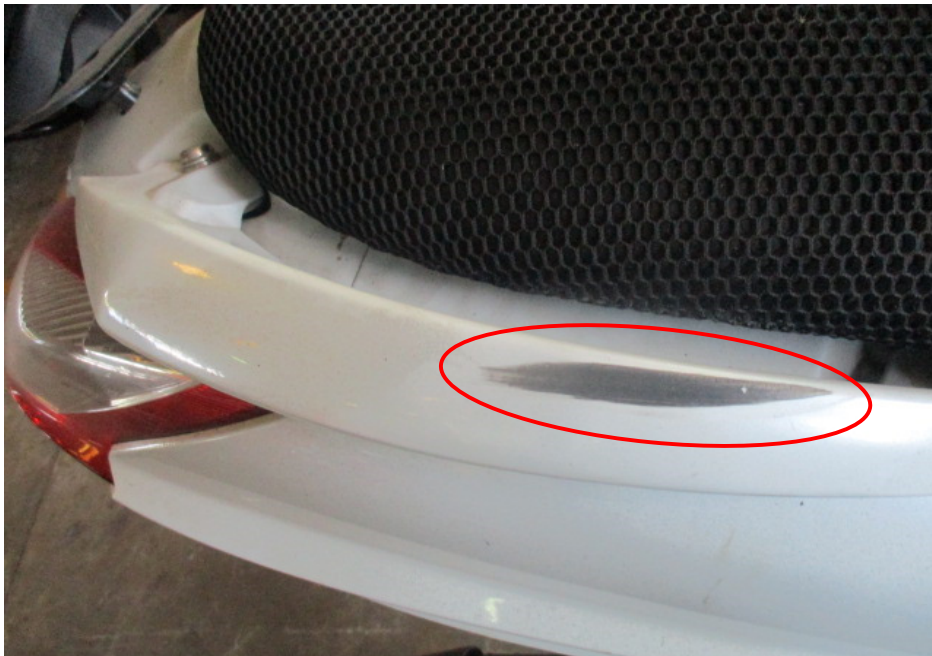
Photo 8 shows the damaged right pillion grab rail of the Motorcycle. The damage sustained was mainly of grazing nature (circled).

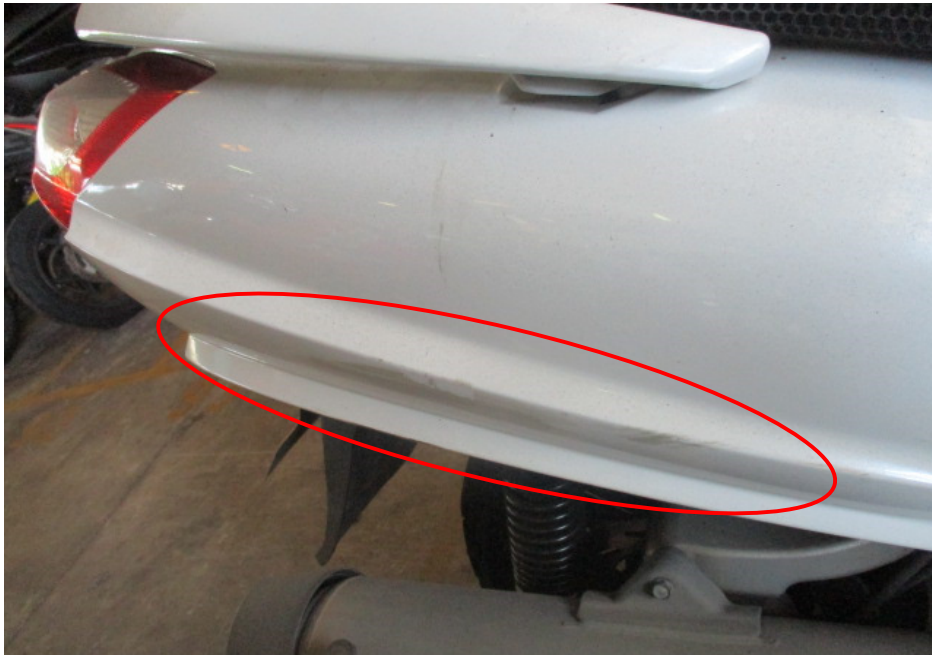
Photo 9 shows a closer view of the damaged right rear side cover of the Motorcycle which was observed to have sustained scratches due to the accident (circled).

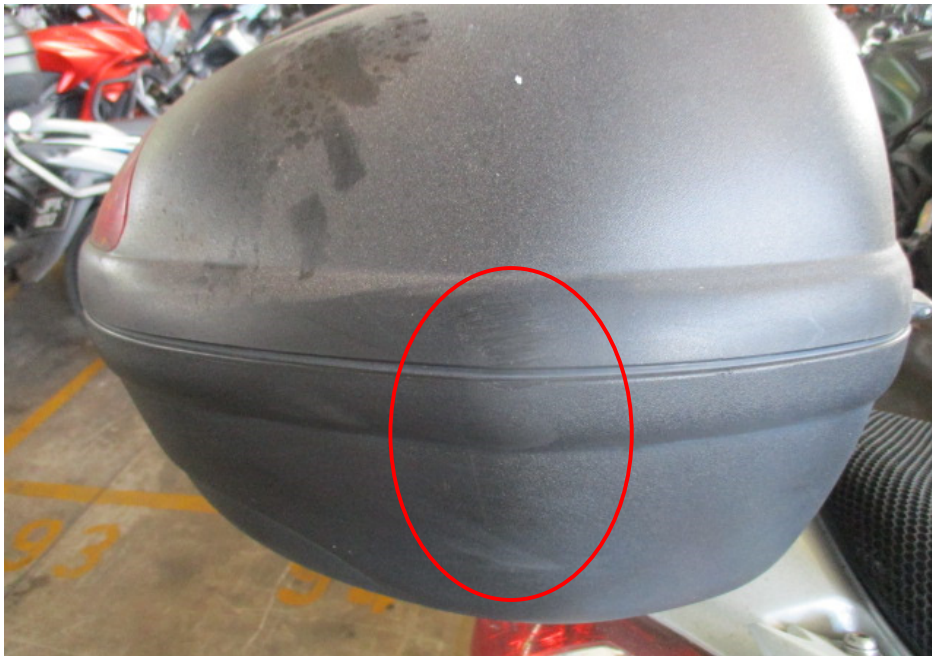
Photo 10 shows a closer view of the top box of the Motorcycle which was observed to have sustained scratches due to the accident (circled).

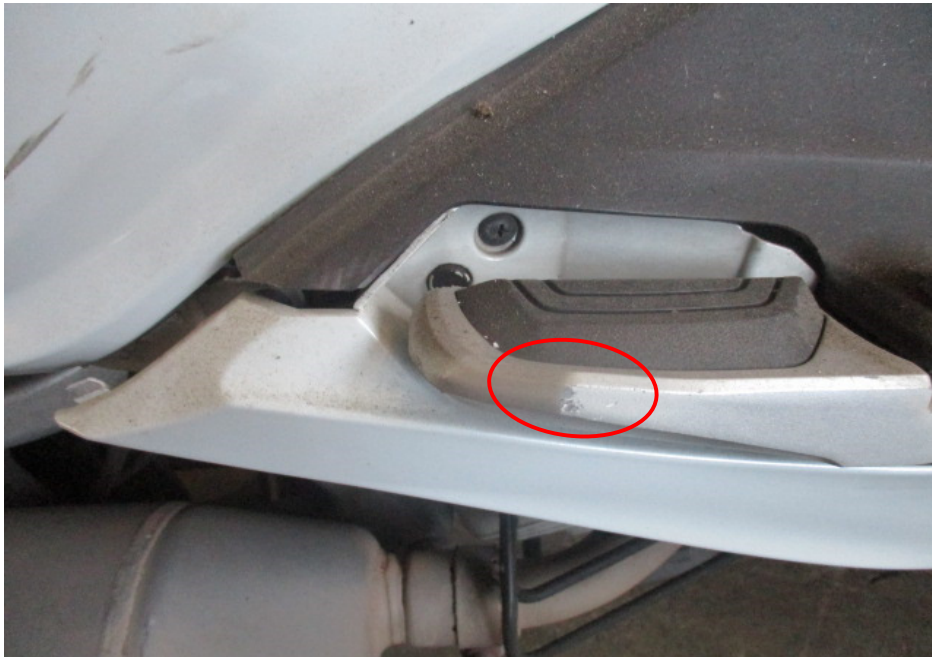
Photo 11 shows a closer view of the damaged right pillion footrest (circled) of the Motorcycle at the time of our inspection.

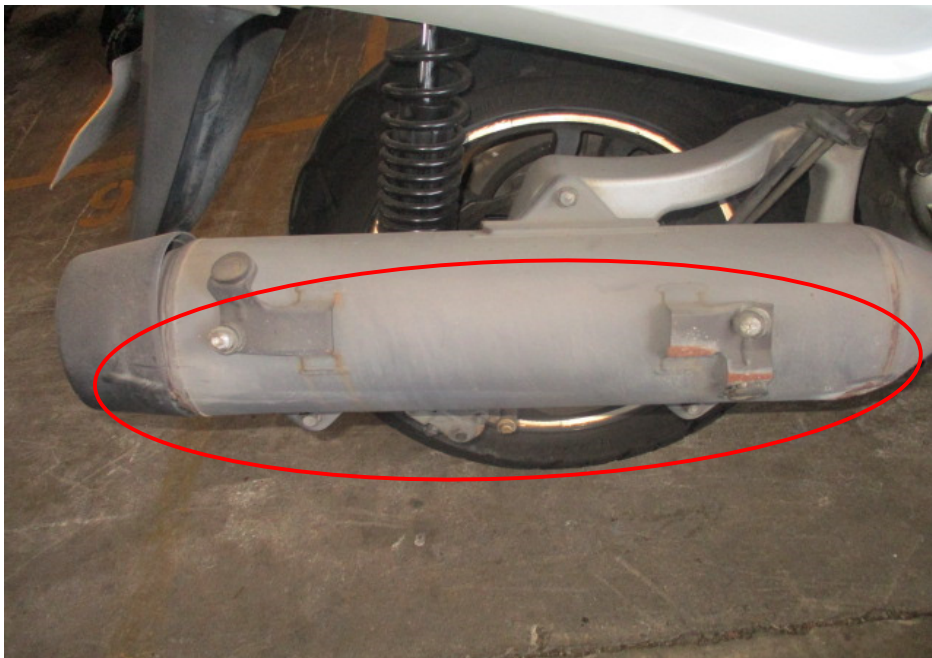
Photo 12 shows a closer view of the exhaust muffler of the Motorcycle which had sustained damage due to the accident (circled).

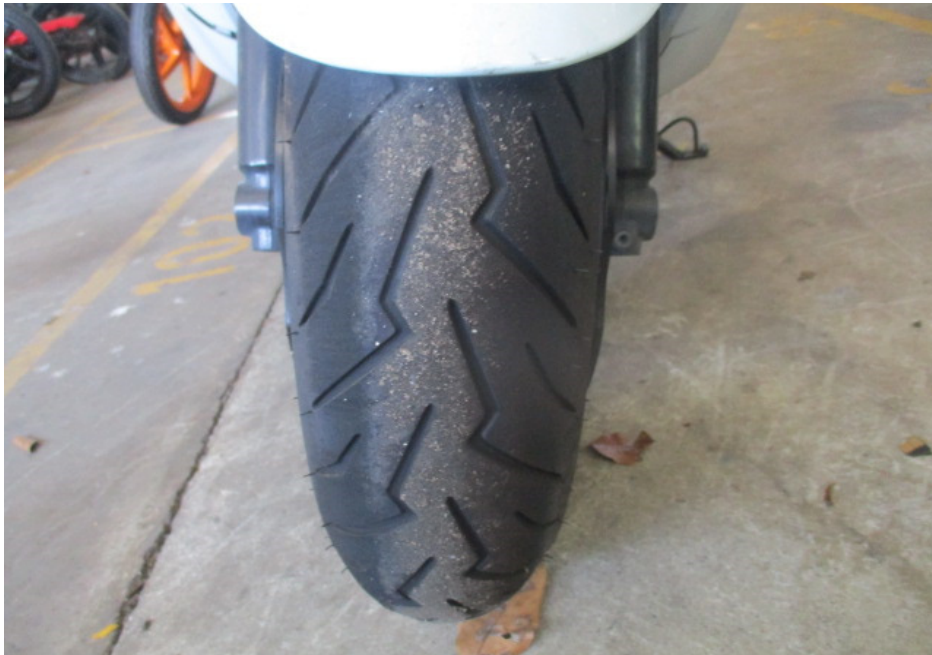
Photo 13 shows the condition of the Motorcycle's front tyre. The front tyre was observed to be in serviceable condition with remaining tread depth of approximately 3mm. There was no tear, burst mark(s) and/or punctured hole(s) on the sidewalls as well as across the tread of the front tyre.

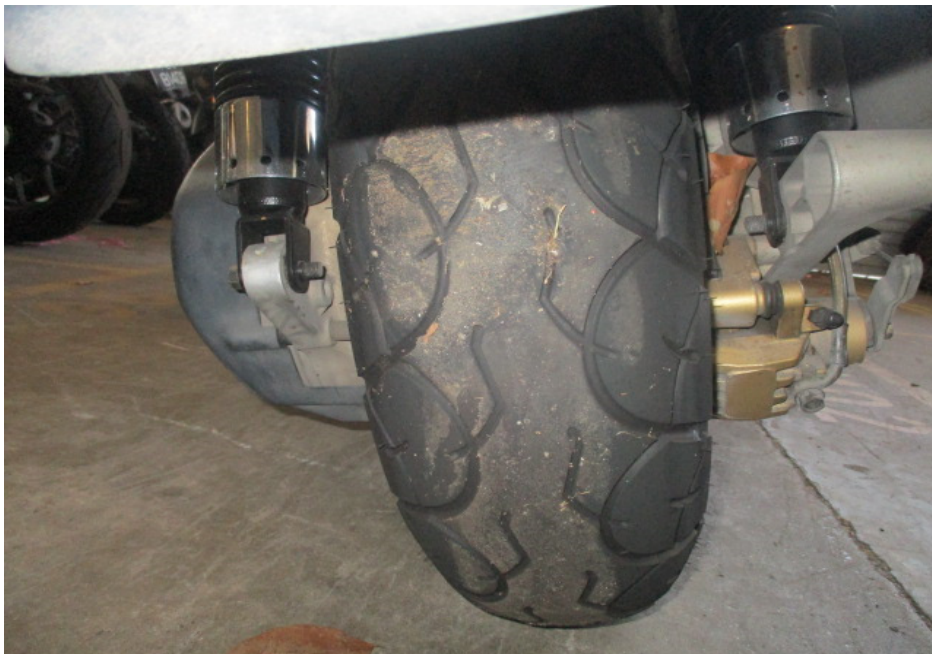
Photo 14 shows the condition of the Motorcycle's rear tyre. The rear tyre was observed to be in serviceable condition with remaining tread depth of approximately 3mm. The tyre was also observed to be sufficiently inflated for vehicular operation. We did not observe any tear, burst mark(s) and/or punctured hole(s) on the sidewalls as well as across the tread of the rear tyre.

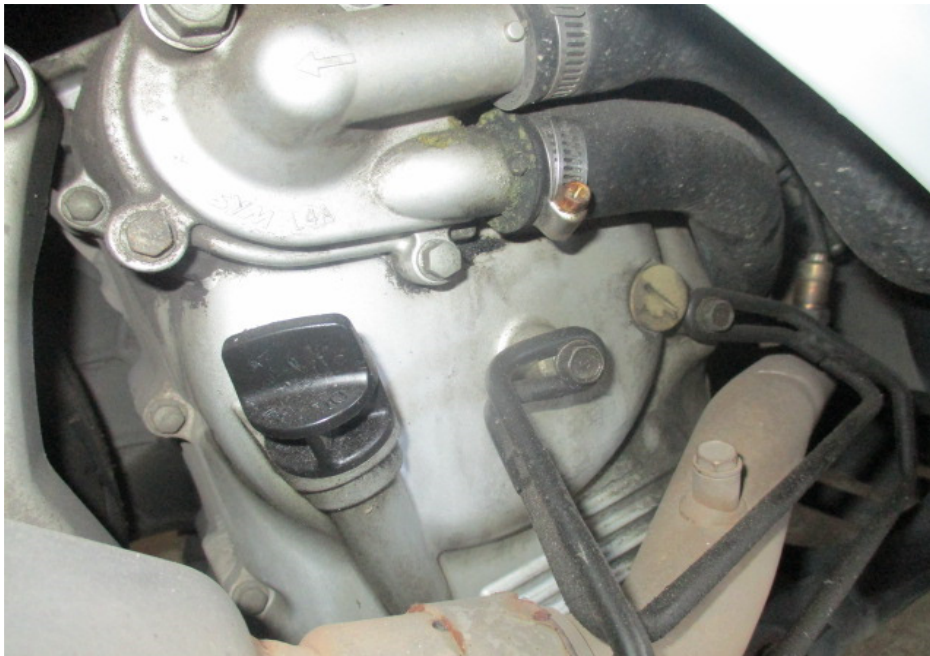
Photo 15 shows the right side of the engine of the Motorcycle at the time of our inspection. The various engine related parts and components were found to be intact with no visible damage. There was also no sign(s) or indication(s) of fluid leak observed around the right engine area of the Motorcycle.

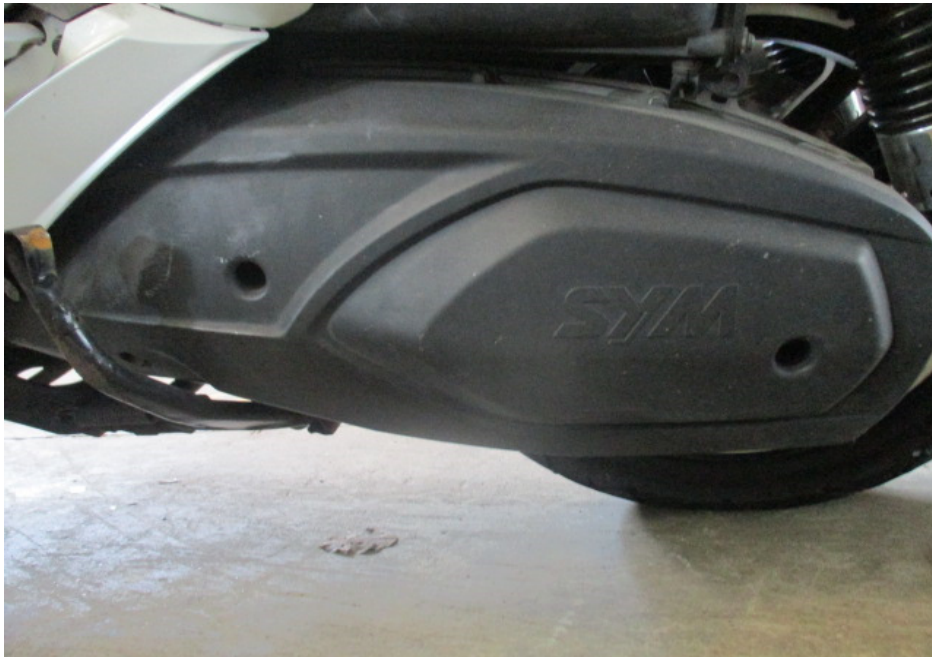
Photo 16 shows the drive train of the Motorcycle which was found to be intact without any misalignment.

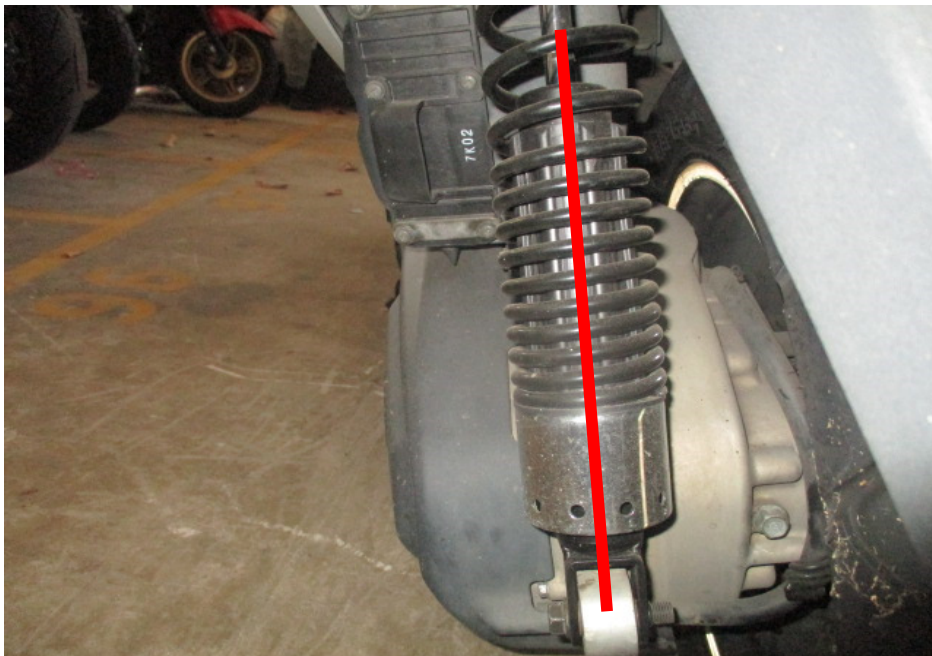
Photo 17 shows the left shock absorber of the motorcycle was found to be intact without any misalignment.

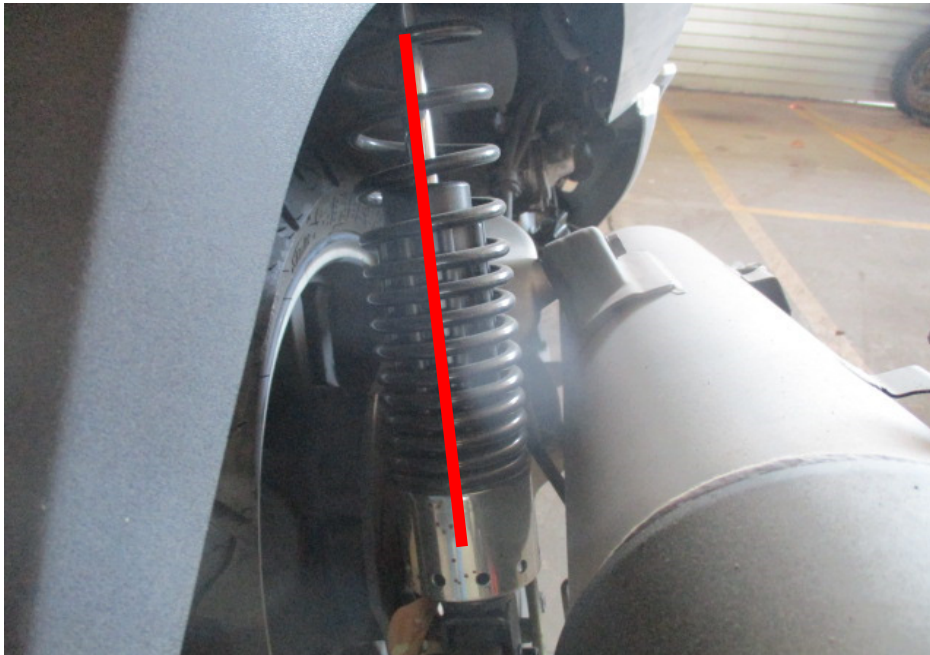
Photo 18 shows the right shock absorber of the motorcycle was found to be intact without any misalignment.

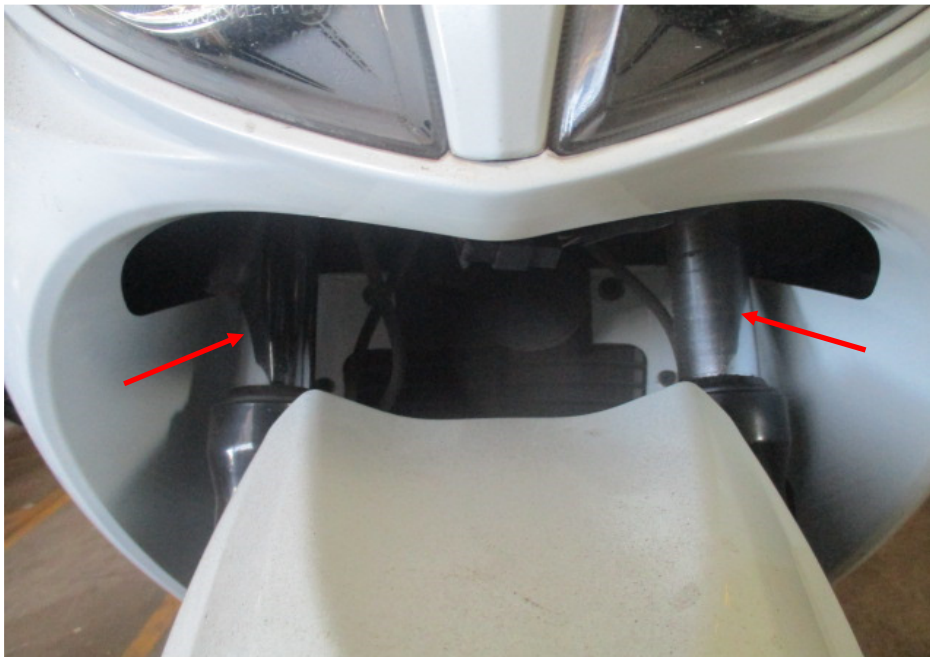
Photo 19 shows the front forks (arrowed) of the Motorcycle. The front forks and fork brackets of the Motorcycle were both found to be intact and undamaged. Turning the Motorcycle's handle bar towards the left and right did not produce any abnormal free play and/or resistance. The steering system of the Motorcycle was in serviceable condition at the time of our inspection.

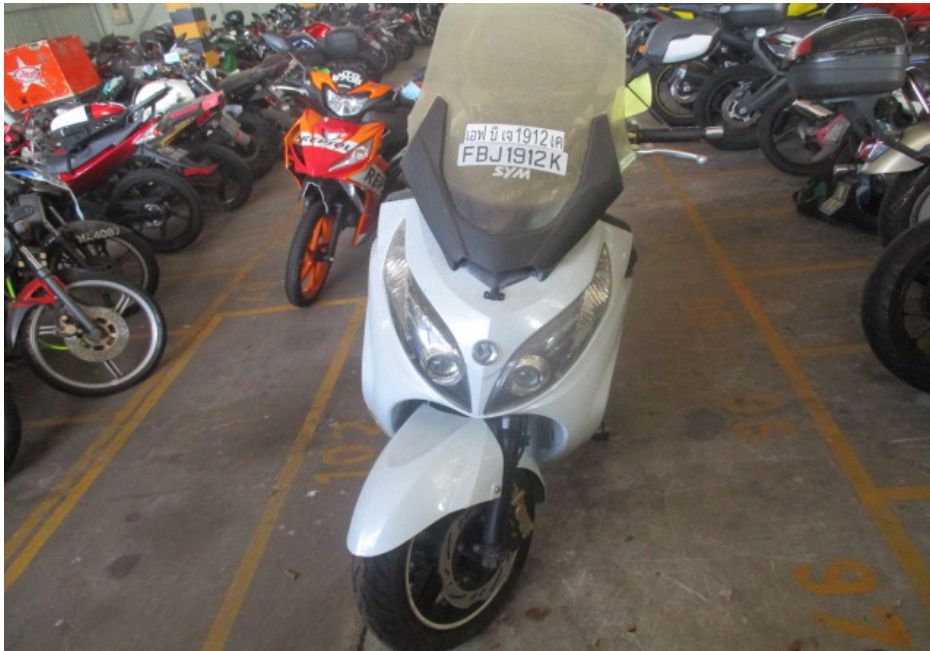
Photo 20 shows the front wheel of the Motorcycle turned towards its full right. Turning the Motorcycle's handle bar towards the left and right did not produce any abnormal free play and/or resistance. This would indicate that the steering system of the Motorcycle was in serviceable condition at the time of our inspection.

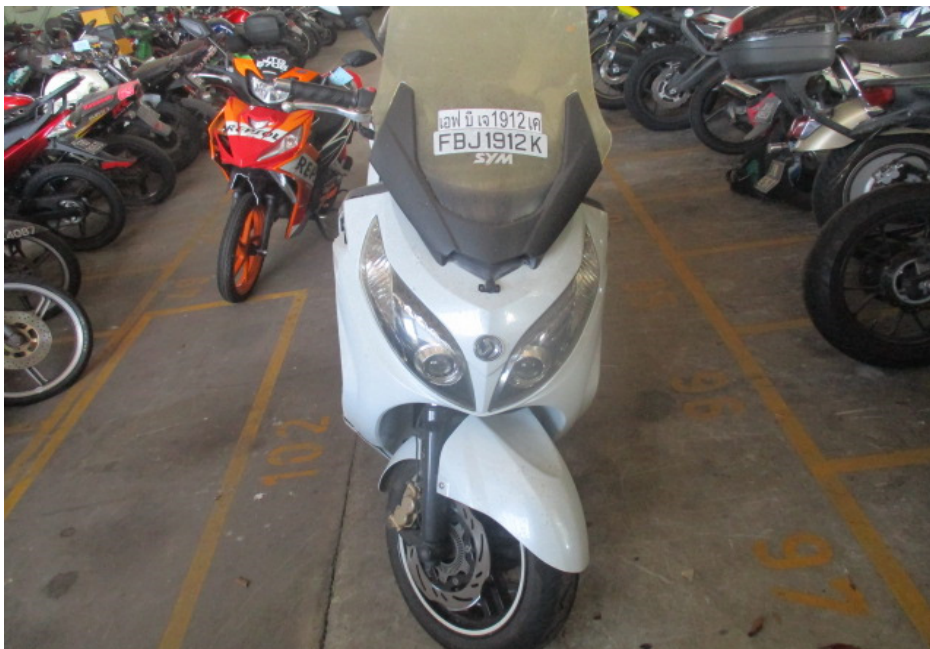
Photo 21 shows the front wheel of the Motorcycle turned towards its full left. Turning the Motorcycle's handle bar towards the left and right did not produce any abnormal free play and/or resistance. This would indicate that the steering system of the Motorcycle was in serviceable condition at the time of our inspection.

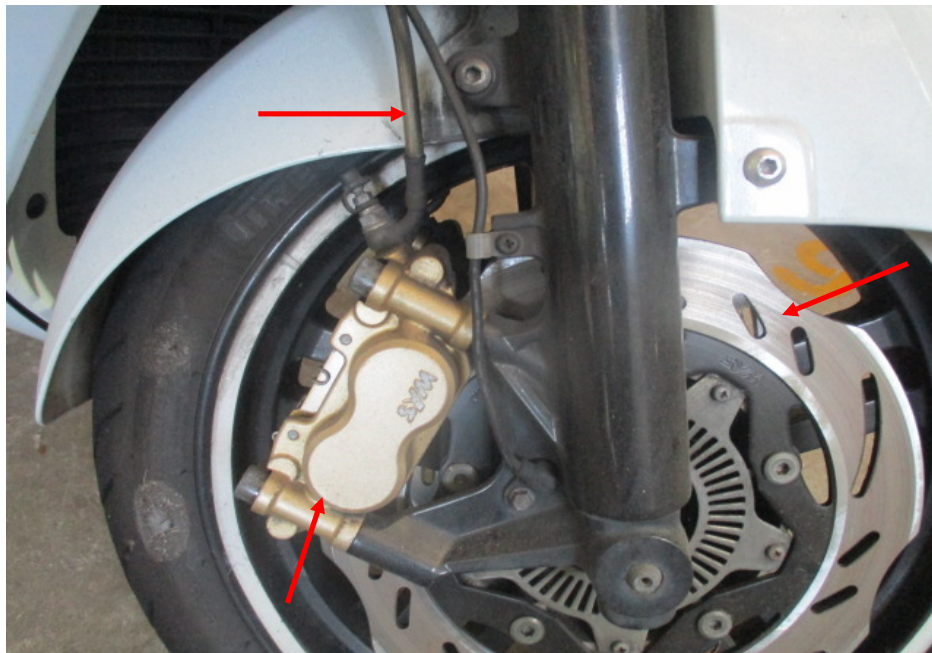
Photo 22 shows a close up view of the front brake caliper, front brake disc and front brake hose (arrowed) at the right side of the Motorcycle's front wheel, which are all part of the components in the hydraulic front brake system of the Motorcycle. Our visual checks of these various components had revealed all to be intact with no visible damage. No leakage of brake fluid was also observed.

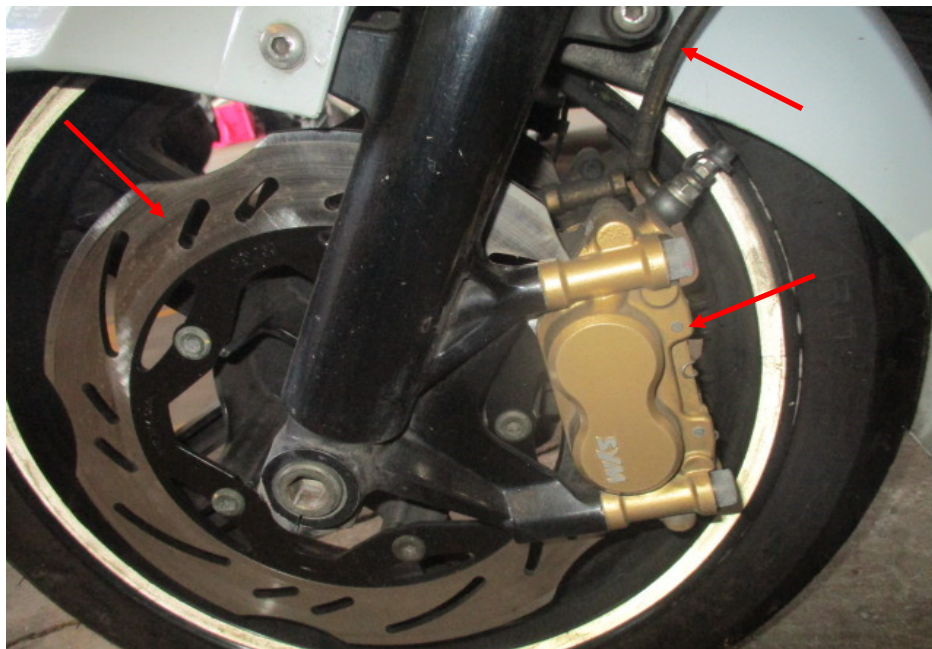
Photo 23 shows a close up view of the front brake caliper, front brake disc and front brake hose (arrowed) at the left side of the Motorcycle's front wheel, which are all part of the components in the hydraulic front brake system of the Motorcycle. Our visual checks of these various components had revealed all to be intact with no visible damage. No leakage of brake fluid was also observed.

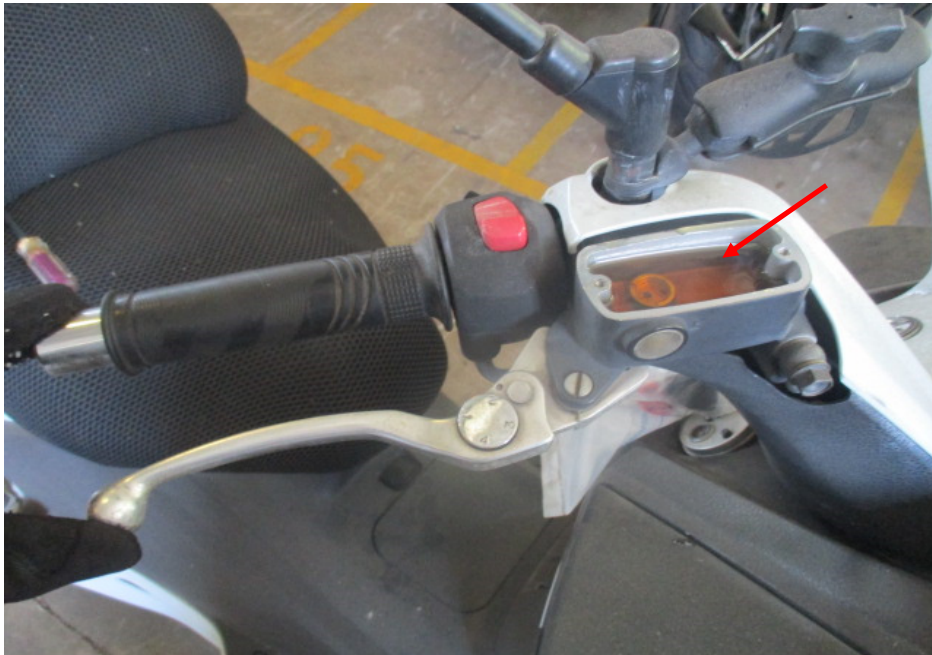
Photo 24 shows the brake fluid reservoir for the front brake of the Motorcycle. The brake fluid was observed to be of sufficient level and without contamination for operational purposes (arrowed).

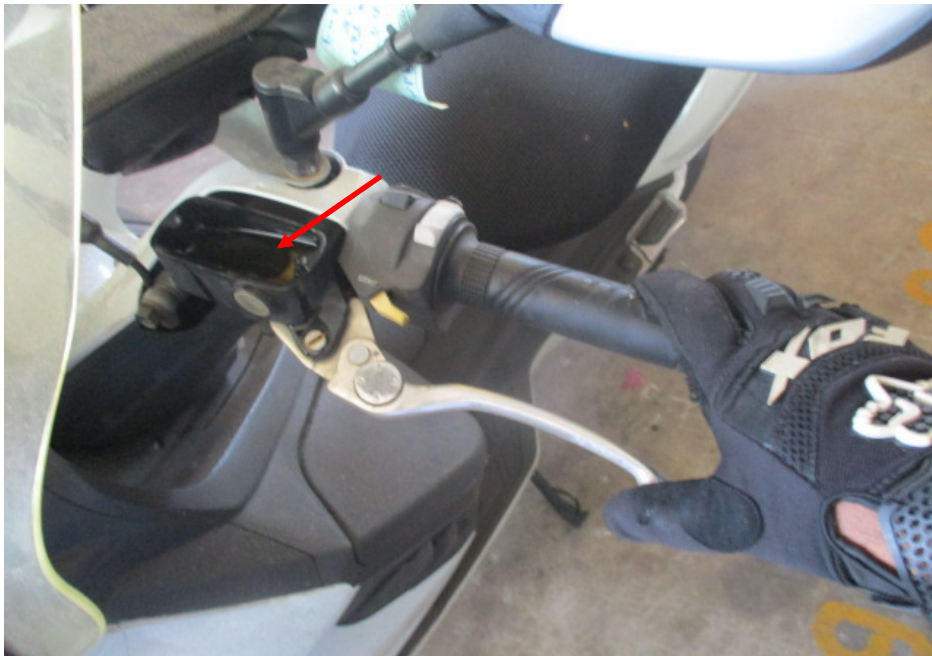
Photo 25 shows the brake fluid reservoir for the rear brake of the Motorcycle. The brake fluid was observed to be of sufficient level and without contamination for operational purposes (arrowed).

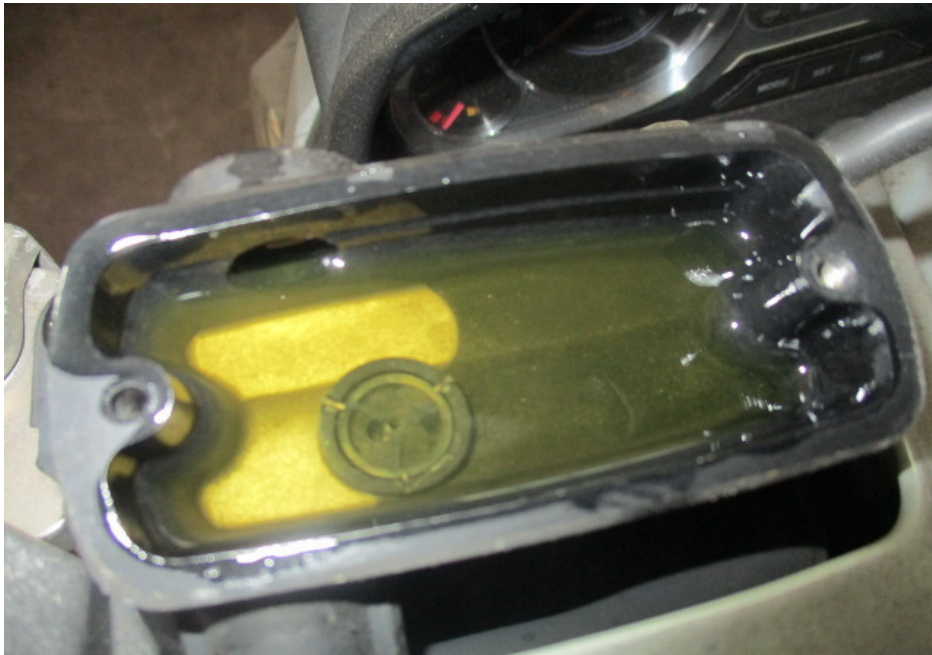
Photo 26 shows a close up view of the brake fluid reservoir for the rear brake of the Motorcycle. The brake fluid was observed to be of sufficient level and without contamination for operational purposes.

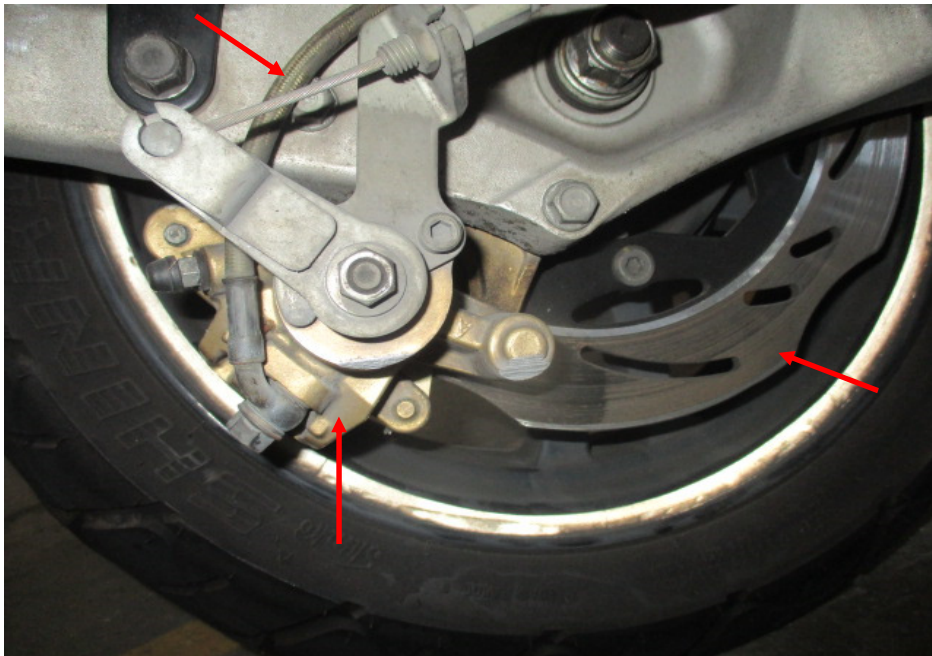
Photo 27 shows a close up view of the rear brake caliper, rear brake disc and rear brake hose (arrowed) of the Motorcycle, which are all part of the components in the hydraulic rear brake system of the Motorcycle. Our visual checks of these various components revealed all to be intact with no visible damage. No leakage of brake fluid was also observed.
