Your Ref: S9M01GF2
Our Ref : CS/ASM19004390/N

**TECHNICAL INVESTIGATION REPORT OF FIRE INCIDENT INVOLVING THE
INSURED VEHICLE SGC 2494X ON 7 MARCH 2019**

Vehicle Registration No.	: SGC 2494X
Make / Model	: Nissan Sunny 1.6EXM
Chassis No	: JN1CFAN16Z0095185
Year of Registration	: January 2006
Mileage	: N.A (wiring affected)

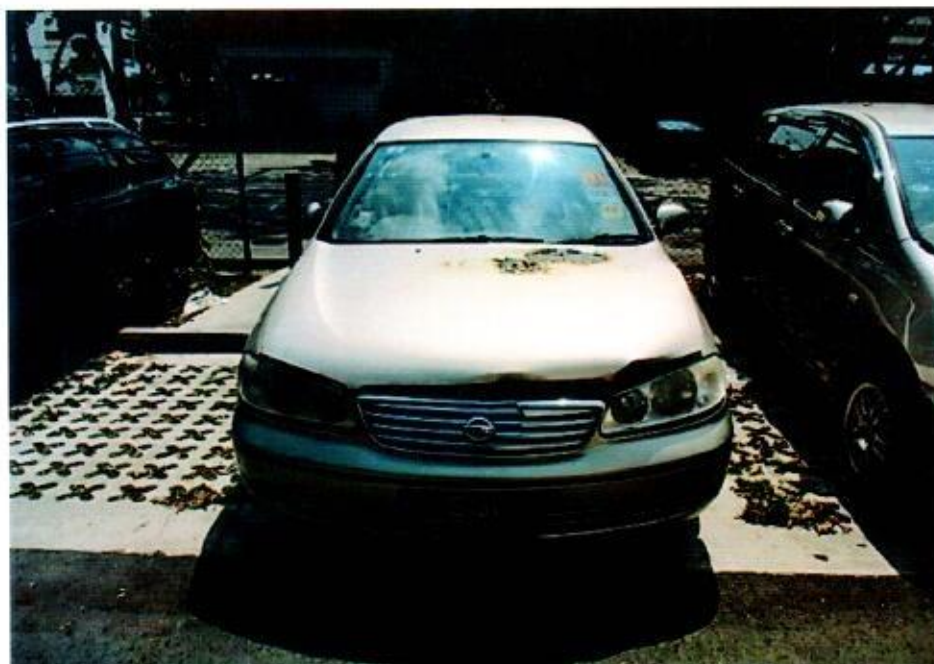
Photo 1 shows the general view of the front portion of the Insured Vehicle at the time of our inspection. The fire damage to the Insured Vehicle was confined to its front portion. Its front bonnet, front grille and front headlamps were amongst the body parts that were found to have been affected as a result of the fire.

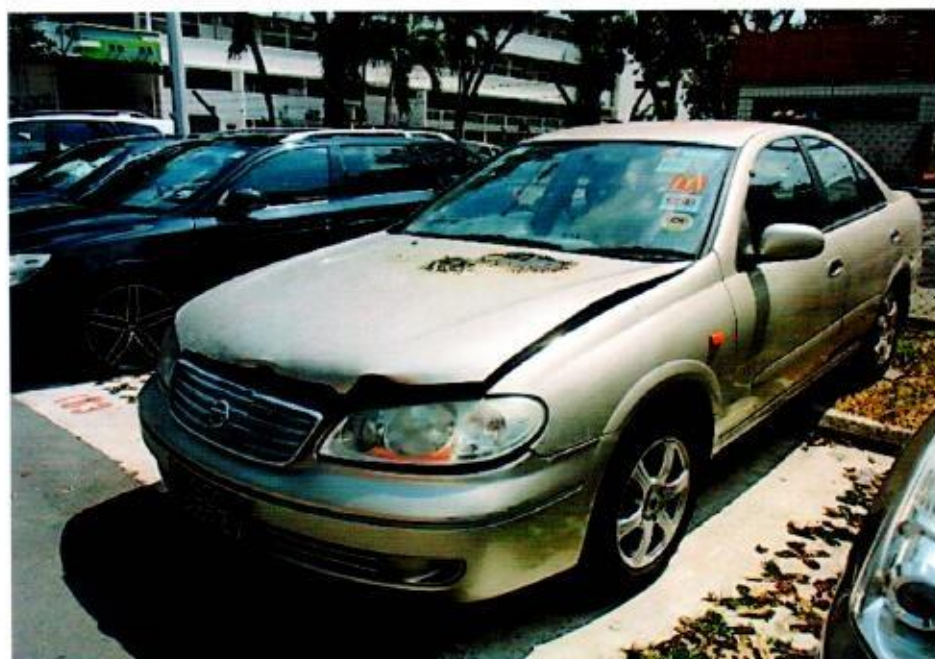
Photo 2 shows the general view of the front left portion of the Insured Vehicle at the time of our inspection. The fire damage to the Insured Vehicle was confined to its front portion. Its front bonnet, left front panel and front left headlamp were amongst the body parts that were found to have been affected as a result of the fire.

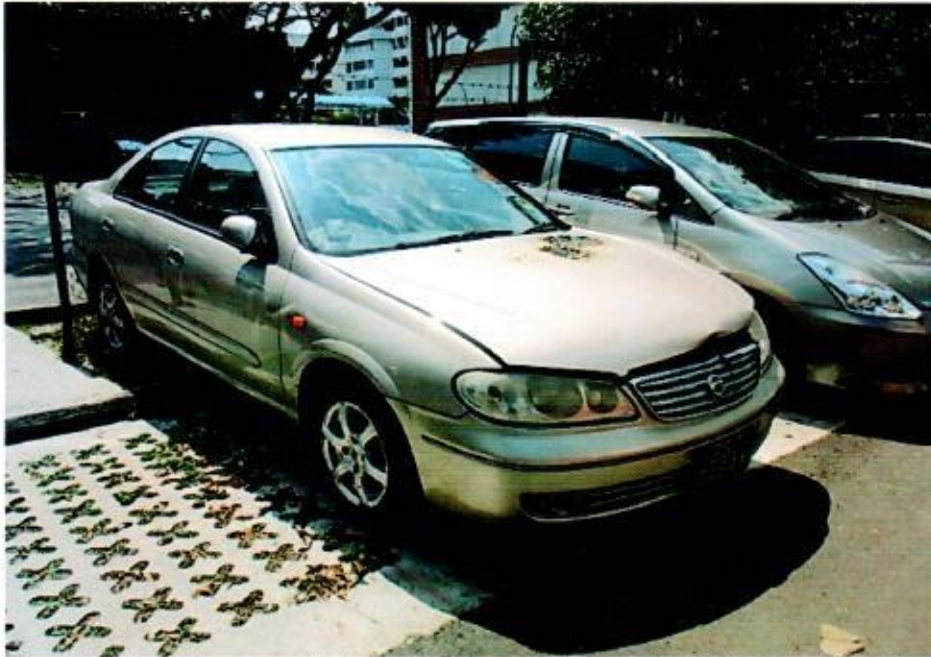
Photo 3 shows the general view of the front right portion of the Insured Vehicle at the time of our inspection. The fire damage to the Insured Vehicle was confined to its front portion. Its front bonnet and front right headlamp were amongst the body parts that were found to have been affected as a result of the fire.

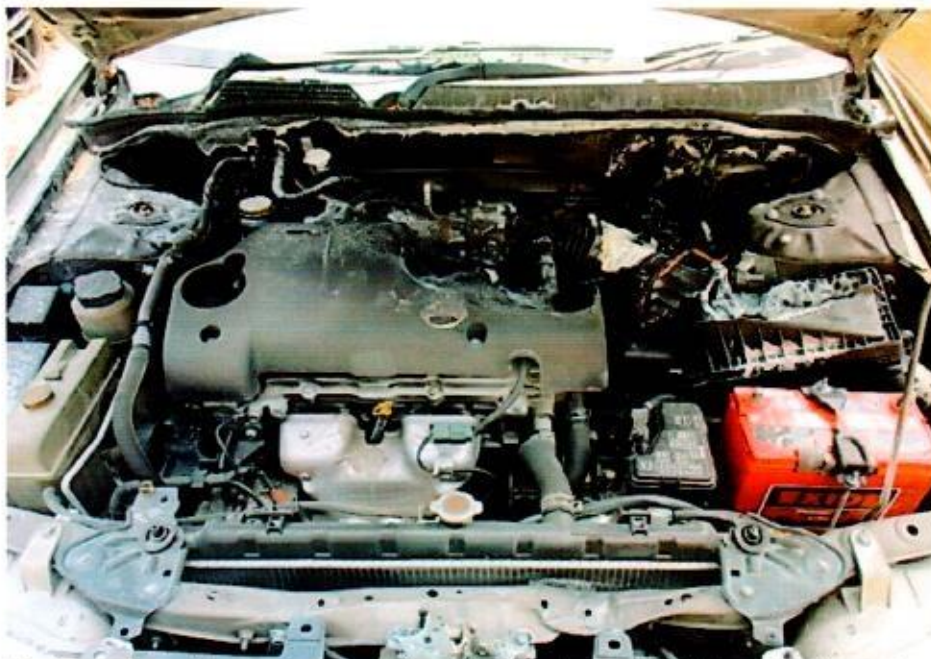
Photo 4 shows the engine compartment of the Insured Vehicle at the time of our inspection. The entire engine compartment of the Insured Vehicle was observed to be severely burnt. Most of the parts inside the engine compartment were found to be burnt and/or melted as a result of the fire.

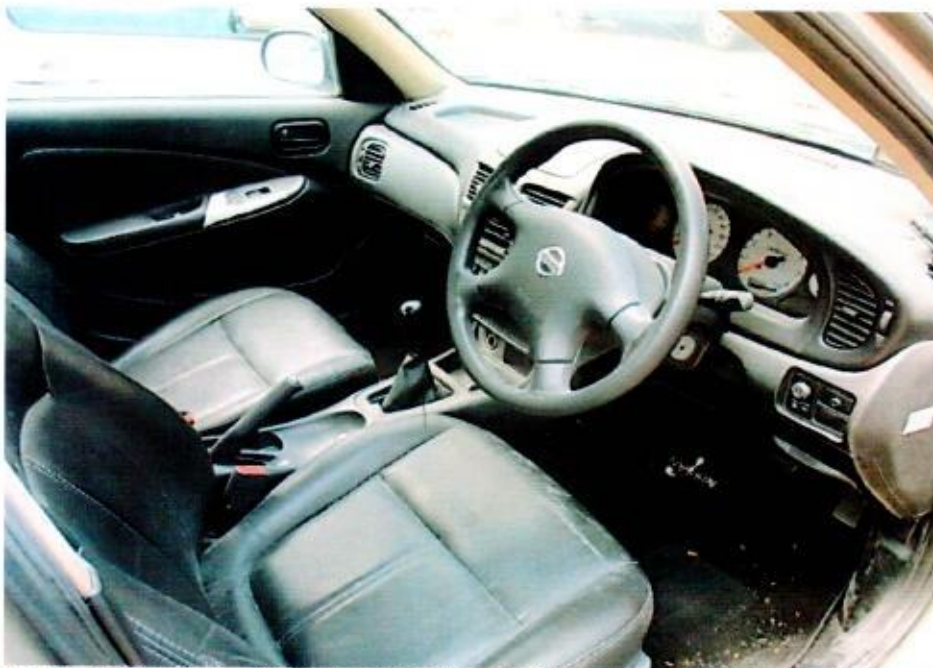
Photo 5 shows the interior compartment of the Insured Vehicle, which was observed to be relatively unaffected by the fire.

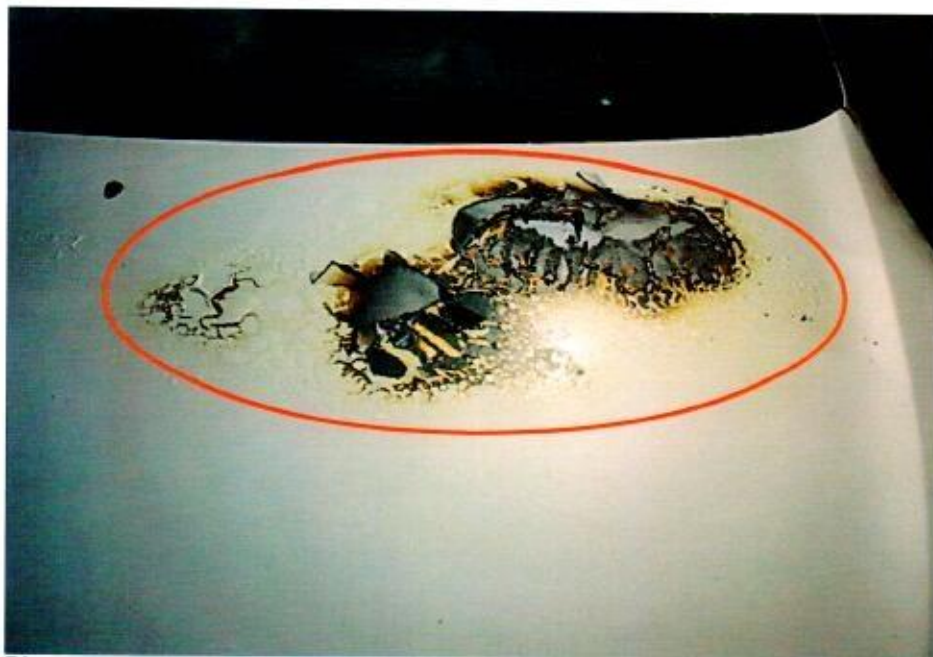
8. For this particular case, the fire appears to have originated within the engine compartment of the Insured Vehicle, somewhere around the left rear portion of the engine compartment. This can be determined from the burn pattern and paint bubbles on the left portion of the front bonnet of the Insured Vehicle as well as the rust that had developed on the underside of the front bonnet, at the left rear area.

9. The whitish burn marks are a result of exposure to prolonged heat intensity. Rust would normally start to develop around these areas soon after a fire as prolonged exposure to high heat intensity usually causes steel/metal material body parts to be exposed to natural environmental condition. The rust that had developed on the underside of the front bonnet, around the left rear area, is an indication that the left rear portion of the engine compartment had sustained exposure to prolonged high heat intensity. See photos 6 & 7 below.

Photo 6 shows the burn pattern and paint bubbles on the left portion of the front bonnet of the Insured Vehicle (circled). Such burn marks are a result of exposure to prolonged heat intensity, which may indicate where the fire had started. Rust would also begin to develop on these areas soon after the fire.

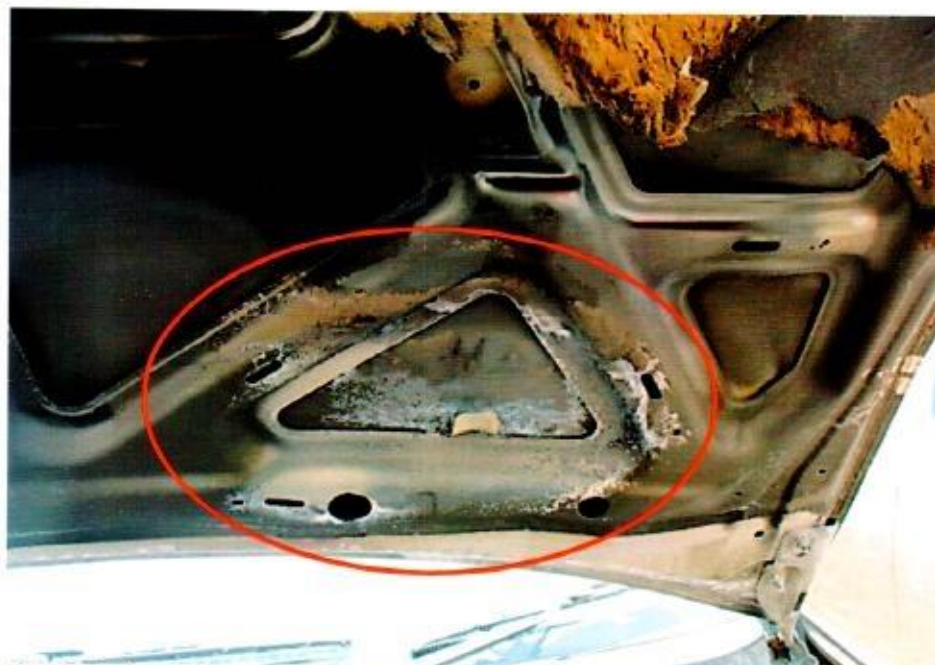
Photo 8 shows the rust that had developed on the underside of the front bonnet, around the left rear area (circled). The development of rust is an indication that the area was exposed to prolonged exposure to high heat intensity, which had caused the steel/metal material of the front bonnet to be exposed to natural environmental condition. Hence the fire to the Insured Vehicle can be determined to have originated towards the left rear portion of the engine compartment.

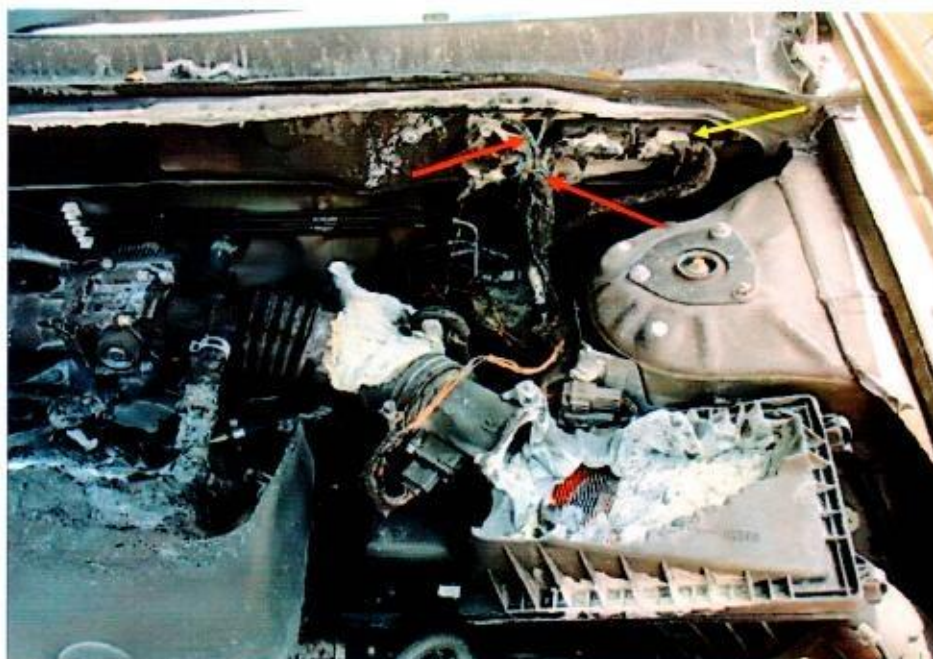
10. Upon closer examination of the area where the fire to the Insured Vehicle had likely started, we had found greenish residue on several stretches of original factory fitted wirings leading towards the Engine Control Module (ECM) of the Insured Vehicle. The presence of greenish residue indicates internal heating of copper wires, a sign of an electrical short circuit occurring. The greenish residue is normally left behind from oxidation as a result of chemical reaction involving the copper wires. This physical evidence would then appear to suggest that the cause of fire to the Insured Vehicle could have possibly been due to electrical in nature. See photos 9 – 11 below.

Photo 9 shows the wirings around the left rear portion of the engine compartment, which is in the immediate vicinity where the fire to the Insured Vehicle had likely started. Greenish residue was found on the wirings (red arrow) leading to the Engine Control Module (ECM) (yellow arrow). The presence of greenish residue indicates internal heating of copper wires, a sign of an electrical short circuit occurring. The greenish residue is normally left behind from oxidation as a result of chemical reaction involving the copper wires.

24. The possibility of the fire being due to electrical in nature would then seem more likely given that engine overheating and external factors would both seem unlikely. The fire being due to electrical nature is also supported by the greenish residue that was found on the wirings of the Insured Vehicle, which was earlier discussed in paragraph 10 above.

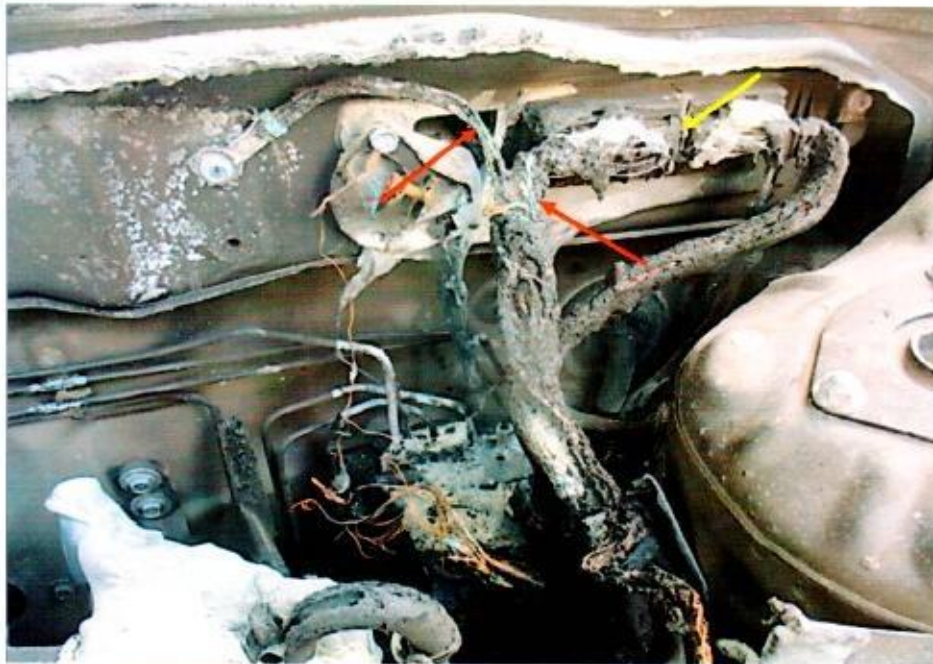
Photo 10 shows a closer view of the wirings with greenish residue (red arrows) leading to the Engine Control Module (ECM) (yellow arrow). The presence of such greenish residue suggest occurrence of an electrical short circuit.

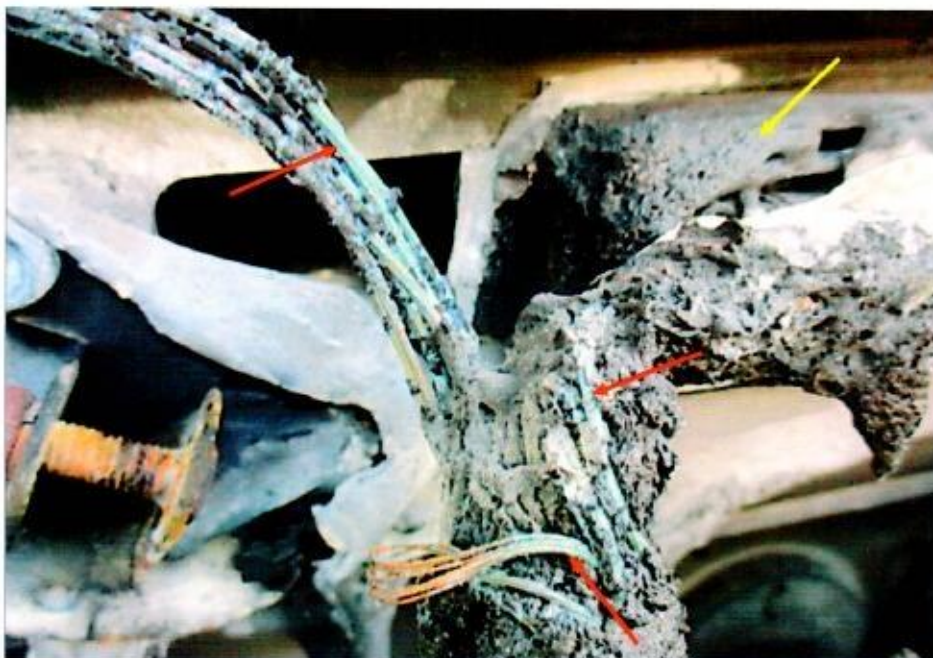
Photo 11 shows a close up view of the wirings with greenish residue (red arrows) leading to the Engine Control Module (ECM) (yellow arrow). The presence of such greenish residue suggest occurrence of an electrical short circuit.

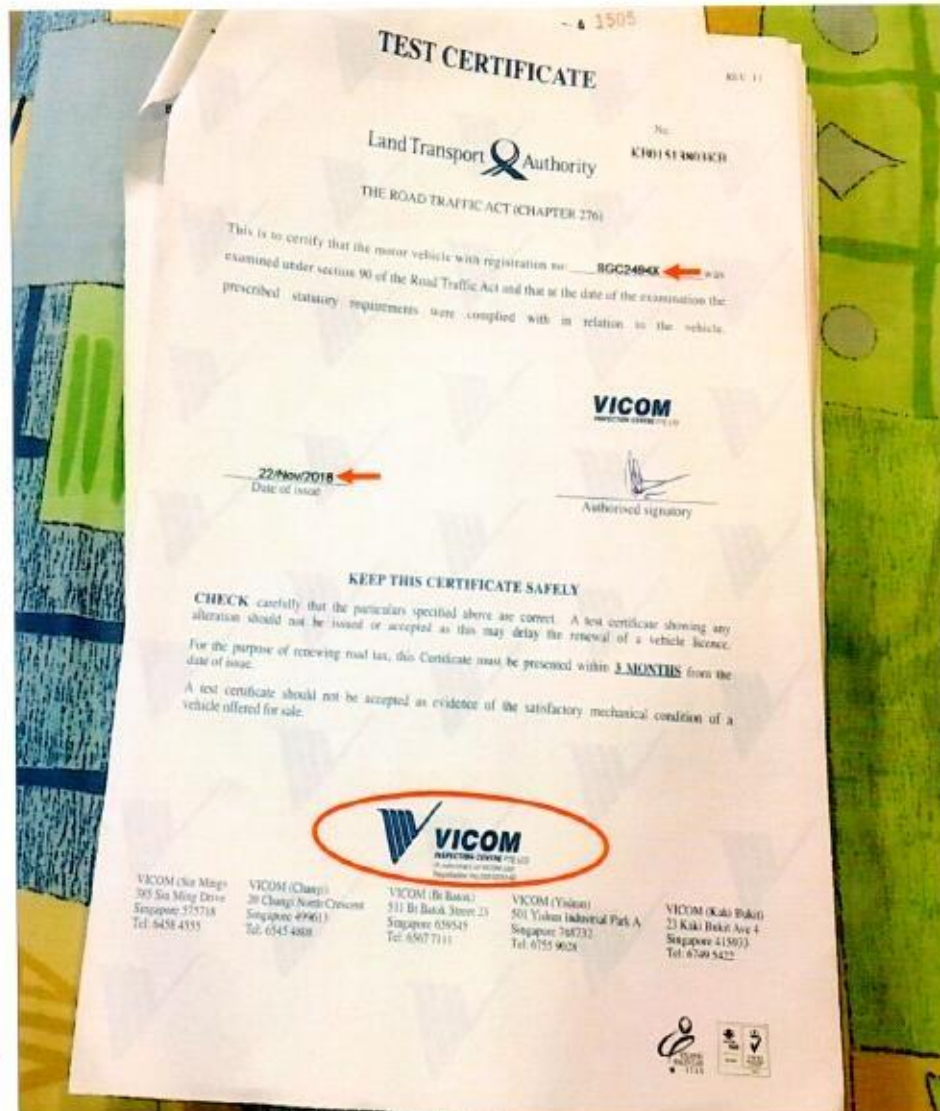
Photo 12 shows the test certificate issued to Mr Tan by Vicom Inspection Centre (circled) to prove that the Insured Vehicle had passed the mandatory yearly vehicle inspection on 22 November 2018 (red arrows).

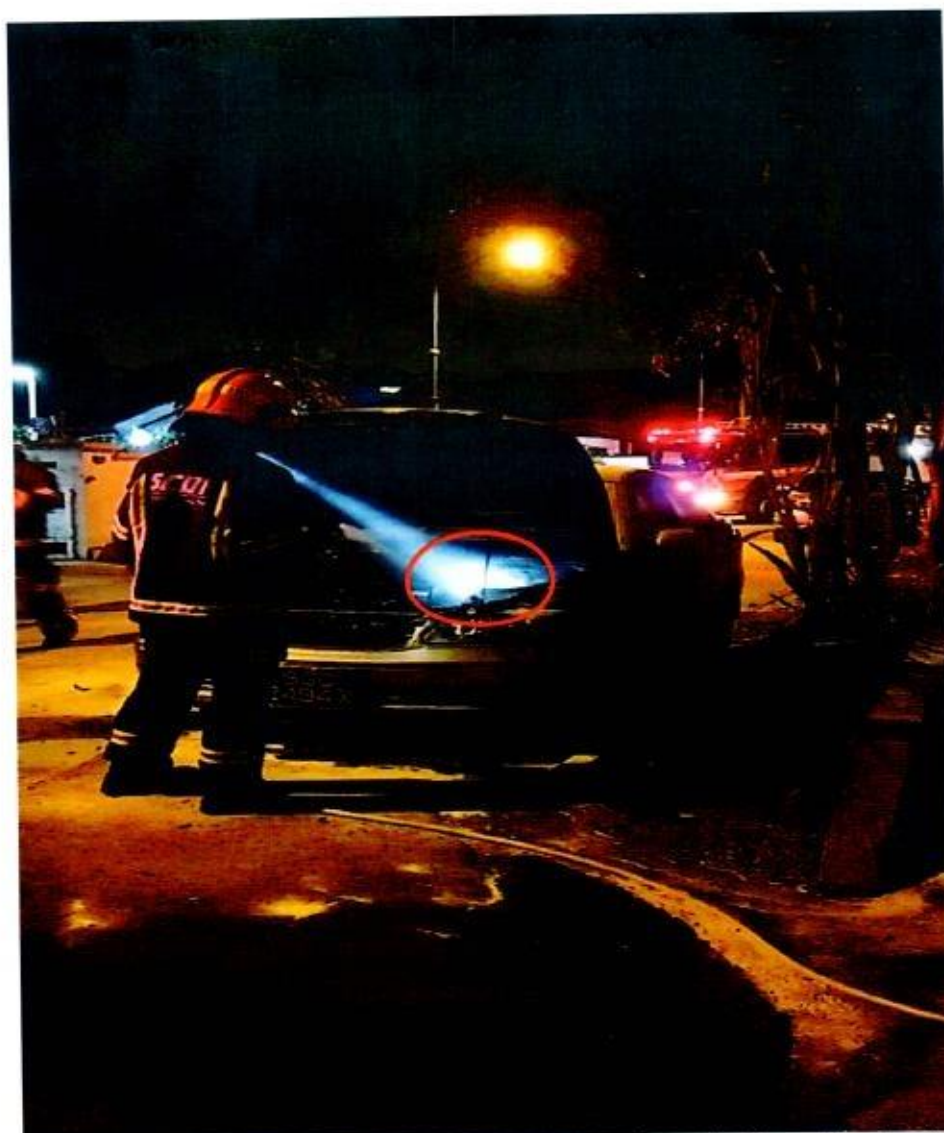
Photo 14 shows the SCDF conducting preliminary investigations after the fire was extinguished. In general, the information that could be gathered from this photograph had corresponded to the events that were related to us by Mr Tan, which is the fire started from the left portion of the engine compartment (circled).

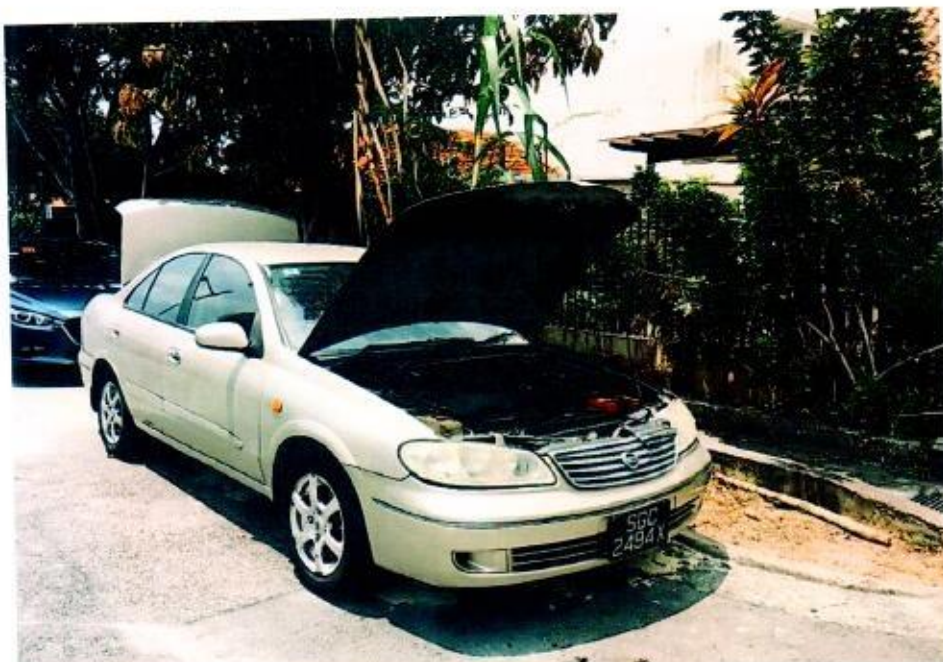
Photo 15 shows the Insured Vehicle at the incident scene the next day after the fire was extinguished.

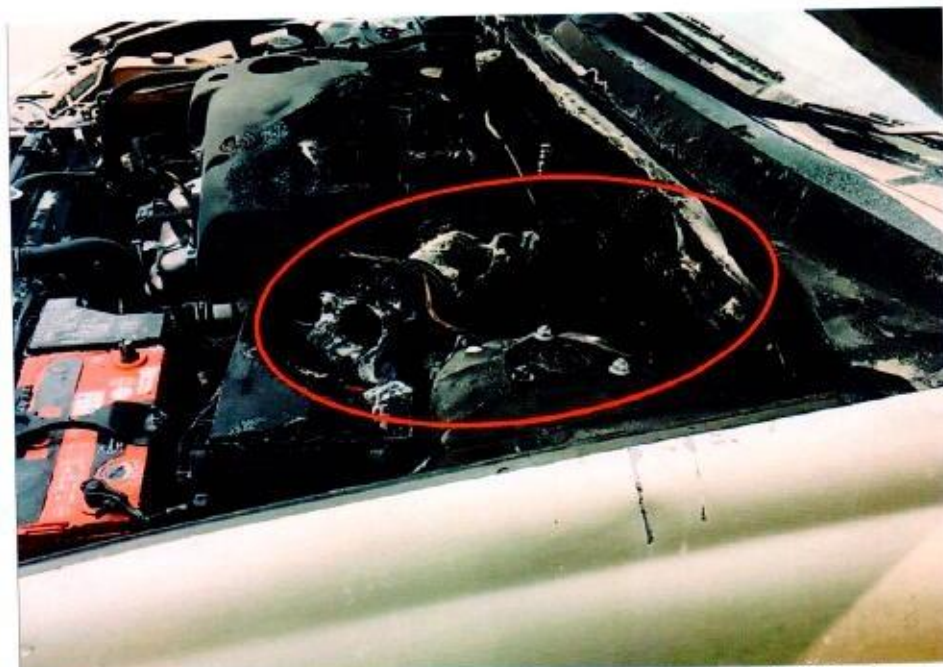
Photo 16 shows a close up view of the engine compartment of the Insured Vehicle at the incident scene after the fire was extinguished. In general, the information that could be gathered from this photograph had corresponded to the events that were related to us by Mr Tan. The extent of fire damage observed indicates that the fire had started from the left rear portion of the engine compartment (circled).
