Your Ref: S9M01GF2
Our Ref : CS/ASM19004390/N

**TECHNICAL INVESTIGATION REPORT OF FIRE INCIDENT INVOLVING THE
INSURED VEHICLE SGC 2494X ON 7 MARCH 2019**

Vehicle Registration No.	: SGC 2494X
Make / Model	: Nissan Sunny 1.6EXM
Chassis No	: JN1CFAN16Z0095185
Year of Registration	: January 2006
Mileage	: N.A (wiring affected)
5. The Insured Vehicle was noted to have sustained fire damage that was confined to its front portion. The entire engine compartment of the Insured Vehicle was observed to be severely burnt while the interior compartment was observed to be relatively unaffected by the fire.
6. The fire had resulted in the body parts at the front portion of the Insured Vehicle to be burnt. This had included its front bonnet, front grille, and front headlamps, amongst others. See photos 1 – 5 below.

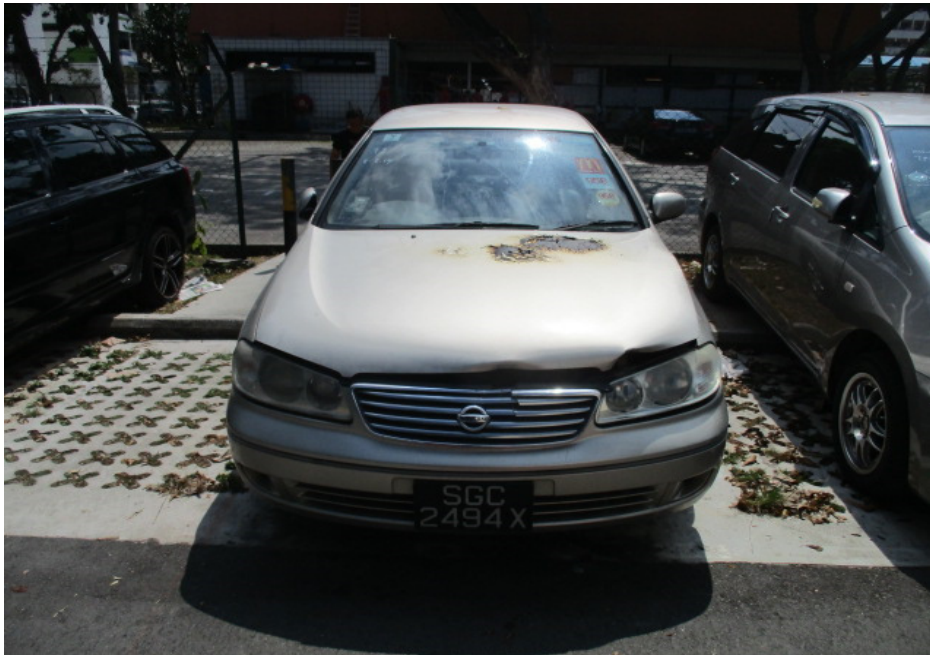
Photo 1 shows the general view of the front portion of the Insured Vehicle at the time of our inspection. The fire damage to the Insured Vehicle was confined to its front portion. Its front bonnet, front grille and front headlamps were amongst the body parts that were found to have been affected as a result of the fire.

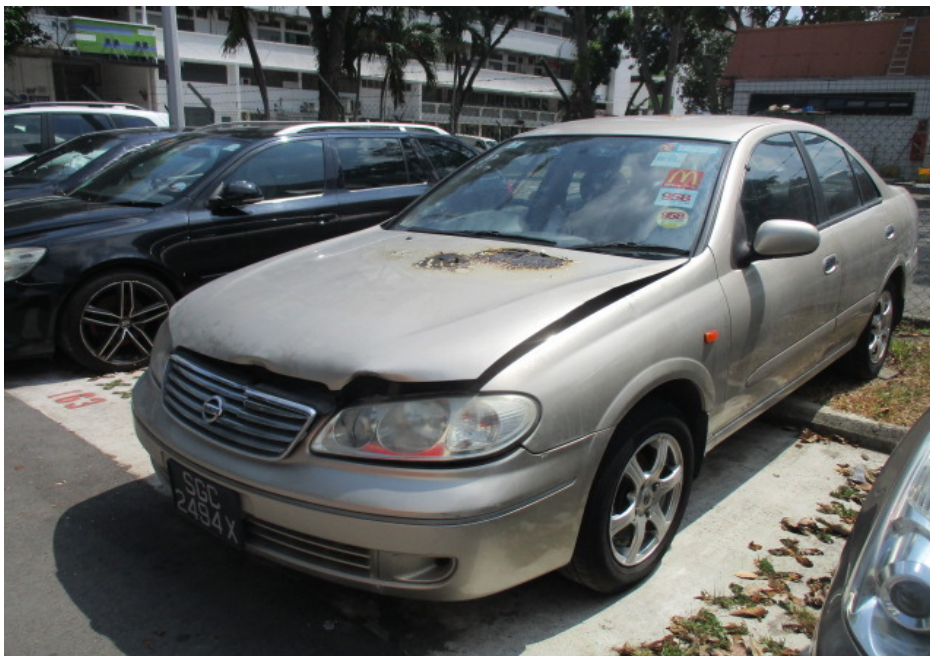
Photo 2 shows the general view of the front left portion of the Insured Vehicle at the time of our inspection. The fire damage to the Insured Vehicle was confined to its front portion. Its front bonnet, left front panel and front left headlamp were amongst the body parts that were found to have been affected as a result of the fire.

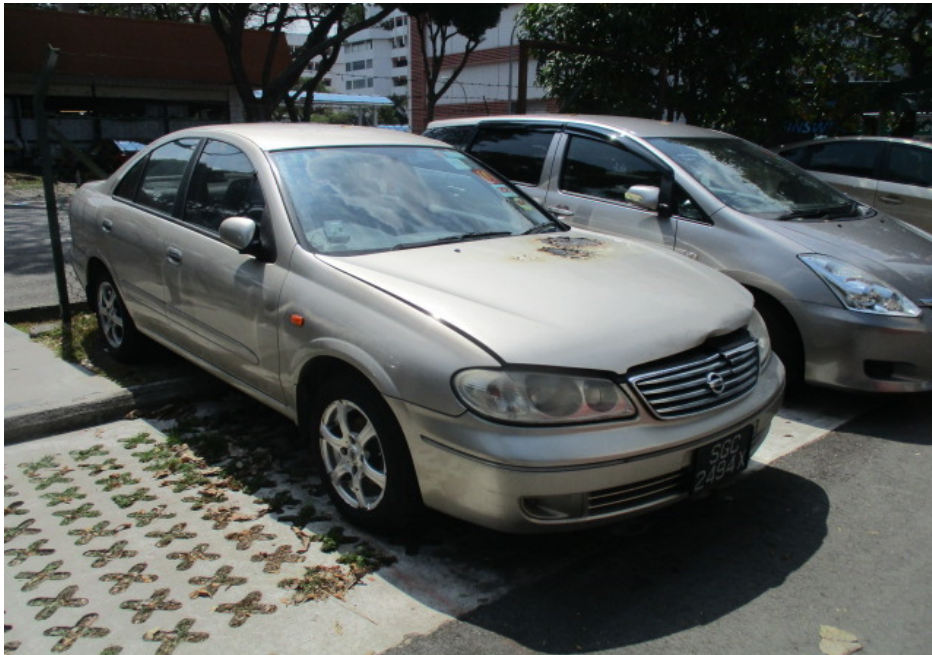
Photo 3 shows the general view of the front right portion of the Insured Vehicle at the time of our inspection. The fire damage to the Insured Vehicle was confined to its front portion. Its front bonnet and front right headlamp were amongst the body parts that were found to have been affected as a result of the fire.

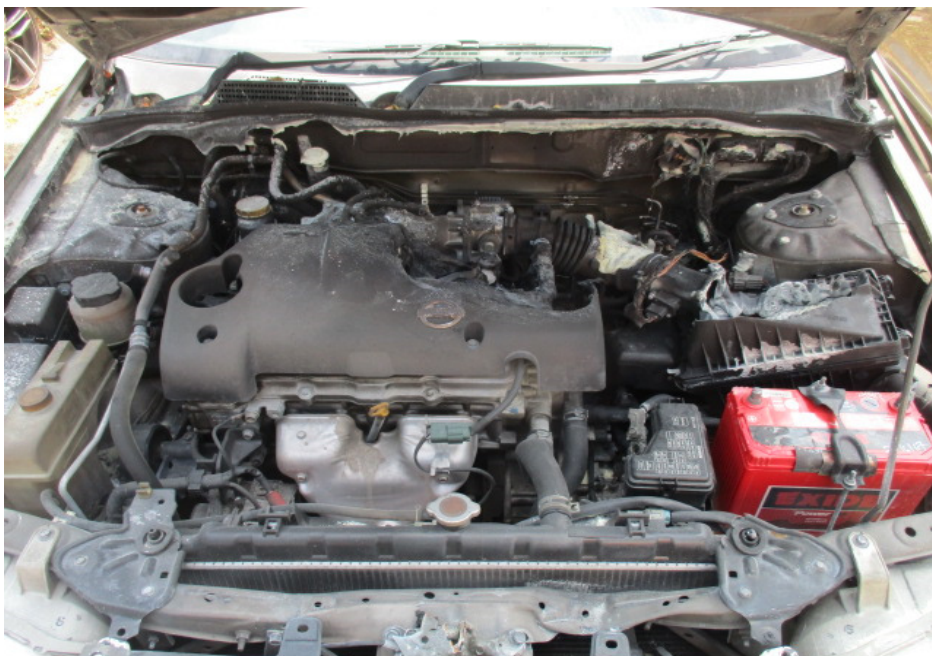
Photo 4 shows the engine compartment of the Insured Vehicle at the time of our inspection. The entire engine compartment of the Insured Vehicle was observed to be severely burnt. Most of the parts inside the engine compartment were found to be burnt and/or melted as a result of the fire.

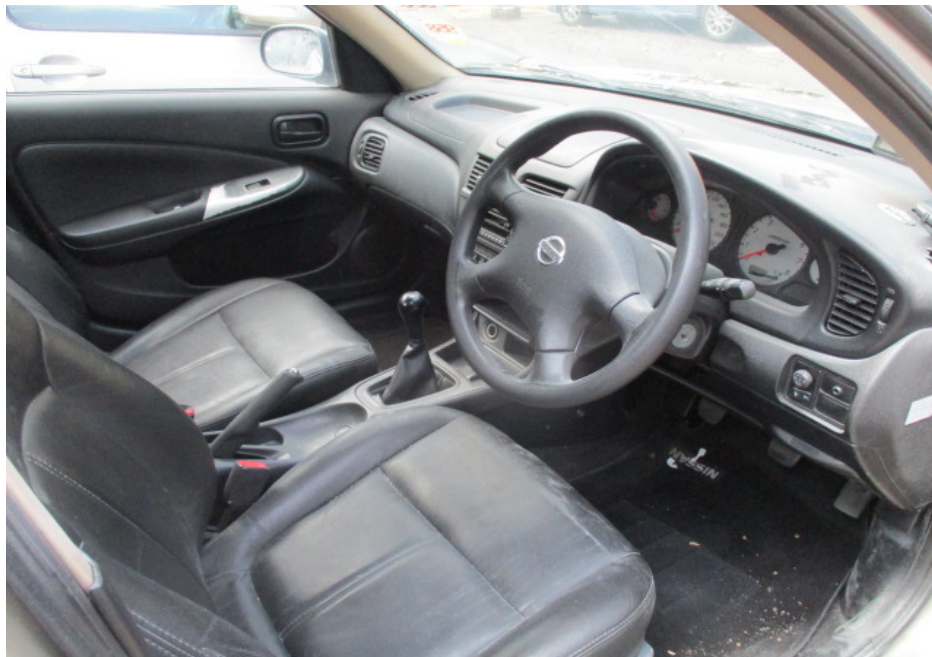
Photo 5 shows the interior compartment of the Insured Vehicle, which was observed to be relatively unaffected by the fire.

7. At the time of inspection of the Insured Vehicle, we did not find any additionally fitted electronic and/or electrical component(s) on the Insured Vehicle. There also appears to be no modification(s) fitted on the Insured Vehicle.

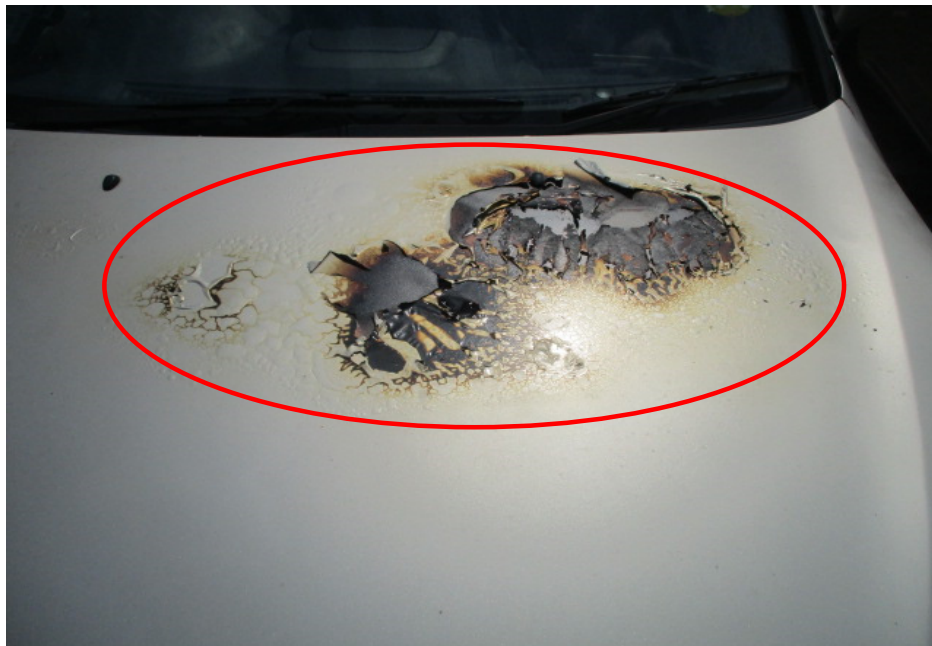
8. For this particular case, the fire appears to have originated within the engine compartment of the Insured Vehicle, somewhere around the left rear portion of the engine compartment. This can be determined from the burn pattern and paint bubbles on the left portion of the front bonnet of the Insured Vehicle as well as the rust that had developed on the underside of the front bonnet, at the left rear area.

9. The whitish burn marks are a result of exposure to prolonged heat intensity. Rust would normally start to develop around these areas soon after a fire as prolonged exposure to high heat intensity usually causes steel/metal material body parts to be exposed to natural environmental condition. The rust that had developed on the underside of the front bonnet, around the left rear area, is an indication that the left rear portion of the engine compartment had sustained exposure to prolonged high heat intensity. See photos 6 & 7 below.

Photo 6 shows the burn pattern and paint bubbles on the left portion of the front bonnet of the Insured Vehicle (circled). Such burn marks are a result of exposure to prolonged heat intensity, which may indicate where the fire had started. Rust would also begin to develop on these areas soon after the fire.

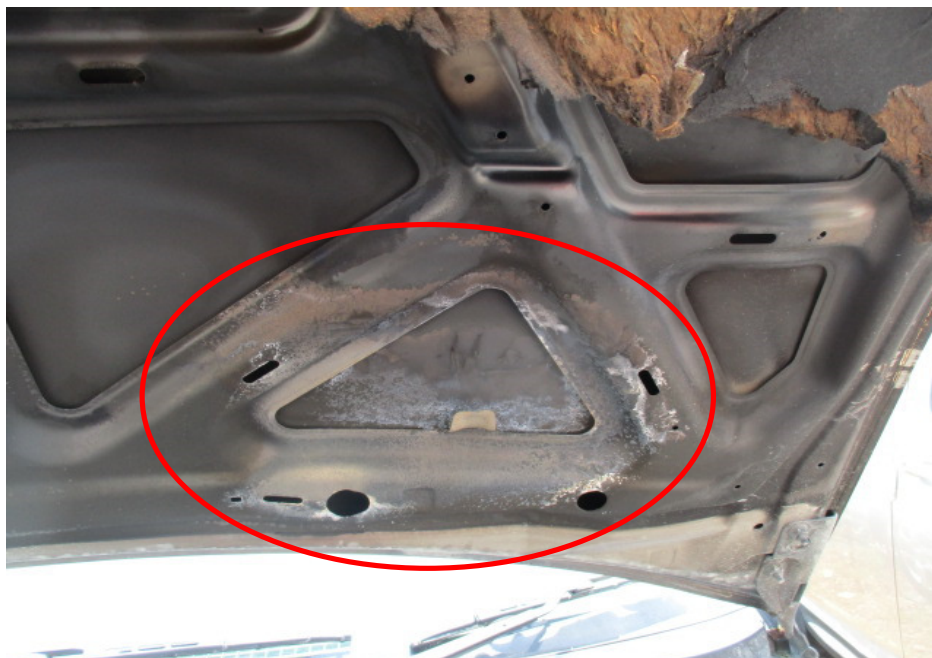
Photo 8 shows the rust that had developed on the underside of the front bonnet, around the left rear area (circled). The development of rust is an indication that the area was exposed to prolonged exposure to high heat intensity, which had caused the steel/metal material of the front bonnet to be exposed to natural environmental condition. Hence the fire to the Insured Vehicle can be determined to have originated towards the left rear portion of the engine compartment.

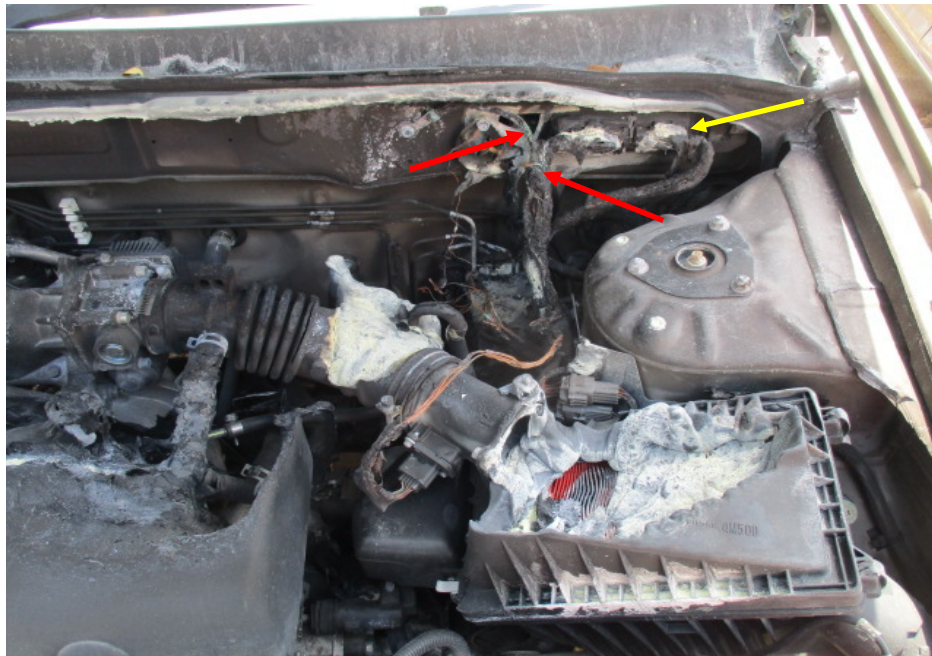
10. Upon closer examination of the area where the fire to the Insured Vehicle had likely started, we had found greenish residue on several stretches of original factory fitted wirings leading towards the Engine Control Module (ECM) of the Insured Vehicle. The presence of greenish residue indicates internal heating of copper wires, a sign of an electrical short circuit occurring. The greenish residue is normally left behind from oxidation as a result of chemical reaction involving the copper wires. This physical evidence would then appear to suggest that the cause of fire to the Insured Vehicle could have possibly been due to electrical in nature. See photos 9 – 11 below.

Photo 9 shows the wirings around the left rear portion of the engine compartment, which is in the immediate vicinity where the fire to the Insured Vehicle had likely started. Greenish residue was found on the wirings (red arrow) leading to the Engine Control Module (ECM) (yellow arrow). The presence of greenish residue indicates internal heating of copper wires, a sign of an electrical short circuit occurring. The greenish residue is normally left behind from oxidation as a result of chemical reaction involving the copper wires.

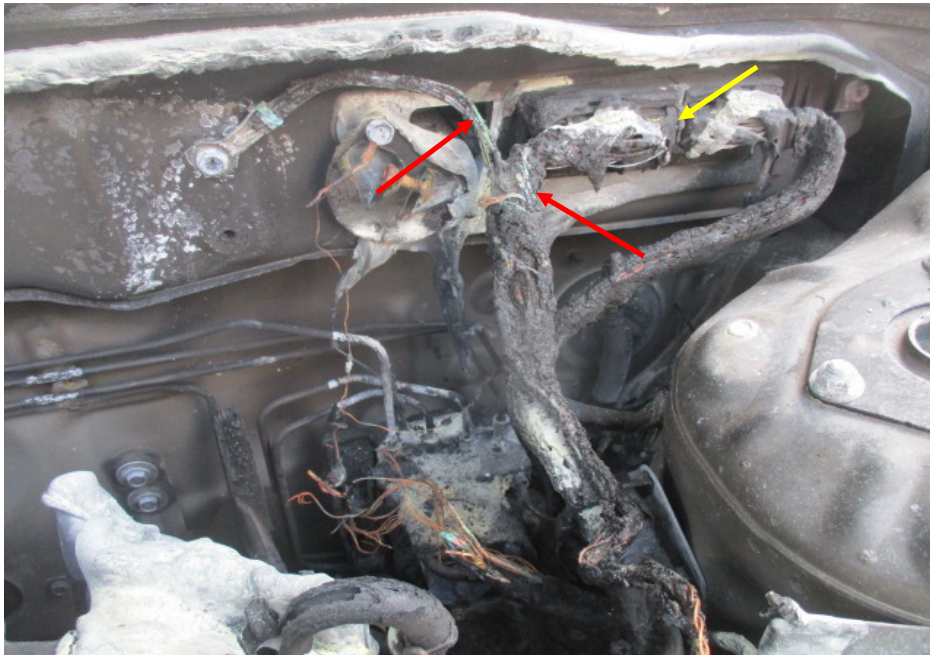
Photo 10 shows a closer view of the wirings with greenish residue (red arrows) leading to the Engine Control Module (ECM) (yellow arrow). The presence of such greenish residue suggest occurrence of an electrical short circuit.

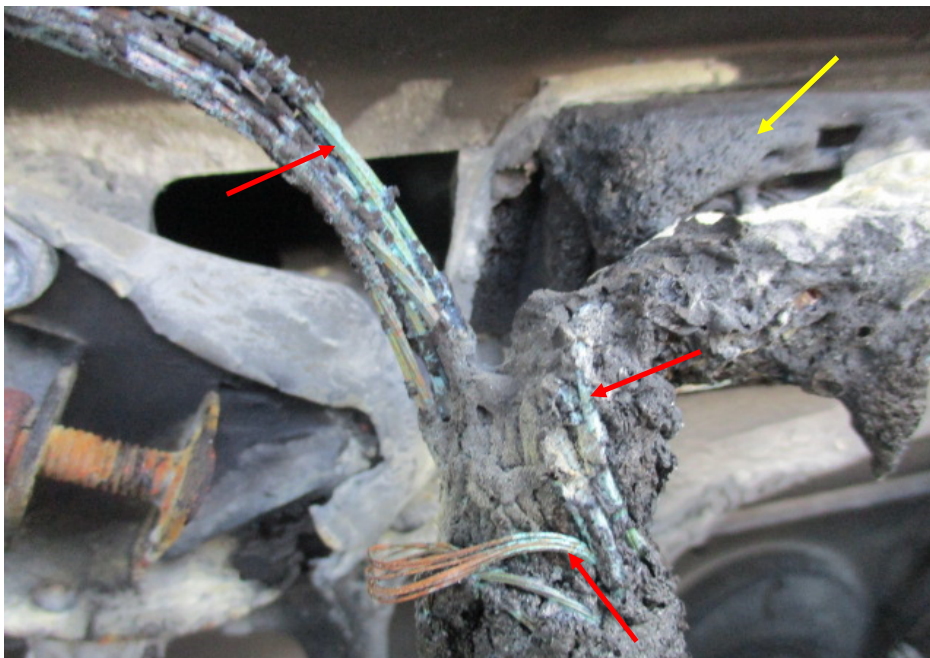
Photo 11 shows a close up view of the wirings with greenish residue (red arrows) leading to the Engine Control Module (ECM) (yellow arrow). The presence of such greenish residue suggest occurrence of an electrical short circuit.

24. The possibility of the fire being due to electrical in nature would then seem more likely given that engine overheating and external factors would both seem unlikely. The fire being due to electrical nature is also supported by the greenish residue that was found on the wirings of the Insured Vehicle, which was earlier discussed in paragraph 10 above.

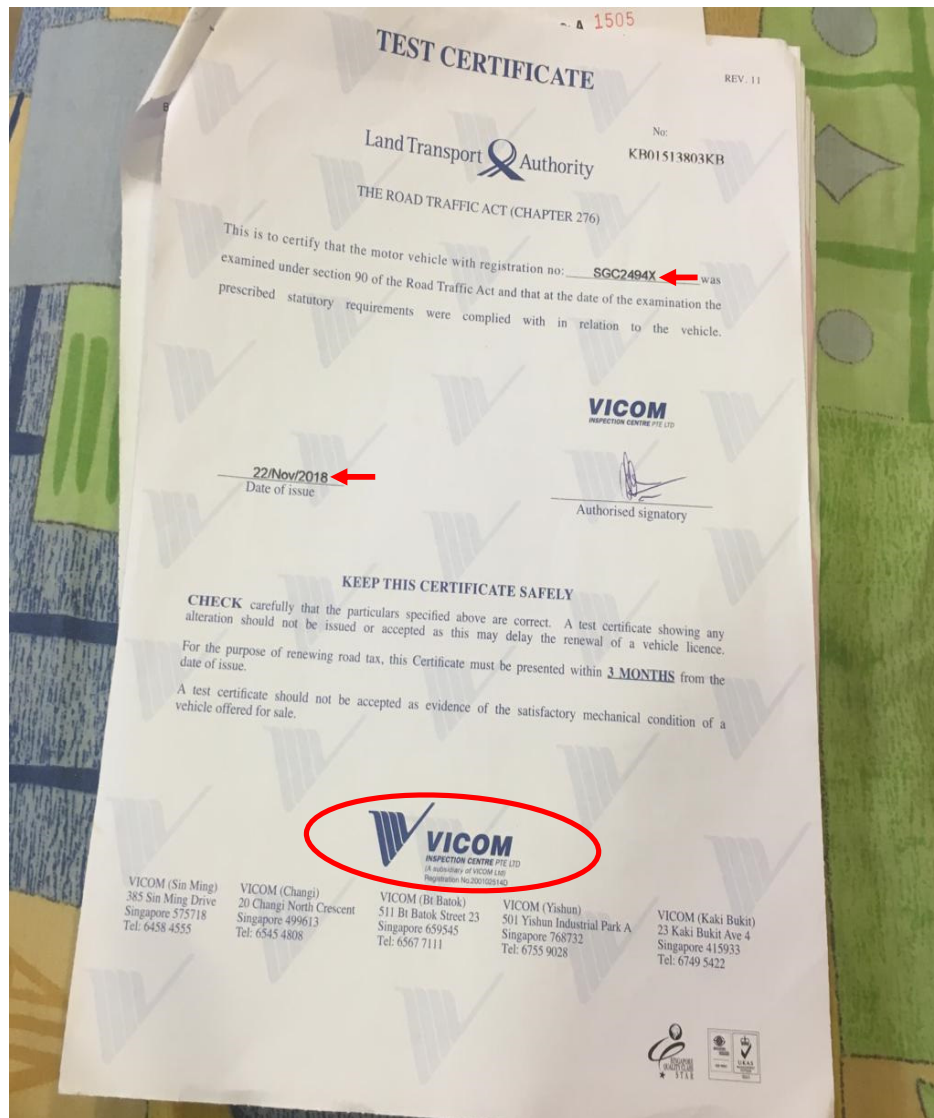
Photo 12 shows the test certificate issued to Mr Tan by Vicom Inspection Centre (circled) to prove that the Insured Vehicle had passed the mandatory yearly vehicle inspection on 22 November 2018 (red arrows).

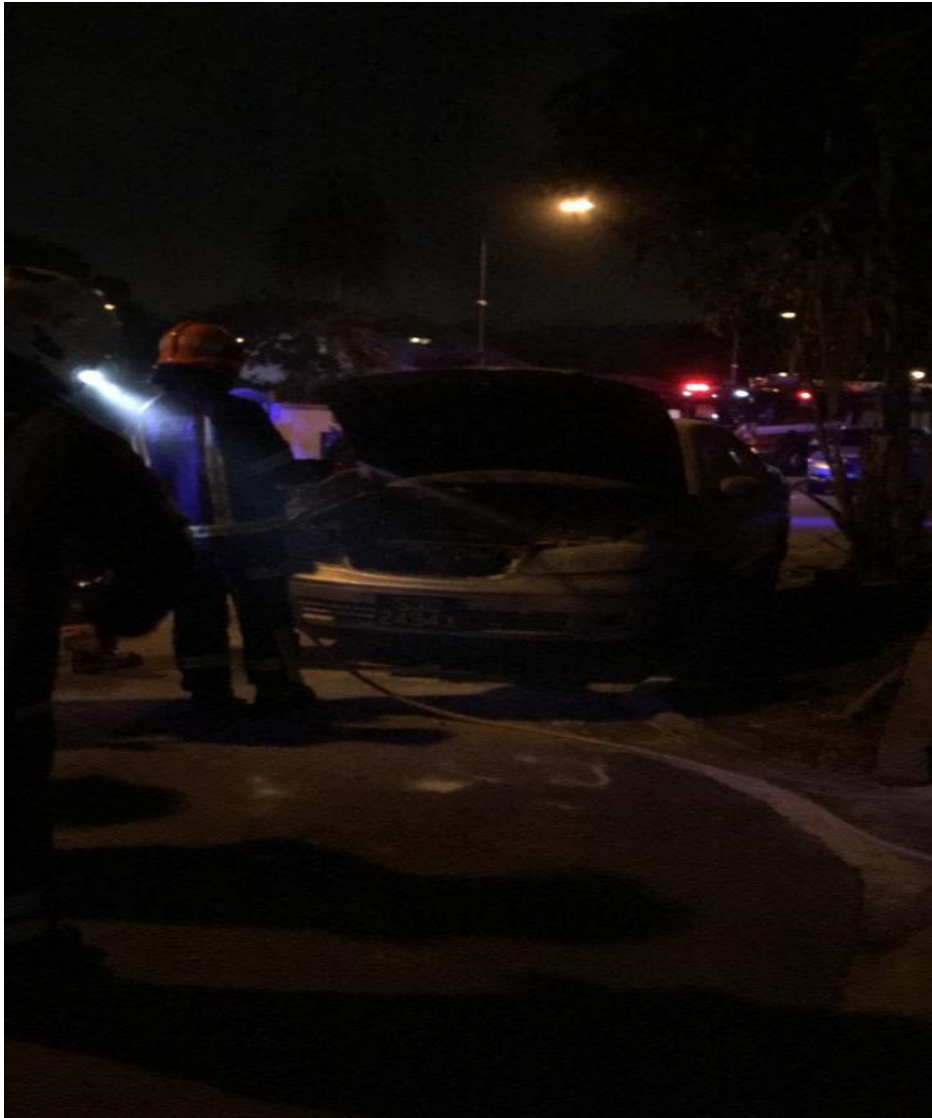
Photo 13 shows firefighters putting out the last remnants of the fire to the Insured Vehicle.

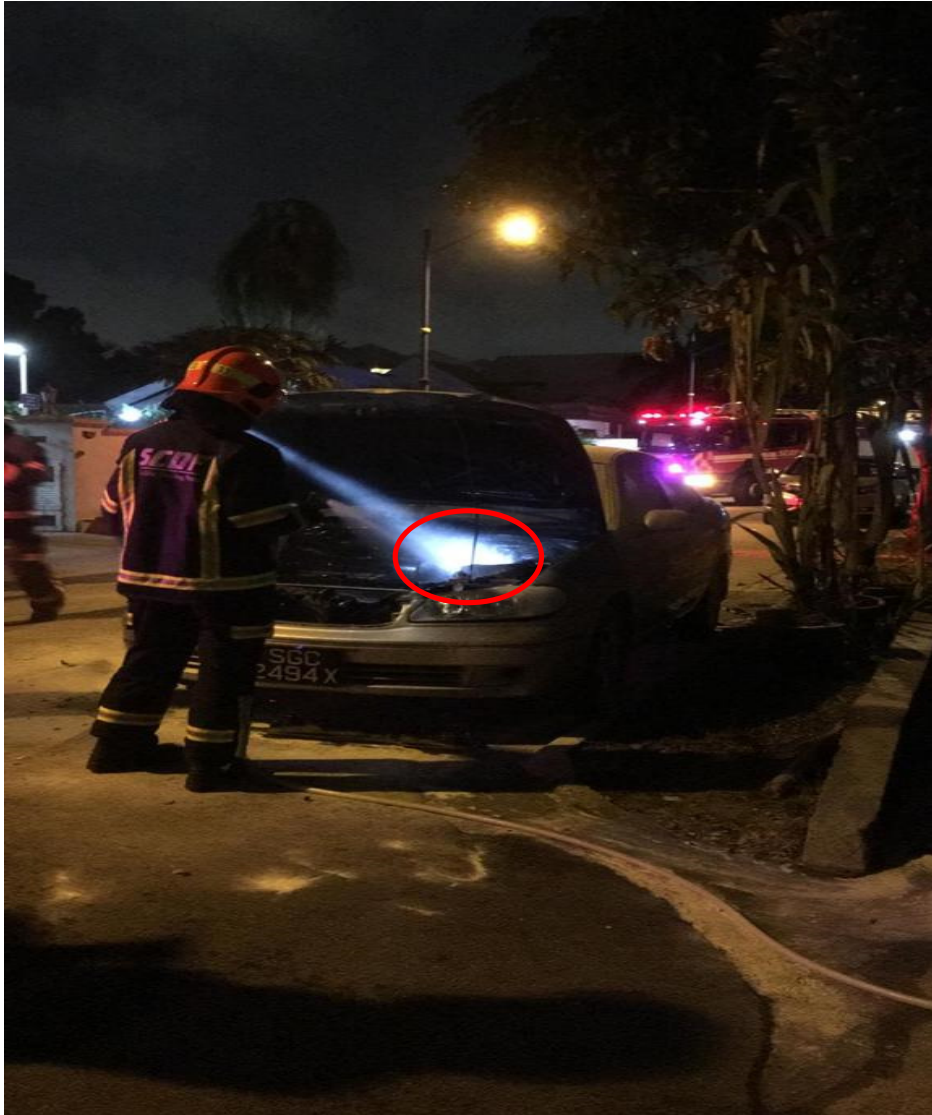
Photo 14 shows the SCDF conducting preliminary investigations after the fire was extinguished. In general, the information that could be gathered from this photograph had corresponded to the events that were related to us by Mr Tan, which is the fire started from the left portion of the engine compartment (circled).

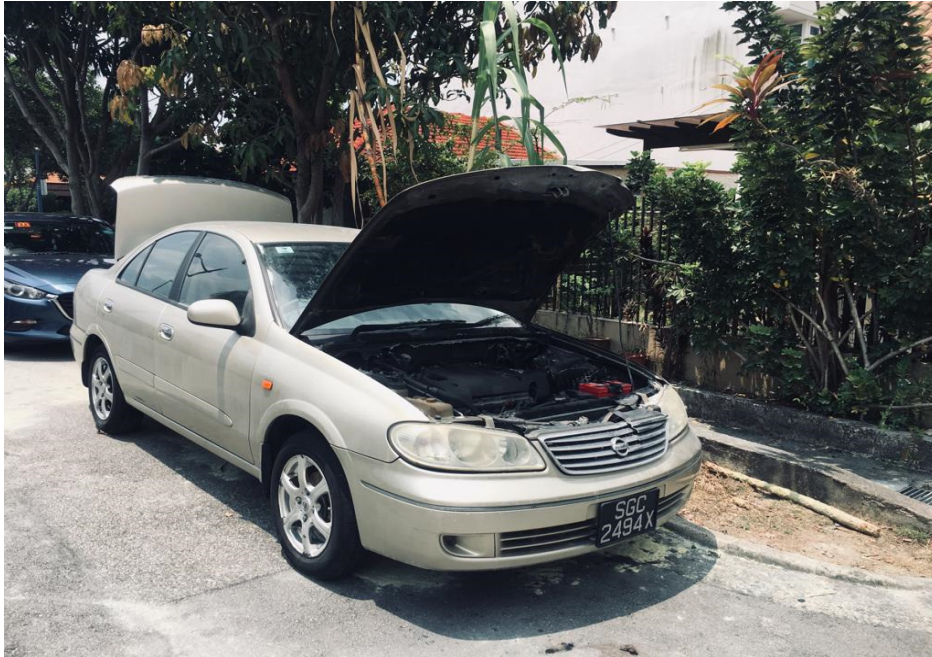
Photo 15 shows the Insured Vehicle at the incident scene the next day after the fire was extinguished.

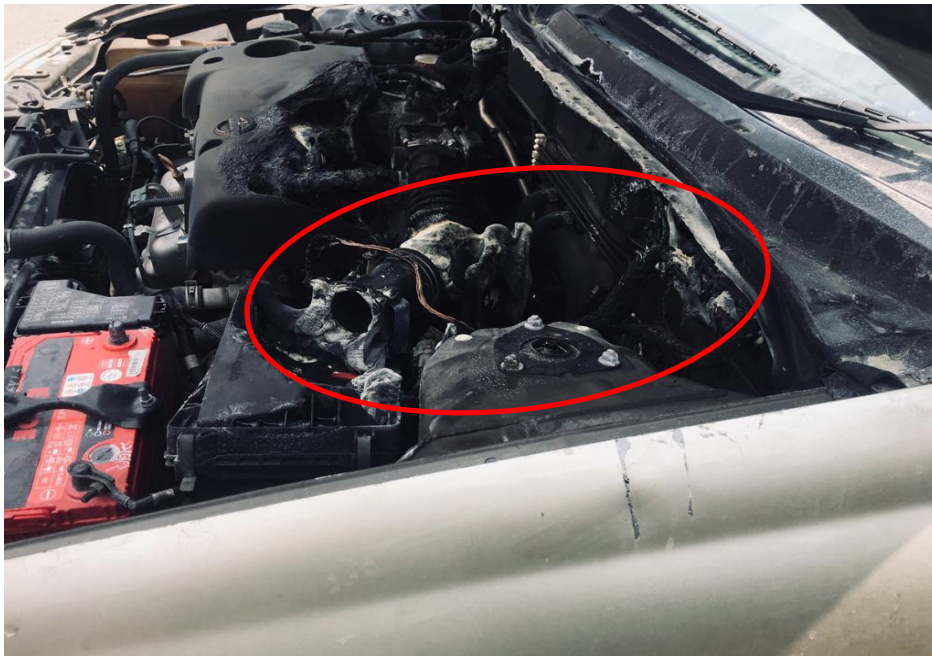
Photo 16 shows a close up view of the engine compartment of the Insured Vehicle at the incident scene after the fire was extinguished. In general, the information that could be gathered from this photograph had corresponded to the events that were related to us by Mr Tan. The extent of fire damage observed indicates that the fire had started from the left rear portion of the engine compartment (circled).
