Auto  
Consultants  
Pte Ltd

Your Ref: SJP 5354T  
Our Ref : CI1/TP19004439/D

**Road Traffic Accident On 16 March 2018 At About  
2345hrs Along Raffles Avenue, In Front Of Ritz-Carlton  
Millenia Hotel, Involving Motor Cars SJP 5354T And SLN  
9226R**

**Requested By  
JD Motorsport Pte Ltd  
25 Kaki Bukit Road 4 #06-38  
Synergy @ KB  
Singapore 417800**

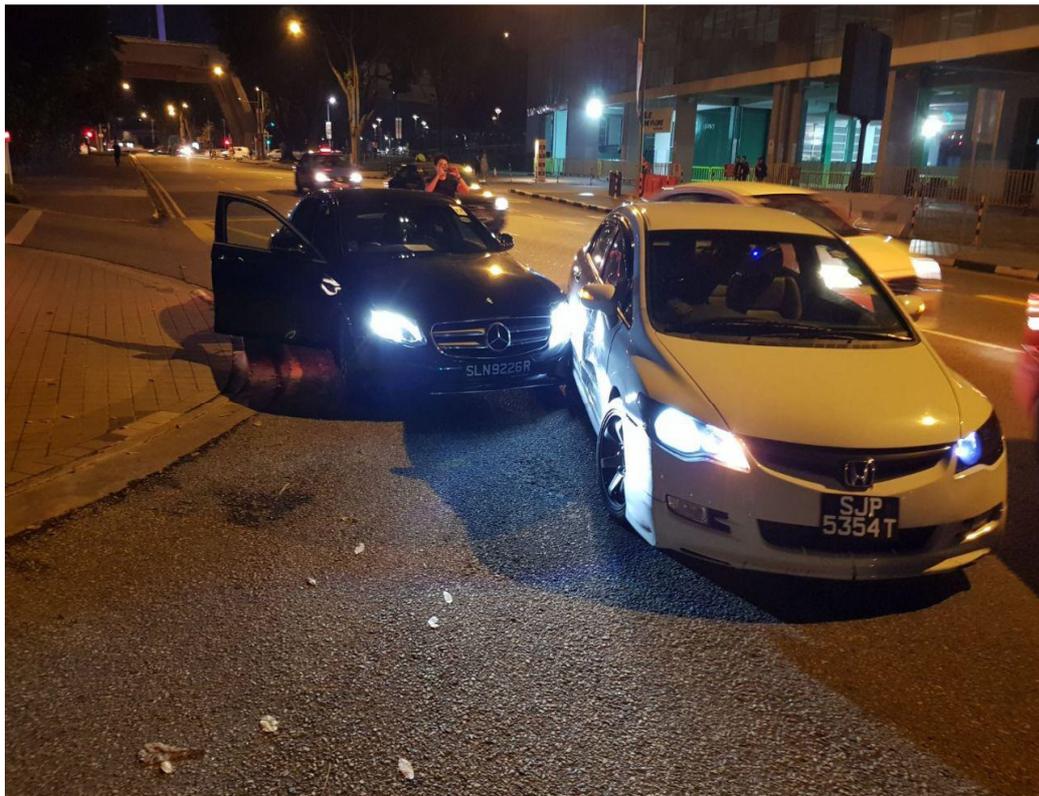
17. The final resting position of the Honda and the Mercedes as seen in the accident scene photographs would seem to suggest that the accident was of a side swipe nature, where the Honda had cut into the travelling lane of the Mercedes. However, when the physical damage of the Honda is examined closer, the actual accident circumstance may not be as what the final resting position of the Honda and the Mercedes seem to suggest. See photo 1 – 3 below showing the final resting position of the Honda and the Mercedes.

**Photo 1** shows the final resting position of the Honda and the Mercedes at the accident scene. The slanting angled position of the Honda could easily suggest that the Honda had cut into the travelling lane of the Mercedes, indicating a side swipe nature of accident. However, for this particular case, when the physical damage of the Honda is examined closer, the actual accident circumstance may not be as what the final resting position of the Honda and the Mercedes seem to suggest.

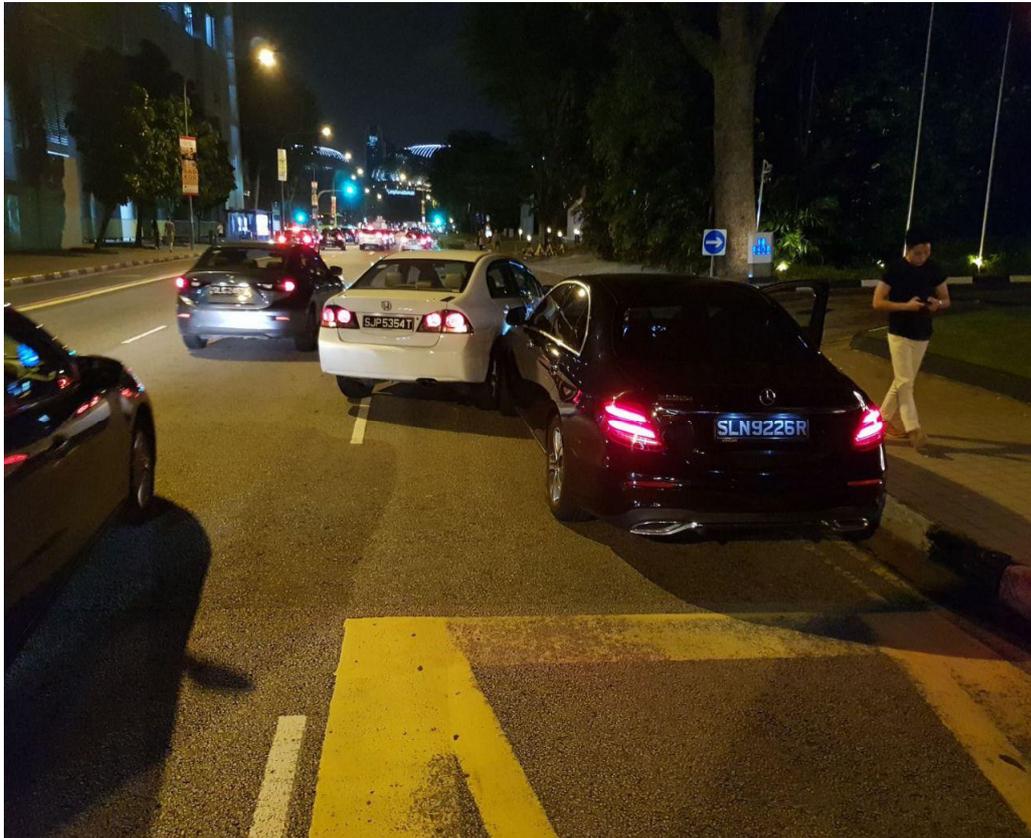
**Photo 2** shows the final resting position of the Honda and the Mercedes at the accident scene. The slanting angled position of the Honda could easily suggest that the Honda had cut into the travelling lane of the Mercedes, indicating a side swipe nature of accident. However, for this particular case, when the physical damage of the Honda is examined closer, the actual accident circumstance may not be as what the final resting position of the Honda and the Mercedes seem to suggest.

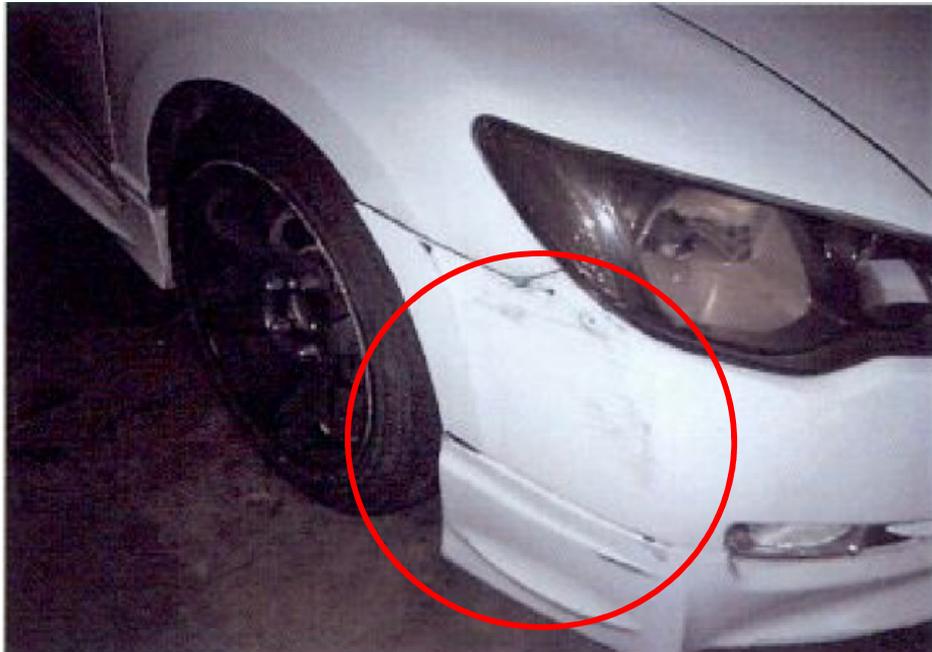
18. My examination of the photographs showing the damage to the Honda that were attached in the inspection report dated 09 April 2018 by Ajax Inspection Services Pte Ltd revealed damages at the right side of the Honda's front bumper. The condition of the front bumper was indicated as deformed in the inspection report. Since the Mercedes had come to a rest in contact with the right rear door of the Honda (refer to photo 1 & 2 above), the right side of the Honda's front bumper was then the first point of contact on the Honda. See photo 3 below.

**Photo 3** shows a general view of the damage to the front bumper of the Honda as seen in the photographs attached in the inspection report of the Honda dated 09 April 2018 by Ajax Inspection Services Pte Ltd. The condition of the Honda's front bumper was indicated as deformed in the inspection report. The presence of grazed marks was also noted on the right side of the Honda's front bumper (circled). This was the first point of contact on the Honda.

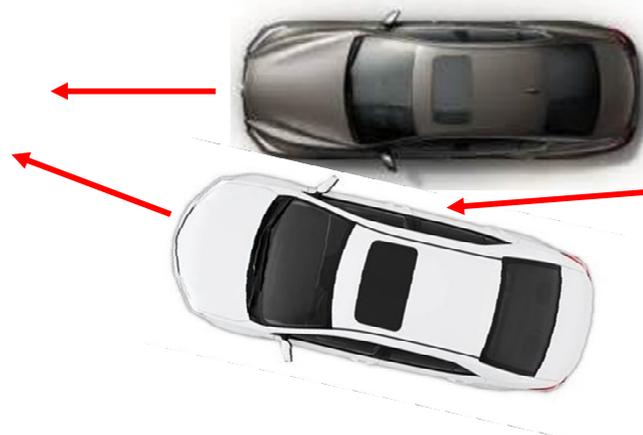
19. In a side swipe scenario where the Honda had cut into the travelling lane of the Mercedes, similar pattern of grazed marks that were seen on the right side of the Honda's front bumper is expected to be found continuously stretching from the front bumper to the rear body. This follows the momentum of the Honda moving into the travelling lane of the Mercedes and the forward moving motion of the Mercedes. In other words, both the Honda and the Mercedes would be in contact till both come to a rest or both disengage (separate). Illustration shown below.

Continuous marks of grazing nature from first contact point at the front body stretching to the rear body due to the momentum of the Honda moving into the travelling lane of the Mercedes

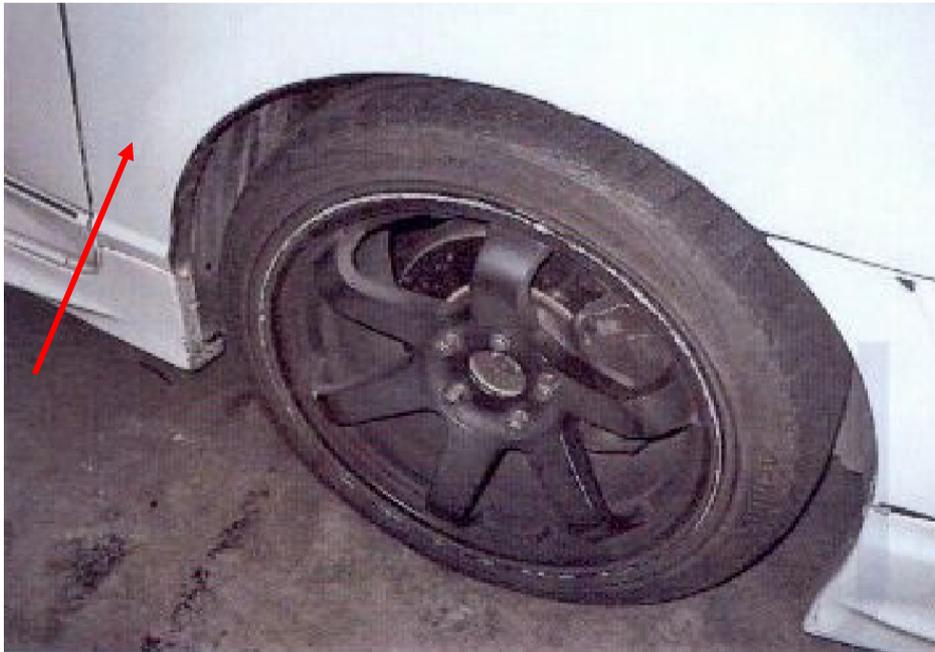
20. Notably, I note that there was no similar pattern of grazed marks found on the front right body of the Honda. This was at the area after the front right wheel. There was in fact no sign of any damage to this body area. Thereafter the front right door and rear right door were found to be dented with the damage ending at the rear right door of the Honda. Basing on this, it can reasonably be determined that there was a break in the damage sustained by the Honda. This break in the damage was due to a relatively brief disengagement between the Honda and the Mercedes where both were not in contact with each other. See photo 4 & 5 below.

**Photo 4** shows a general view of the damage to the Honda as seen in the photographs attached in the inspection report of the Honda dated 09 April 2018 by Ajax Inspection Services Pte Ltd. From the available photographs of the Honda, I note that the front right body did not sustain similar pattern of grazed marks that were found on the front bumper. In particular, at the area (arrowed) after the front right wheel rim. The lack of damage at this body area suggest that there was a relatively brief disengagement between the Honda and the Mercedes where both were not in contact with each other.

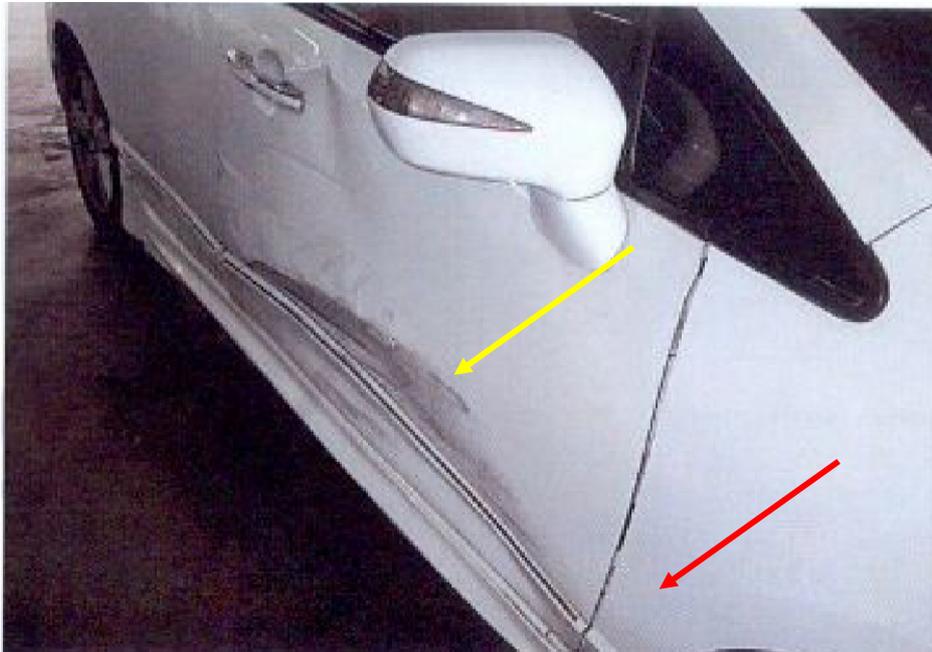
**Photo 5** shows a general view of the damage to the Honda as seen in the photographs attached in the inspection report of the Honda dated 09 April 2018 by Ajax Inspection Services Pte Ltd. From the available photographs of the Honda, I note that the front right body did not sustain similar pattern of grazed marks that were found on the front bumper. In particular, at the area (red arrow) after the front right wheel rim. The damage to the Honda continued thereafter on the front right door (yellow arrow) before ending at the rear right door. The lack of damage at this body area (red arrow) suggest that there was a relatively brief disengagement between the Honda and the Mercedes where both were not in contact with each other.

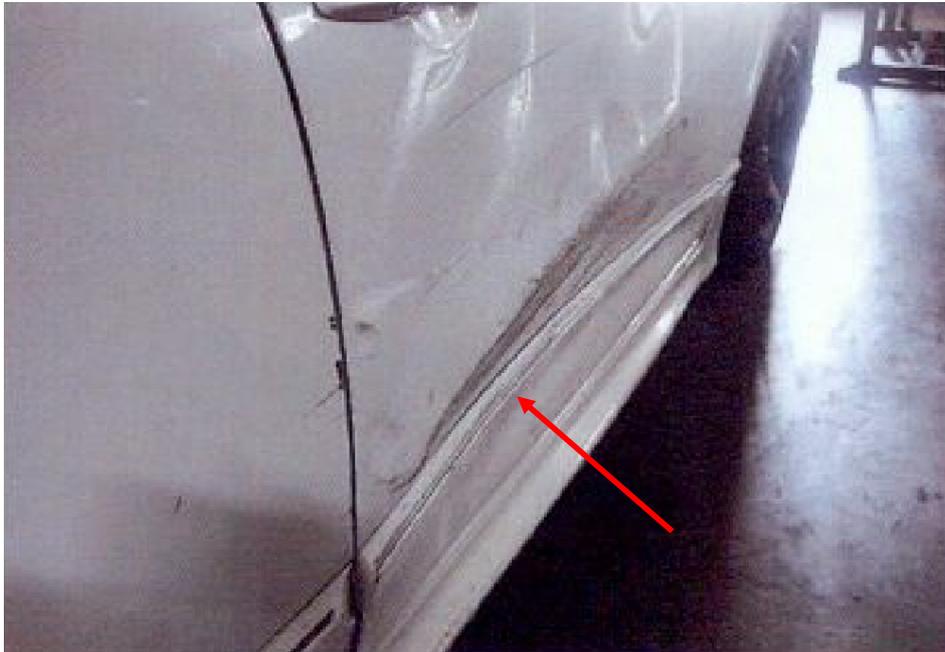
21. In a typical lane change accident, continuous damage stretching from the first contact point to the end point is expected for the vehicle that was travelling at a higher speed than the other involved vehicle. This is due to momentum or simply put, the follow through phase of such nature of accident. The break in the physical damage that was seen on the Honda hence does not correspond to a typical lane change accident.
22. Another notable physical damage observed that does not correspond to a side swipe nature, typical lane change accident was the damage profile of the Honda's front right door. The front right door was observed to be dented inwards, akin to a curve shape. Closer examination revealed several distinctive indentations shaped in a "C" like pattern. See 6 - 8 below.

**Photo 6** shows a general view of the damage to the Honda's front right door as seen in the photographs attached in the inspection report of the Honda dated 09 April 2018 by Ajax Inspection Services Pte Ltd. The front right door was observed to be dented inwards, akin to a curve shape (arrowed).

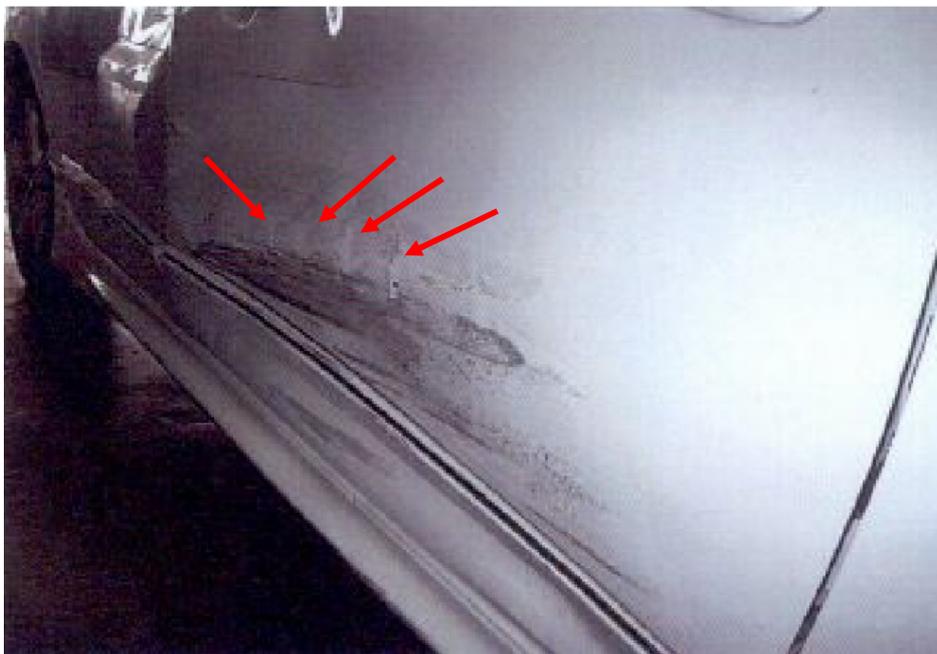
**Photo 7** shows a general view of the damage to the Honda's front right door as seen in the photographs attached in the inspection report of the Honda dated 09 April 2018 by Ajax Inspection Services Pte Ltd. The front right door was observed to be dented inwards, akin to a curve shape. Upon closer examination, several distinctive indentations shaped in a "C" like pattern (arrowed) was observed.

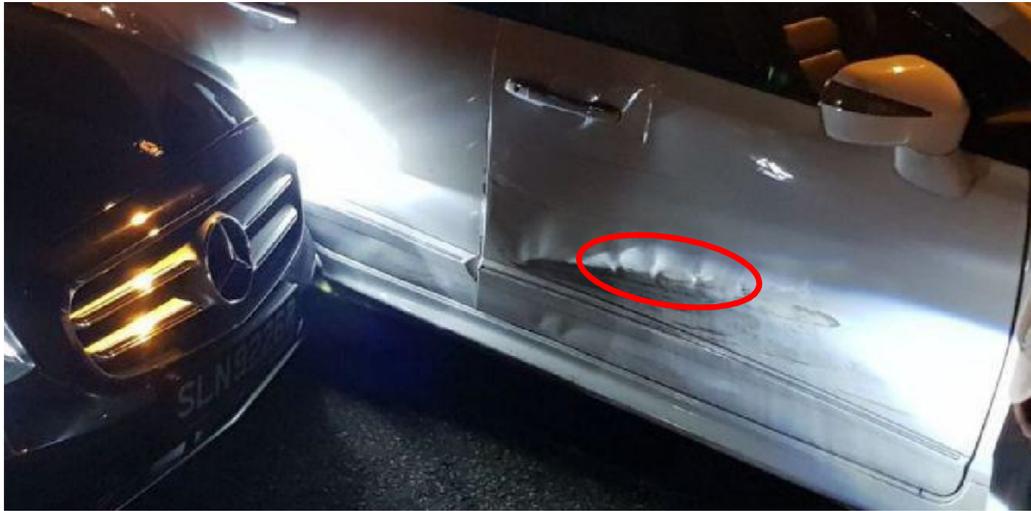
**Photo 8** shows the Honda at the accident scene. The same distinctive indentations shaped in a "C" like pattern (circled) was observed on the front right door of the Honda.

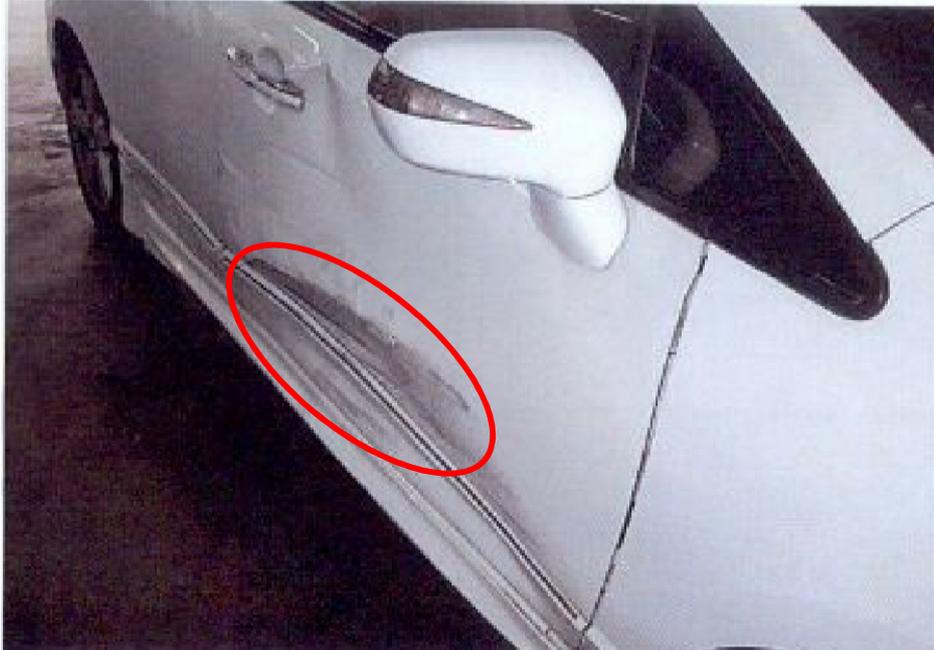
23. From the damage profile of the Honda's front right door, it can be established that the Honda was exposed to an impact with grazing nature rather than an impact that was purely of grazing nature. This follows the inward dent, akin to a curve shape that was observed on the front right door.

**Photo 9** shows a general view of the damage to the Honda's front right door as seen in the photographs attached in the inspection report of the Honda dated 09 April 2018 by Ajax Inspection Services Pte Ltd. The inward dent (circled) observed on the front right door suggests that the front right door was exposed to an impact with grazing nature rather than an impact that was purely of grazing nature.

27. Given the inward dent on the front right door of the Honda, it would be more reasonable for the Mercedes to be turning out from the exit driveway, impacting into the front right door rather than for the Honda to be cutting into the travelling path of the Mercedes, where damage that is of pure grazing nature would be formed instead.

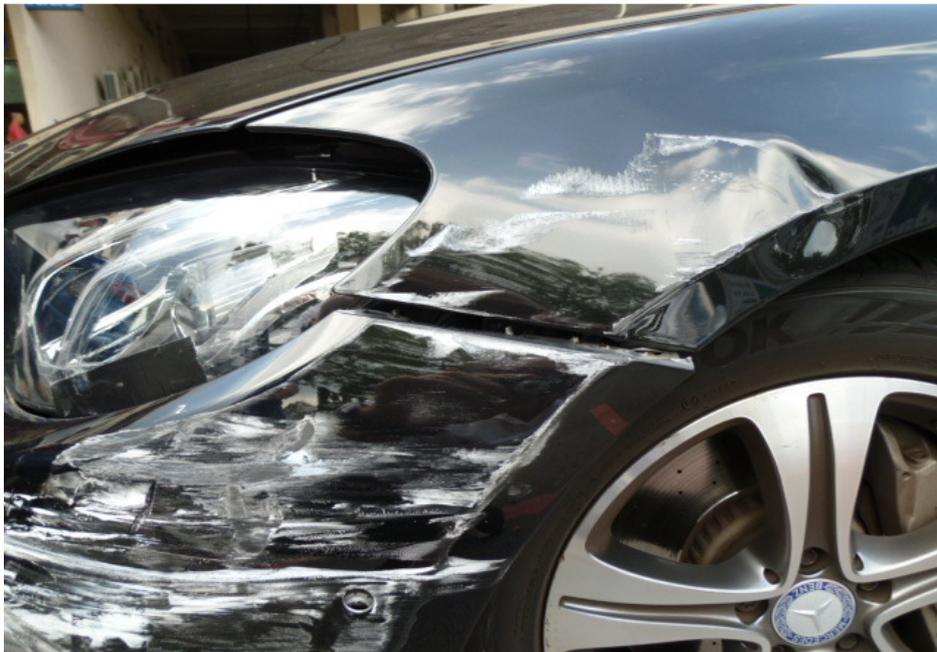
24. The distinctively shaped indentation was clearly caused by an object that was on of similar type of shape. For this case, the Mercedes had sustained damage that was confined to a single area, which was at its left front body. The shape of the body panel and/or part fitted at the left front body of the Mercedes that could have impacted the front right door of the Honda causing the distinctively shaped indentation, was the trailing side of the Mercedes's front left wheel rim, which corresponds to a "C" like shape. The front left wheel of the Mercedes coming into contact with the area where the distinctively shaped indentation was formed is also supported by the black grazed marks, which corresponds to tyre marks. See 9 -12 below.

**Photo 10** shows the damage to the Mercedes as seen in the photographs that were attached in the Singapore Accident Statement of the Mercedes. The damage to the Mercedes was confined to its left front body.

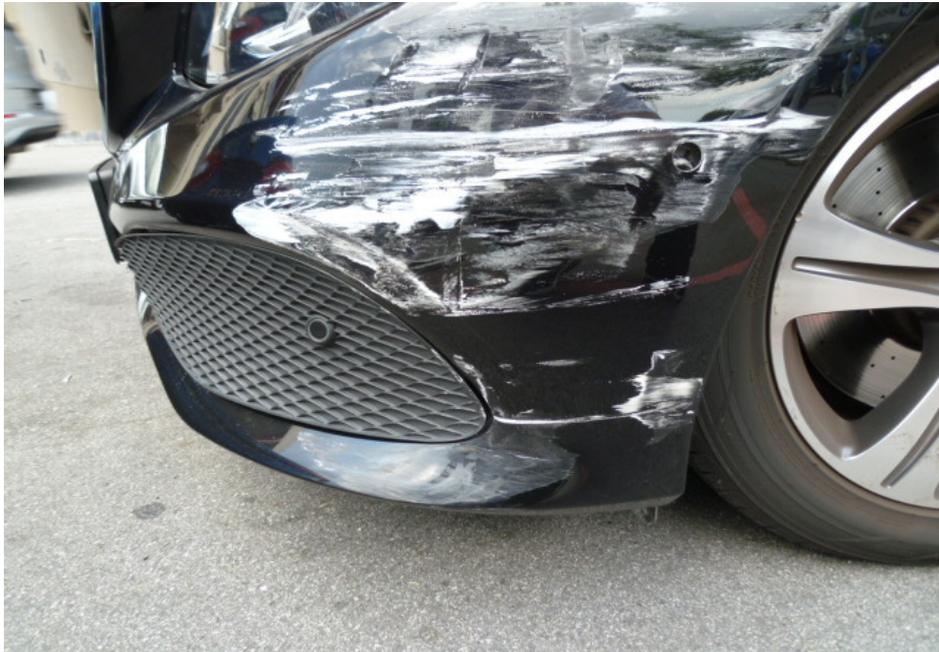
**Photo 11** shows the damage to the Mercedes as seen in the photographs that were attached in the Singapore Accident Statement of the Mercedes. The damage to the Mercedes was confined to its left front body.

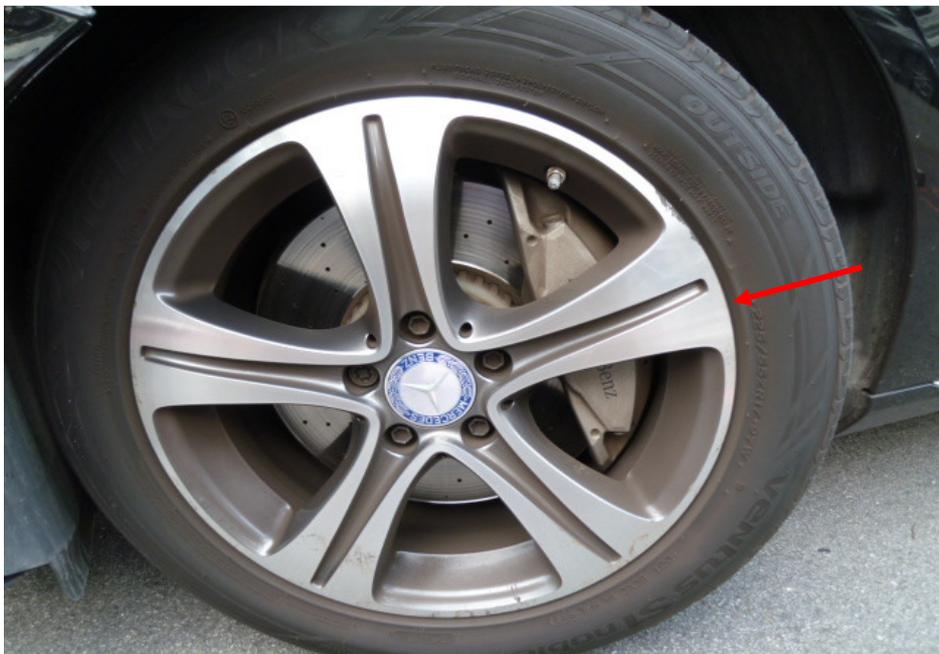
**Photo 12** shows front left wheel rim of the Mercedes as seen in the photographs that were attached in the Singapore Accident Statement of the Mercedes. The damage to the Mercedes was confined to its left front body. The only body panel and/or part fitted at the left front body of the Mercedes that could have impacted the front right door of the Honda causing the distinctively shaped indentation, was the trailing side (arrowed) of the Mercedes's front left wheel rim, which corresponds to a "C" like shape.

25. Under normal circumstance, the wheels of a motor car will sit behind the outer edges of the fenders and will not protrude out from the body of the motor car. For this case, in order for the trailing side of the Mercedes's front left wheel rim to come into direct contact with the front right door of the Honda, it would have to protrude out from the front left fender (body) of the Mercedes. For the trailing side to protrude out, the front left wheel would have to be turned towards the right. In other words, the front wheels of the Mercedes were not in a straight-ahead position at the time of contact with the front right door of the Honda.
