Report No: 0706-18-N51

## ACCIDENT VEHICLE SURVEY REPORT

| Vehicle Reg No.: | SLN4634D | Odometer: | 16492km |

## VEHICLE DAMAGE INSPECTION REPORT

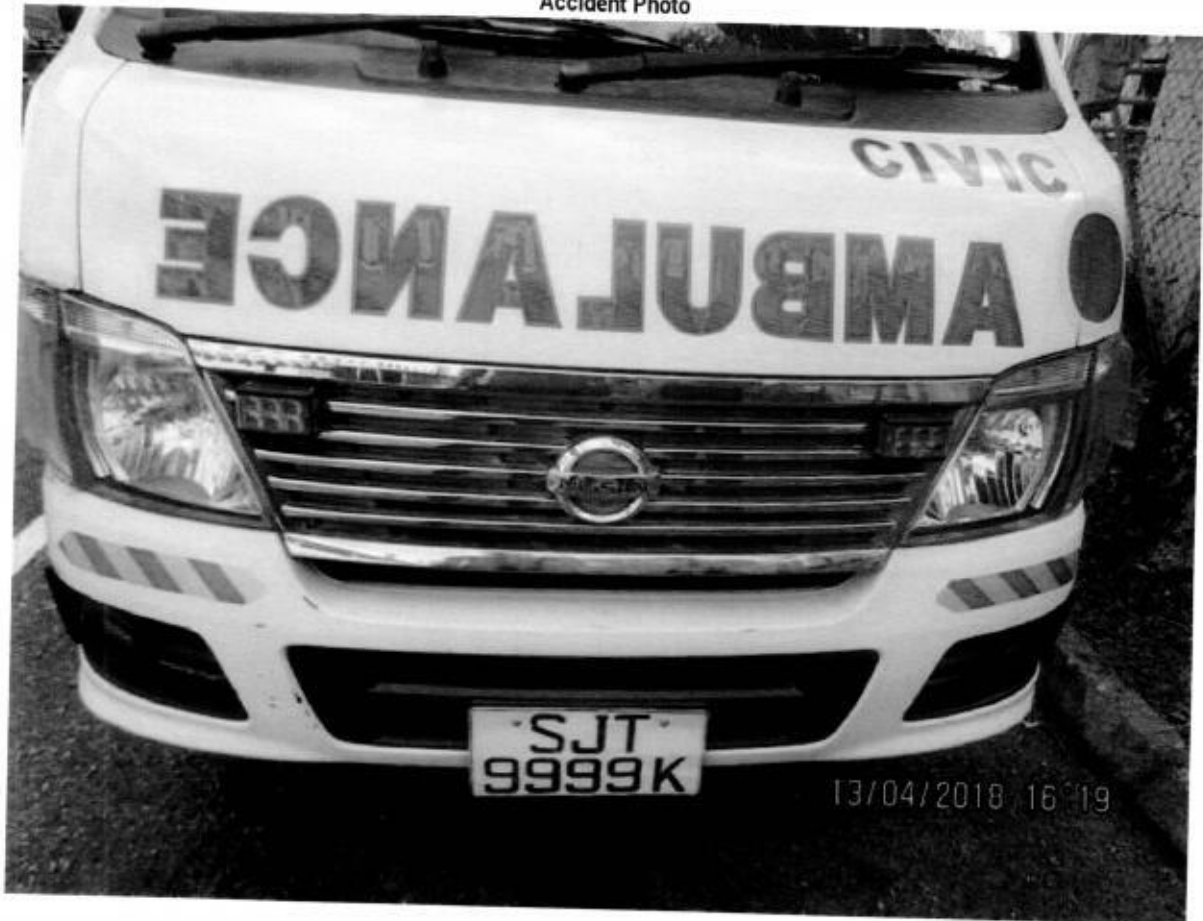
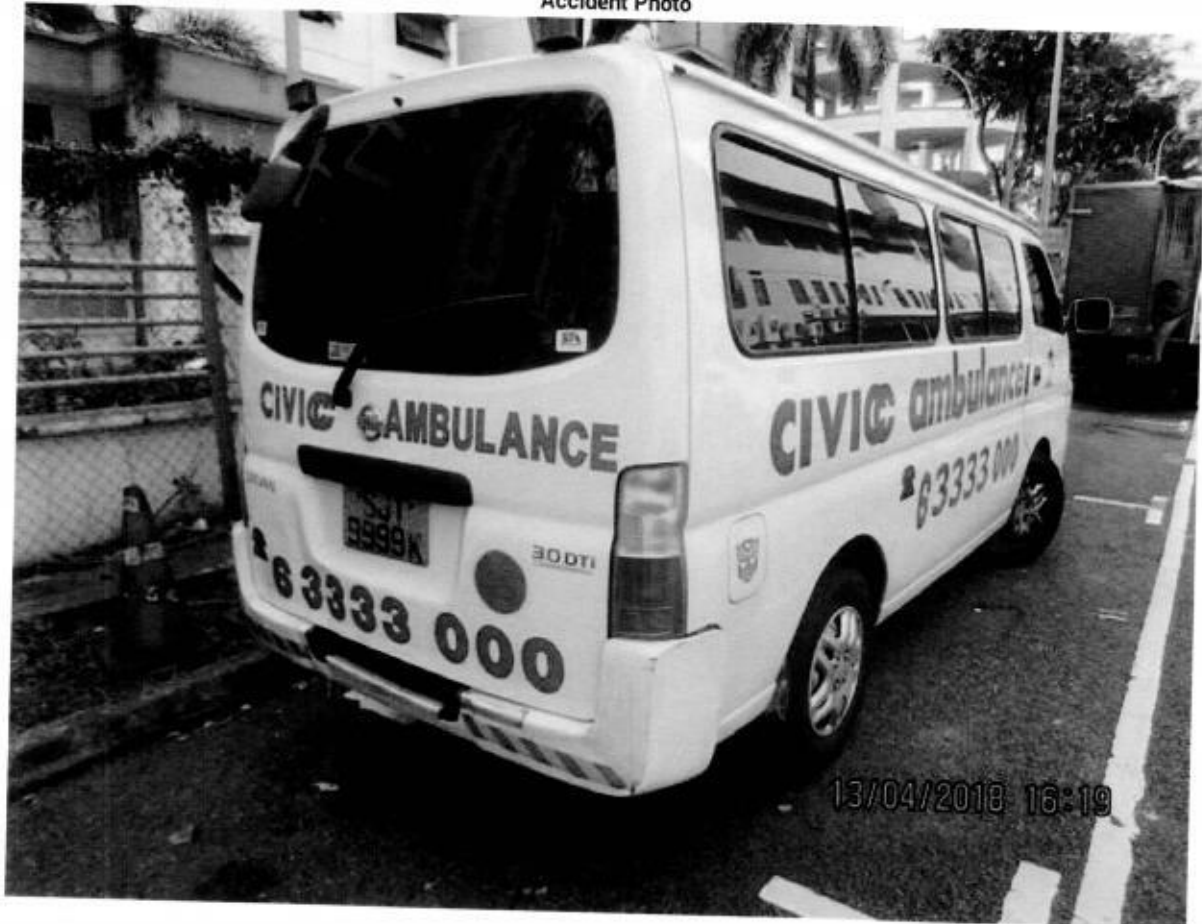
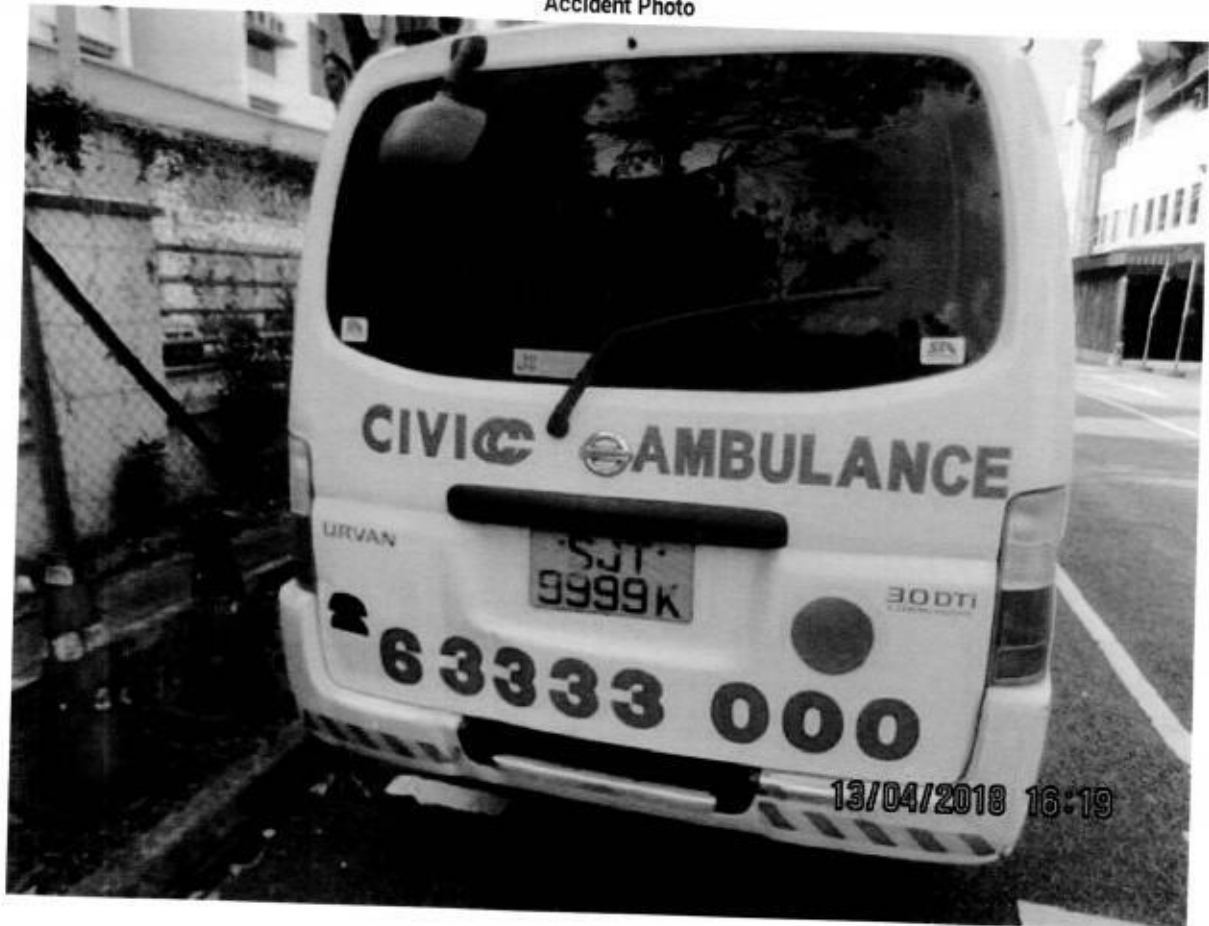
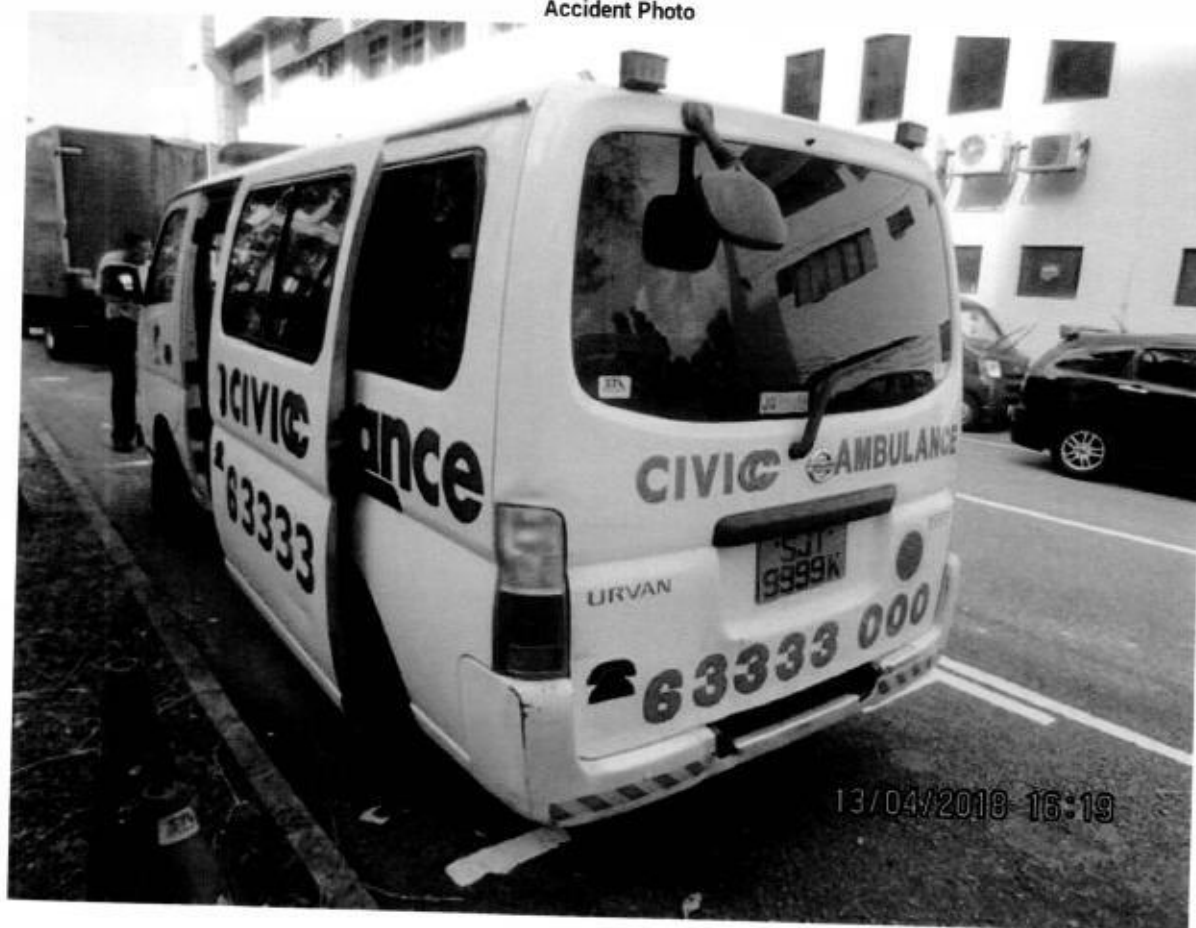
Accident Photo

Impact on the rear portion.
