Your Ref: G0056197
Our Ref : CI/AVI19004628/N

1 March 2019

TECHNICAL INVESTIGATION REPORT OF FIRE INCIDENT INVOLVING THE INSURED VEHICLE SGT 8291K ON 26 FEBRUARY 2019

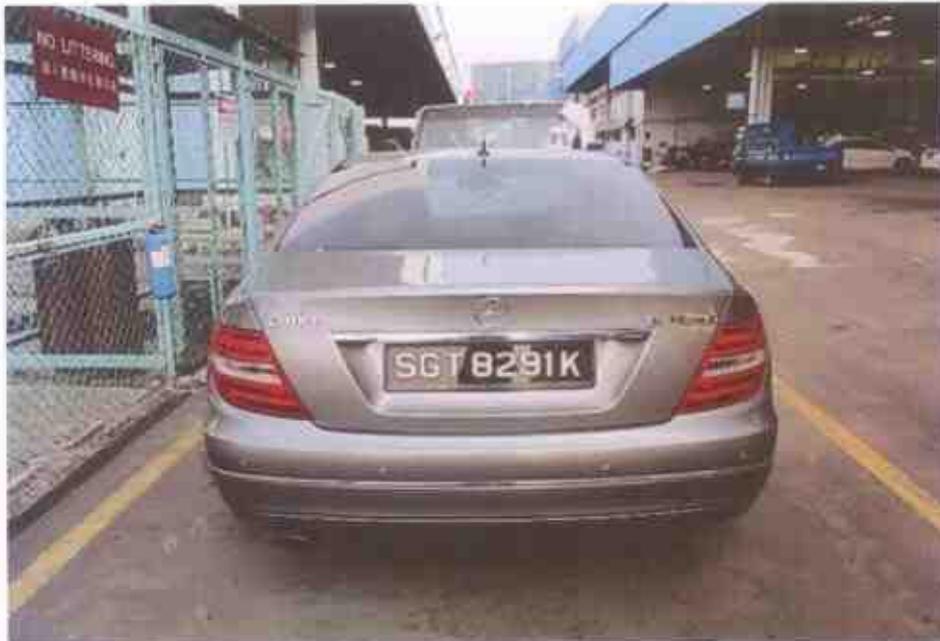
Photo 1 shows the rear view of the Insured Vehicle. The rear portion of the Insured Vehicle was observed to be relatively unaffected by the fire.

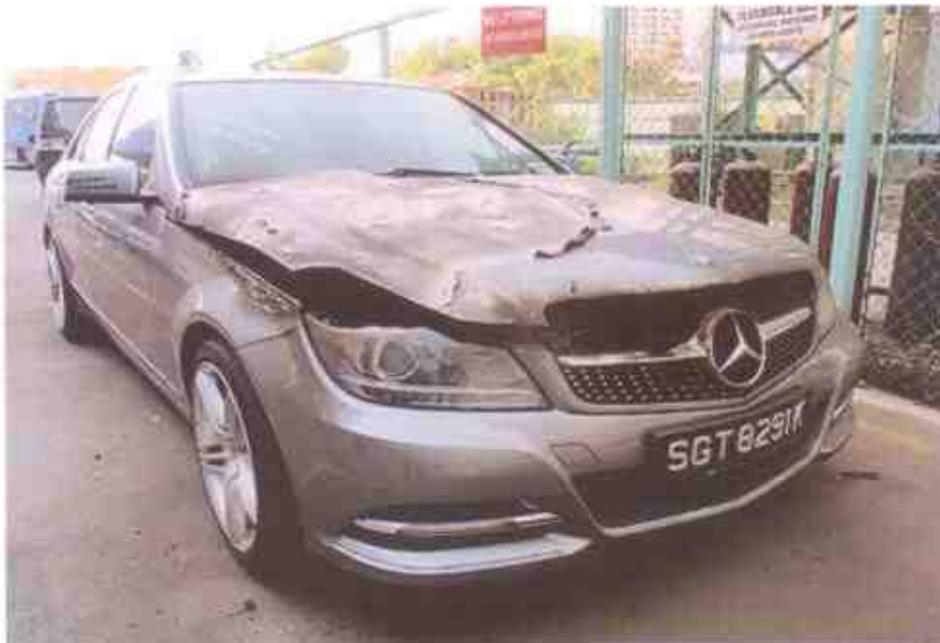
Photo 2 shows the general view of the right portion of the Insured Vehicle at the time of our inspection. The exterior body of the Insured Vehicle had sustained visible fire damage. This included its front windscreen, front bonnet, front bumper, right front panel and right headlight.

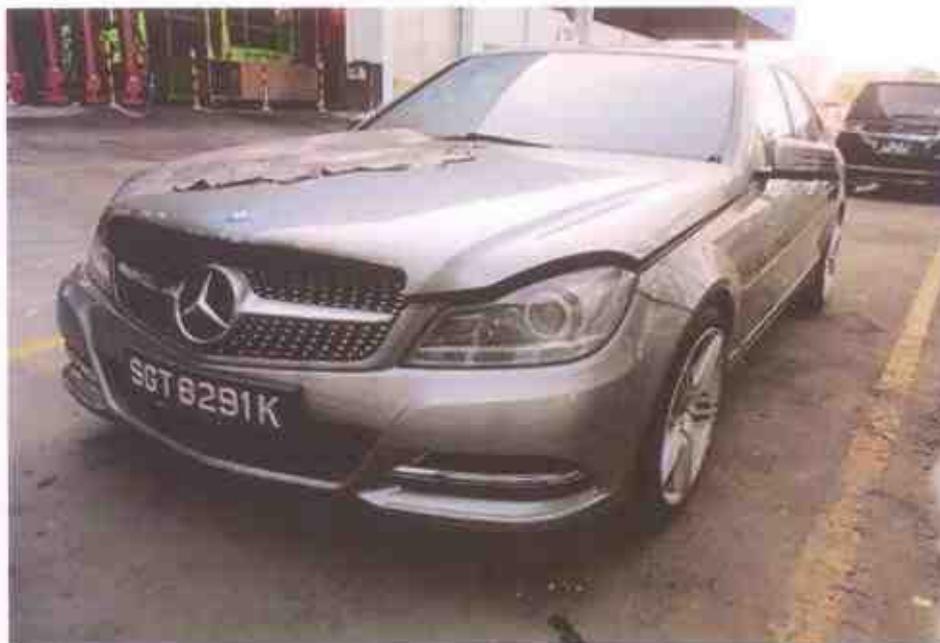
Photo 3 shows the general view of the left portion of the Insured Vehicle at the time of our inspection. The exterior body of the Insured Vehicle had sustained visible fire damage. This included its front windscreen, front bonnet, left headlight, front bumper and left front panel.

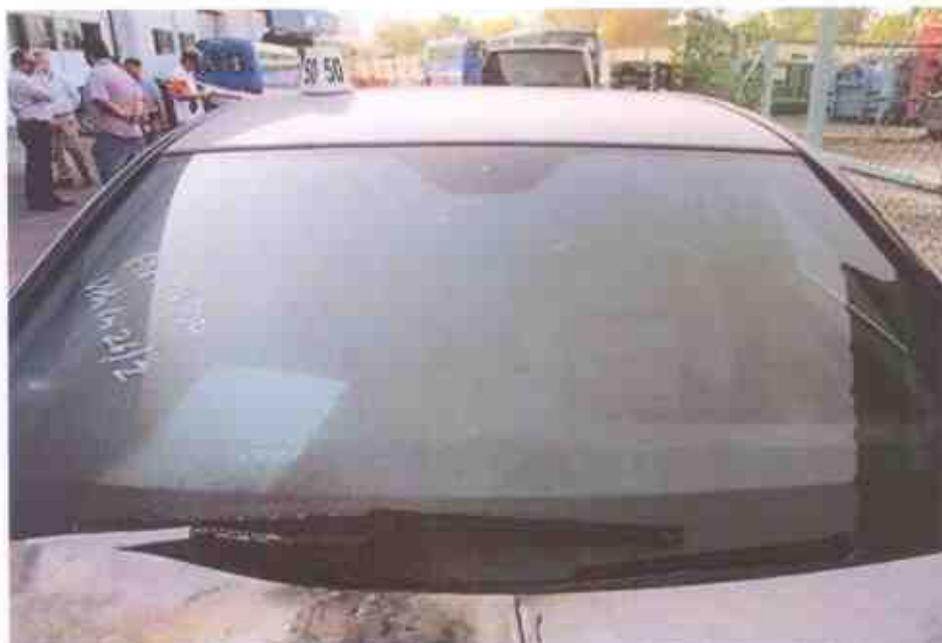
Photo 4 shows a closer view of the front windscreen of the Insured Vehicle at the time of our inspection. The front windscreen had sustained significant fire damage.

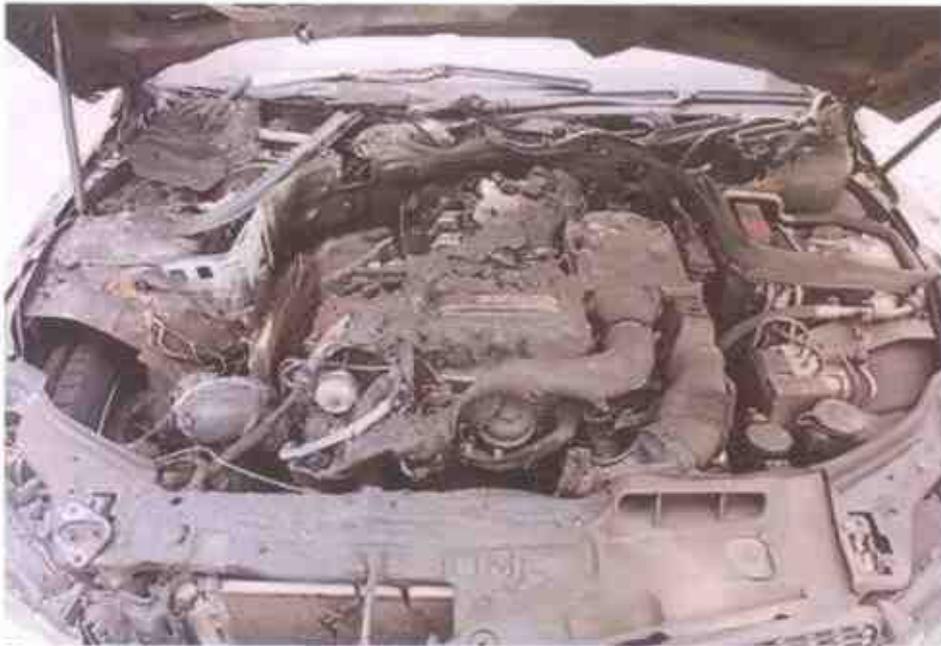
Photo 5 shows a general view of the engine compartment of the Insured Vehicle at the time of our inspection. Most of the components inside the engine compartment were found to be severely burnt and/or melted as a result of the fire.

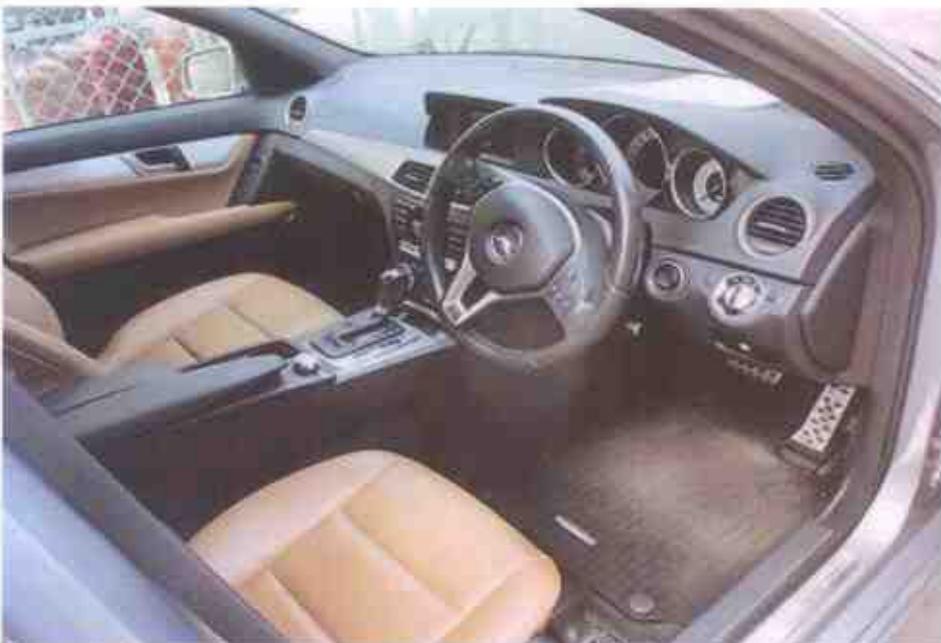
Photo 6 shows the interior compartment of the Insured Vehicle, which was observed to be relatively unaffected by the fire.

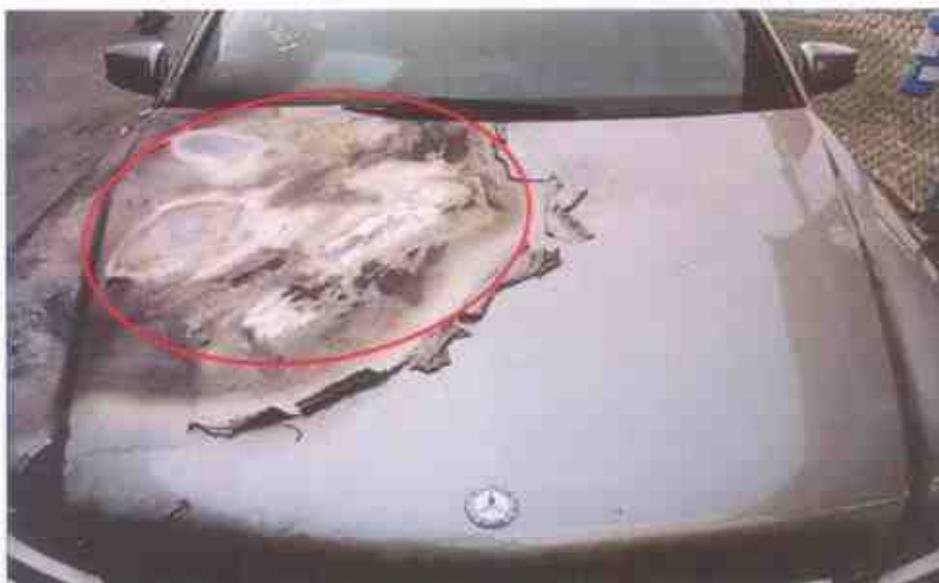
8. For this particular case, the fire appears to have originated within the engine compartment of the Insured Vehicle, somewhere around the right rear portion of the engine compartment. This can be determined from the burn pattern and the high heat intensity burn marks (whitish burn marks) found on the right rear portion of the bonnet of the Insured Vehicle and also the rust that had developed on the underside of the front bonnet, at the right rear portion.

9. The whitish burn marks are a result of exposure to prolonged heat intensity. Rust would normally start to develop around these areas soon after a fire as prolonged exposure to high heat intensity usually causes steel/metal material body parts to be exposed to natural environmental condition. The rust that had developed on the underside of the front bonnet, around the right rear portion, is an indication that the right rear portion of the engine compartment had sustained exposure to prolonged high heat intensity. See photos 7 & 8 below.

Photo 7 shows the burn pattern and whitish burn marks that were found on the right rear portion of the front bonnet of the Insured Vehicle (circled). Such whitish burn marks are a result of exposure to prolonged heat intensity, which may indicate where the fire had started. Rust would also begin to develop on these areas soon after the fire.

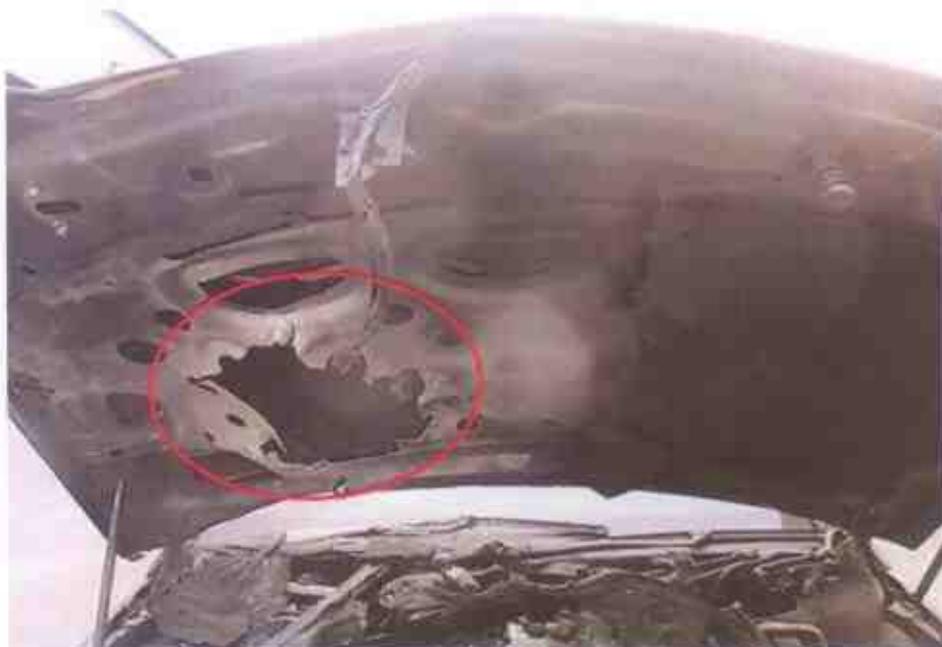
Photo 8 shows the rust that had developed on the underside of the front bonnet, around the right rear portion (circled). The development of rust is an indication that this area was subjected to prolonged exposure to high heat intensity, which had caused the steel/metal material of the front bonnet to be exposed to natural environmental condition. Hence the fire to the Insured Vehicle can be determined to have originated towards the right rear portion of the engine compartment.

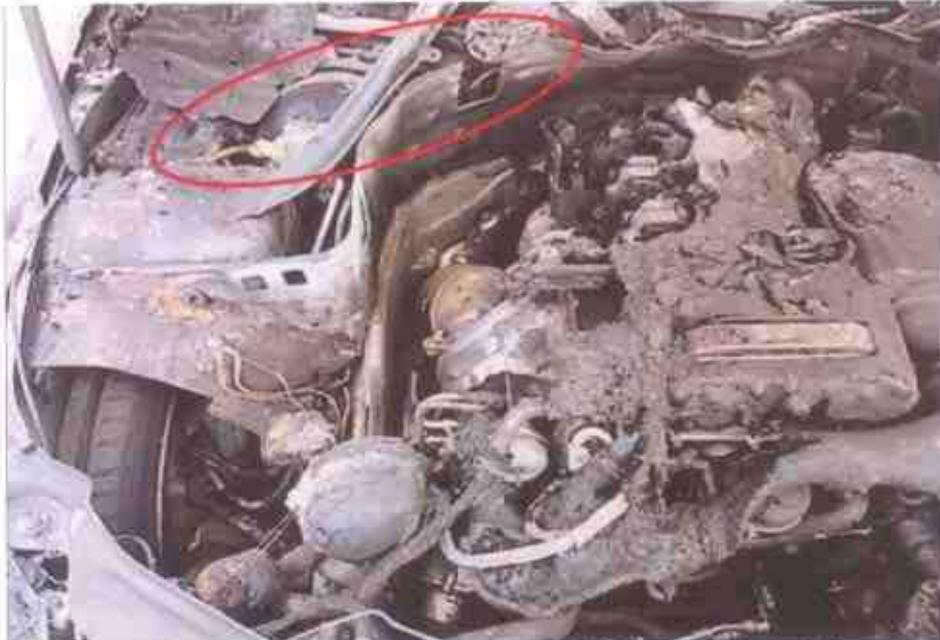
10. Upon closer examination of the right rear portion of the engine compartment, which was where the fire to the Insured Vehicle had likely started, we had found traces of greenish residue on several stretches of burnt wirings. The presence of greenish residue indicates internal heating of copper wires, a sign of an electrical short circuit occurring. The greenish residue is normally left behind from oxidation as a result of chemical reaction involving the copper wires. This physical evidence would then appear to suggest that the cause of fire to the Insured Vehicle could have possibly been due to electrical in nature. See photos 9 - 12 below.

Photo 9 shows the burnt wirings around the right rear portion of the engine compartment (circled), which is in the immediate vicinity where the fire to the Insured Vehicle had likely started.

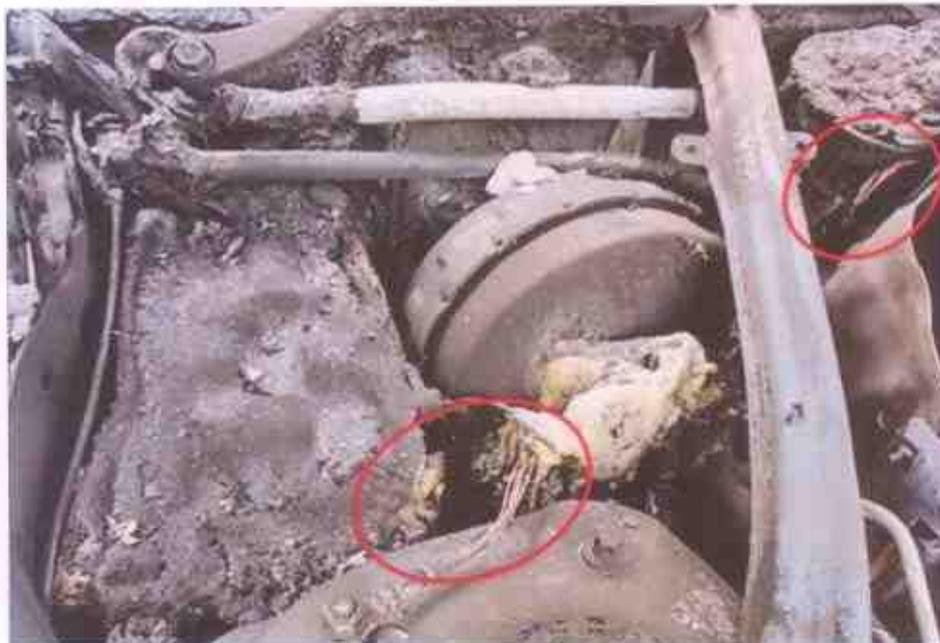
Photo 10 shows a closer view of the burnt wirings around the right rear portion of the engine compartment, which is in the immediate vicinity where the fire to the Insured Vehicle had likely started. We noticed greenish residue on several stretches of burnt wirings (circled). The presence of greenish residue indicates internal heating of copper wires, a sign of an electrical short circuit occurring. The greenish residue is normally left behind from oxidation as a result of chemical reaction involving the copper wires.

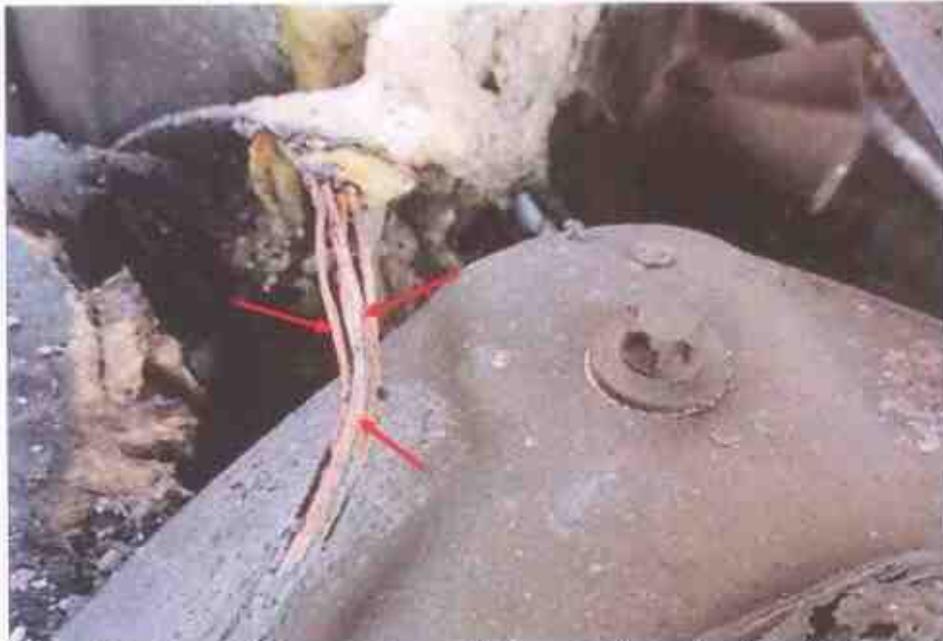
Photo 11 shows a close up view of the greenish residue found on several stretches of burnt wirings (red arrows). The presence of such greenish residue suggests occurrence of an electrical short circuit.

25. The possibility of the fire being due to electrical in nature would then seem more likely given that engine overheating and external factors would both seem unlikely. The fire being due to electrical nature is also supported by the condition of the wirings that were found in the engine compartment of the Insured Vehicle, which was earlier discussed in paragraph 10 above.

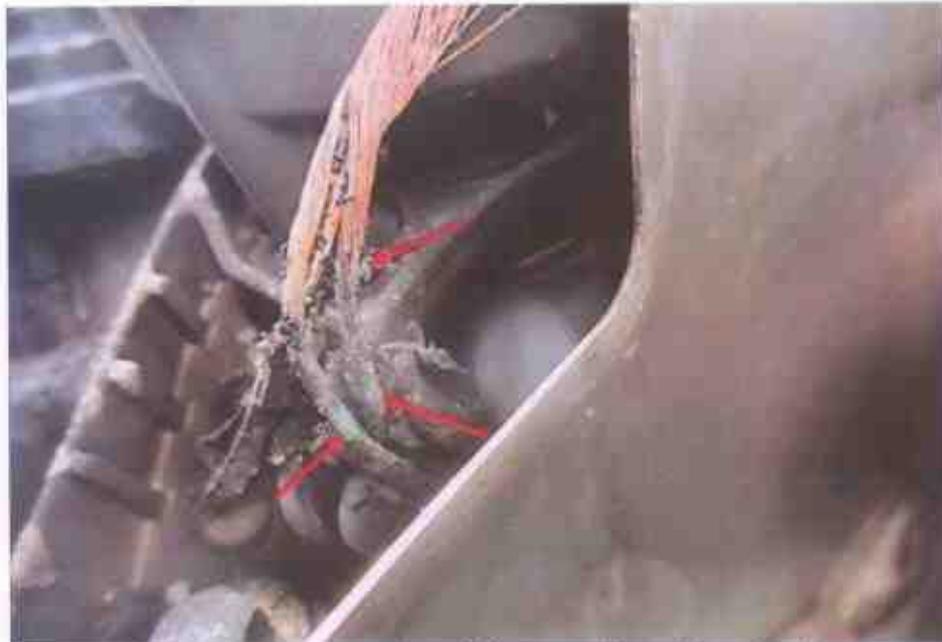
Photo 12 shows a close up view of the greenish residue found on several stretches of burnt wirings (red arrows). The presence of such greenish residue suggests occurrence of an electrical short circuit.

27. Having investigated and technically analysed the damages to the Insured Vehicle, we are of the view that the cause of fire to the Insured Vehicle was of electrical in nature. For this particular case, the fire had originated along the wirings inside the engine compartment, somewhere around the right rear portion. The wirings were original factory wirings of the Insured Vehicle.
28. We did not find any evidence which had suggested that the cause of fire to the Insured Vehicle was due to poor maintenance and/or recurring electrical problem.
29. There were no modification(s) or additional electronic and/or electrical component(s) fitted on the Insured Vehicle at the time of our inspection of the Insured Vehicle.

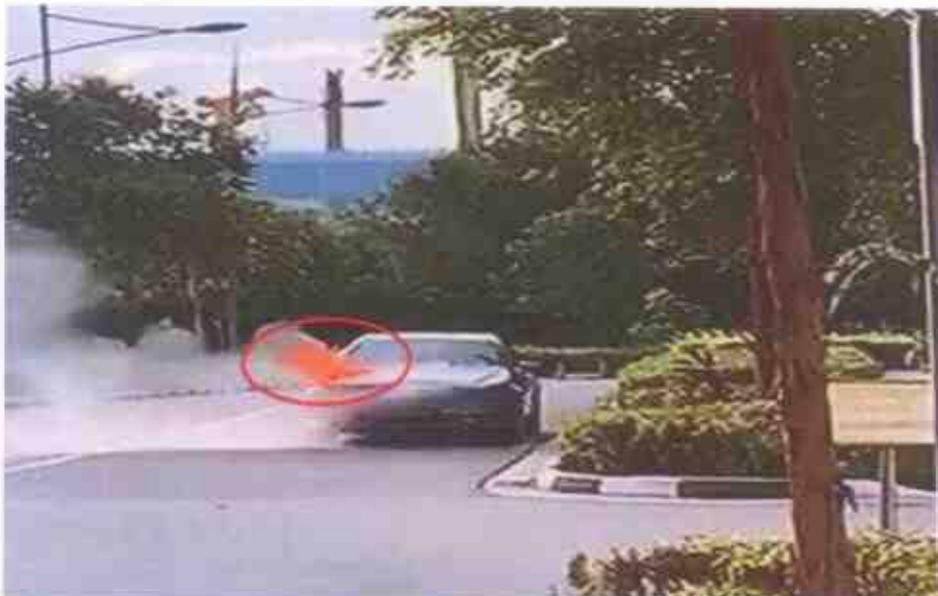
Photo 13 shows the Insured Vehicle on fire before the arrival of the SCDF. In general, the information that could be gathered from this photograph had corresponded to the events that were related to us by Mr Ng which is the white smoke and subsequently the fire had started from the right rear portion of the engine compartment (circled).

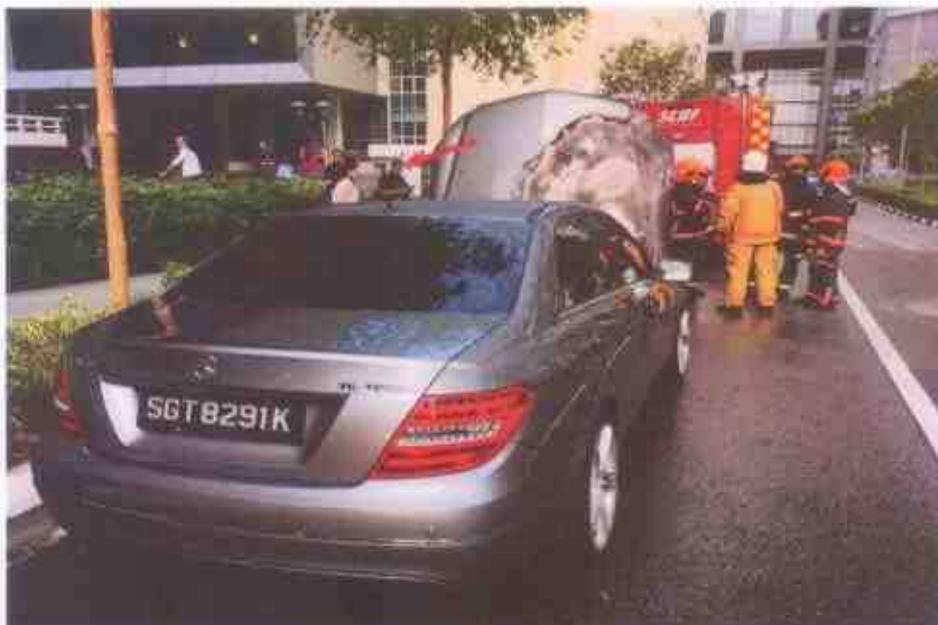
Photo 14 shows the SCDF having just put out the fire on the Insured Vehicle. In general, the information that could be gathered from this photograph had corresponded to the events that were related to us by Mr Ng which is the police were also at the incident scene (arrowed).

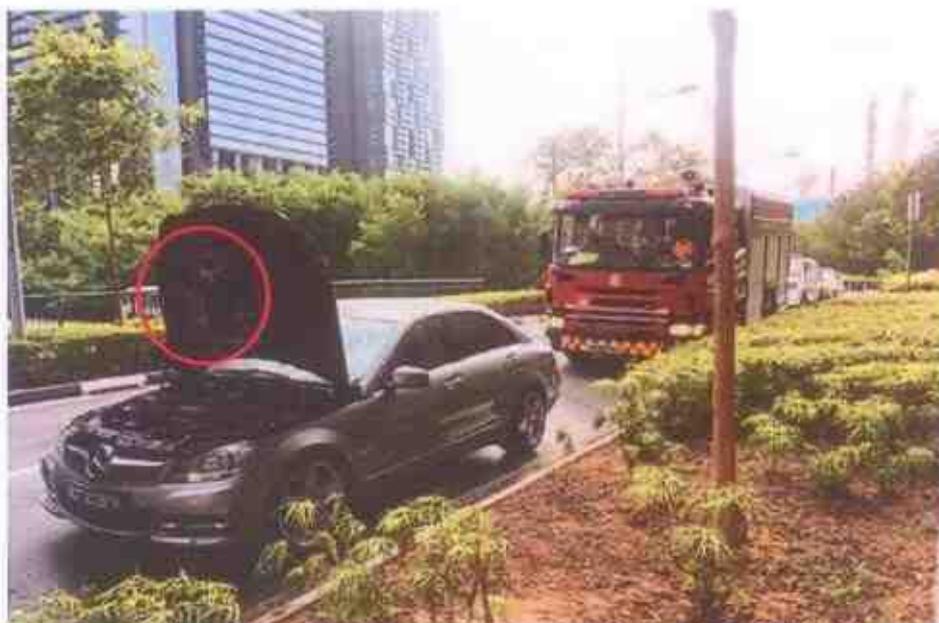
Photo 15 shows the Insured Vehicle at the incident scene after the fire was extinguished. In general, the information that could be gathered from this photograph had corresponded to the events that were related to us by Mr Ng. Whitish burn marks were observed on the front bonnet, at the right rear portion (circled) which indicates that the fire had started in the right rear portion of the engine compartment.
