Claim Reference: TP-GBA 5655Z
Assessment number: 70314
Version: 1810
Date calculated: 04/08/2019 10:30 AM

Full Report
Registration: SGX 7980R
Printed: 08/04/2019 10:31 AM

Vehicle			
Manufacturer:	TOYOTA		
Model:	RUSH (F700)		
Sub Model:	BASE MODEL		
Model Sheet Number:	70 R1 01		
Registration:	SGX 7980R		
VIN number:			
Odometer:			
Model Specs			
FROM 08/2007	AIR CONDITIONING	FOG LAMPS	1.5 LTR 80KW
TWO COAT METALLIC	PREPARE OFF VEHICLE

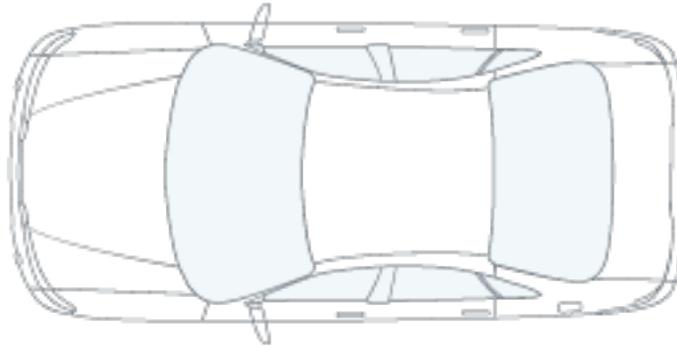
Damage Areas

All
Underbody

Code	Description	Time Base 10 WU/h	Price = 42.00 SGD/h	
			WU	Price SGD
642091)	R + R REAR DOOR INCLUDES: REAR DOOR TRIM AND REQUIRED ATTACHED REMOVE AND REFIT		5.0	21.00
642091)	RENEW REAR DOOR (REMOVED)		27.0	113.40
743111	R + R L/UPPER C-PILLAR TRIM		6.0	25.20
743111	R + R R/UPPER C-PILLAR TRIM		6.0	25.20
645011)	R + R LEFT REAR SIDE WINDOW GLASS		9.0	37.80
645011)	R + R RIGHT REAR SIDE WINDOW GLASS		9.0	37.80
520051)	R + R REAR BUMPER		5.0	21.00
520051)	RENEW REAR BUMPER (REMOVED)		1.0	4.20
	INCLUDES: R + R NECESSARY ATTACHED PARTS			
2711	REAR PANEL REPAIR		15.0*	63.00
